**विषय: Report of Standing Committee of Experts on Failure of 220 kV and above Voltage Class Substation Equipment failed between July 2023 to December 2024-reg.**

**REPORT OF STANDING COMMITTEE OF EXPERTS ON FAILURE OF 220 kV &  
ABOVE VOLTAGE CLASS SUBSTATION EQUIPMENT  
(July 2023 - Dec 2024)**

**GOVERNMENT OF INDIA  
MINISTRY OF POWER  
CENTRAL ELECTRICITY AUTHORITY**

**May 2025**

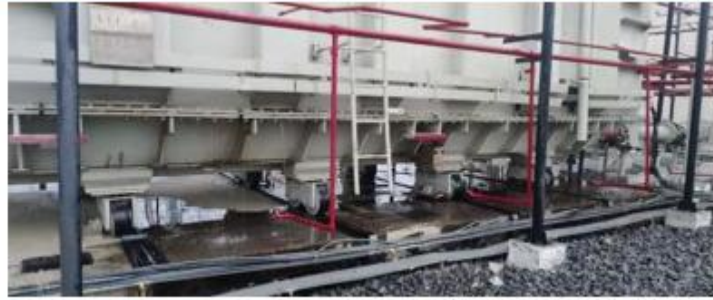
Bulging of tank and crack on stiffener toward B-phase observed after tripping of the Transformer. It resulted in oil drain from Transformer.

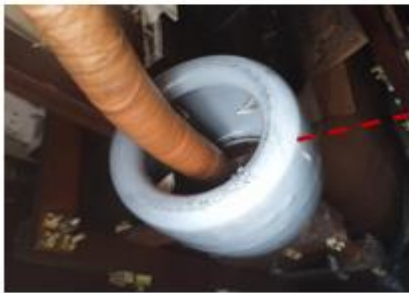
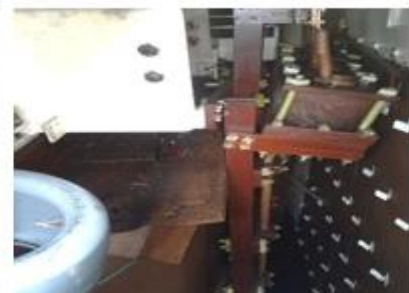
B-phase 400 kV HV Bushing shield found detached and shield mount lugs broken

NCT mounting support found broken

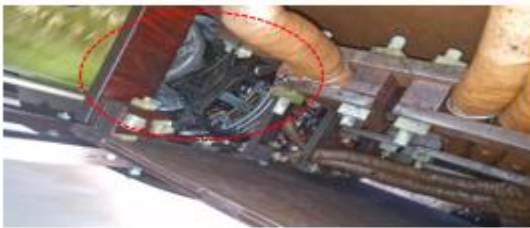
- B and Y-phase OLTC found damaged;
- B-phase selector switch mounting lug found broken;
- B-Phase selector switch displaced its mounting position;
- Y-Phase selector switch mounting lug also found broken.

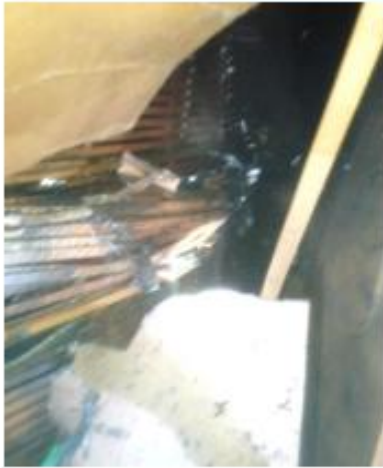
Bulging observed on B-phase HV winding conductors

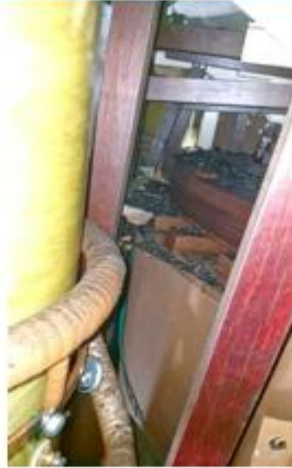
Burn Marks on Insulations Paper  
Carbon deposition observed on all over the active part

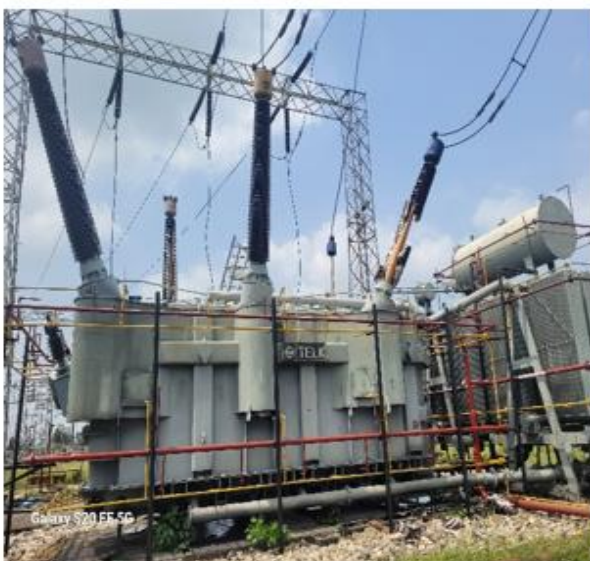
400kV B-Phase Bushing damaged

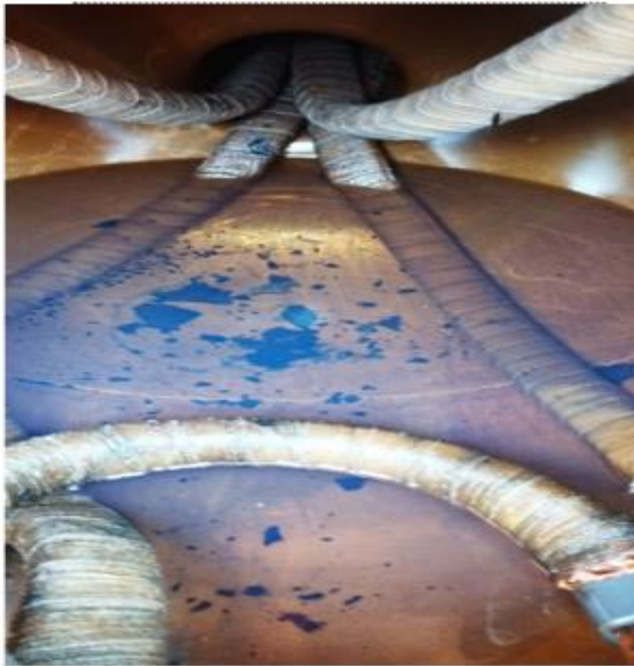
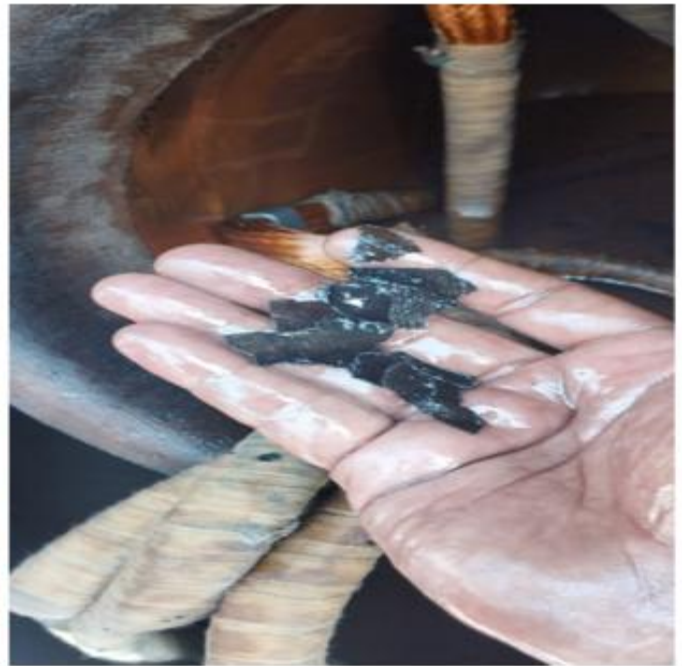
**Carbon & burnt paper on Star winding Y1 Bushing winding lead take-out area**

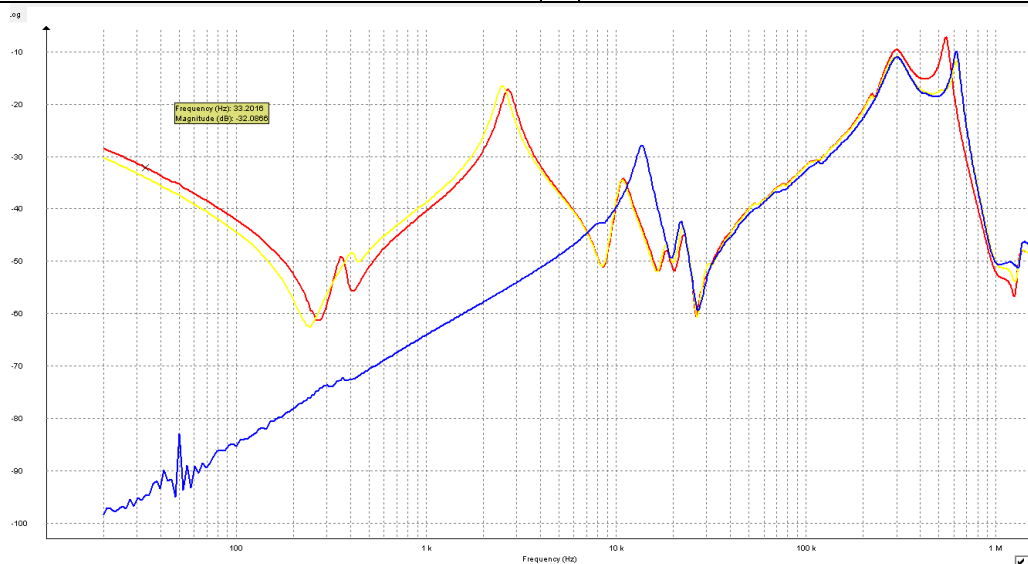
| In SFRA Signature (HV-IV open circuit), B phase open circuit signature is flat. | | | |

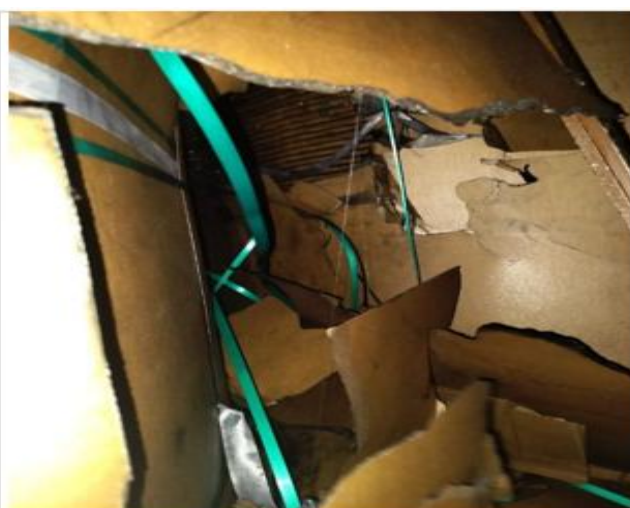
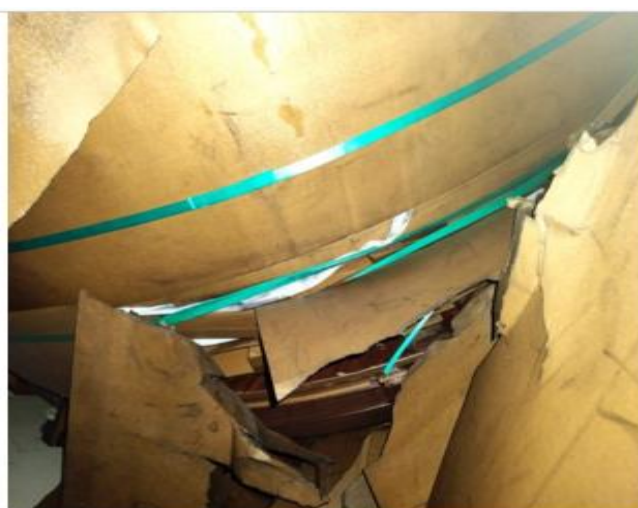
**Broken pressboard & barriers of series winding of Y & B Phase**

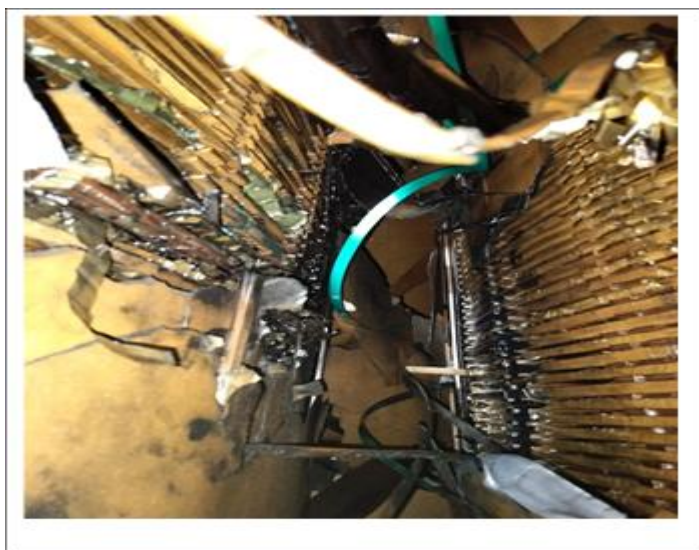
**Y-phase to B-phase Series winding fault.**

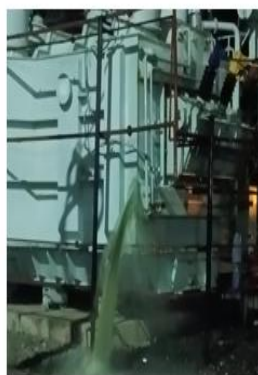
Oil gushed out

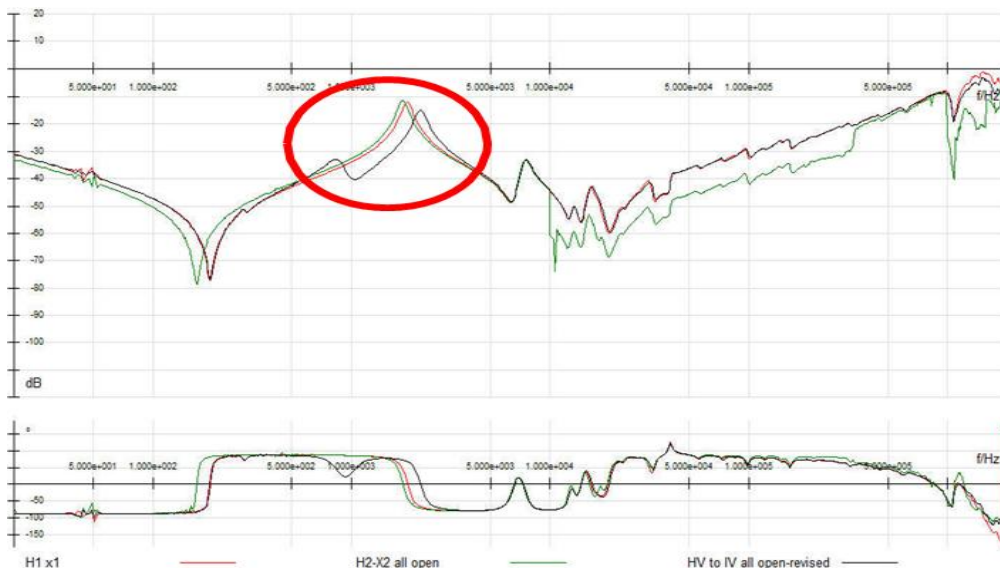
HV to IV all open condition, deviation was observed in B-ph of HV to IV at 1 kHz to 5 kHz.

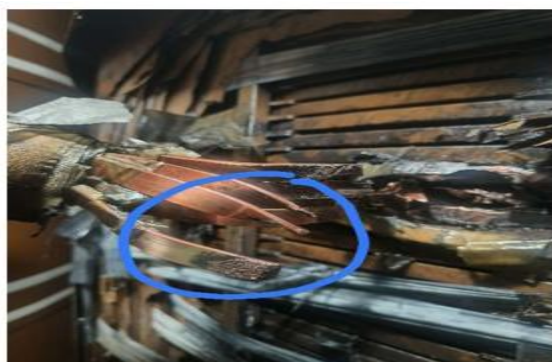
3nos conductor was found broken.

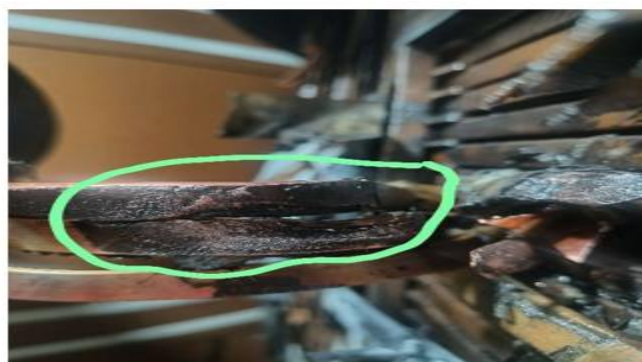
2 No's of winding conductors were melted

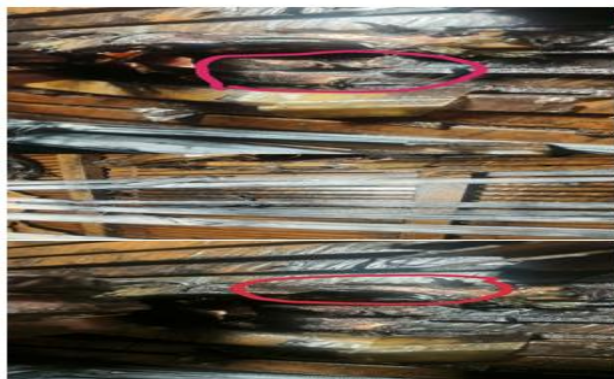
4No's disc layer conductor were found melted

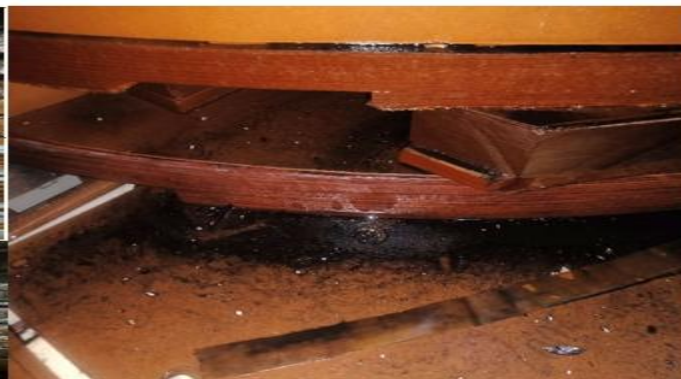
Black marks were observed on below the HV winding lead take off.

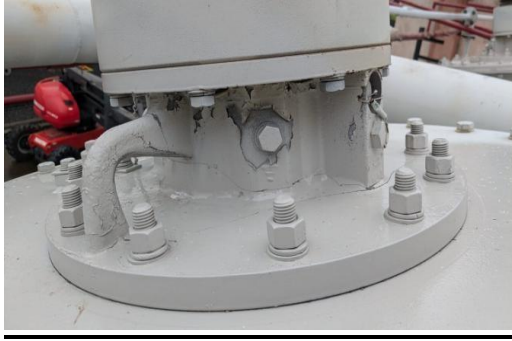
Crack in 220 kV -Phase bushing flange

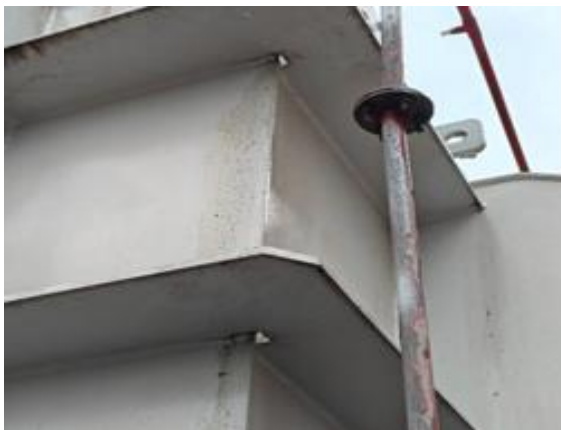
Cracks in HV side plate stiffeners welding side bottom near to B phase joints towards B Phase

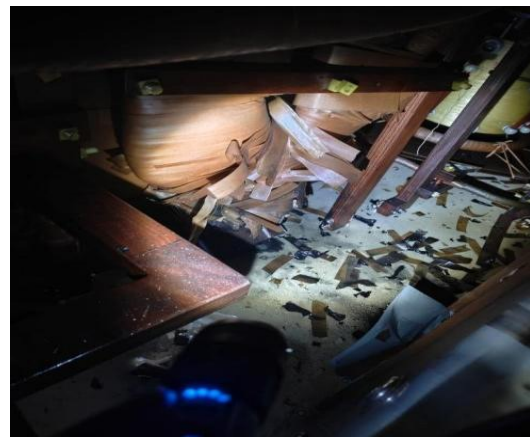
Burnt and carbonized crepe paper – IV

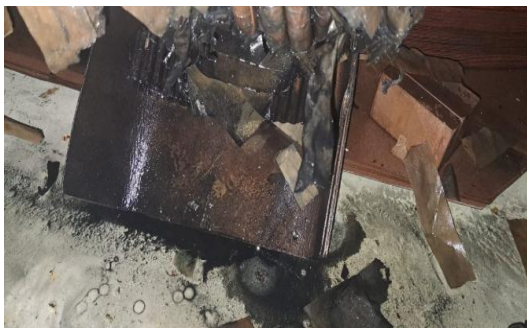
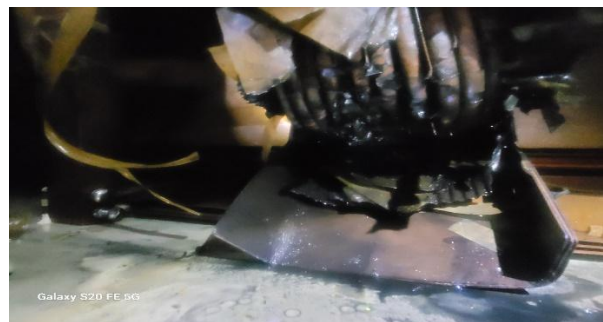
Flashover between B-phase tap lead and tank bottom

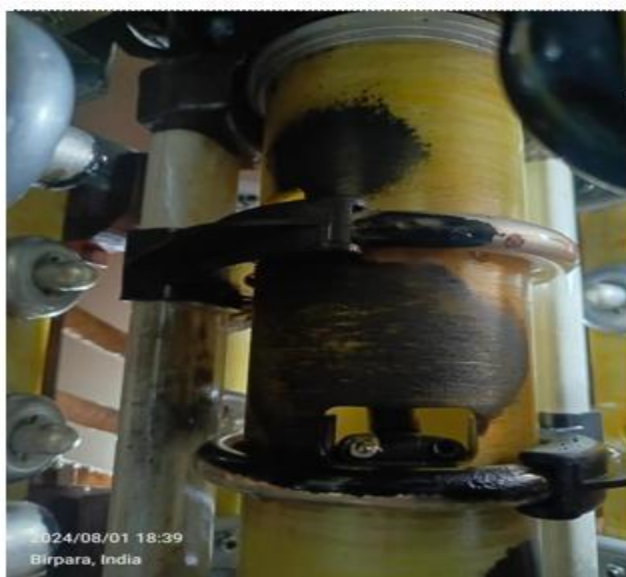
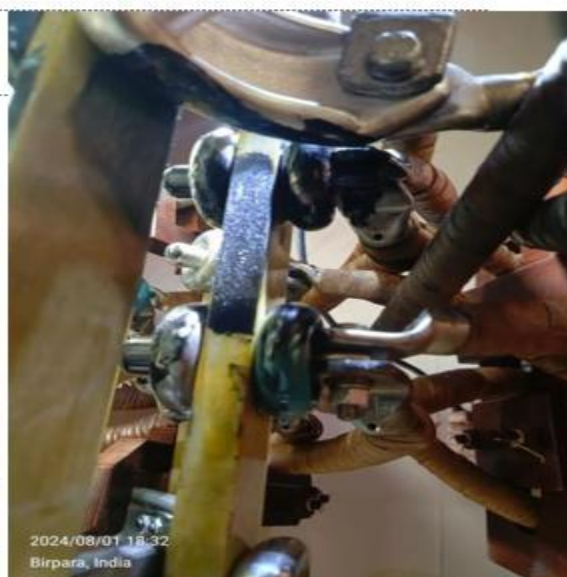
**Flash mark on Y-Ph OLTC selector switch**

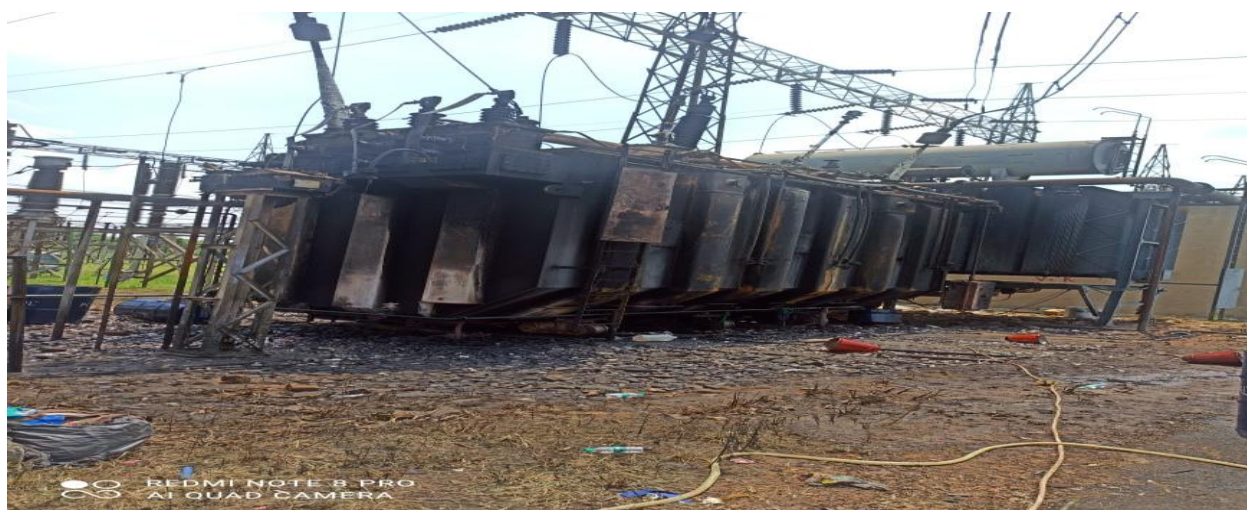
**BHEL make Transformer caught fire due to internal fault.**

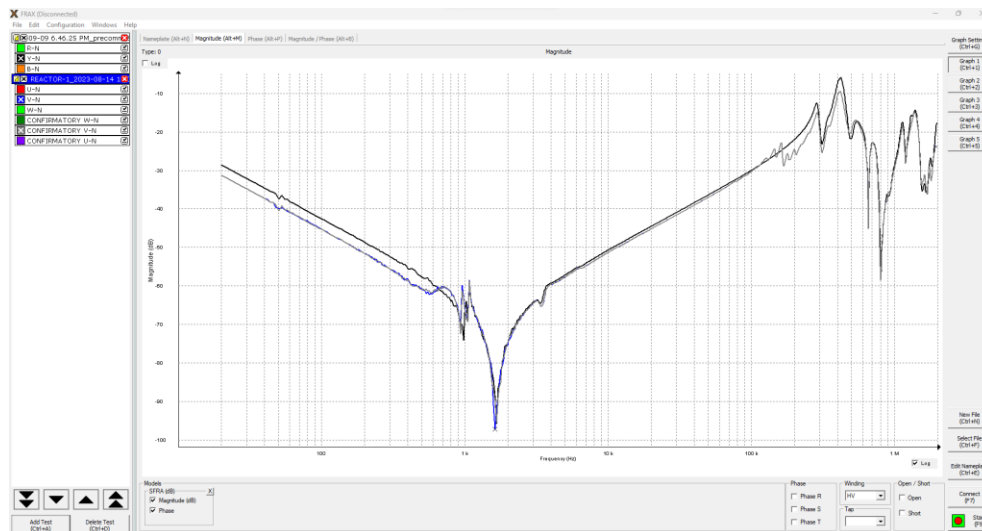
4) SFRA: Y Phase Pre-commissioning (09.09.2019) vs After fault.

Conclusion: Deviation is SFRA observed.

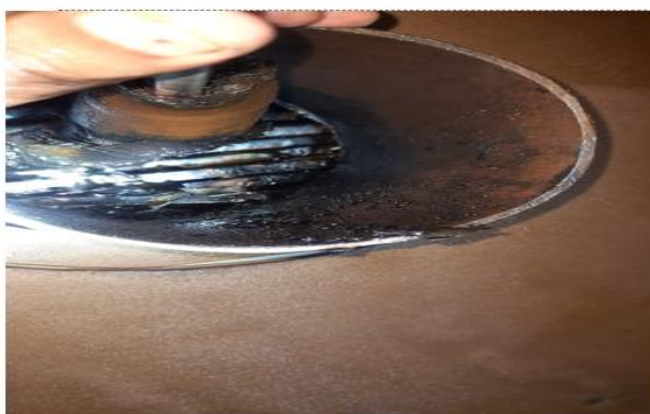
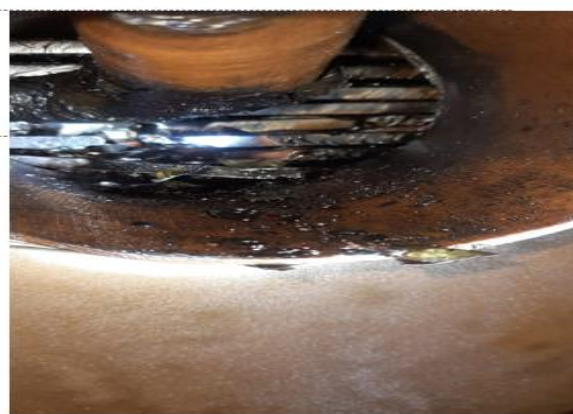
Damage at HV take-off point Y-Ph winding.

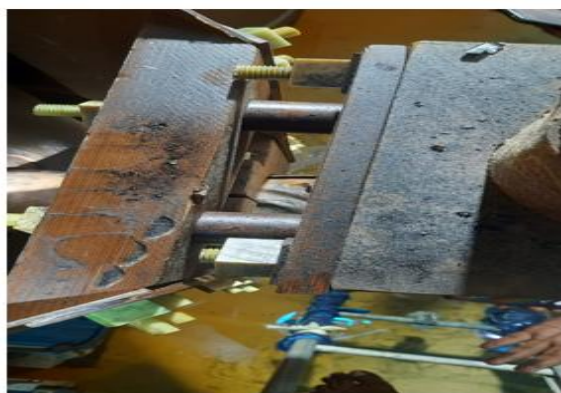
Carbon powder on lead exit support

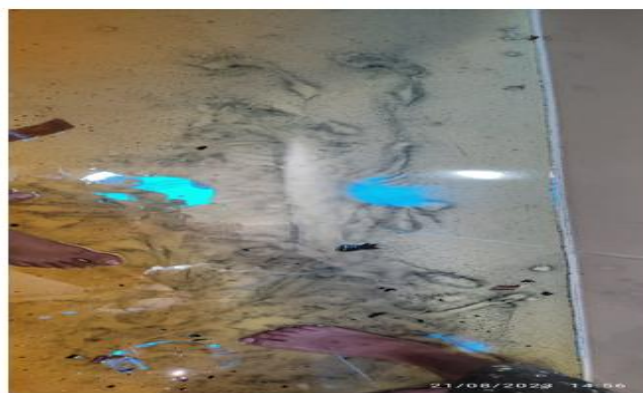
Carbon Powder on tank floor

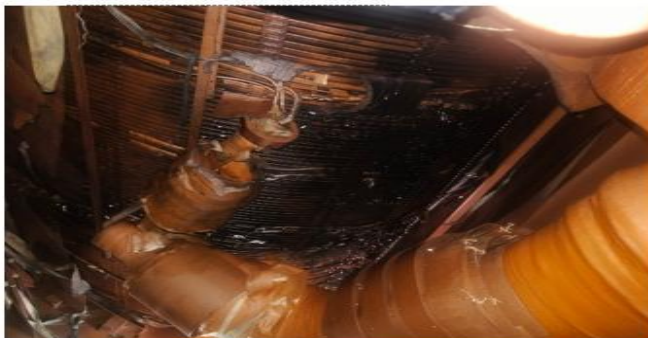
HV lead take out was found dislocated

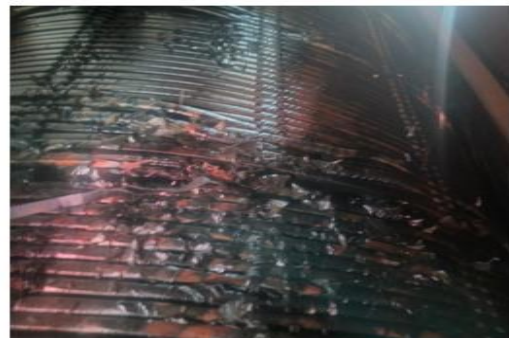
Hv winding discs were found severely burnt

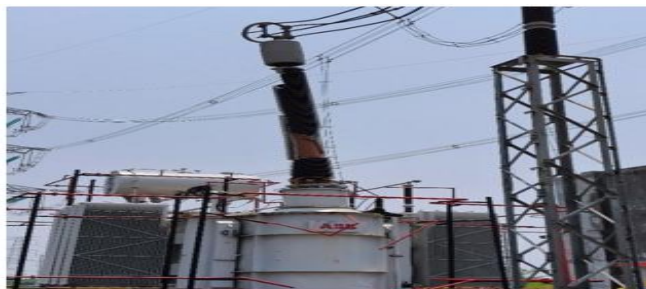
Physical damage of HV bushing

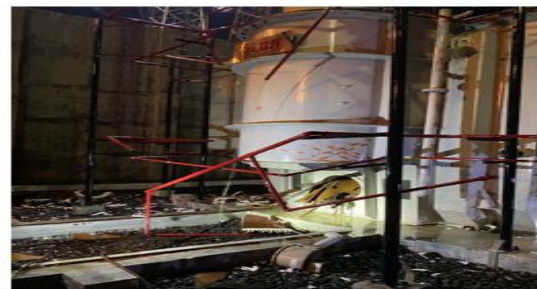
HV side inspection cover got busted and found 2mtrs away from the reactor. Also, pressboard and paper insulation were came out.

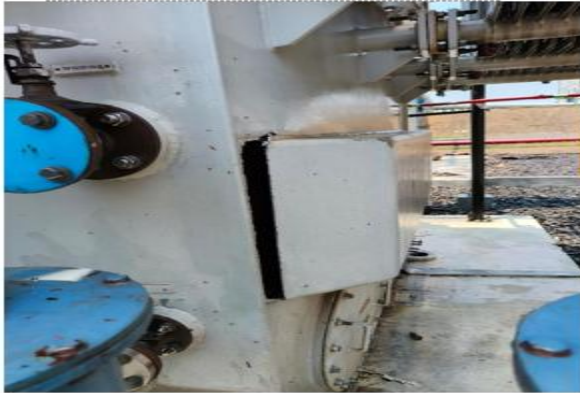
Main tank ruptured & cracks observed at stiffeners

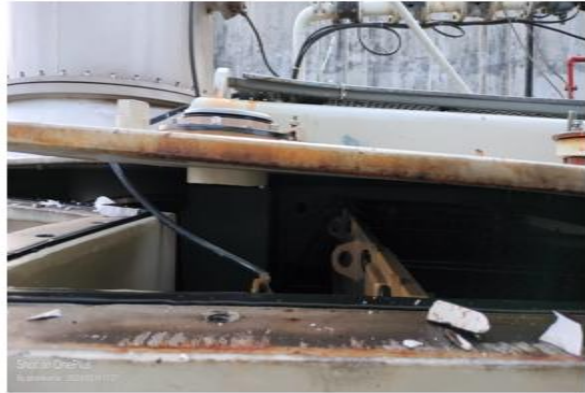
Top side main tank ruptured near HV bushing.
