**भारत सरकार/Government of India**  
**विद्युत मंत्रालय/Ministry of Power**  
**केन्द्रीय विद्युत प्राधिकरण/Central Electricity Authority**  
**विद्युत प्रणाली अभियांत्रिकी एवं प्रौद्योगिकी विकास प्रभाग**  
**Power System Engineering & Technology Development Division**

**विषय: Minutes of the Meeting of the Standing Committee of Experts to investigate the failure of 220 kV and above voltage level transmission line towers during the period of January 2026 to June 2026 -reg.**

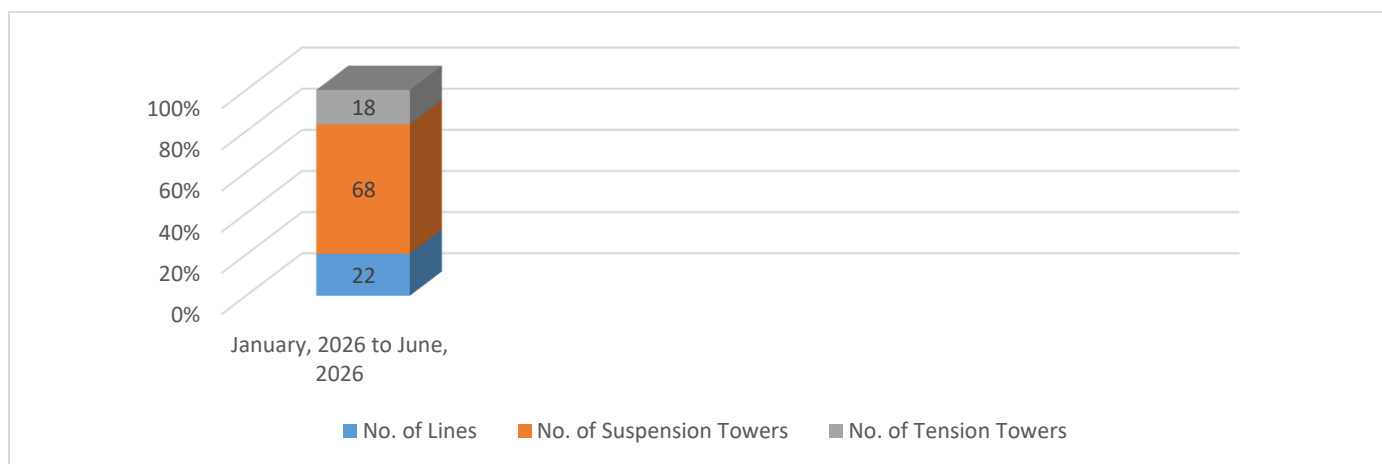
- b) The total number of incidences of failures of EHV Transmission Line Towers, and the Nos. of affected Tension type and Suspension type towers that have been reported to CEA for the period of January, 2026 to June, 2026 are indicated in the Fig. 1 given below.

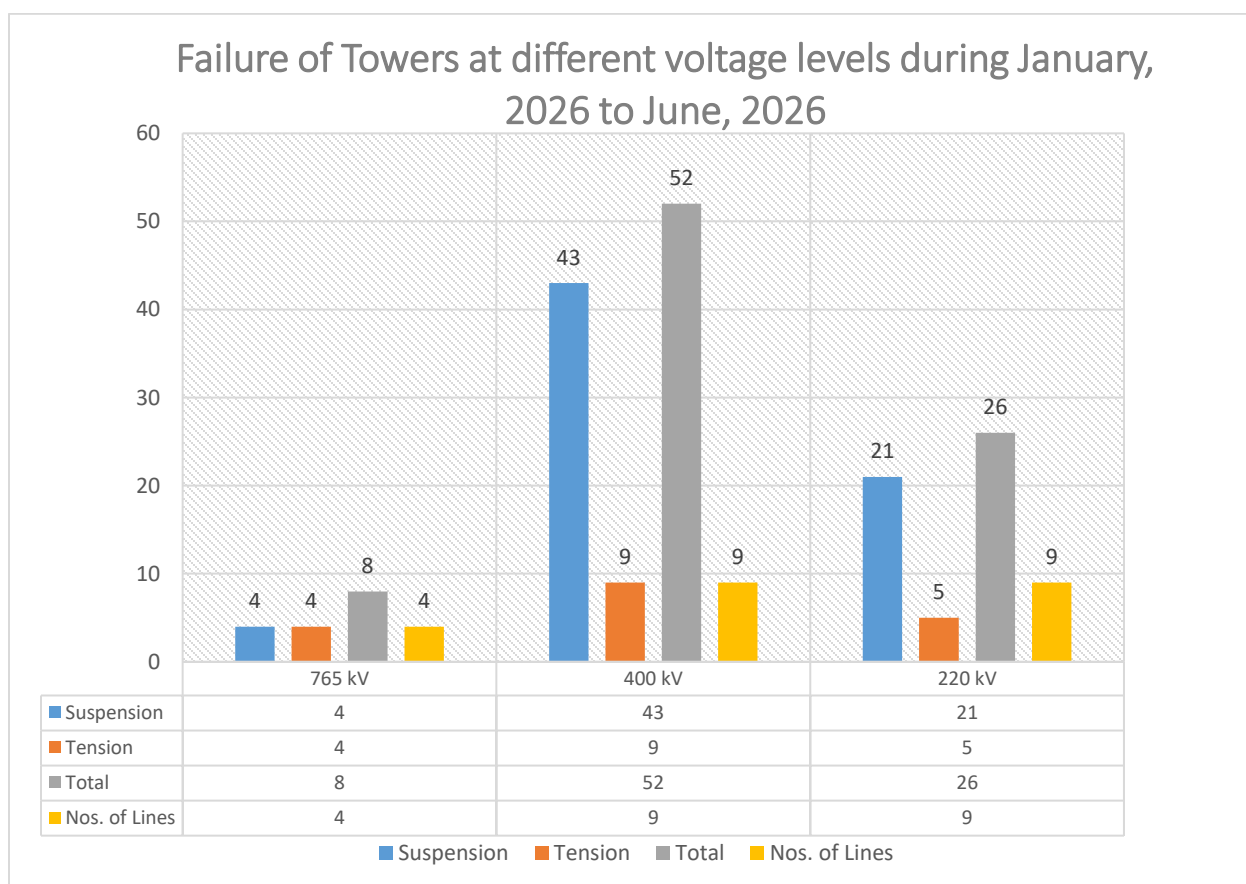
- d) It can be seen from the below **Fig. 2** that at 765 kV Voltage level, 04 Nos. of Suspension type tower and 04 Nos. of Tension Type towers were failed in 02 Nos. of Transmission Line, at 400 kV Voltage level 43 Nos. of Suspension type tower and 09 Nos. of Tension type towers have failed in 06 Nos. of Transmission Line, and at 220 kV Voltage level 21 Nos. of Suspension type tower and 05 Nos. of Tension type towers was failed in 08 Nos. of Transmission Line.

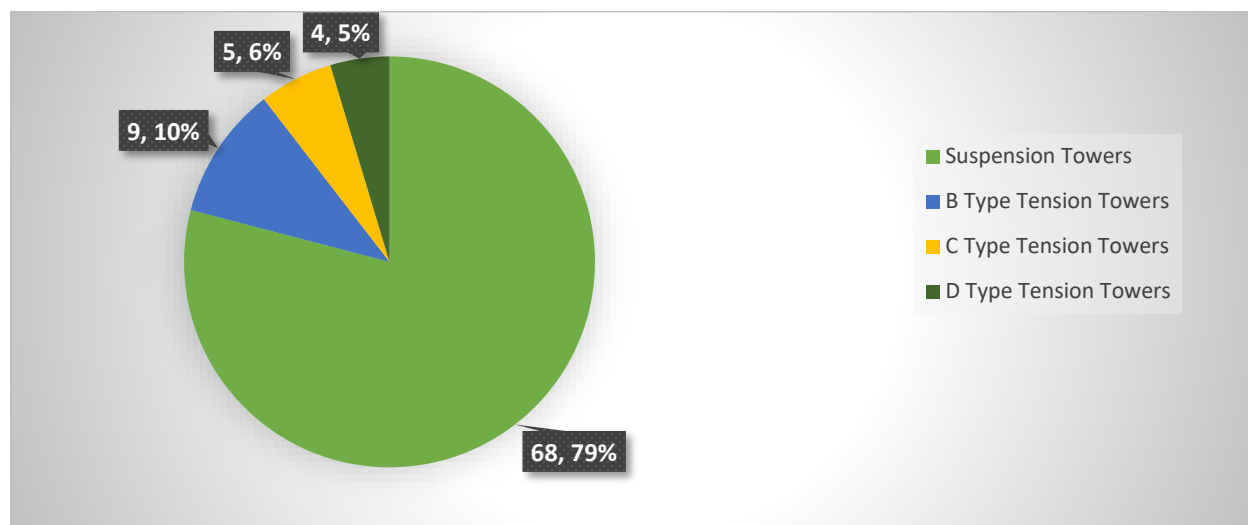
- e) It can be seen from the below **Fig. 3** that out of total 86 Nos. of EHV Line Tower failure, 68 Nos. are of Suspension type tower leading to its share of 79 % of total towers failed and 18 Nos. are of Tension

type towers leading to its share of 21 % of total towers failed. Out of total 18 Nos. of Tension Type tower, 09 No. are of Type B leading to its share of 10 %, 05 Nos are of Type C leading to its share of 06 % and 04 Nos. are of Type D leading to its share of 05 % Tension tower.

- f) It has been observed that the failure rate of Suspension type tower is higher in comparison to Tension type tower. This may be because in normal terrain, generally, the Nos. of Suspension type tower in any particular line is much higher than that of Tension type tower. Further, the Suspension type towers are not designed to take horizontal forces in the longitudinal direction and hence the failures of one suspension type tower causes secondary failure of adjacent Suspension towers due to the pulling force of conductors. In view of above, the loading criteria for the Suspension type towers have been made more stringent and the longitudinal and transverse force acting on Suspension type towers under security condition has been increased in revised IS 802: 2015.

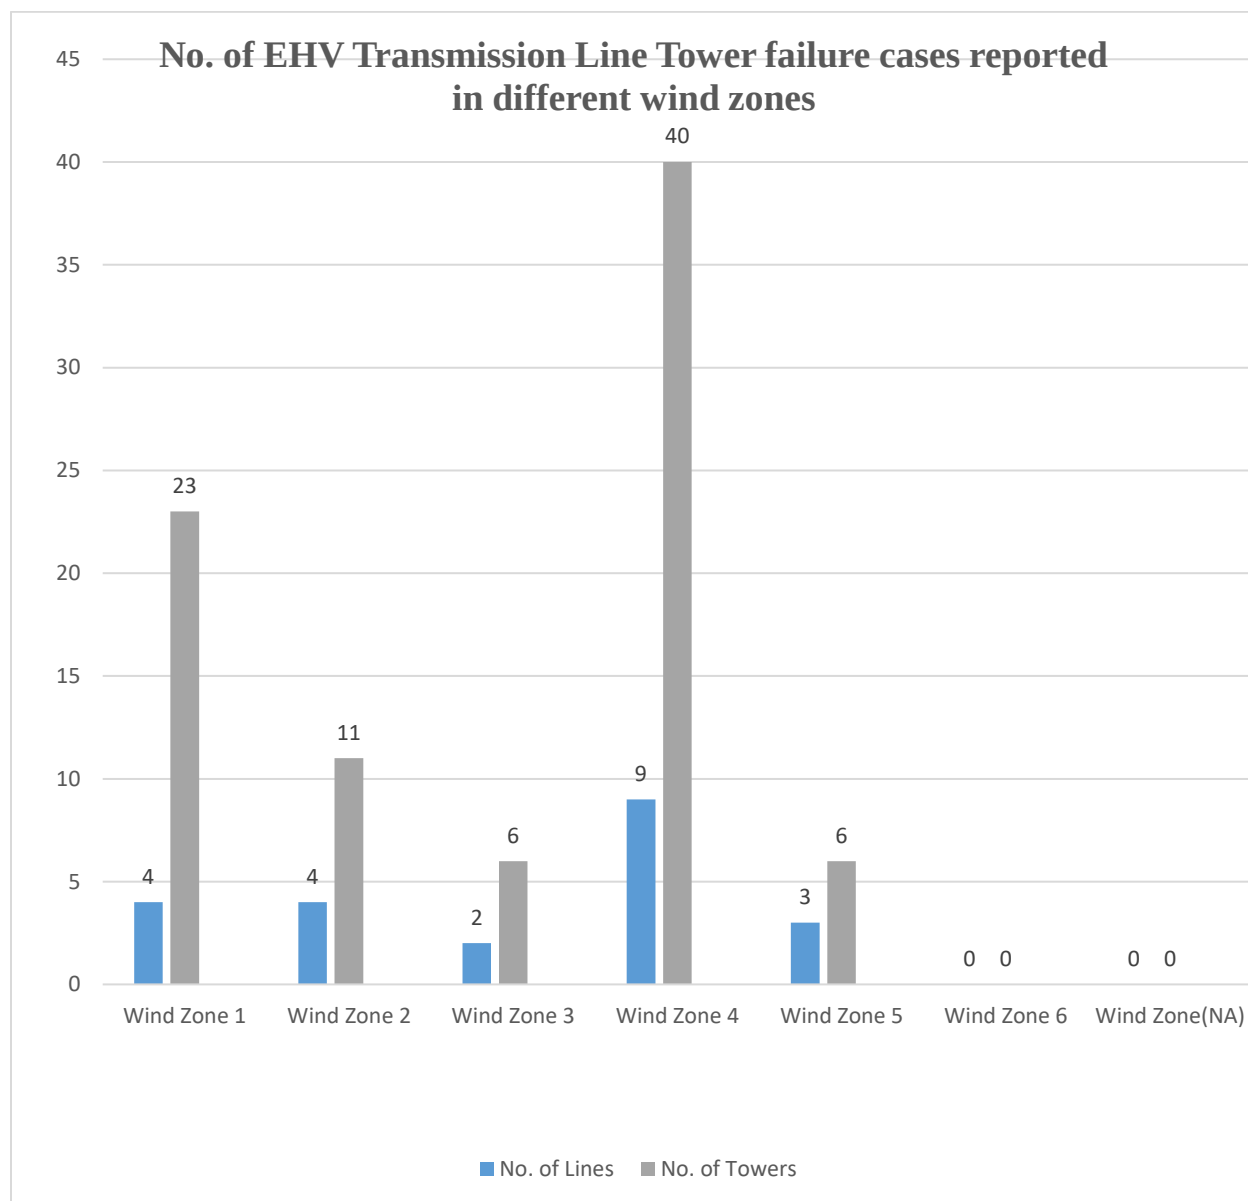
- g) The wind map of India was divided into three wind pressure zones that is light, medium & heavy, before the revision of IS 802 in 1995. In the third revision of IS 802: 1995, 6 wind zones were specified dividing various regions on the basis of 3 second wind gust speed. The No. of transmission lines and towers, failed during the period from January, 2026 to June, 2026 and designed according to various wind zones is given in **Fig. 4** below. It can be seen that the maximum No. of failure of towers have occurred for transmission lines which were designed for wind zone 4. It may be noted that maximum area of India is covered under the wind zones 2 and 4.

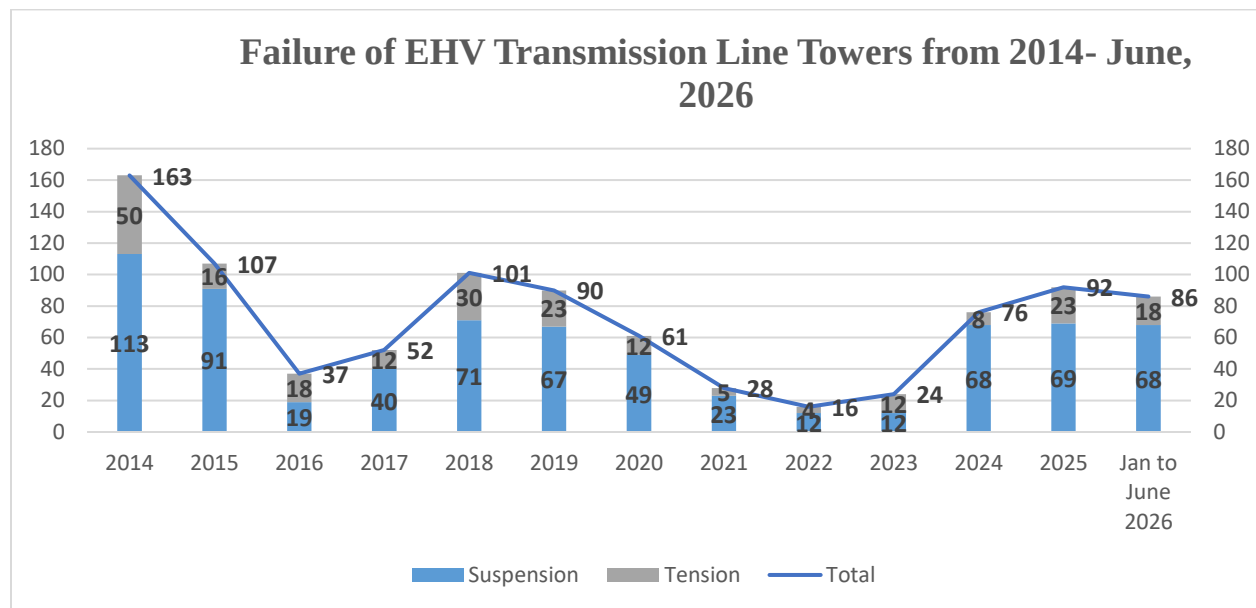
**Fig. 5**

suspension towers due to the pulling force of conductors which have been developed due to failure of another tower.

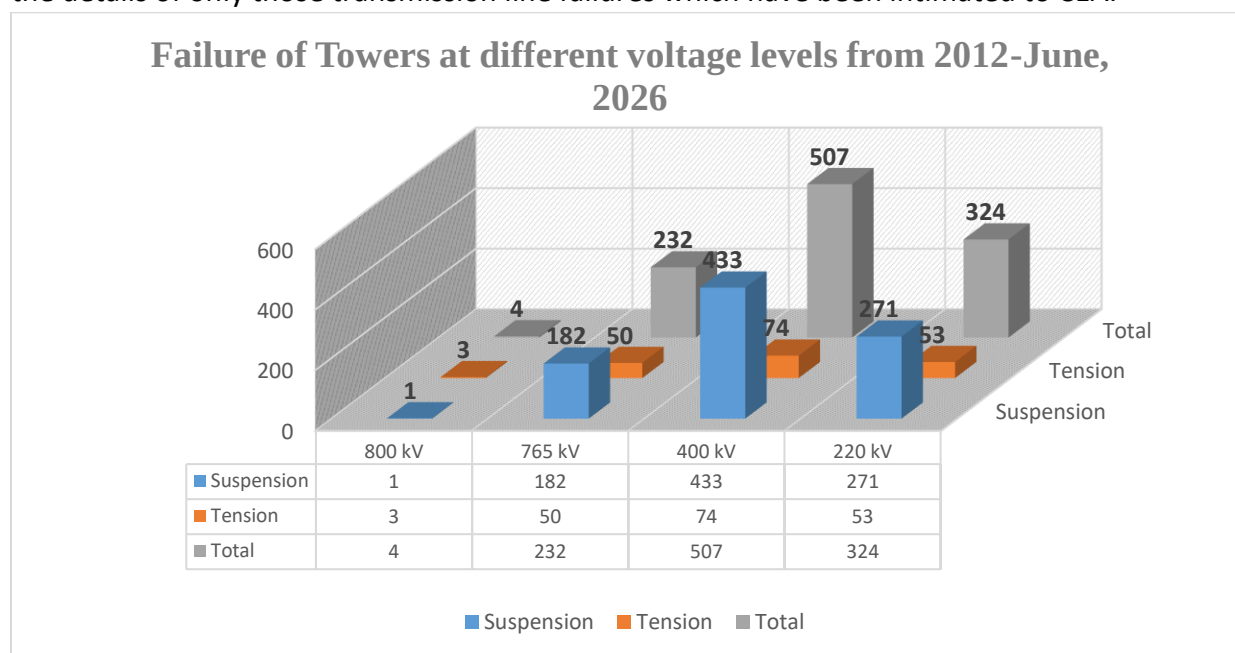
**Fig. 6**

- b) The graph depicting the failures of towers at various voltage levels that have occurred in past years (2012-June, 2026) and intimated to CEA which have been discussed in the Standing committee meetings are shown below in Fig. 6. It may be observed that towers of 400 kV voltage level have maximum incidents of failure. It may be noted that the mandate of the Standing Committee is to investigate failure of towers of 220 kV and above voltage class transmission line and the graph shows the details of only those transmission line failures which have been intimated to CEA.
