# **Report of the Committee on Addressing Insulator Failures on Transmission Lines**

**Government of India  
Ministry of Power  
Central Electricity Authority  
May, 2026**

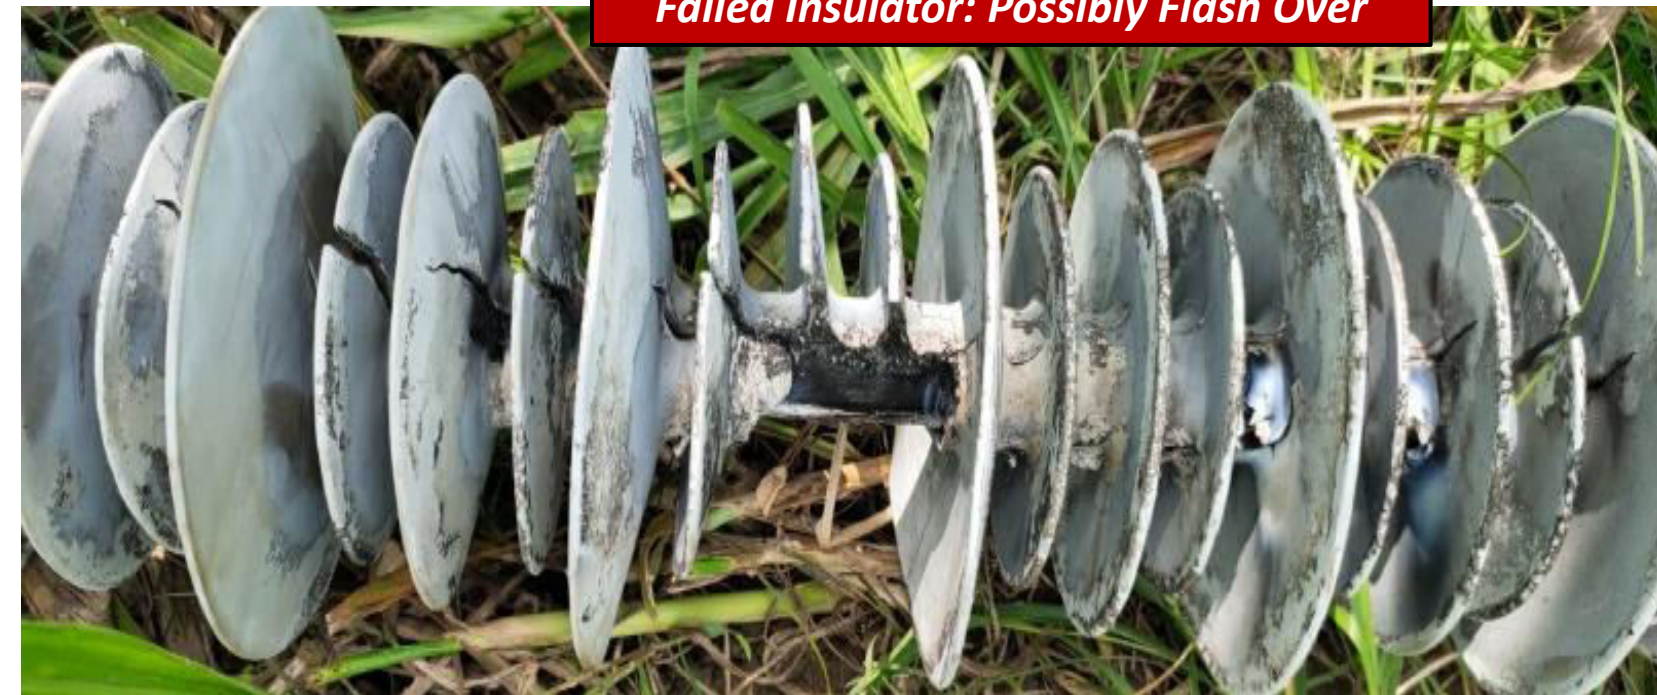
**Failed Insulator: Possibly Flash Over**

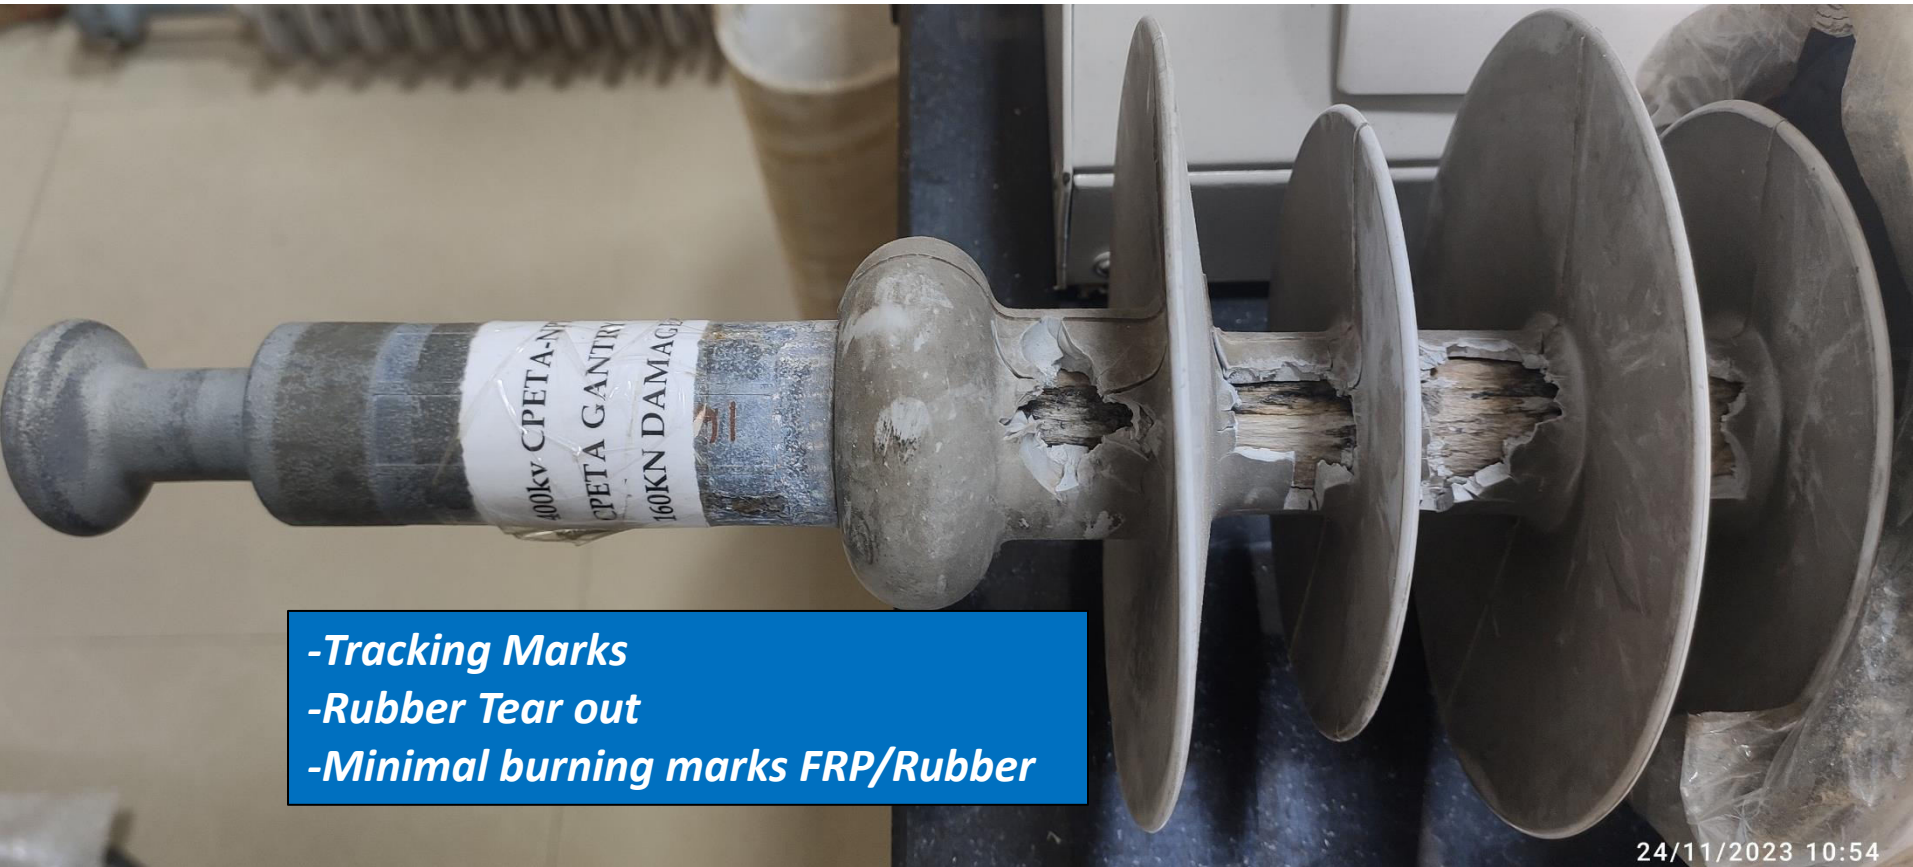
Tracking Through FRP or Rubber or Interface or Surface.....?

- Tracking Marks
- Rubber Tear out
- Minimal burning marks FRP/Rubber

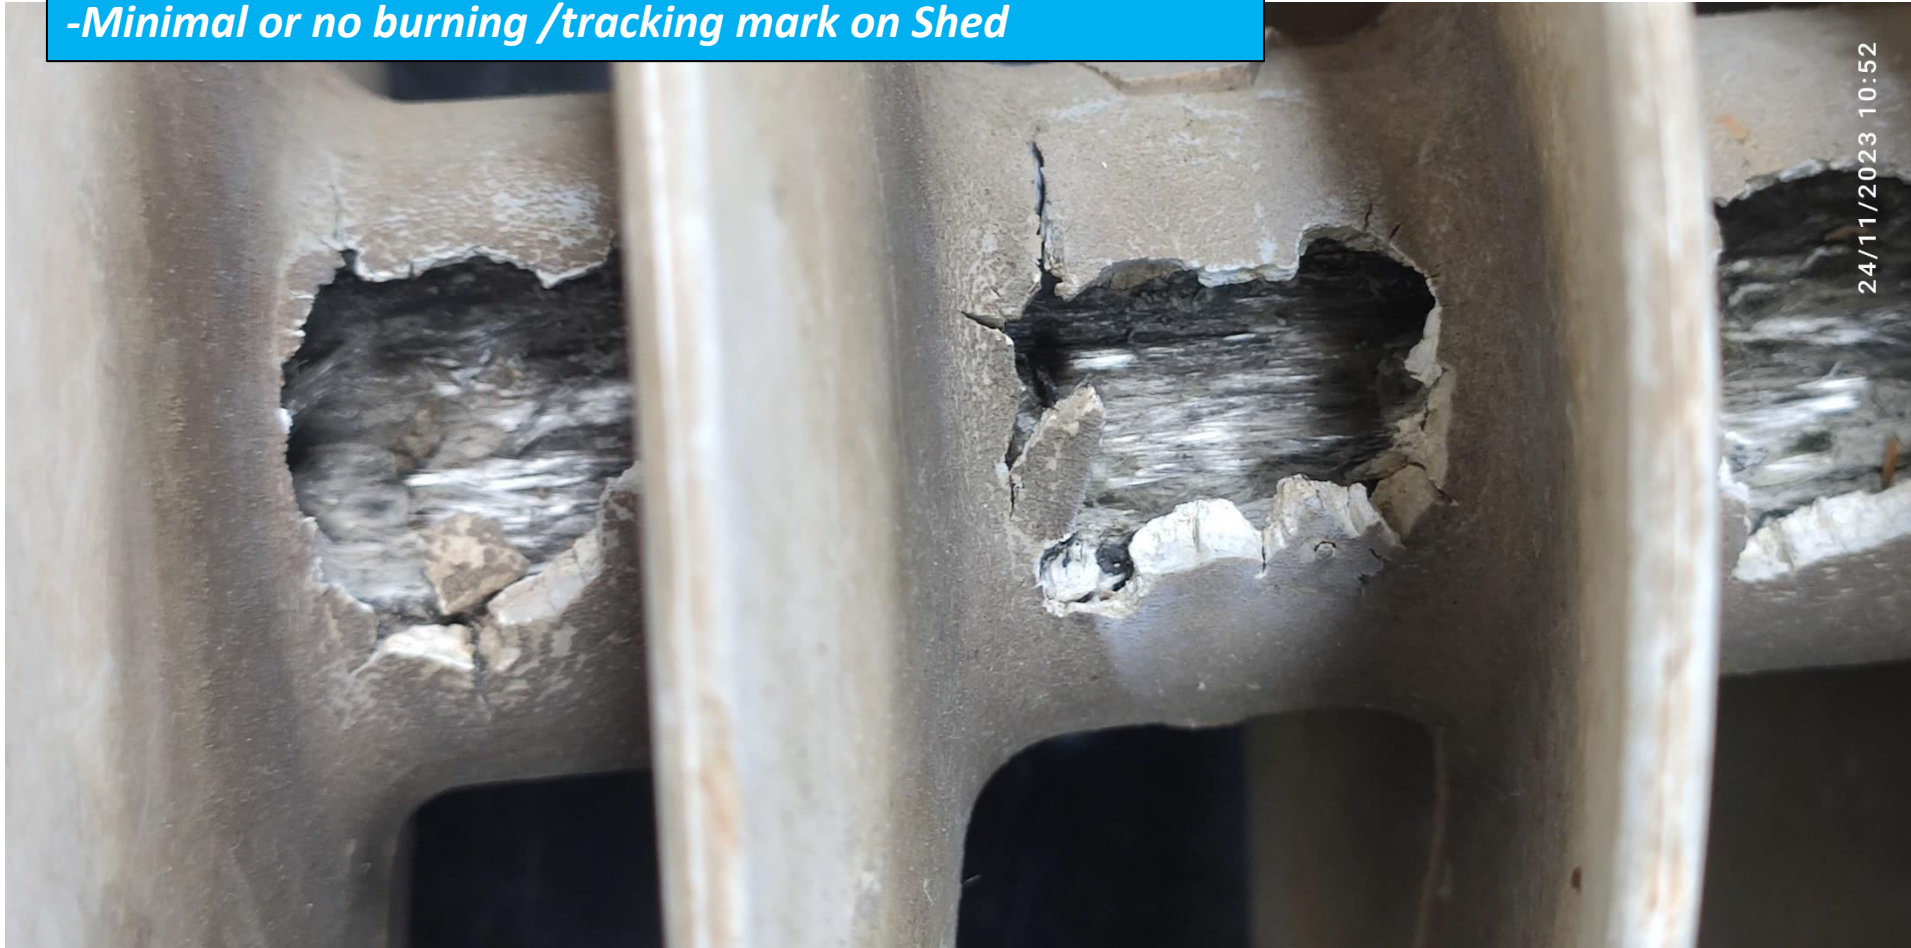
- Burning of FRP*
- Burning of Sheath Rubber*
- Minimal or no burning /tracking mark on Shed*

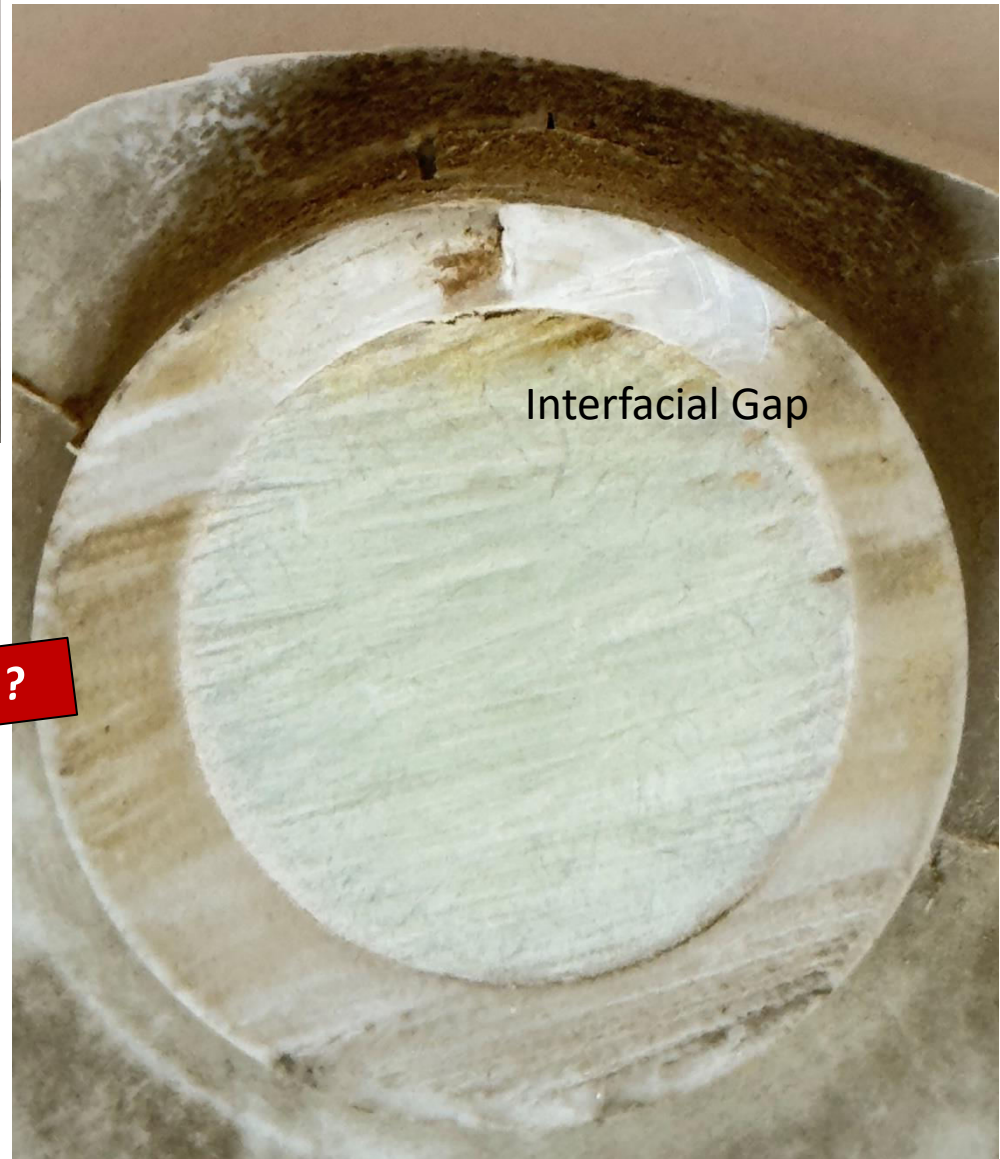
***Progression of Phenomenon: Crack opening***

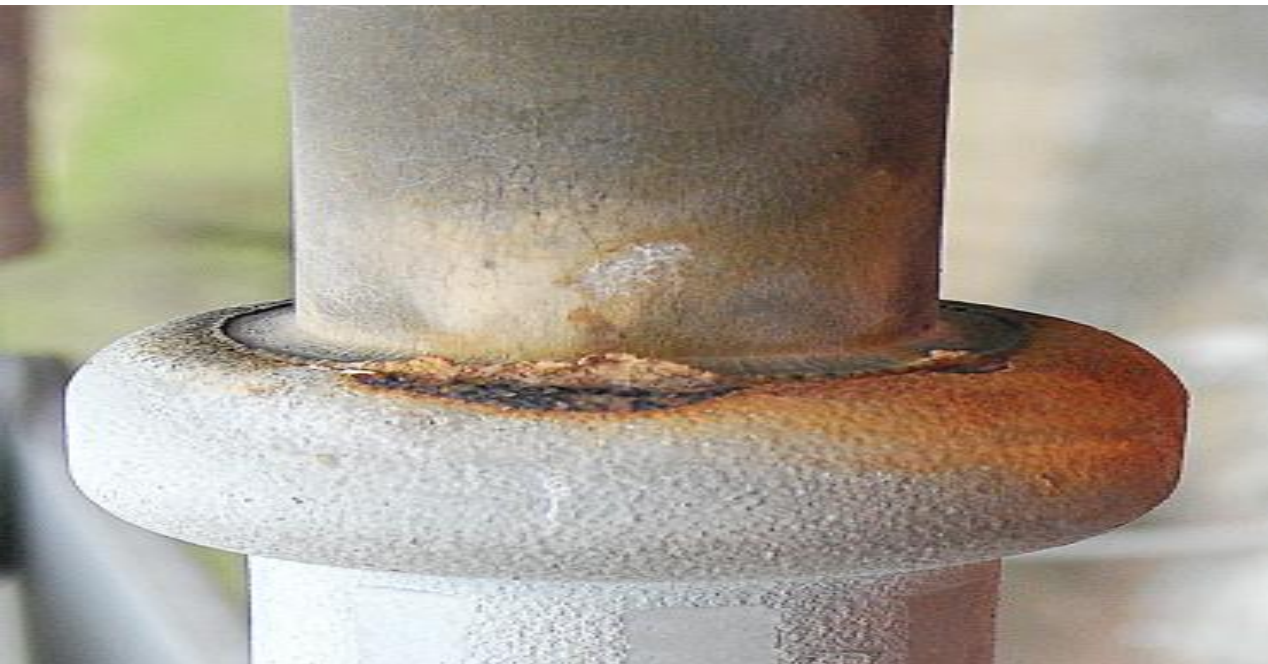
**Damage to seal and degraded shank surface of tension insulator without appropriate corona protection**

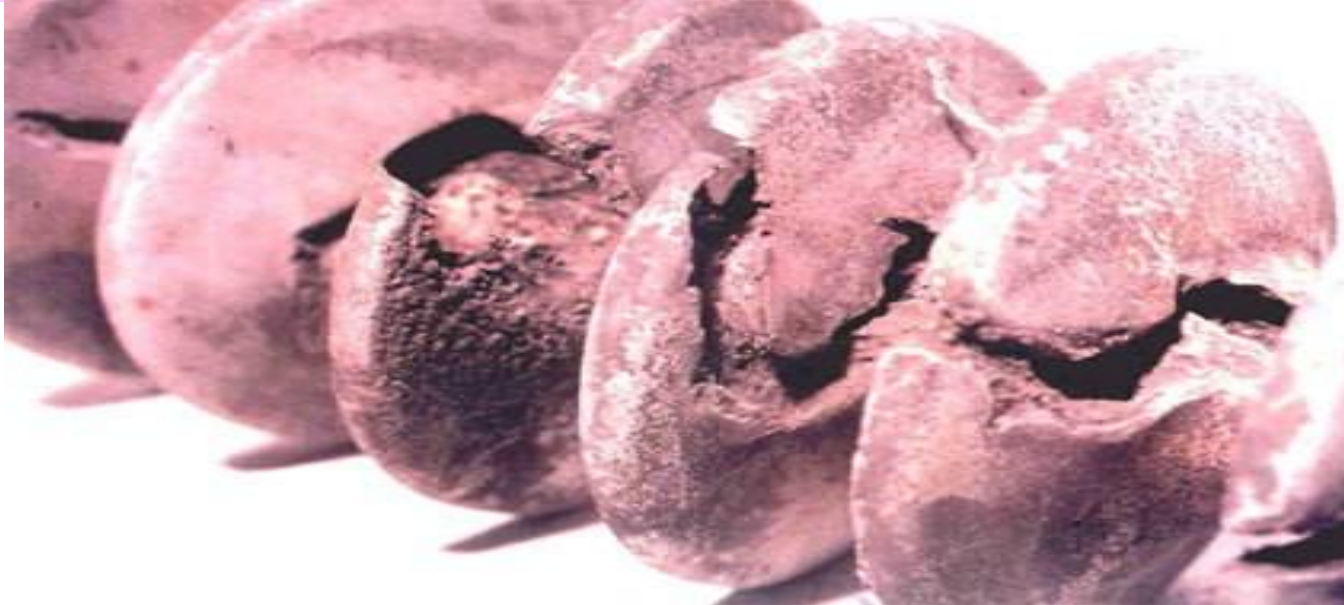
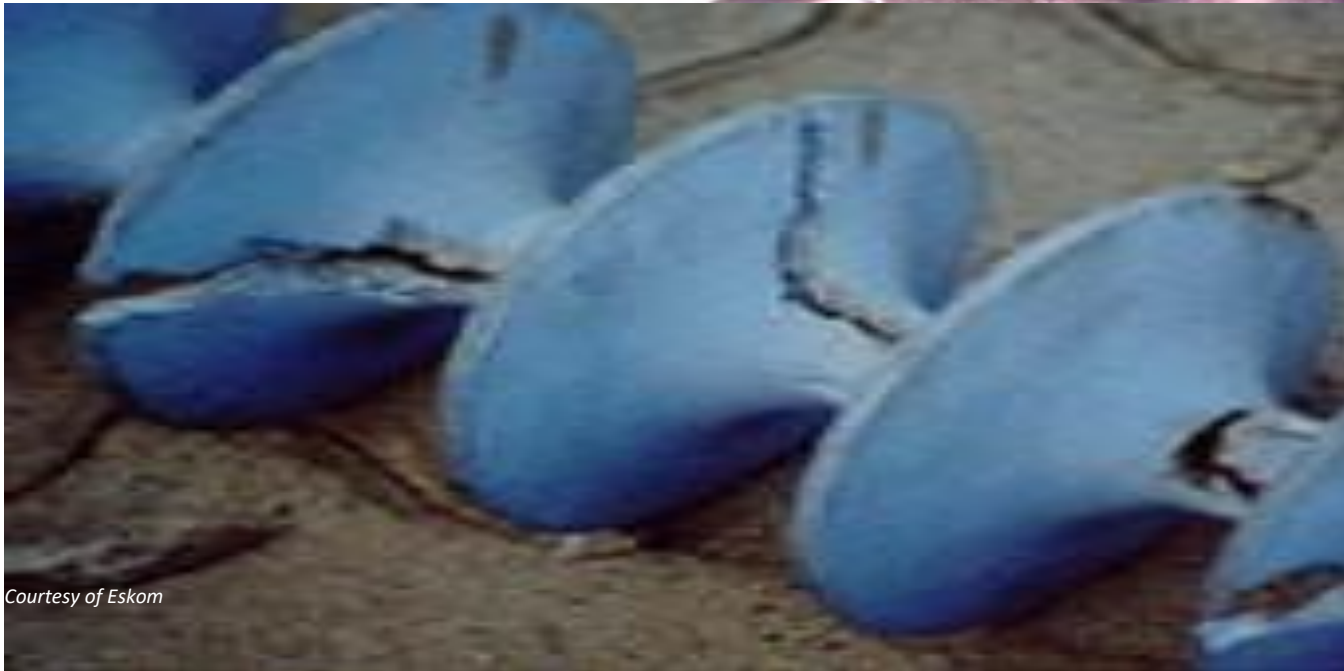
**Erosion of  
Silicone rubber  
housings**

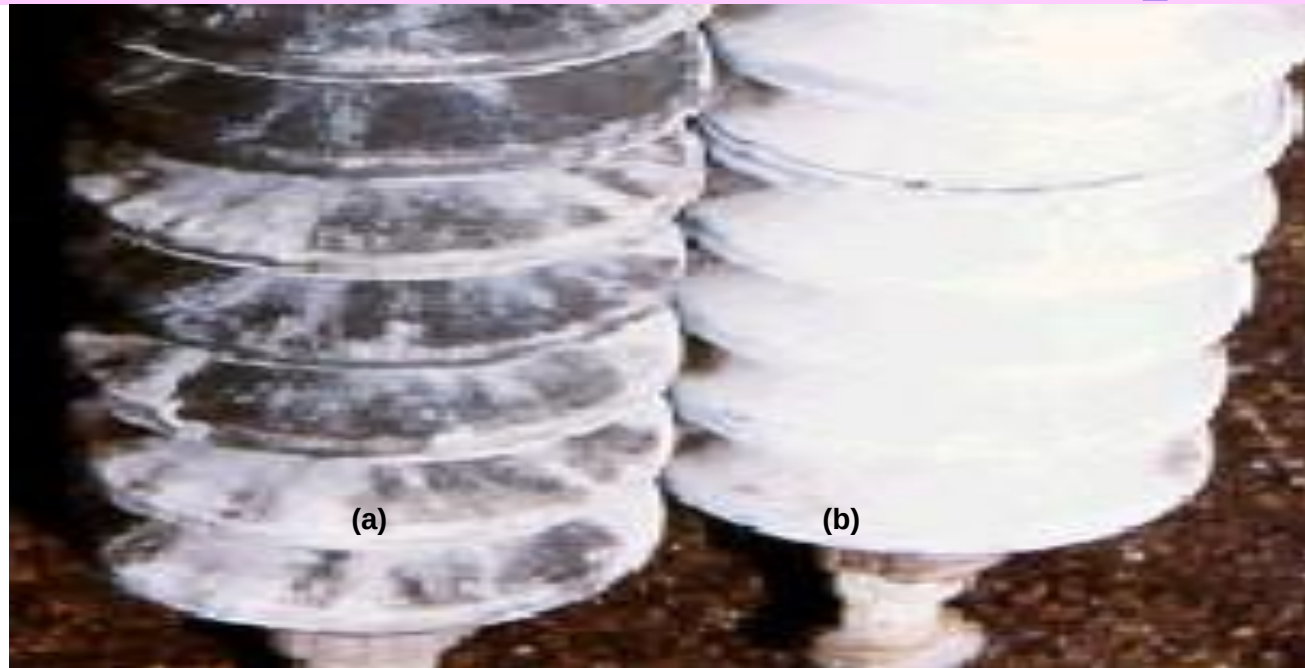
**Chalking of shed material caused by leakage current activity (a) and ultraviolet radiation (b)**

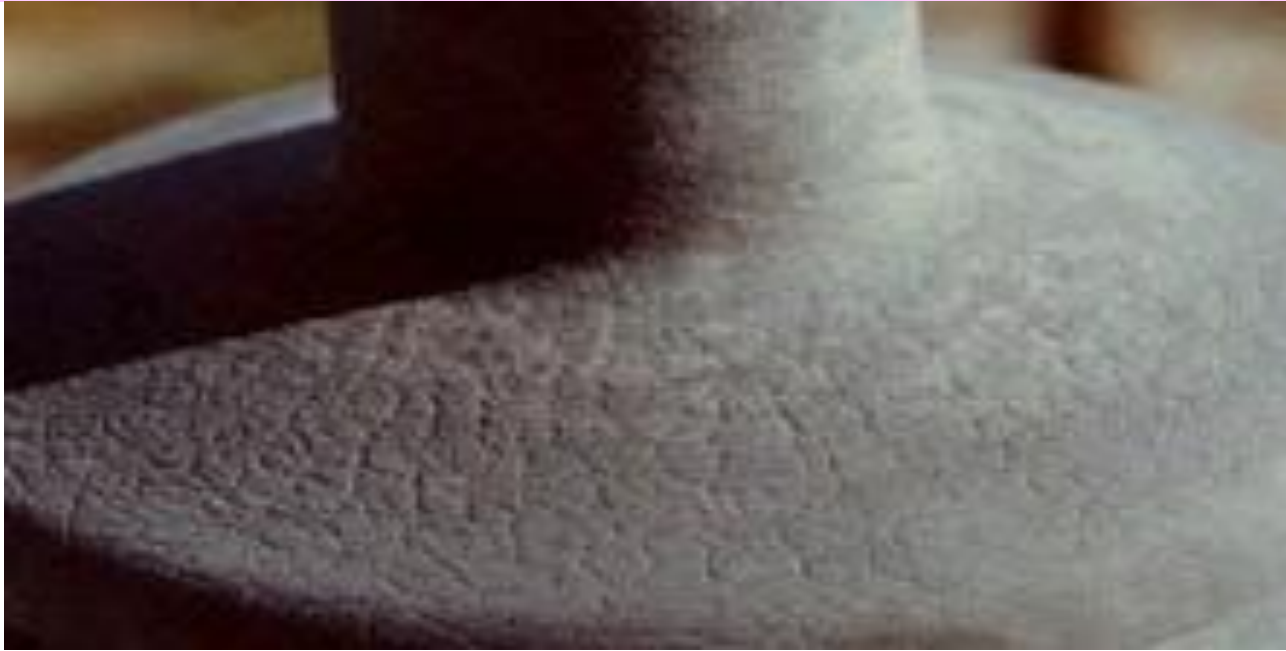
**Erosion  
(alligatoring)  
due to UV,  
weathering  
and  
electrical  
activity**

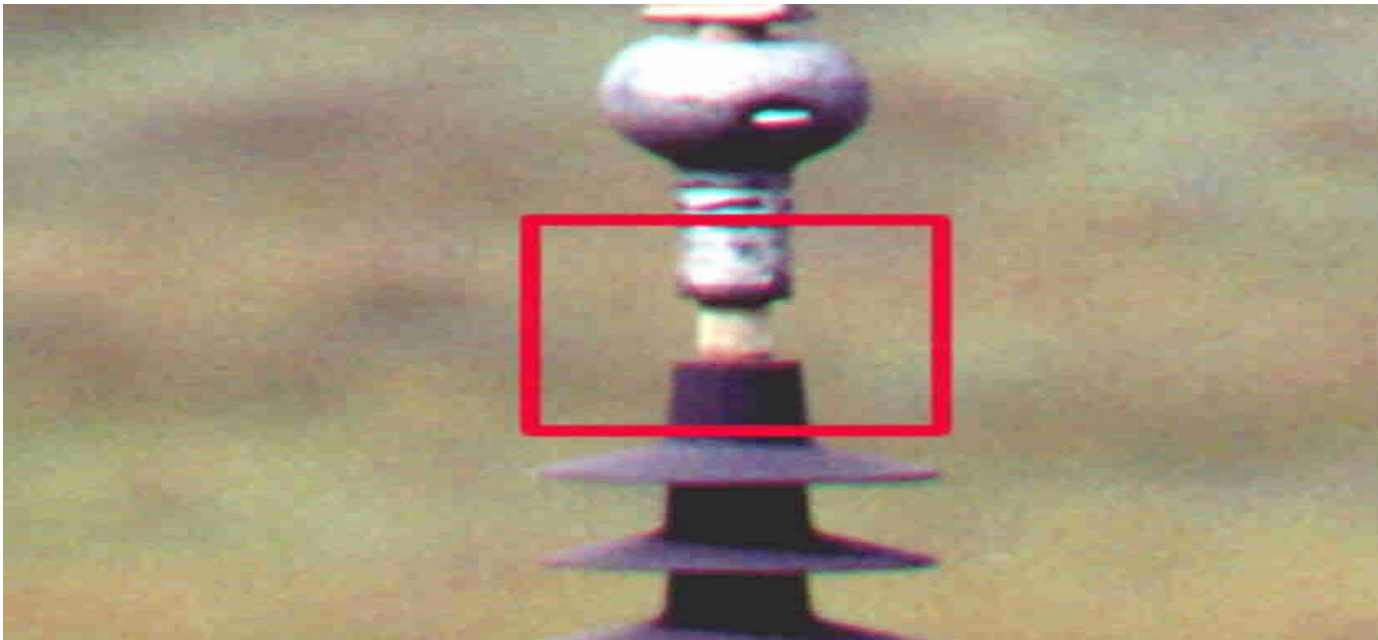
**Exposure of  
core owing to  
shed  
movement**

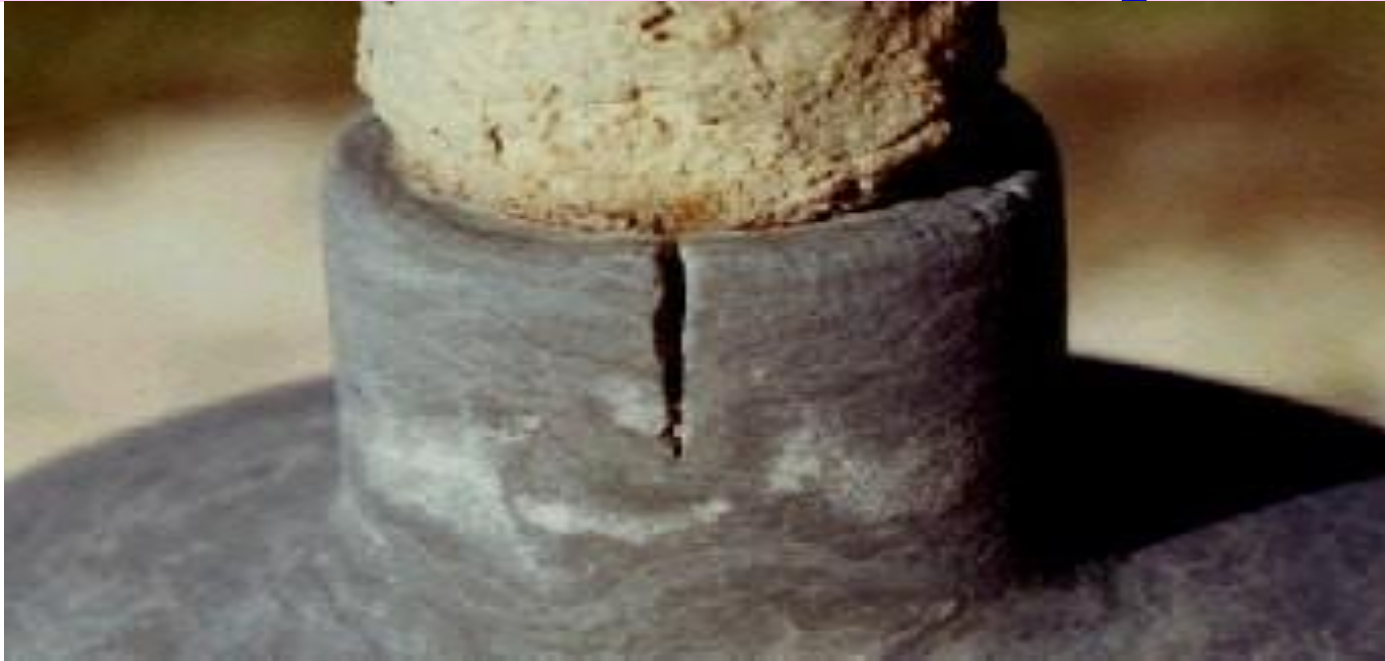
**Splitting of  
sheds owing  
to radial  
mechanical  
stress**

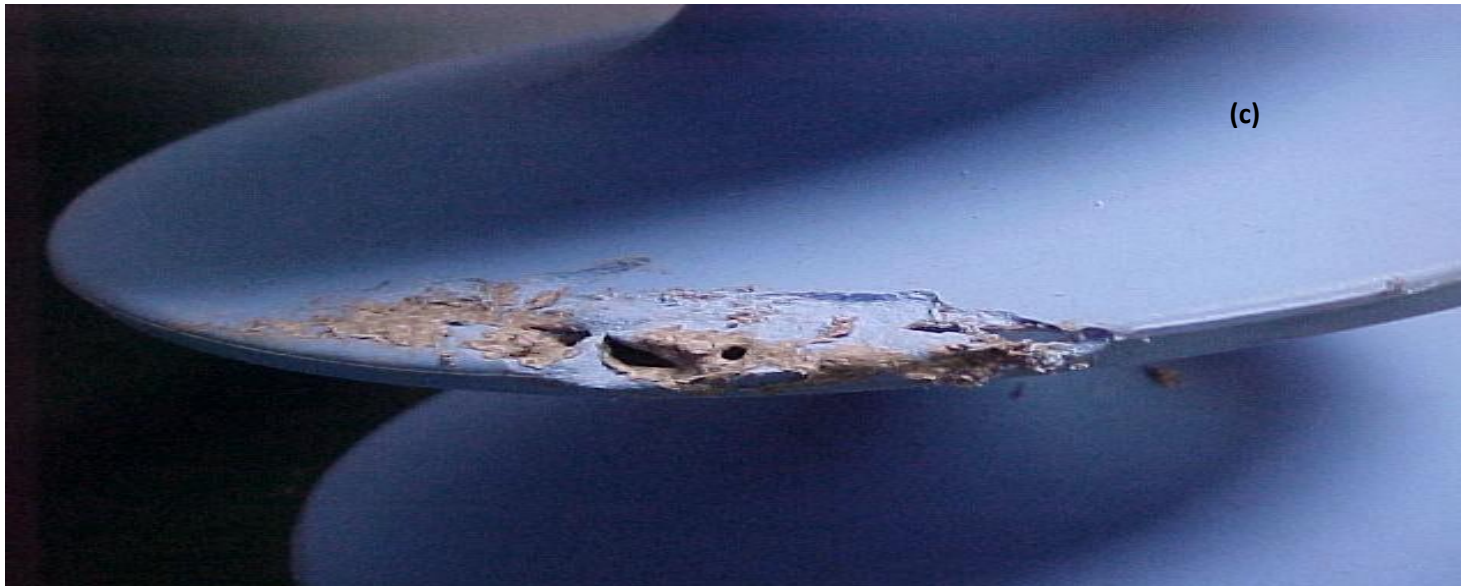
**Shed  
damage  
caused by  
birds (a),  
rodents (b) &  
termites (c)**

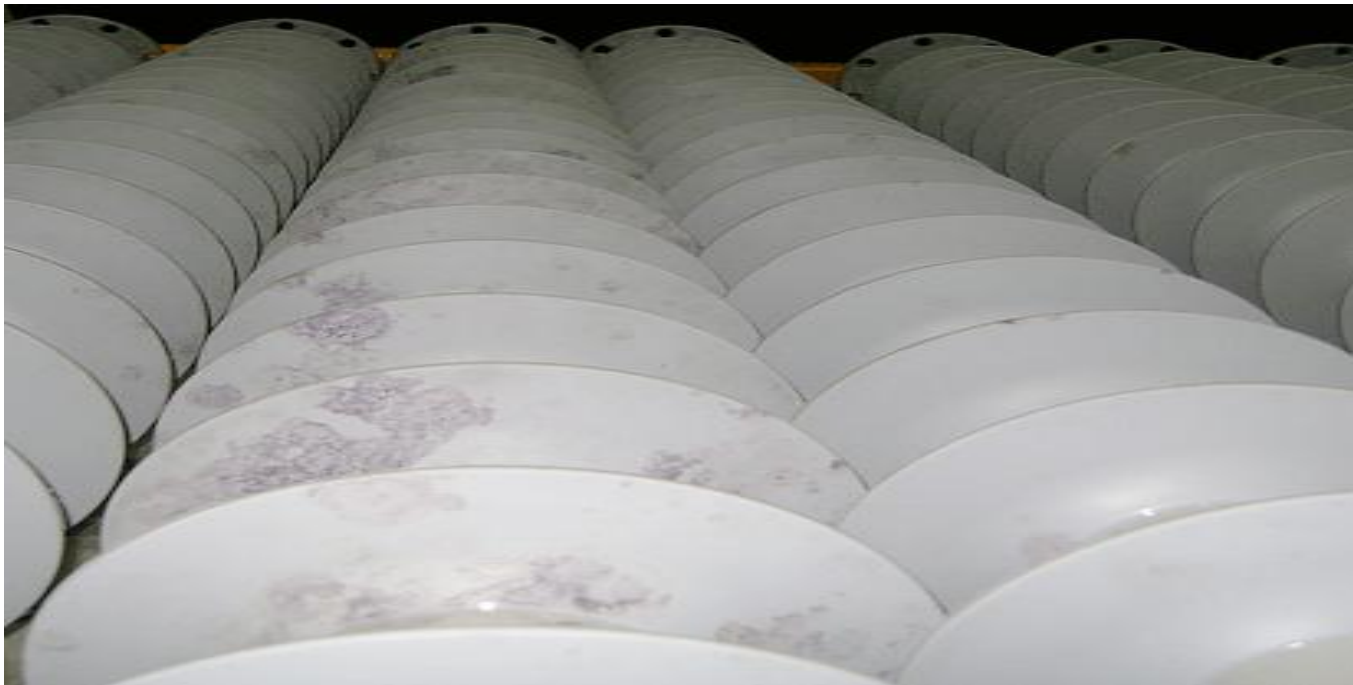
**Colonization by  
Chaetomium,  
Cladosporium and  
Methylobacteria  
leaves pinkish residue**

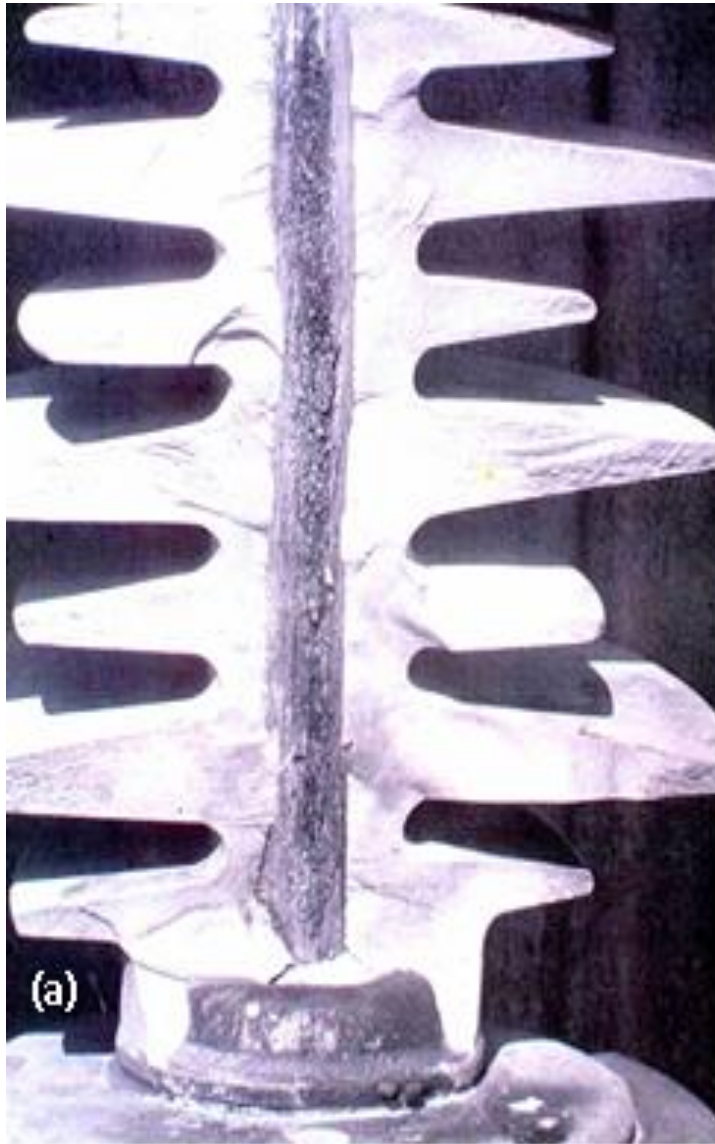
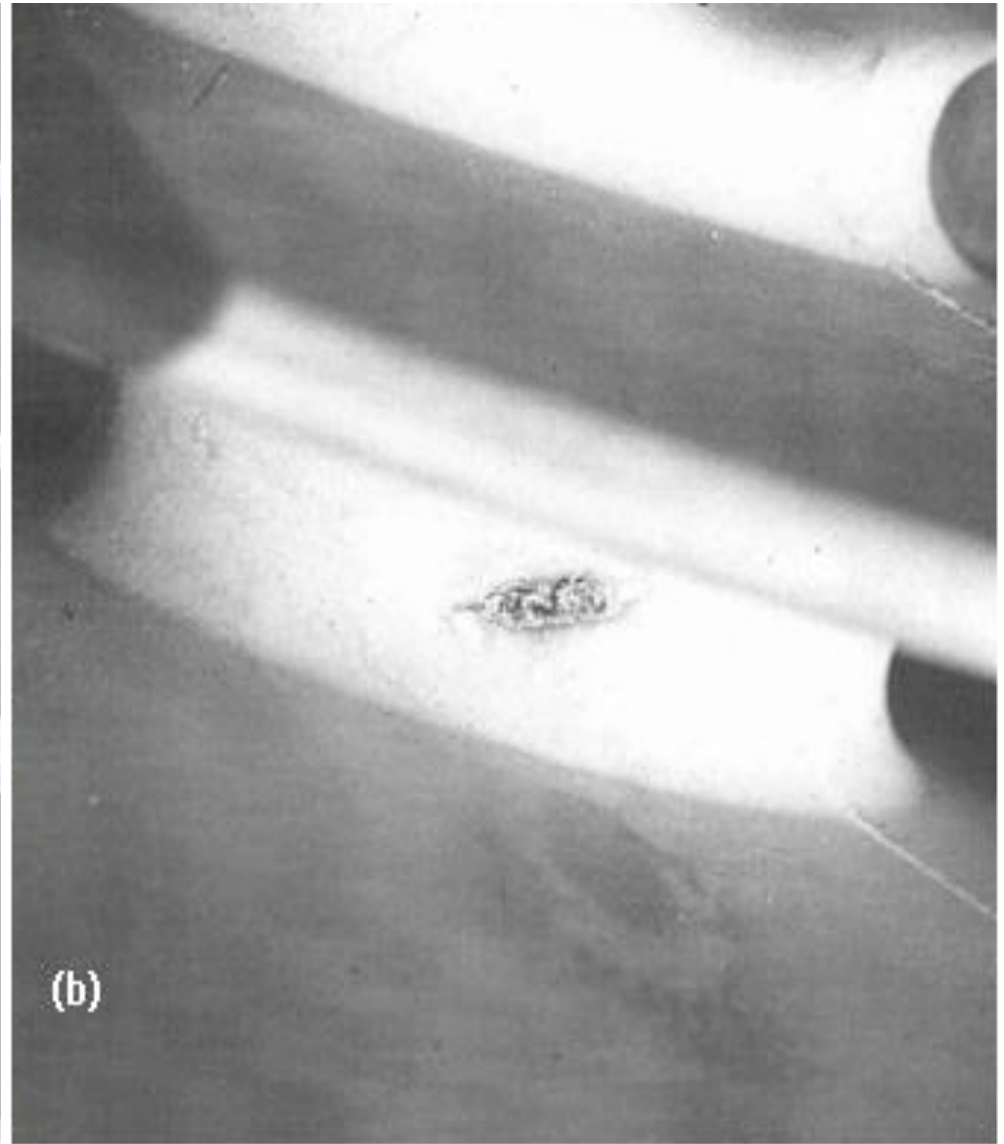
Internal breakdown and fracture of the housing (a) and puncture (b) caused by tracking up the core/housing interface

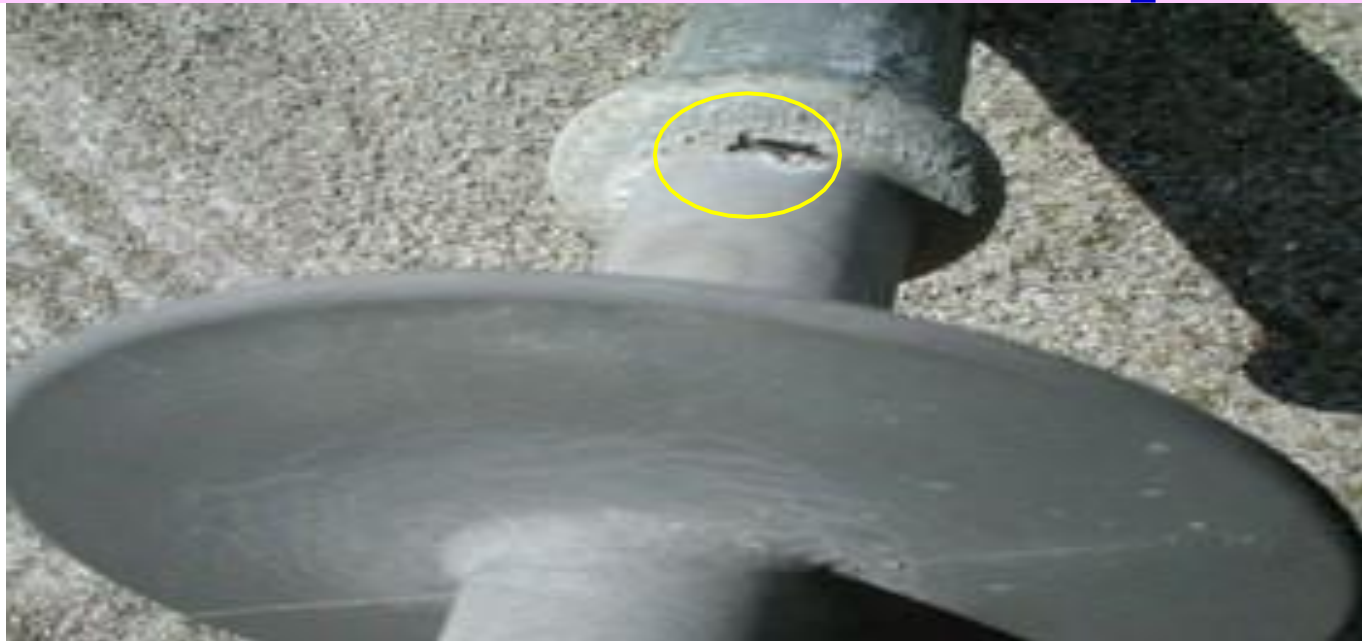
**Housing to end fitting interface failure due to erosion**

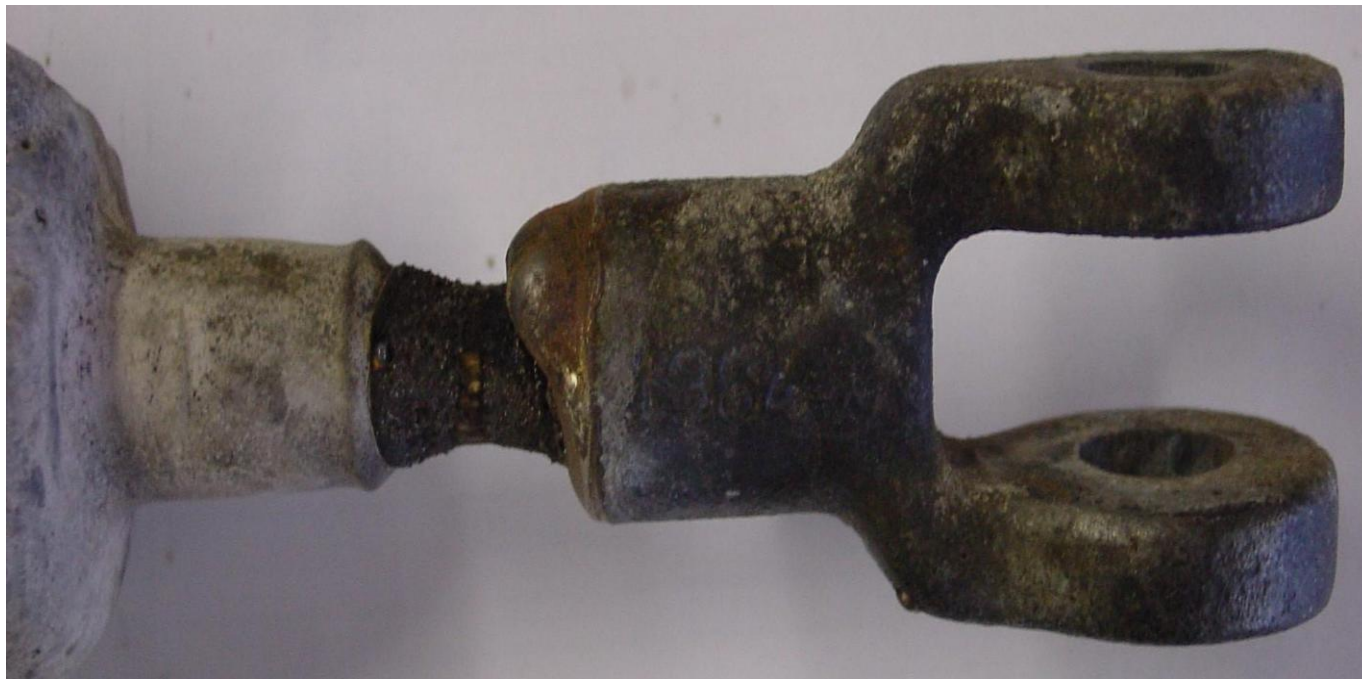
**End fitting damage from power arc**
