**भारत सरकार/ Government of India**  
**विद्युत मंत्रालय/ Ministry of Power**  
**केन्द्रीय विद्युत प्राधिकरण/ Central Electricity Authority**  
**विद्युत प्रणाली अभियांत्रिकी एवं प्रौद्योगिकी विकास प्रभाग**  
**Power System Engineering & Technology Development Division**

**विषय:** Minutes of the meeting of the Standing Committee of the Experts to discuss the failure of 220 kV and above voltage level Transformers during period of July, 2025 to December, 2025 -reg.

### Minutes of the meeting of the Standing Committee of the Experts to discuss the failure of 220 kV and above voltage level Transformers during period of July, 2025 to December, 2025 -reg.

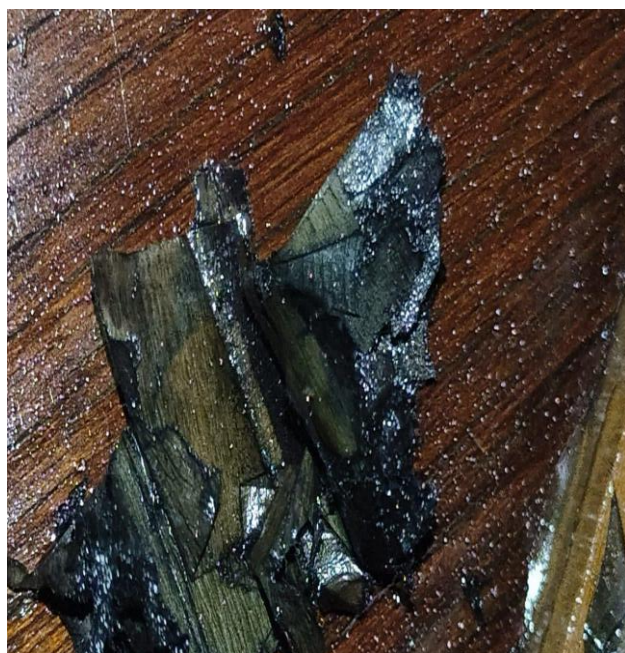
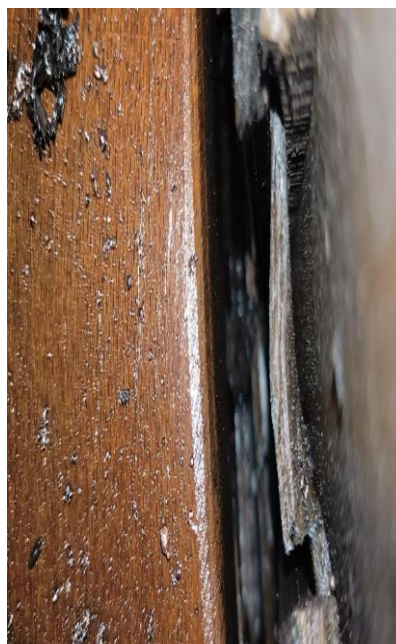
- (d) From the data it was inferred that the cause of the failure is mechanical failure due to the dynamic forces induced by the through fault current. From the internal inspection it was found that the intensity of the damage of core and coil assembly the ICT is very high.

- (e) DGA results taken before the failure showed a gradual increase in thermal gases, confirming that thermal stress was developing inside the transformer over time which indicate progressive insulation ageing. The transformer, being old and previously repaired, was already in a weakened condition. From the post-failure test results, it is observed that the R-phase of the transformer developed an internal fault. 66 kV side of Okhla Substation is connected radially to 220/66 kV Power Transformers-II. Due to this arrangement, the fault occurred on 66 kV Incomer-II was completely fed by the Transformer-II. The Transformer is 29 years old and has been repaired in year 2013. High fault current has led to development of forces in the winding which ultimately led to development of internal fault in Transformer. Magnetic balance and SFRA tests also show indications of possible core/winding movement in the R-phase. Differential relay operation also confirms an internal transformer fault.

CE (PSE&TD Division), CEA concluded that ageing, repeated through-faults, overvoltage stresses, and repeated bushing failures had progressively weakened the winding structure, resulting in insulation breakdown and internal fault. CE enquired about the present load management status, to which it was clarified that load is being managed through other substations and that replacement/augmentation is targeted by March-end.

**Burnt marks observed on Transformer**

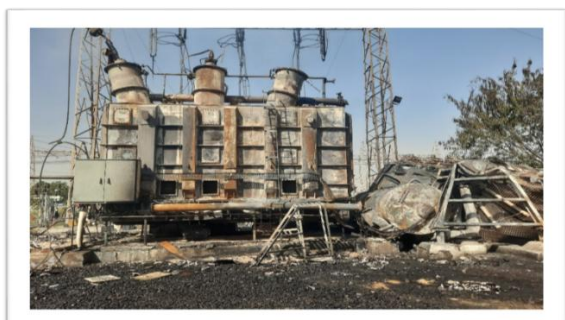
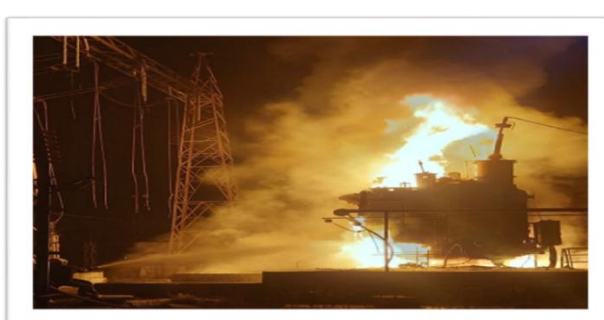
Representative of GETCO presented their case of failure of 160 MVA, 220/66 kV Power Transformer at Morbi Substation. It was informed by representative of GETCO that the above mentioned Transformer was manufactured in the year 2018 and commissioned on 24.20.2019. The Transformer got failed on 06.11.2025, at 18:35 hrs. The Transformer failure was most likely triggered by a sudden LV side R-phase bushing failure—either internal insulation breakdown or external flashover—despite tan delta and capacitance values of all the bushings as per last test conducted on 16.04.2025 were within permissible limits. This caused a high-energy internal fault with fault current around 19.8 kA, rapidly cleared by differential protection within three and half cycles. However, fire was observed near the LV R-phase bushing immediately thereafter. Mechanical protections such as PRV and Buchholz operated with a time delay of around two minutes, corresponding to pressure rise and gas accumulation due to ongoing burning. The Nitrogen Injection Fire Protection System (NIFPS)

failed to activate because its DC supply cables were damaged by hot oil and fire in a nearby trench. The fire completely destroyed the transformer and caused collateral damage to associated lightning arresters, conductors, and control cables. As the transformer was fully burnt in the incident, all external and internal non-metallic components were completely damaged. All HV, LV bushings and neutral bushings were also found burnt and shattered. Due to the high damage due to fire, no meaningful site testing or internal inspection could be carried out. Hence, a perfectly precise root-cause analysis could not be established based on physical evidence.

**Failed Transformer at Morbi S/s**

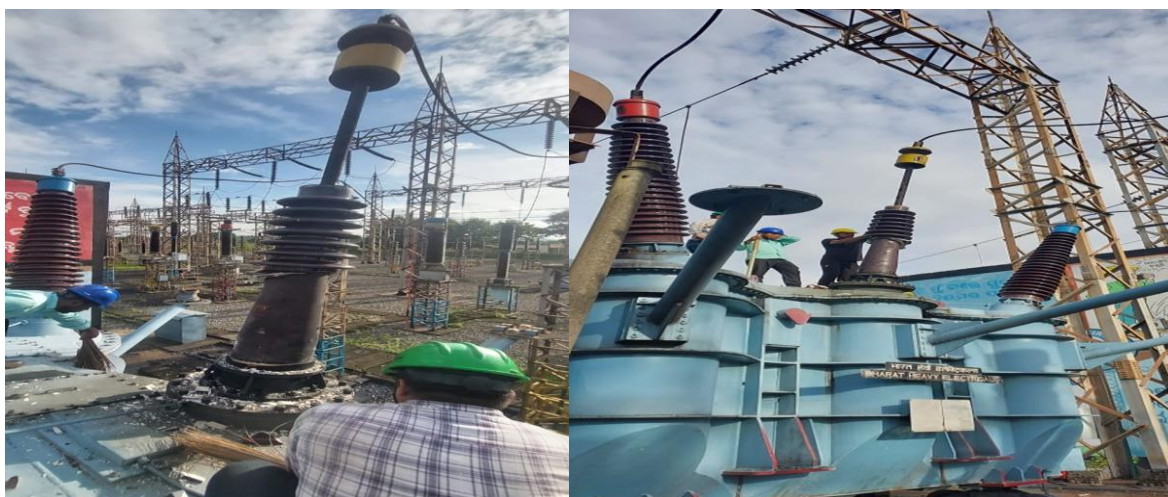
Representative of OPTCL stated that main reason of the failure of Transformer is failure of Y phase bushing lead. He said that detailed inspection is to be done inside the transformer after transformer oil removal from tank.

**Damaged Bushing**

CE (PSE&TD Division), CEA emphasized that a structured and scientific maintenance philosophy must be established highlighting three critical aspects: first, identification of the complete set of diagnostic tests required to assess transformer health—such as IR, PI, Tan Delta, DGA, BDV, winding resistance, SFRA, bushing capacitance and tan delta, and thermal monitoring; second, defining clear periodicity and frequency for each test (quarterly, half-yearly, annual, or condition-based) depending on voltage class, age, and criticality; and third, establishing well-defined acceptance limits and alarm thresholds so that results are

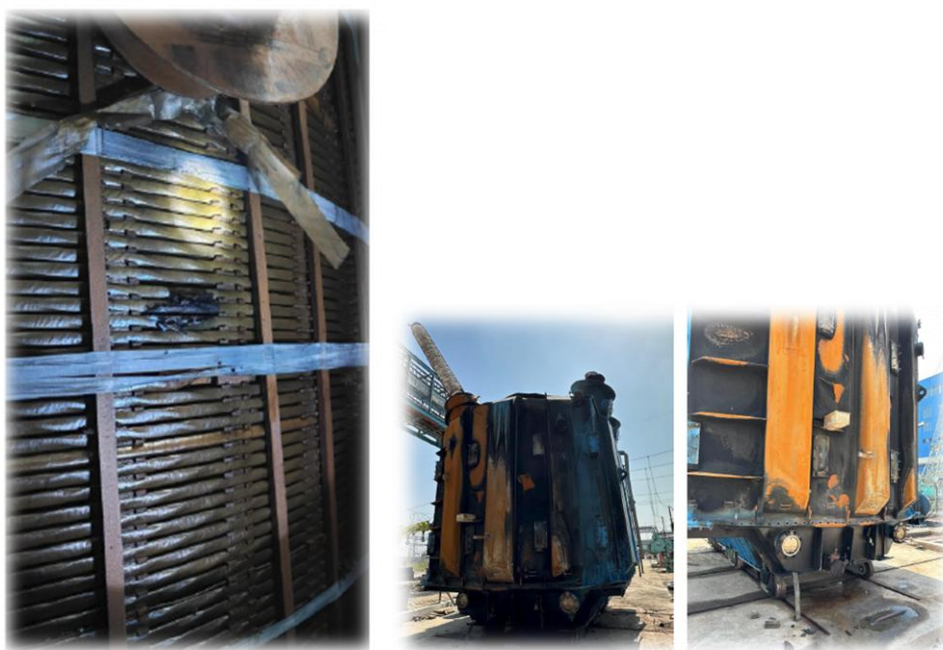
**The Arching spot and burnt Transformer**
