**विषय: Report of the Standing Committee of Experts on failure of EHV transmission towers failed during the period January 2022 to December 2023-reg.**

**REPORT OF THE STANDING COMMITTEE OF EXPERTS ON  
FAILURE OF EHV TRANSMISSION TOWERS  
(JANUARY 2022 - DECEMBER 2023)**

### A.1 400 kV S/C Gooty-Somanhalli Transmission line failed on 8.05.2022

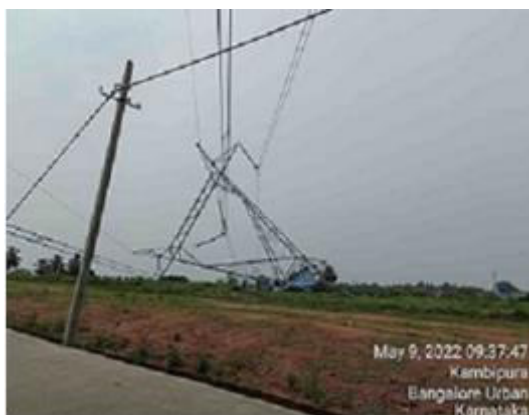
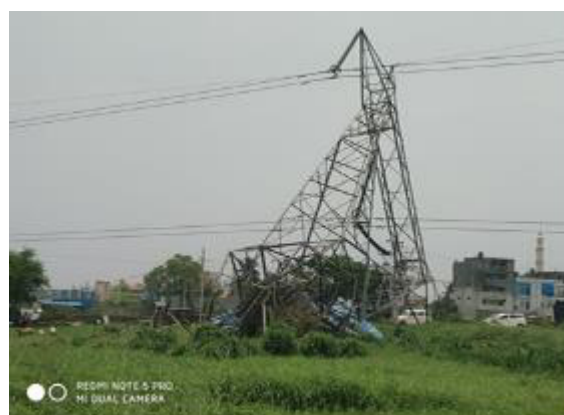
| | <ul style="list-style-type: none"> <li>• Tower collapsed completely as shown in Fig 7(a).</li> <li>• Foundation was intact.</li> <li>• All four stubs are damaged as shown in Fig 7(b).</li> <li>• Main leg members along with many bracing members were deformed.</li> </ul> | | | | |

**Fig 7(a). Collapsed tower Loc. No. 763 (A+0)**

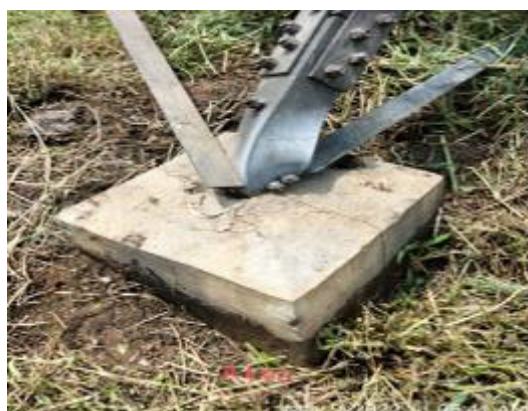
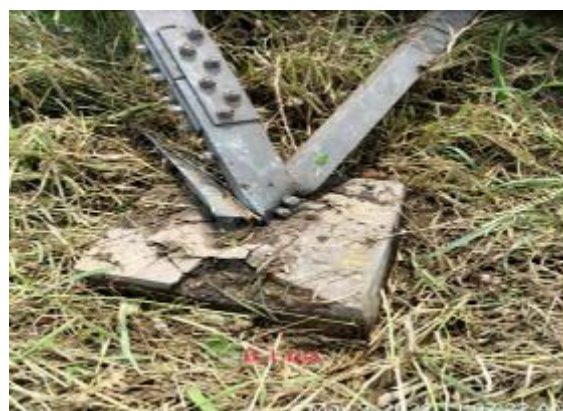
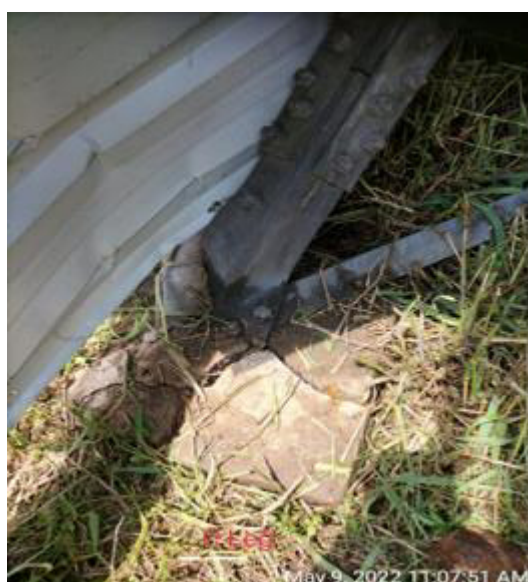
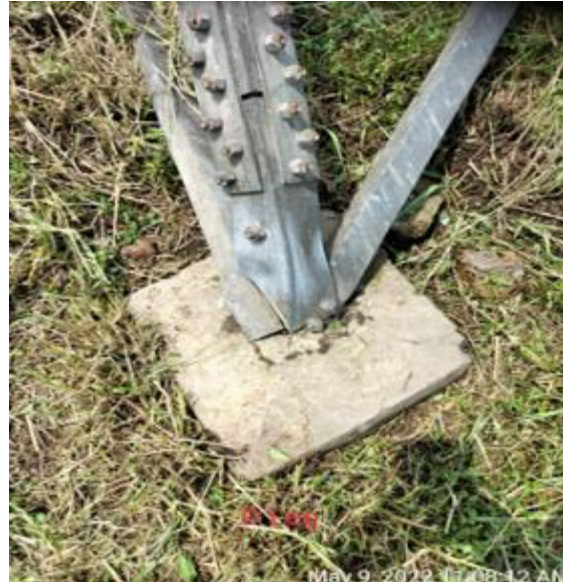
**Fig 7 (b). Damage of the Stubs**

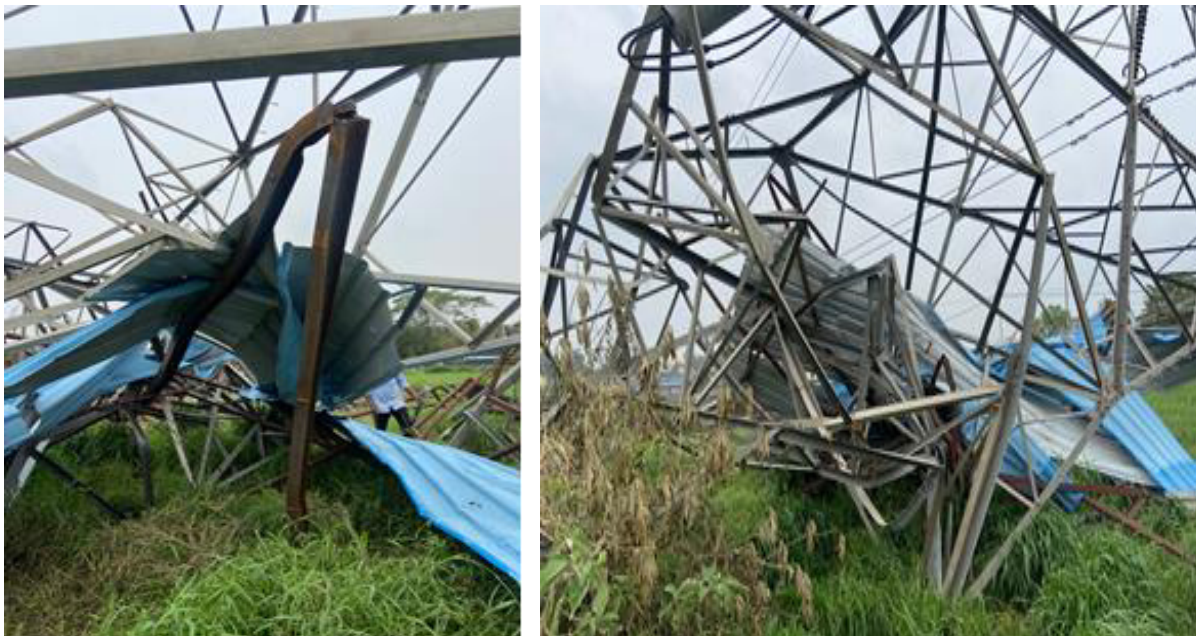
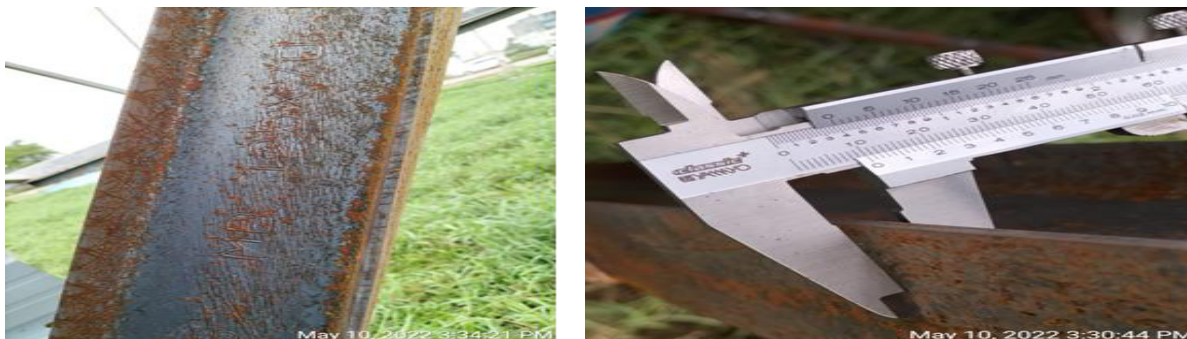
| <b>e.</b> | It is observed that the roof of nearby building made of steel sheets along with C-channel and steel square pipes for holding the steel sheets has dislocated from its place (approx. 50 meters away from tower) and collided with the leg section of the tower (be-tween A-leg and D-leg) due to very heavy wind. The roofs steel sections were very heavy as is evident from pictures attached [Fig.7(c)]. | | | | |

**Fig 7(c). The roofs steel sections.**

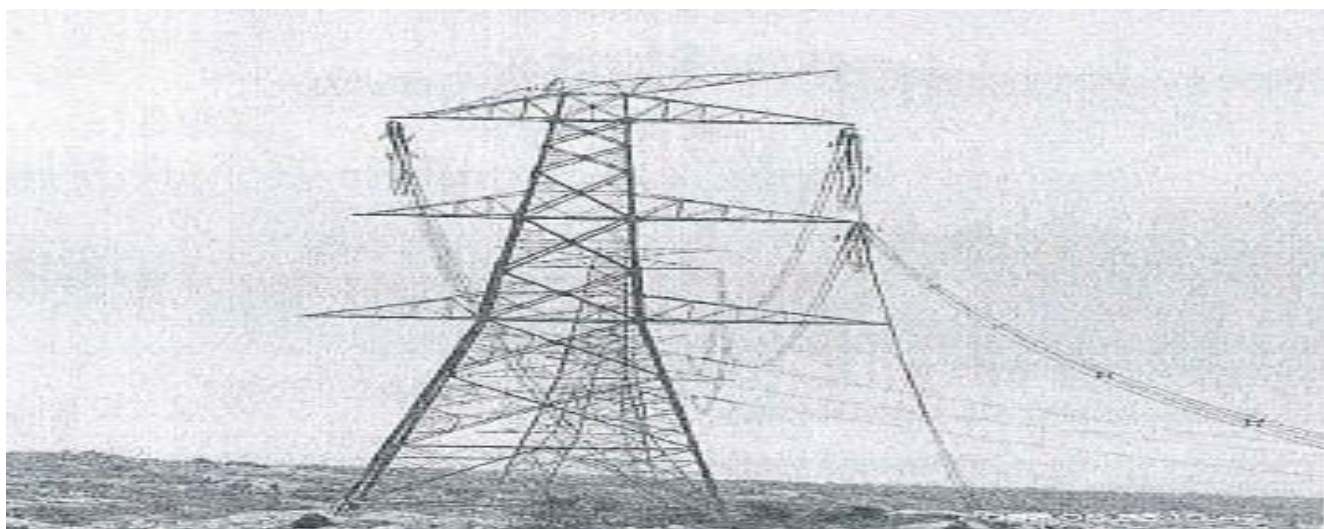
**Fig 4(a). Tower at Location No.: 1079 (DB+6) - Earth wire peak damaged.**

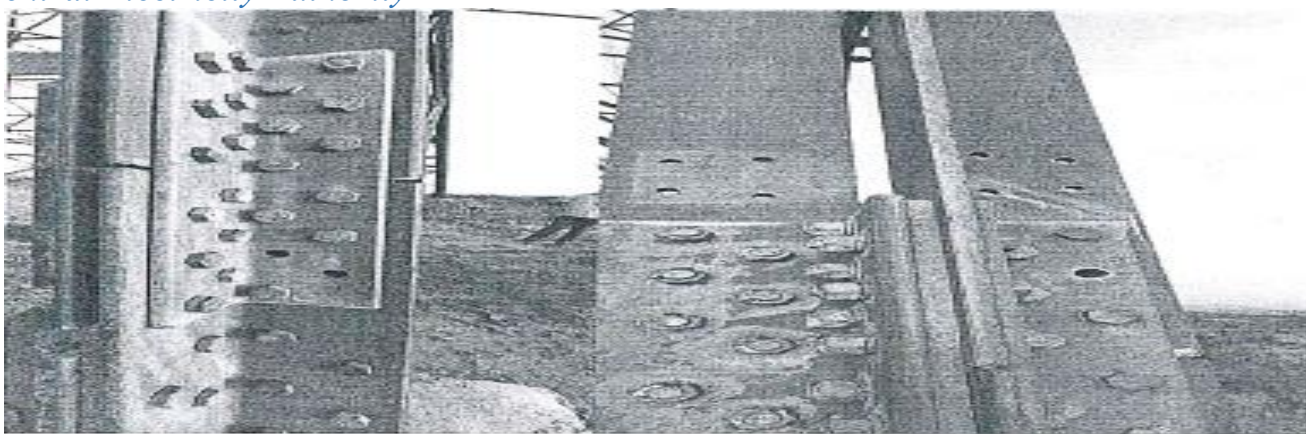
**Fig 4(b). Tower at Location No.: 1079 (DB+6) – Missing Nut/Bolts.**

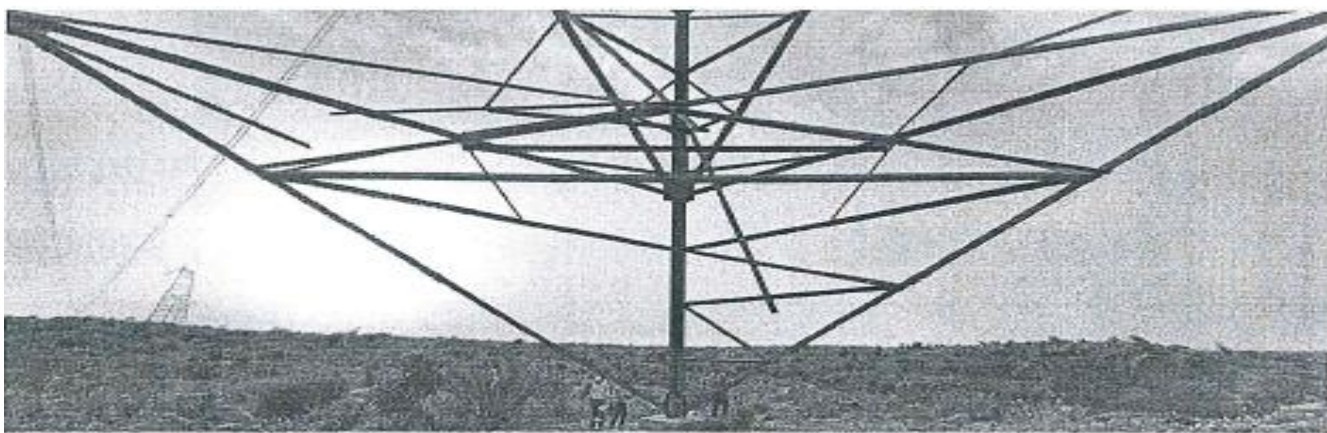
**Fig 4(c). Tower at Location No.: 1079 (DB+6) – Missing Members.**

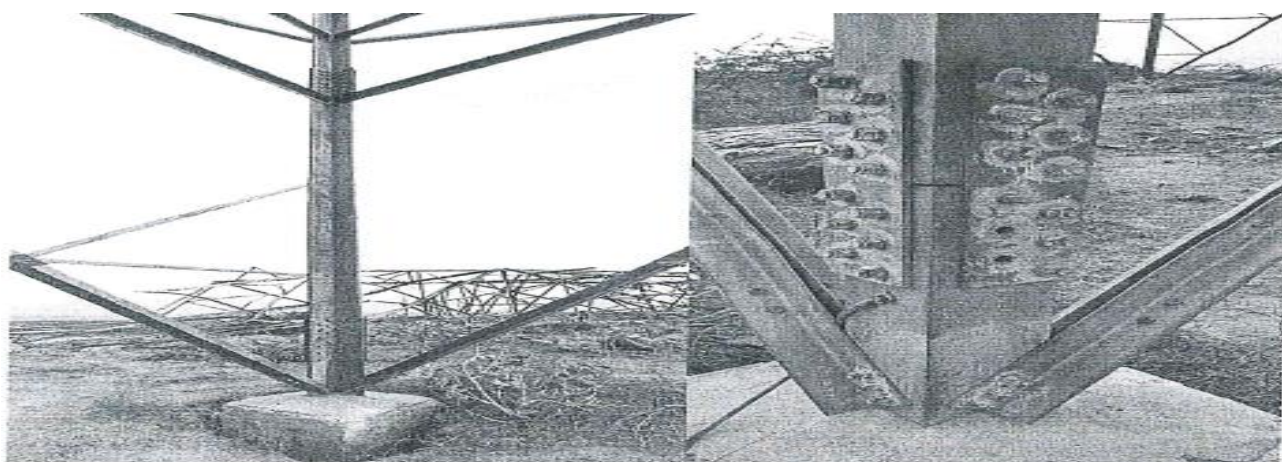
**Fig 4(f). Tower at Location No.: 1080 (DA+9) – Missing Nut/Bolts.**

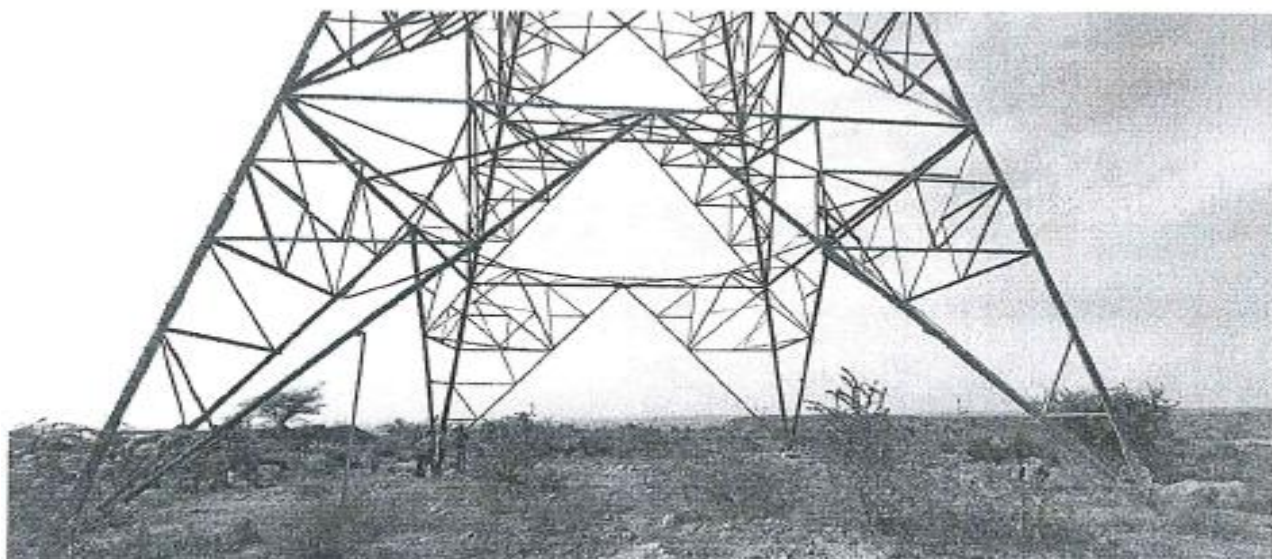
**Fig 4(g). Tower at Location No.: 1080 (DA+6) – Missing Members.**

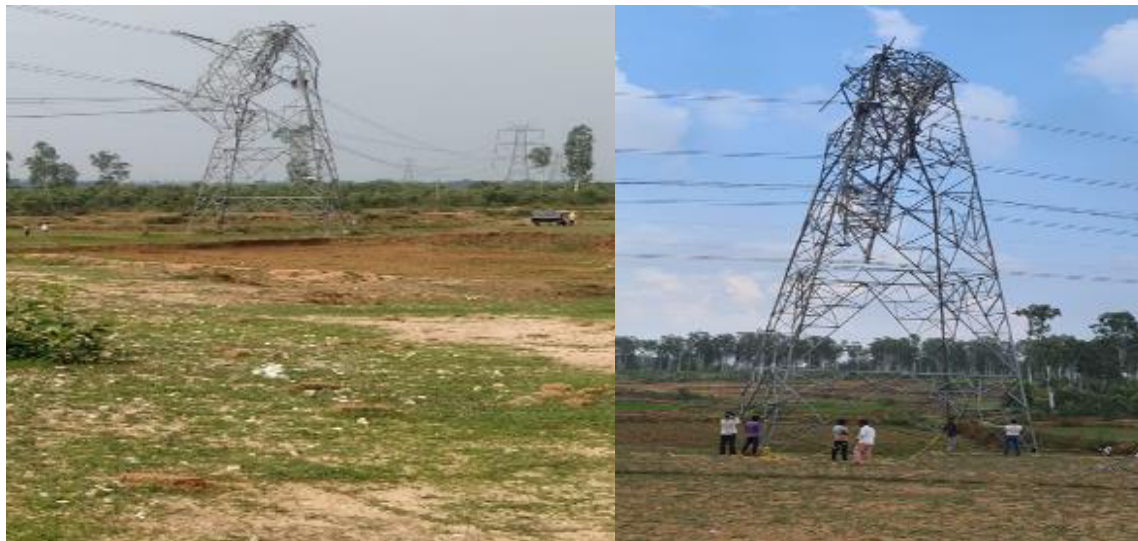
Committee observed that the tower failure occurred due to sabotage of members by the miscreants.

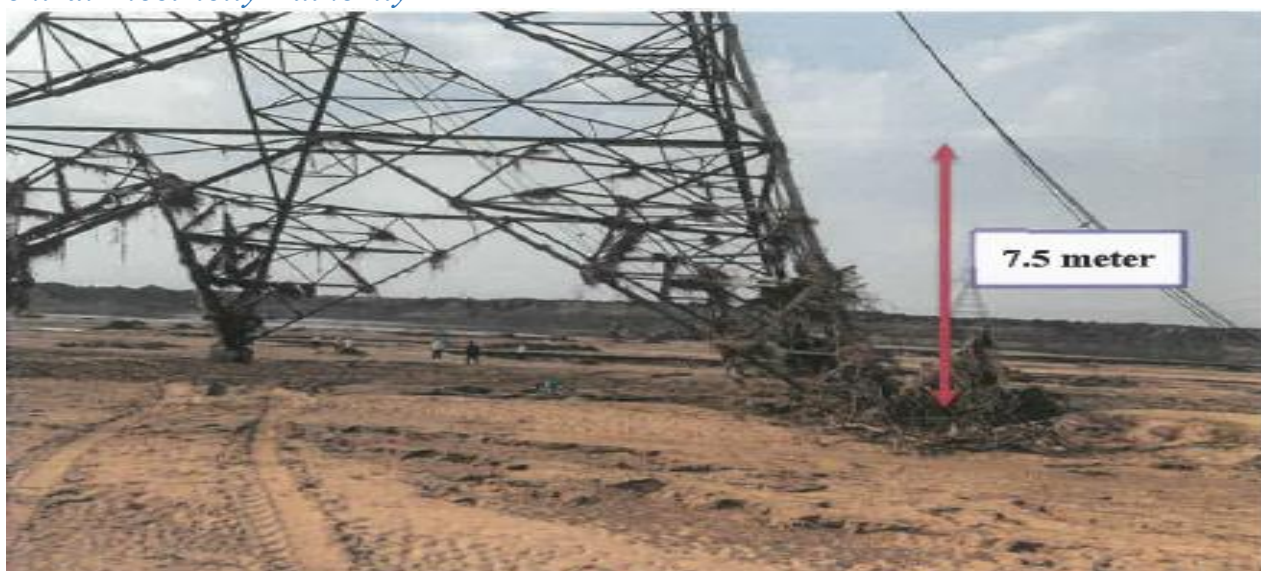
**Fig 5(c). Tower at Location No.: 246 (D+0)-Debris Observed**

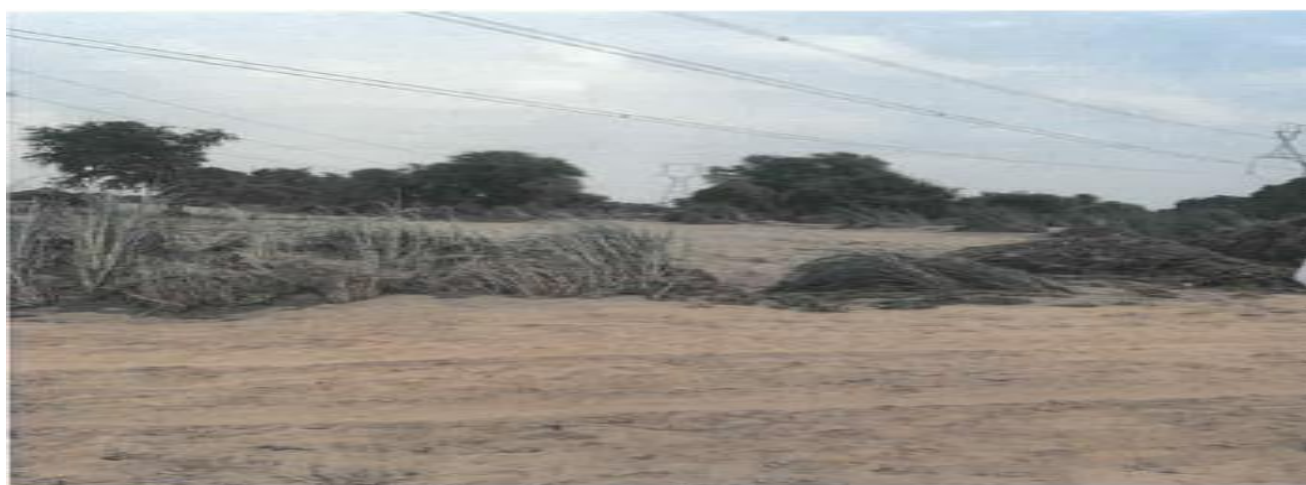
- c. Patrolling data of tower was checked and no defects in the reports found.
- d. During the committee visit, visible evidence of water logging/bend grass in direction of water flow along with accumulated debris up to 7.5 meter height in tower at location no. 246 was also observed.
- e. Committee identified and recommended samples for material testing in laboratory.
- f. Results of recommended test samples have yet to be received.

**Fig (d). Bend Grass in the direction of Water Flow.**

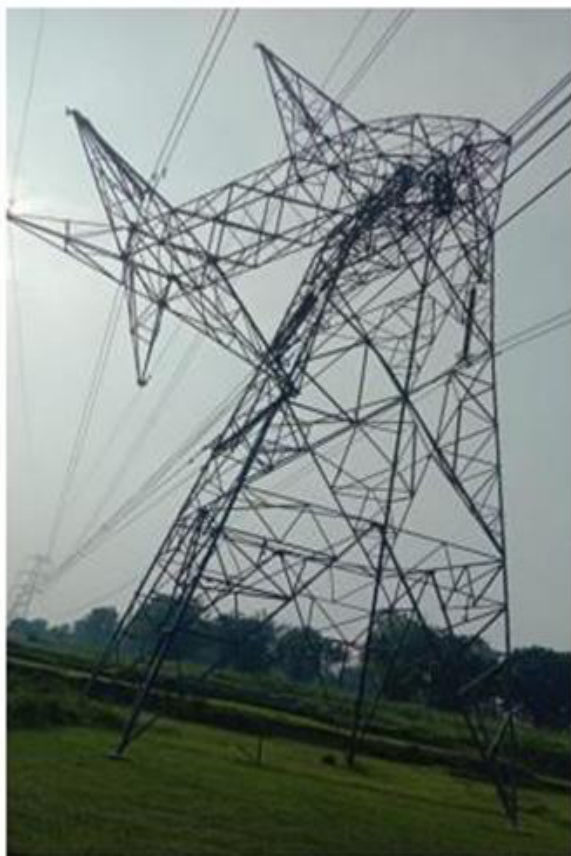
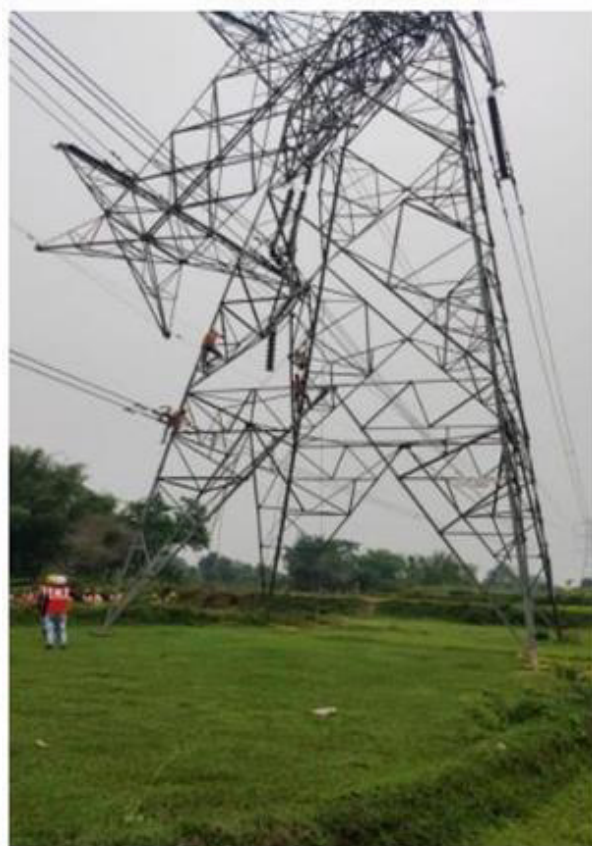
Committee observed that the tower failure occurred due to sabotage of members by the miscreants.

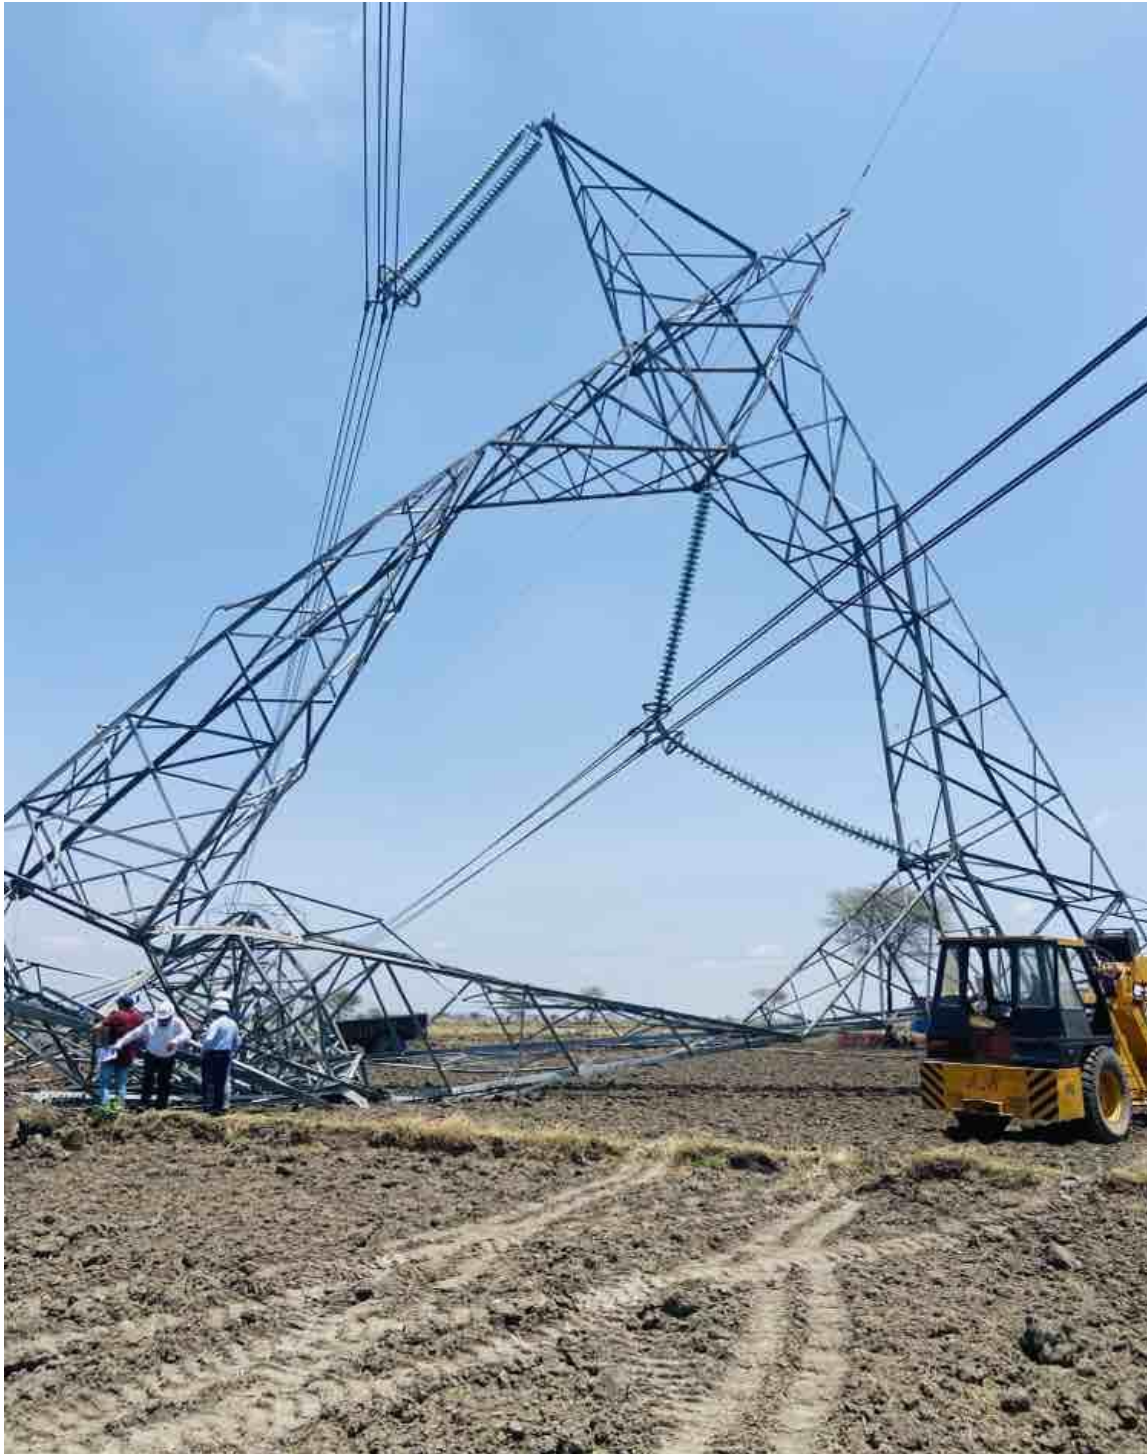
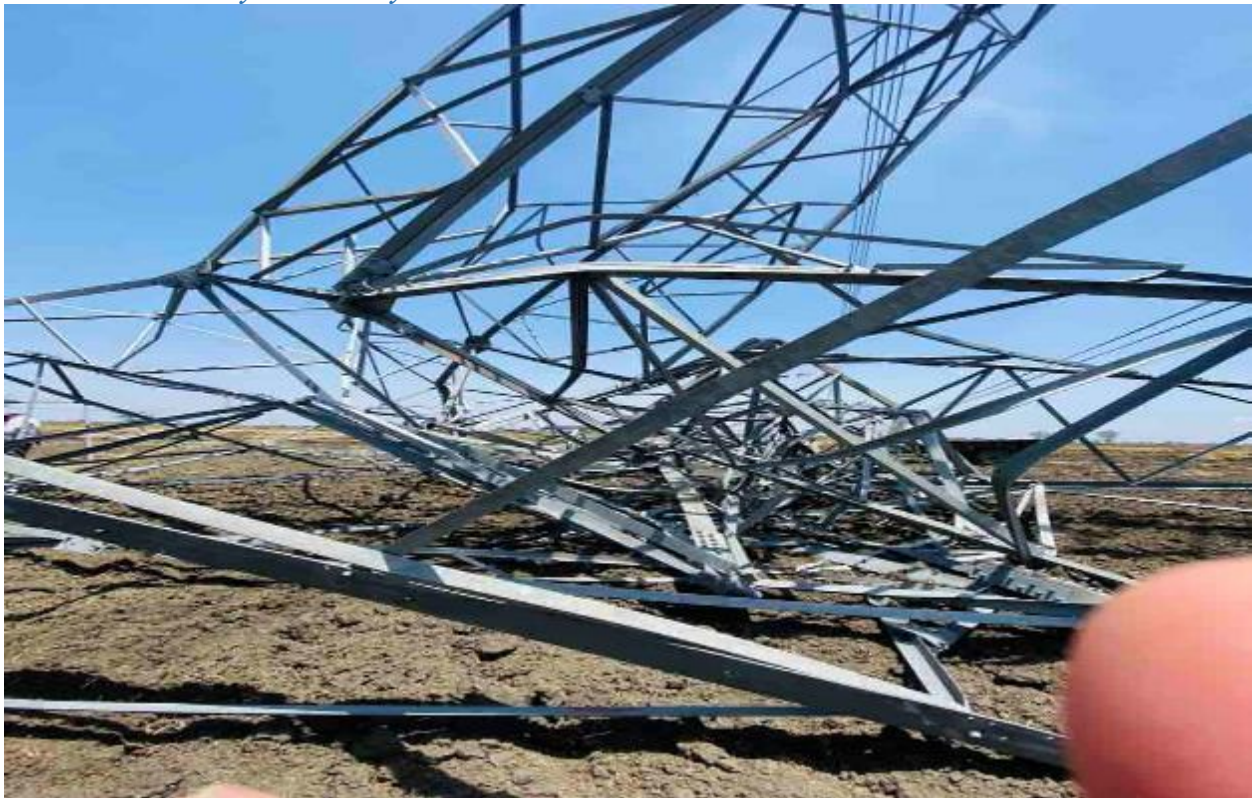
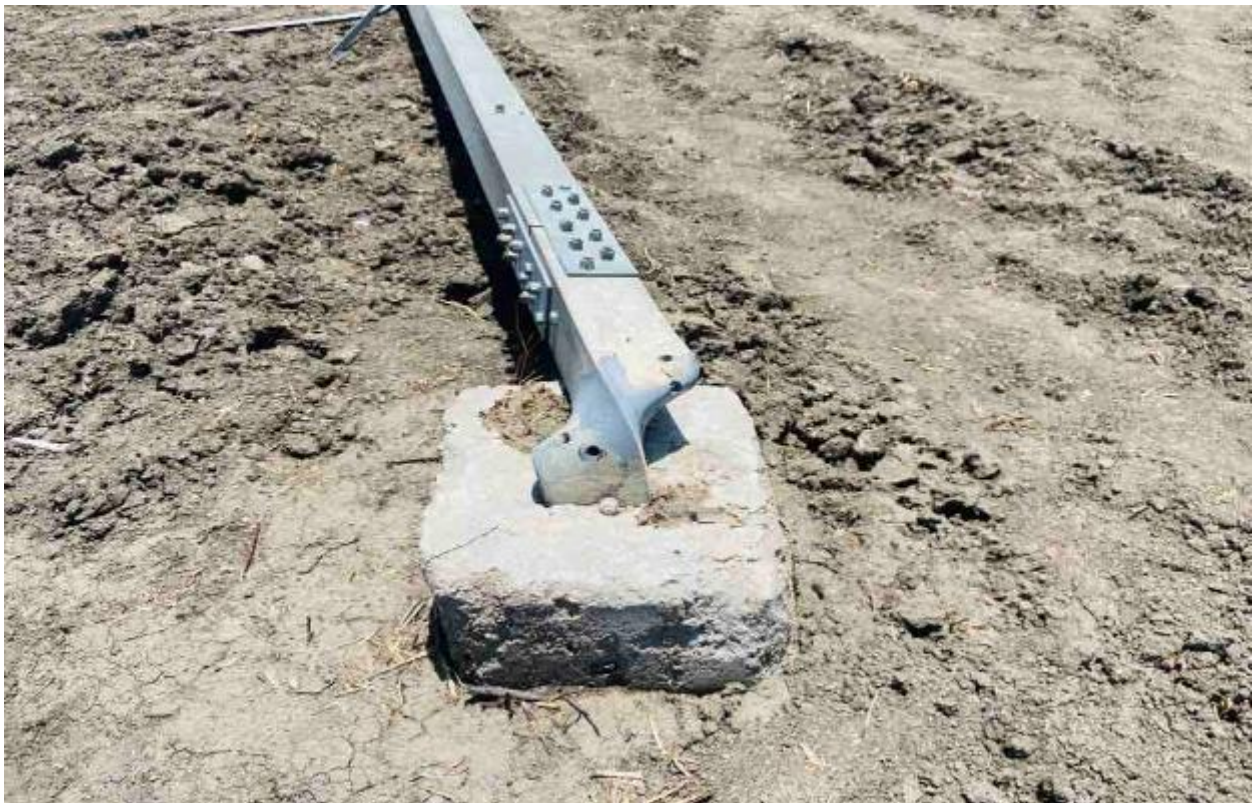
It was observed that 01 No. of Suspension Type tower at location No. 560 got collapsed. Committee observed that the tower failure occurred due to theft of tower members.

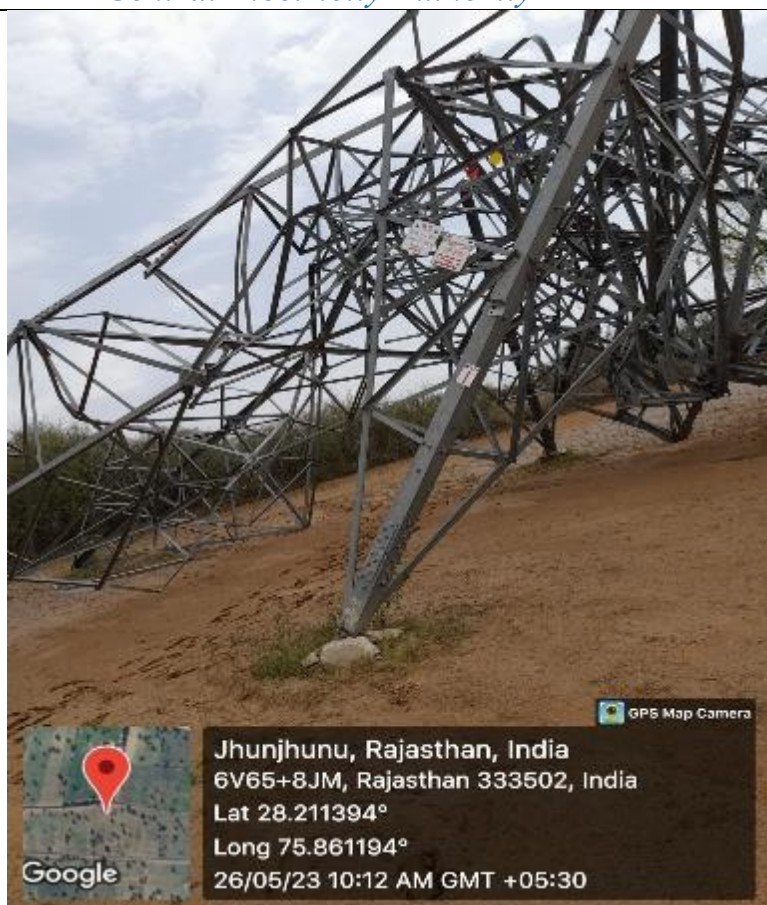
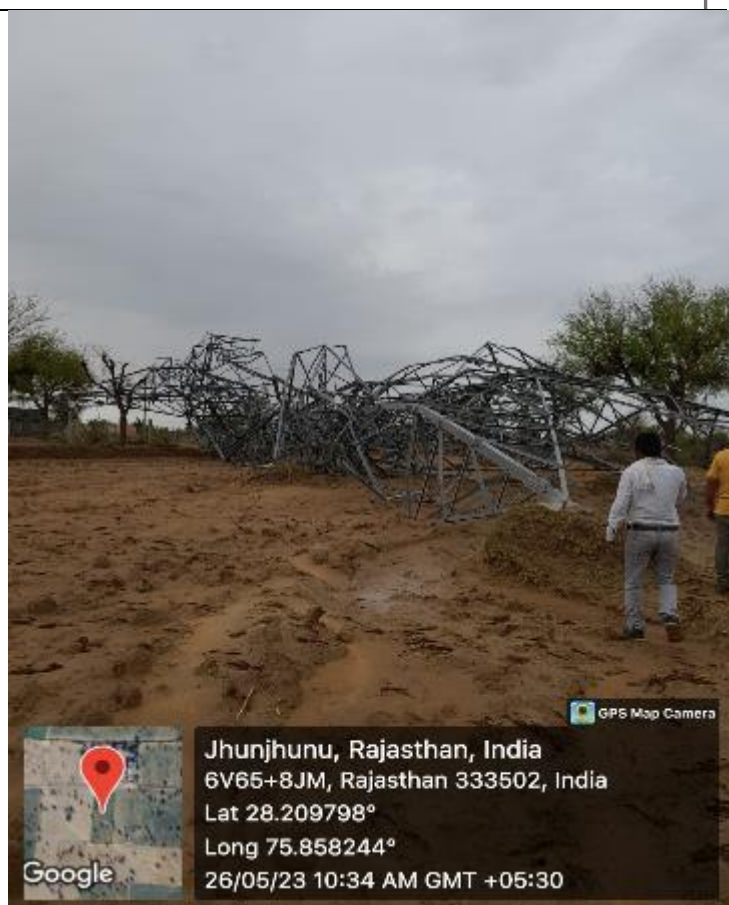
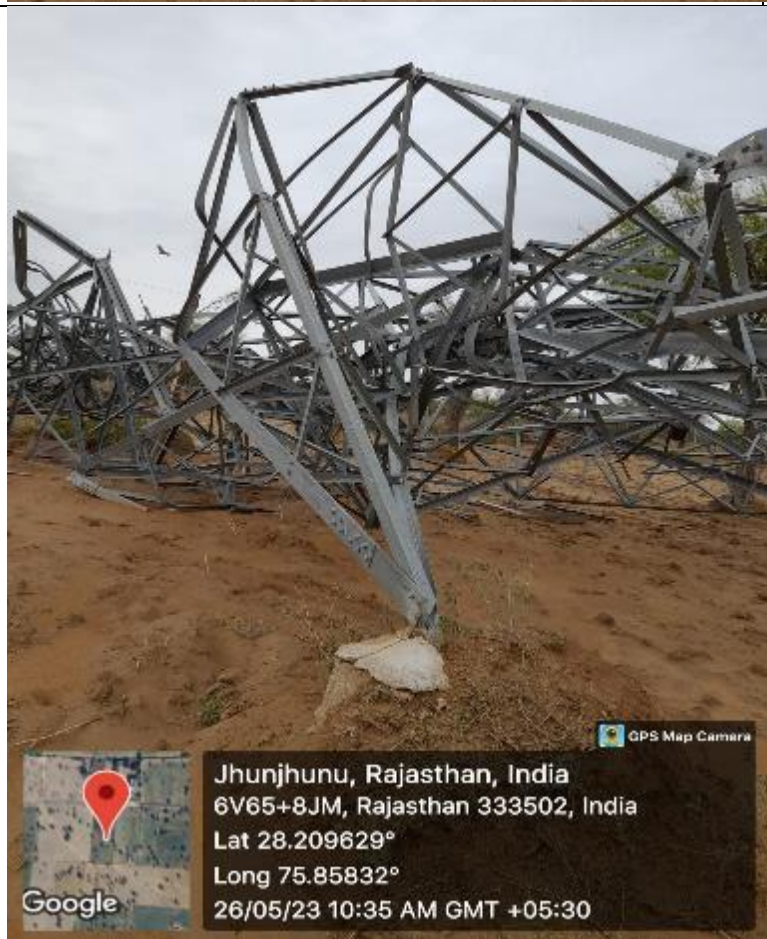
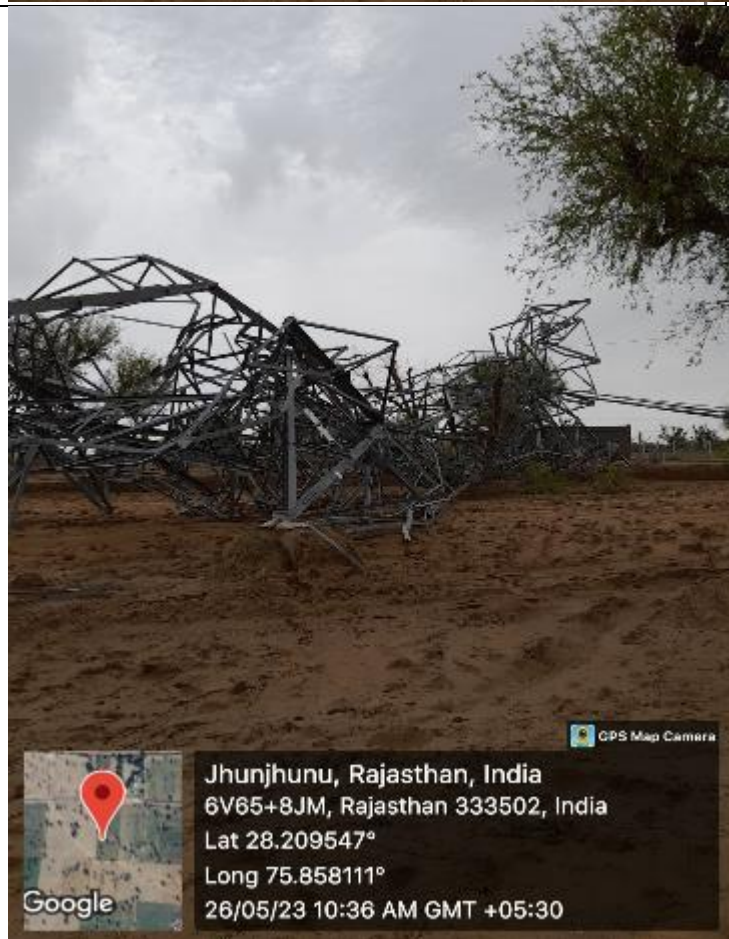
It was observed by the committee that the 07 Nos. of Transmission Line Towers at Location No. 556 (SA+0), 557 (SA+0), 558 (SB+6), 559 (SA+0), 560 (SB+6), 561 (SA+0) and 562 (SA+0) got collapsed. The towers was designed for basic wind speed of 47 m/s corresponding to wind zone-4 and as per IS: 802-1995. It was also observed that this is the third instance of tower failure of the line. Earlier on 23.05.2016, 08 Nos. of Towers at Location No. 65/4 (SA+0), 66/0 (SE+0), 66/1 (SA+0), 66/2 (SA+0), 67/0 (SD+0), 67/1 (SA+0), 67/2 (SA+0) and 67A/0 (SB+0) collapsed which was 30 km from Bhiwani Substation. Also, on 07.05.2023, 01 No. of tower got bent from upper portion of K-frame.

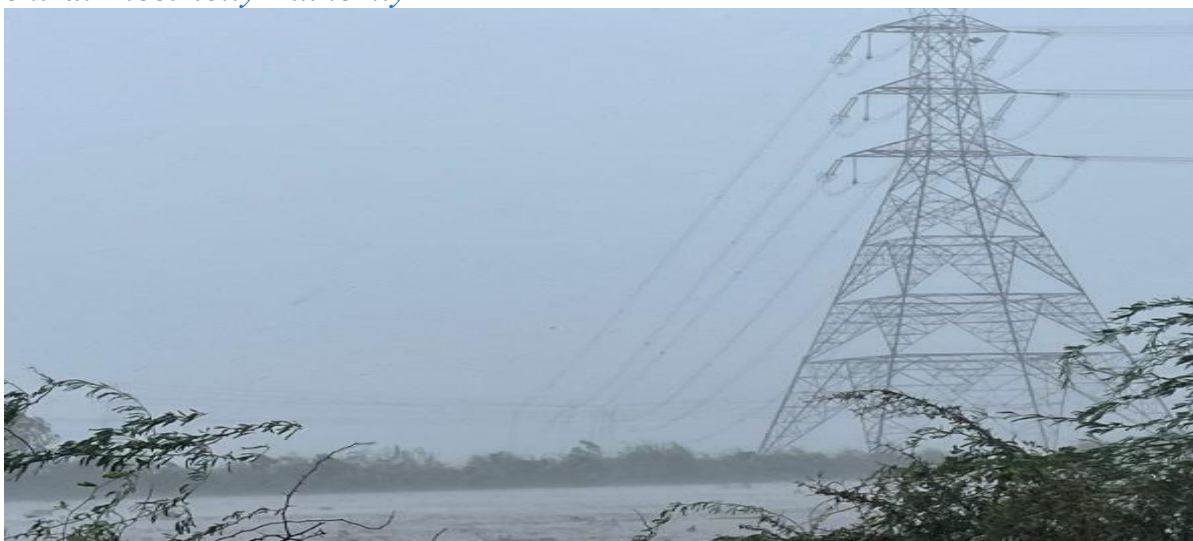
It was observed that 01 No. of Tension Tower (DD+23.5 Extn. 1.5 RC) at location no 248, designed as per IS: 802-1995. Committee concluded that the tower failure was due to heavy wind and rain due to Biparjoy Cyclone in that area. All stubs of leg A, B, C, D got bent and raised Chimney of leg B got completely broken and remaining legs have crack in it.
