**विषय: Report of the Standing Committee of Experts on failure of EHV transmission towers failed during the period January 2022 to December 2023-reg.**

**REPORT OF THE STANDING COMMITTEE OF EXPERTS ON  
FAILURE OF EHV TRANSMISSION TOWERS  
(JANUARY 2022 - DECEMBER 2023)**

### A.1 400 kV S/C Gooty-Somanhalli Transmission line failed on 8.05.2022

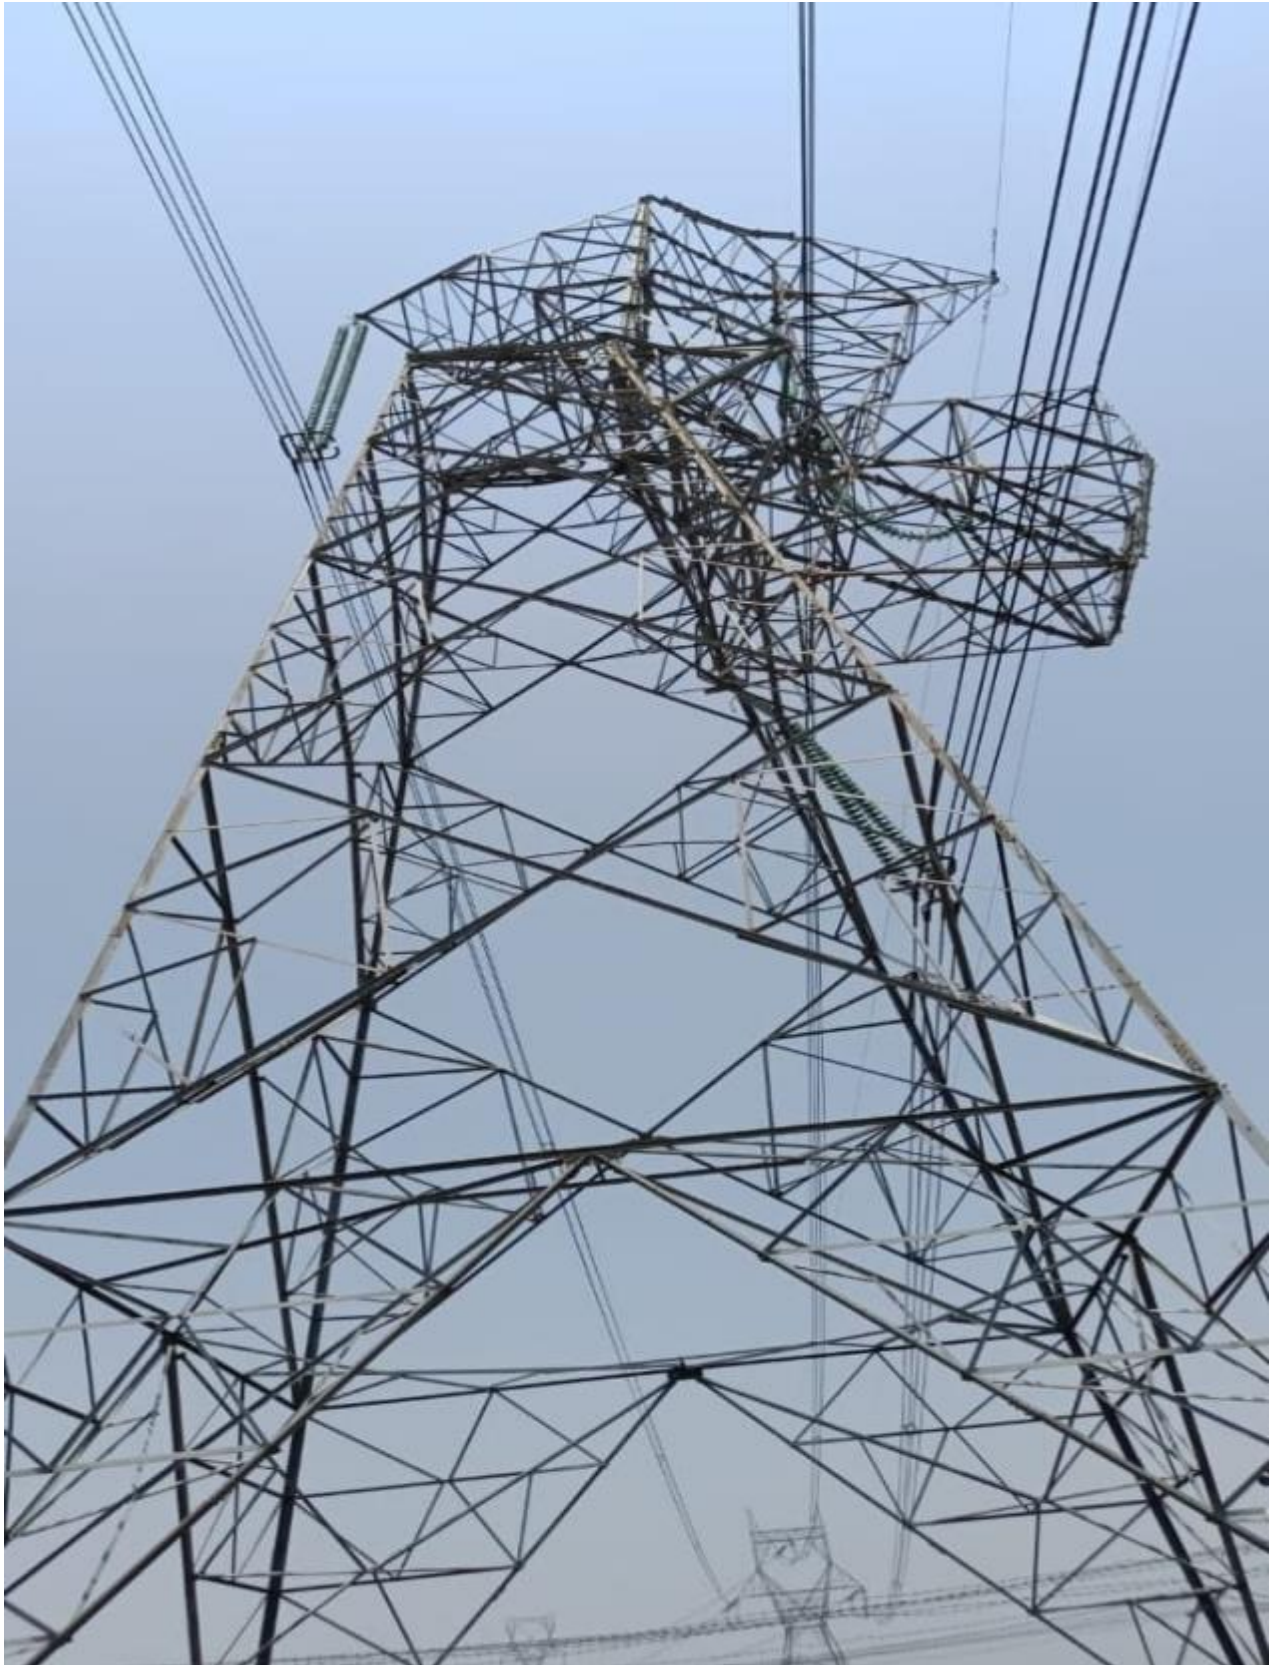
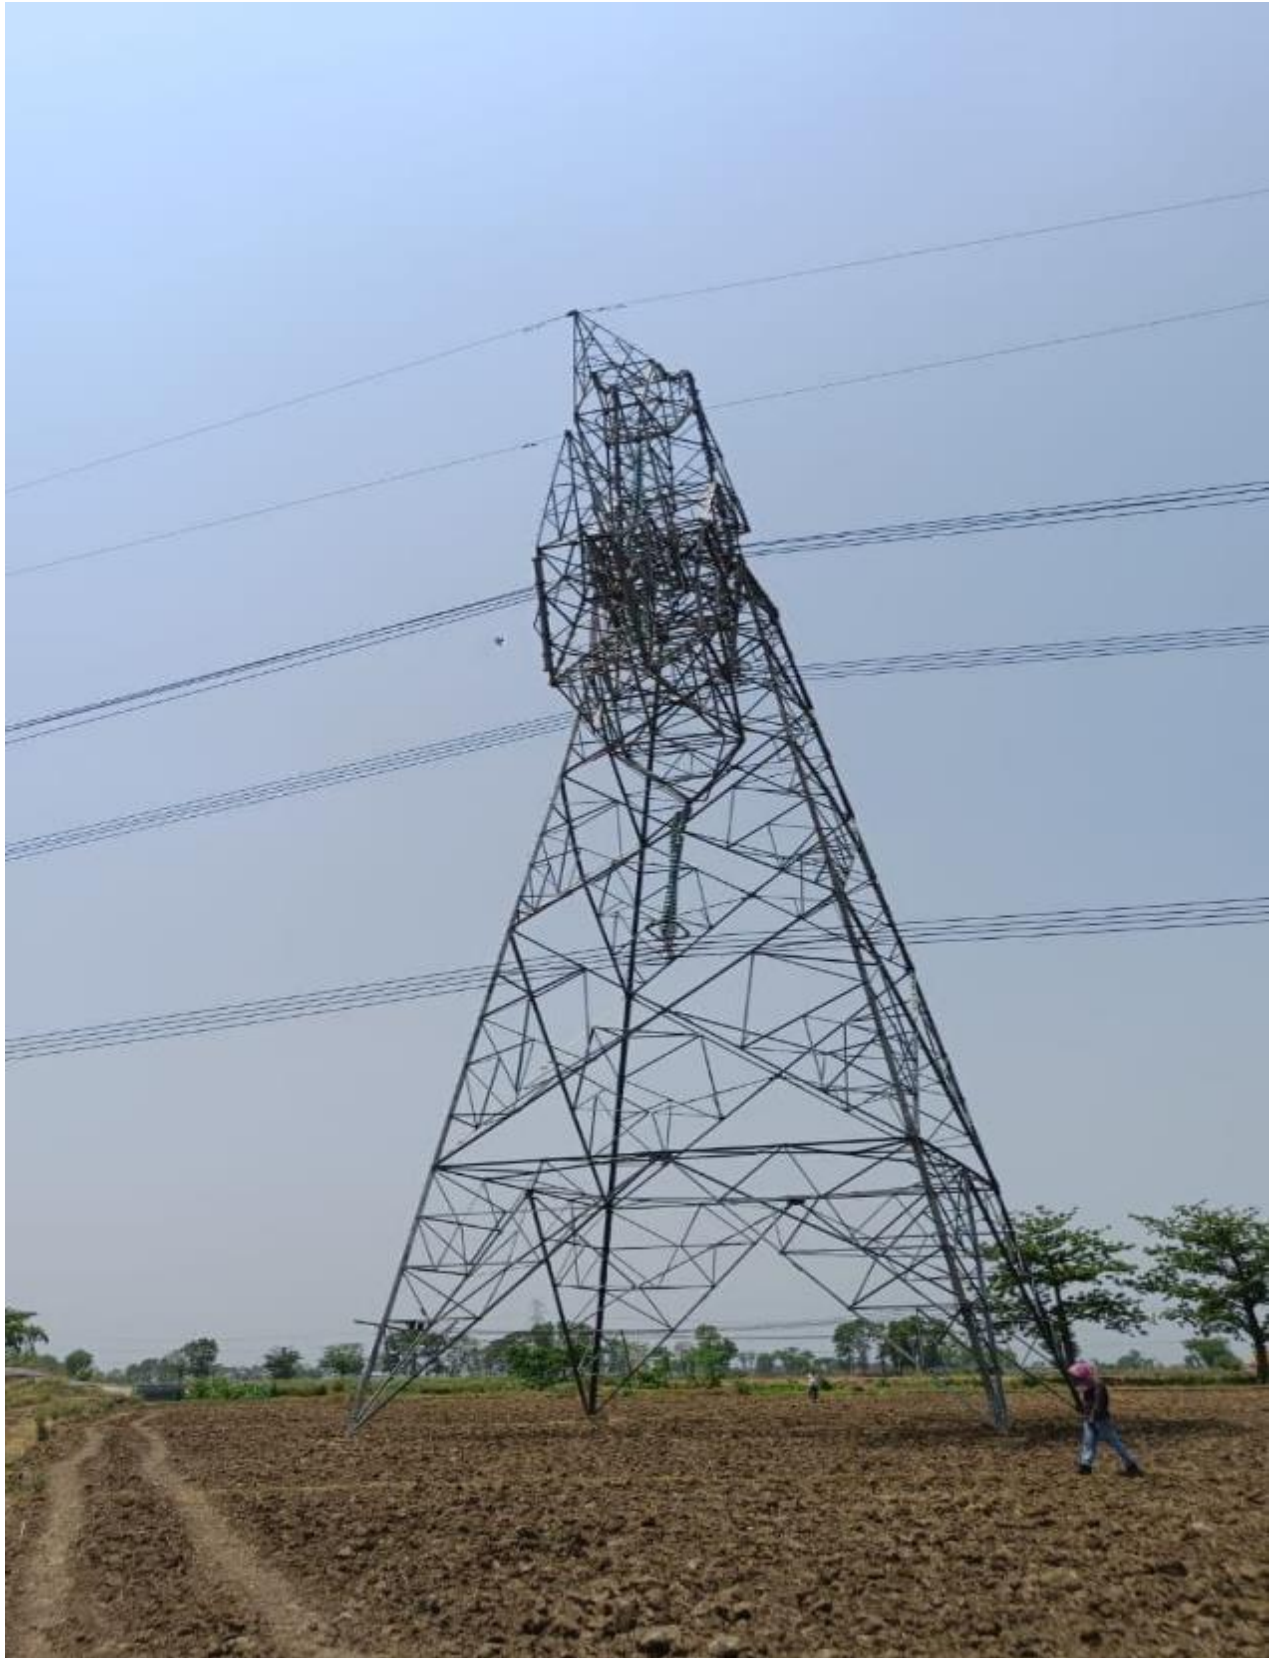
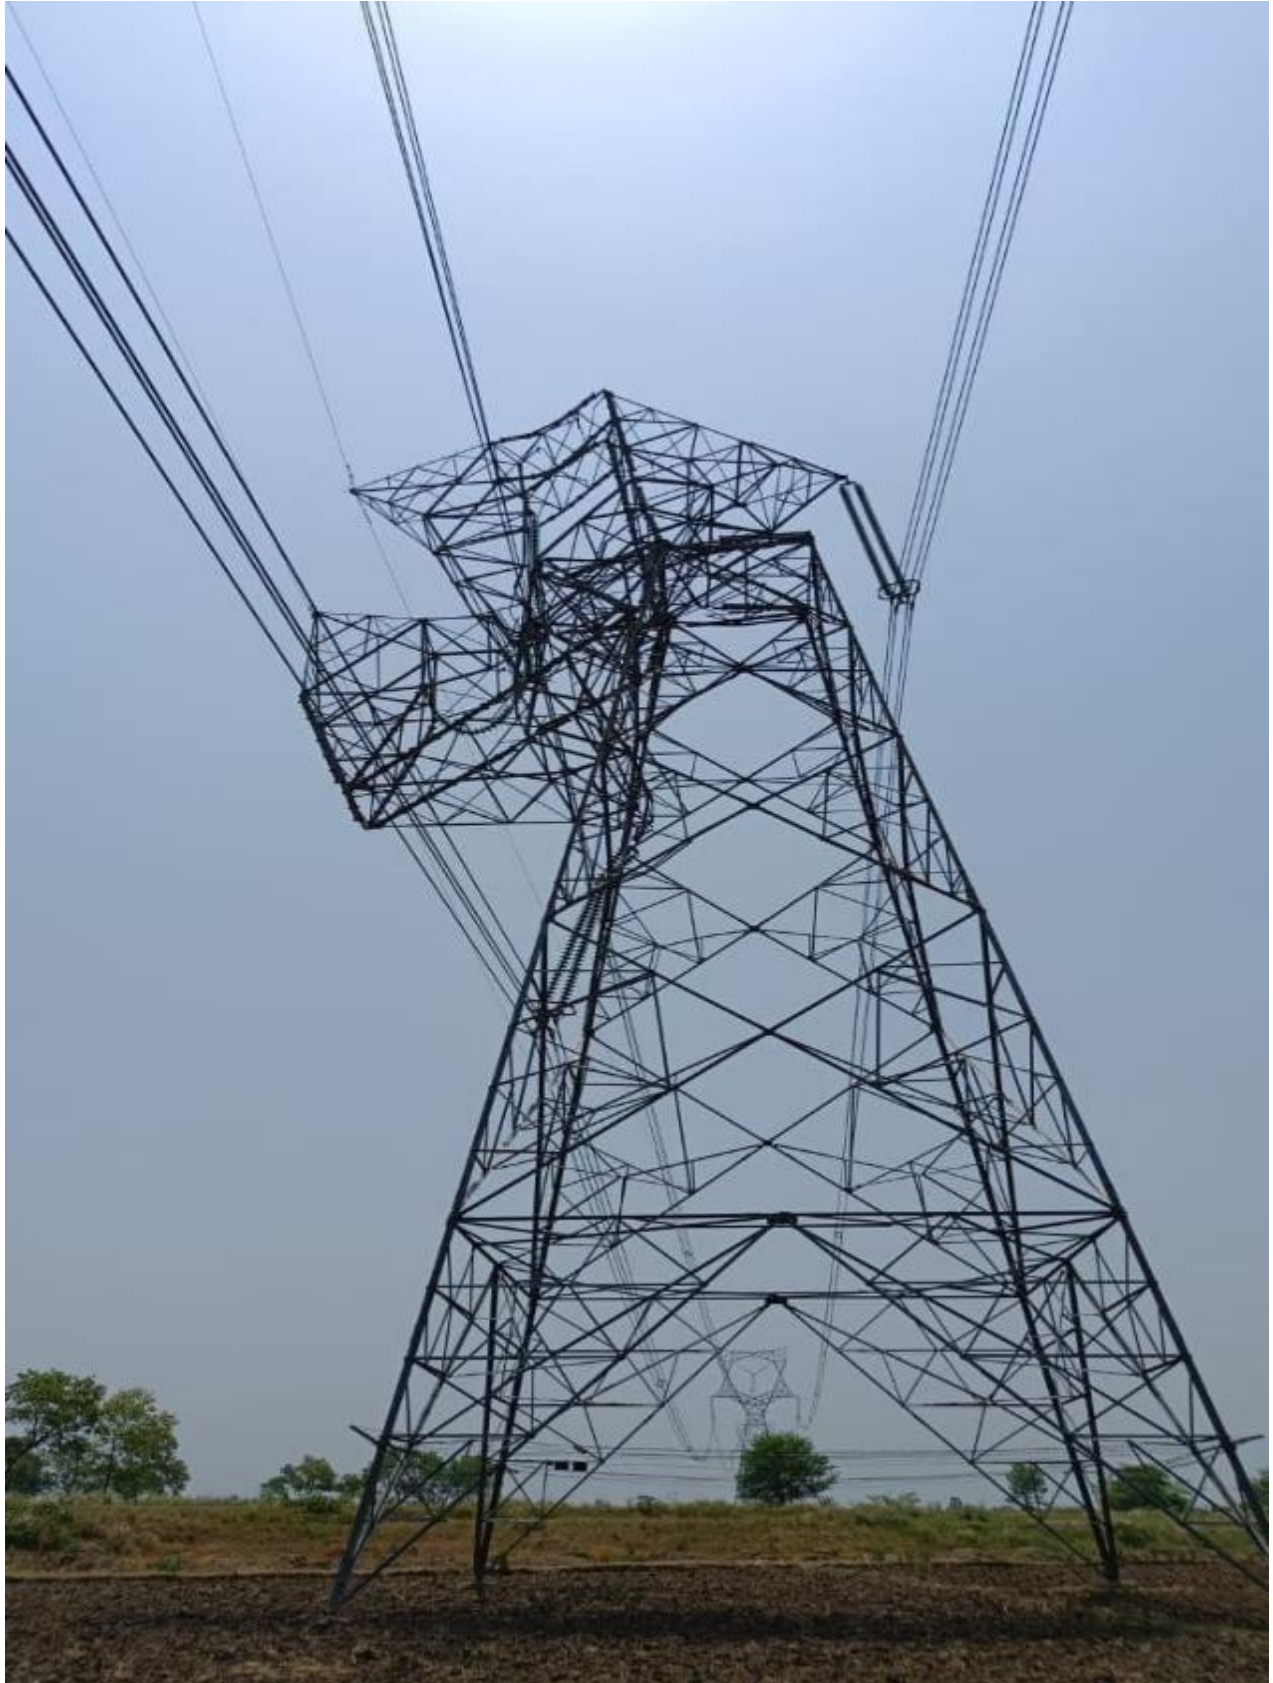
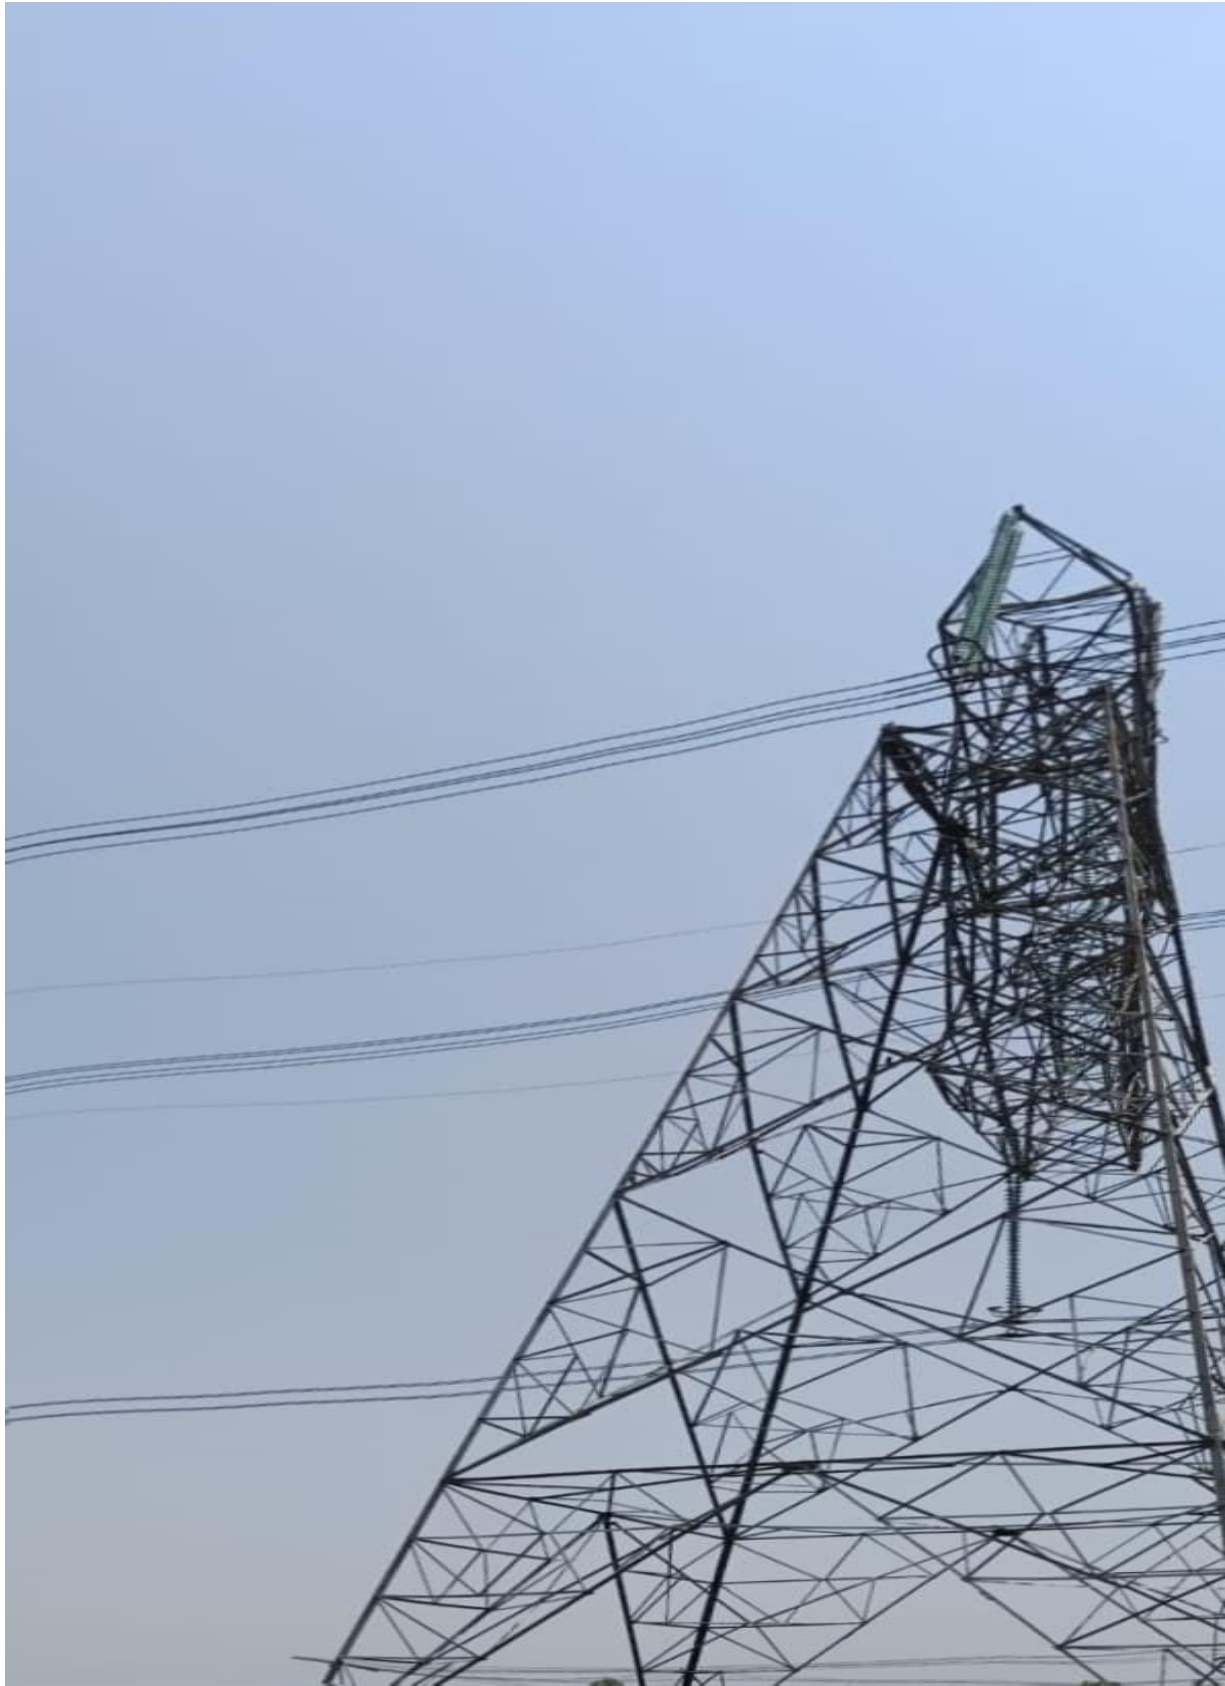
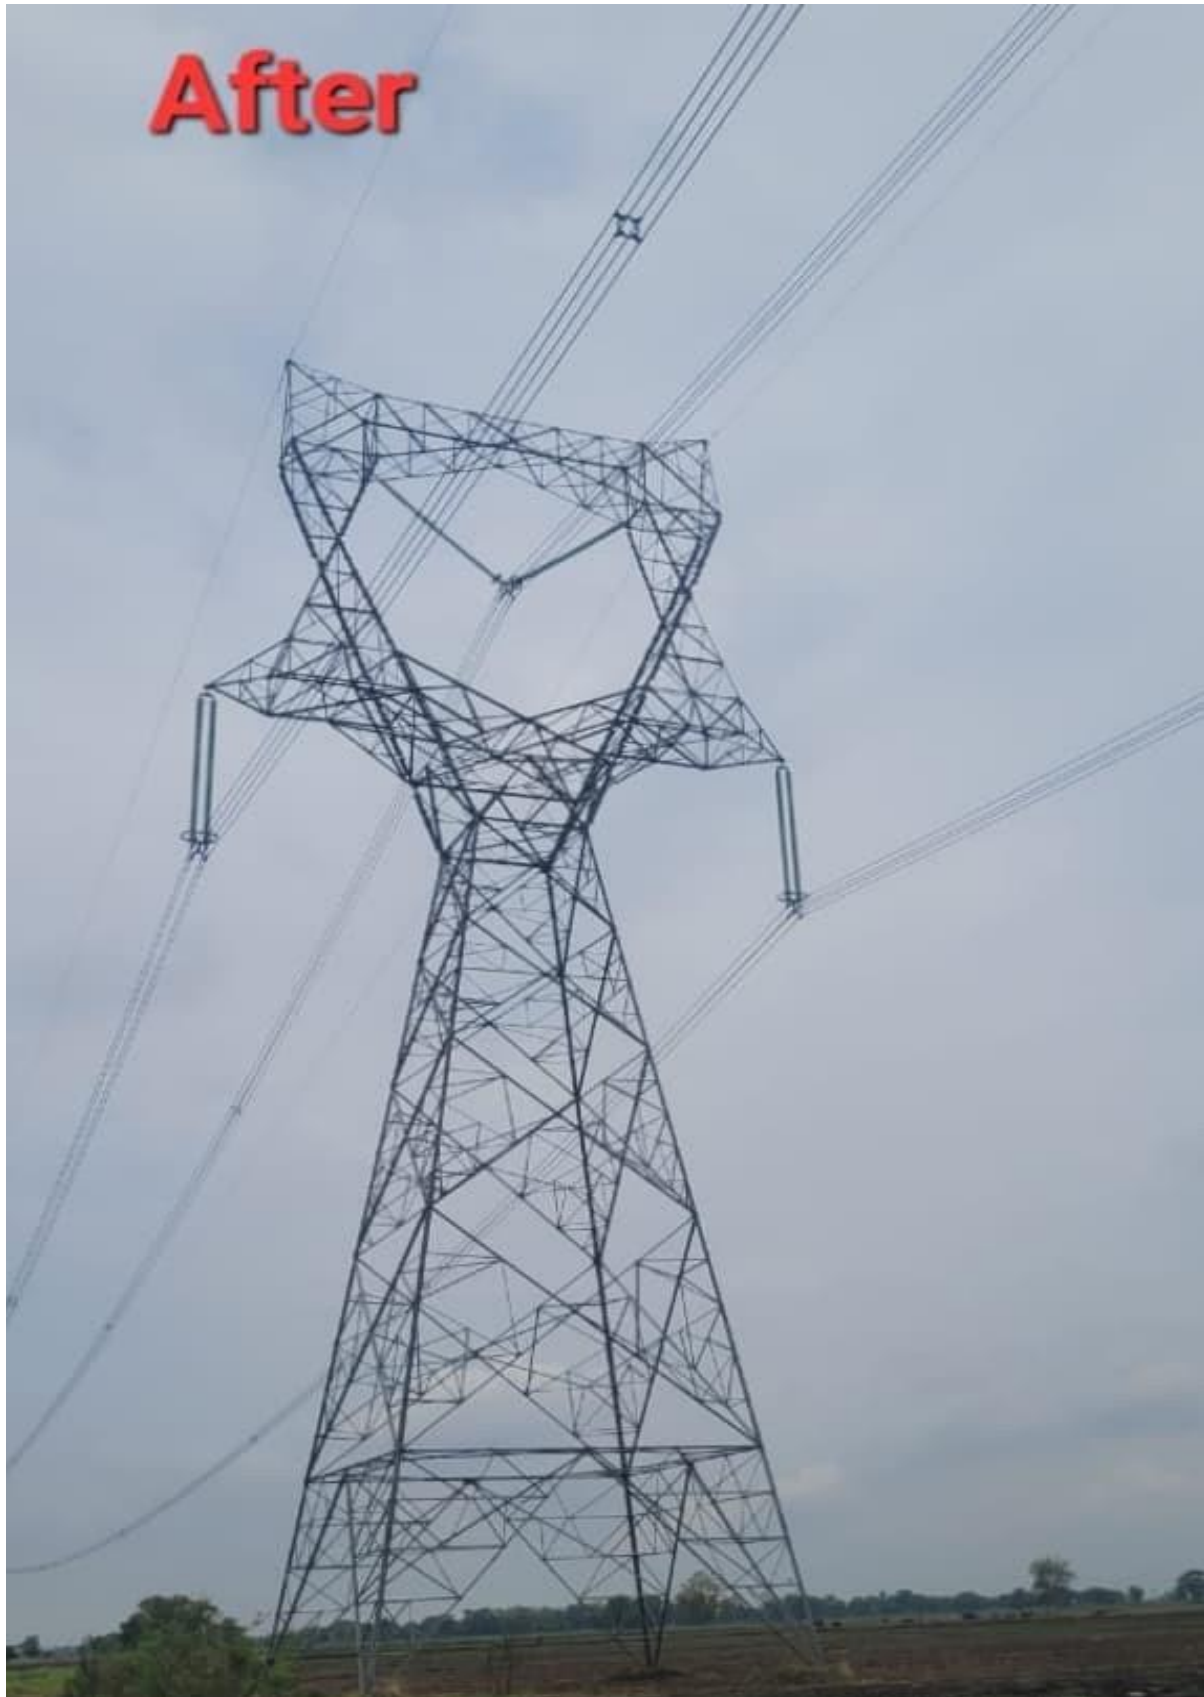
It was observed by the committee that the failed tower (A+0 Delta) at Location No. 318 is located in a plain agricultural field and was designed for wind zone-4 for basic wind speed of 47 m/s as per IS:802-1995. It was observed that the foundation, main legs and stubs of the tower were intact. The tower was collapsed from above K-frame waist level leading to damage of cross arms and peaks. There was no damage to adjacent tower locations, i.e. at 317 and 319.

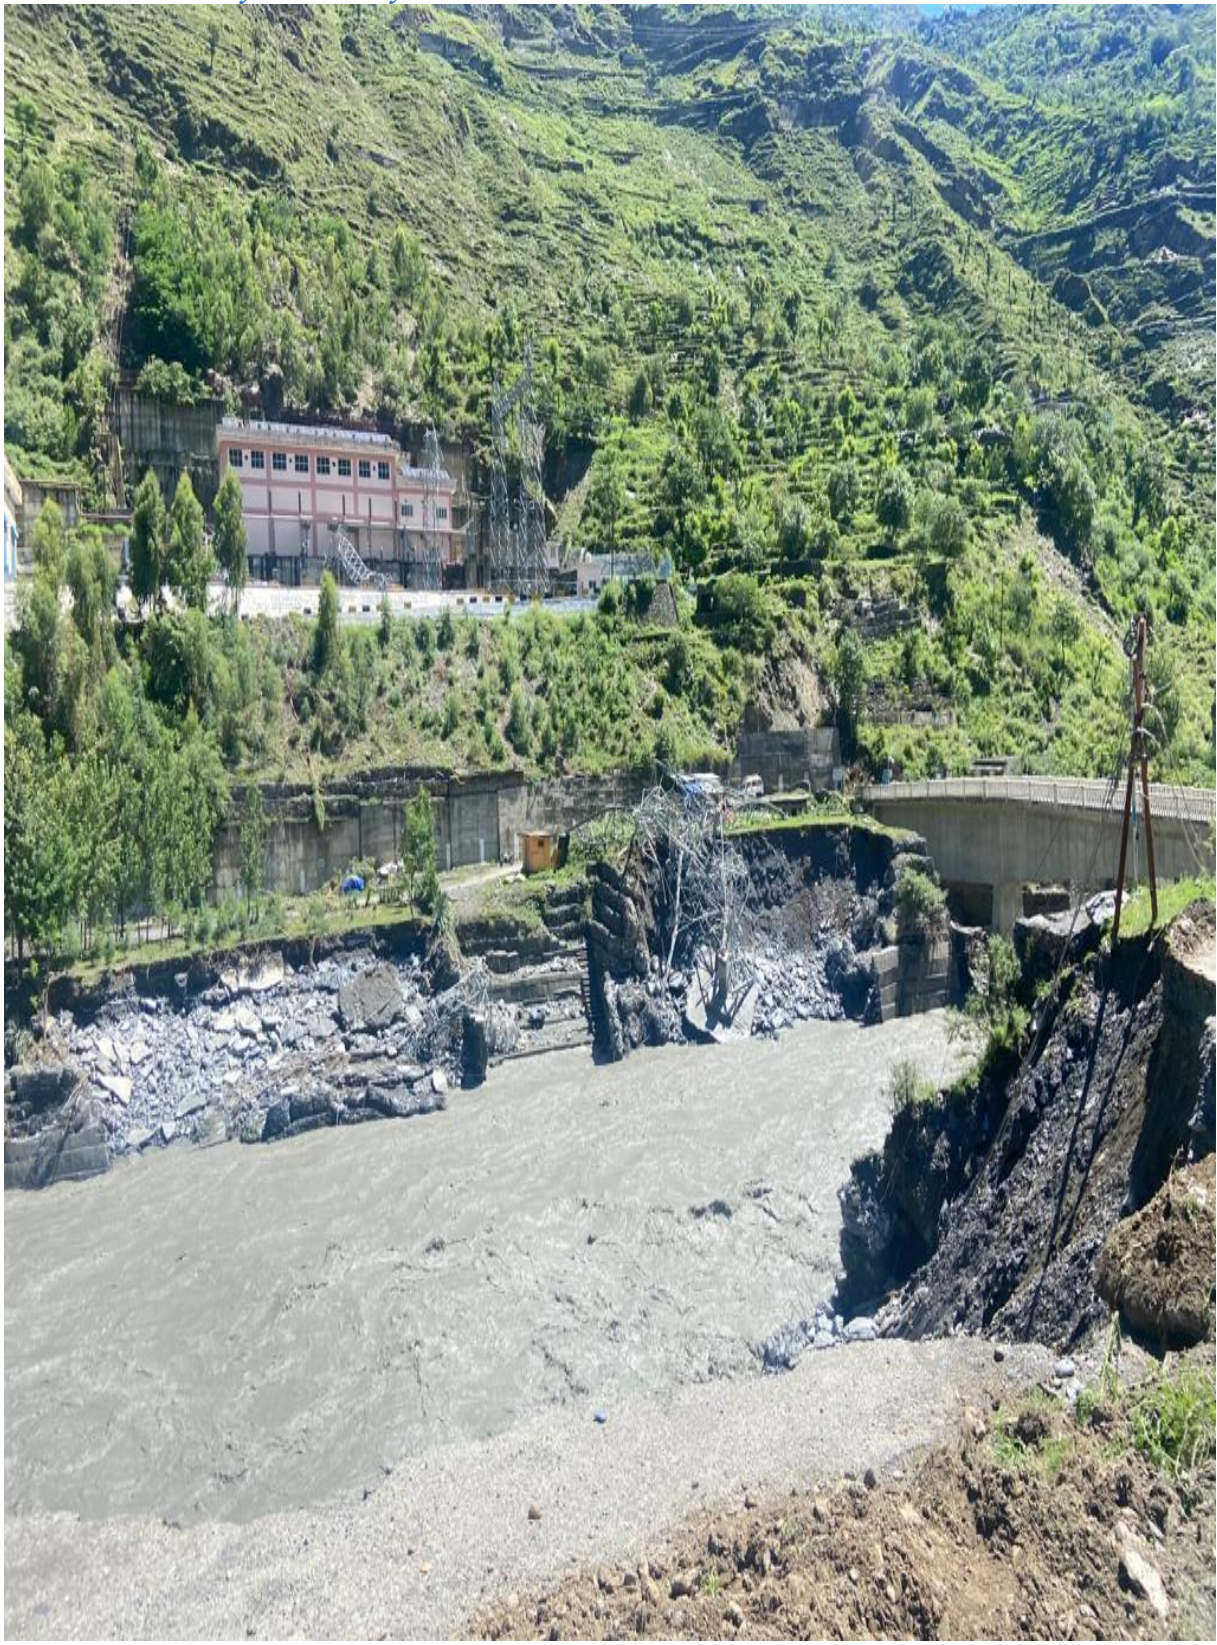
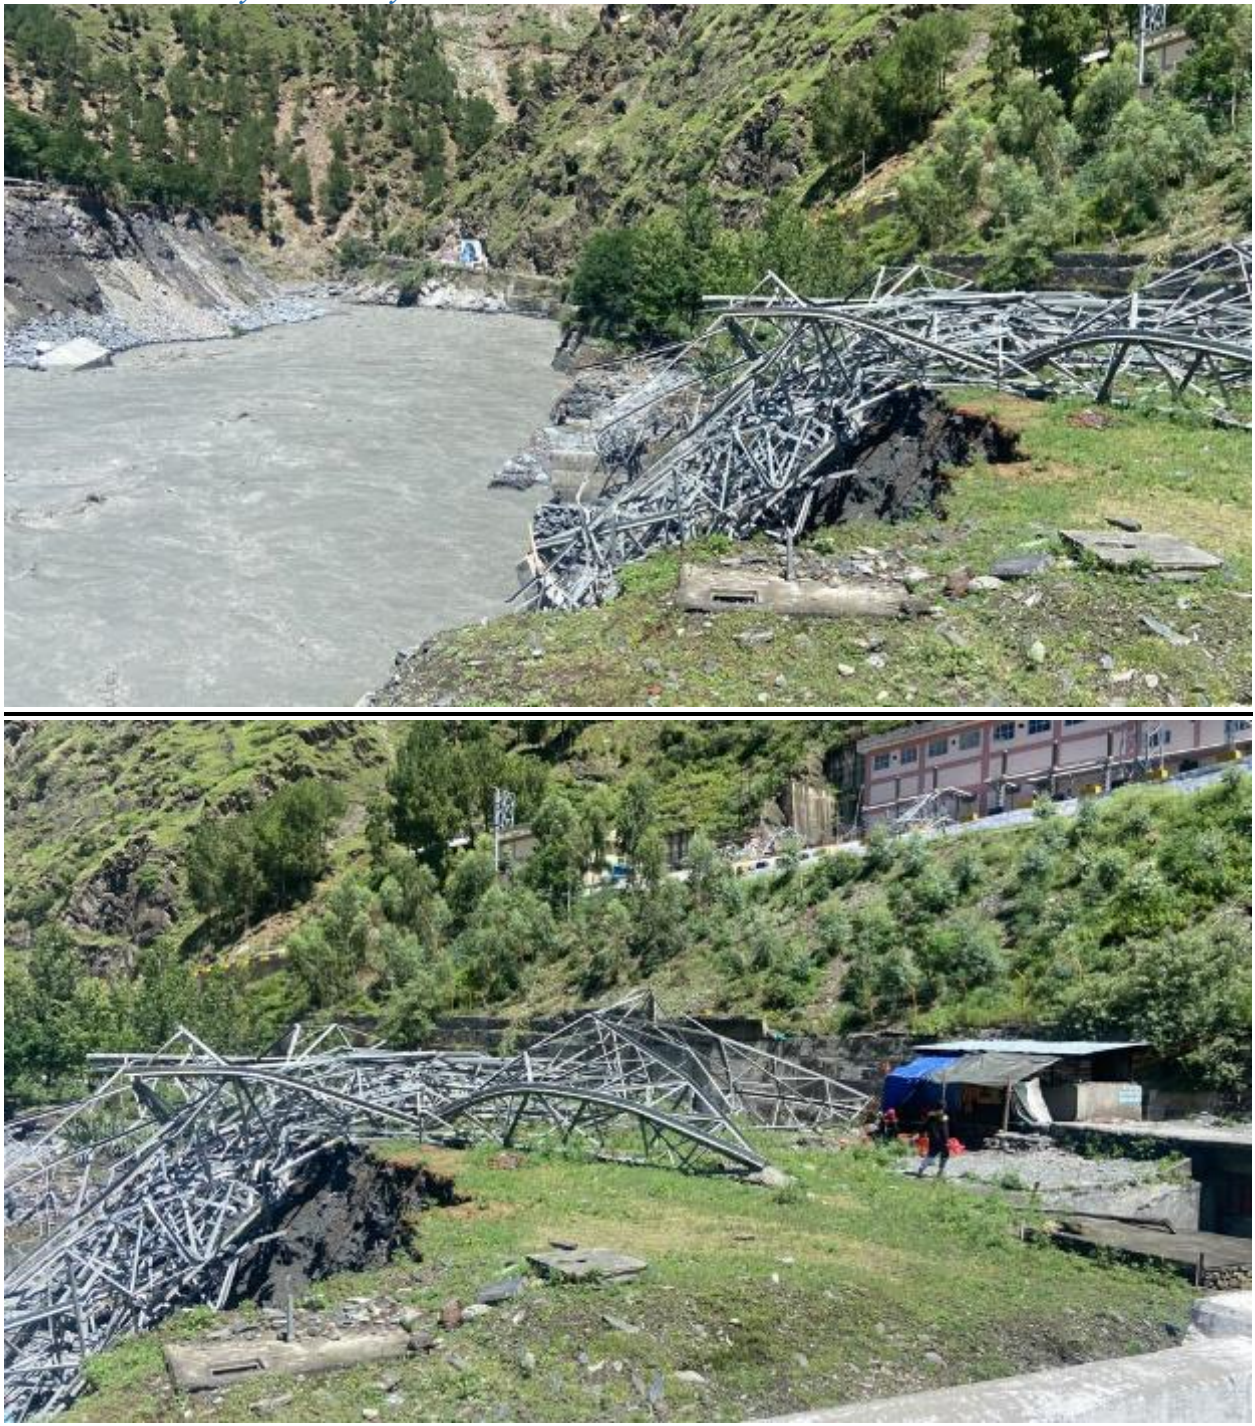
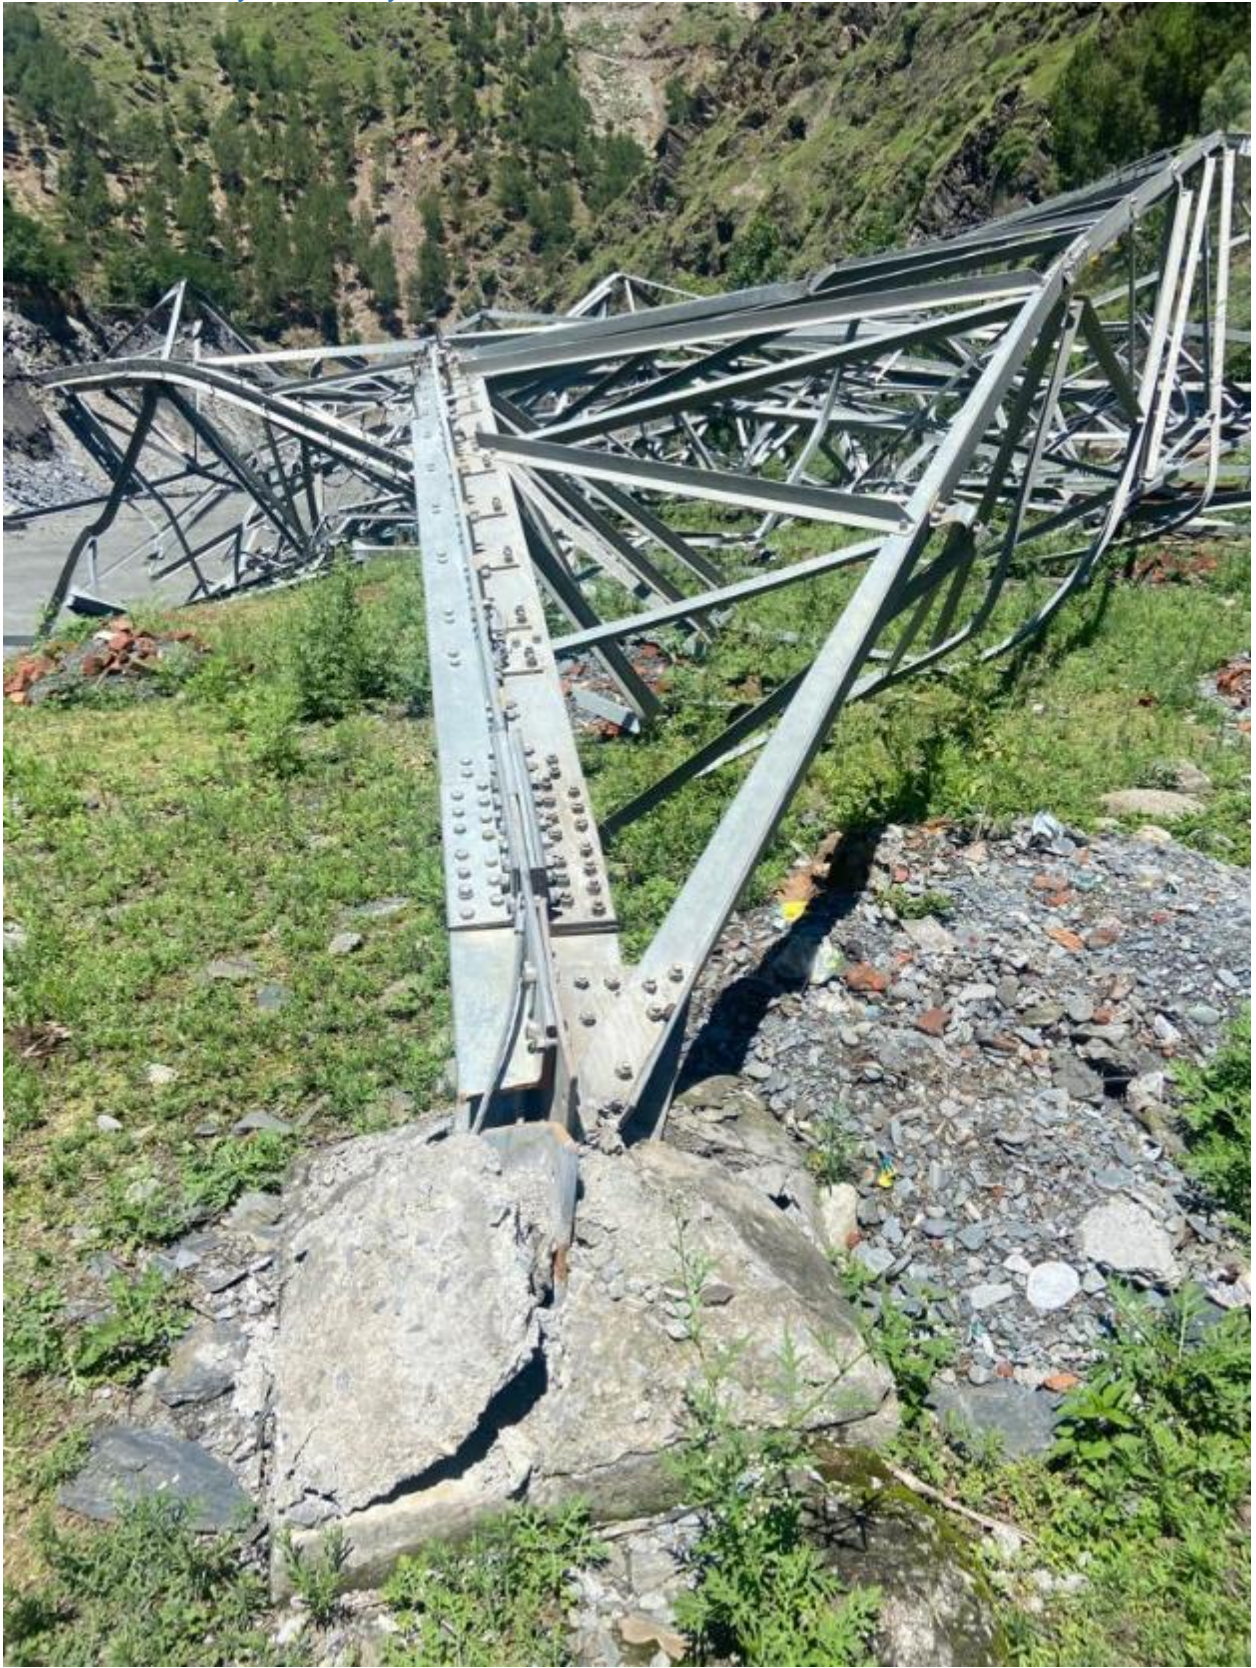
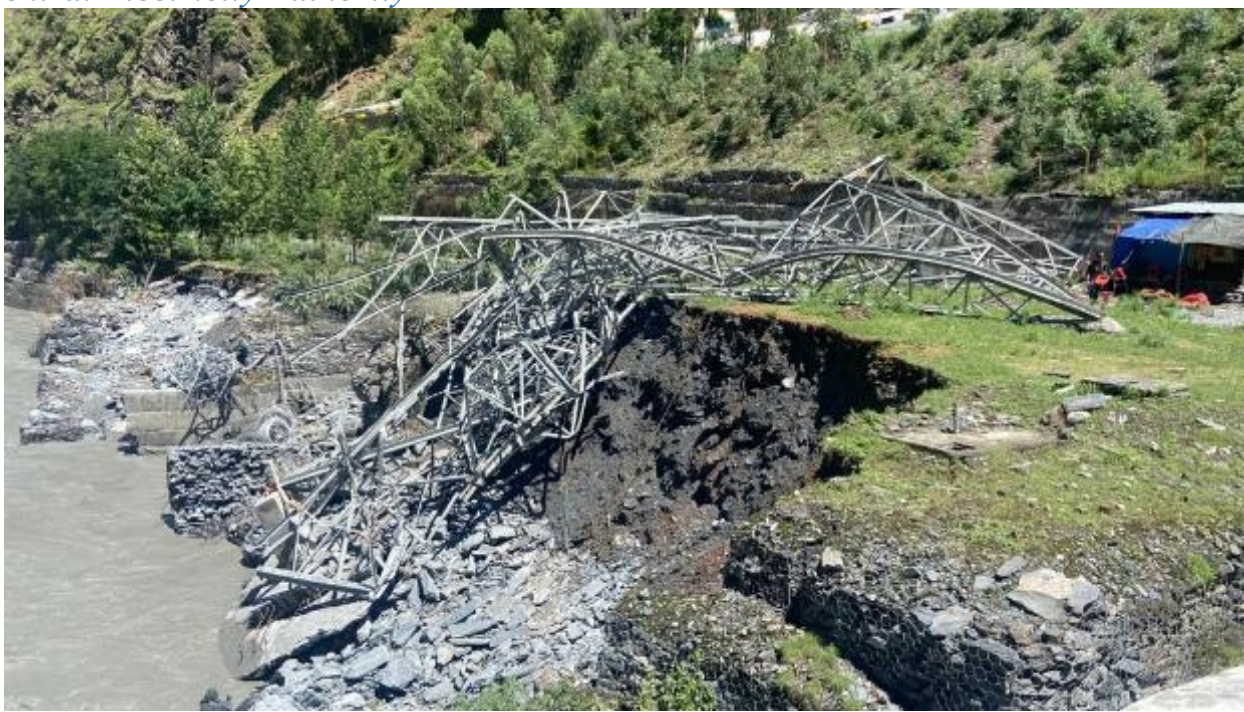
Committee observed that the failure of tower was due to increased flow of water caused due to extensive floods in River Ravi on account of sudden inrush of water owing to torrential rainfall over night in whole state of Himachal Pradesh (H.P.).

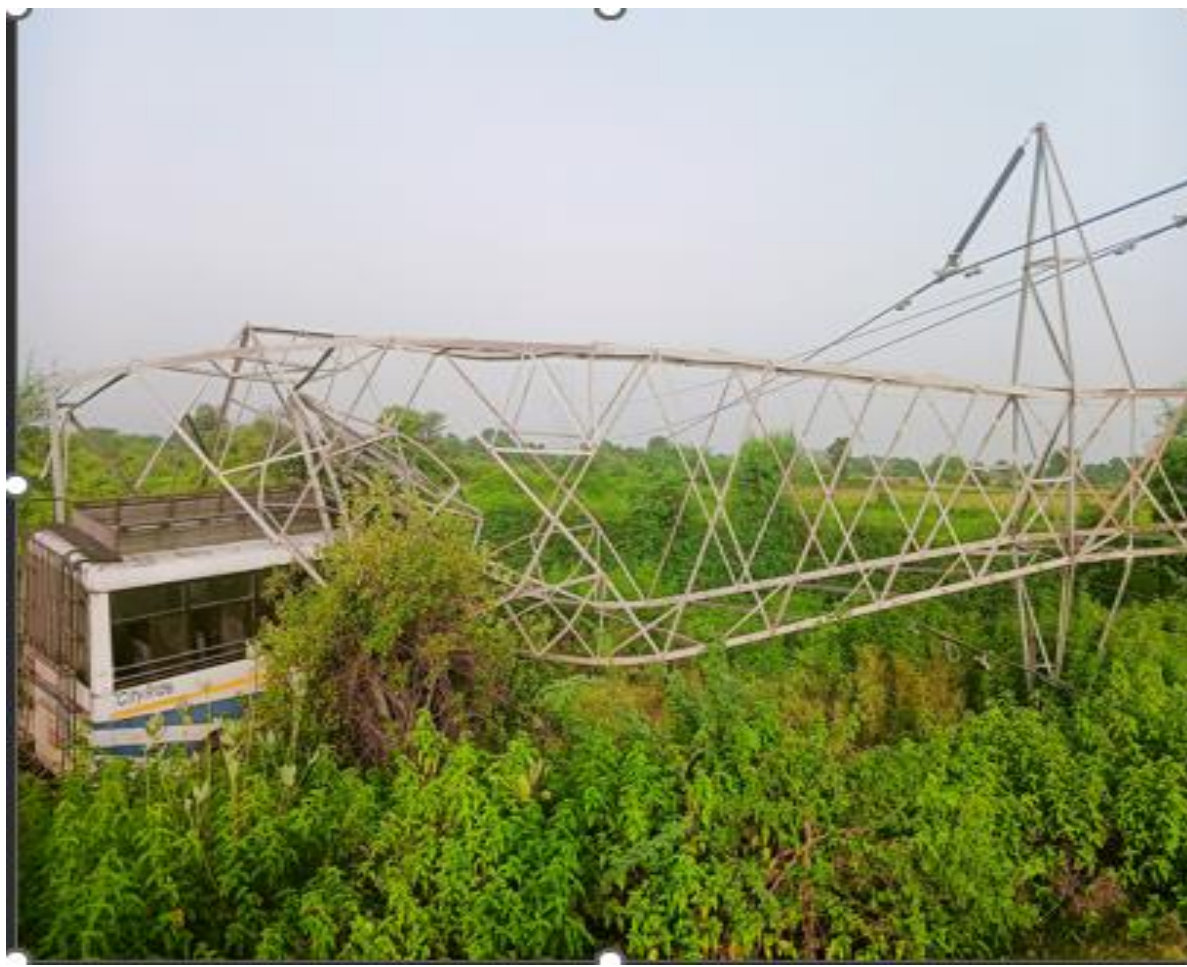
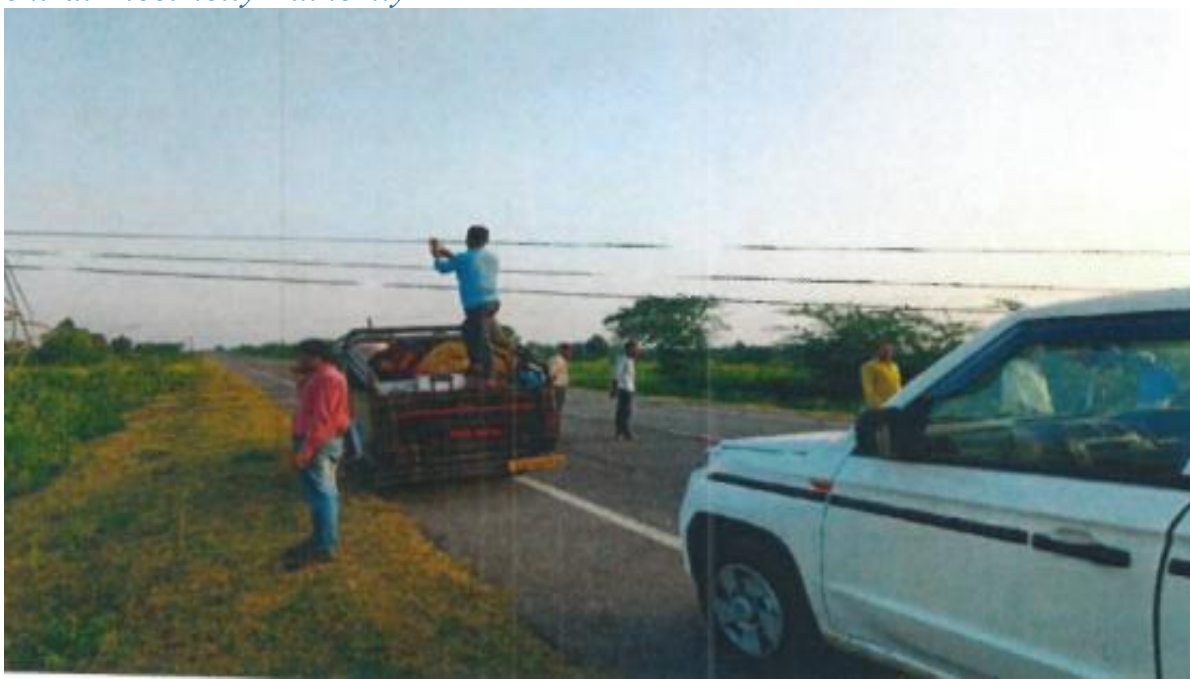
A passenger bus bumped into Tower no 512 of 220 kV Anta - Bhilwara D/C line leading to collapse of tower.

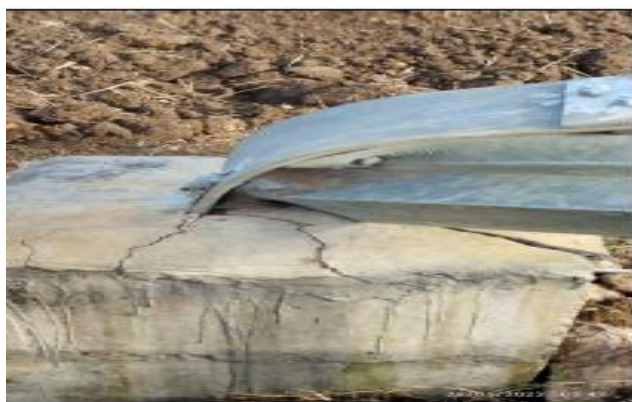
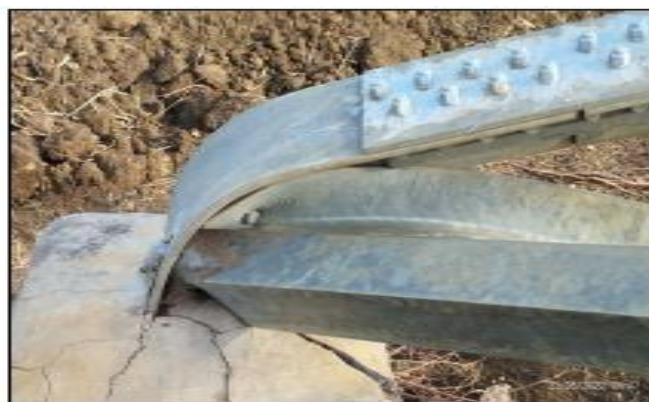
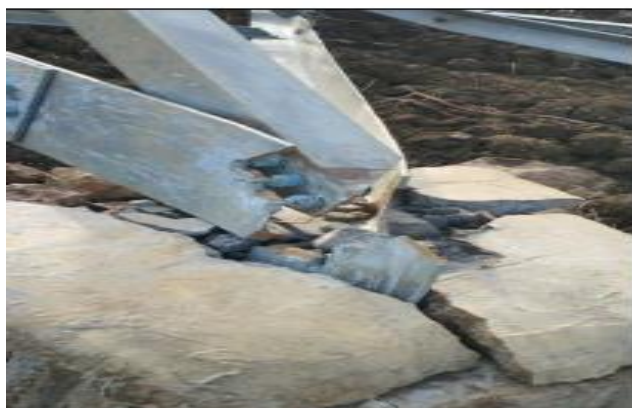
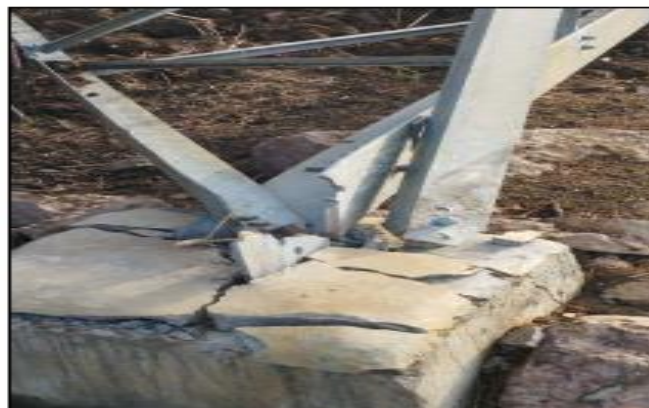
**Fig 9(c). Tower at Location No.: 413 (DHA+3)- Legs and Foundation.**

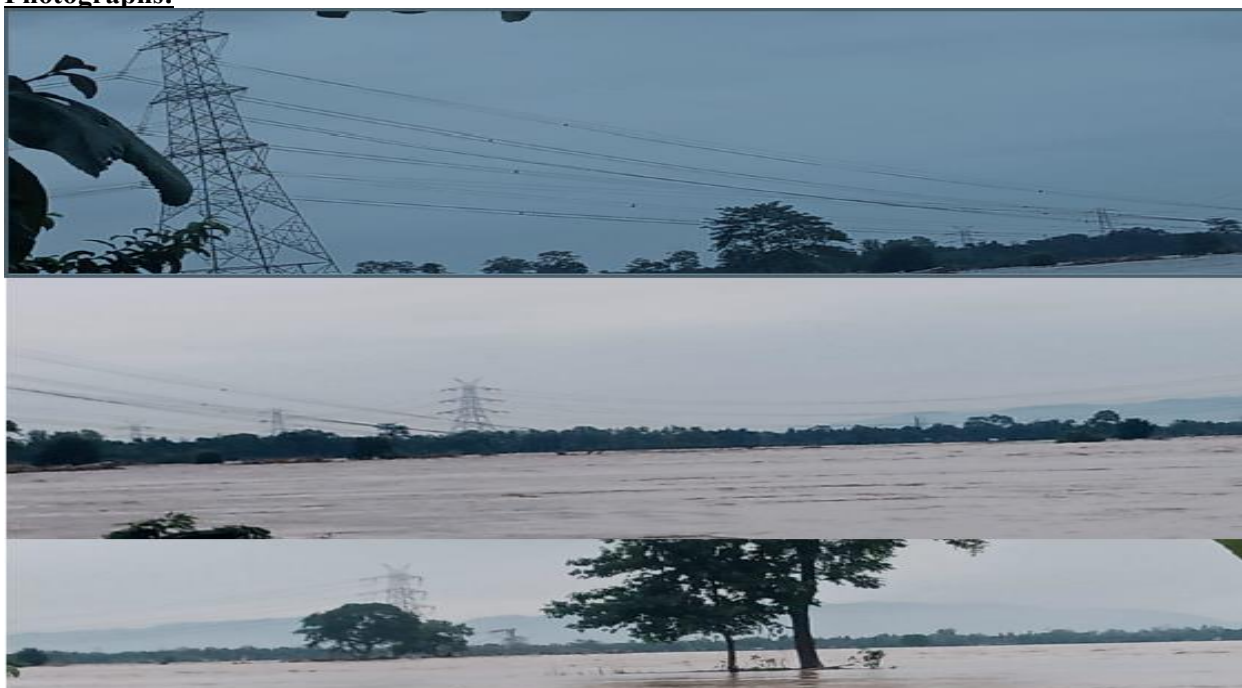
**Fig 2(a). Surrounding Area to Damaged Towers**

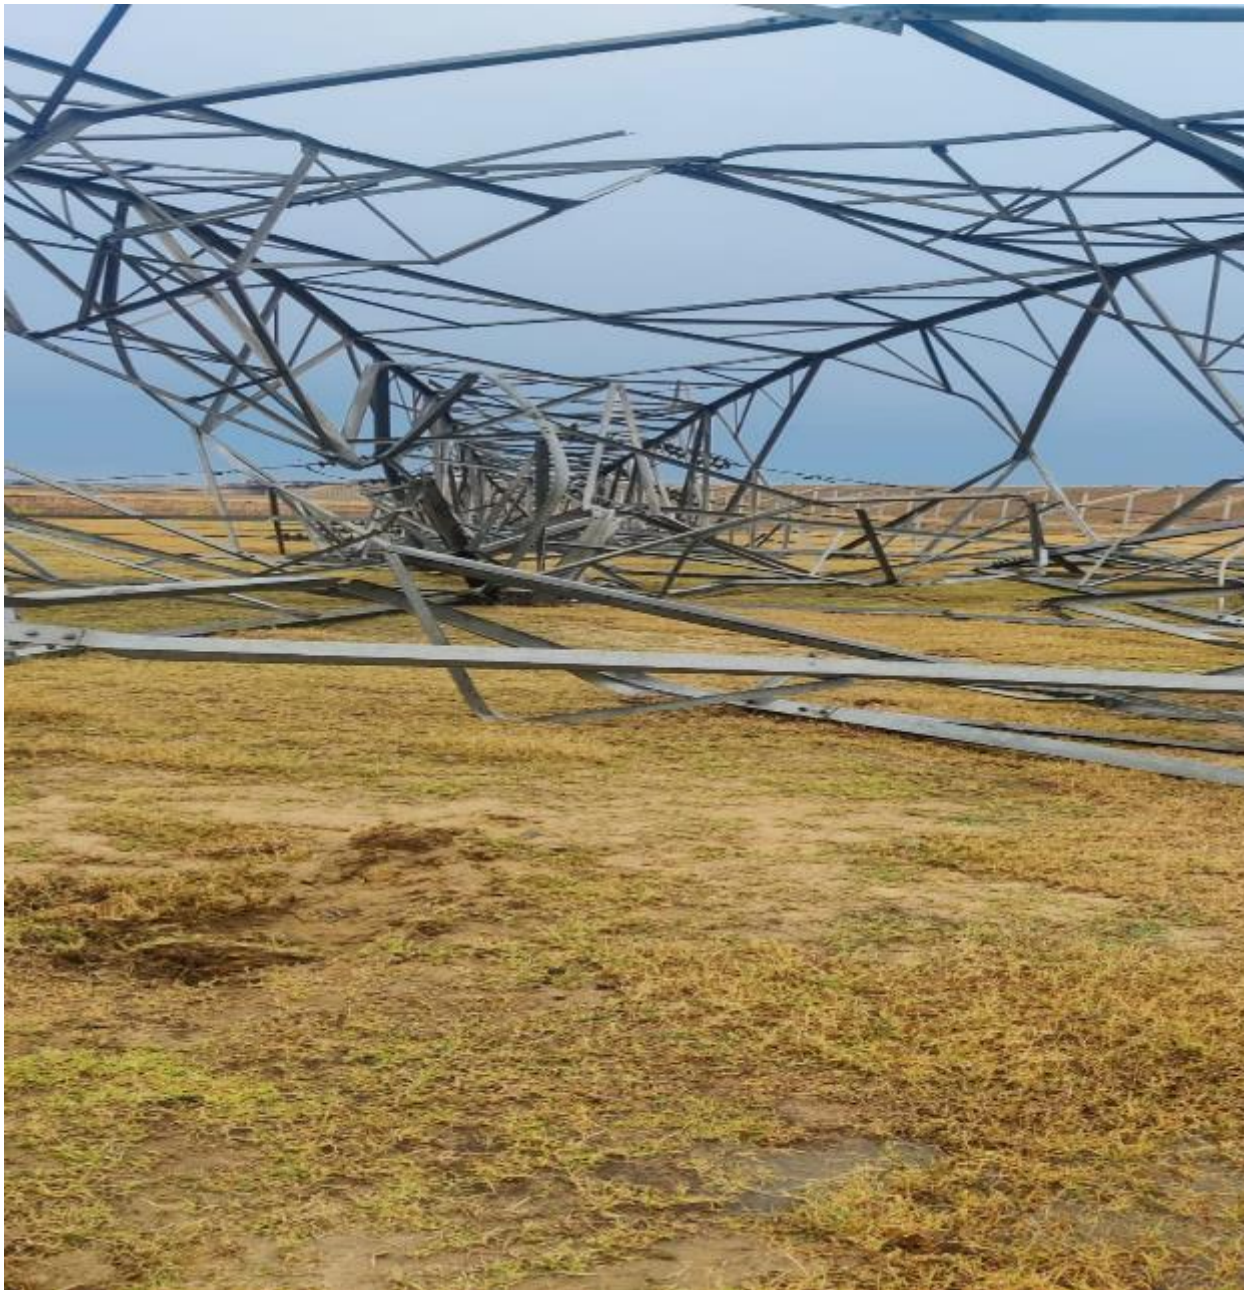
**Tower no.60**

Committee concluded that the high wind velocity might have prevailed in the vicinity of transmission line leading to failure of towers. However, wind speed data received from any authenticated observatory indicating speed of wind prevailing at the failure location at the time of the failure is not provided by the transmission utility. The committee requested to submit the wind speed data from the nearest observatory to ascertain the cause of failure. The recommendations of “Task Force on Cyclone Resilient Robust Electricity Transmission & Distribution Infrastructure in coastal areas” should be followed by utilities while designing/erection of transmission lines in cyclone affected area.
