**विषय: Report of the Standing Committee of Experts on failure of EHV transmission towers failed during the period January 2022 to December 2023-reg.**

**REPORT OF THE STANDING COMMITTEE OF EXPERTS ON  
FAILURE OF EHV TRANSMISSION TOWERS  
(JANUARY 2022 - DECEMBER 2023)**

### A.1 400 kV S/C Gooty-Somanhalli Transmission line failed on 8.05.2022

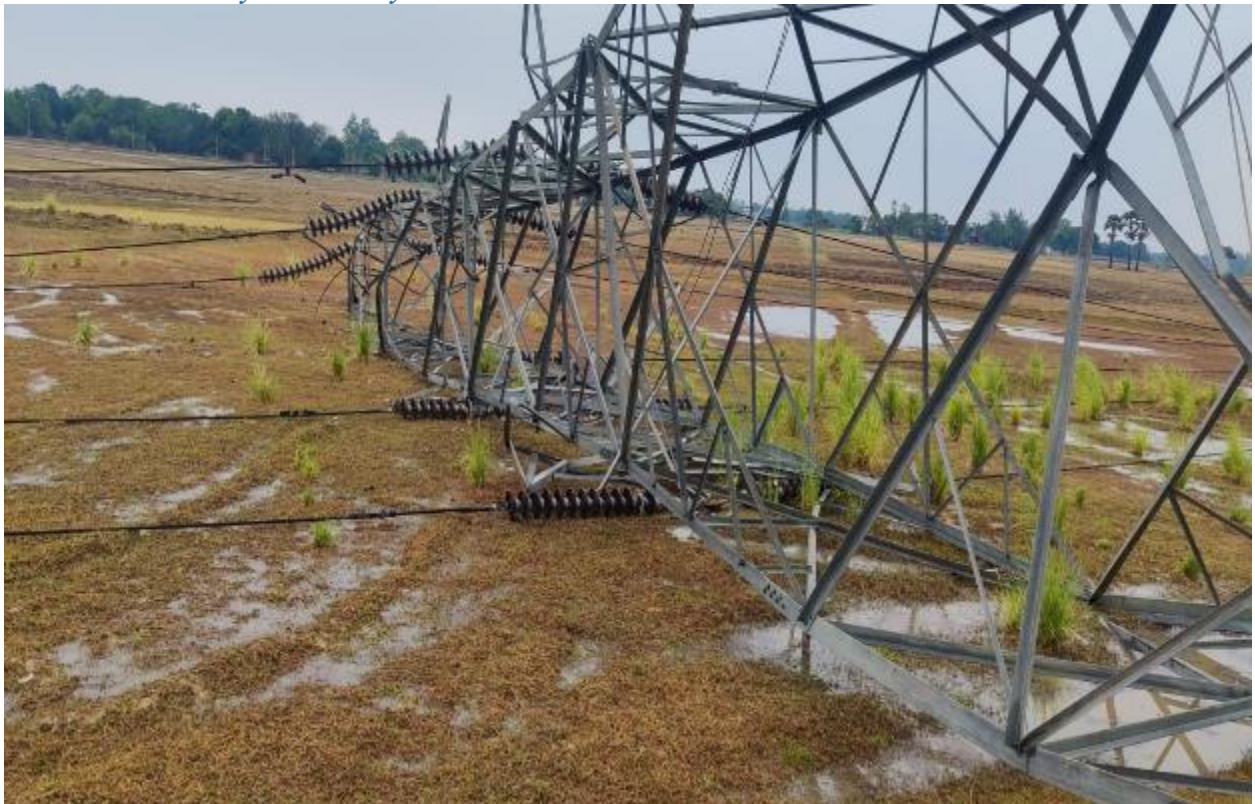
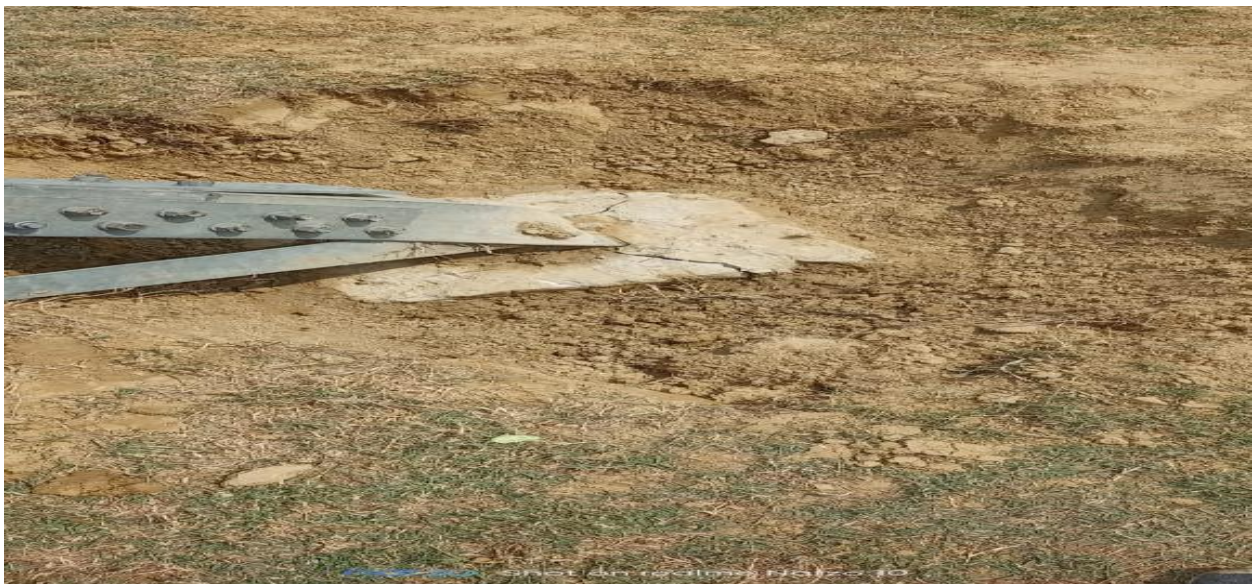
**Tower no. 59**

Committee concluded that the high wind velocity might have prevailed in the vicinity of transmission line leading to failure of towers. However, wind speed data received from any authenticated observatory indicating speed of wind prevailing at the failure location at the time of the failure is not provided by the transmission utility. The committee requested to submit the wind speed data from the nearest observatory to ascertain the cause of failure. The recommendations of “Task Force on Cyclone Resilient Robust Electricity Transmission & Distribution Infrastructure in coastal areas” should be followed by utilities while designing/erection of transmission lines in cyclone affected area.

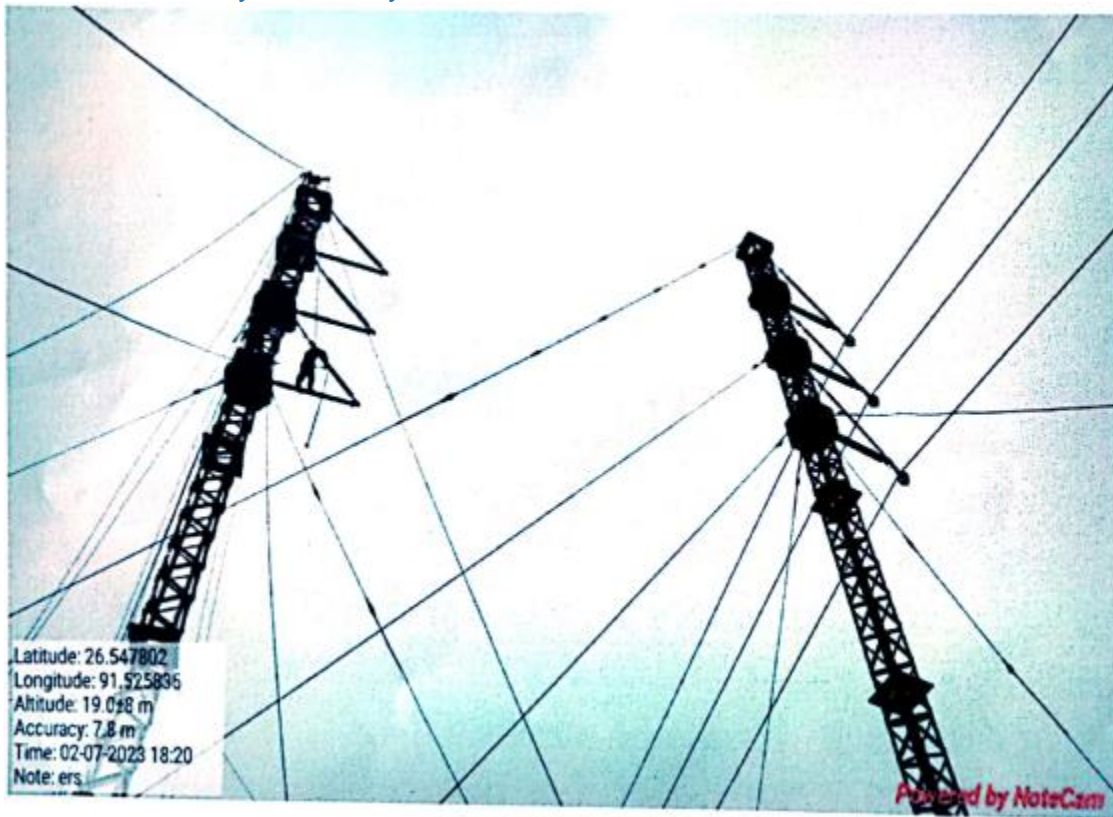
Committee observed that the failure of tower was due to increase in water level and high current in Pagladiya River. It was submitted that the water level of Pagladiya River was attained as 53.64 m against the danger level of 52.75 m on 21.06.2023. The water level of Pagladiya River is as under:
