२२० के वी एवं उच्चतर विभव के सबस्टेशनों के क्षतिग्रस्त उपकरणों पर विशेषज्ञों की स्थायी
समिति की रिपोर्ट

(अप्रैल २०१८-मार्च २०१९)

**REPORT OF STANDING COMMITTEE OF EXPERTS ON FAILURE OF 220 kV &
ABOVE VOLTAGE CLASS SUBSTATION EQUIPMENT
(APRIL 2018 - MARCH 2019)**

Central Electricity Authority
विद्युत मंत्रालय

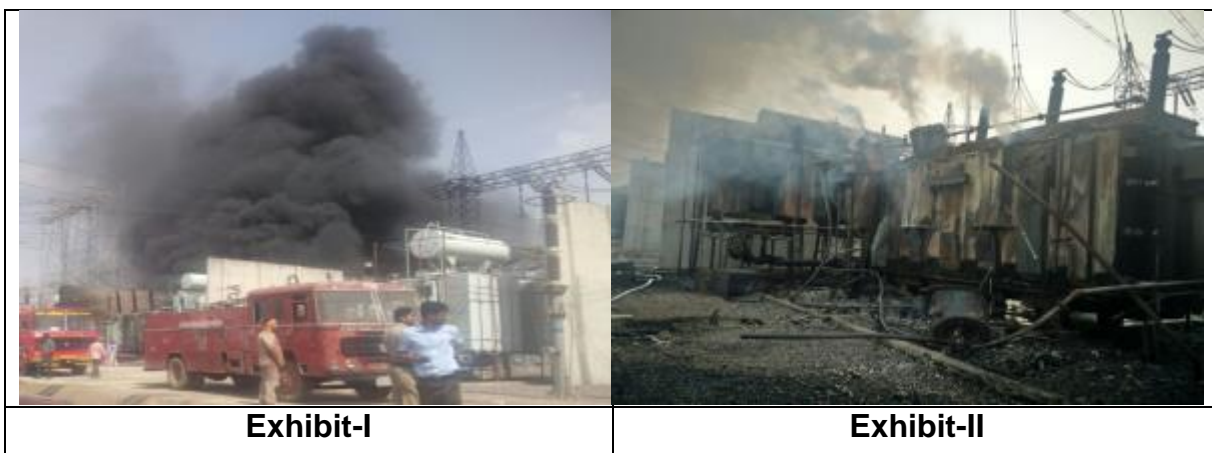
- I. Transformer caught fire immediately after the tripping of the Transformer and fire was extinguished with the fire tender. However, the intensity of the fire was so severe that black smoke continued to come out of the tank for hours(Exhibit-I &II).

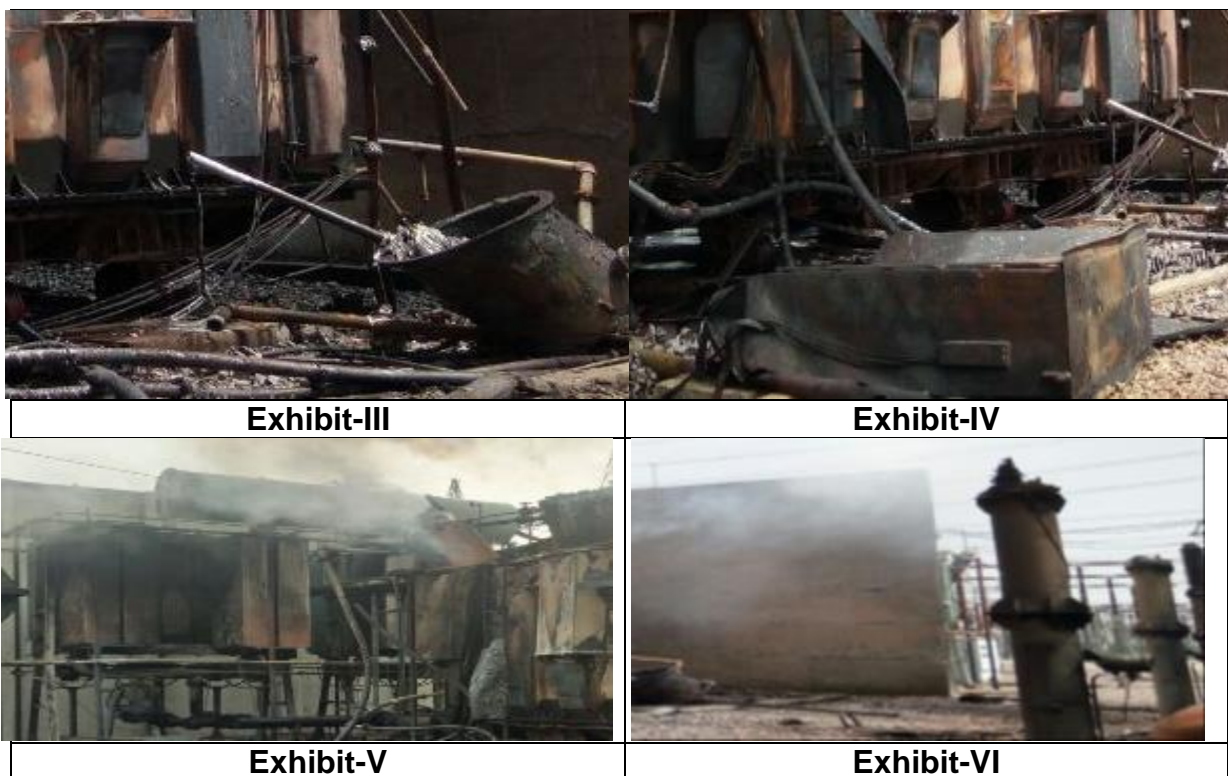
- II. All 3 HV bushings are burnt and damage busing parts are lying on the ground(Exhibit-III). All 220 kV & tertiary bushings found intact with the tank but due to intensity of the fire, all these bushings have also lost their property due to heat.
- III. Main tank found burnt and bulged towards HV side. Rim found distorted.
- IV. All Turret CT of R, Y & B phase were completely burnt/ damaged in this fire incidence.
- V. Due to heavy fire, all windings, insulations, cleat support and support structures were completely burnt out.
- VI. The marshaling box (Exhibit-IV), cables, Radiator pipe line, cooler bank, Conservator was also damaged badly due to fire.

- VII. All 3 HV side LAs and associated structures (Exhibit-VI) were found to be damaged and lying on the ground. 220 kV side LAs were intact on the structure however, cannot be reused.

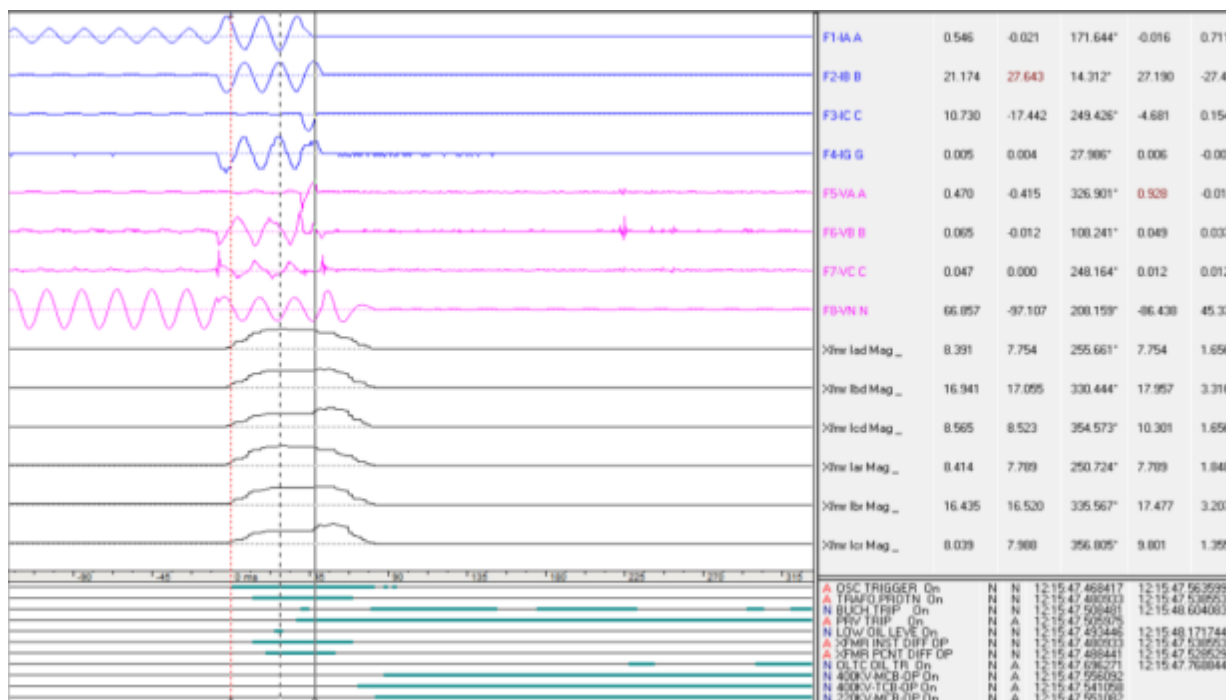
Figure: DR of Differential relay of 400kV ICT-I Gwalior

It was observed that there was fault current of 21.4 kA in Y ph of 400 kV side and 1.67 kA from 220 kV side. Fault current of 10.7 kA was also observed in B ph of 400 kV side after 40 ms.

As seen from Back O/C DR, Voltage of B ph bus reduced up to 8.6 kV. From DR and EL records, fault current got cleared in around 73 ms. Prima facie, it seems that fault was initiated from Y phase. It was suspected that faults may be initiated from the Y phase.

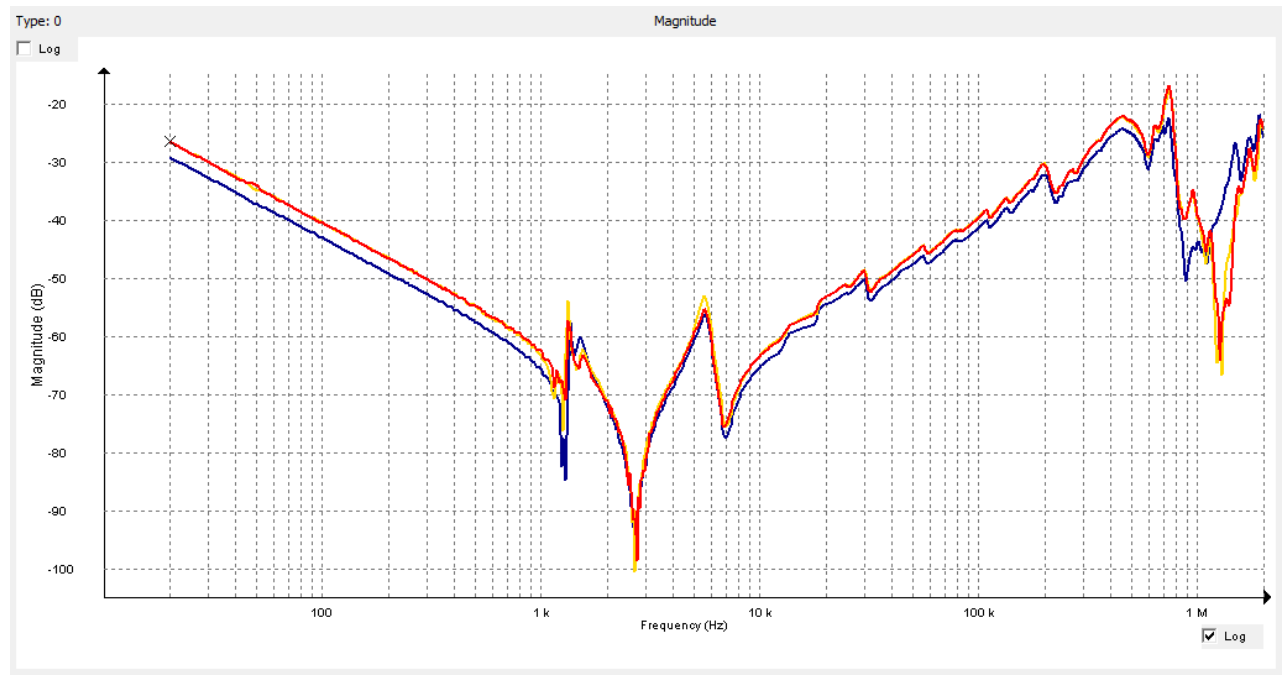
All LV test results indicate probable fault in B phase winding

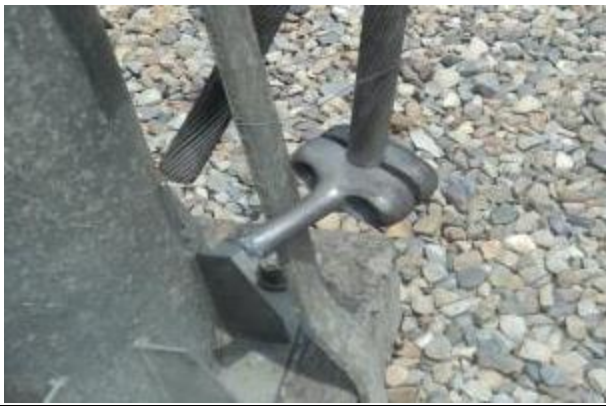
Exhibit-I

- I. Twin moose connector of B-phase bushing found broken apart as shown in Exhibit-I.

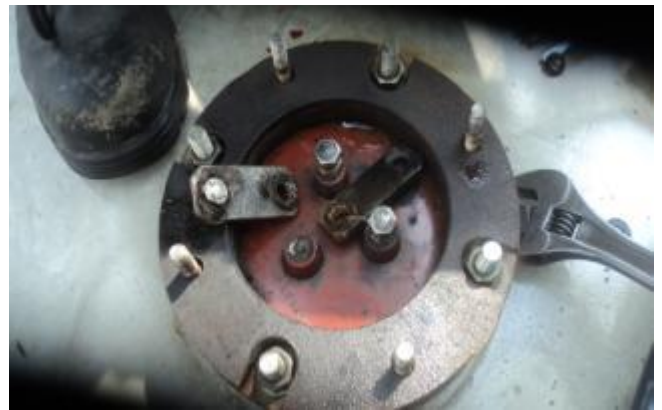
Exhibit-II

- II. In CC-CL epoxy terminal board Core Clamp terminal was found melted as shown in Exhibit-II.
- III. LA of reactor is intact and no advances of LA counters were observed. LA counter are read as 7 for B-Phase, 4 for Y- phase & 6 for R- phase as shown in Exhibit-II.

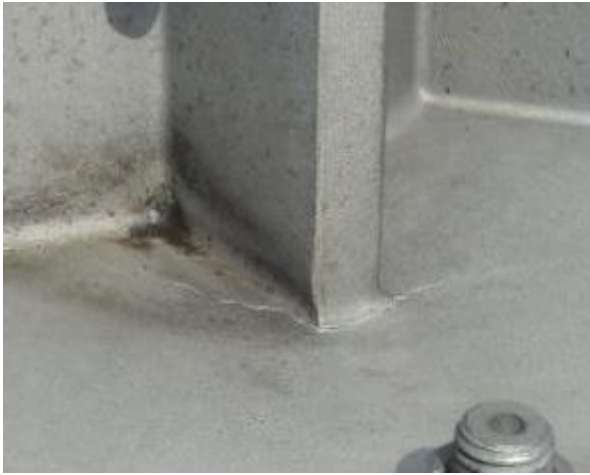
Exhibit-III

- IV. Cracks developed in flange of R-phase (Sr.No: 1616740) & B-phase (Sr.No: 1616737) bushings as shown in Exhibit-III.

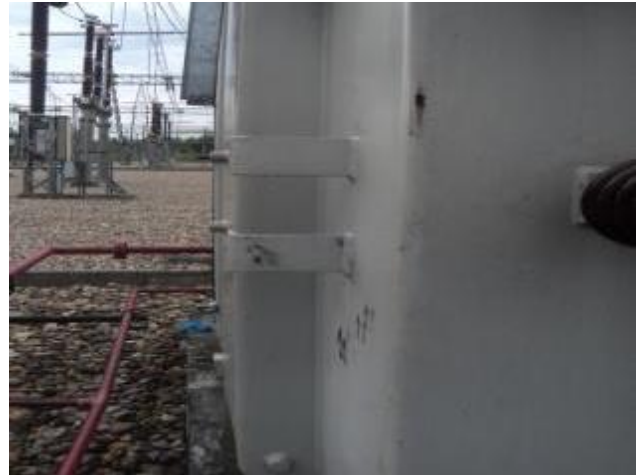
Exhibit-IV

- V. Very slight bulging /deformation observed in reactor tank as shown in Exhibit-IV.
- VI. OTI & WTI reading went up to 75 centigrade max
- VII. Carbon particles were observed inside the Reactor and same were spread on core coil assembly as well as at the bottom of the tank as shown in Exhibit-V

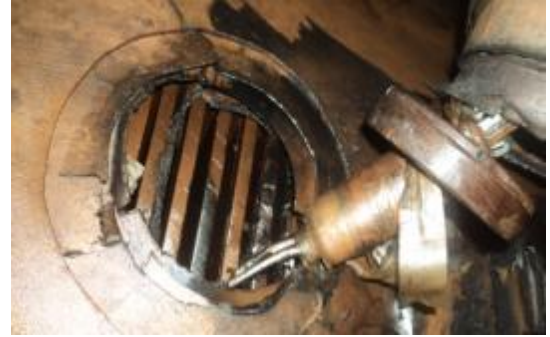
Exhibit-VI

- VIII. B-phase winding found damaged from lead take off location as shown in Exhibit-VI.
- IX. Melting of lamination was observed at the bottom cross flux plate as shown in Exhibit-VII. Melting of lamination sheets observed in auxiliary limb of core adjacent to R-Phase winding and bottom part of auxiliary limb adjacent to B-Phase winding.
- X. Tracking observed through outer press board barrier surface emanating from conductor of lower half of the winding to flux plate as shown in Exhibit-VIII. On further removal of the press board barrier, tracking and treeing marks resembling the

branches of a tree were observed on both side of the winding insulation from lead take off to the ground.

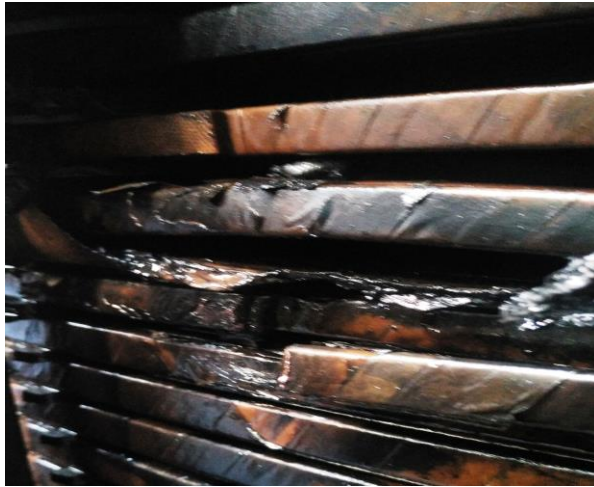
Exhibit-IX

- XI. All the insulation pressboard barriers were removed and burning of Conductors is observed in lead take of area of winding. Two conductor strip were broken / melted in the 3rd disc from the top of the lower half the winding as shown in Exhibit-IX.

- XII. Unlike press board, no treeing/ tracking is observed in the winding as shown in Exhibit-IX.

“Electrical treeing generally occur when a dry dielectric material is subjected to high and divergent electrical field stress over a period of time and it generally originates at points where impurities, gas voids, mechanical defects, or conducting projections cause excessive electrical field stress within small regions of the dielectric. This can ionize gases within voids inside the bulk dielectric, creating small electrical discharges between the walls of the void. Gases are often liberated as the dielectric degrades, creating new voids and cracks. These defects further weaken the dielectric strength of the material, enhance the electrical stress, and accelerate the PD process.”

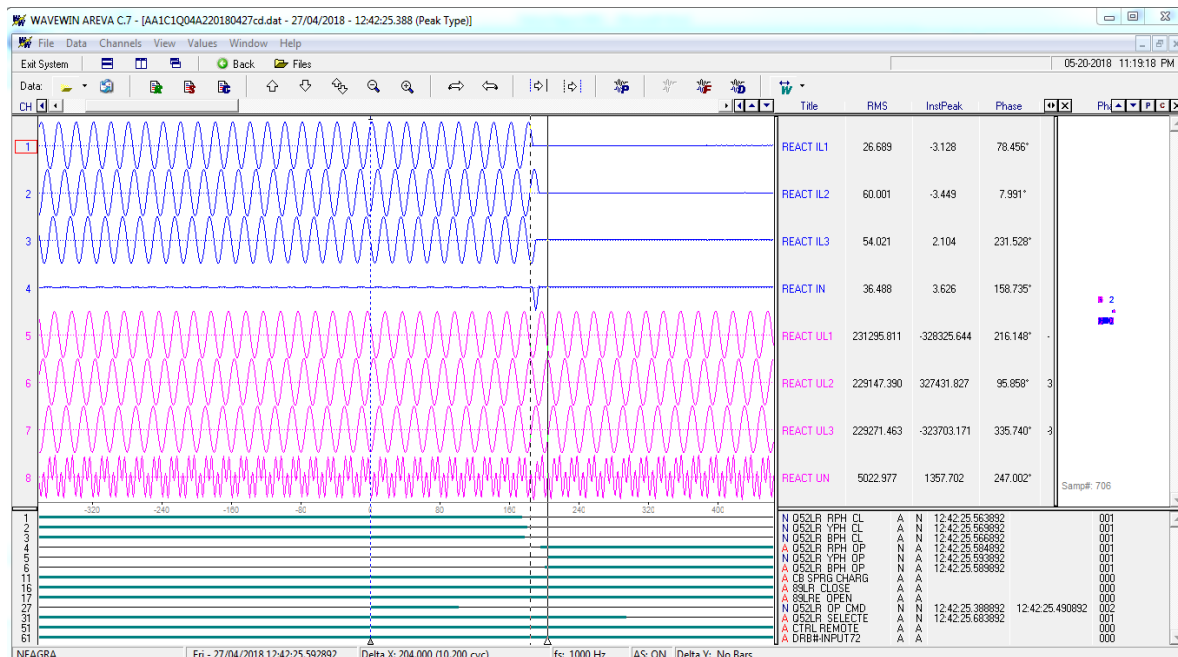
Fig-I

- XIII. As the on line DGA system was defective, any development of fault gasses during last two month prior to failure could not be known.
- XIV. Equi-potential lead was checked and was found to be intact as shown in Exhibit-X. Also, no such mechanical defect was observed in the lead take off area.
- XV. Opening and closing voltage/current response taken at 12:45 hrs from CSD device was found to be normal as shown in Fig-I.
