Report on investigation of failure of 315 MVA Auto transformer at 400 kV Bawana Substation of Delhi Transco Ltd.(DTL)

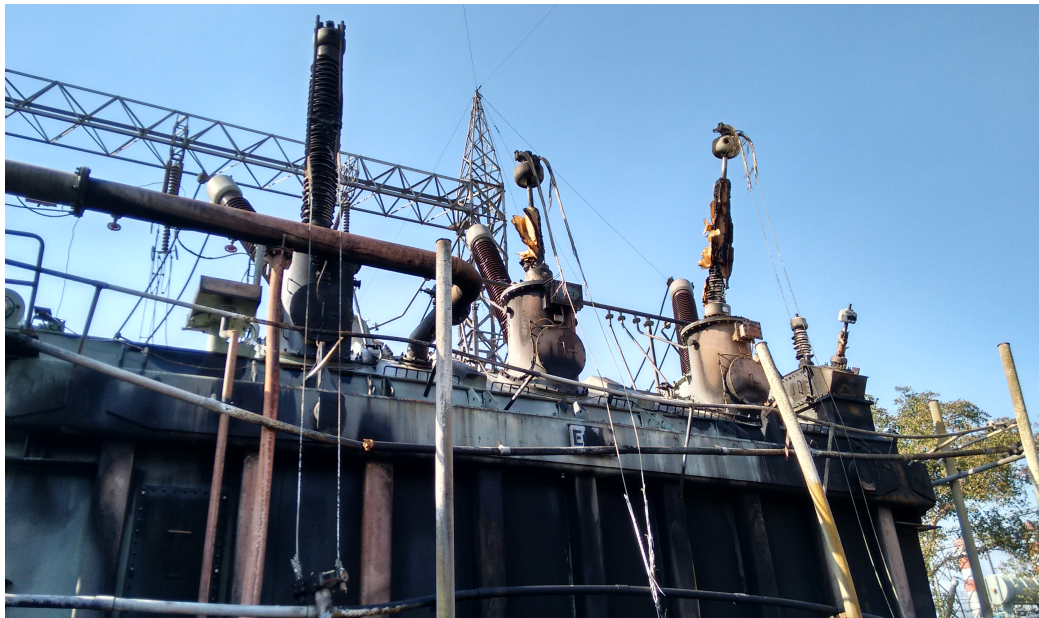
Exhibit-I

- 4.1 Prior to fault, load on transformer was 121 MW. The transformer was operating on normal tap 9B at the time of failure. OLTC has not been operated since commissioning.
- 4.2 During physical inspection of the failed transformer at site, it was observed that MV Bushings of Y & B-phase had completely damaged due to fire, burnt insulation paper and connecting rods of bushings were visible, ceramic housing was found scattered around transformer and flanges had damaged (Exhibits-I & II).

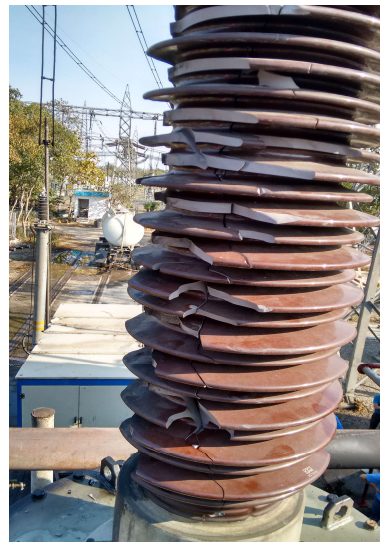
Exhibit-III

- 4.3 MV bushing of R-phase and tertiary bushings were also found damaged (Exhibit-III & IV). Since the direction of wind was away from HV bushings, not much damage to HV bushings was observed, however some petticoats of bushings had chipped.

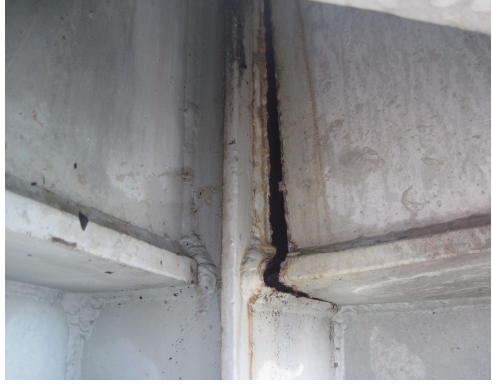
Exhibit-V

- 4.4 Transformer tank was found bulged at MV side and it had cracked at a number of places (Exhibits-V & VI).

- 6.3 High energy arcing due to fault inside the transformer tank might have led to sudden pressure rise in tank and tripping of Buchholz & PRV. PRV being a slow operating device might not have been able to bring down the gas pressure inside the tank to safe value and high rate of rise of gas pressure might have resulted in cracks at weak areas of the transformer tank.

- 7.2 The frequency/periodicity of measurement should be changed depending on condition/health of transformer in operation.
- 7.3 In addition to PRV which operates when static pressure inside the transformer tank crosses a pre-set pressure limit, use of Fast Depressurization System which works on first dynamic peak of pressure and is very fast should be explored for future orders of transformers.

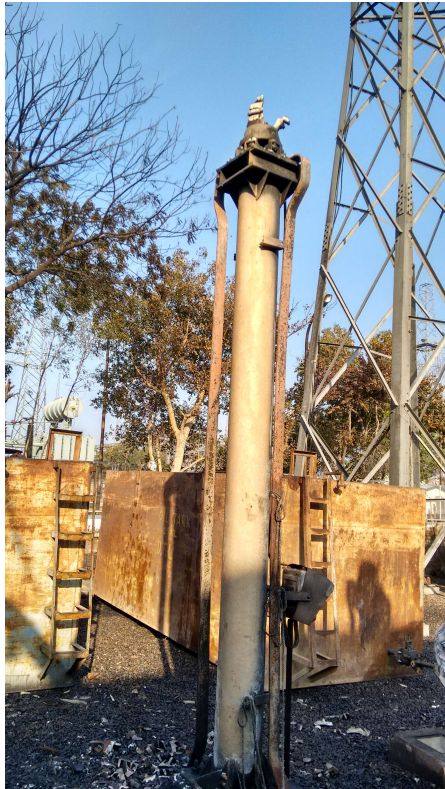
Exhibit-VII

- 4.5 220 kV Surge Arresters had completely damaged due to heat (Exhibit-VII), surge counters had melted and ZnO blocks & pieces of arrester housing were scattered on the ground (Exhibit-VIII).

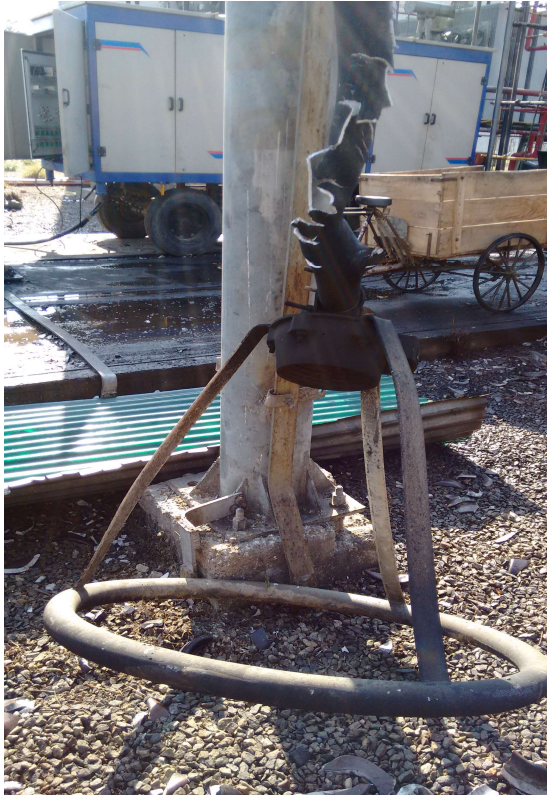
Exhibit-IX

- 4.6 220 kV Bus Post Insulators, aluminium pipes, and disc insulators of jack bus on MV side were also burnt due to fire (Exhibits-IX & X).
