**REPORT OF STANDING COMMITTEE OF EXPERTS ON FAILURE OF 220 kV &  
ABOVE VOLTAGE CLASS SUBSTATION EQUIPMENT  
(SEPTEMBER 2015-DECEMBER 2016)**

भारत सरकार  
**Government of India**  
केन्द्रीय विद्युत प्राधिकरण  
**Central Electricity Authority**  
विद्युत मंत्रालय  
**Ministry of Power**  
नई दिल्ली  
**New Delhi**

**REPORT ON INVESTIGATION OF FAILURE OF 100 MVA, 220/66-33/11 KV POWER TRANSFORMER AT 220KV GEETA COLONY SUBSTATION OF DELHI TRANSCO LTD. (DTL)**

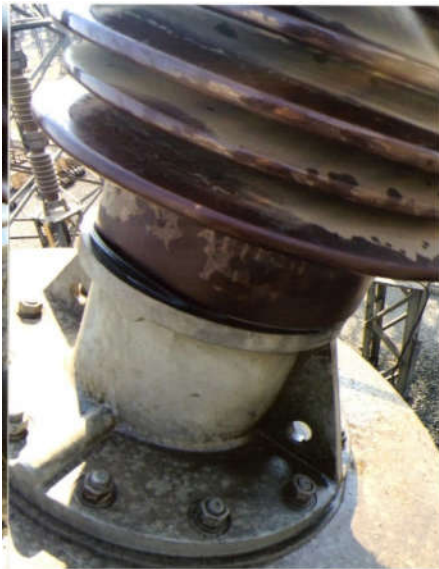
**Exhibit-I**

- 3.1 Prior to fault, load on transformer was 23 MW. Maximum loading on transformer was 32 MW on the day of fault (2<sup>nd</sup> February). Transformer was not loaded even up to 50% of its capacity for the last many days. The transformer was operating on tap 5 (Normal Tap is Tap 3) at the time of failure.
- 3.2 Tertiary of transformer is unloaded. All three terminals of tertiary winding have been brought outside the tank and terminals were not insulated.
- 3.3 During physical inspection of the failed transformer at site, it was observed that there was minor dislocation of all three HV bushings from their turrets (Exhibit-I), MV bushing flanges of Y & B phases had cracked, LV bushing of B phase had punctured (Exhibit-II) and transformer tank had cracked at a number of places (Exhibits -III&IV), although there was no visible sign of bulging of the tank.

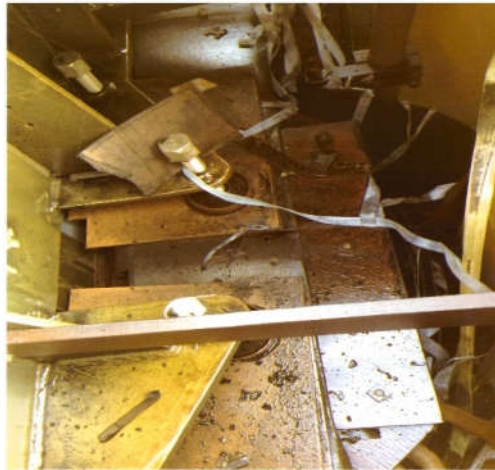
**Exhibit-V**

- 3.4 There was no damage to nearby equipment/ material of the substation.
- 3.5 Transformer was checked for internal damage through inspection window. Visible damage was observed on Y-phase winding (Exhibits- V&VI). Damage on other windings was not visible through inspection window. The extent of damage inside the transformer would be assessed only after opening of tank.

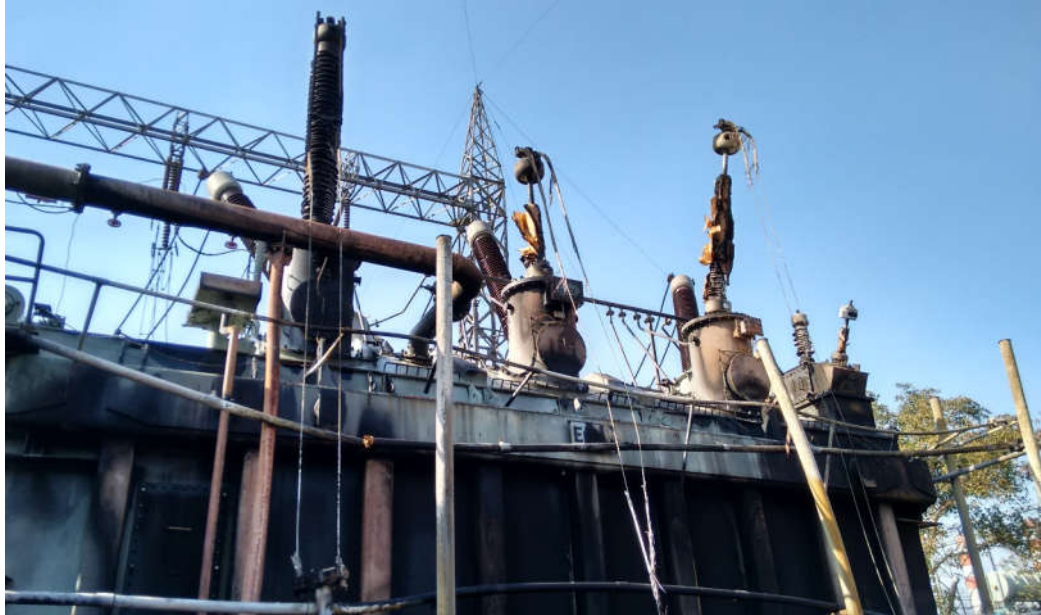
**Exhibit-I**

- 4.1 Prior to fault, load on transformer was 121 MW. The transformer was operating on normal tap 9B at the time of failure. OLTC has not been operated since commissioning.
- 4.2 During physical inspection of the failed transformer at site, it was observed that MV Bushings of Y & B-phase had completely damaged due to fire, burnt insulation

paper and connecting rods of bushings were visible, ceramic housing was found scattered around transformer and flanges had damaged (Exhibits-I & II).

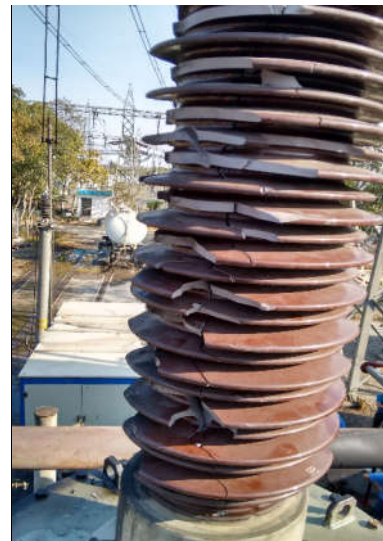
**Exhibit-III**

- 4.3 MV bushing of R-phase and tertiary bushings were also found damaged (Exhibit-III & IV). Since the direction of wind was away from HV bushings, not much damage to HV bushings was observed, however some petticoats of bushings had chipped.

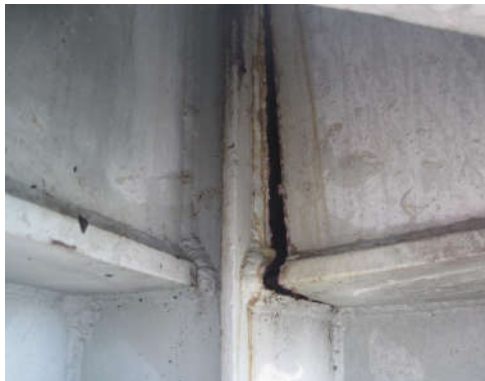
**Exhibit-V**

- 4.4 Transformer tank was found bulged at MV side and it had cracked at a number of places (Exhibits-V & VI).

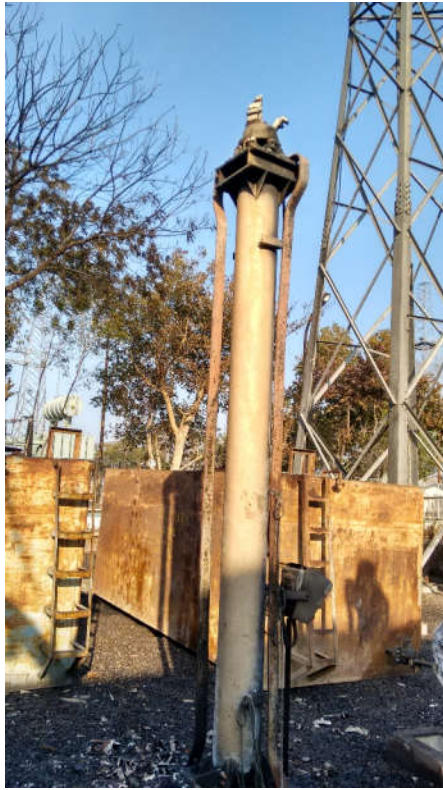
**Exhibit-VII**

- 4.5 220 kV Surge Arresters had completely damaged due to heat (Exhibit-VII), surge counters had melted and ZnO blocks & pieces of arrester housing were scattered on the ground (Exhibit-VIII).

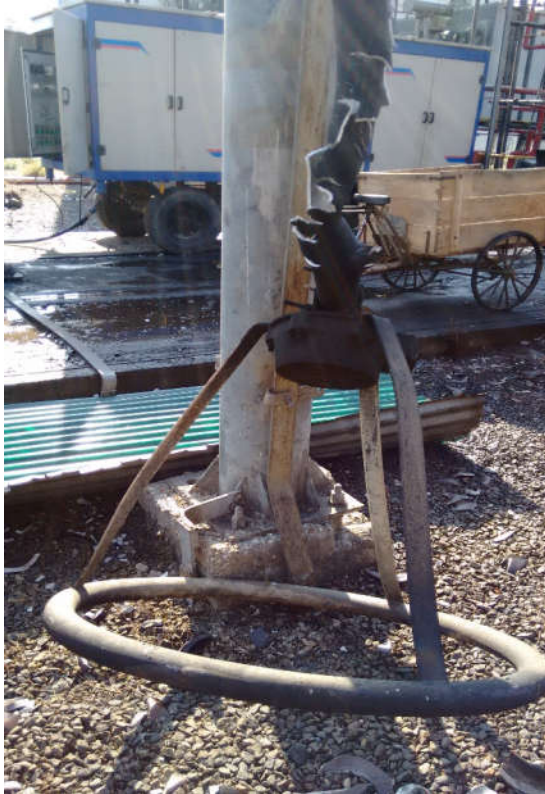
**Exhibit-IX**

- 4.6 220 kV Bus Post Insulators, aluminium pipes, and disc insulators of jack bus on MV side were also burnt due to fire (Exhibits-IX & X).

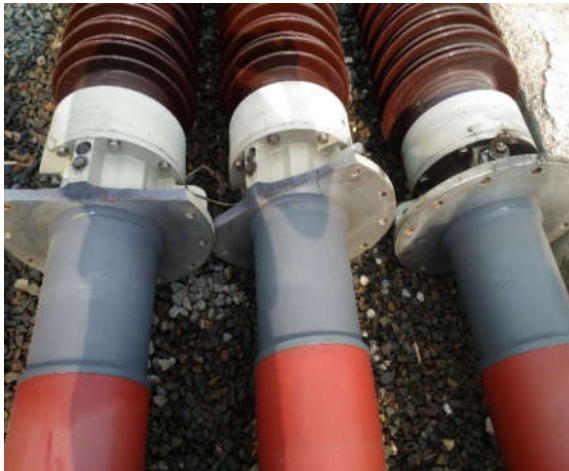
**Exhibit-I** (HV bushings)

- a) DTL informed that the transformer had tripped on differential relay, Buchholz relay, PRD and SPRV, flange plates of all three phases of HV and MV windings were found to be cracked and oil was leaking. It was informed that the transformer was operating on normal tap (tap no. 5) at the time of failure and OLTC was last operated on 18.05.16.
- b) During physical inspection of the failed transformer at site, it was observed that flange of all bushings were cracked (Exhibit-I and Exhibit-II).

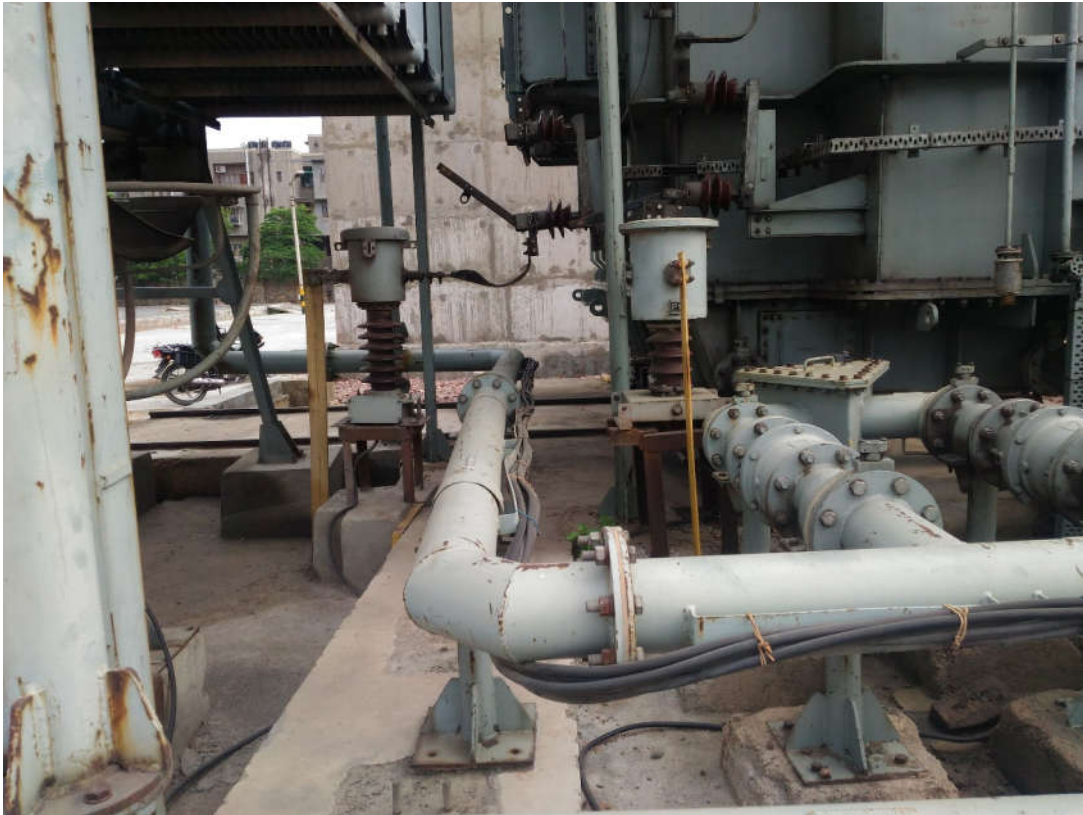
**Exhibit-III**

- c) There was no visible sign of bulging of the tank or cracks on the tank (Exhibit III).

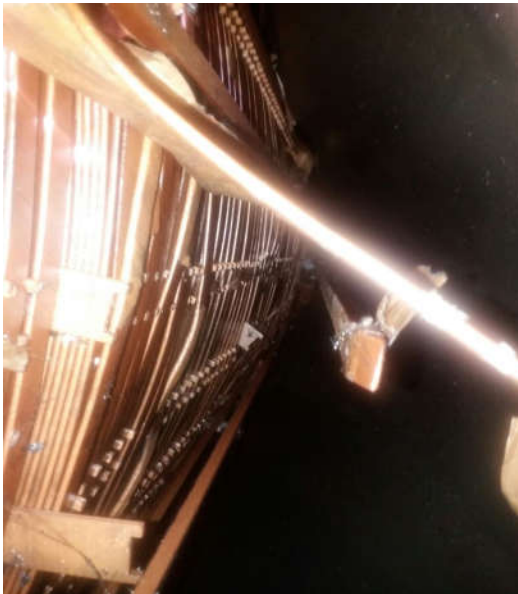
**Exhibit-V**

- i. Due to damage in HV Y-ph winding, it is not possible to rectify the fault at site. The transformer needs to be taken back to the factory for the replacement of winding.
  - ii. The healthiness of remaining windings shall be ascertained at the time of joint Physical Verification Report at works.
- e) Transformer was checked for internal damage through inspection window. As transformer was refilled with oil to prevent moisture ingress, damaged windings were not visible from the inspection window. However, following photographs of windings taken after opening of the tank were provided by DTL (Exhibits V and VI). The damage to the windings can be seen in these photographs. Some burnt material can also be observed.
