**Sub: Minutes of the meeting of the Standing Committee of Experts held on 8/12/2015 at CEA Headquarter regarding failure of towers in 132 kV and above voltage level transmission lines of PGCIL/ RRVPNL/ UPPTCL/ WBSETCL/ JINDAL POWER LTD. in the Western/ Eastern/ Northern region during October 2014 to June 2015 including failure of 765 kV S/C Gaya- Fatehpur Trans line in May, 2014.**

**Minutes of Meeting of the Standing Committee of Experts on Failure of Transmission Line Towers held in CEA, New Delhi on 8/12/2015 in respect of failure of towers in 132 kV & Higher Voltage Transmission Lines during the period from October, 2014 to June, 2015.**

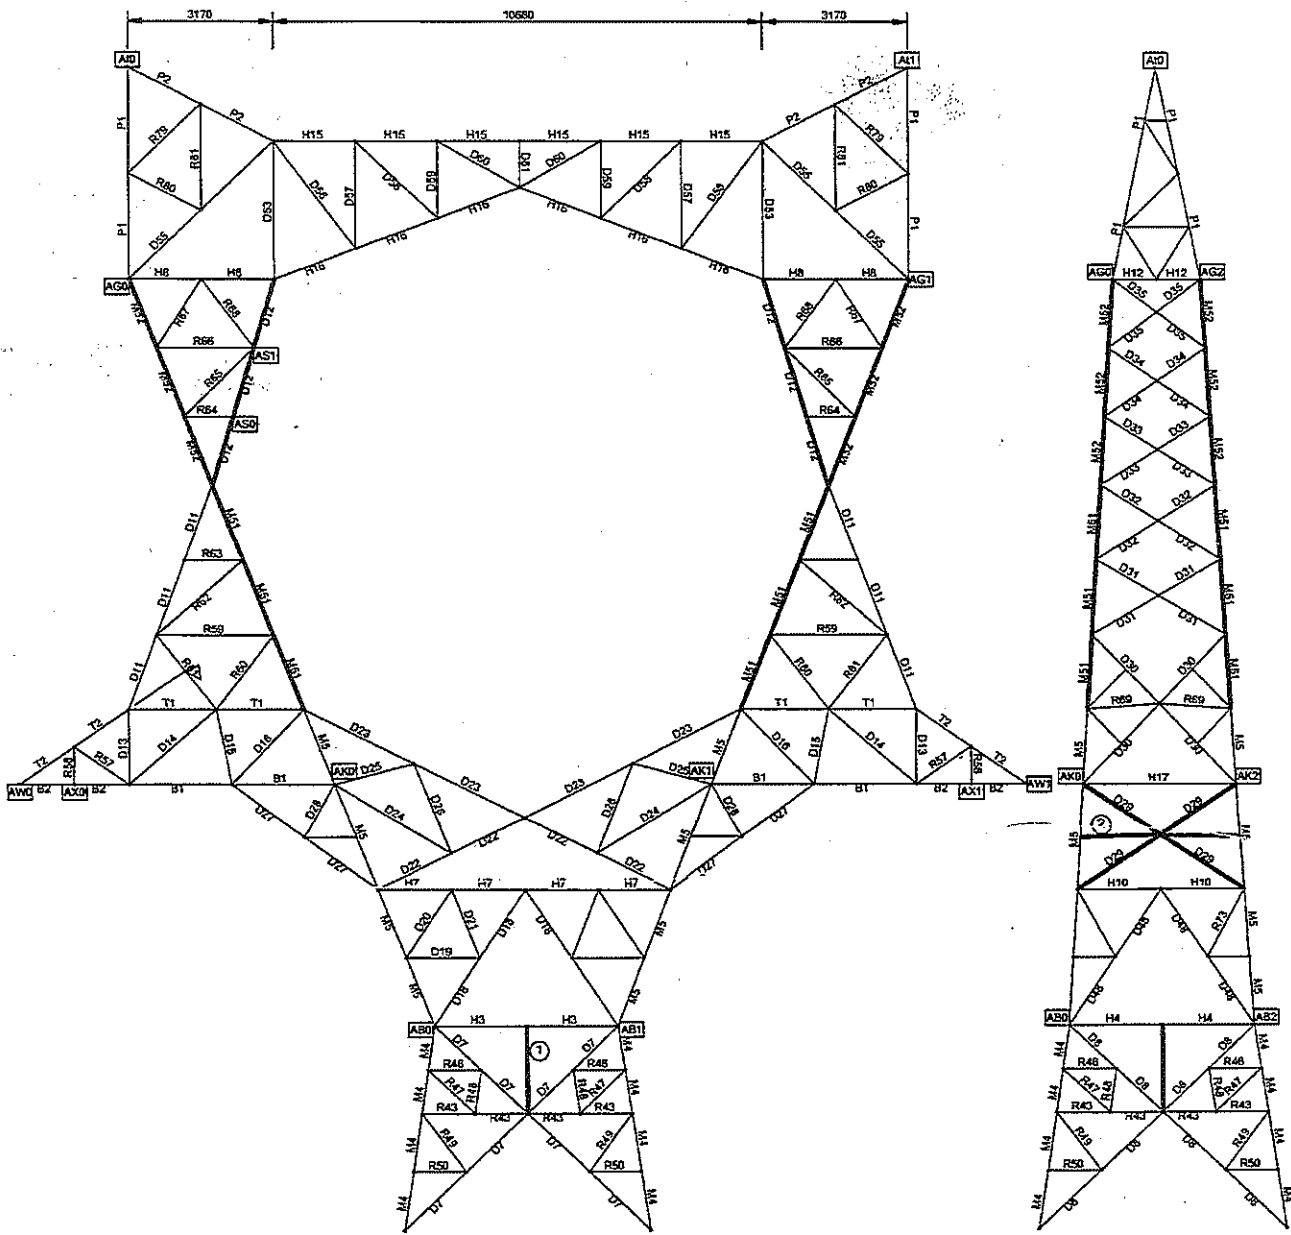
- In absence of meteorological data, it has become difficult to assess the actual wind velocity at site of failure in order to verify with the design value of wind speed. However, the detailed analysis of structural design of suspension tower (with delta configuration) of 765kV S/C line was carried out by CPRI and PGCIL using two different softwares [STAAD Pro and i-Tower]. The strengthening of suspension towers (with delta configuration) of 765kV S/C line traversing through wind Zone - 4 has to be carried out as indicated below by increasing the member / section size of six (6) members and adding two (2) more redundant members. The drawing showing the member location is enclosed as **Annexure - II**.

Member	Section	Bolts
D13	65*65*6	MS 2 S/S - 16Ø
D16	90*90*6	MS 2 S/S - 16Ø
D29	90*90*6	MS 3 S/S - 16Ø
① ②	50*50*5	MS 1 S/S - 16Ø
M51/52	110*110*8	HT 6 D/S - 16Ø
D12	80*80*6	HT 3 S/S - 16Ø

Rev: 1  
 Typographical error in grade of M51/52, R12 correct grade is HT. 2mm

- Since strengthening of tower is to be done above bottom cross arm / waist level (near diamond section), long shutdown shall be required for replacement of members / sections of towers in existing line and the nature of work and the risk involved in replacement of member of towers in existing line is different from fabrication of towers afresh. The fabrication of fresh towers can be taken up easily. But replacement of members in the existing towers is very difficult and lot of risk is involved. Moreover, many of the executing agencies may not be interested to
