**REPORT OF THE STANDING COMMITTEE OF EXPERTS
ON FAILURE OF EHV TRANSMISSION LINE TOWERS
(APRIL 2018 – MARCH 2019)**

Central Electricity Authority

4.0 ANALYSIS OF FAILURE OF TOWERS OCCURRED DURING THE PERIOD FROM APRIL 2018, TO MARCH, 2019

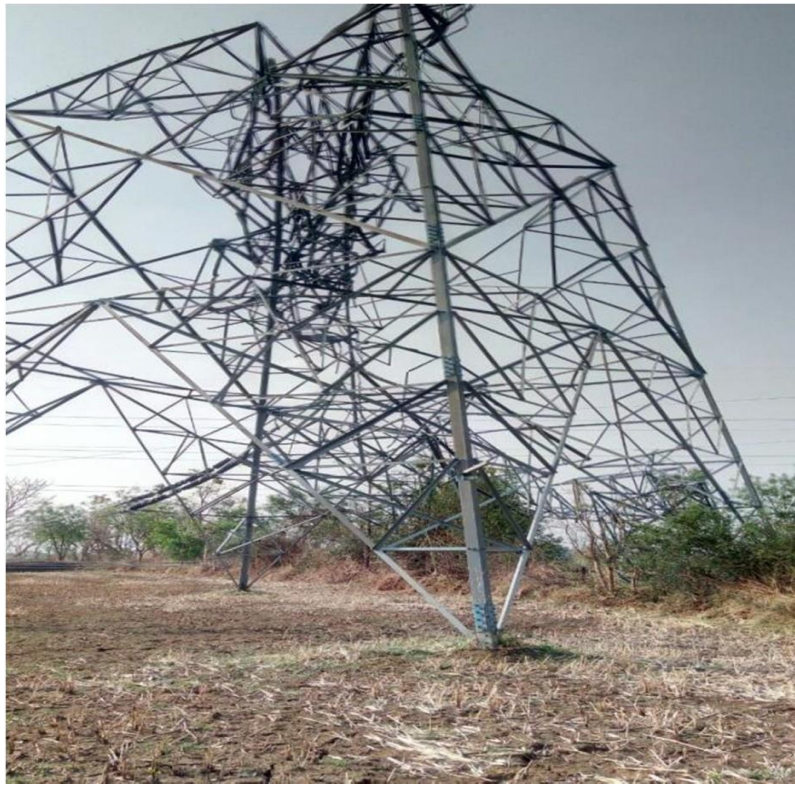
Tower at Loc. No. 120

b. **Tower at location no. 120(A+0)** was located in cultivated fields of village Charpara, Tehsil-Baloda, District Janjgir-Champa, Chhattisgarh. The tower had collapsed from second panel level. All the four stubs of the tower were intact.

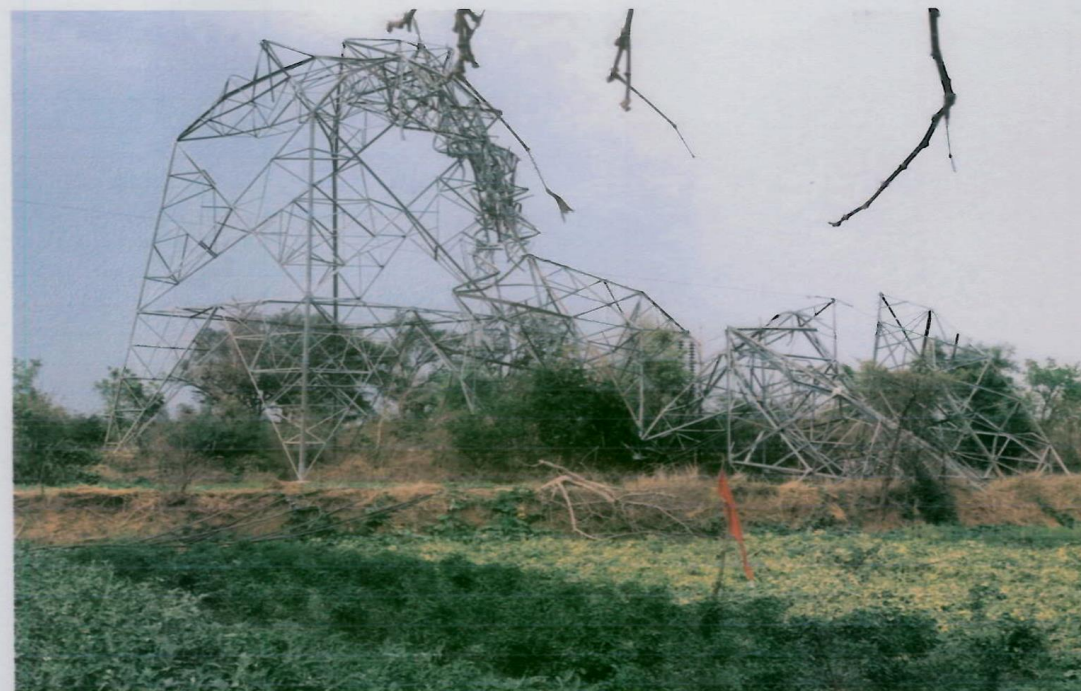
Tower at Loc. No. 122

- d. **Tower at location no. 122 (A+0)** had collapsed from the third panel level and all the four stubs of the tower were intact.

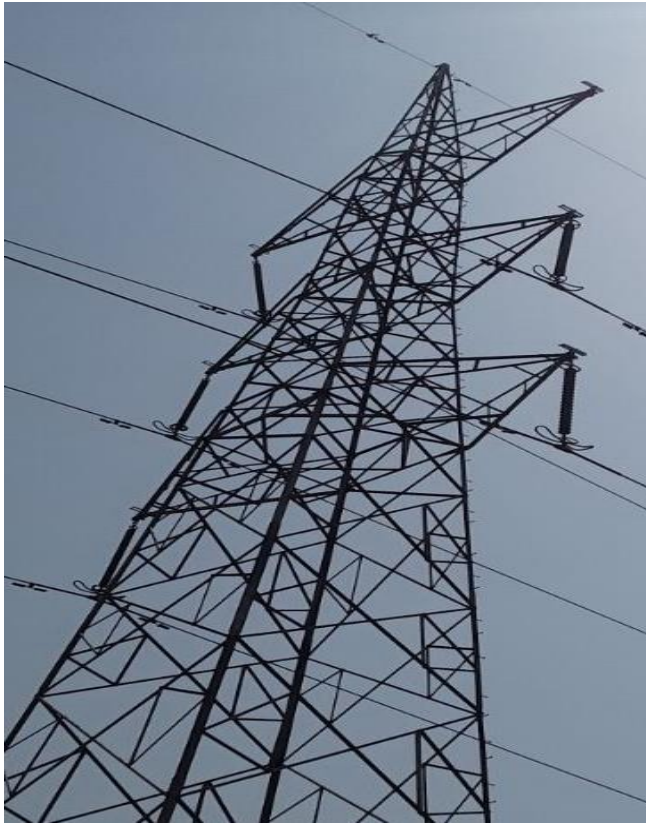
Tower at Loc. No. 266

b. **The towers at Loc. No. 266 (DA+0), 267 (DA+0) & 268 (DA+0)** were located in cultivated field with very few trees in the vicinity. It was observed that top cross-arm of these towers got damaged. However, all the four stubs of the tower were found intact. From the failure pattern, it appeared that these towers were damaged due to pulling force developed due to failure of adjacent tower at Loc. No. 270. As reported by PGCIL, no members were found missing at these towers.

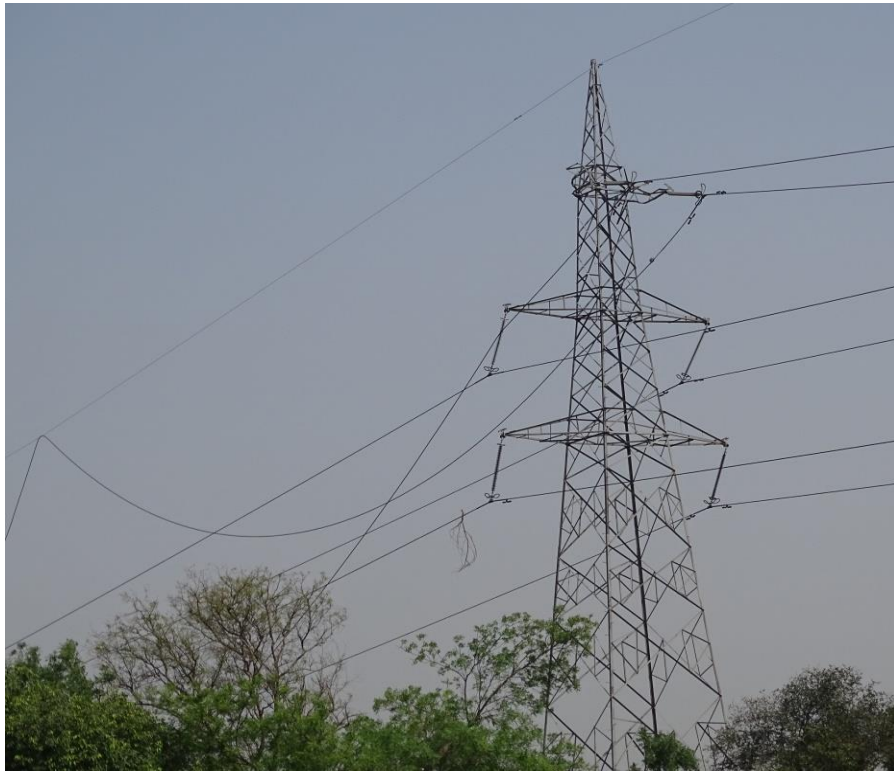
Tower at Loc. No. 269

that the conductor of the top cross arm swirled after breakage and was resting on the Earthwire.

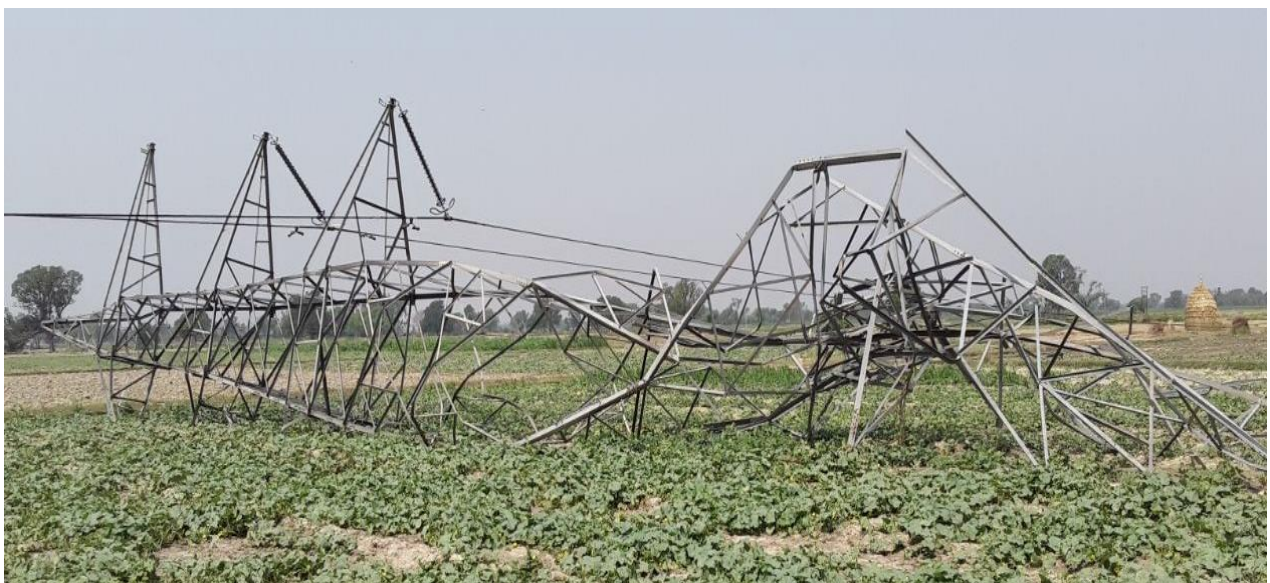
Tower at Loc. No. 270

- d. **Tower at location no. 270 (DA+0), 271 (DA+3) and 272 (DA+0)** were located in cultivated field with some trees in the vicinity. All the three towers had collapsed from the first panel in the transverse direction of the line. All the stubs of these towers were damaged. It was reported by PGCIL that there were no missing members at the towers except some broken bolts on the field which may be shared during collapse of towers.

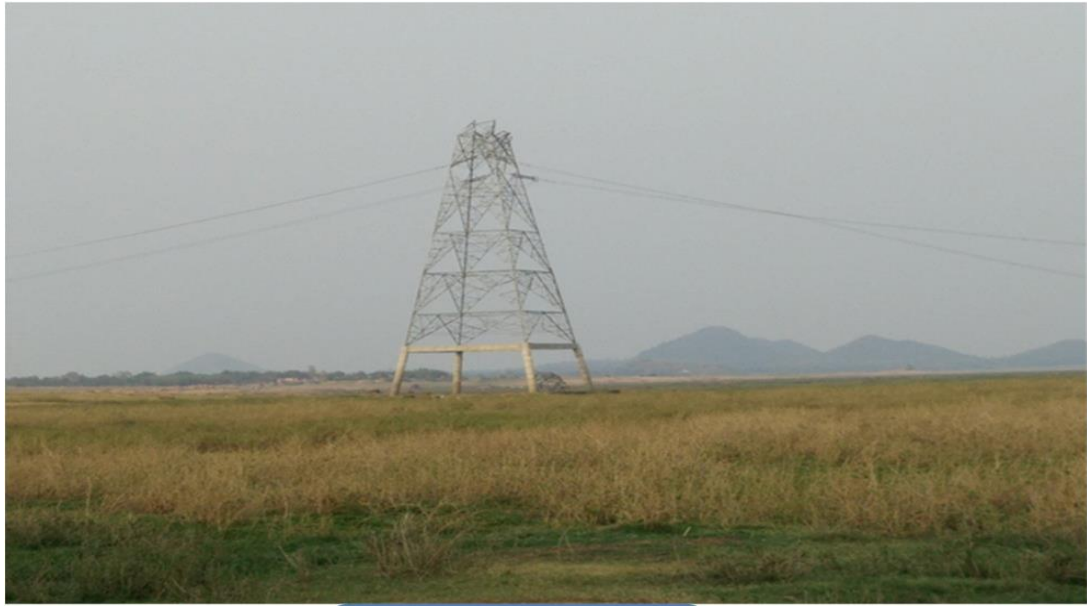
Tower at Loc. No. 63

not damaged and was in erect position. All the stubs were not damaged. It was reported that there were no missing members at the tower.

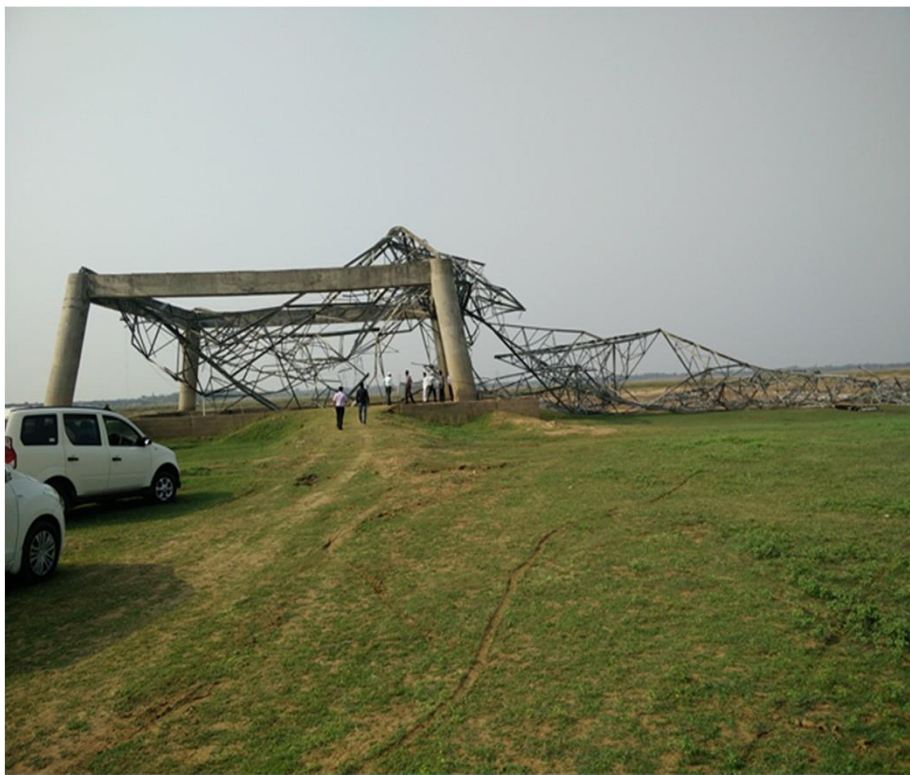
Tower at Loc. No. 64

- d. **Tower at location no. 64 (DD+25)** had completely fallen to the ground in transverse direction. All 4 stubs of the tower were damaged. However, pile foundations of all the legs were intact. It was reported that there were no missing members at the tower.

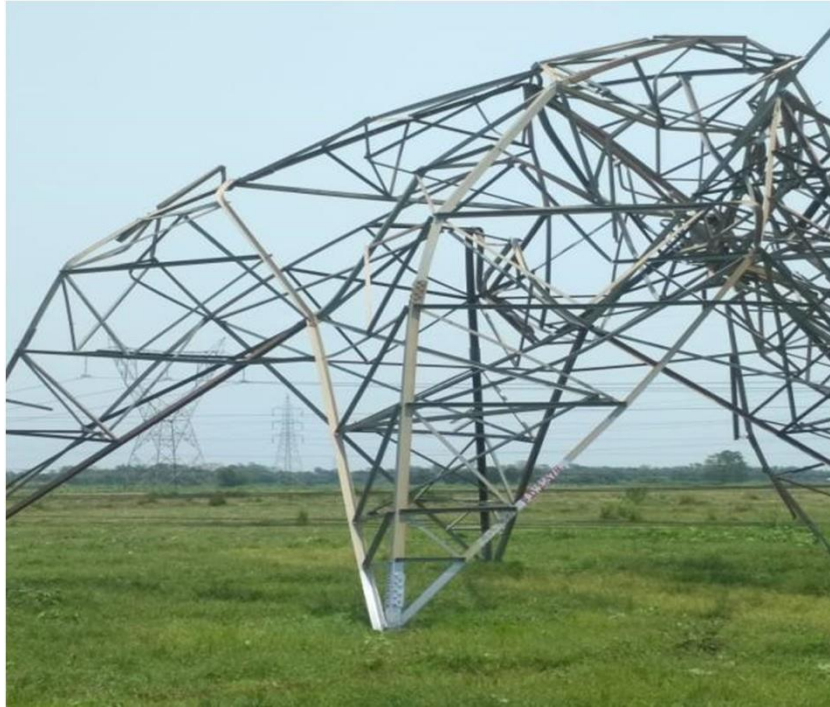
Tower at Loc. No. 378 (A+0)

- c. **Tower at location no. 378 (A+0)** was located in cultivated field with very few trees in the vicinity. The failure pattern of location no. 378 was similar to that of location no. 377 and the tower collapsed from 1st panel. All the four stubs were found to be intact. No members were reported missing at the tower.

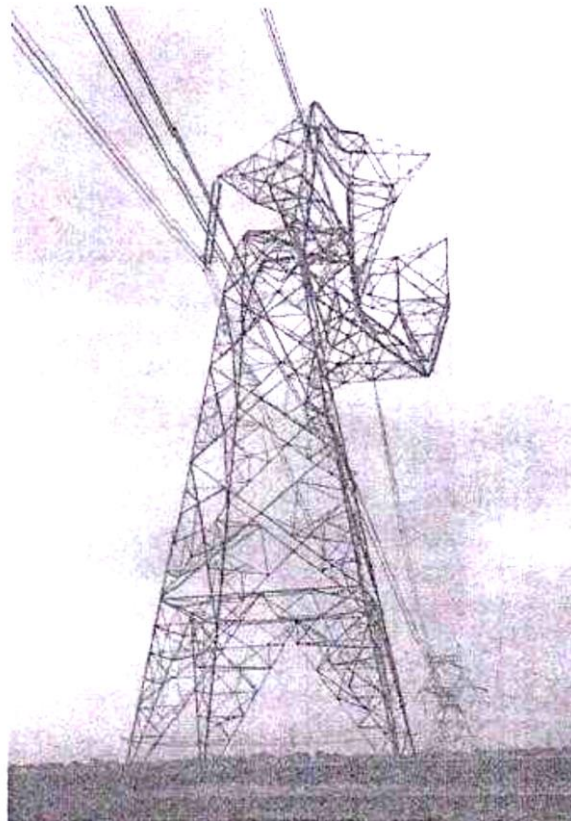
Location no. 368 (A+3)

- f. It was reported that some trees were found uprooted and some LT poles were also found tilted/fallen in nearby area of the failed tower location.

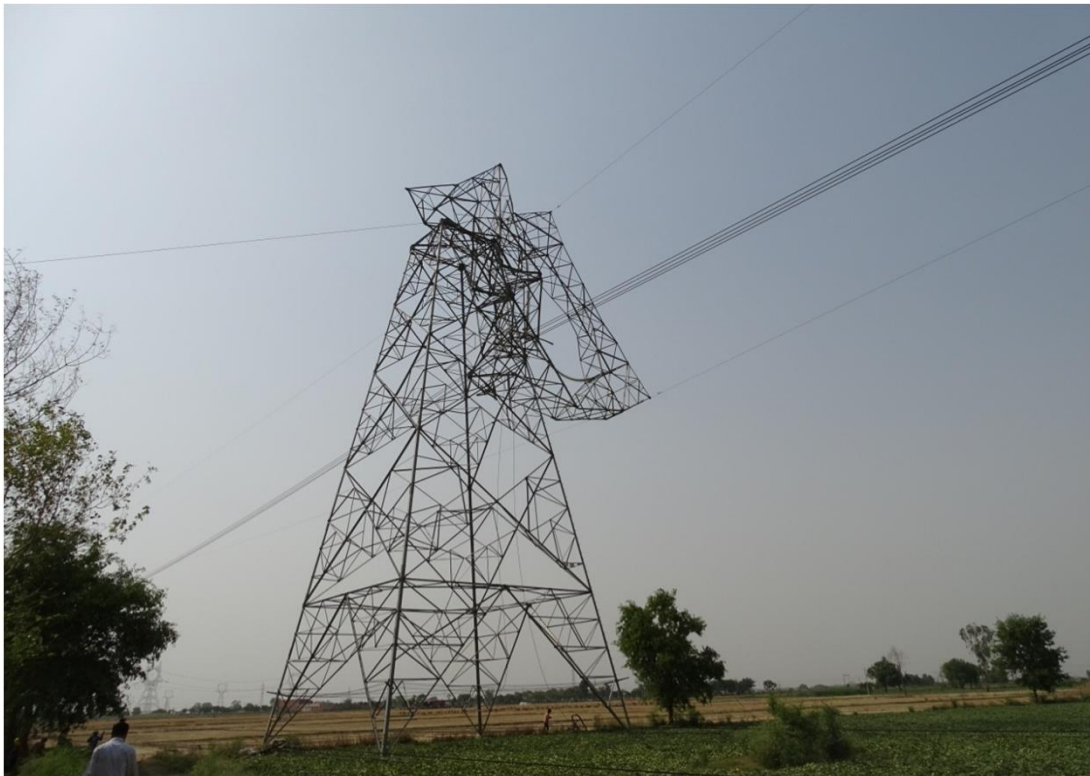
Tower at Loc. No 568 (A+0)

- e. It was informed by PGCIL that as per the advice of standing committee for strengthening of 765 kV Wind Zone-IV Delta configuration suspension (A type) towers, strengthening of towers of this line was in progress. However, strengthening of failed tower was pending.

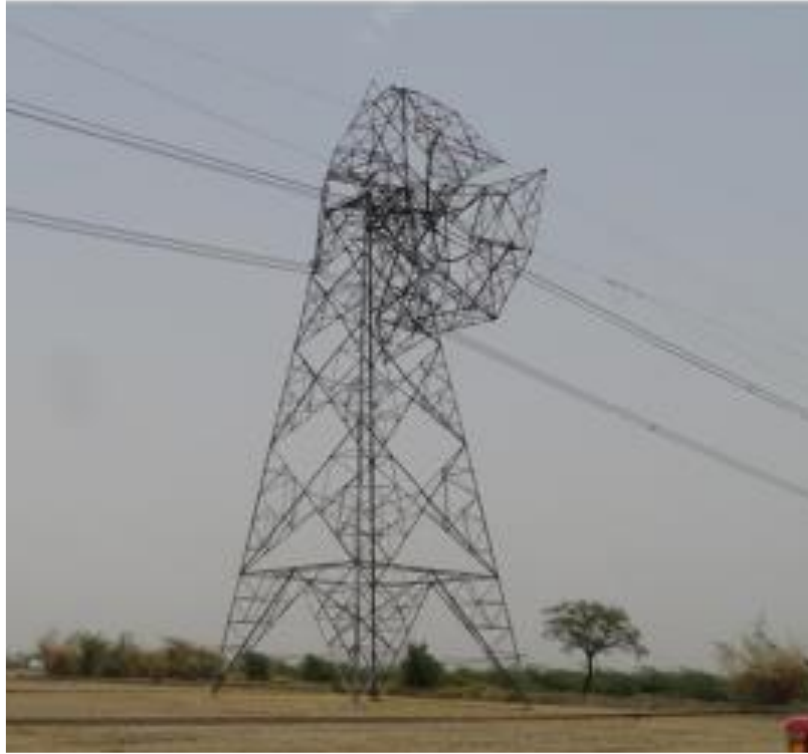
Tower at Loc. No. 17 (A+0)

- d. As reported by PGCIL, a high intensity localized cyclone in a belt of 50 meter width prevailed in the vicinity of transmission line which was confirmed by the local people from nearby villages and the local newspaper.
- e. It was informed by PGCIL that Material tests were conducted on samples selected from site at CPRI, Bangalore. Results were found to be generally within the permissible limits as per IS.
- f. It was informed by PGCIL that as per the advice of standing committee for strengthening of 765 kV Wind Zone-IV Delta configuration suspension (A type) towers, strengthening of towers of this line was in progress. However, strengthening of failed tower was pending.

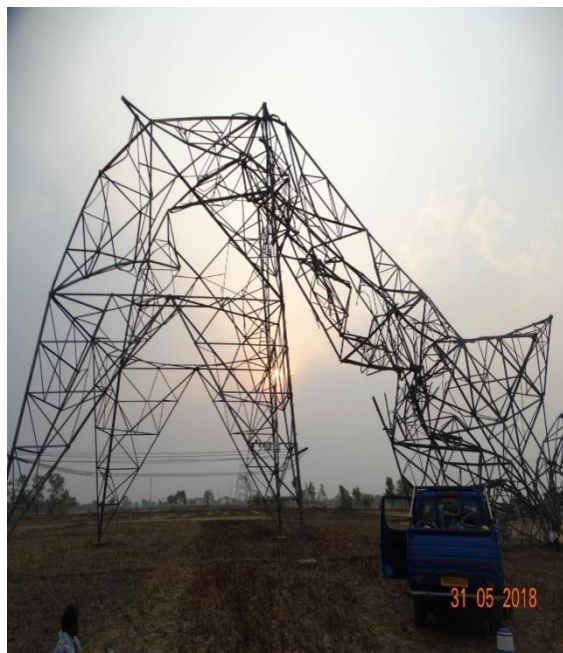
Tower at Loc. No. 185

b. **Tower at Loc. No. 185 (A+0)** was situated/located in cultivated fields of village- Kajhwan, Block- Obera, District-. Aurangabad, Bihar. Tower had collapsed from second panel level and all the four stubs of the tower were intact.

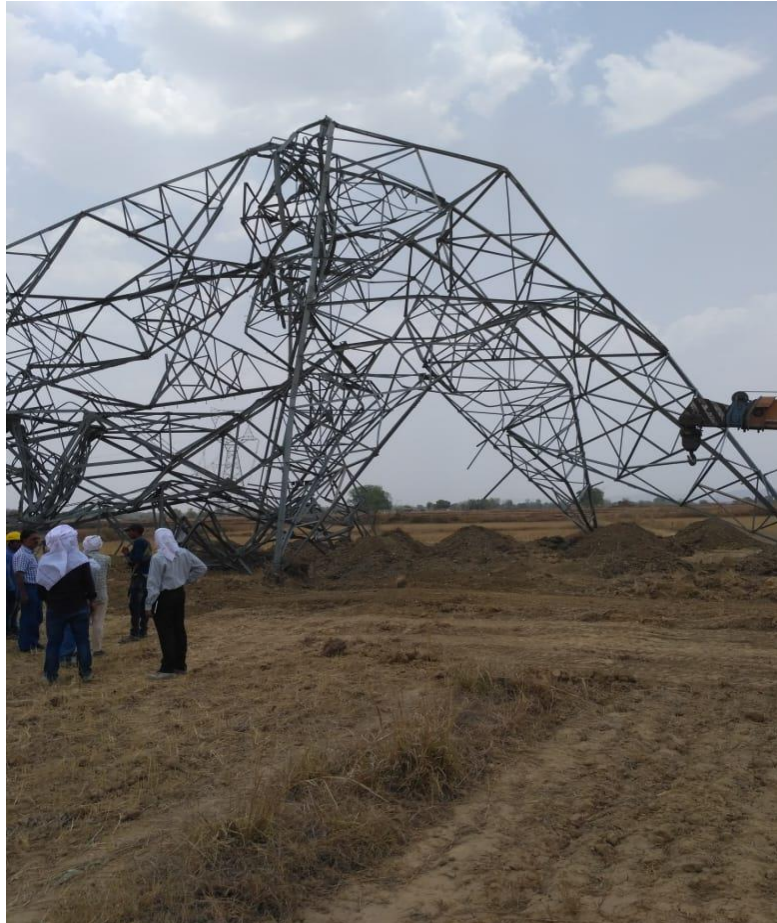
Tower at Loc. No. 63(A+0)

- d. As reported by PGCIL, the site visiting team discussed with the local people in the nearby villages about the wind and it revealed that exceptionally high storm prevailed at the time of tower collapse in the area and such high intensity localized storm is very uncommon in the locality. The effect of storm gets intensified because of presence of hill in the backdrop of location
- e. It was informed by PGCIL that Material tests were conducted on samples selected from site at independent lab. Results were found to be generally within the permissible limits as per IS.

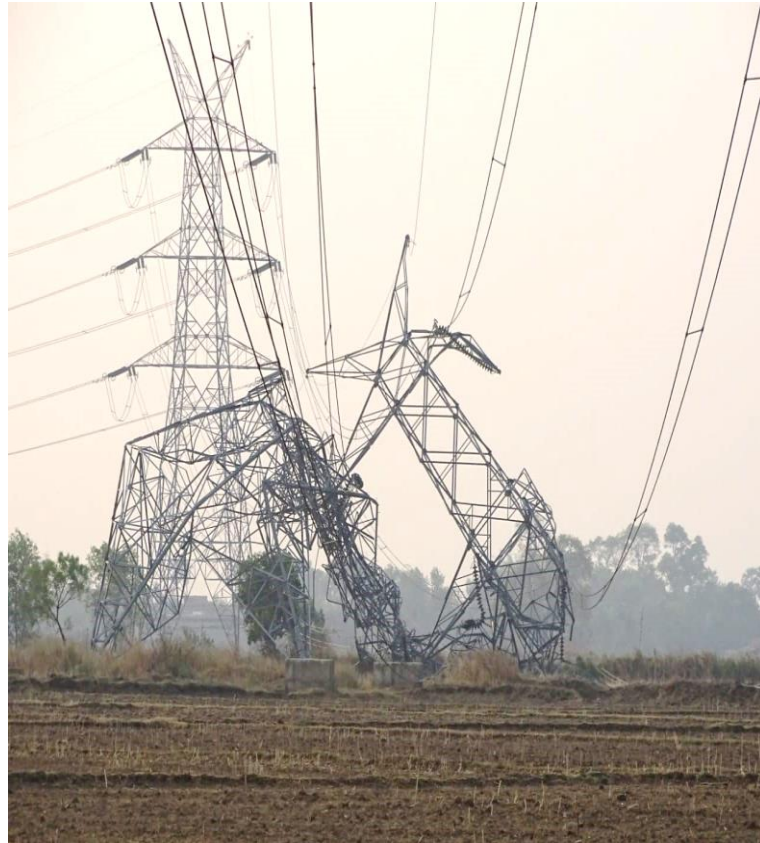
Tower at Loc. No. 36

b. **Tower at Location No. 36 (DA+9)** was situated in the agricultural fields in Itahi Kahuaa village of Kudra tehsil in Kaimur district. Tower had collapsed from second panel level. The top portion above bottom cross arm level was bent and was resting on bottom tower structure due to support of the conductors. All the four stubs of the tower were intact.

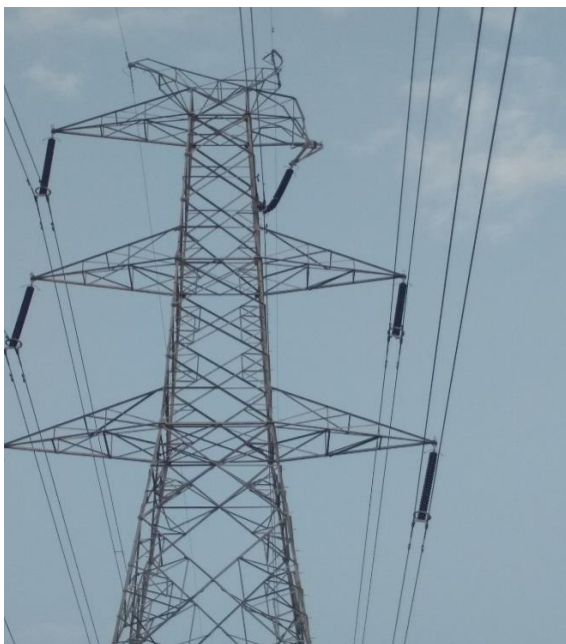
Tower at Loc. No. 37

- c. **Towers at Location No. 37 (DA+0) & 38 (DA+6)** were in erect position. Bending of few members at top cross arm level and in earth wire peak members were observed at these towers due to pulling force of the conductors.

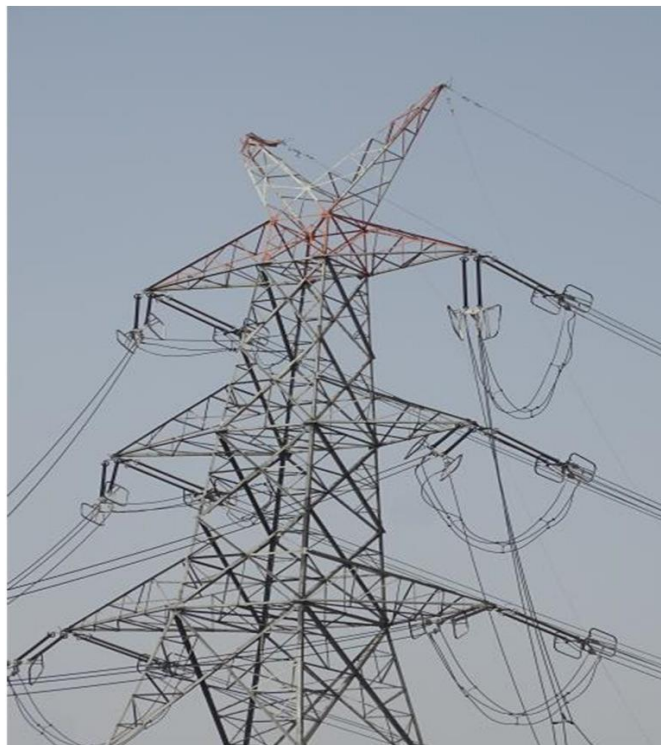
Tower at Loc. No. 54

b. **Tower at Location No. 54 (DB+0)** was in erect position. One of the earth wire peak was damaged. All the stubs and chimney were intact.

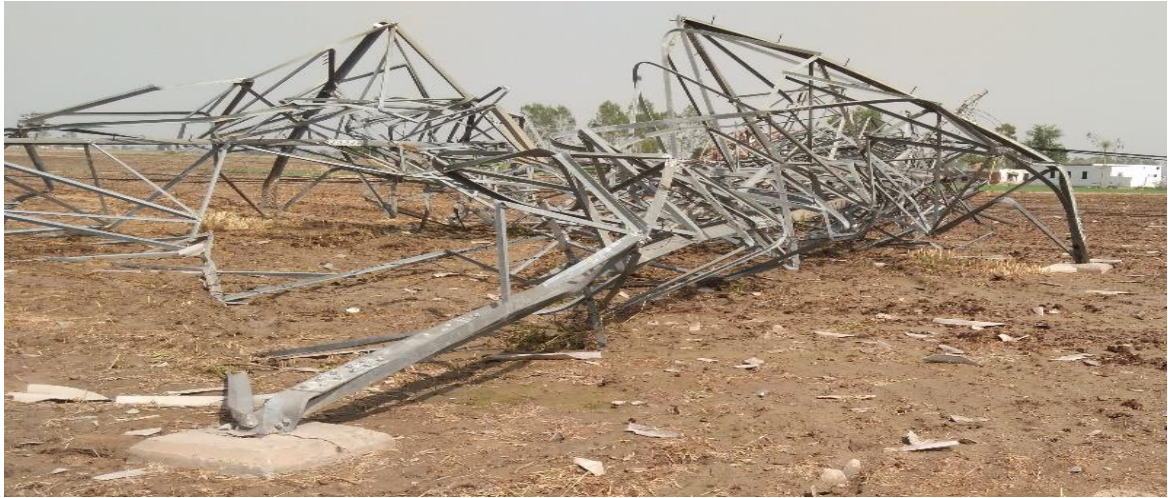
Tower at Loc. No. 55

- c. **Tower at Location No. 55 (DA+0)** was located in agriculture field. The tower was completely collapsed from the stub level in transverse direction. All stubs were bent and damaged.

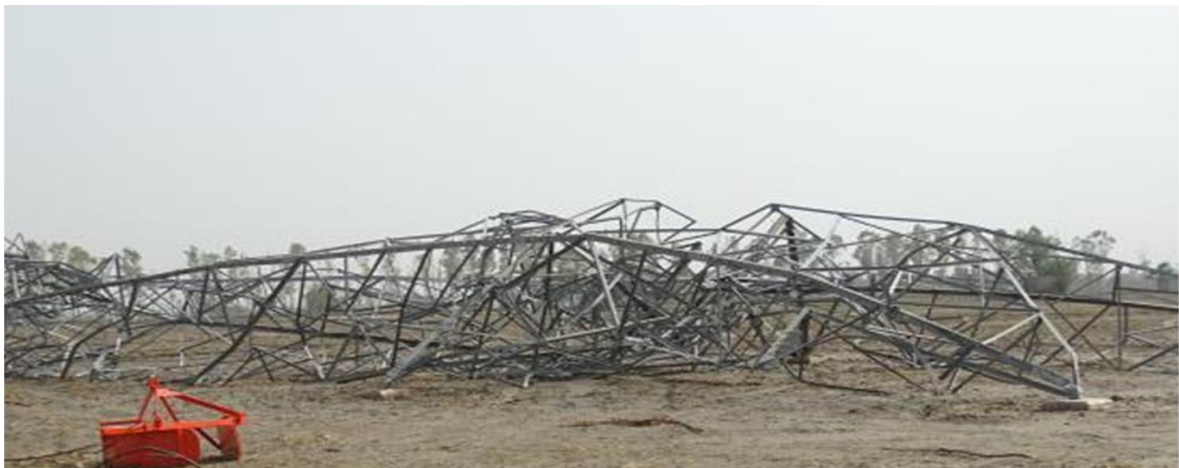
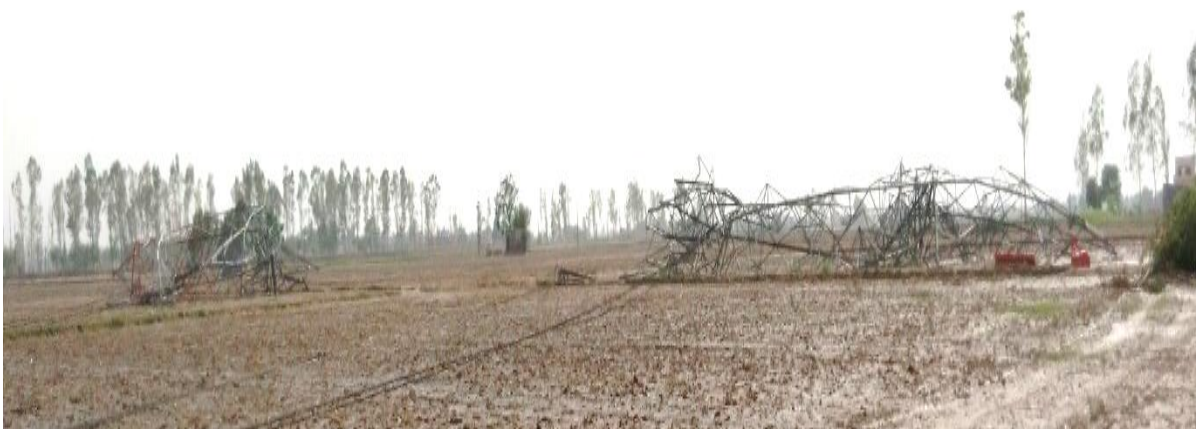
Tower at Loc. No. 56

- d. **Tower at Location No. 56 (DA+0)** had collapsed from stub level in transverse direction. The portion of cage above bottom cross arm got detached from the tower body and fell apart. Three stubs of tower were bent/ damaged.

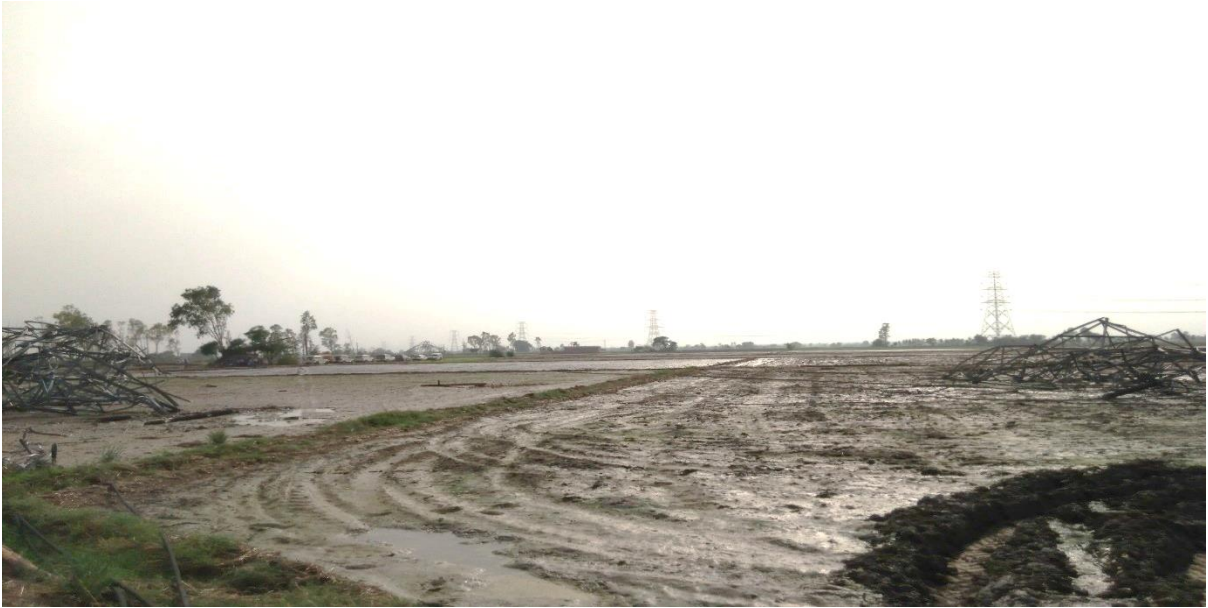
Tower at Loc. No. 57

- e. **Tower at Location No. 57 (DA+0)** had collapsed from stub level in transverse direction and the portion of cage above bottom cross arm got detached and fell a few meters apart from the original standstill position of the tower. All the four stubs were bent.

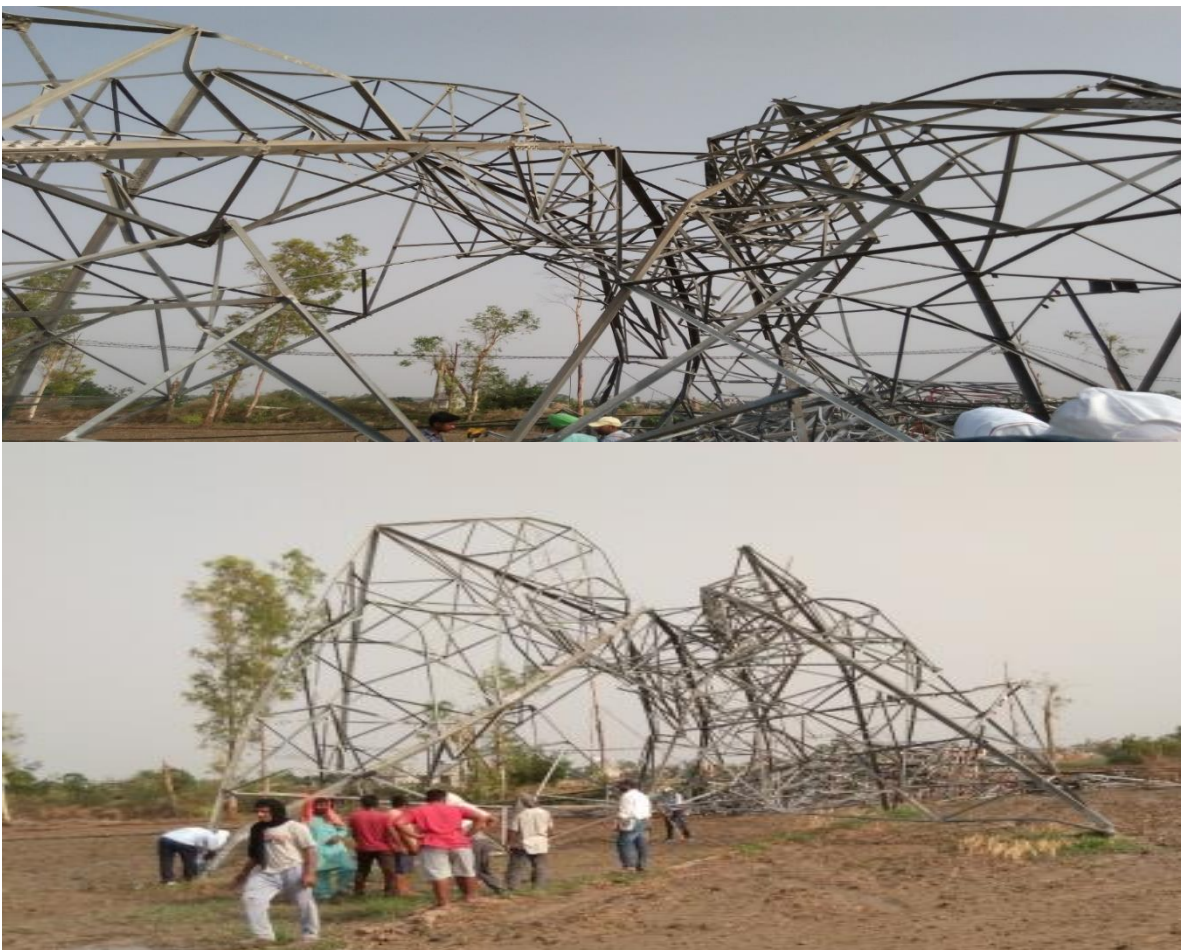
Tower at Loc. No.58

- f. **Tower at Location No. 58 (DA+0)** had collapsed in transverse/ longitudinal direction and two stubs were bent/ damaged. Minor damages were observed in the chimneys.

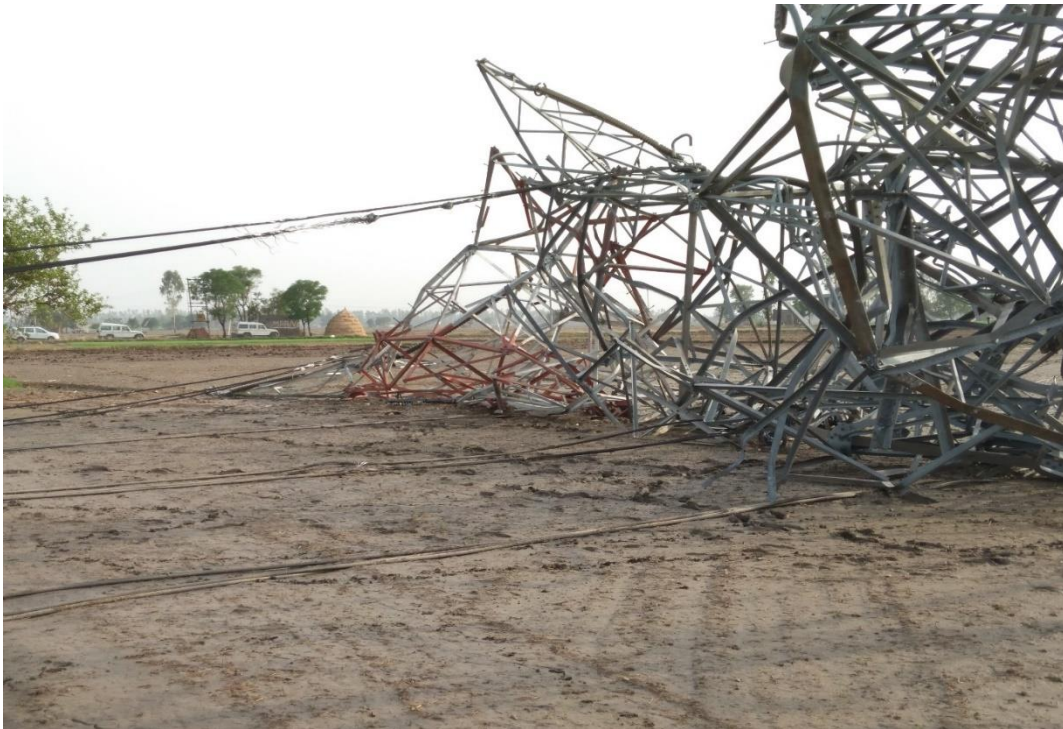
Tower at location no 59

- g. **Tower at Location No. 59 (DA+0)** was located in Paddy field. The tower had collapsed in transverse/ longitudinal direction and two stubs were bent/ damaged

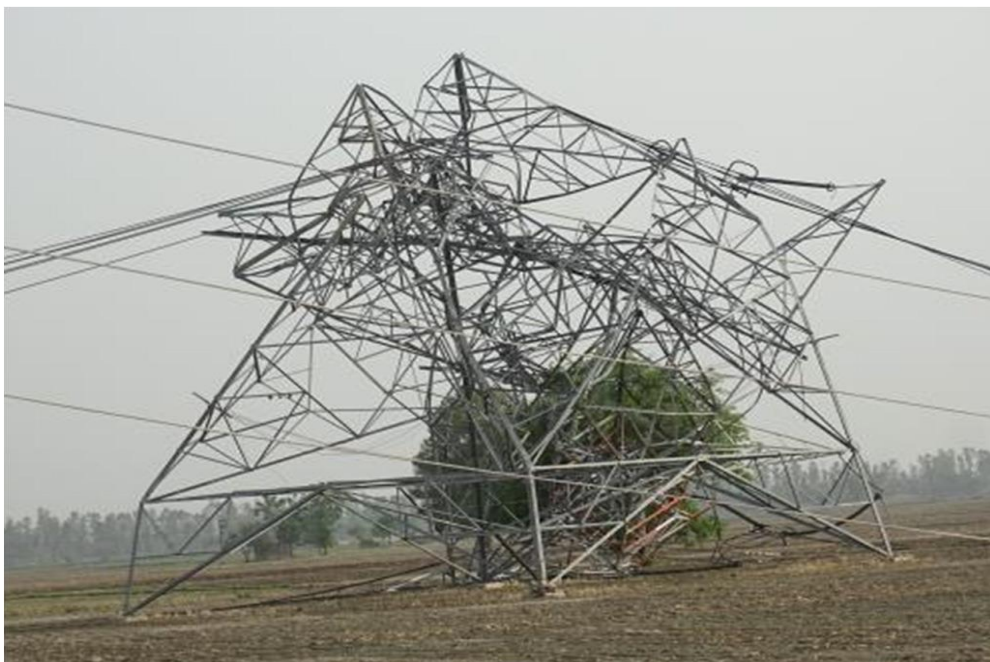
Tower at Loc. No. 60

- h. **Tower at Location No. 60 (DA+3)** failed from above +3m body level in transverse direction and all four stubs were found intact.

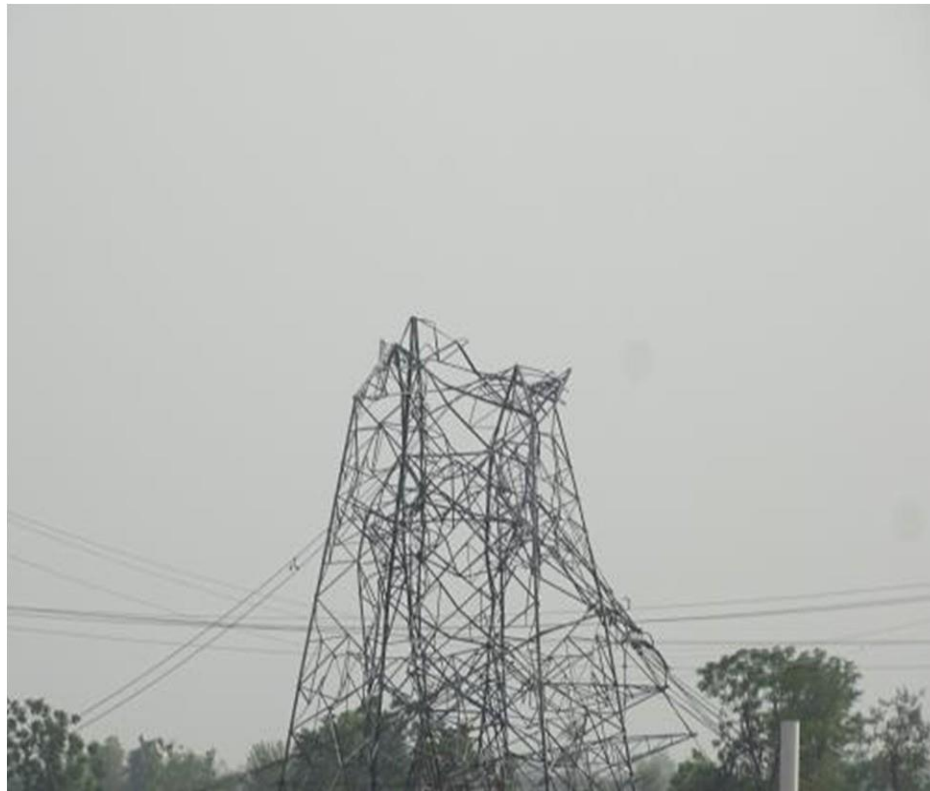
Tower at Loc. No. 61

- i. **Tower at Location No. 61 (DA+0)** failed above second panel level in transverse direction and all stubs were intact.

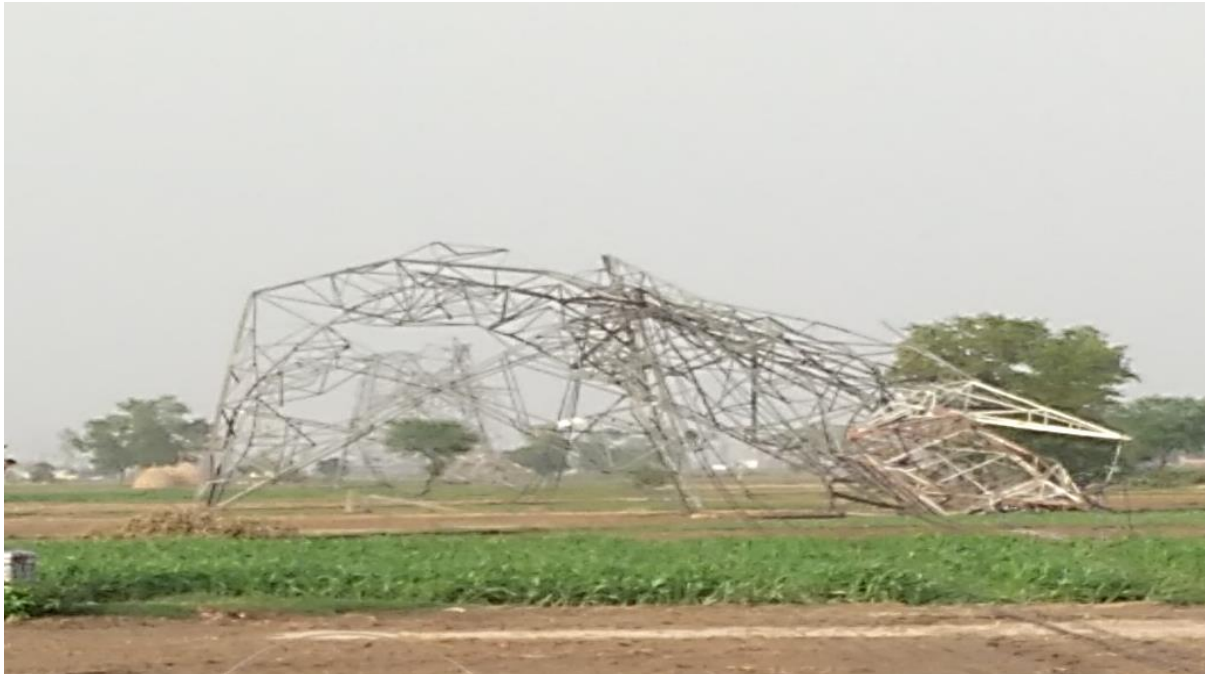
Tower at Loc. No. 62

- j. **Tower at Location No. 62 (DA+0)** failed above first panel level in transverse direction and all stubs were found intact.

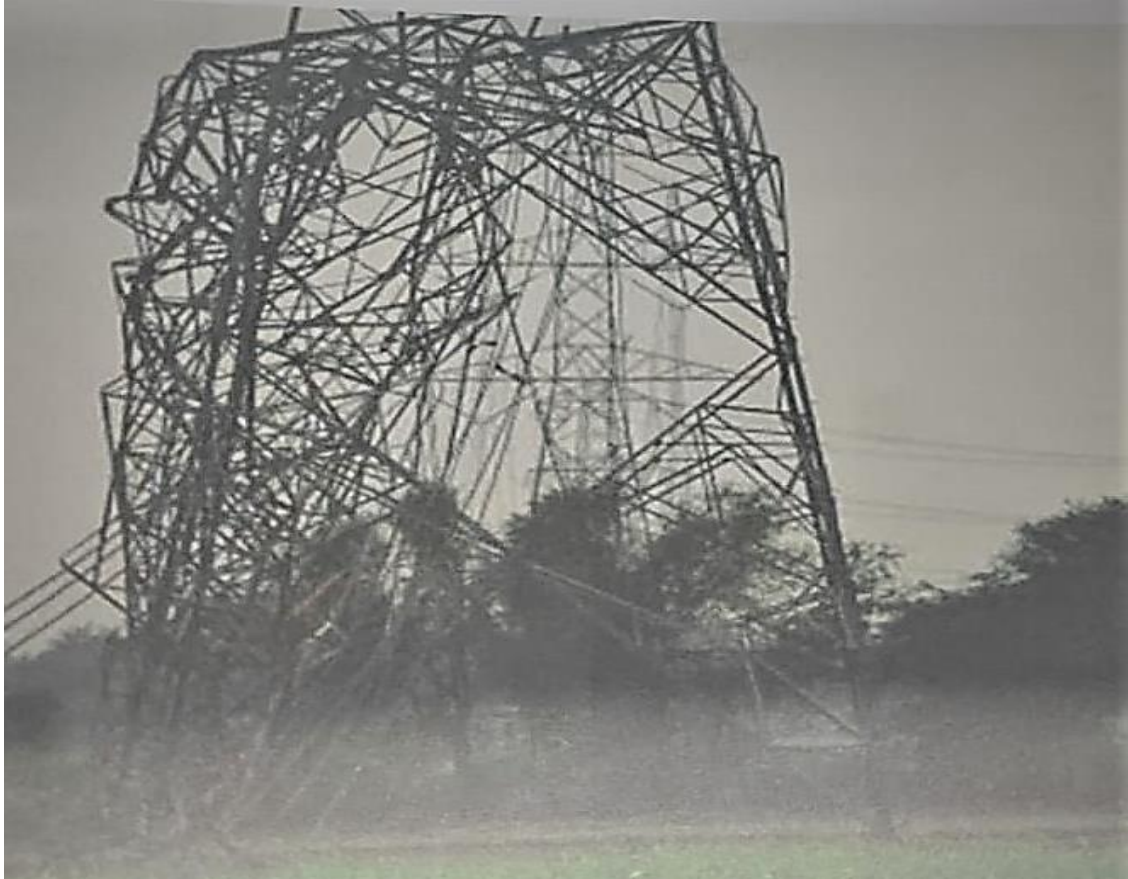
Tower at Loc. No. 63

- k. **Tower at Location No. 63 (DA+0)** was failed above second panel level in transverse direction and all stubs were found intact.

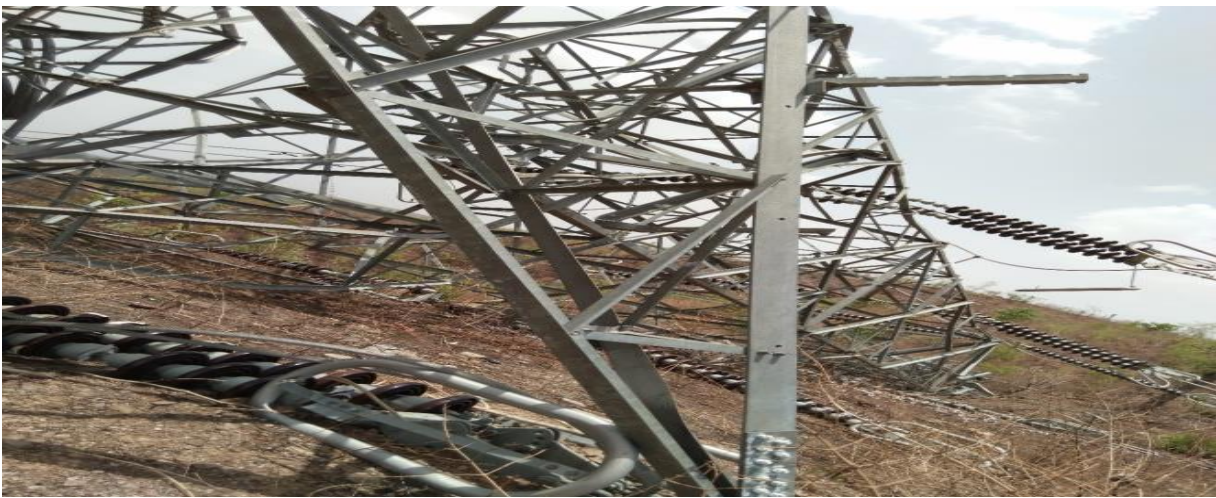
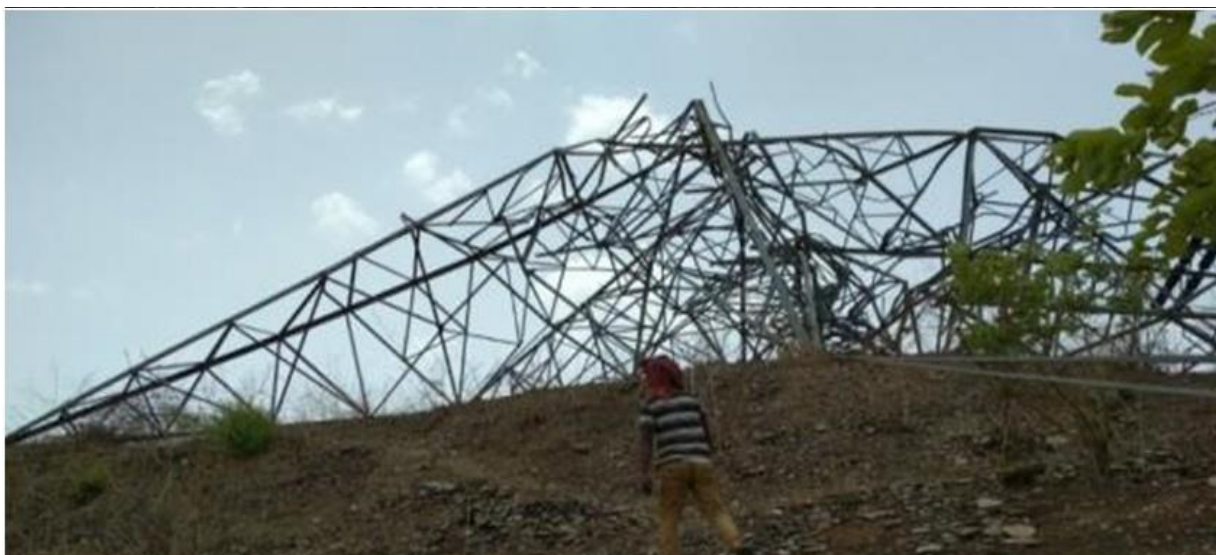
Tower at Loc. No. 218

b. **Tower at Location No. 218 (DB+0)** was located on top of the hill. It was completely collapsed in the transverse direction and all of the stubs were bent. As per report of team visiting the tower failure site, between tower locations 218 & 219 a valley like shape was formed between the hills which might have increased the intensity of the winds. No missing members and bolts and nuts were observed at the tower except few step bolts and earthing bolts.

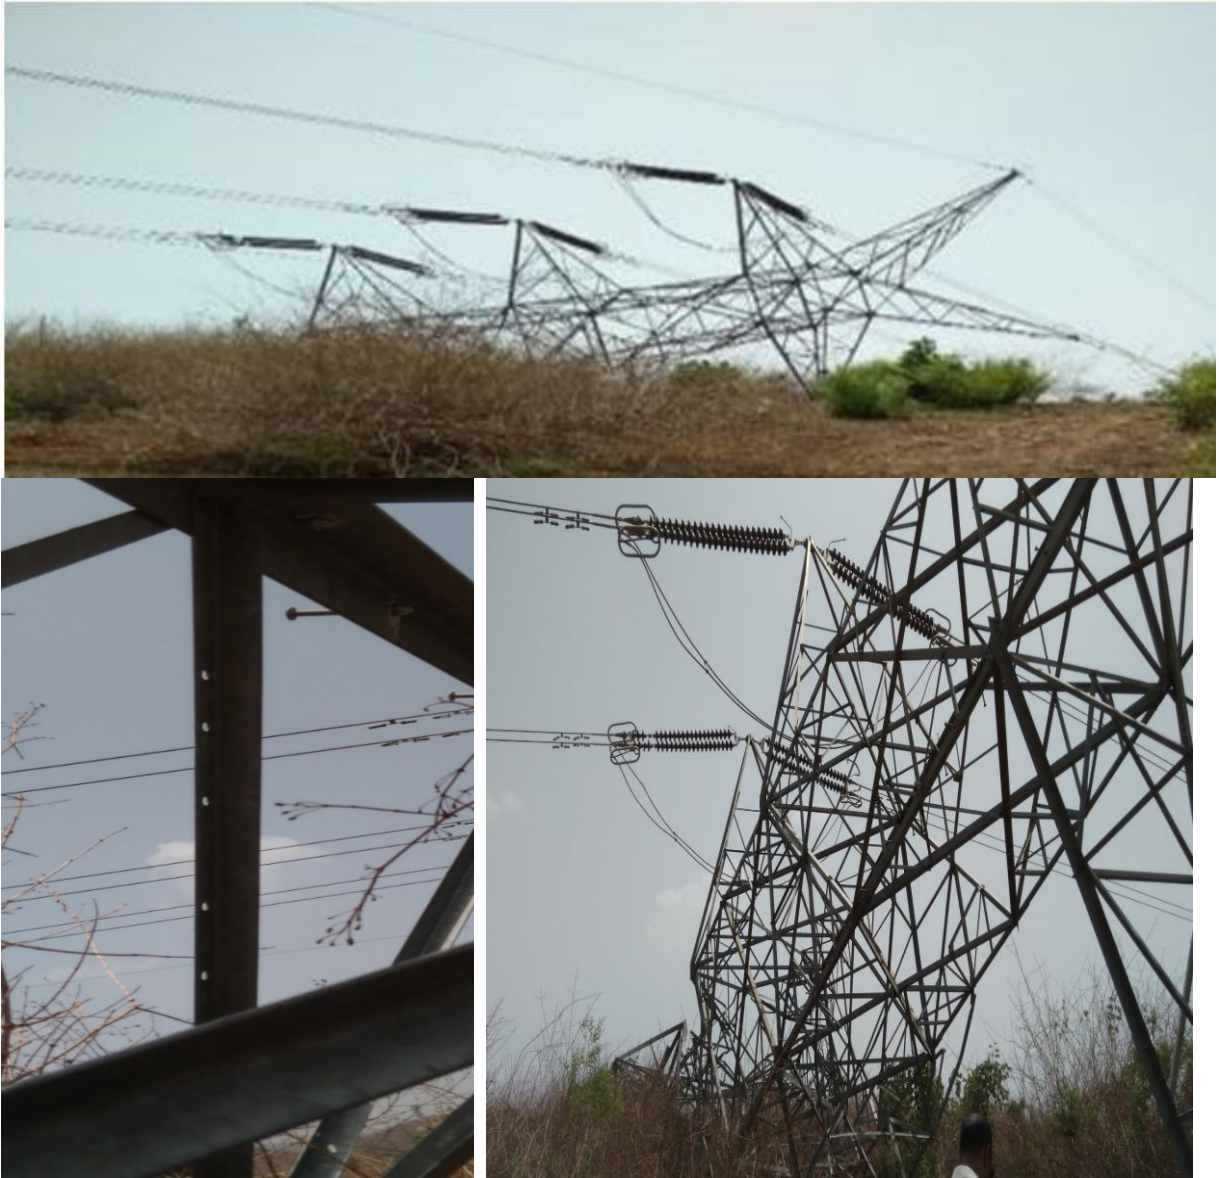
Tower at Loc. No. 219

- c. **Tower at Location No. 219 (DB+6)** had collapsed from waist level in the transverse direction and two of the stubs were broken. As per report of team visiting the tower failure site, between tower locations 218 & 219 a valley like shape was formed between the hills which might have increased the intensity of the winds. No missing members and bolts and nuts were observed at the tower except few step bolts and earthing bolts, name plate bolts, danger plate bolts, phase sequence bolts.
