**REPORT OF THE STANDING COMMITTEE OF EXPERTS
ON FAILURE OF EHV TRANSMISSION LINE TOWERS
(APRIL 2018 – MARCH 2019)**

Central Electricity Authority

4.0 ANALYSIS OF FAILURE OF TOWERS OCCURRED DURING THE PERIOD FROM APRIL 2018, TO MARCH, 2019

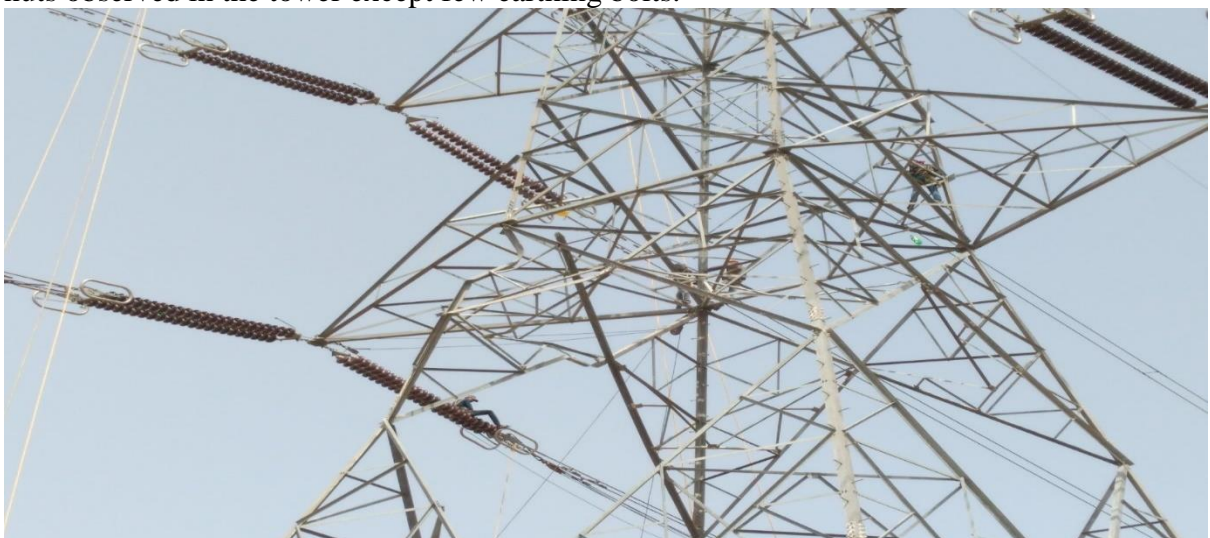
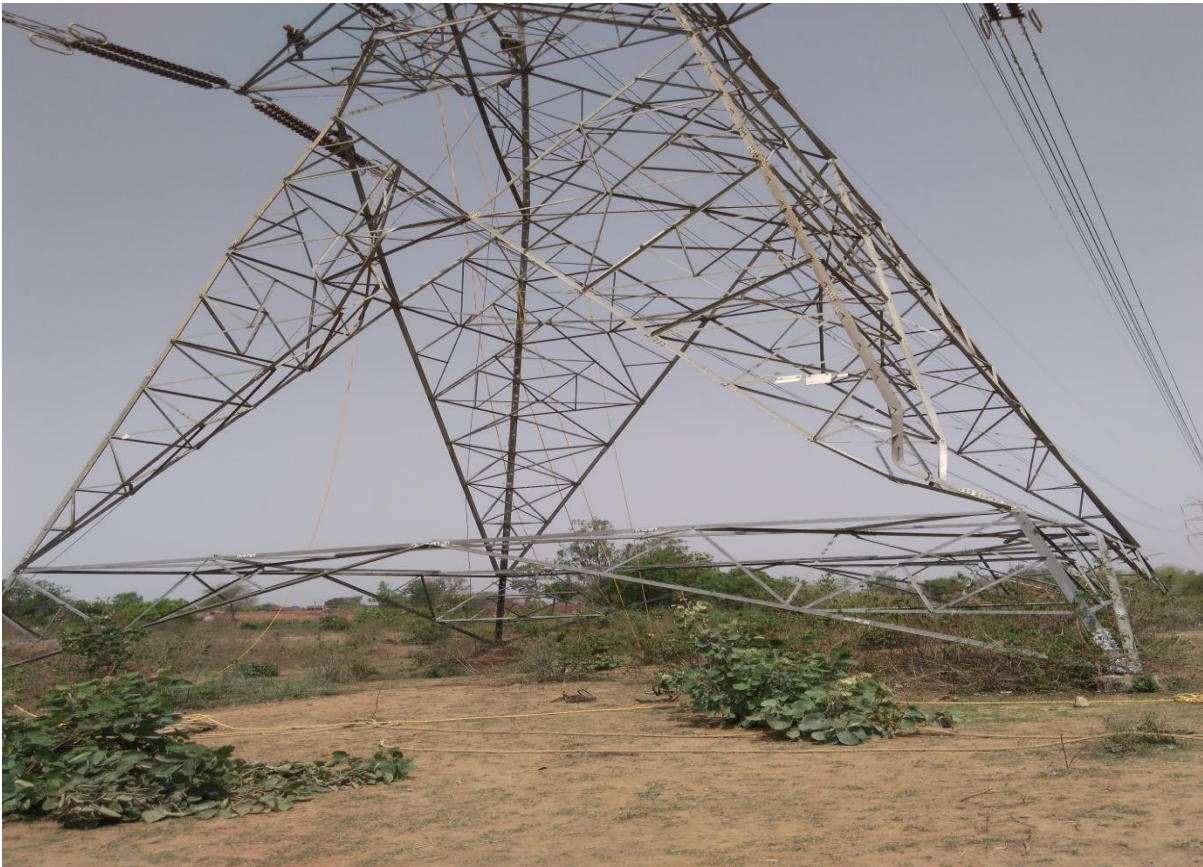
Tower at Loc. No. 220

- d. **Tower at Location No. 220 (DB+3)** was in erect position and was deformed at +3 M extension level and at bottom cross arm level. All stubs of the tower were intact. According to the team visiting to the failure site, the reason of deformation of the tower was pulling force imparted due to collapsing tower at location 219. No missing members and bolts and nuts observed in the tower except few earthing bolts.

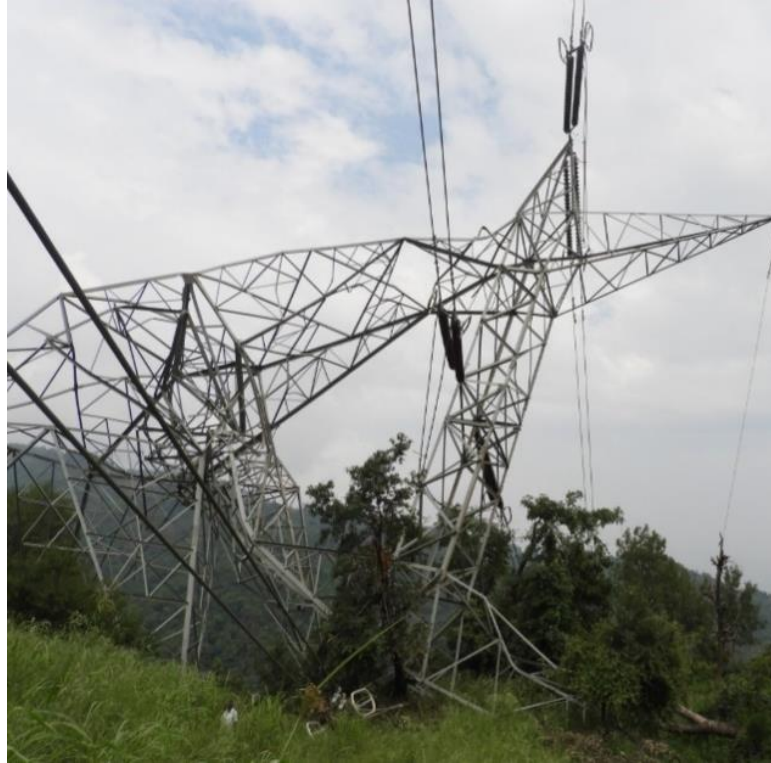
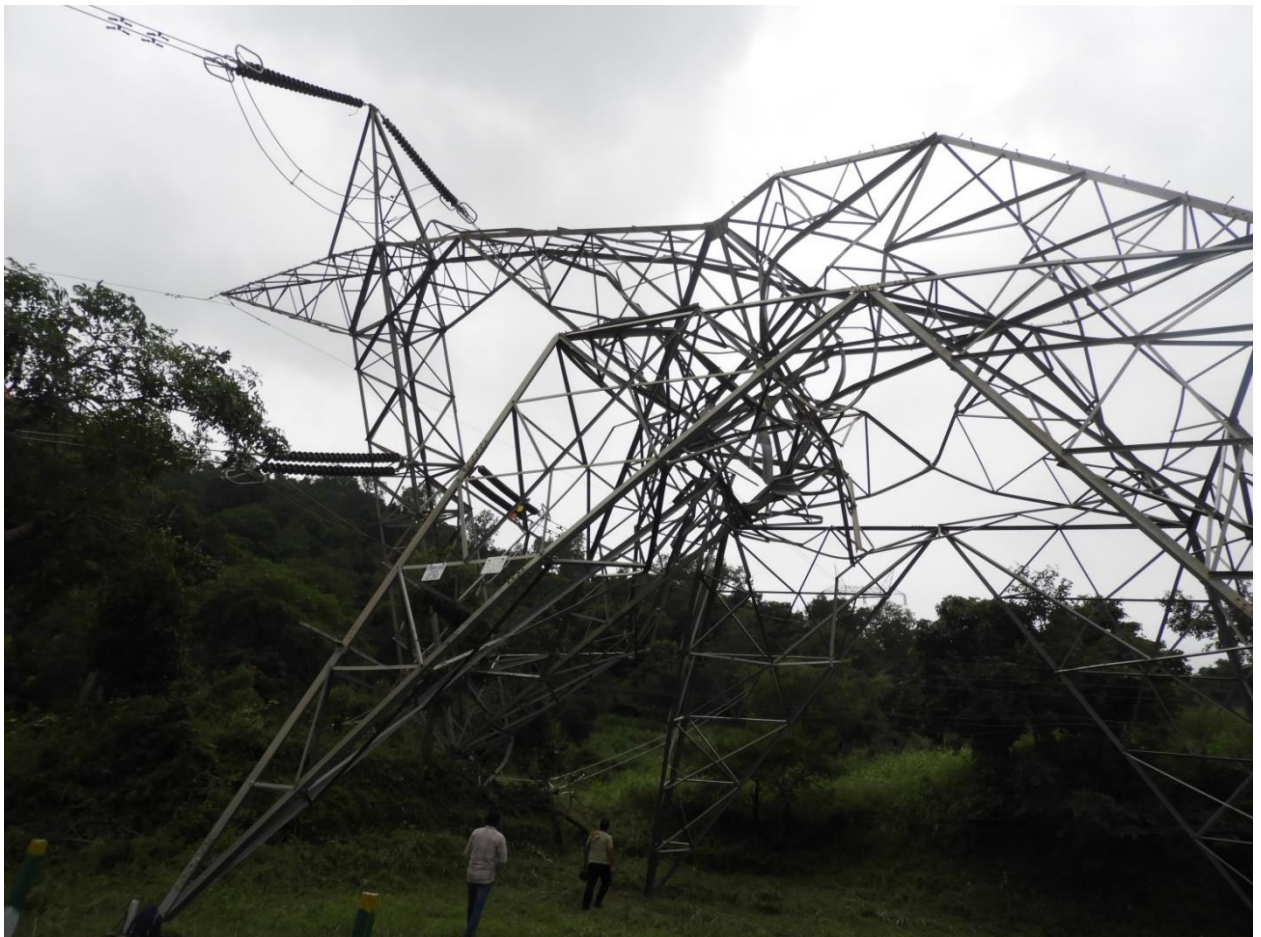
Tower at Loc. No. 238

- b. **Tower at Location No. 238** collapsed from waist level and was tilted across the line in transverse direction. Two no. of stubs of the tower were damaged.

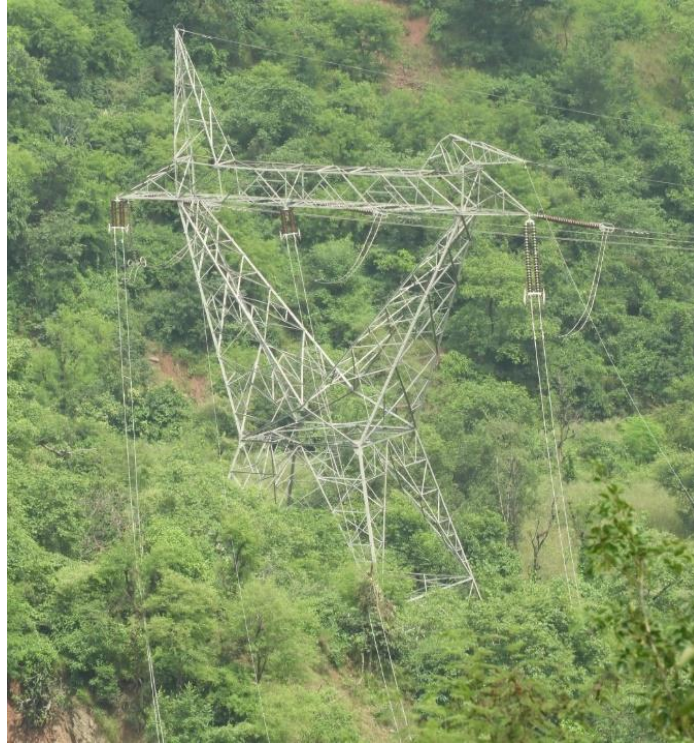
Tower at Loc. No. 239

- c. **Tower at Location No. 239** was partially damaged as the Earth wire Peak was damaged due to pulling force of the wires.

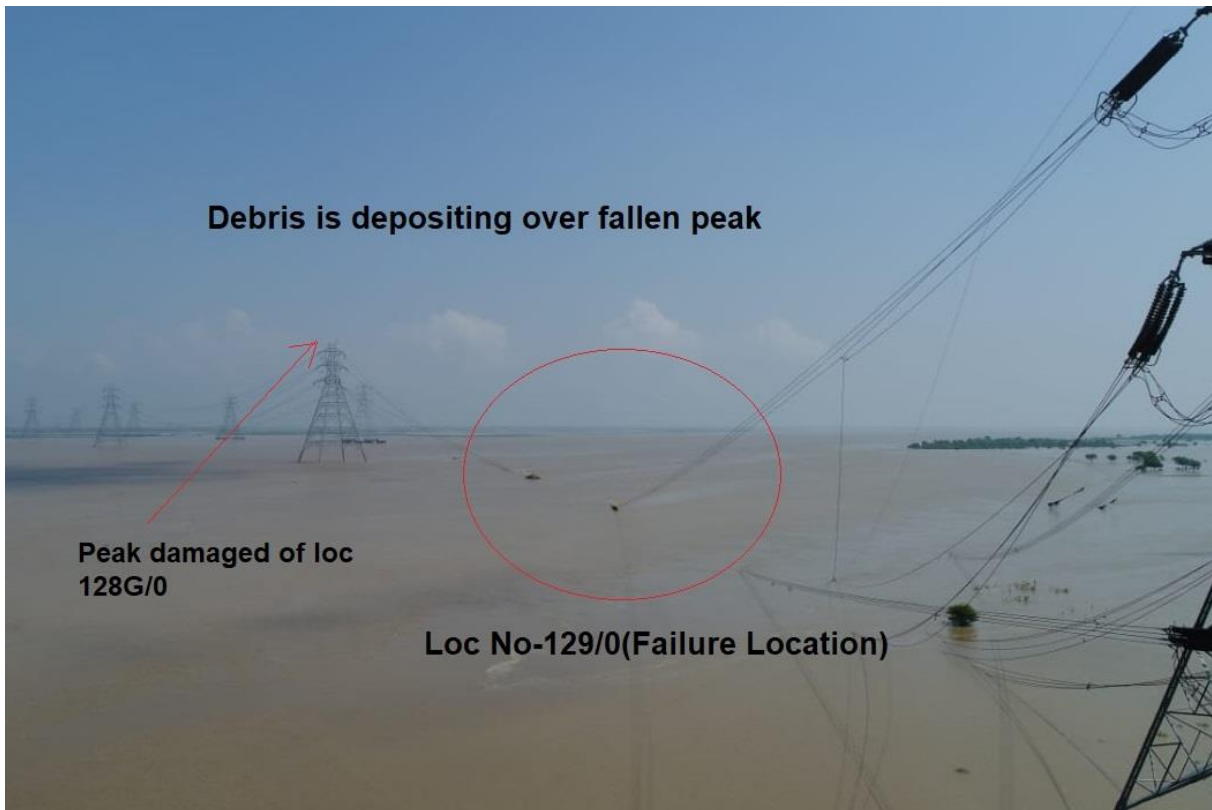
Tower at Loc. No. 128G/0 & 129/0

- c. **Tower at Location No. 128G/0 (DD+25)** was located in mid-stream on newly constructed pile foundation. The earthwire peak and one side of bottom cross arm was damaged because of pulling of conductor/earthwire due to tower collapse at Loc. No. 129/0.

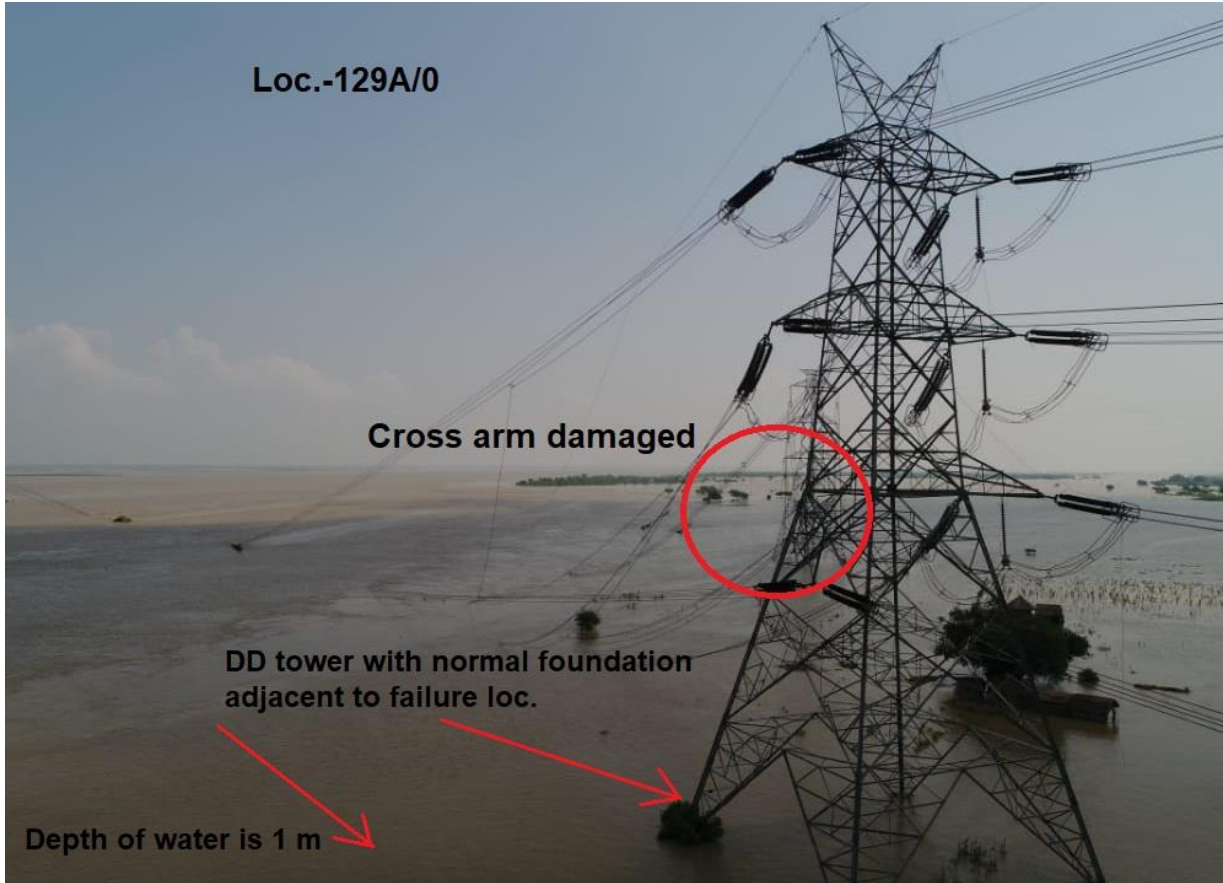
Tower at Loc. No -129A/0

- e. **Tower at Location No. 129A/0 (DD+0)** was constructed on normal open cast foundation. One side of bottom cross arm was observed to be damaged due of pull of conductor towards collapsed tower loc. no. 129/0. Presently the location was almost on the edge of an island towards the main river course. Bottom portion of about 1m portion of the tower was under flood water. It was informed that the foundation at this location had also become susceptible to failure due to eminent soil erosion by the main river course.

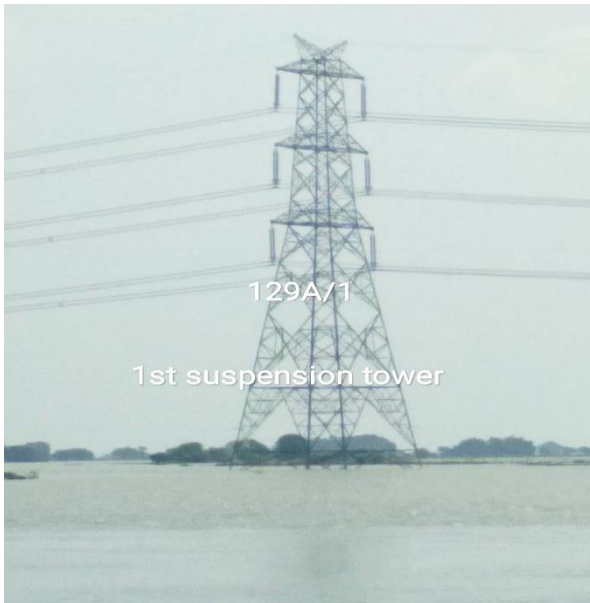
Tower at Loc. No. 129A/1

- f. **Towers at Location Nos. 129A/1(DA+3), 129A/2(DA+0), 129A/3(DA+3) & 129A/4(DA+0):** Bottom portion of towers (about 1m) at location no 129A/1(DA+3), 129A/2(DA+0), 129A/3(DA+3) was submerged in flood water. Location no-129A/4 has also come perilously close to river flow. As reported by PGCIL, the river formed flow channels around these locations and it was observed that all the above foundations became vulnerable to failure.

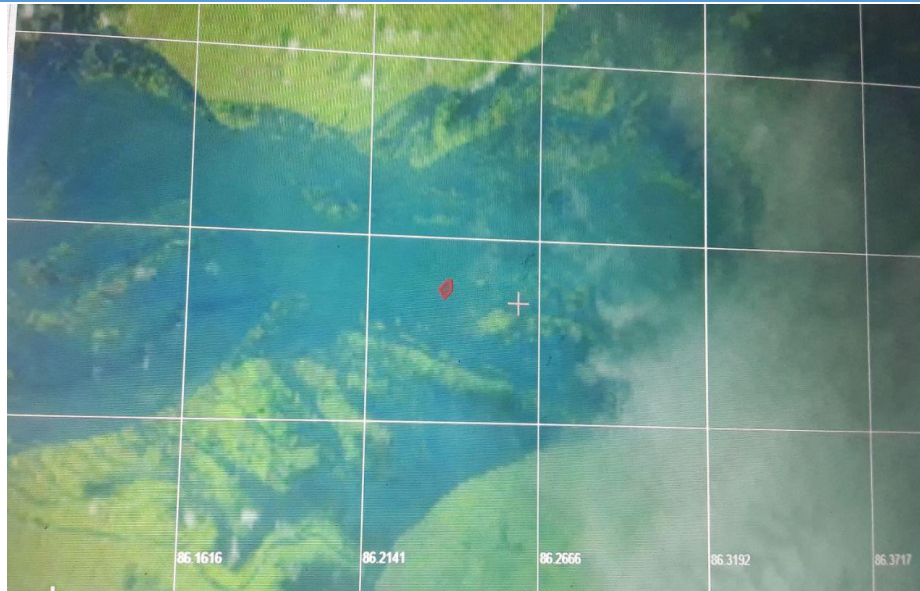
- i. PGCIL informed that after discussion with the local people in the nearby villages, it was gathered that every year the river course is changing towards right bank (towards Patna). Analysis of Google Map for the change in river course during last five years at the crossing locations was done PGCIL. From the analysis, it was clear that there is continuous river bank erosion towards Patna side bank and the distance of river course from bank location no. 129/0 (tower no. 568) has reduced from 576m in Feb-2013 to 105m in Dec-2017. Further, satellite map of 10th Sept-2018 shown below also highlights the heavy soil erosion towards the collapsed tower location (marked as red dot).

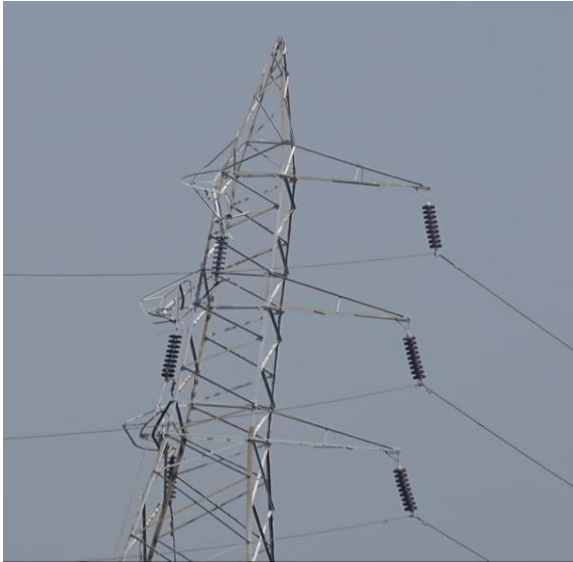
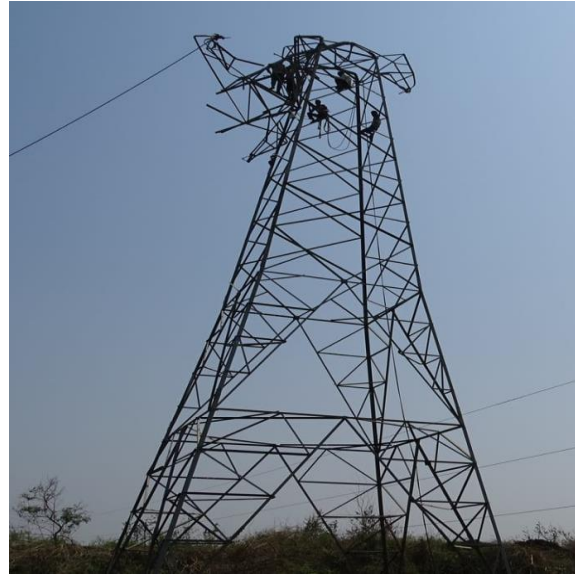
Damaged APTRANSCO's transmission line
