IMPORTANCE & PROCESS OF RLA STUDIES IN ASSESSMENT OF NEED FOR R&M - A CASE STUDY

CPRI, Bengaluru

Residual Life Assessment of 8 MW Hydro Power Plant Penstock Pipelines

Health Assessment of 126 MW Hydro Generator Shaft - Case study

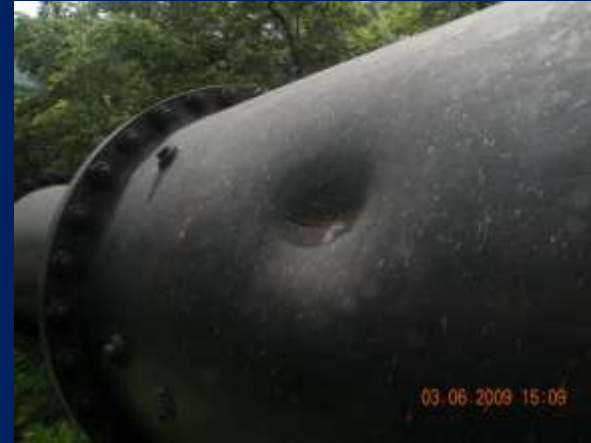
Severe dent on Penstock No. 1

One deep dent around 50 mm depth and two minor dents around 15 mm depth were observed on the pipeline no. 1 between the first & second anchor block at the location near to the Saddle Support No.2

The dents on the pipeline no. 1 between the first & second anchor block at the location near to the Saddle Support No.2 & 3 are to be repaired.

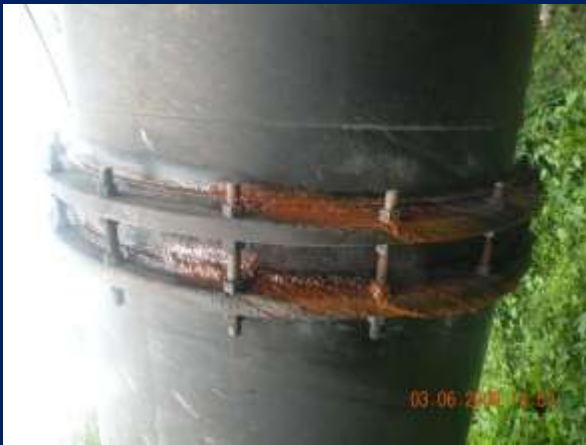
Flange leakage in Penstock No.4

Leakages in the expansion joints of all penstocks are to be prevented / arrested.

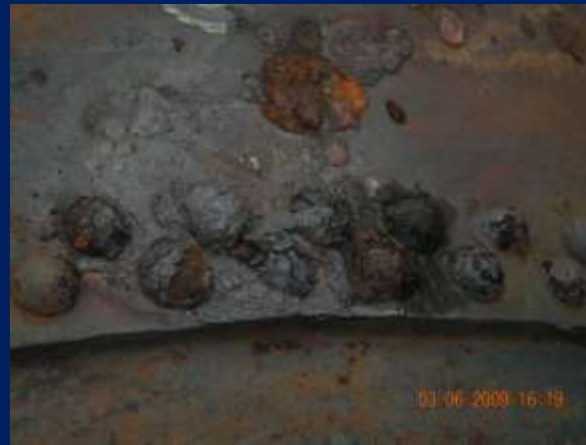
Severe corrosion on rivets

It is also recommended that the practices of regular visual inspection of penstocks, clearing of vegetation, painting whenever needed, etc. are to be continued. Some of the riveted joints found to be in moderate rusted condition and the practice of coating should be continued periodically.

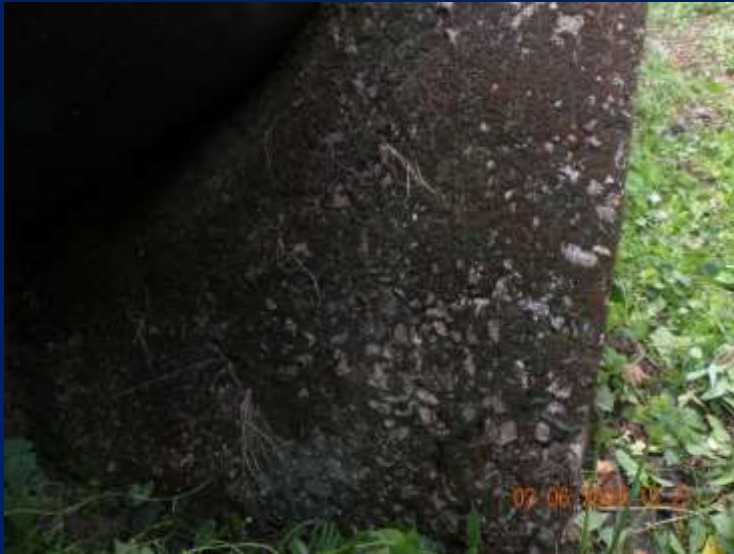
Porosity in Saddle support

Minor porosity was observed in very few locations on the masonry saddle supports & looseness in some anchor blocks which represented the weakness of foundation

Few foundations of saddle supports & anchor blocks are found to be weak, which needs to be strengthened.

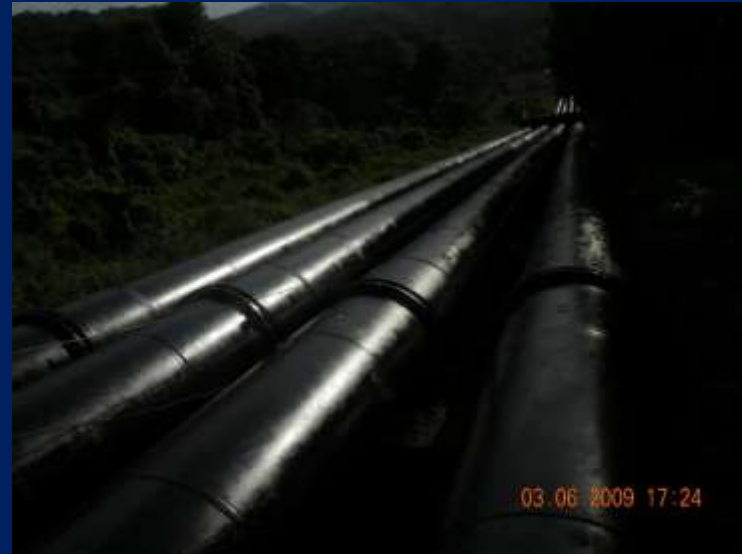
Penstocks under process of painting

The quality of painting of penstocks appeared to be good. The red oxide primer with epoxy (Black) paint was given to the penstocks as per the normal practice

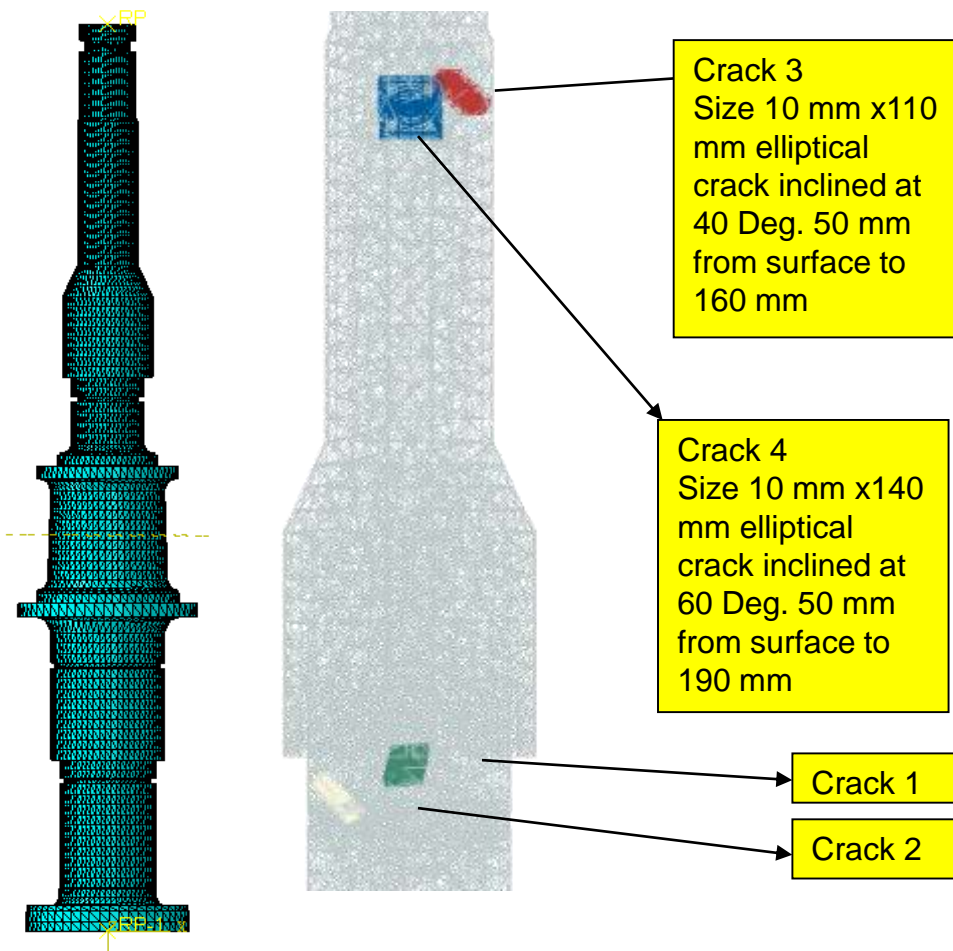
Meshed Geometrical
model of Gen.rotor shaft
(79500 Tetra elements)

Crack 3
Size 10 mm x110
mm elliptical
crack inclined at
40 Deg. 50 mm
from surface to
160 mm

Crack 4
Size 10 mm x140
mm elliptical
crack inclined at
60 Deg. 50 mm
from surface to
190 mm

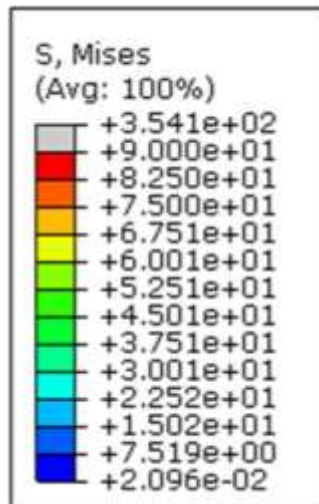
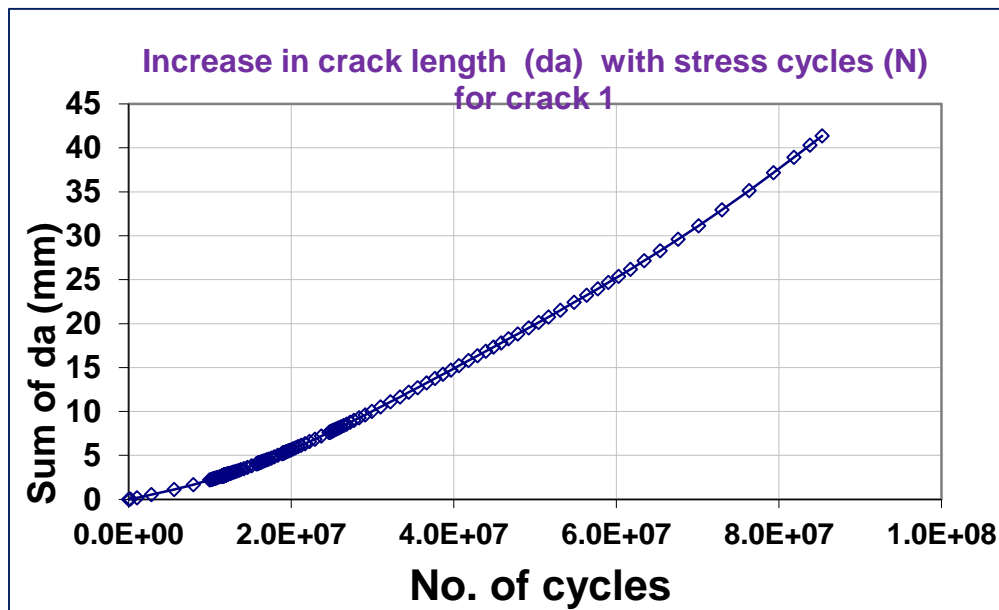
Crack Growth rate of Generator Shaft

Fatigue Life of
Un-cracked shaft
= 3.20×10^9

Sl No	Crack size	No of cycles	Equivalent no. of Days
1	20.1	5,04,28,232	210
2	29.6	6,76,01,489	281
3	42.4	8,53,07,505	355
4	50	~8,80,00,000	366

“ Suggested for re-inspection of the shaft close to 250 days of operation”
