KERALA STATE ELECTRICITY BOARD LIMITED

**RENOVATION, MODERNISATION,
UPRATING & LIFE EXTENSION OF
HYDROPOWER PLANT- DIVERSE
ISSUES AND HANDLING STRATEGIES**

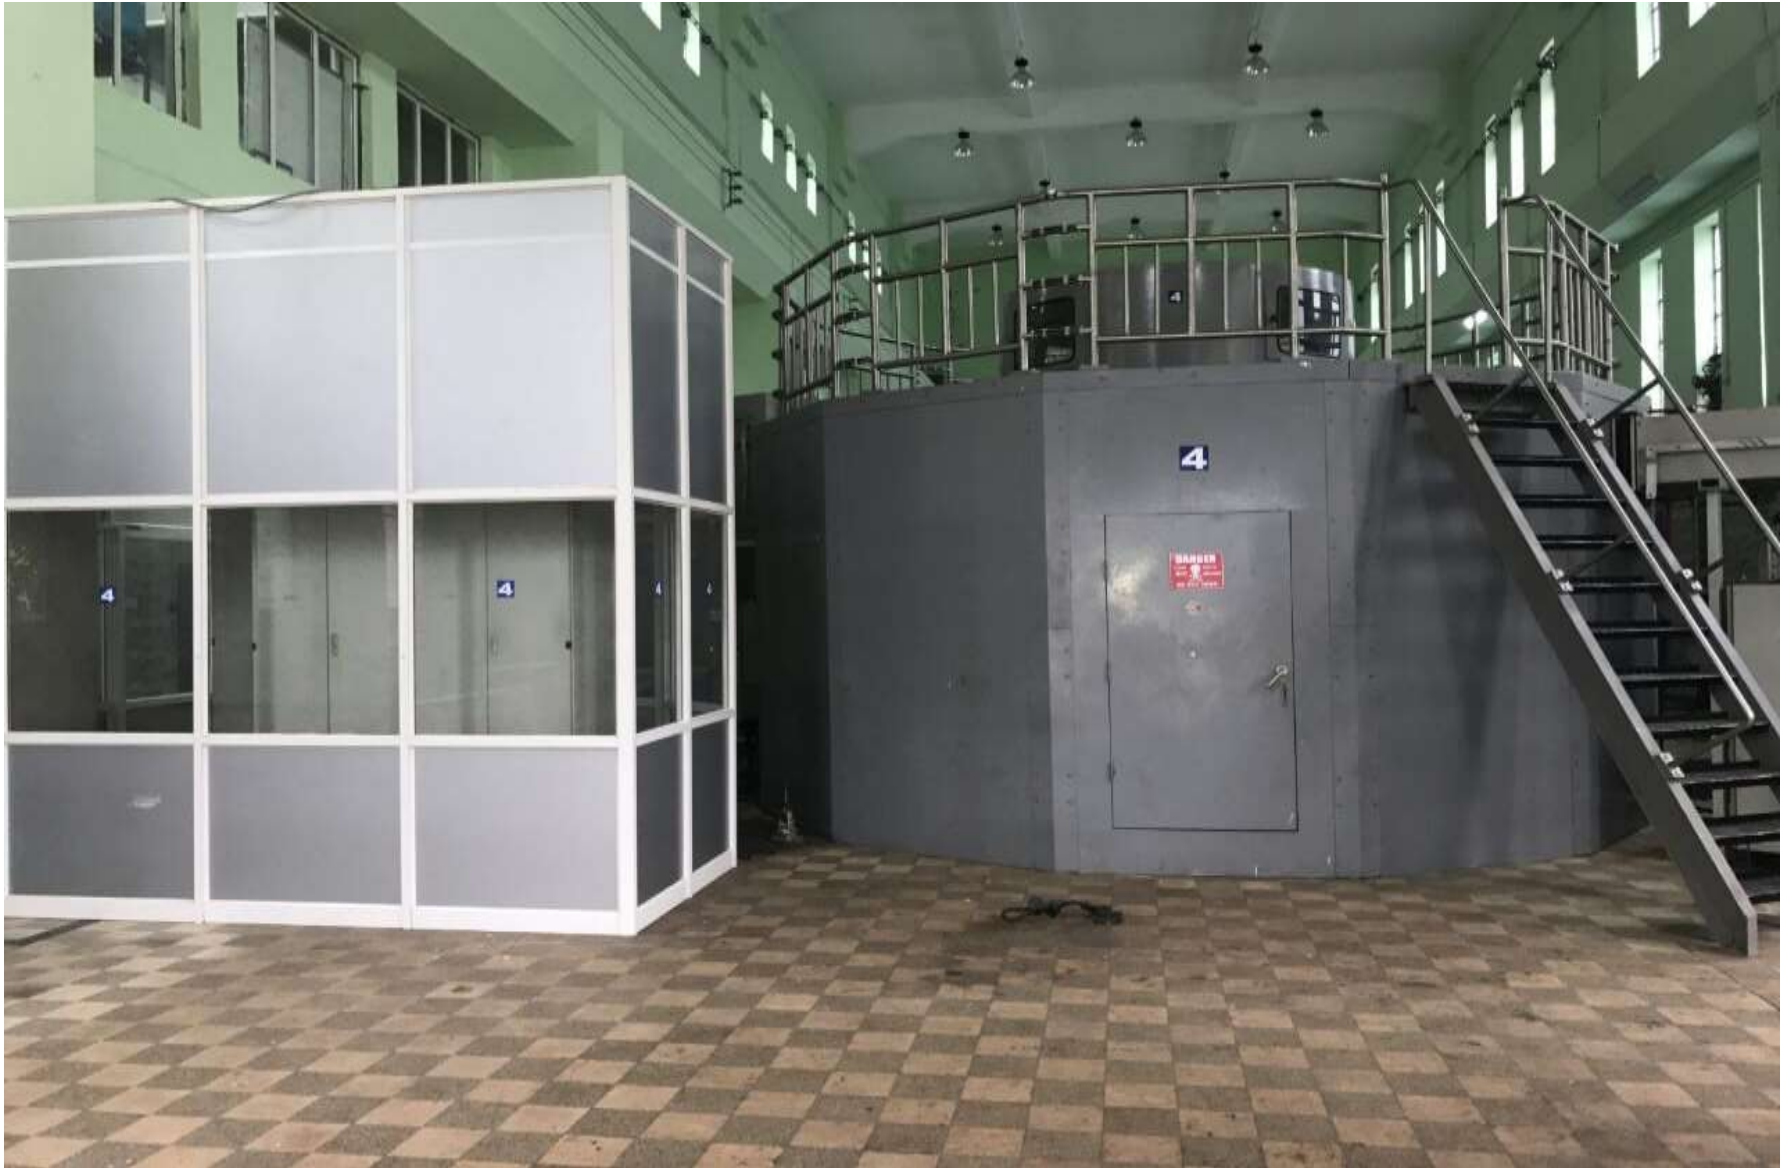
After renovation

- This was the first task. This necessitated the total shutdown of the generating station to dismantle existing pumps and pipes, erect new pumps, pipes, panel etc. It was very difficult to achieve the schedule due to very bad condition of existing pipes.

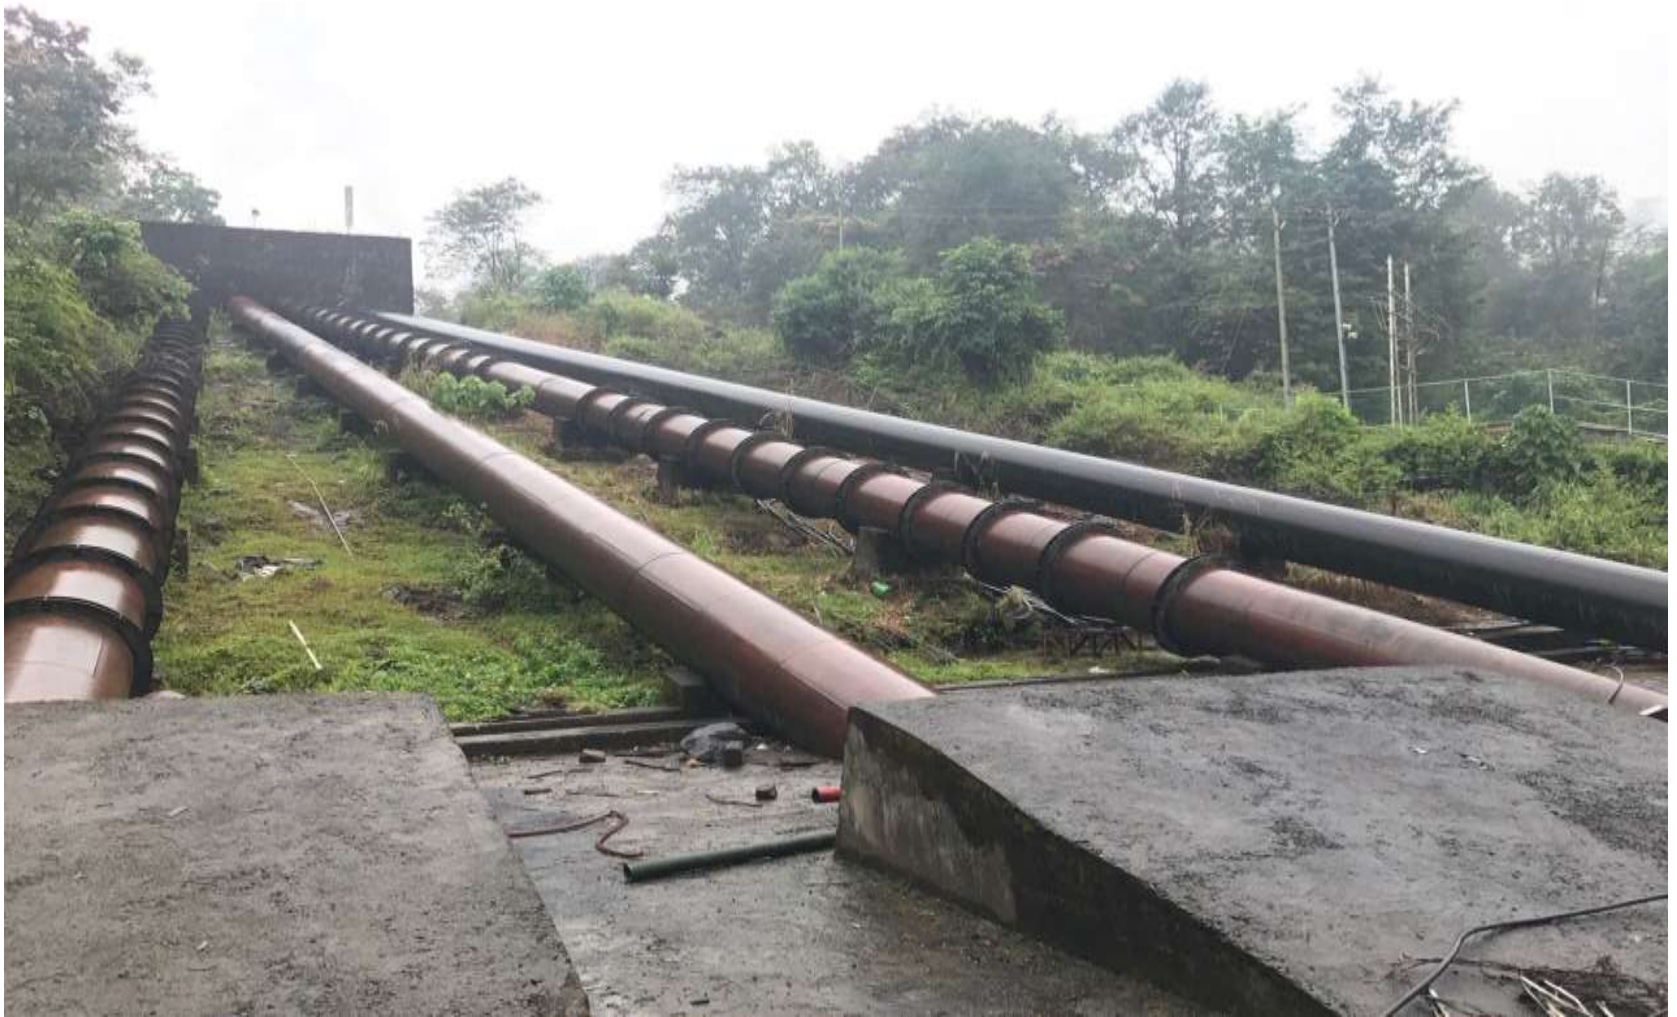
Penstock repair

- Butterfly Valve -It is difficult to decide on the residual life of existing which are performing well.
 - new versions with competitive design with a view to reduce cost may not perform in the long run
- Trash rack inside the surge requires replacement.
- For the penstock- inside corroding causes much problem.
 - In the case of Poringalkuthu the riveted joints were found weak where as the penstock is in good condition.

- After removing the riveted joints, welded joints were provided. May be this is the first time a penstock is being reused after repair.
 - While the work was progressing, it was noticed that the inside of the penstock was corroded and flakes of rust were peeling out.
 - Based on the expert opinion from CPRI, it was decided to sand blast and paint the inside of the penstock.
 - All the expansion joints, manholes needed overhauling
 - By this, there was an increase in the capacity of the Unit from 9.3MW to 9.9MW.
- The MIV is to be replaced if it is not in good condition.
 - The entire Turbine and its controls, PRV, Generator and controls, Exciter, Governor are to be replaced with modern equipment and controls.
