भारत सरकार Government of India
विद्युत मंत्रालय Ministry of Power
केंद्रीय विद्युत प्राधिकरण Central Electricity Authority
क्षेत्रीय निरीक्षण संगठन (उत्तर) Regional Inspectorial Organization(North)
कमरा सं 328 उ०क्षेणिविण्या भवन Room No.328, NRPC Building,
18-ए शहीद जीत सिंह मार्ग 18-A Saheed Jeet Singh Marg
कटवारिया सराय ,नई दिल्ली -110016 Katwaria Sarai New Delhi — 110016
website:www.cea.nic.in, टेली फैक्स: 011- 26510249

Dated: 12-06-2018

Subject: - Inquiry report of fire accident occurred at House No. 742, Sector-12, R.K. Puram, New Delhi.

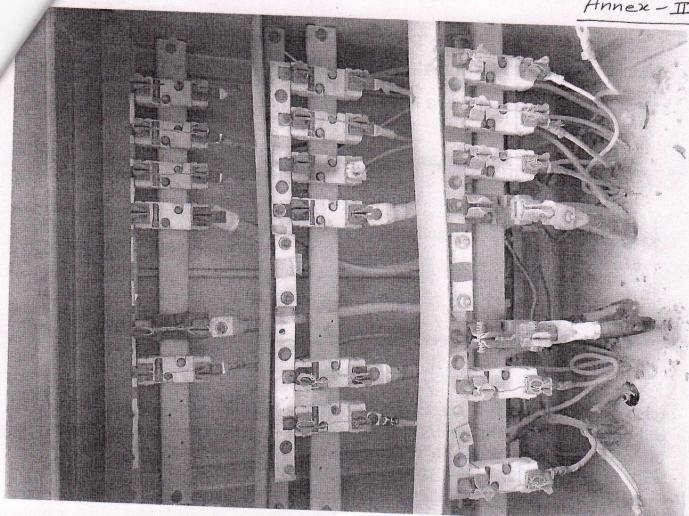
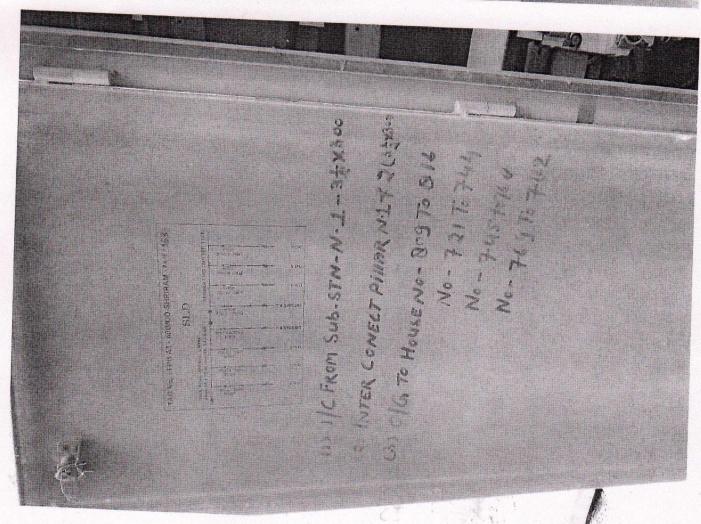
- inflammable petrol in their tanks and produced highly toxic gases which led to death of a child and three persons unconscious in the House No. 742.
- 5. The meter board of House no. 741-744 was completely burnt out, however, at the meter board of house No. 737-740 in nearby block, it was observed that DP located after meter was of rating 40 Amps for sanctioned household load of 2kW but at the distribution board of house No. 743 the MCB of rating 63 Amps was used which is highly overrated for 2kW sanctioned load. Further it was mentioned by CPWD person that 6 sqmm Cu wire has been used for house wiring. Since the Mains DP after meter is of 40 Amps and the MCB at house DB is 63 Amps is used, in case of overload 63 Amps MCB would not trip and overloading would persist which would cause insulation failure of wires due to heating leading to short circuit.

It was also seen that at meter board no DP MCB was used after meter for connection to House No. 40 instead direct connection was given by making joints in the wires to the house DB. Moreover, the meter boxes were seen poorly maintained. The photograph showing the same is enclosed herewith at Annex-I. All the switchgears and wiring after meter is taken care by CPWD, therefore it is negligence of CPWD for not providing protective switchgears having proper ratings in the electric circuit. CPWD shall provide the MCBs of proper ratings after meter to individual households according to the sanctioned load and do the periodic inspections.
