Report of 3rd Pilot audit of Transmission Tower by the audit team of the committee for Audit of Transmission Tower

In pursuance of Ministry of Power Letter No. 3/5/2017-Trans. Dated 07.08.2017, for the audit of the transmission towers with respect to design and the life of the towers (on a 5% sampling basis), the 3rd pilot audit was carried out for the towers of the transmission lines (tabulated below) on 20th, 21st & 22nd April, 2018, wherein the following members participated:

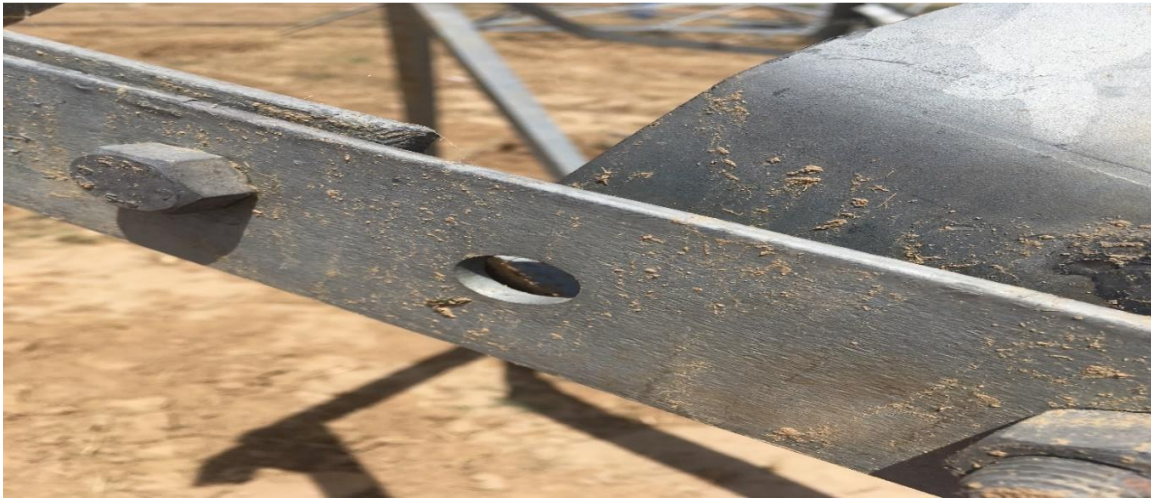
Similarly, missing bolts of member's connection will cause reduction in strength of joint and causing excessive stresses in the intact bolt of a joint leading failure of joint/s & in-turn may lead to failure of tower.

Figure 1. Missing bolt in bracing

Bent/buckled members to be replaced at the earliest, Dummy bolts, missing step bolts need to be plugged in order to keep the line in healthy condition. Inspection / patrolling of towers to be carried out regularly.

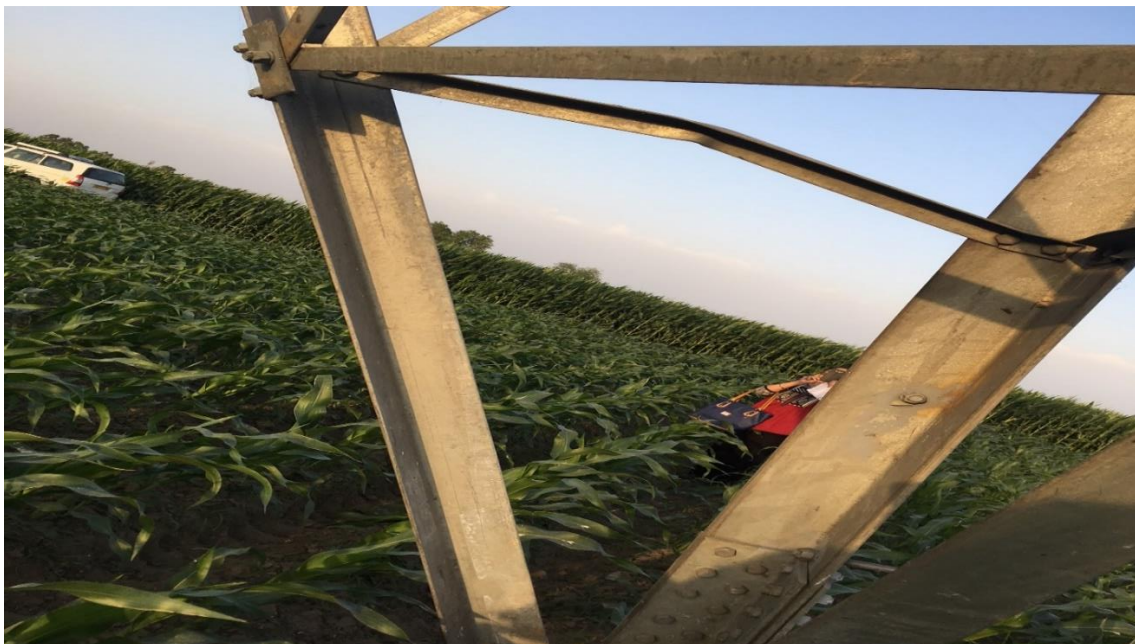
Observation & Conclusion: Buckling of a secondary member in tower no. 20, Anti climbing devices (ACD) were found partially damaged in the tower no. 15 & 20 of 400 kV Jalandhar-Sambha D/C Transmission Line. Anti-climbing device was absent in the tower no. 91/3 & 94/0 of 400 kV Malerkotla- Amritsar D/C Transmission Line, bending of a member and also step bolts were found below ACD level in all the towers of this line. Moreover, the peak was damaged, bolts were missing & ACD was absent in the tower of 400 kV Agra (PG)-Agra (UP) and a bracing was found to be missing from 765 kV Agra – Jhatikara S/C Transmission Line, details of which can be referred from **Annexure**.

Figure 2. Buckled member

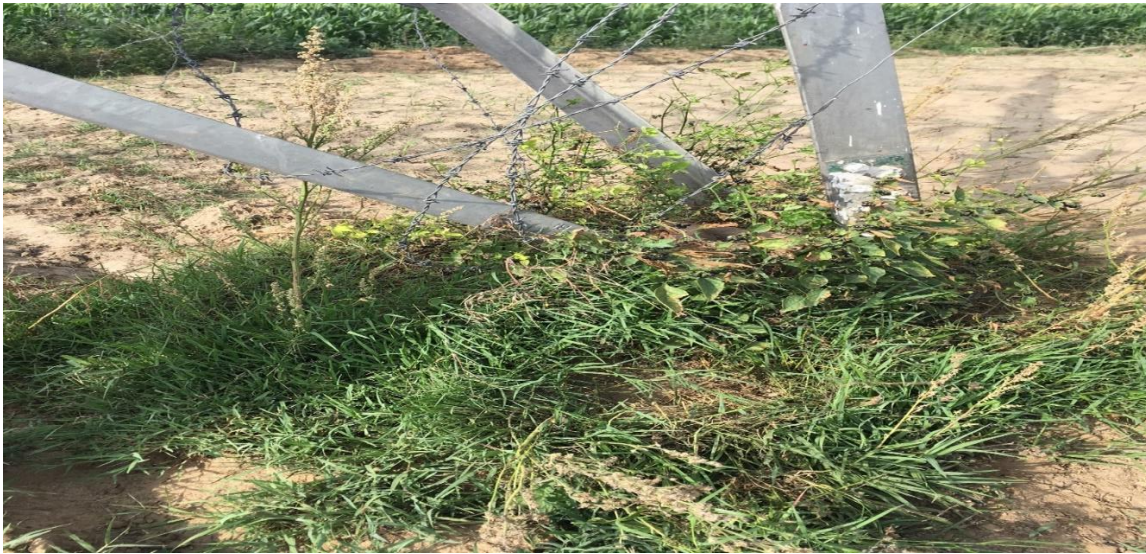
Figure 3. Damaged Anti Climbing Device (ACD)

Recommendation: Missing ACD shall be installed, step bolts below ACD shall be removed,

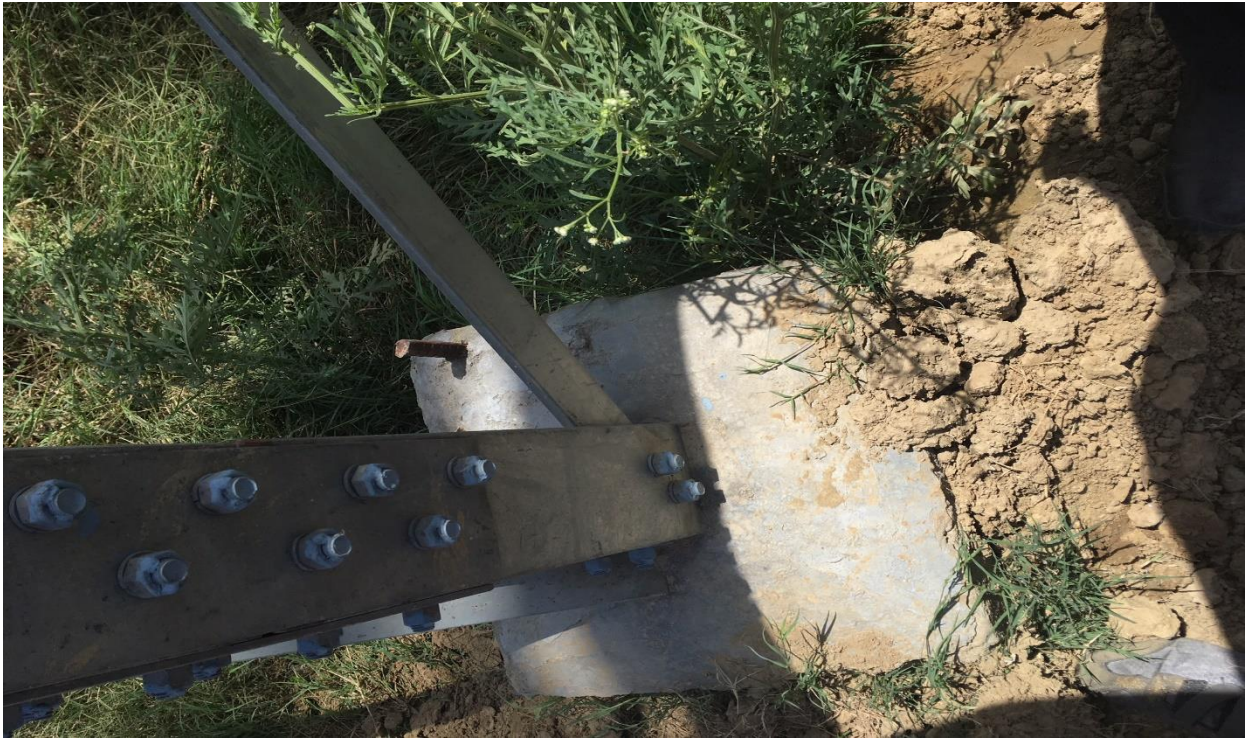
Figure 4. unexposed chimney

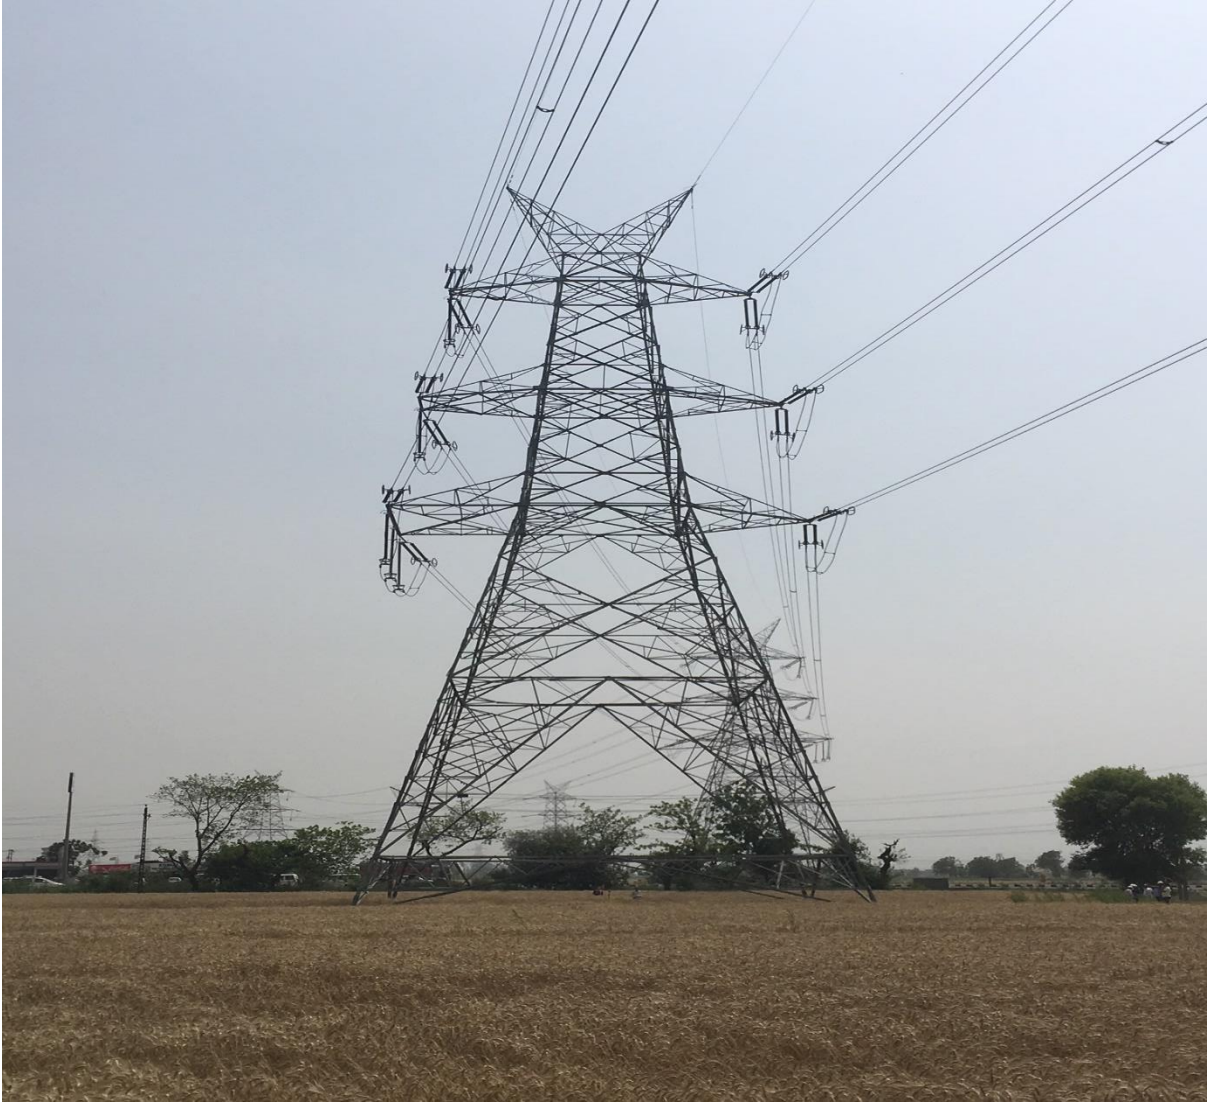
Figure 6. Transverse view of Verticality

Conclusion: The deviation in verticality for tower no. 90/0 of 400 kV Malerkotla- Amritsar D/C Transmission Line could not be measured as measurement was not feasible there and the deviation in verticality for rest all towers were well within limits.

Recommendation: To avoid the eccentricity & deviation in verticality, the stubs to be casted to the correct position (Base width and Diagonal) & to the correct inclination (slope) and also at common level. The surface near the tower footing shall be regularly inspected and maintained in condition to withhold the tower. Due care shall be taken during stringing to maintain the correct sag tension coordination for a given span.
