Report of 4th Pilot audit of Transmission Tower by the audit team of the committee for Audit of Transmission Tower

Sub: Observations of 4th pilot audit of transmission line towers – Reg.

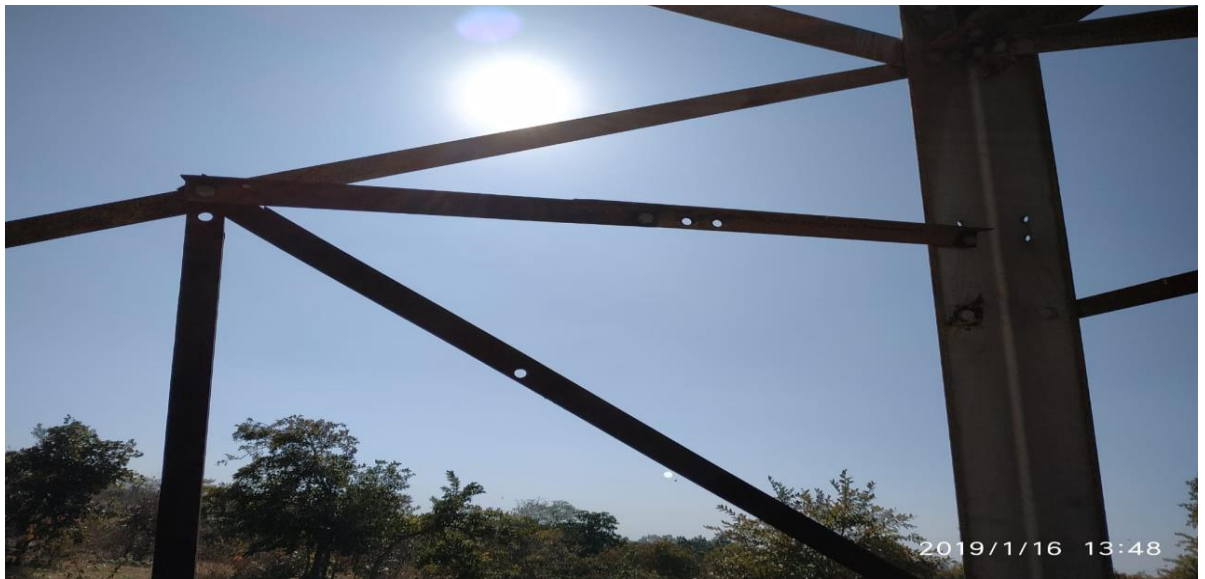
Figure 1. Holes in Members

Observation: Missing of members due to theft, absence of redundant members, bending, buckling of few members, missing of some bolts were found in the audited towers of 400 kV Seoni-Sarni D/C Transmission. Anti-climbing device (ACD) was absent in the two towers of 400 kV Jabalpur-Vindhayachal D/C Transmission line, bending of a member and absence of member was found in the first two audited towers of 765 kV Jabalpur-Bina D/C transmission, details of which can be referred from **Annexure A**.

Recommendation: Bent/buckled members to be replaced at the earliest, Dummy bolts, missing step bolts need to be plugged in order to keep the line in healthy condition. Inspection / patrolling of towers to be carried out regularly.

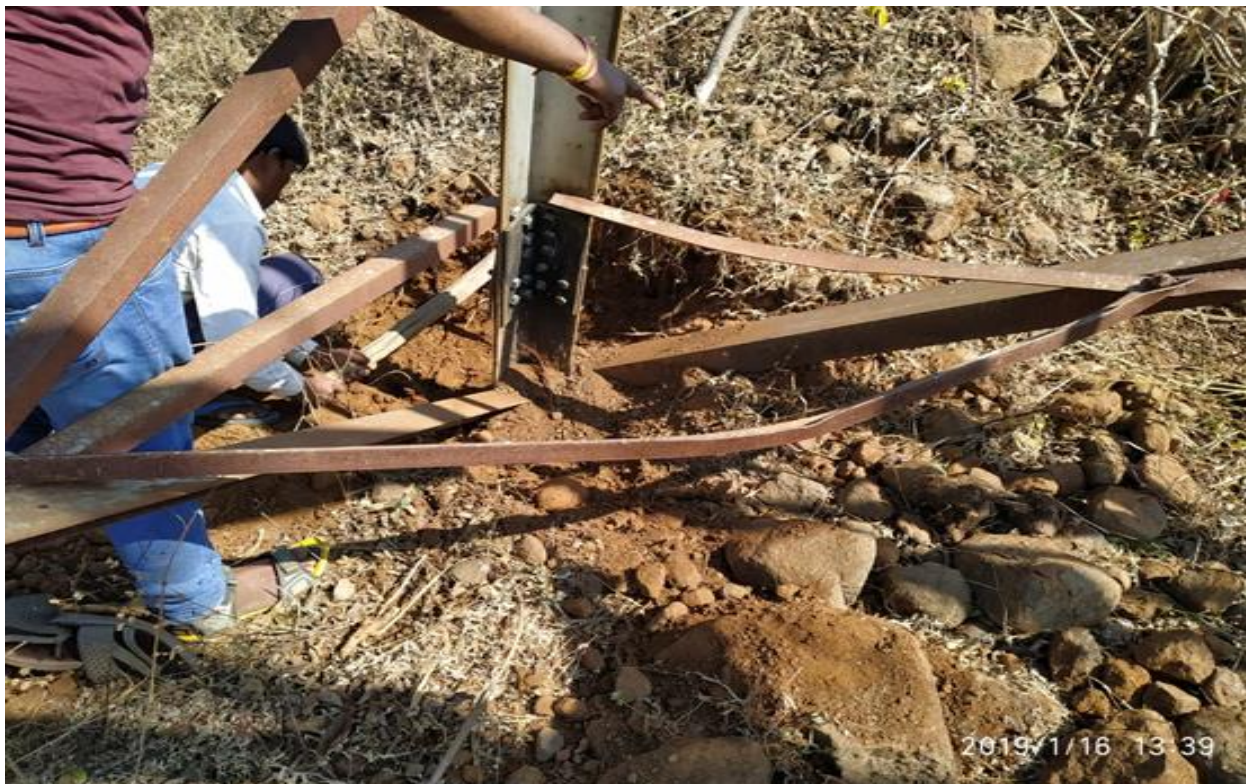
Conclusion: Tower structures were found intact with some minor aberration i.e. missing of bolts in some towers, buckling of some tower members and missing of ACDs in some towers.

Figure 2. Bent, Buckled Members

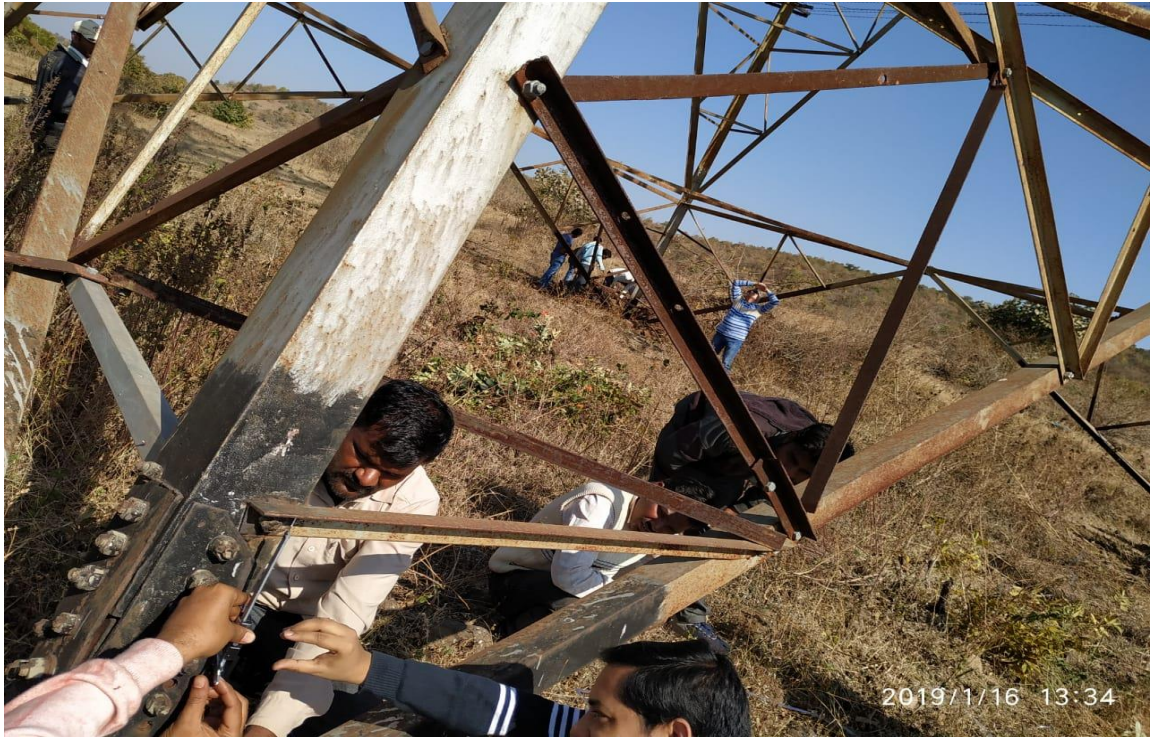
Figure 3. Corroded Members

Observation: Members were heavily corroded in the towers of 400 kV Seoni-Sarni D/C Transmission Line, members of other transmission towers were in adequate condition. Stubs were corroded at few locations in some of the audited towers.

Conclusion: The members, stubs have not been maintained in required condition.

Recommendation: Water logging near towers shall be avoided. Periodical inspection and anti-corrosive painting shall be applied for the tower members wherever onset of corrosion is noticed.

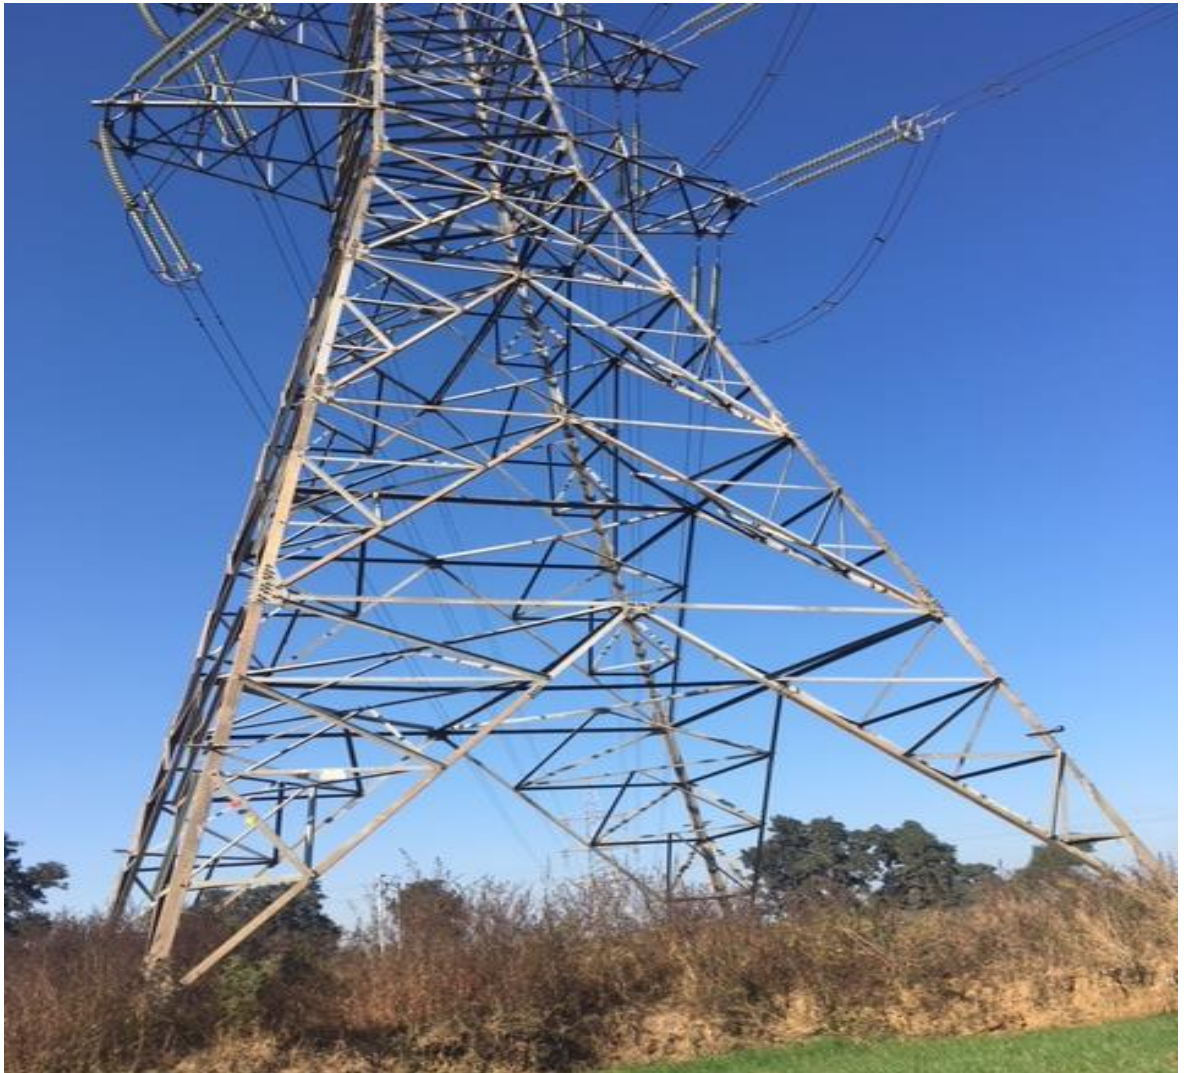
Figure 4. Transverse view of Verticality

Conclusion: All the measured Transverse & longitudinal of towers were within permissible limit.

Recommendation: To avoid the eccentricity & deviation in verticality, the stubs to be casted to the correct position (Base width and Diagonal) & to the correct inclination (slope) and also at common level. Due care shall be taken during stringing to maintain the correct sag tension coordination for a given span.

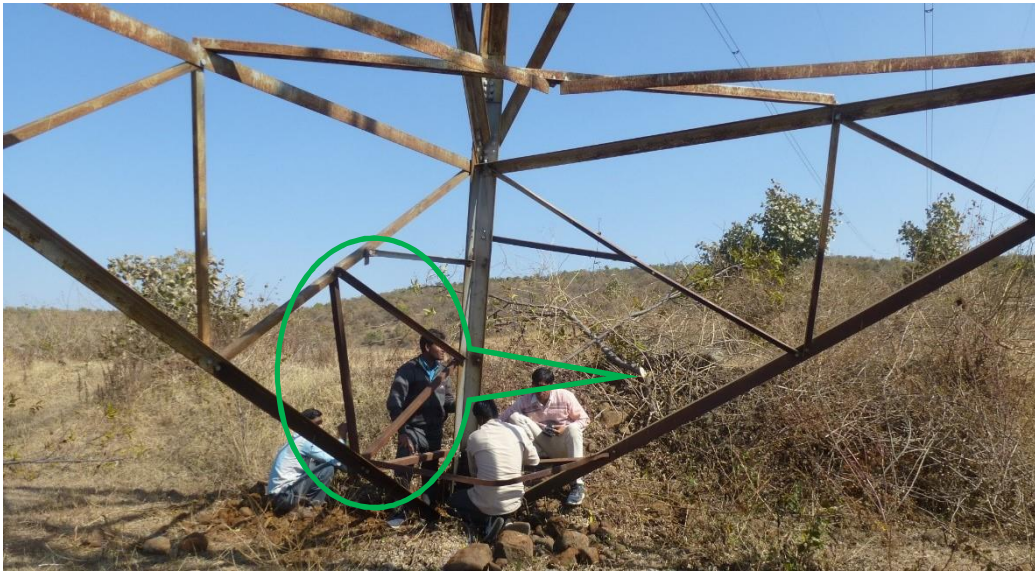
- 1) Total eight numbers of towers were audited in three days in three different transmission lines. The general observations are missing secondary bracing members (refer Fig. 1), unplugged bolt-holes and missing bolts in the bottom panel. The missing members and bolts need to be replaced immediately as per the respective original structural drawings. Further, all the open bolt-holes have to be plugged with bolts or welding.

Fig.1 Typical Missing Member

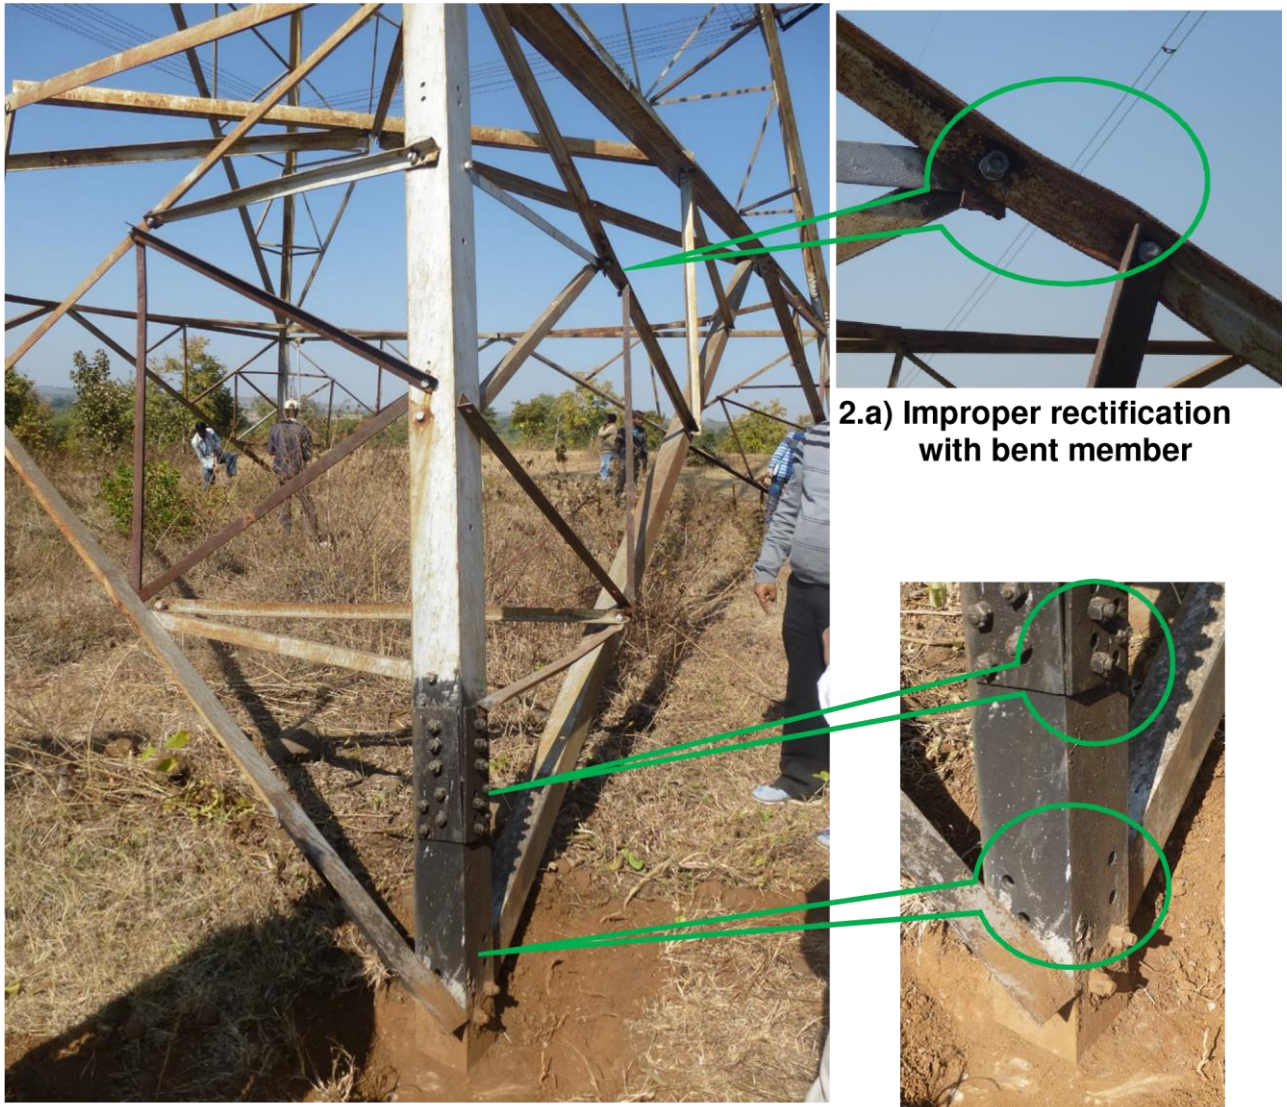
Fig. 2 Tower-1 Audited on 16/01/2019

- 2) Improper rectification/ replacement of stolen members (by cutting the original members) was observed for the first tower audited on 16/01/2019 in the 400 kV Seoni - Sarni TL, which is operated and maintained by M/s MPPTCL. For fixing the new member in place of stolen/missing member additional holes were drilled, which creates eccentricity leading to additional forces in the structure. Most of the secondary bracing members are bent during the rectification work. In some places replaced member has two pieces connected with single bolt in one of the flanges. All the above representative deficiencies are indicated in Fig. 2. In order to ensure the safety and stability of TL tower, it is necessary to carry out proper rectification immediately as per the structural drawings.

2.a) Improper rectification with bent member

2.b) Unplugged Holes

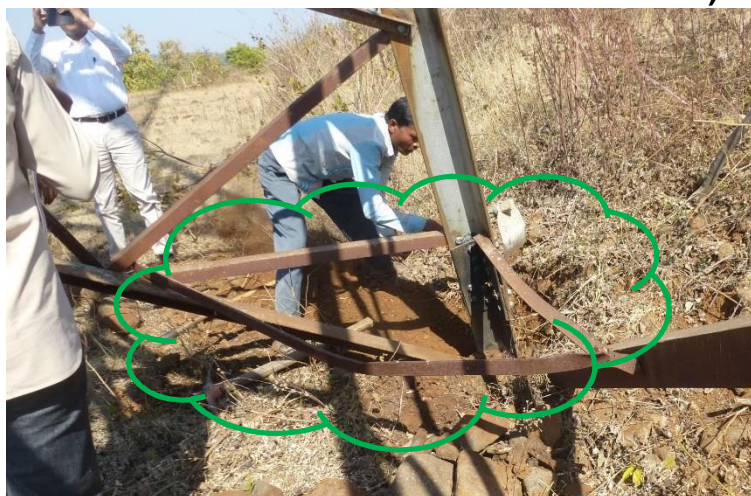
2.c) Bent/sagged members

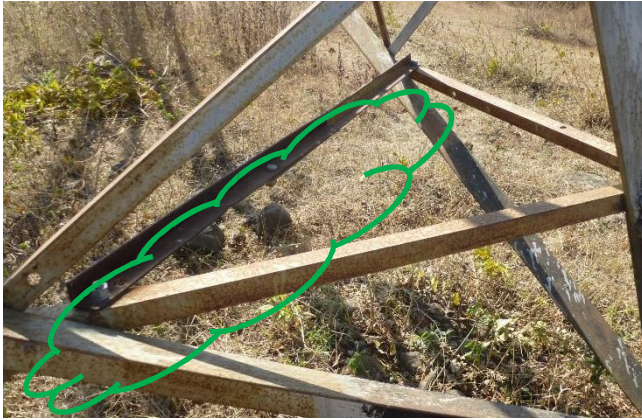
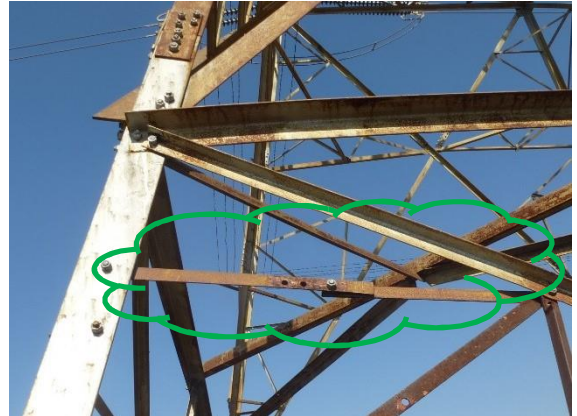
2.d) Rectification with two member pieces connected with single bolt on one flange
