**REPORT**  
**ON**  
**FAILURE OF CIRCUIT BREAKER AND**  
**TRANSFORMER**  
**AT**  
**RANASAN AND LIMDI SUBSTATIONS**  
**OF**  
**GUJRAT ELECTRIC TRANSMISSION COMPANY**  
**(GETCO)**

**CENTRAL ELECTRICITY AUTHORITY**  
**MINISTRY OF POWER**  
**GOVERNMENT OF INDIA**  
**NEW DELHI**

**SEPTEMBER, 2006**

# **Report on failure of 132kV Circuit Breaker (CB) at Ranasan substation and 220kV/132kV/11kV, 50 MVA Transformer at Limdi substation of GETCO on 22-07-2006 and 29-06-2006 respectively**

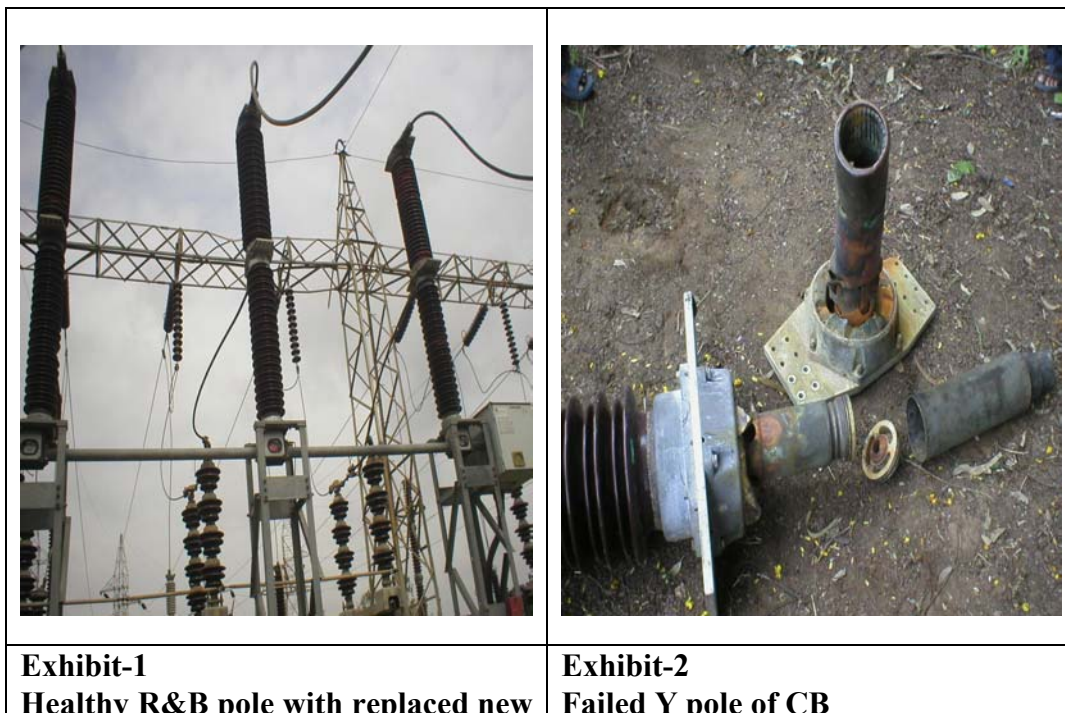
1. Interrupter chamber was completely damaged (**Exhibit-2**). The porcelain housing of interrupter chamber had broken into pieces. The healthy CB pole along with replaced new pole after re-energisation is shown in **Exhibit-1**.

<b>Y pole of the CB and damaged petticoats of porcelain housing of R &amp; B poles</b>	
--	--

1. Support Insulators and Porcelain housing of interrupter chamber of R and B pole of the CB (**Exhibit -1**)
2. Support Insulators of isolator and CT of nearby bay (**Exhibit -7 &8**)

Interrupting chamber of Y pole of the CB had damaged beyond repairs and was replaced by spare healthy pole. Other poles (R&B) were overhauled and CB was put back into service on 29-07-2006.

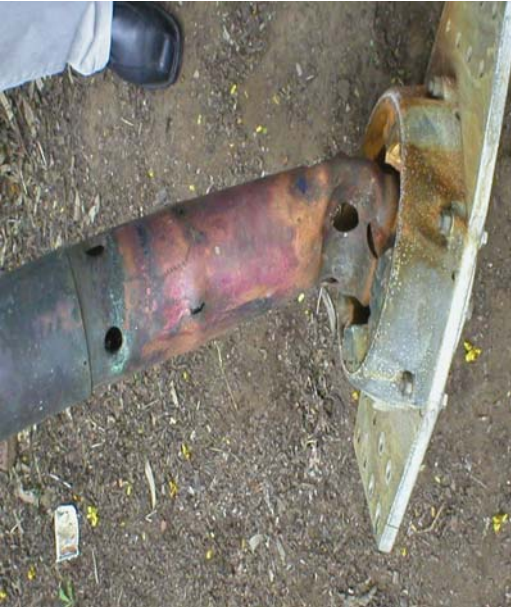
2. Abnormal flashover marks with holes on the metallic portion of arcing chamber are clearly visible (**Exhibit-3**).
3. Support insulator of failed breaker pole was found to be almost healthy (**Exhibit-4**) except breakage at linkage with gang operating rod connected to the common motor.

<p><b>Exhibit-3</b> Abnormal Flashover mark with holes</p>	<p><b>Exhibit-4</b> Bottom Support insulator intact</p>

power flow in the line prior to failure(at 19 hours) was only 15 MW and current was only 75 Amps. From the record it was also observed that maximum system voltage goes only upto 138kV which is well within highest system voltage of 145kV. The CB has served only for about 5 years. The visible holes on metallic part of main contact shows severe arcing marks.

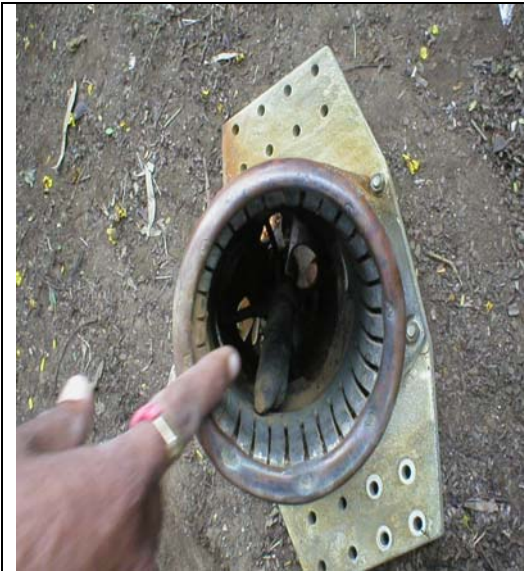
4. Fingers of main contact are found to have no severe arcing marks (**Exhibit-5**). However, connecting rod was found to be damaged.
5. Although the substation is operating in industrial area, there is no polluting industry in the vicinity of the substation.

**Exhibit-5**  
**Main arcing contact**

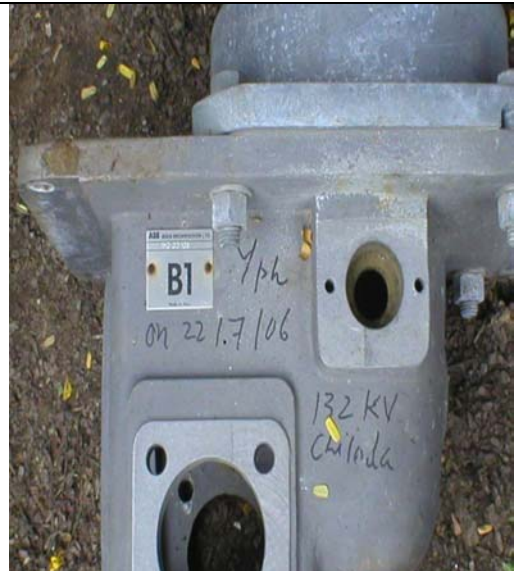
**Exhibit-6**  
**Broken metallic part disengaged from common driving rod**

Y pole of the CB got disengaged from the gang / common operating rod connected to a common motor. The blasted pole of breaker(Y pole) being disengaged from the common operating rod fell over the nearby isolator of the same bay causing bus fault and outage of both 132kV and 66kV system for about 31 minutes.

**From above, it may be concluded that ABB make CB installed in Ranasan substation had failed due to failure of mechanical linkage of Y pole of the breaker with common driving assembly while breaking the fault current.**

1. The premature failure of circuit breaker and problem with operating mechanism are matter of serious concern. It raises question about the quality of product. Problem with common driving assemblies could also be the cause of failure of similar make breaker in future. As six(6) numbers of breakers of similar model are also in the operation in the substation at Ranasan, the matter may be discussed with the manufacturer (M/s ABB), so that remedial measures, if required, could be taken by the manufacturer in advance to avert repetition of such failure in future.

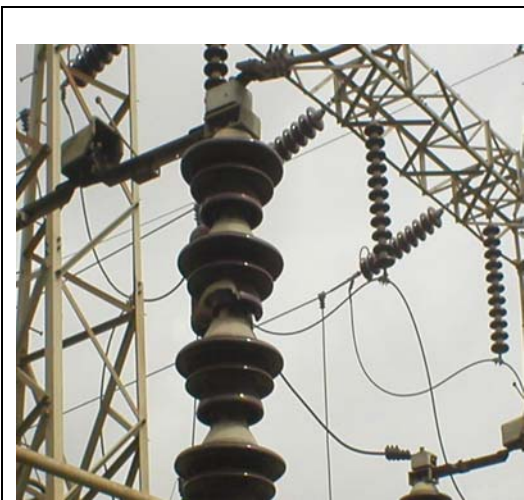
**Exhibit-7**  
**Broken support insulator of isolator**

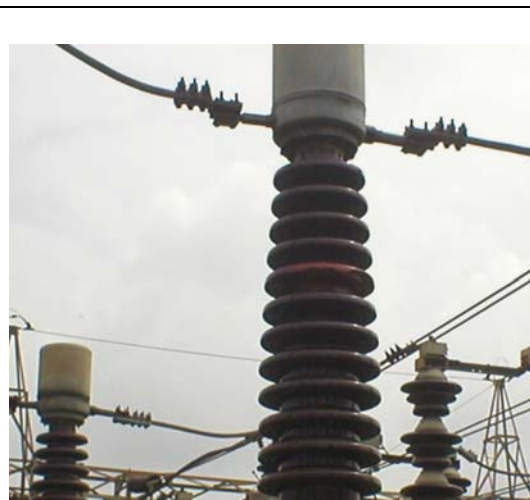
**Exhibit-8**  
**Broken petticoat of CT**

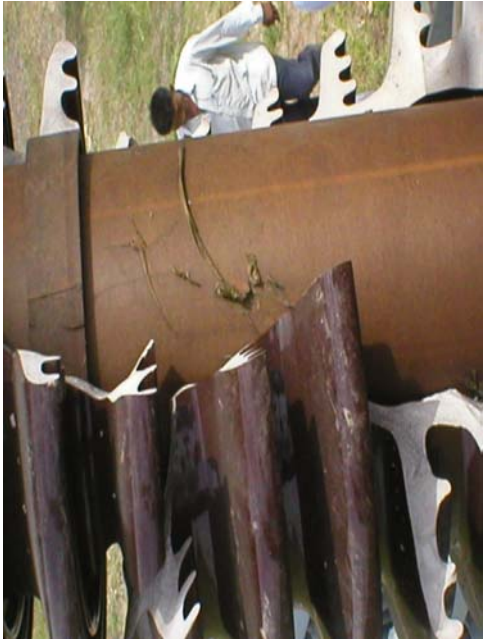
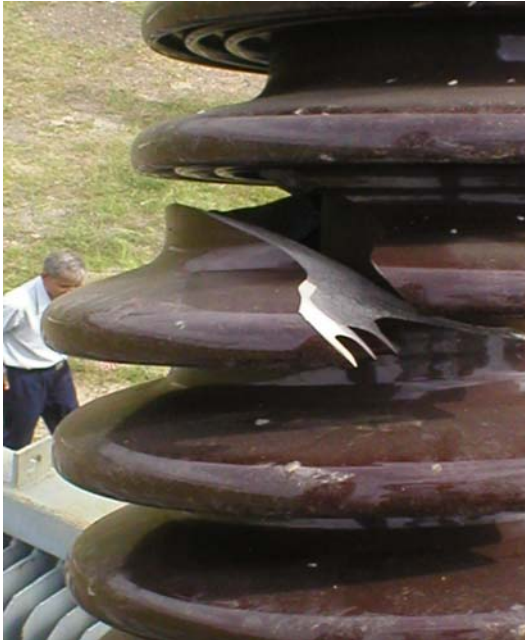
1. Lower part of R-phase of HV (220kV) bushing had damaged exposing the cellulose insulation (Exhibit-1,2)

<p><b>Exhibit-1</b> <b>Damaged R-phase of HV (220kV) bushing exposing the cellulose insulation</b></p>	<p><b>Exhibit-2</b> <b>Another view of Damaged R-phase of HV (220kV) bushing</b></p>

- (e) The test conducted on 04-01-2006 shows that measured values of tandelta of HV, LV bushings are quite high (HV bushing: R-phase-0.57, Y-phase-1.26, B-phase-0.67; LV bushing: R-phase-0.60, Y-phase-52, B-phase-69). Since there was no previous / subsequent test result to compare, the change in tandelta & capacitance value can not be known. Although Tandelta value of Y-phase of HV bushing is quite high (1.26), porcelain housing of R-phase HV bushing has blasted. Similar things could have happened to other bushings also. Such situation in general calls for immediate action to avert failure of bushing.

6. Bushing failure has become a major cause of failure of transformers. Therefore, as a general practice, periodicity of measurement of capacitance and tan delta of bushings be decided based on condition assessment. In general the value of tan delta for bushings or windings should not exceed 0.5% at 20 deg. C and 0.7% in worst case and the rate of rise of tandelta per year should not exceed 0.1%. Based on the trend / relative change in measured value, remedial action, even the replacement of bushing (if required), should be taken urgently so as to avoid catastrophic failure of bushings and transformers

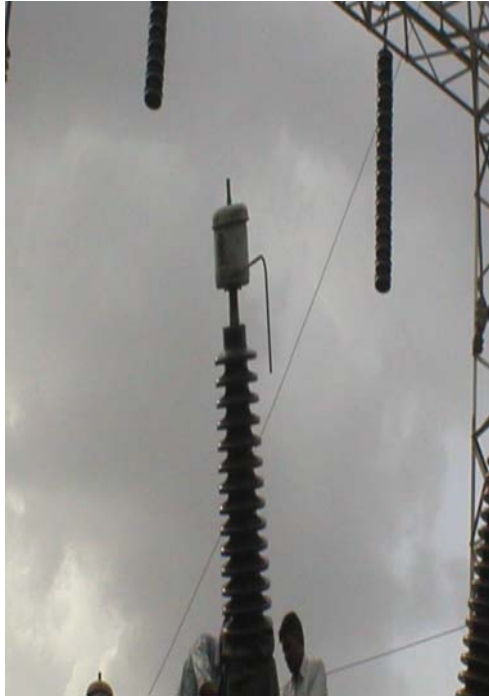
2. Upper part of the R-phase bushing had popped up. (Exhibit-3)

**Exhibit-3**  
**Popped up R –phase of HV bushing**

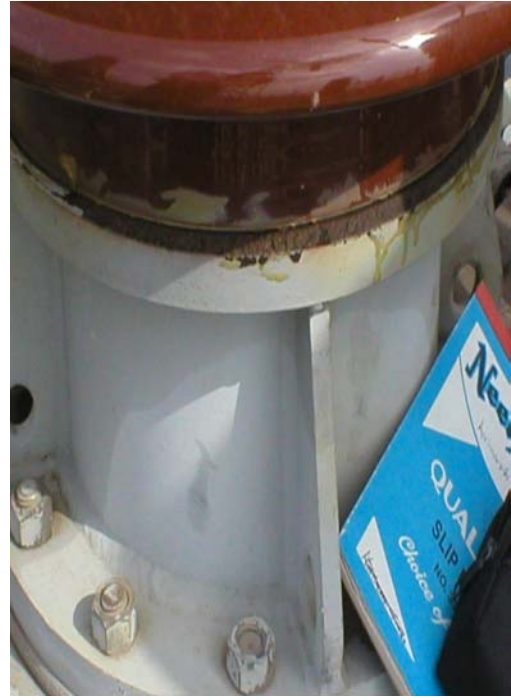
**Exhibit-4**  
**Displacement of bushing from cemented portion**

3. Y-phase and B-phase of HV (220kV) bushing were found to be displaced from at bottom part. The gaskets were in very bad condition and continuous oil leakage found from bottom of Y-phase of HV bushing (**Exhibit-4,5**).

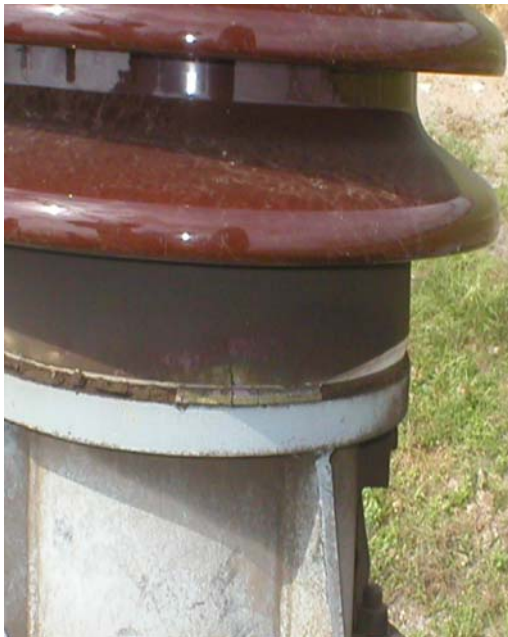
**Exhibit-5**  
**Displacement of bushing from cemented portion**

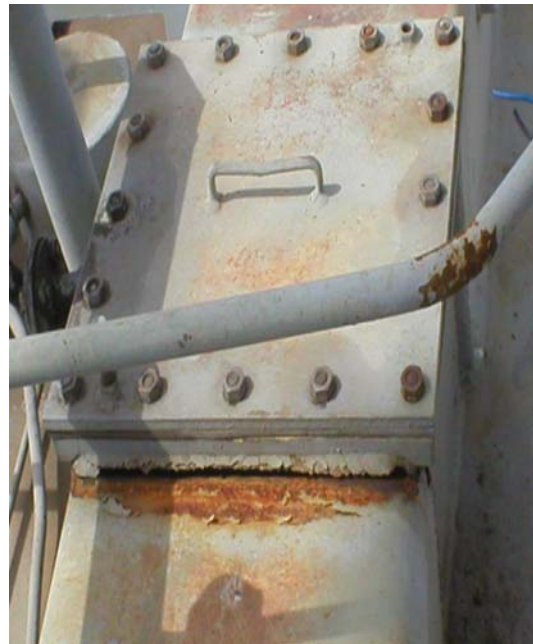
**Exhibit-6**  
**Lifted inspection window**

- Both inspection window and main tank of transformer was found lifted up from welded joint portion under pressure (**Exhibit-6,7**).

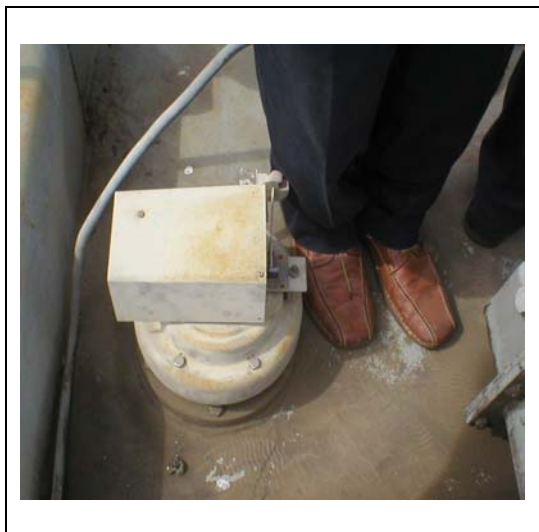
- (h) Continuous increase in content of oxygen and Nitrogen and insulation failure might have led to high energy arcing, accumulation of other fault gases and rise in gas pressure ultimately resulted in operation of gas operated Buchholz relay. The high gas pressure development inside the transformer and non operation of PRD possibly due to

blockage (**clearly visible from Exhibit-9**) have resulted in creating openings at vulnerable regions / weak points of transformer tank and some welded junctions to vent out the gases.

**Exhibit-9**  
**Clearly visible non operation of PRD**
