**REPORT ON INVESTIGATION OF FAILURE OF 100 MVA, 220/66-33/11 KV
POWER TRANSFORMER AT 220KV GEETA COLONY SUBSTATION OF DELHI
TRANSCO LTD. (DTL)**

1.0 Introduction:

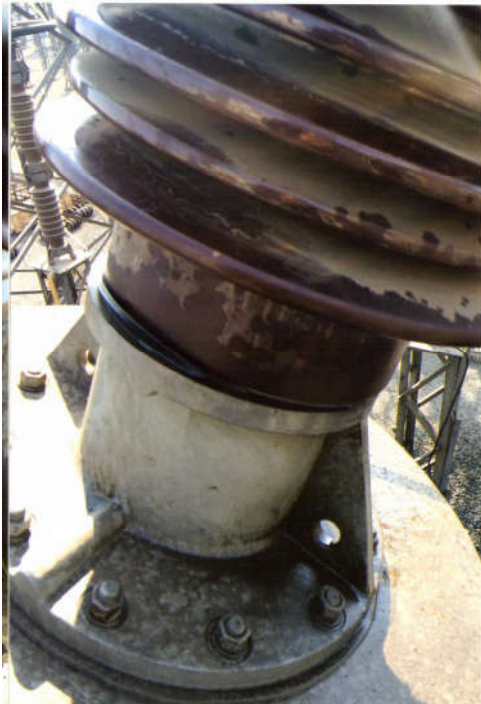
Exhibit-I

- 3.1 Prior to fault, load on transformer was 23 MW. Maximum loading on transformer was 32 MW on the day of fault (2nd February). Transformer was not loaded even up to 50% of its capacity for the last many days. The transformer was operating on tap 5 (Normal Tap is Tap 3) at the time of failure.
- 3.2 Tertiary of transformer is unloaded. All three terminals of tertiary winding have been brought outside the tank and terminals were not insulated.
- 3.3 During physical inspection of the failed transformer at site, it was observed that there was minor dislocation of all three HV bushings from their turrets (Exhibit-I), MV bushing flanges of Y & B phases had cracked, LV bushing of B phase had punctured (Exhibit-II) and transformer tank had cracked at a number of places (Exhibits -III&IV), although there was no visible sign of bulging of the tank.

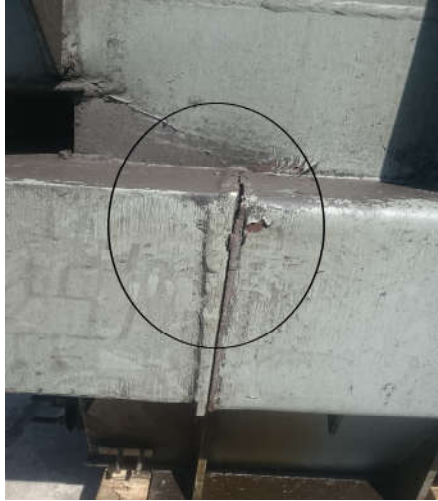
Exhibit-III

5.4 High energy arcing inside the transformer tank might have led to sudden pressure rise and tripping of oil surge relay & PRV. Rate of rise of gas pressure might be very high (before operation of PRV), which might have resulted in cracks at weak areas of the transformer tank.

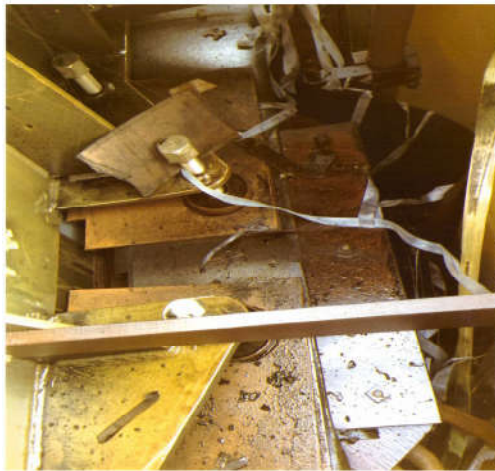
Exhibit-V

- 3.4 There was no damage to nearby equipment/ material of the substation.
- 3.5 Transformer was checked for internal damage through inspection window. Visible damage was observed on Y-phase winding (Exhibits- V&VI). Damage on other windings was not visible through inspection window. The extent of damage inside the transformer would be assessed only after opening of tank.

5.3 Operation of Differential, Buchholz, OSR & PRV relays indicates internal fault of the transformer. The internal winding insulation failure might have led to inter turn winding insulation failure, which is also supported by the test results and preliminary internal inspection. The fault is most likely in Y- ph of winding. The detailed investigation after opening of tank will provide the extent of damage, type of failure(s) and other valuable information.

- 6.6 During visit of CEA officers, the failed transformer tank was inspected through inspection window only. Detail inspection of the transformer is required to be carried out by OEM/ expert of repairing agency after opening the tank, which may not be possible at site. The feedback/ warnings from the investigation should be used for planning future course of action. A detailed report of the failed transformer may be provided to CEA after thorough internal inspection of the failed transformer is carried out.
