**Sub: Final Report of Standing Committee of Experts to investigate failure of towers during the period October 2014 to June, 2015.**

# REPORT OF THE STANDING COMMITTEE OF EXPERTS ON FAILURE OF TOWERS DURING OCTOBER 2014 TO JUNE 2015

# **REPORT OF STANDING COMMITTEE OF EXPERTS TO INVESTIGATE FAILURE OF TOWERS DURING THE PERIOD OCTOBER 2014 to JUNE 2015**

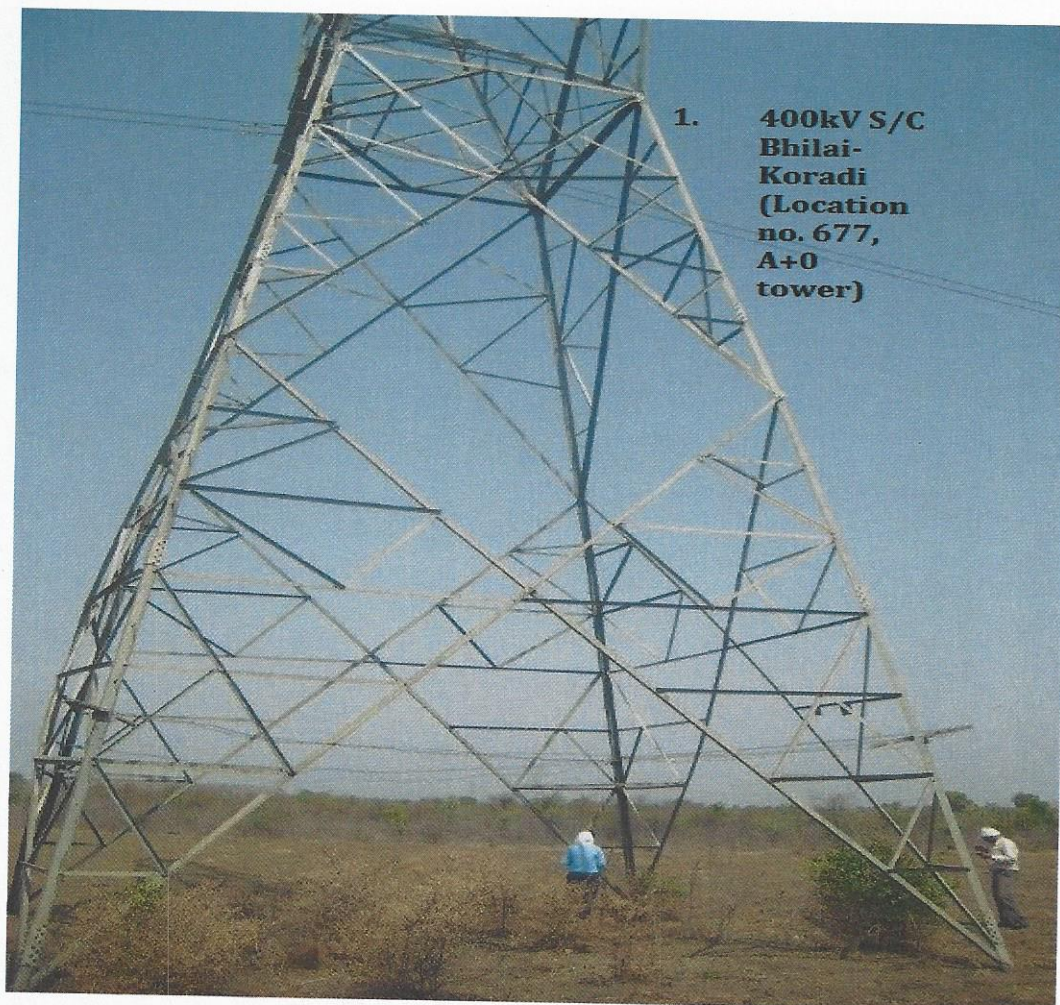
During the meeting, officials of PGCIL informed that the line was taken under shut down on 06.06.2015 for rectification of deformed tower due to uneven settlement of foundation of legs of the tower. The bottom panel of the tower was deformed completely. The detail report has not been submitted by PGCIL.

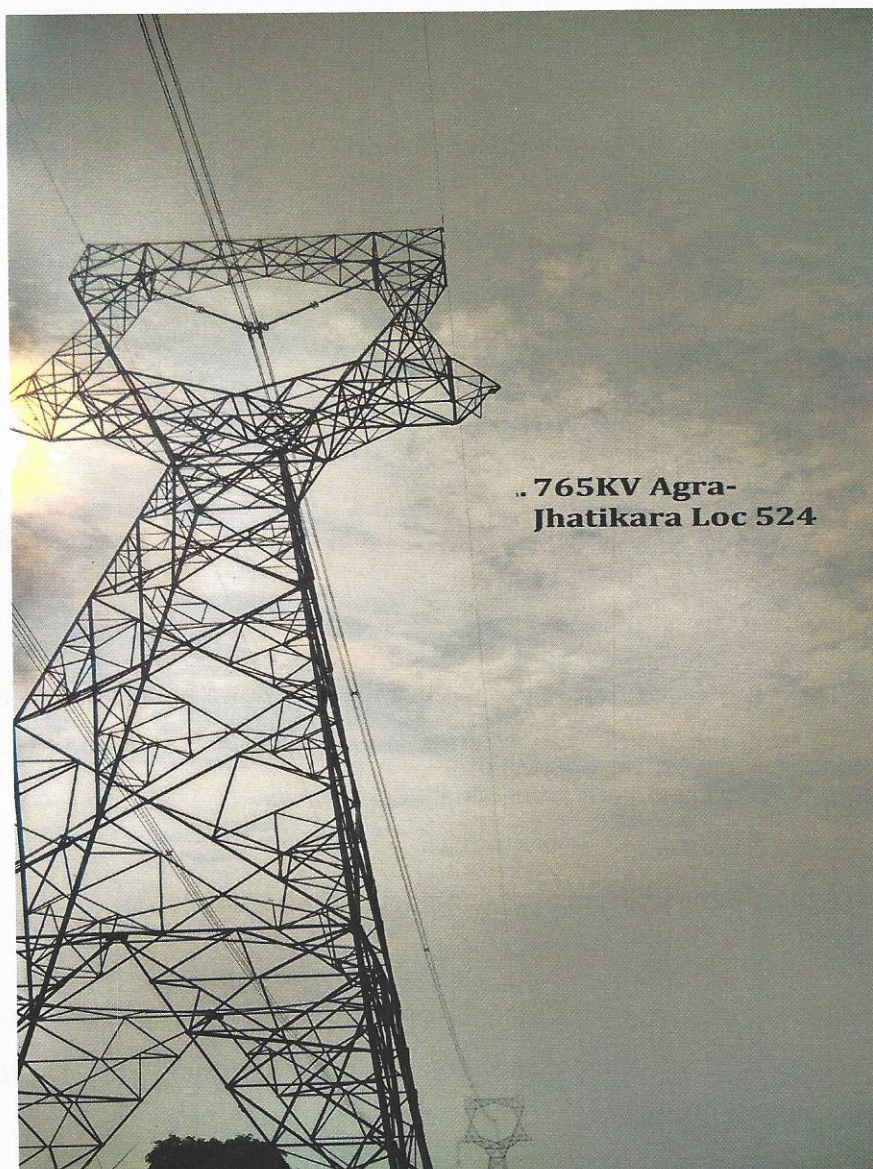
.. 765KV Agra-  
Jhatikara Loc 524

During the meeting, officials of PGCIL informed that shut down of the line was taken on 23.06.2015 for rectification of cross arm damaged due to localized storm. Detail report has not been submitted by PGCIL.

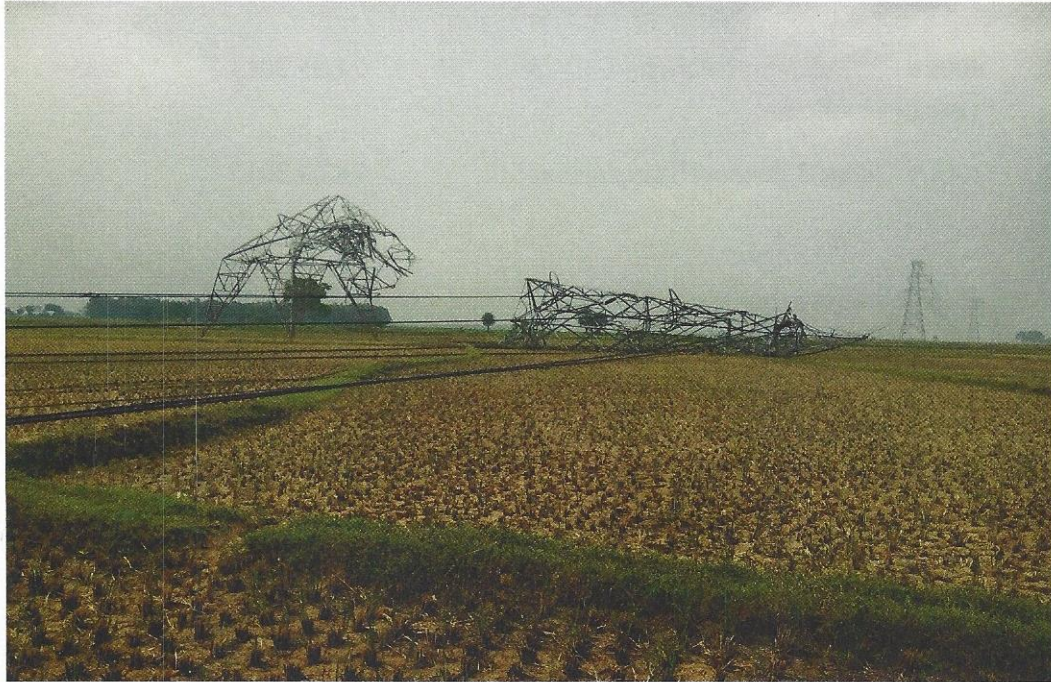
It was observed that towers at location Nos. 141 & 142 have collapsed from ground level whereas 3 towers collapsed from upper level. The tower at location No. 141 had collapsed fully. Similarly the tower at location No. 142 had collapsed with stub bent. The towers at location Nos. 139 & 143 had partially damaged with one of the top cross arm bent. But tower at location No. 140 had partially damaged with top, middle & bottom cross arm bent and earthwire peak damaged. All these affected towers were located in plain stretch of cultivated field having very few trees and might have experienced critical wind during the storm. All these affected towers have fallen in left side in transverse direction facing Durgapur. PGCIL informed that the suspension towers were designed for 75% wind load for broken wire condition and is being used widely across the country.
