**REPORT OF THE STANDING COMMITTEE OF EXPERTS
ON FAILURE OF EHV TRANSMISSION LINE TOWERS
(APRIL 2018 – MARCH 2019)**

Central Electricity Authority

Ministry of Power

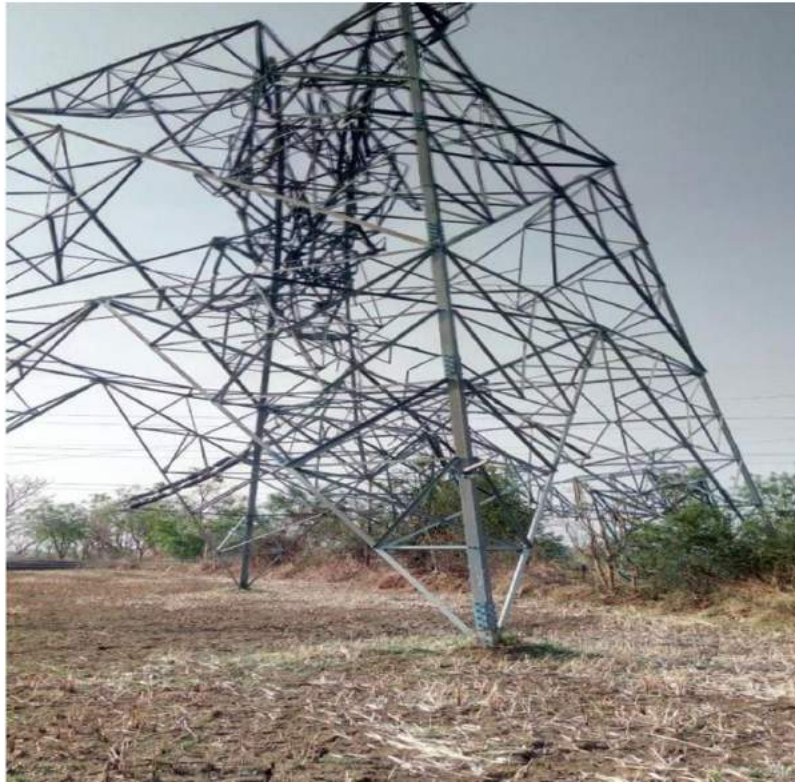
Tower at Loc. No. 120

b. **Tower at location no. 120(A+0)** was located in cultivated fields of village Charpara, Tehsil-Baloda, District Janjgir-Champa, Chhattisgarh. The tower had collapsed from second panel level. All the four stubs of the tower were intact.

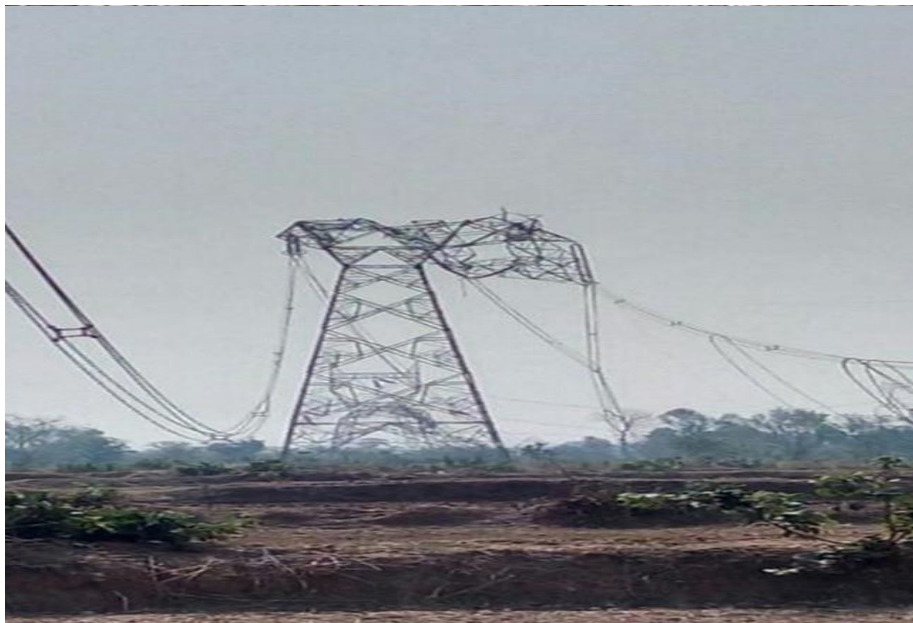
Tower at Loc. No. 121

- c. **Tower at location no. 121 (A+0)** had failed above waist level from the K frame portion of the tower. All the four stubs of the tower were found intact.

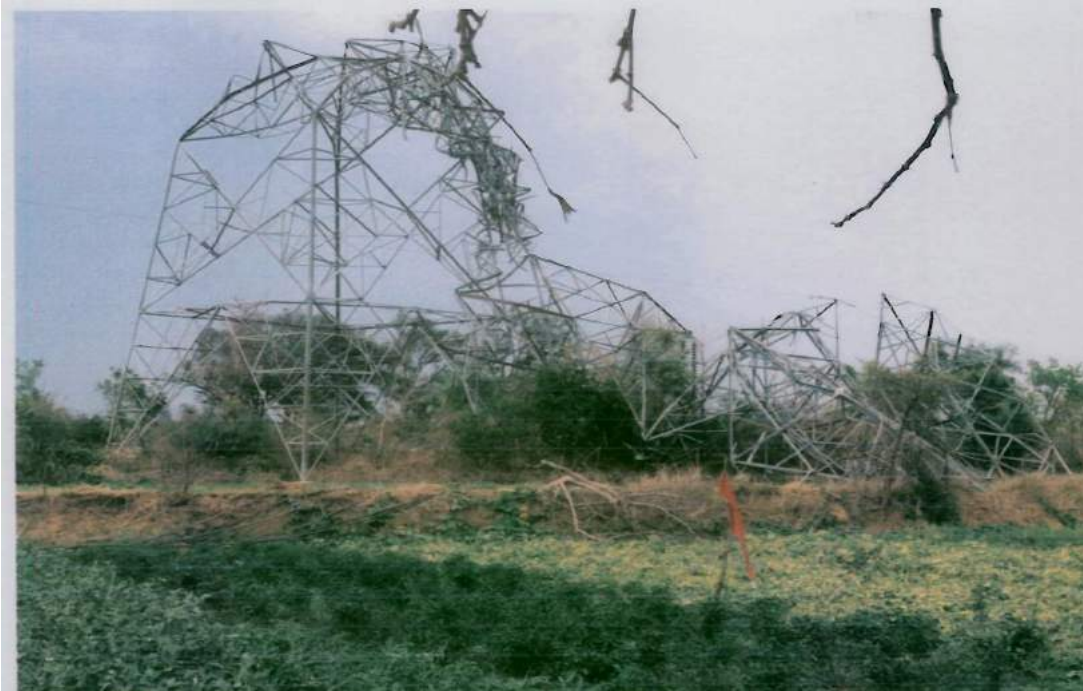
Tower at Loc. No. 122

- d. **Tower at location no. 122 (A+0)** had collapsed from the third panel level and all the four stubs of the tower were intact.

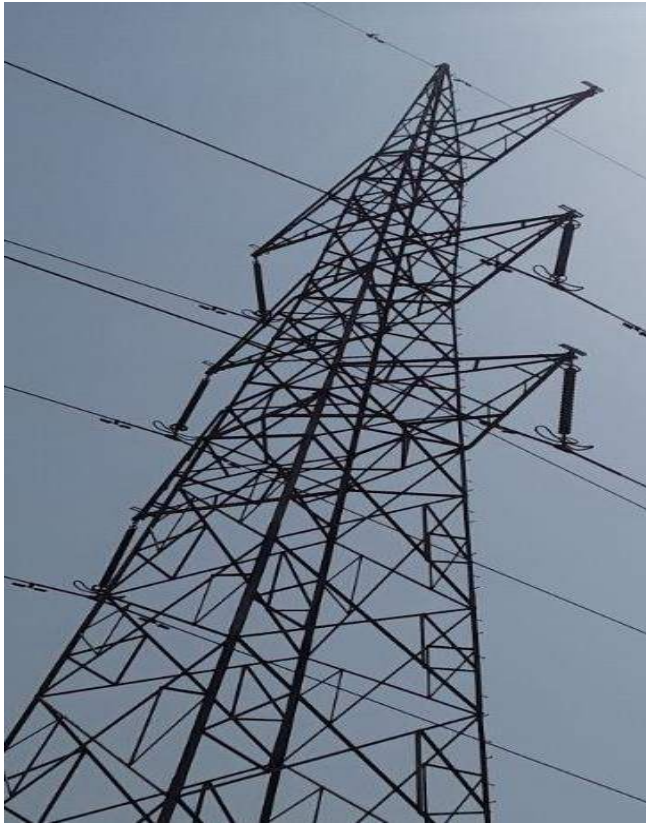
Tower at Loc. No. 266

b. **The towers at Loc. No. 266 (DA+0), 267 (DA+0) & 268 (DA+0)** were located in cultivated field with very few trees in the vicinity. It was observed that top cross-arm of these towers got damaged. However, all the four stubs of the tower were found intact. From the failure pattern, it appeared that these towers were damaged due to pulling force developed due to failure of adjacent tower at Loc. No. 270. As reported by PGCIL, no members were found missing at these towers.

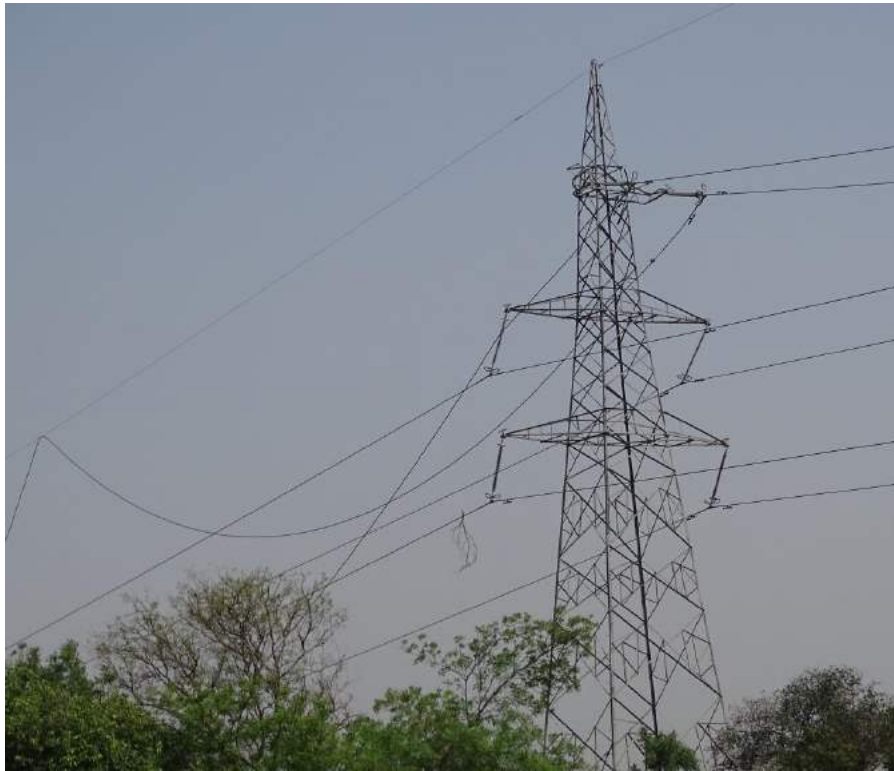
Tower at Loc. No. 269

that the conductor of the top cross arm swirled after breakage and was resting on the Earthwire.

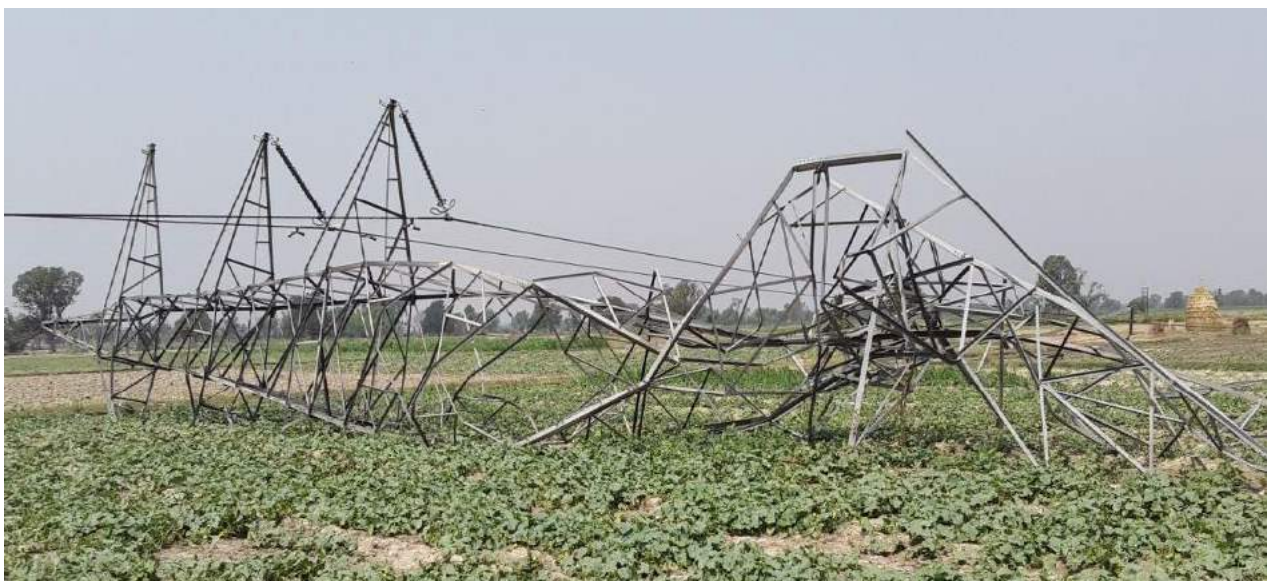
Tower at Loc. No. 270

- d. **Tower at location no. 270 (DA+0), 271 (DA+3) and 272 (DA+0)** were located in cultivated field with some trees in the vicinity. All the three towers had collapsed from the first panel in the transverse direction of the line. All the stubs of these towers were damaged. It was reported by PGCIL that there were no missing members at the towers except some broken bolts on the field which may be shared during collapse of towers.

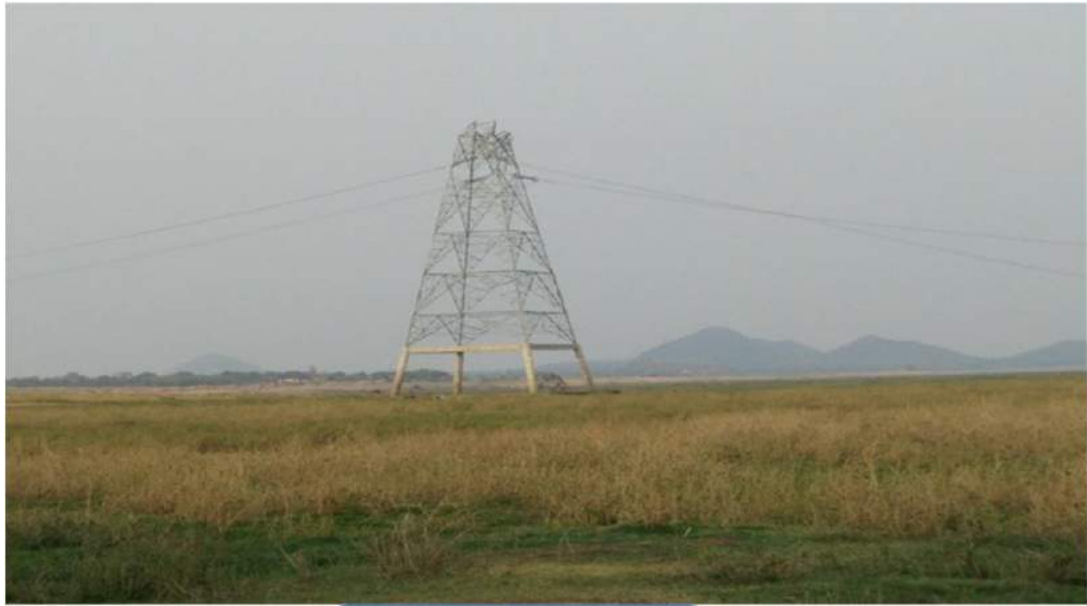
Tower at Loc. No. 63

not damaged and was in erect position. All the stubs were not damaged. It was reported that there were no missing members at the tower.

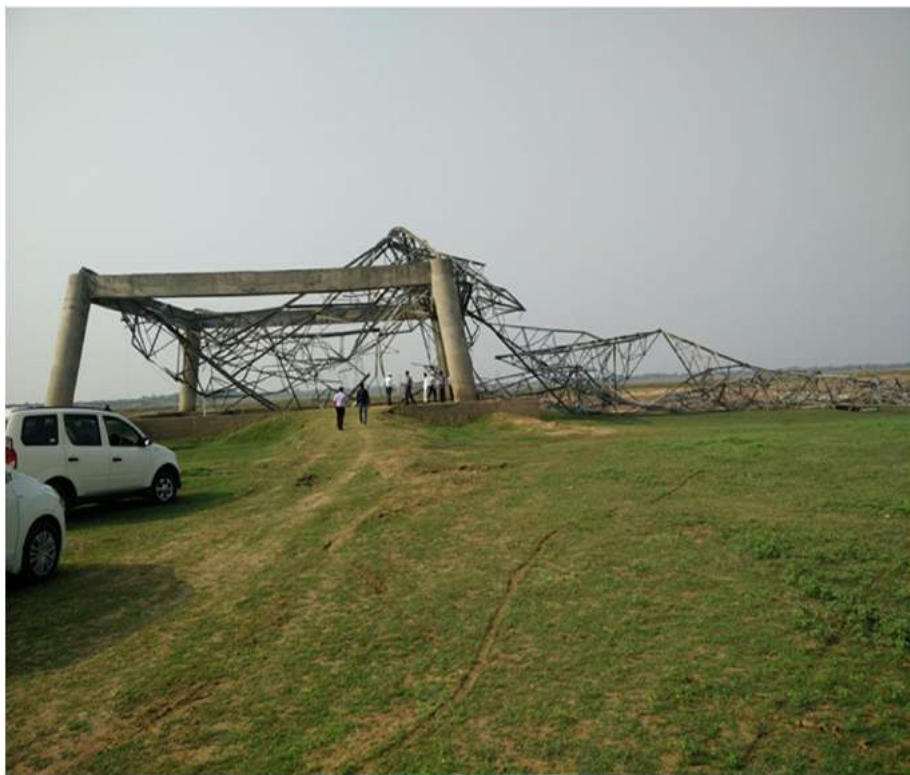
Tower at Loc. No. 64

- d. **Tower at location no. 64 (DD+25)** had completely fallen to the ground in transverse direction. All 4 stubs of the tower were damaged. However, pile foundations of all the legs were intact. It was reported that there were no missing members at the tower.

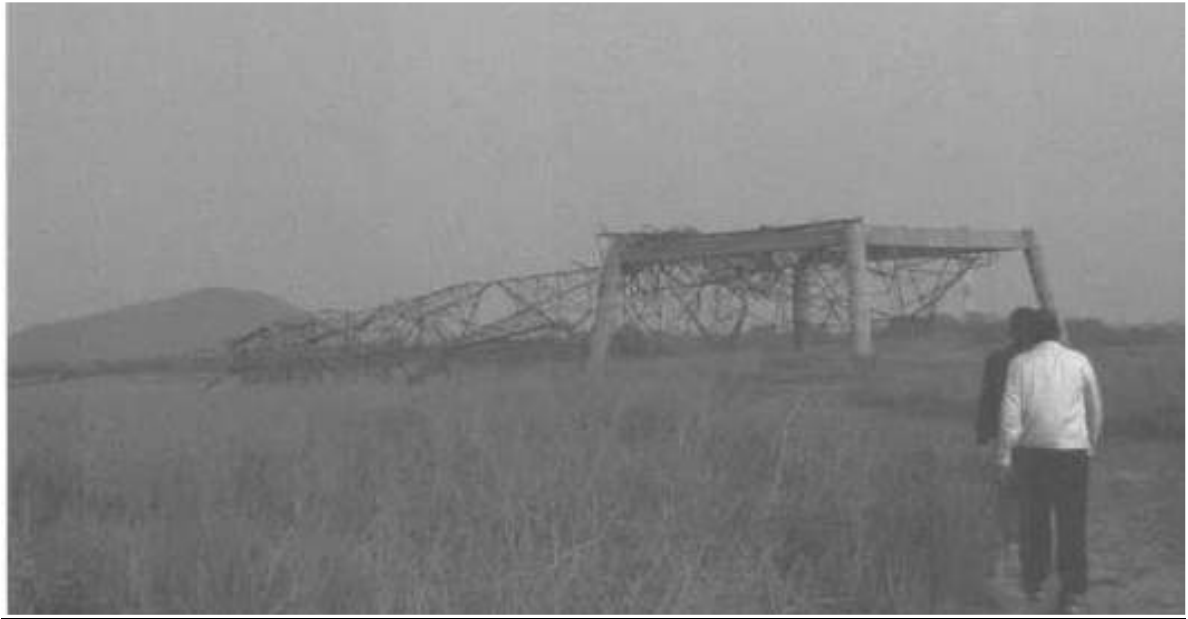
- e. **Tower at location no. 65 (DD+25)** had completely fallen to the ground in transverse direction. All 4 stubs of the tower were damaged. However, pile foundation of all the legs were intact. It was reported that there were no missing members at the tower.

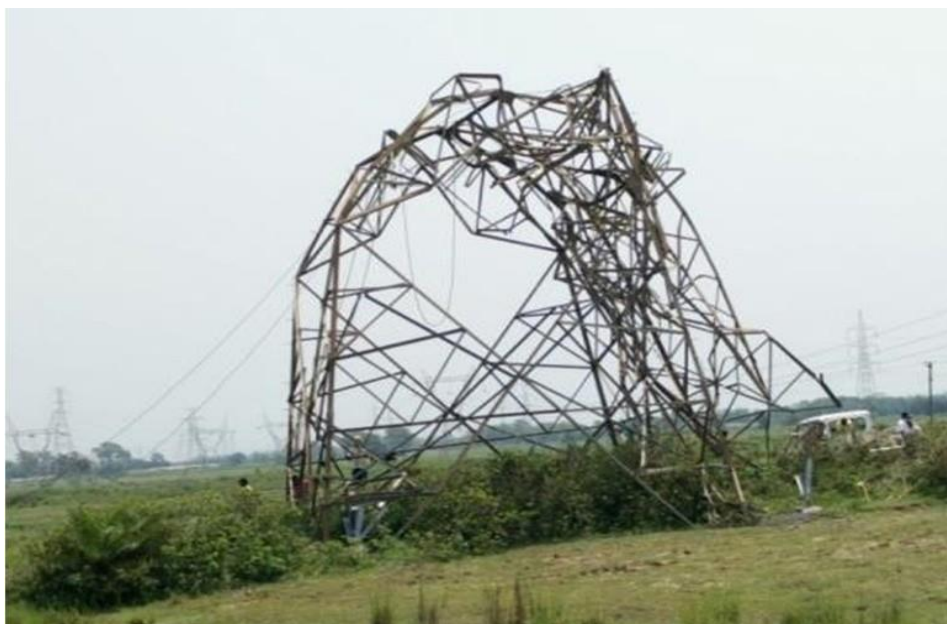
Tower at Loc. No. 377 (A+0)

b. **Tower at location No. 377 (A+0)** was located in cultivated field with very few trees in the vicinity. Tower had collapsed from 1st panel in transverse direction to the ground, although stubs were not damaged. No members were reported missing at the tower.

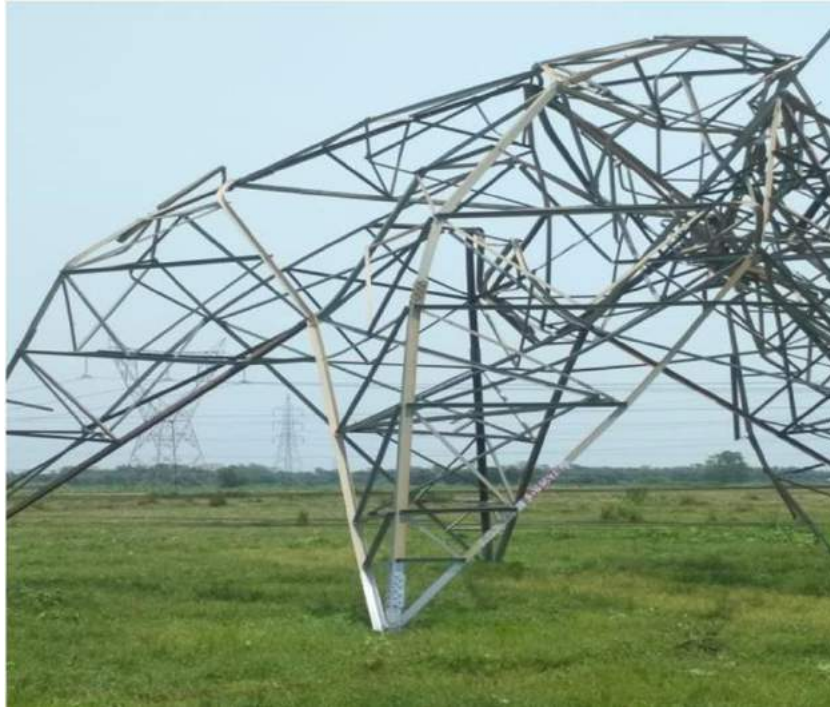
Tower at Loc. No. 378 (A+0)

- c. **Tower at location no. 378 (A+0)** was located in cultivated field with very few trees in the vicinity. The failure pattern of location no. 378 was similar to that of location no. 377 and the tower collapsed from 1st panel. All the four stubs were found to be intact. No members were reported missing at the tower.

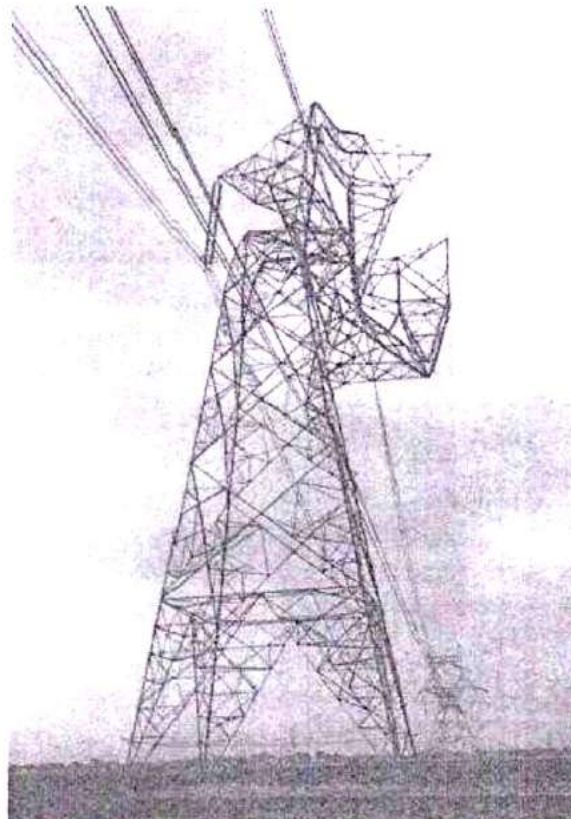
Location no. 368 (A+3)

- f. It was reported that some trees were found uprooted and some LT poles were also found tilted/fallen in nearby area of the failed tower location.

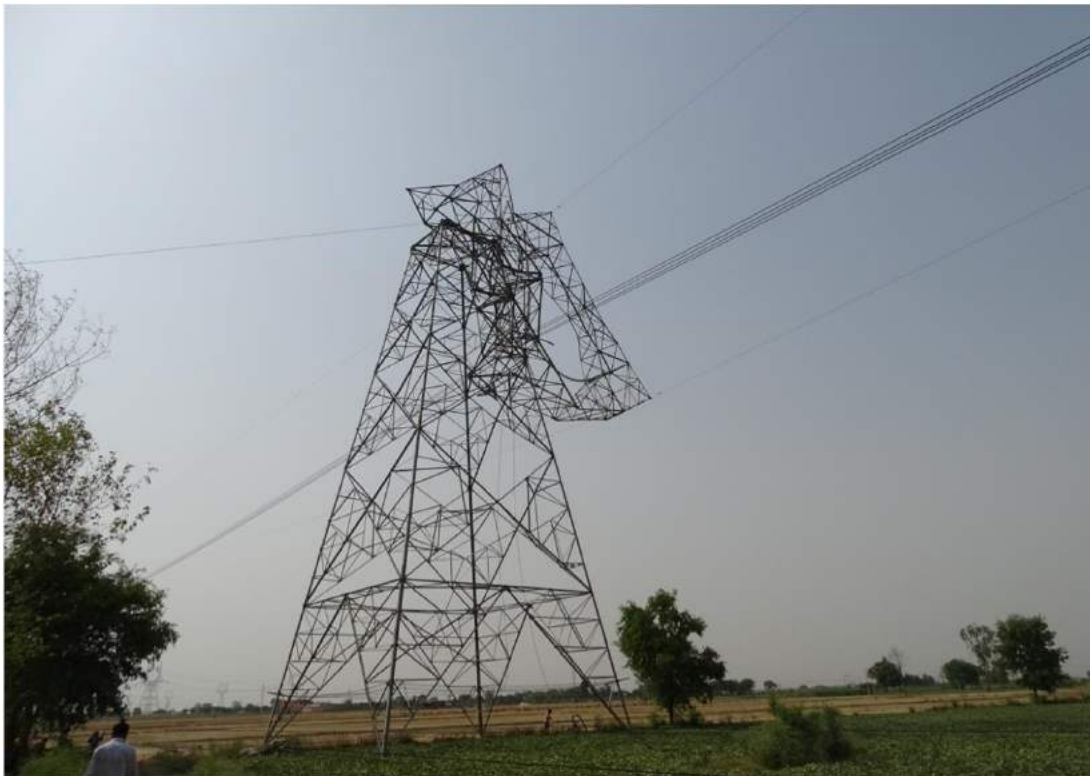
Tower at Loc. No 568 (A+0)

- e. It was informed by PGCIL that as per the advice of standing committee for strengthening of 765 kV Wind Zone-IV Delta configuration suspension (A type) towers, strengthening of towers of this line was in progress. However, strengthening of failed tower was pending.

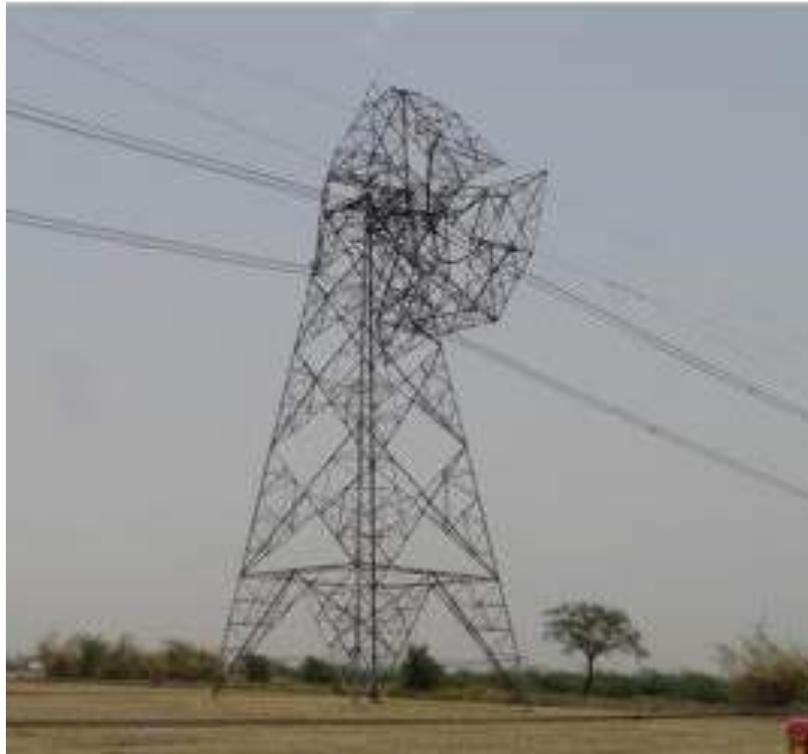
Tower at Loc. No. 17 (A+0)

- d. As reported by PGCIL, a high intensity localized cyclone in a belt of 50 meter width prevailed in the vicinity of transmission line which was confirmed by the local people from nearby villages and the local newspaper.
- e. It was informed by PGCIL that Material tests were conducted on samples selected from site at CPRI, Bangalore. Results were found to be generally within the permissible limits as per IS.
- f. It was informed by PGCIL that as per the advice of standing committee for strengthening of 765 kV Wind Zone-IV Delta configuration suspension (A type) towers, strengthening of towers of this line was in progress. However, strengthening of failed tower was pending.

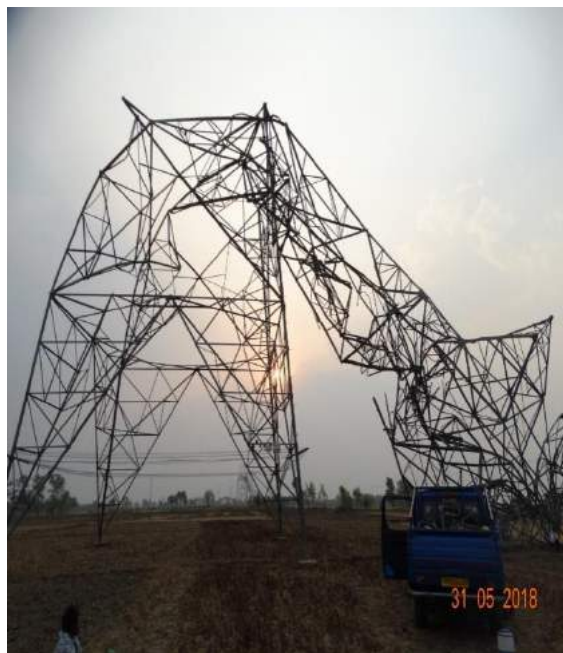
Tower at Loc. No. 185

- b. **Tower at Loc. No. 185 (A+0)** was situated/located in cultivated fields of village- Kajhwan, Block- Obera, District-. Aurangabad, Bihar. Tower had collapsed from second panel level and all the four stubs of the tower were intact.

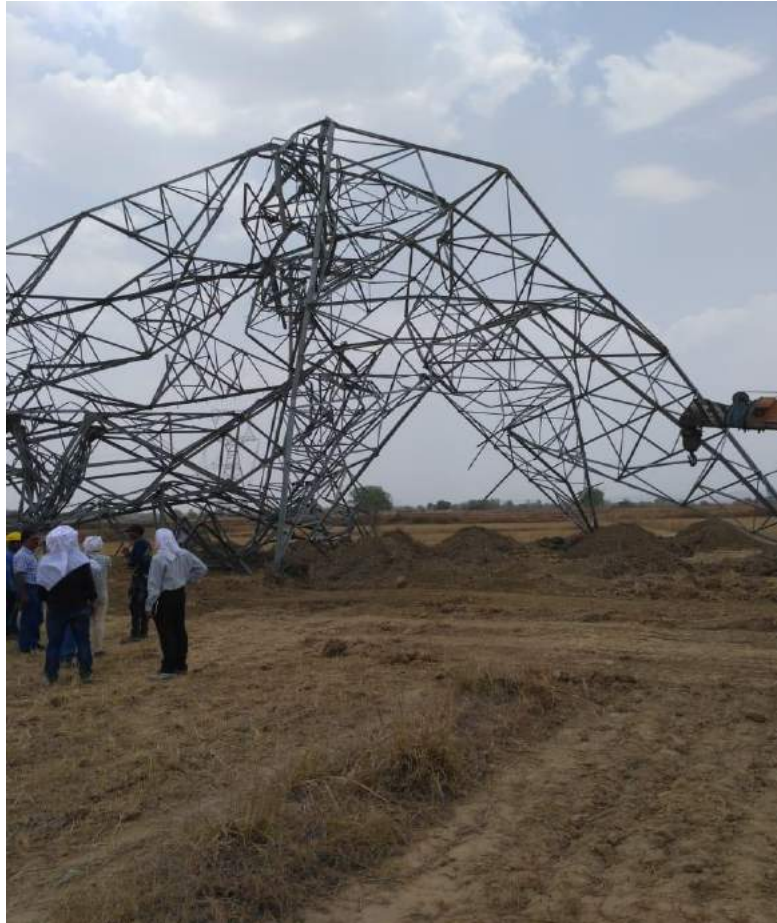
Tower at Loc. No. 63(A+0)

- d. As reported by PGCIL, the site visiting team discussed with the local people in the nearby villages about the wind and it revealed that exceptionally high storm prevailed at the time of tower collapse in the area and such high intensity localized storm is very uncommon in the locality. The effect of storm gets intensified because of presence of hill in the backdrop of location
- e. It was informed by PGCIL that Material tests were conducted on samples selected from site at independent lab. Results were found to be generally within the permissible limits as per IS.

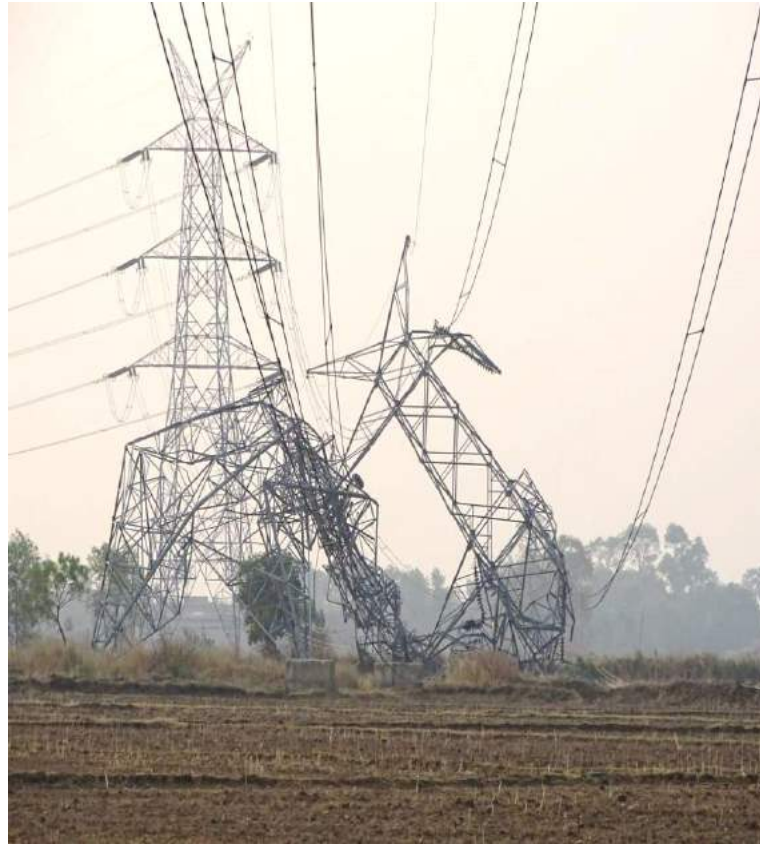
Tower at Loc. No. 36

b. **Tower at Location No. 36 (DA+9)** was situated in the agricultural fields in Itahi Kahuaa village of Kudra tehsil in Kaimur district. Tower had collapsed from second panel level. The top portion above bottom cross arm level was bent and was resting on bottom tower structure due to support of the conductors. All the four stubs of the tower were intact.

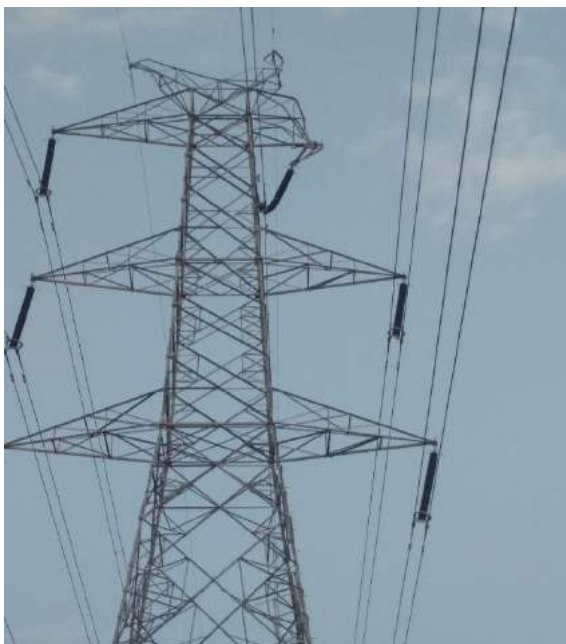
Tower at Loc. No. 37

- c. **Towers at Location No. 37 (DA+0) & 38 (DA+6)** were in erect position. Bending of few members at top cross arm level and in earth wire peak members were observed at these towers due to pulling force of the conductors.

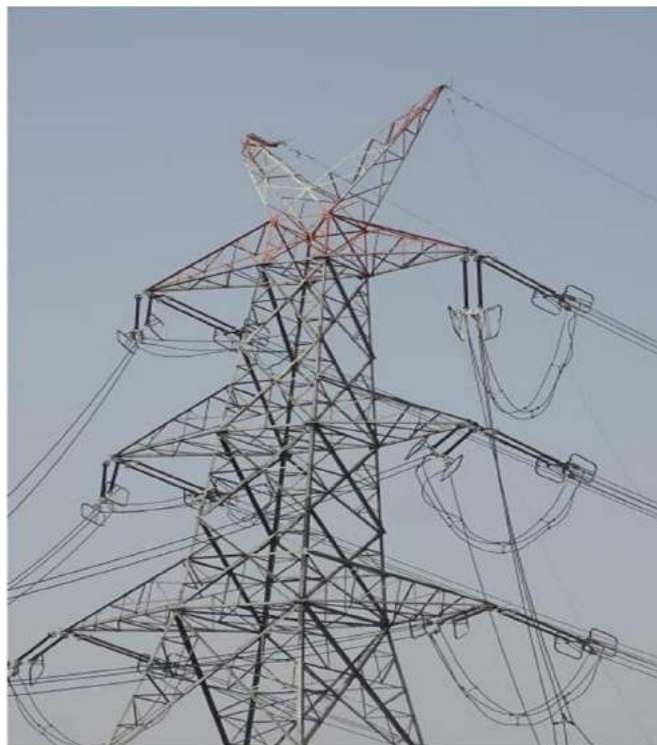
Tower at Loc. No. 54

b. **Tower at Location No. 54 (DB+0)** was in erect position. One of the earth wire peak was damaged. All the stubs and chimney were intact.

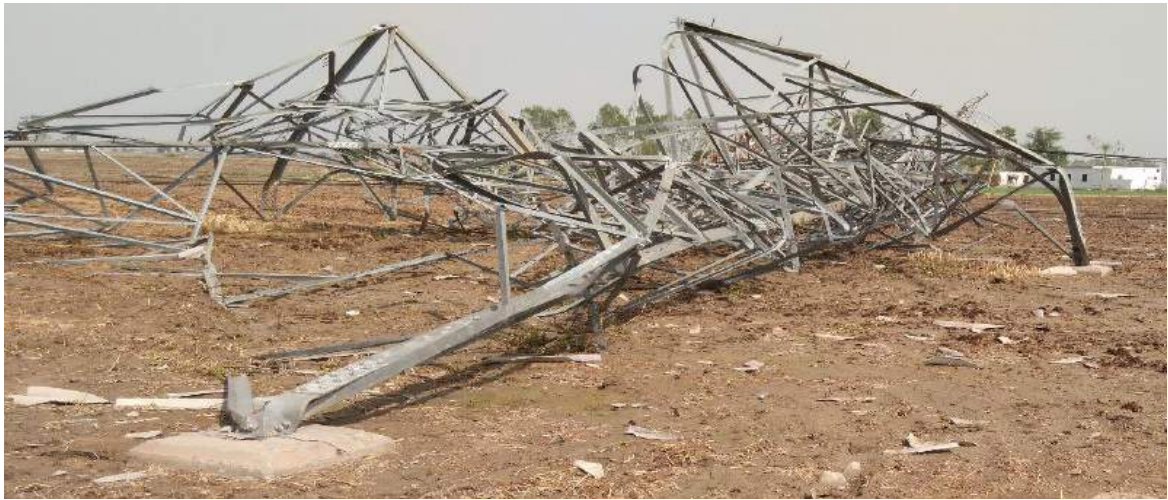
Tower at Loc. No. 55

- c. **Tower at Location No. 55 (DA+0)** was located in agriculture field. The tower was completely collapsed from the stub level in transverse direction. All stubs were bent and damaged.

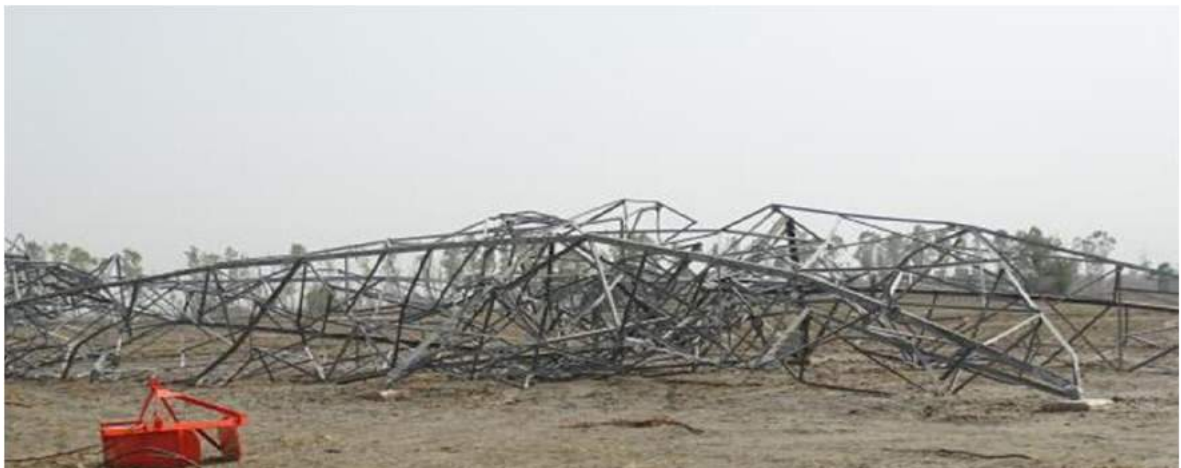
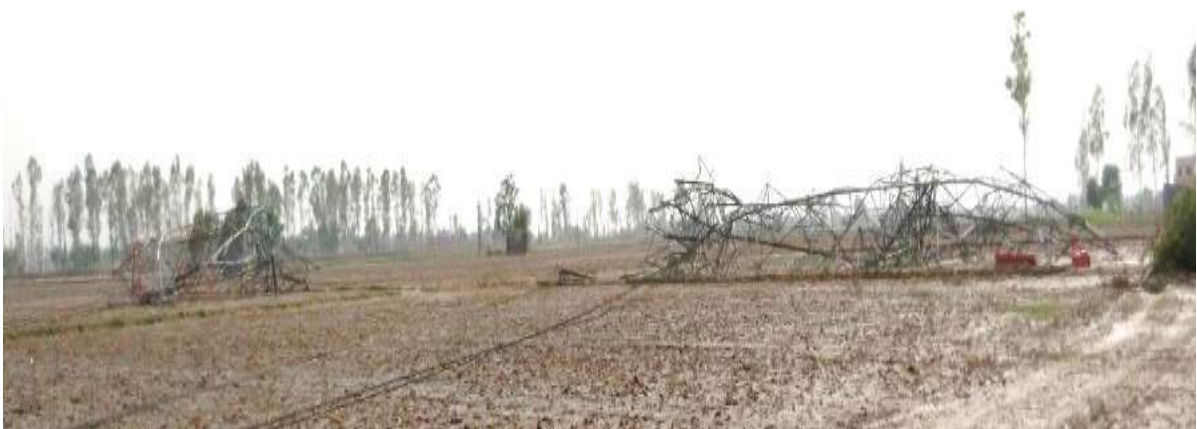
Tower at Loc. No. 56

- d. **Tower at Location No. 56 (DA+0)** had collapsed from stub level in transverse direction. The portion of cage above bottom cross arm got detached from the tower body and fell apart. Three stubs of tower were bent/ damaged.

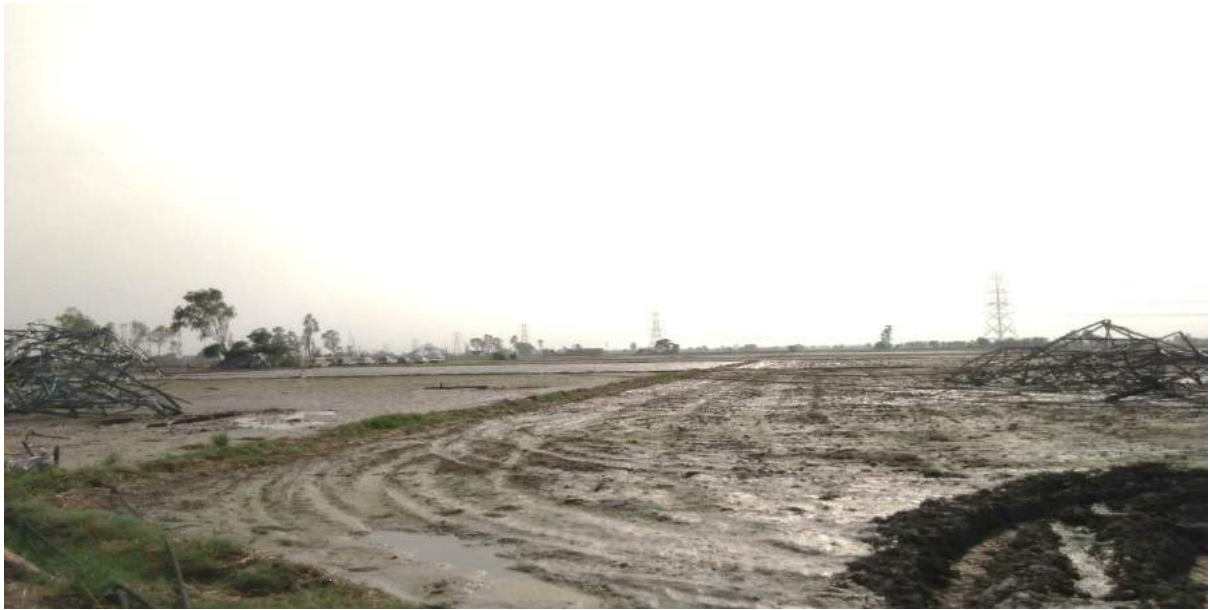
Tower at Loc. No. 57

- e. **Tower at Location No. 57 (DA+0)** had collapsed from stub level in transverse direction and the portion of cage above bottom cross arm got detached and fell a few meters apart from the original standstill position of the tower. All the four stubs were bent.

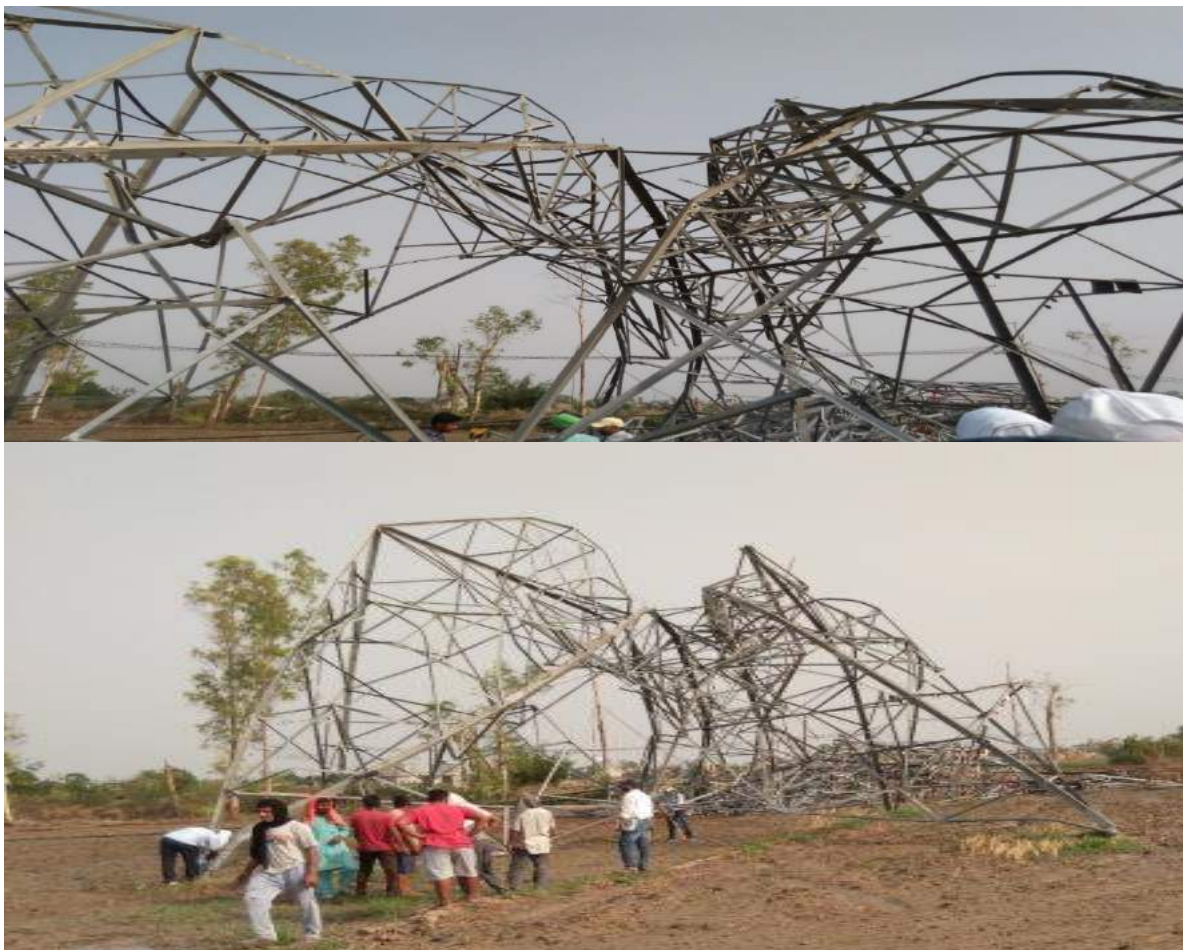
Tower at Loc. No.58

- f. **Tower at Location No. 58 (DA+0)** had collapsed in transverse/ longitudinal direction and two stubs were bent/ damaged. Minor damages were observed in the chimneys.

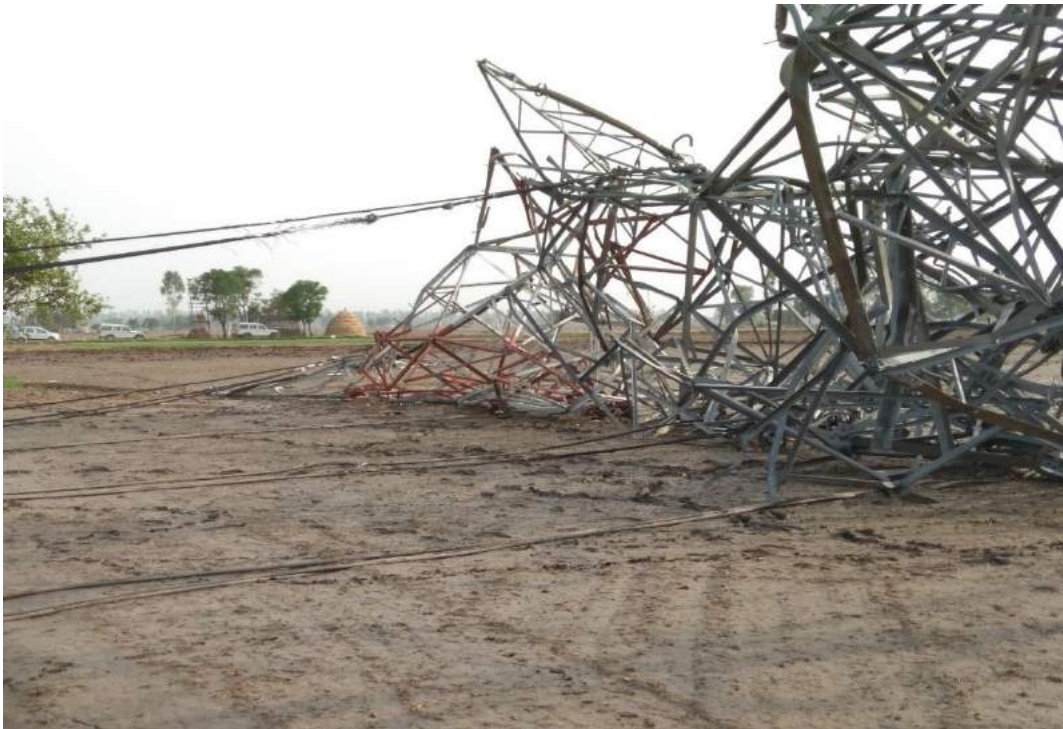
Tower at location no 59

- g. **Tower at Location No. 59 (DA+0)** was located in Paddy field. The tower had collapsed in transverse/ longitudinal direction and two stubs were bent/ damaged

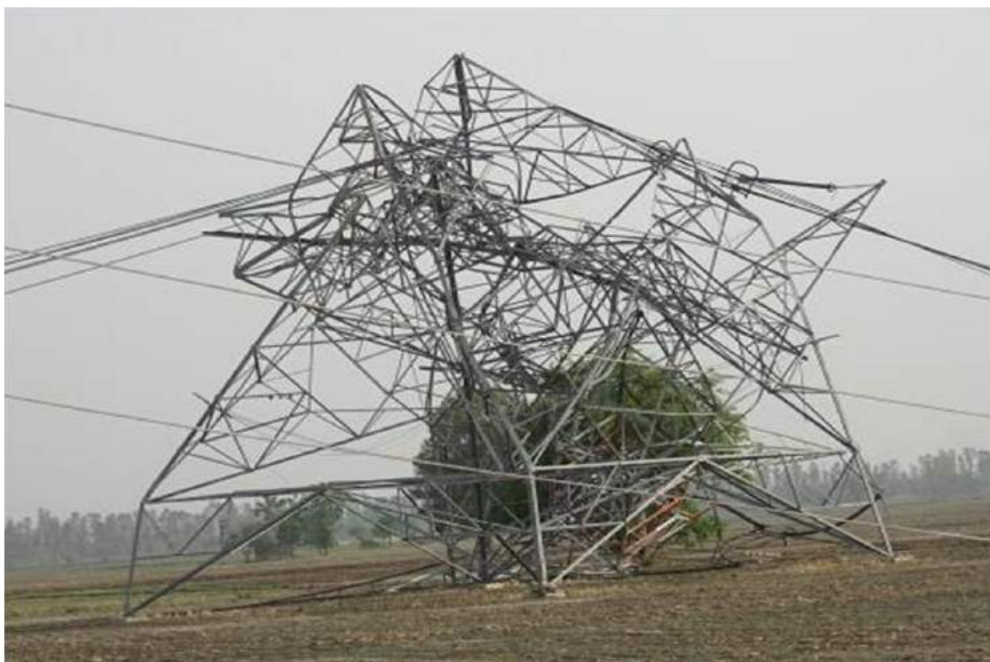
Tower at Loc. No. 60

- h. **Tower at Location No. 60 (DA+3)** failed from above +3m body level in transverse direction and all four stubs were found intact.

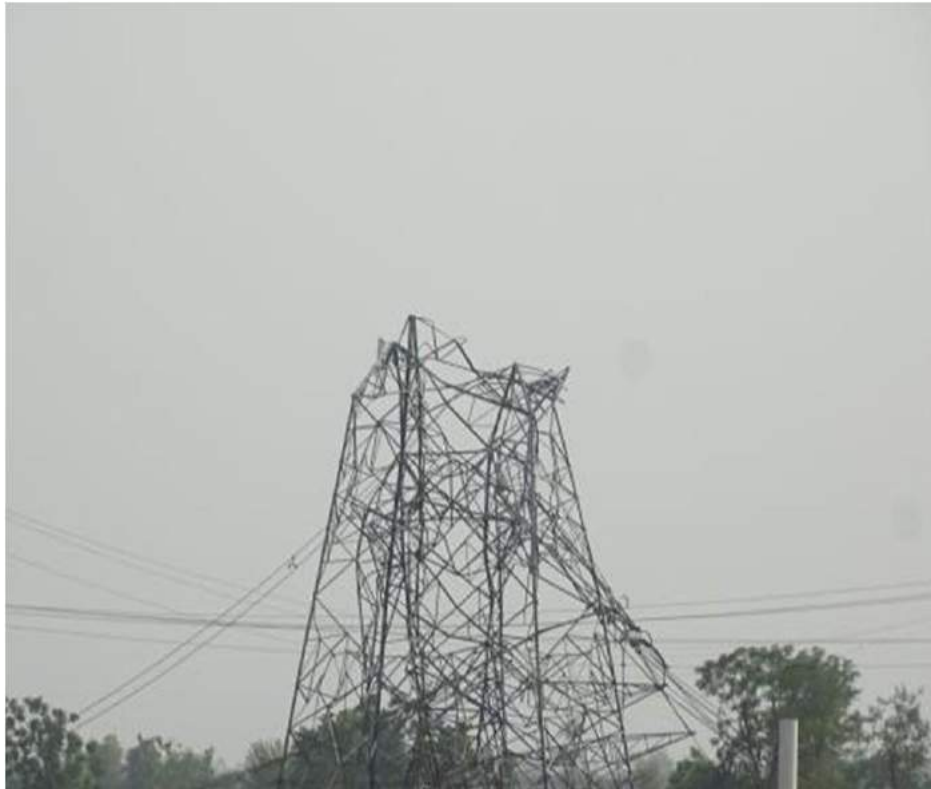
Tower at Loc. No. 61

- i. **Tower at Location No. 61 (DA+0)** failed above second panel level in transverse direction and all stubs were intact.

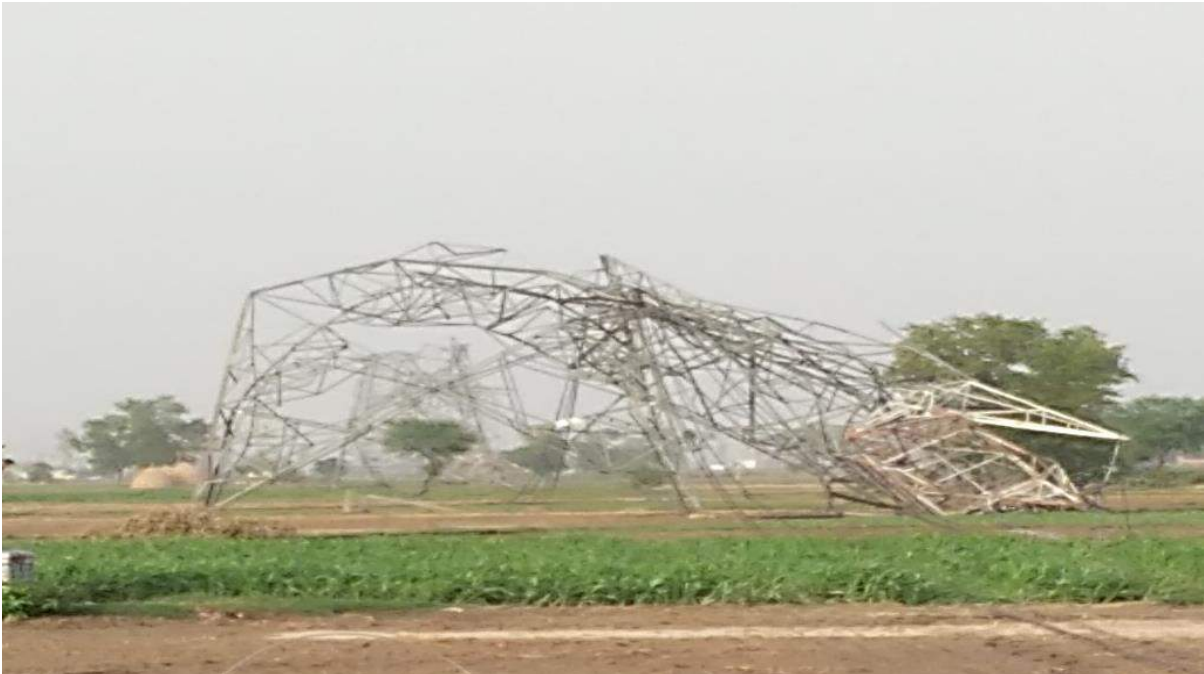
Tower at Loc. No. 62

- j. **Tower at Location No. 62 (DA+0)** failed above first panel level in transverse direction and all stubs were found intact.

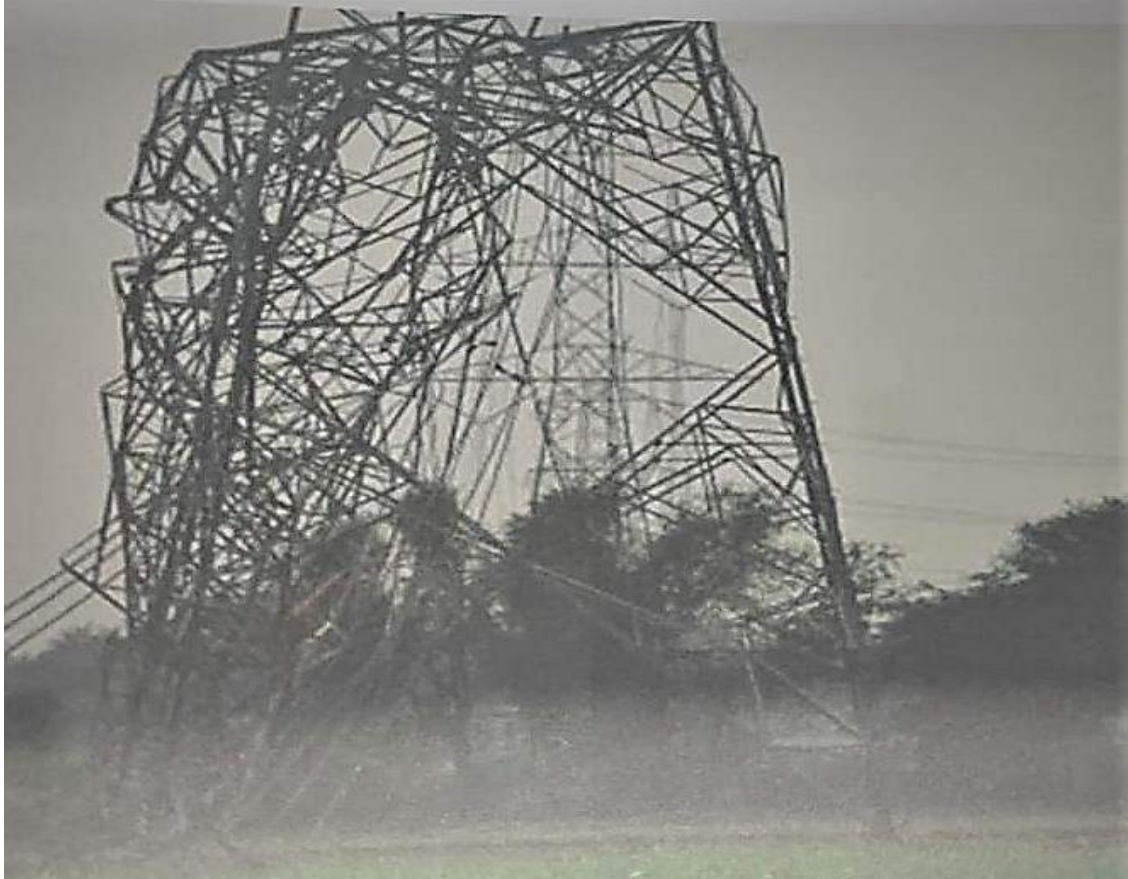
Tower at Loc. No. 63

- k. **Tower at Location No. 63 (DA+0)** was failed above second panel level in transverse direction and all stubs were found intact.
