**REPORT OF THE STANDING COMMITTEE OF EXPERTS
ON FAILURE OF EHV TRANSMISSION LINE TOWERS
(APRIL 2018 – MARCH 2019)**

Central Electricity Authority

Ministry of Power

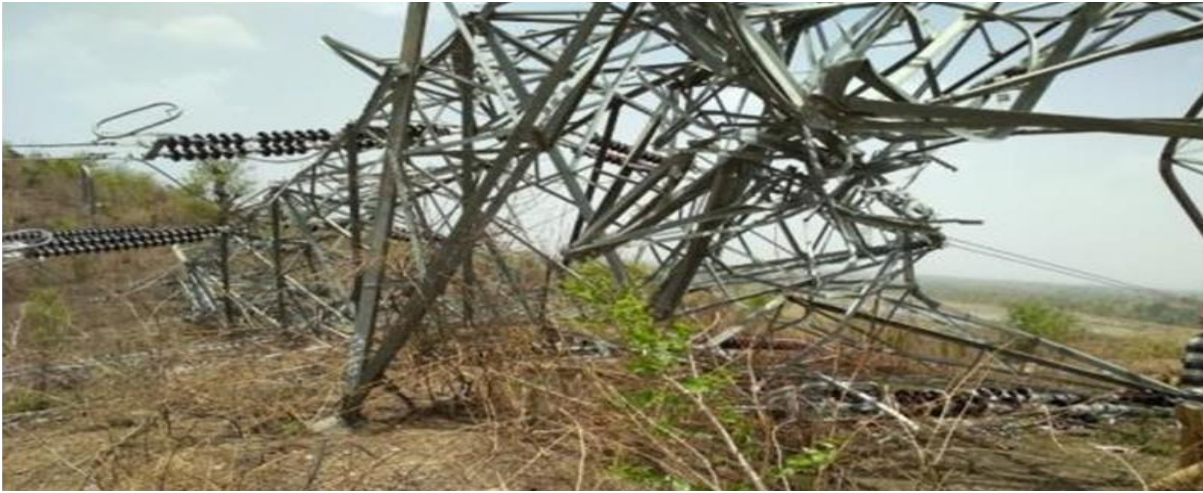
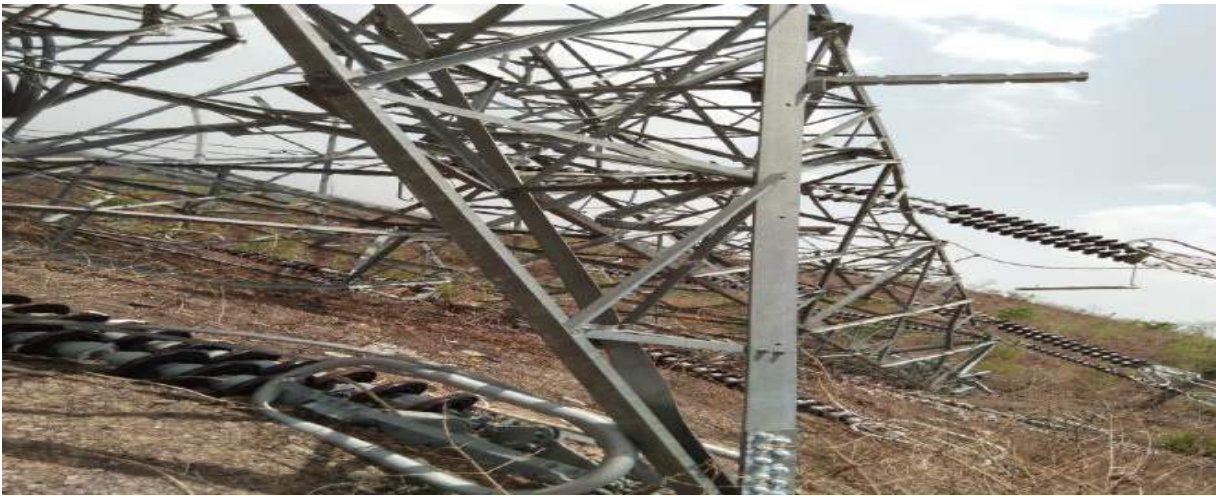
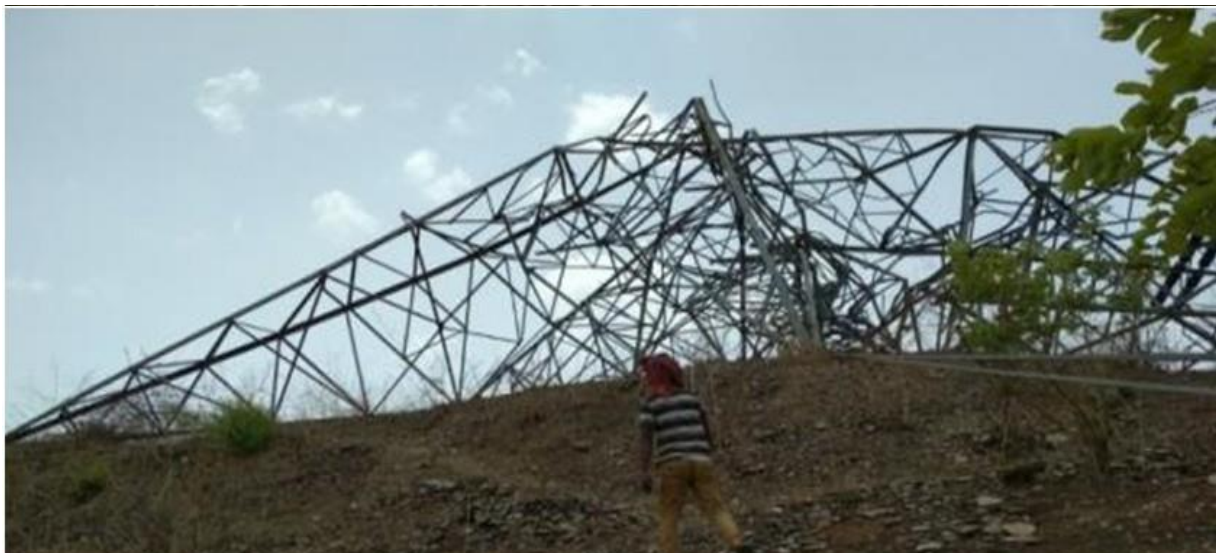
Tower at Loc. No. 218

b. **Tower at Location No. 218 (DB+0)** was located on top of the hill. It was completely collapsed in the transverse direction and all of the stubs were bent. As per report of team visiting the tower failure site, between tower locations 218 & 219 a valley like shape was formed between the hills which might have increased the intensity of the winds. No missing members and bolts and nuts were observed at the tower except few step bolts and earthing bolts.

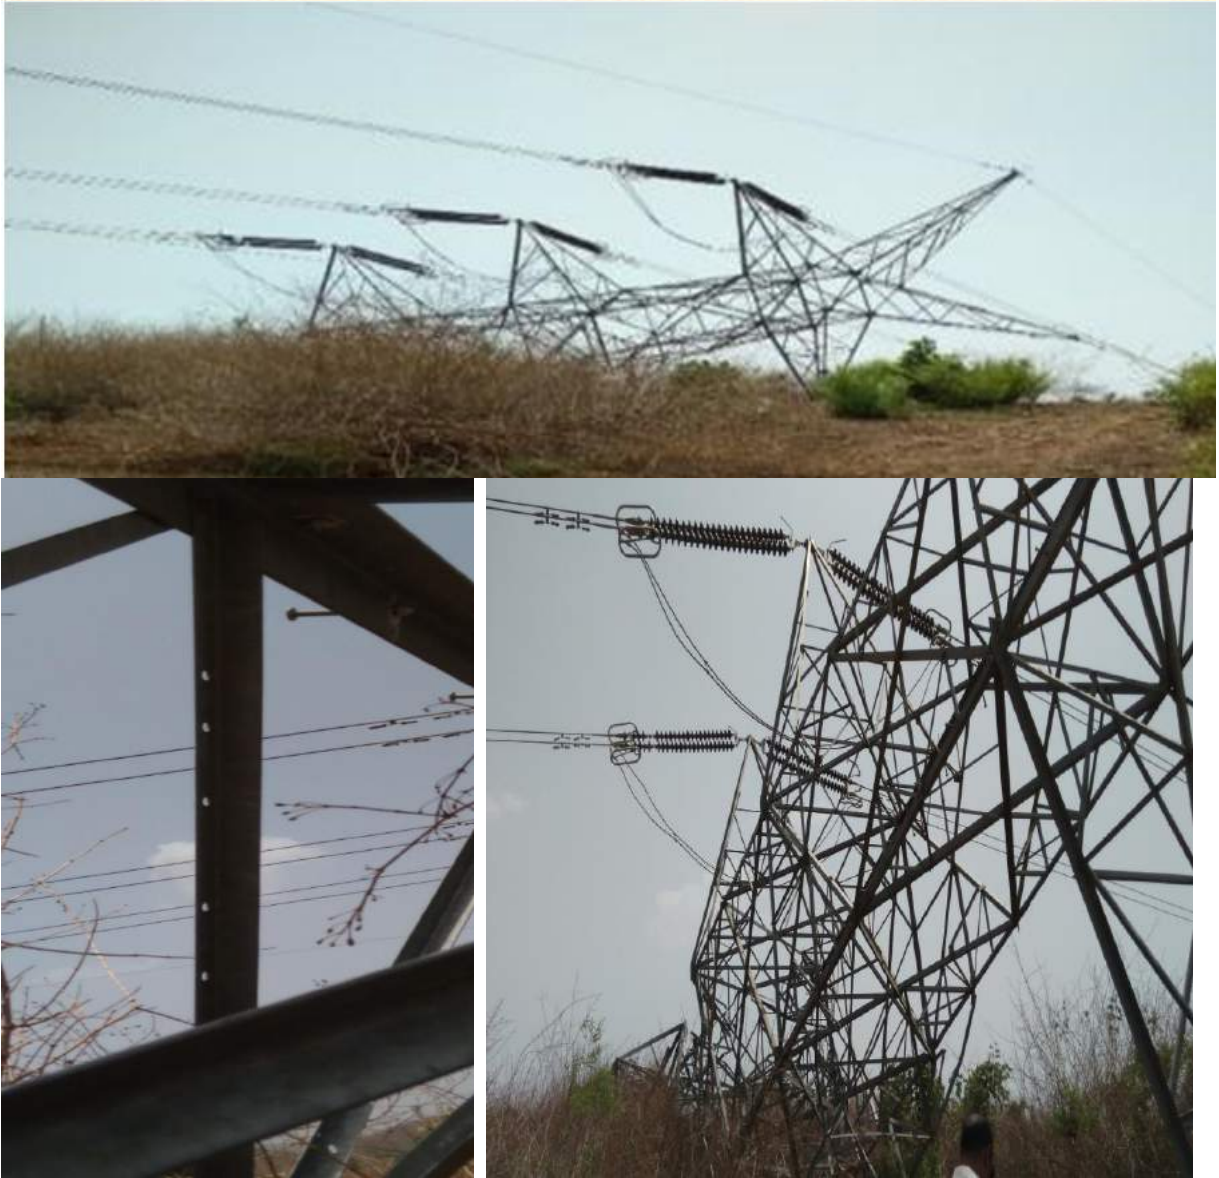
Tower at Loc. No. 219

- c. **Tower at Location No. 219 (DB+6)** had collapsed from waist level in the transverse direction and two of the stubs were broken. As per report of team visiting the tower failure site, between tower locations 218 & 219 a valley like shape was formed between the hills which might have increased the intensity of the winds. No missing members and bolts and nuts were observed at the tower except few step bolts and earthing bolts, name plate bolts, danger plate bolts, phase sequence bolts.

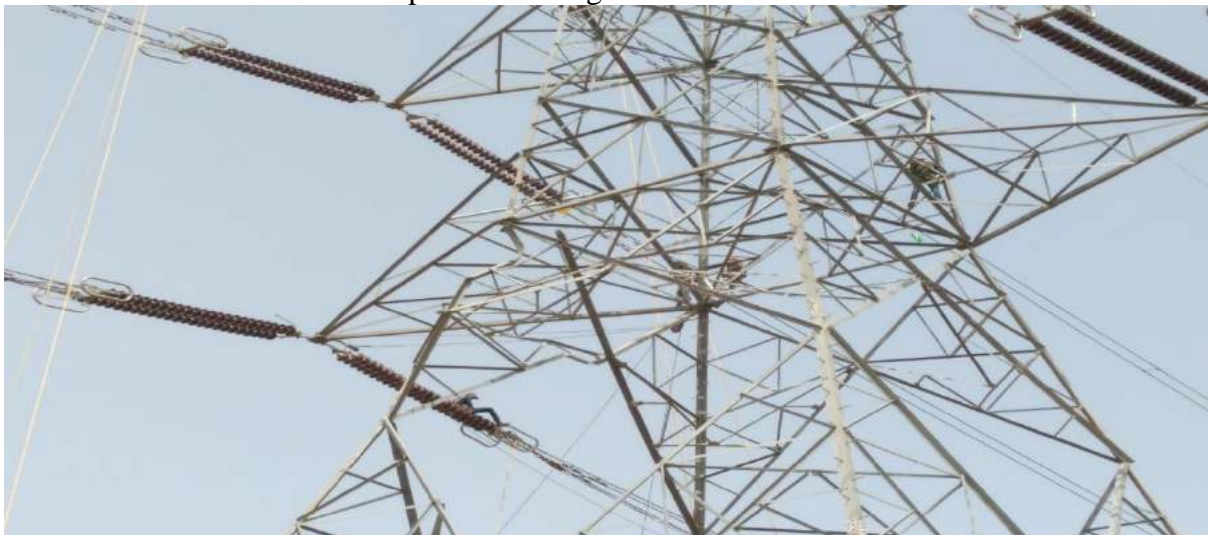
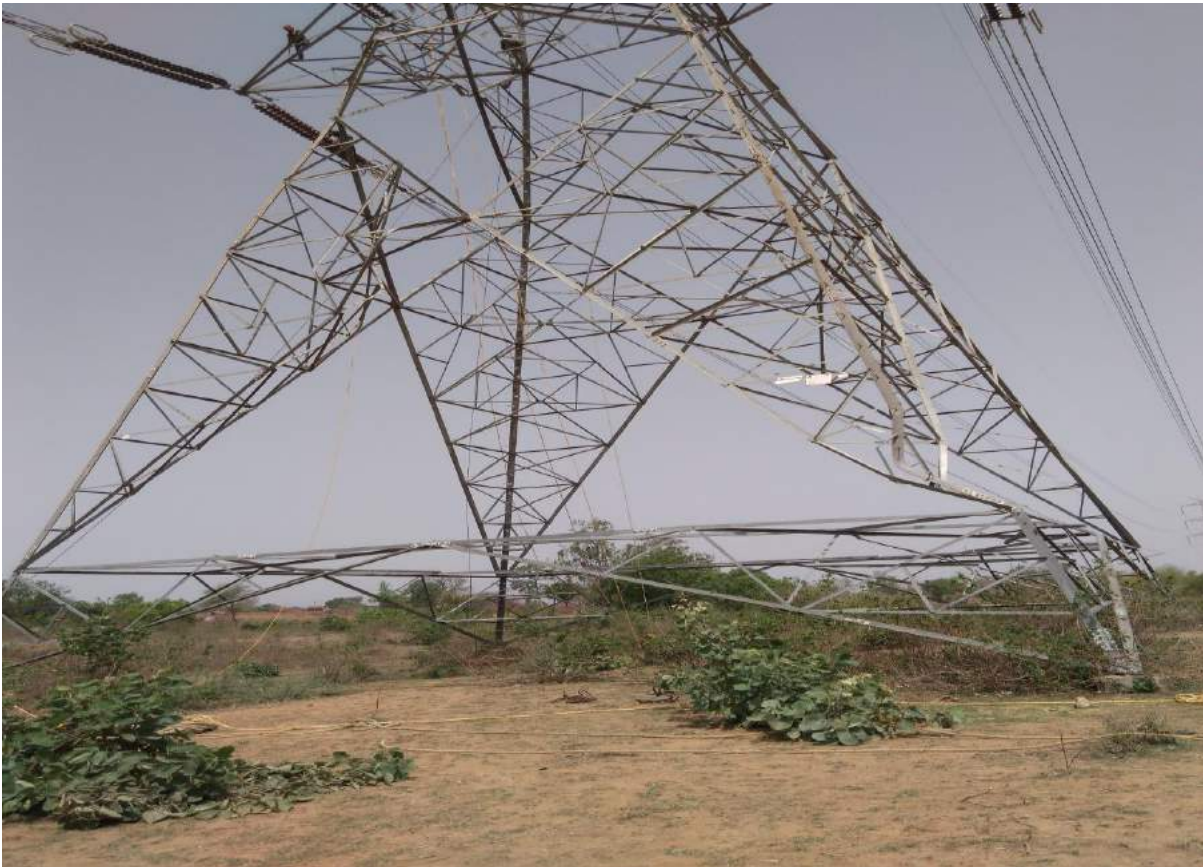
Tower at Loc. No. 220

- d. **Tower at Location No. 220 (DB+3)** was in erect position and was deformed at +3 M extension level and at bottom cross arm level. All stubs of the tower were intact. According to the team visiting to the failure site, the reason of deformation of the tower was pulling force imparted due to collapsing tower at location 219. No missing members and bolts and nuts observed in the tower except few earthing bolts.

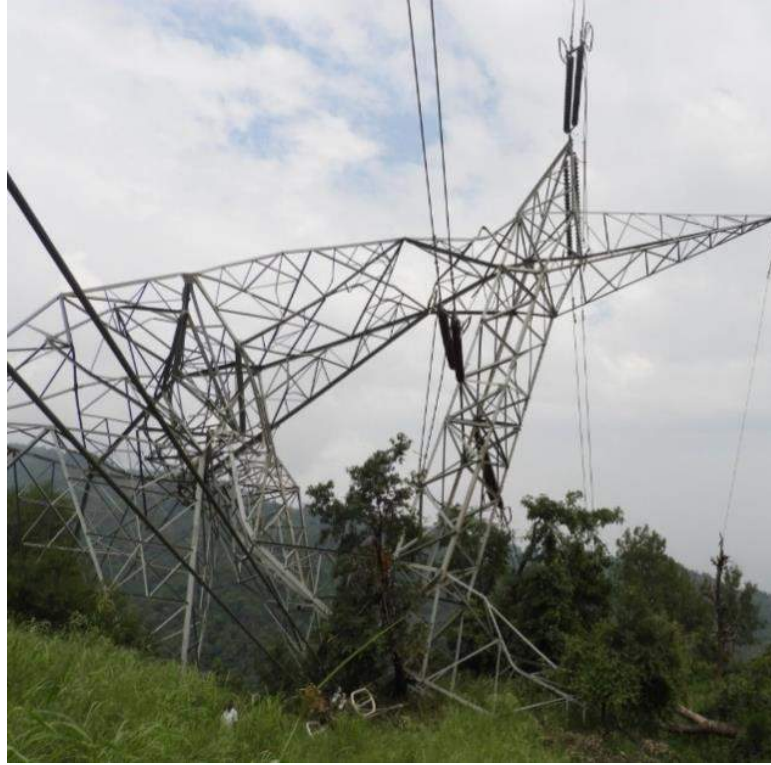
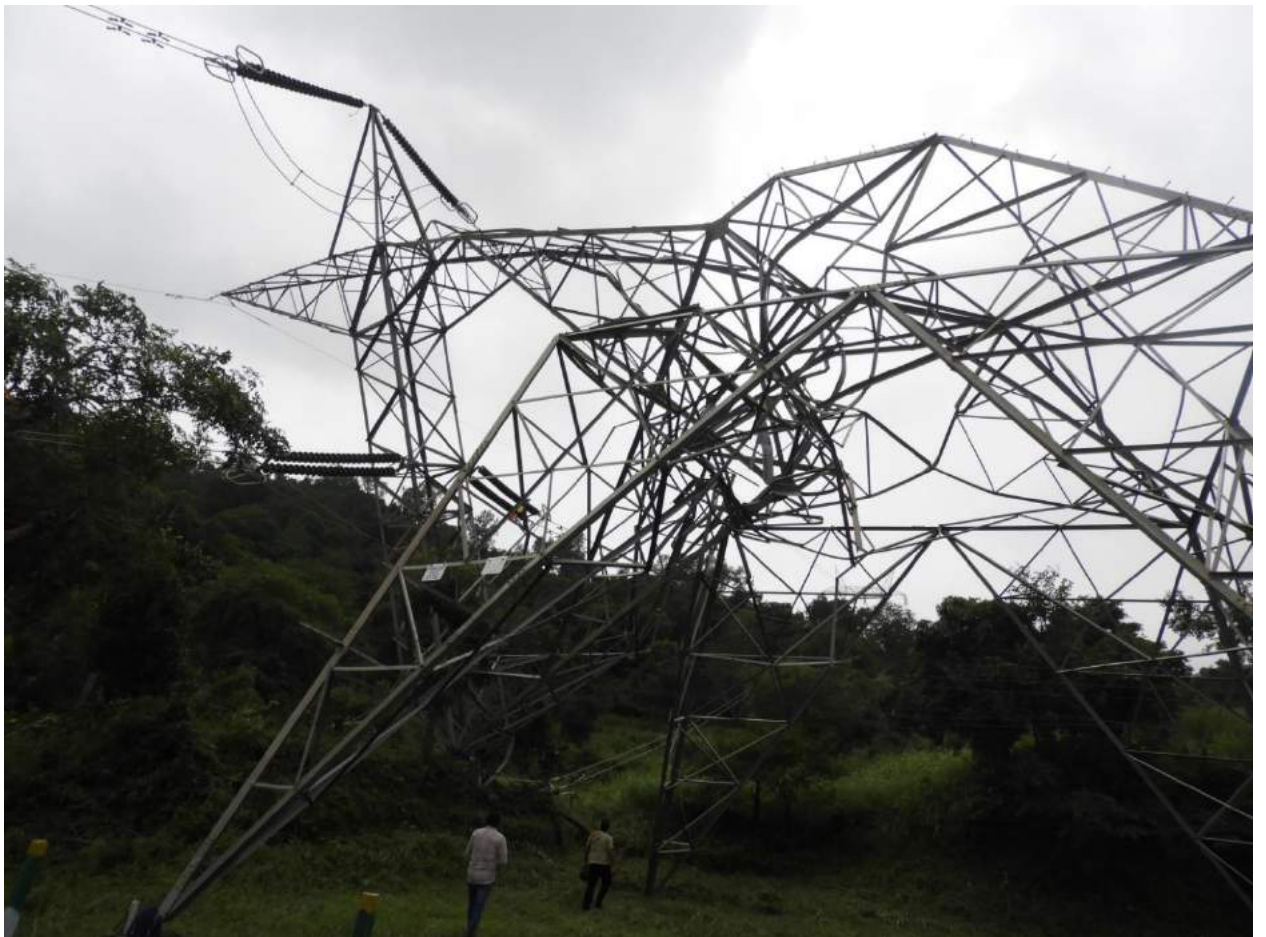
Tower at Loc. No. 238

- b. **Tower at Location No. 238** collapsed from waist level and was tilted across the line in transverse direction. Two no. of stubs of the tower were damaged.

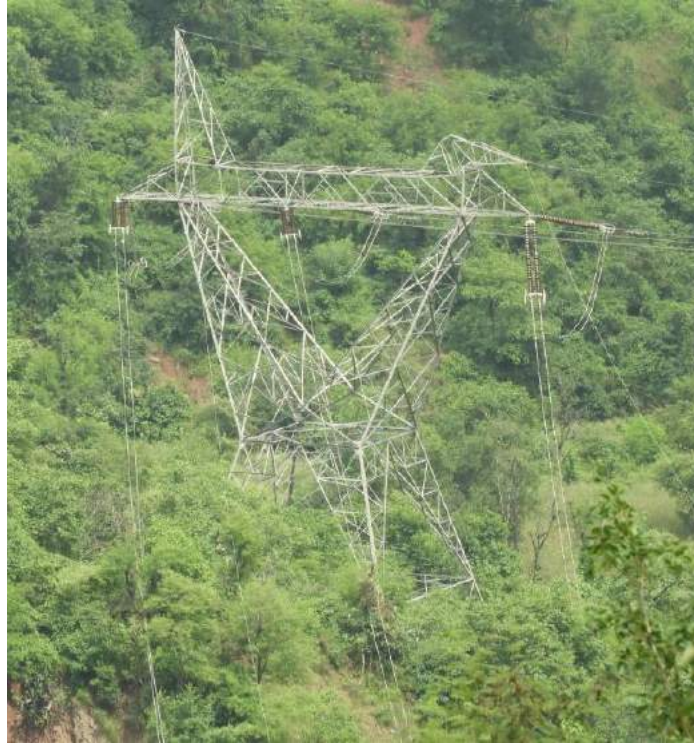
Tower at Loc. No. 239

- c. **Tower at Location No. 239** was partially damaged as the Earth wire Peak was damaged due to pulling force of the wires.

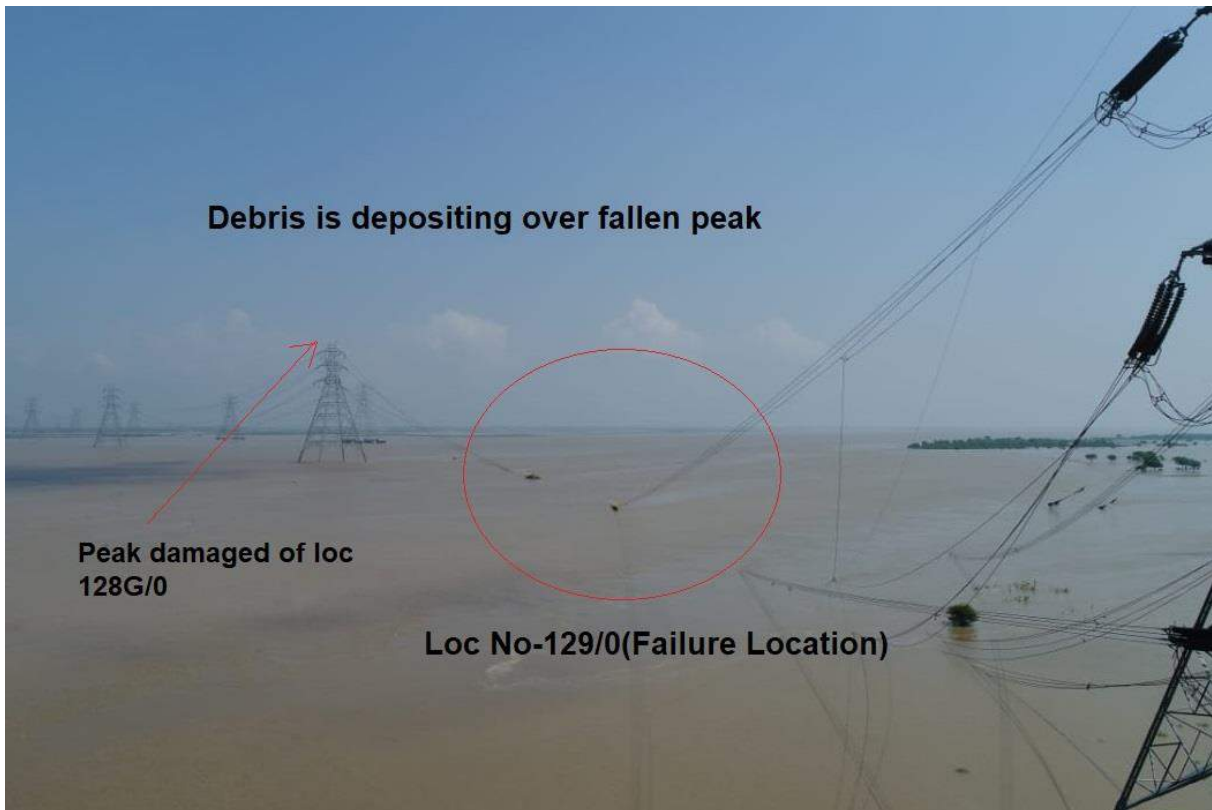
Tower at Loc. No. 128G/0 & 129/0

- c. **Tower at Location No. 128G/0 (DD+25)** was located in mid-stream on newly constructed pile foundation. The earthwire peak and one side of bottom cross arm was damaged because of pulling of conductor/earthwire due to tower collapse at Loc. No. 129/0.

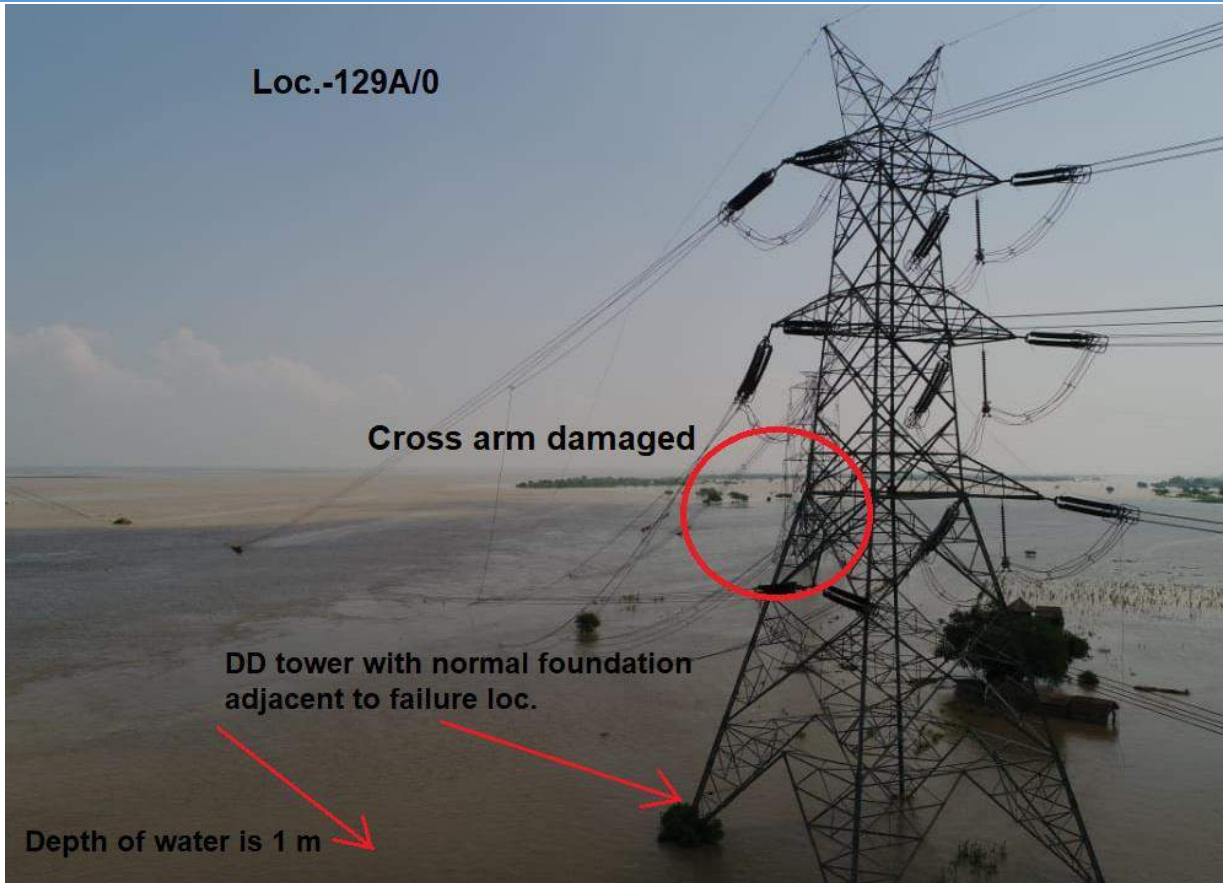
Tower at Loc. No -129A/0

- e. **Tower at Location No. 129A/0 (DD+0)** was constructed on normal open cast foundation. One side of bottom cross arm was observed to be damaged due of pull of conductor towards collapsed tower loc. no. 129/0. Presently the location was almost on the edge of an island towards the main river course. Bottom portion of about 1m portion of the tower was under flood water. It was informed that the foundation at this location had also become susceptible to failure due to eminent soil erosion by the main river course.

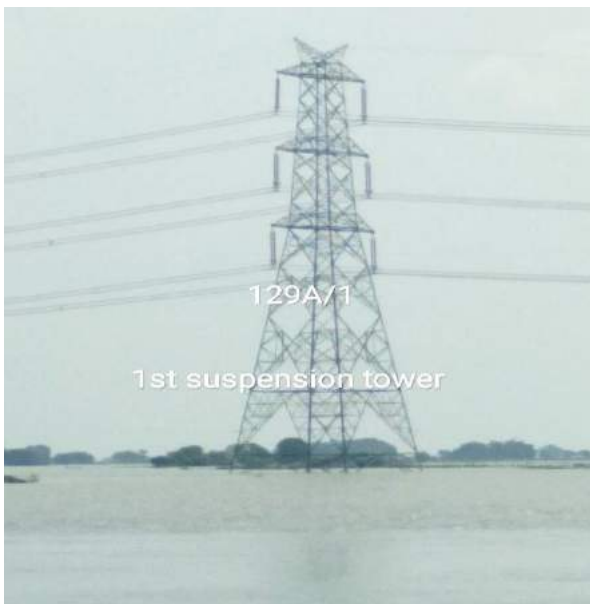
Tower at Loc. No. 129A/1

- f. **Towers at Location Nos. 129A/1(DA+3), 129A/2(DA+0), 129A/3(DA+3) & 129A/4(DA+0):** Bottom portion of towers (about 1m) at location no 129A/1(DA+3), 129A/2(DA+0), 129A/3(DA+3) was submerged in flood water. Location no-129A/4 has also come perilously close to river flow. As reported by PGCIL, the river formed flow channels around these locations and it was observed that all the above foundations became vulnerable to failure.

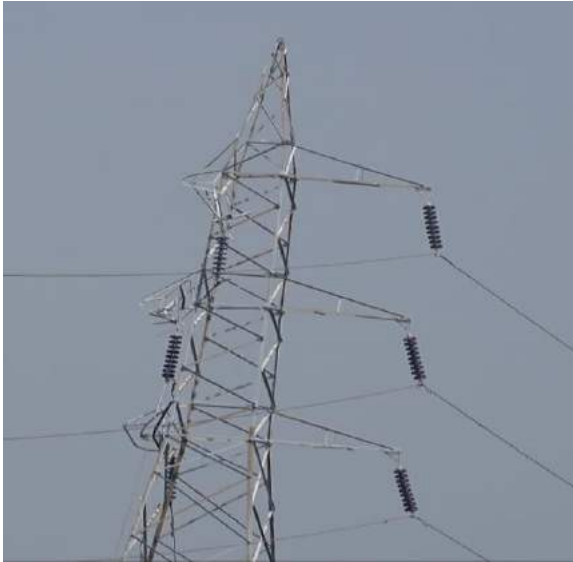
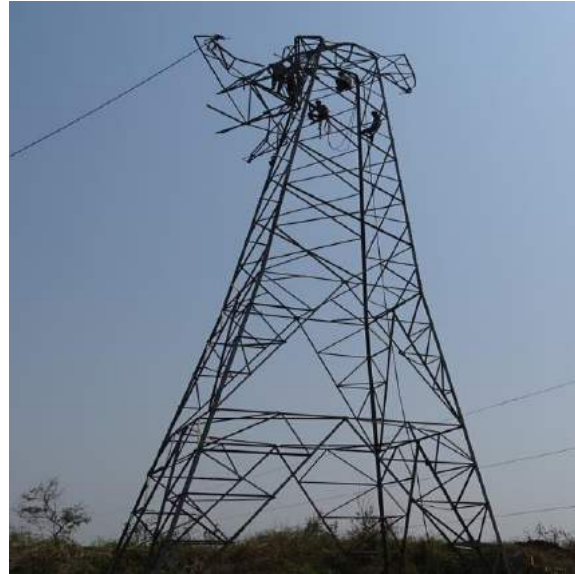
Damaged APTRANSCO's transmission line
