### क्षतिग्रस्त ट्रांसमिशन लाइन टॉवरों पर विशेषज्ञों की स्थायी समिति की रिपोर्ट

REPORT OF THE STANDING COMMITTEE OF EXPERTS ON FAILURE OF EHV TRANSMISSION LINE TOWERS (APRIL 2019 – DECEMBER 2021)

भारत सरकार Government of India केन्द्रीय विद्युत प्राधिकरण Central Electricity Authority

### **EXECUTIVE SUMMARY**

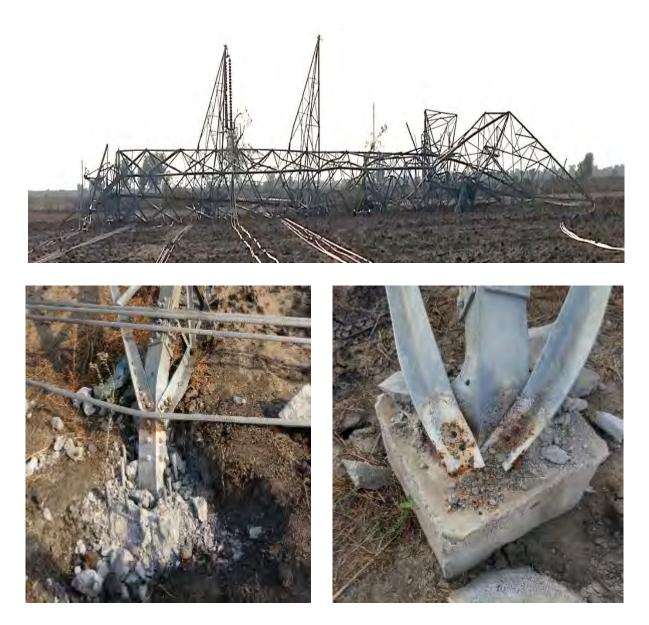
Tower loc. No. 547 (DA+0)

when observed facing Gooty. All the four stubs of the tower were bent. Coping of legs were damaged due to the impact of falling tower. Chimney of leg A & leg C were damaged and other two chimneys were intact. Rusting at the bottom end of all the stubs and nuts & bolts (near to chimney) was observed. No missing tower members/nut bolts were observed in the failed tower.

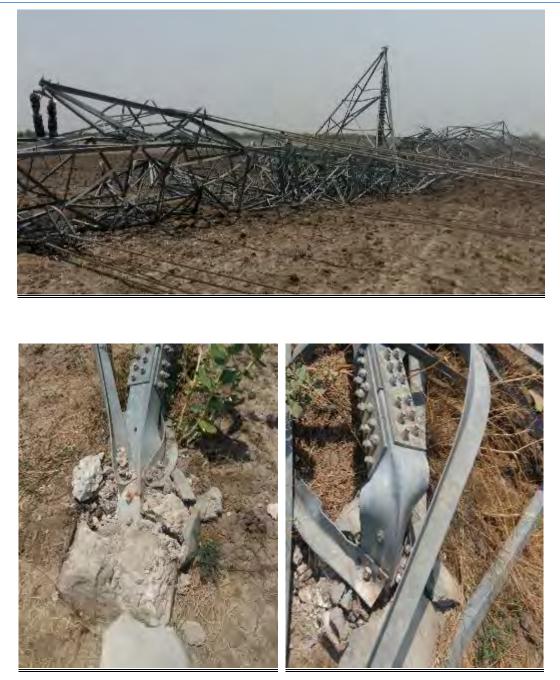
Tower loc. No. 551 (DA+0)

h. **Tower at Location No. 551 (DA+0)** was completely collapsed to the ground from the stub level in transverse direction towards left side when observed facing Gooty. All four stubs of the tower were bent.

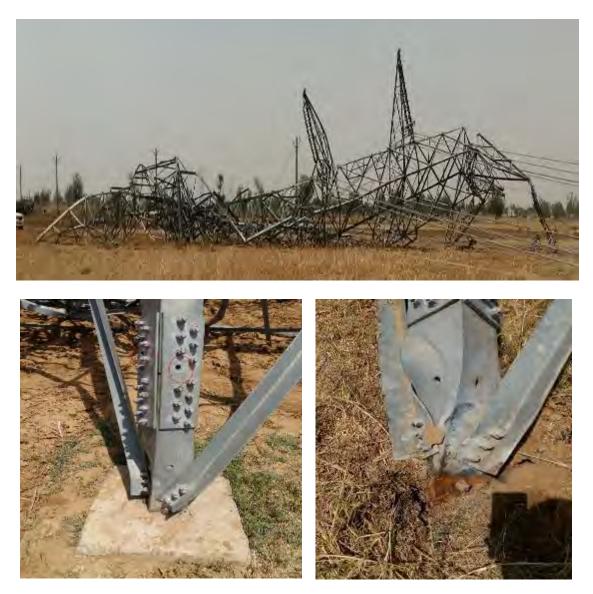
Tower loc. No. 552 (DA+9)

Sikar. There were minor damages to all four stubs. No tower members/ nut bolts were found missing. It was observed that leg C and leg D were bent from stub level (near to chimney) and the remaining two legs were bent from 1<sup>st</sup> panel level. All the foundation chimneys were intact. Coping of chimneys were not provided. Rusting at the bottom end of all the Stubs (near to chimney) were observed. Few bolts were found missing in the Butt joint connecting leg B and stub. The spacing of bolts from the edge of the members was observed to be inadequate.

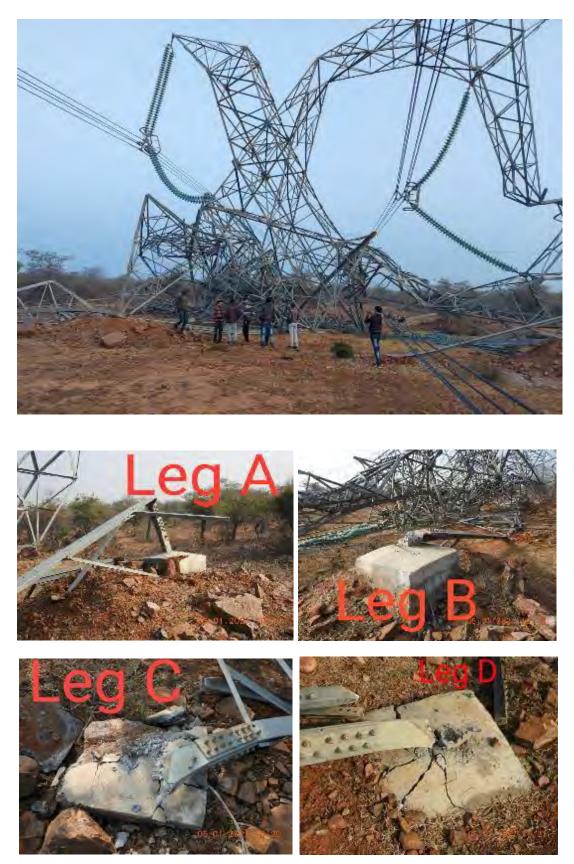
Tower at Loc. No.611 (B+0)

b. **Tower at Location No. 611 (B+0)** was located near village Bilauaa, Jaurasi Ghati Dabra Taluk in Gwalior district (Madhya Pradesh). The tower was completely collapsed from stub level to the ground and only one stub of the tower along with its foundation was found intact. It was observed that Leg B was bent from top of chimney level and the remaining two legs were sheared from just above concrete/chimney level. All the redundant members connected to leg A & leg B below belt level of bottom panel were stolen. In leg-C and leg-D, all redundant members from cross bracing to the main legs were missing. Removed tower member pieces, bolts and nuts were found scattered at the tower collapse site.

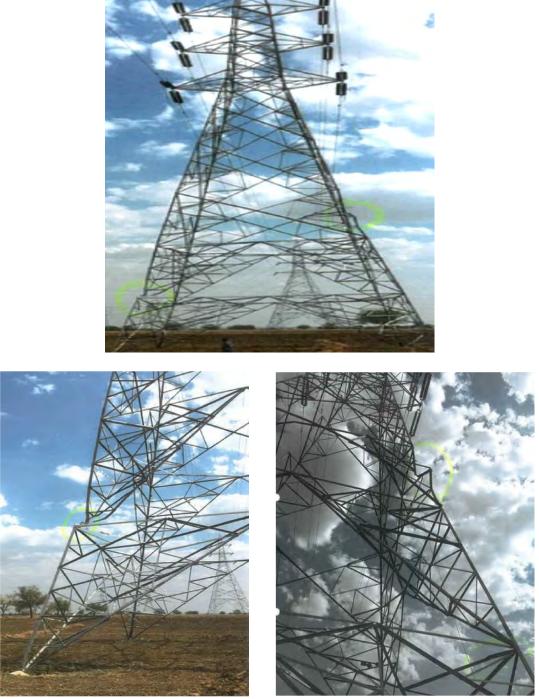
c. Tower at location No. 389 (DB+18) & 391 (DA+3) were in erect condition. The leg members and bracing members of the tower at location No. 389 were buckled. At location No. 391, the peak members were buckled. There was no damage to the foundations of these towers. These were reported as secondary failures caused due to pulling forces/ jerk of conductors/earthwires.

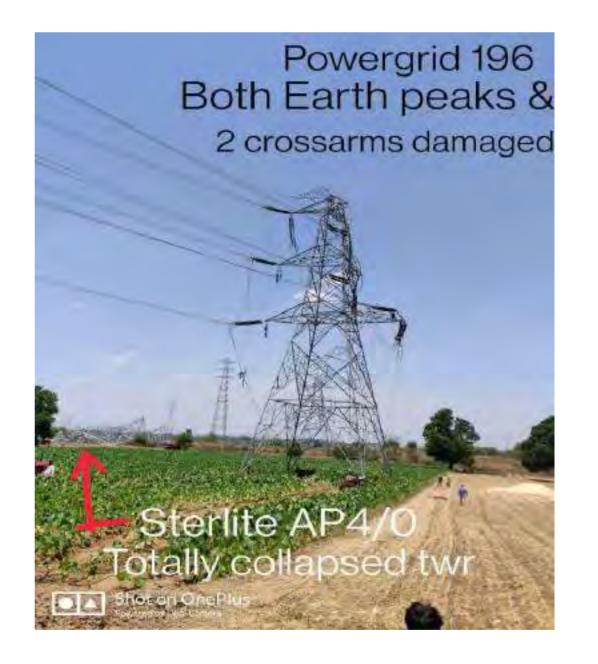
Powergrid 197

Date of Failure/ Commissioning		16.04.2019/July 2016
No. of Towers	Tension tower	1
failed	Suspension tower	0
	Total	1
Observa	tions	<ul> <li>Tower Configuration :- Vertical</li> <li>Conductor Type :-Twin ACSR Moose</li> <li>Insulator type :-"I" Suspension insulator string</li> </ul>
		• Reason Given by Utility :- The crossing Towers AP4/0 and AP5/0 of 765 KV D/C Hexa Khandwa-Dhule line of M/s Sterlite had collapsed and conductor of that Hexa D/C line had fallen over POWERGRID's existing 400KV D/C Khandwa-Indore Line over the conductor span between tower 196-197. This has resulted into damage of Tower 196(DD+0), insulators and conductor in the span (196-197).

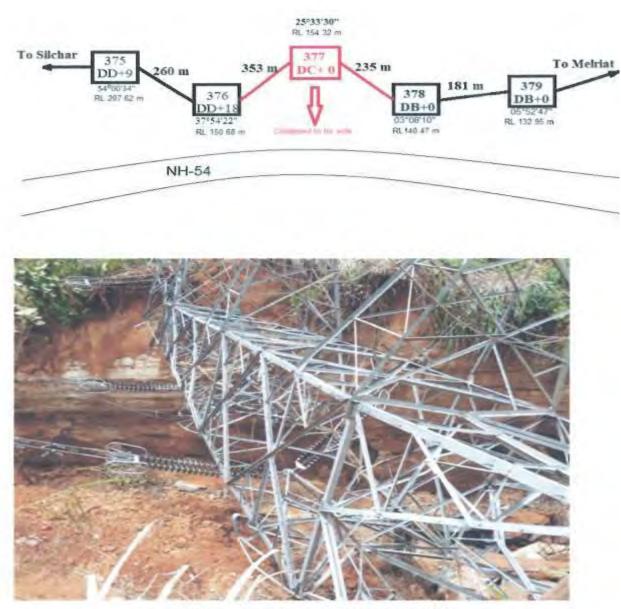
Date of Failure/ Commissioning		19.07.2019/Dec 2018
No. of Towers	Tension tower	1
failed	Suspension tower	0
	Total	1
Observations		<ul> <li>Tower Configuration :- Vertical</li> <li>Conductor Type :-Twin ACSR Moose</li> <li>The Tower Location No. 377 fully collapsed laterally due to displacement of landmass suddenly during landslide.</li> <li>The foundation of the Leg-A fell on the fault line of the separation and completely collapsed.</li> <li>The tower had a deviation of 25°33'30" towards right.</li> <li>Wind Zone 6</li> </ul>
		<b>Reason Given by Utility :-</b> The tower at this location collapsed due to the displacement of landmass during landslide.

Collapsed tower no. 377 due to landslide

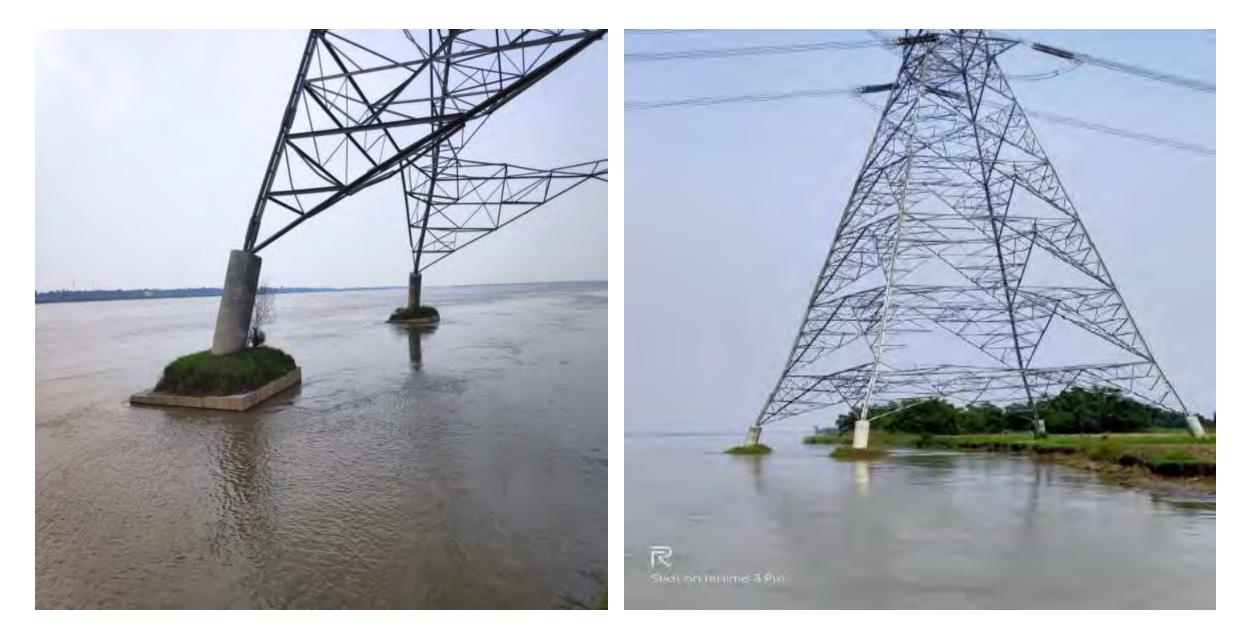
Date of Failure/ Commissioning		06.08.2019/29.03.2016
No. of Towers failed	Tension tower	1
	Suspension tower	0
	Total	1
Observations		<ul> <li>Tower Configuration :- Vertical</li> <li>One of the main leg (Leg-D) was in the main river course and some members of the tower were deformed due to the differential settlement of pile foundation under Leg-A and Leg-D.</li> <li>Wind Zone-4</li> <li>Tower with Pile foundation no. 409/0 (DD+25)</li> <li>HFL had not crossed the design value, still the pile had failed.</li> <li>Reports of pile foundation testing is awaited.</li> </ul>
		<b>Reason Given by Utility :-</b> At the time of construction, tower at location no. 409 was on the right bank of the Koshi river. The pile foundation of the tower got failed due to change in river course towards right bank during recent heavy flood in the river Koshi resulting in bank erosion upto tower location.

Tilt in tower legs causing bending of members

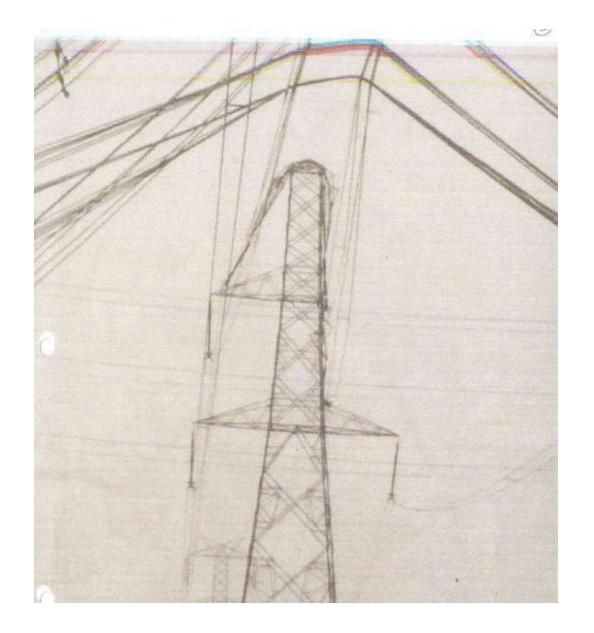
#### Tower at location 217

Date of Failure/ Commissioning		16.04.2019/17.10.2013
No. of Towers failed	Tension tower	0
	Suspension tower	2
	Total	2
Observations		<ul> <li>Conductor Type :- Twin Moose ACSR</li> <li>Insulator type :- "I" Suspension insulator string</li> <li>2 no. of tower partially damaged at the location No. 216 (FD0) and 217 (FD0)</li> <li>Tower located in Wind Zone 2</li> <li>Line designed as per old IS 802 :1977</li> </ul>
		<b>Reason Given by Utility :-</b> On 16.04.2019, five towers of <b>765kV Khandwa-Dhule line of M/s</b> <b>Khrgone transmission Corporation Ltd.</b> collapsed, due to which conductor of this line fall on the crossing position of 400kV TPH-Pithampur DCDS line of MPPTCL which partially damaged the crossing location towers (216(FD0) & 217(FD0)).

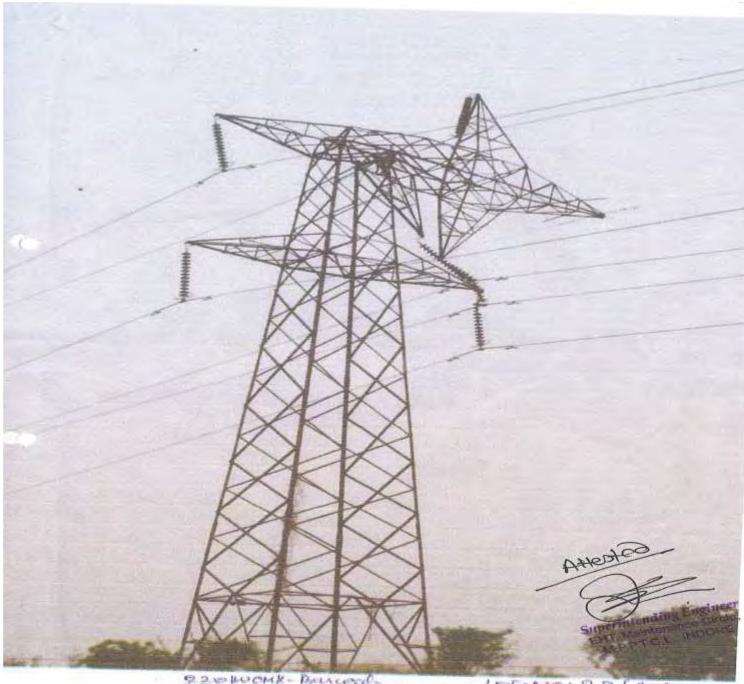
Tower at location 22

Date of Failure/ Commissioning		16.04.2019/19.02.1982
No. of Towers failed	Tension tower	0
	Suspension tower	1
	Total	1
Observations		<ul> <li>Conductor Type :- Zebra ACSR</li> <li>Insulator type :- "I" Suspension insulator string.</li> <li>Designed as per old IS 802 : 1977</li> <li>One tower partially damaged at location no. 22(A0)</li> <li>Located in Wind Zone 2.</li> </ul>
		<b>Reason Given by Utility :-</b> On 16.04.2019, <b>five towers of 765kV Khandwa-Dhule line of M/s</b> <b>Khrgone transmission Corporation Ltd. collapsed</b> , due to which conductor of this line fall on the crossing position of 220kV Omkareshwar Barwaha tap to Nirmani DCDS line of MPPTCL which partially damaged the crossing location towers (22(A0)).

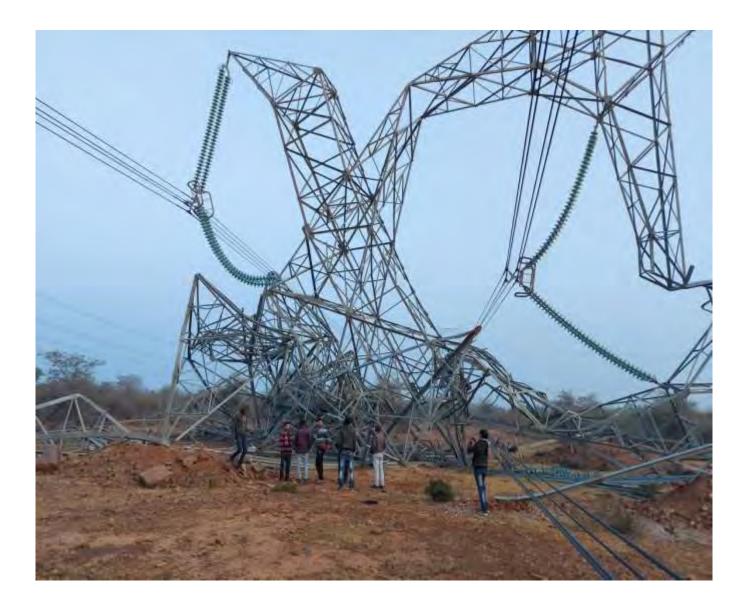
Date of Failure/ Commissioning		05.01.2021/ May 2014
No. of Towers failed	Tension tower	1
	Suspension tower	0
	Total	1
Observations		<ul> <li>Delta Configuration</li> <li>The Tower is designed as per IS 802: 1995 and Wind Zone-4</li> <li>The tower at location no. 611 has collapsed from top of concrete, just above stub level on the ground in the transverse direction.</li> <li>Removed tower member pieces, bolts and nuts were found scattered at the tower collapse site.</li> <li>Cutting of main bracing observed.</li> <li>All the redundant members of bottom section and three main bracing of the adjacent suspension tower at location no. 612 (A type) has also been removed, but the tower is standing.</li> <li>Last patrolling was done on 12.10.2020- No theft observed by utility representatives.</li> </ul>
		Reason Given by Utility :- Theft/ Sabotage of Tower members

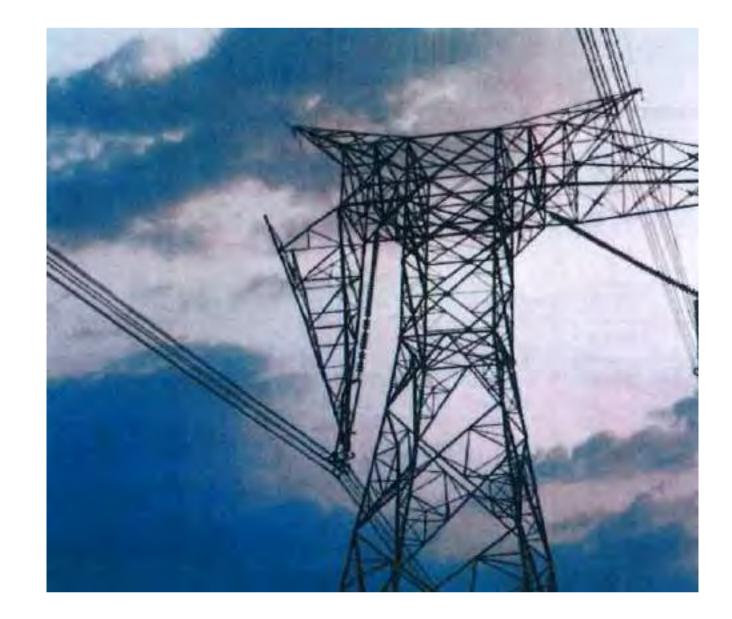
Date of Failure/ Commissioning		10.05.2021/ Nov 2015
No. of Towers failed	Tension tower	0
	Suspension tower	1
	Total	1
Total Observations		<ul> <li>Cross Arm of Pole-II at location no. 3118 was found damaged</li> <li>Hexa ACSR Lapwing Conductor</li> <li>Line is designed as per IS 802:1995 and Wind Zone-4</li> <li>Tower is designed with Y string having Glass insulator.</li> <li>Last failure inline on 2.05.2018 (Agra Region) at location no. 4328,4347,4348 (DD+25)</li> </ul>
		Reason Given by Utility :- High Speed Thunderstorm

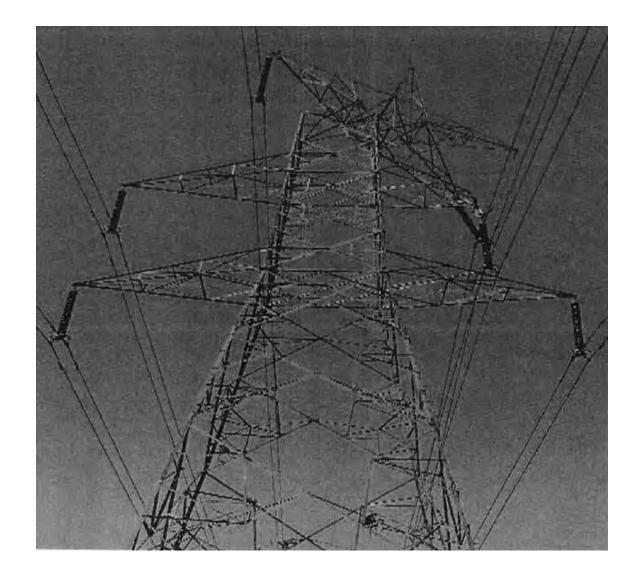
Date of Failure/ Commissioning		11.05.2021/01.07.2011
No. of Towers failed	Tension tower	0
	Suspension tower	1
	Total	1
Total Observations		<ul> <li>ACSR Moose Conductor</li> <li>Line is designed as per IS 802: 1995 and Wind Zone-2</li> <li>The 'DA' type towers of this line were designed with Single "I" porcelain insulator string.</li> <li>At location no. 303 (DA+0) both of top cross arms and one middle cross arm of the tower got damaged</li> <li>At location no. 302 (DA+0) insulator de-capping occurred in top phase.</li> </ul>
		Reason Given by Utility :- Due to lightining decapping of insulator at location no. 302. high speed wind coupled with sudden jerk due to decapping resulted in failure of cross arms.

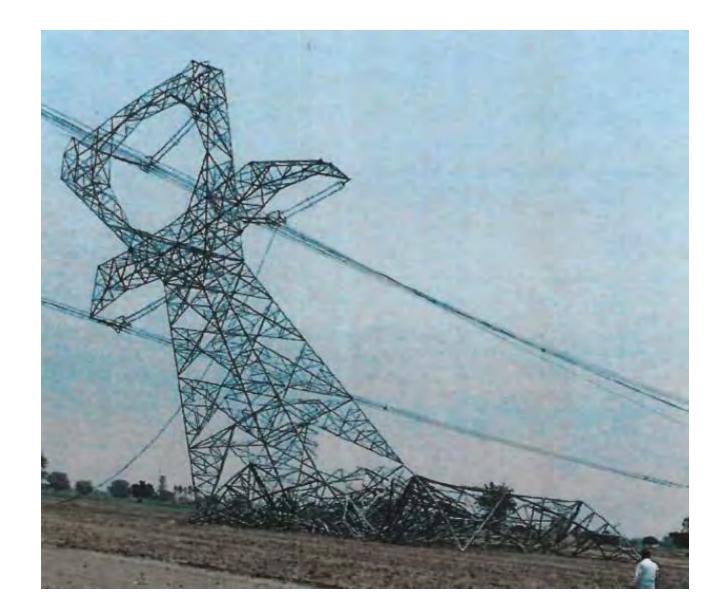
Date of Failure/ Commissioning		12.06.2021/ 01.06.2012
No. of Towers failed	Tension tower	3
	Suspension tower	
	Total	3
Observations		<ul> <li>Line is designed as per IS:802 1995 and Wind Zone 4</li> <li>Quad ACSR Bermisis Conductor</li> <li>Delta Configuration</li> <li>Type B Tower is designed with Double V-V-V insulator string</li> <li>One tower at location no. 293 (B +25) has collapsed</li> <li>Earth peaks of adjacent towers at location no. 292 and 294 has damaged</li> </ul>
		Reason Given by Utility :- Highly Localized Windstorm with high speed wind

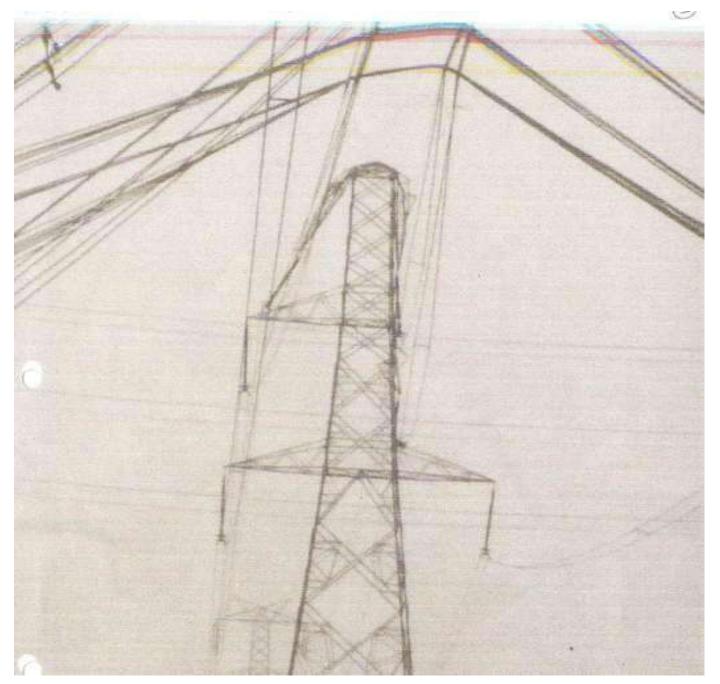
- > Date of Failure: 16/04/2019, Commissioning: 2013
- Line designed as per IS 802:1977, Wind Zone Medium.
- Conductor: Twin Moose, Insulator: I String
- Number of Tower collapsed: 2 numbers Suspension Towers.
- Reason of Failure: Collapse of 765kV Khandwa Dhule Transmission line of M/s Khargone Transmission Corporation Limited.
- Excessive loading on our Transmission Line resulting into partial damage of tower.

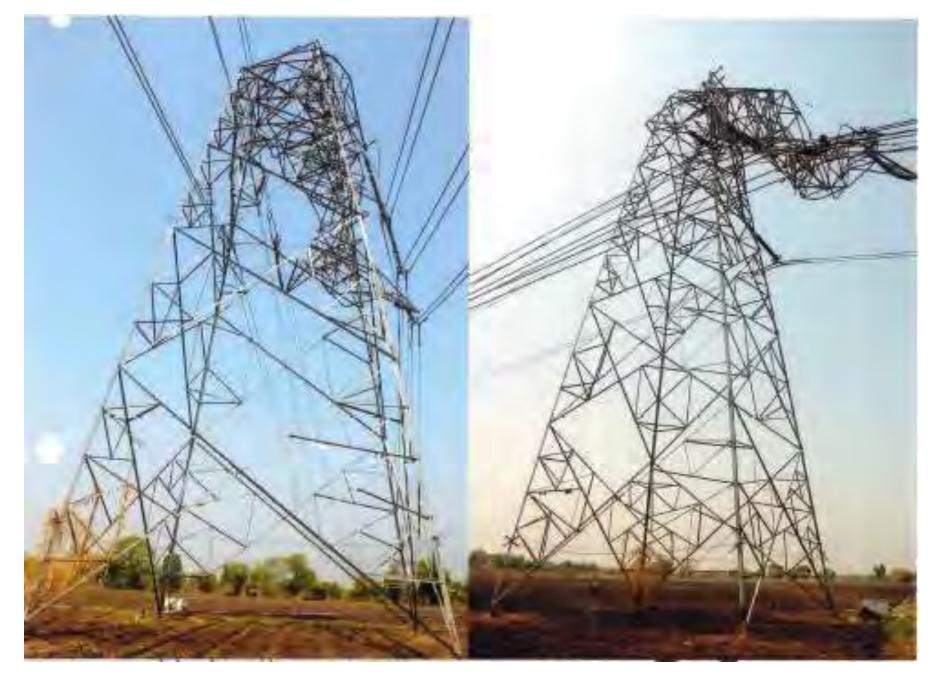
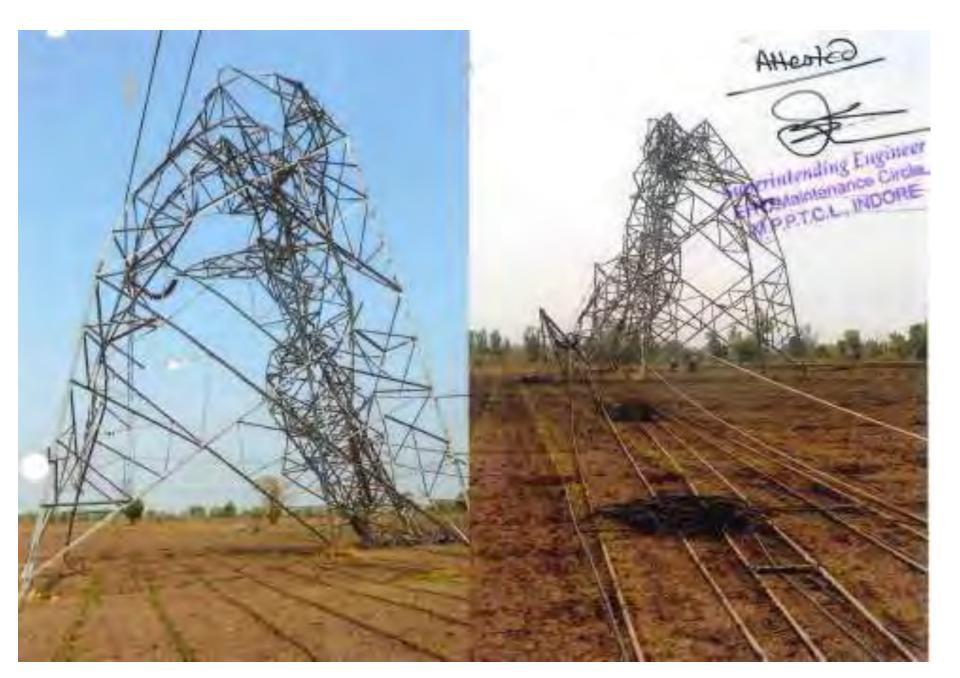
- Our Team of Experts along with Design Expert visited to investigate the cause of failure of structures.
- The committee opined that structure failure was due to heavy cyclonic circulation in the area.
- The wind data of the local area also indicates strong wind presence.
- We have taken up the matter with Designer for strengthening the design as per IS 802: 1995
- Accordingly the strengthening of tower has been designed by our designer.
- MPPTCL will take up the strengthening work of all suspension towers of this design in a phased manner.

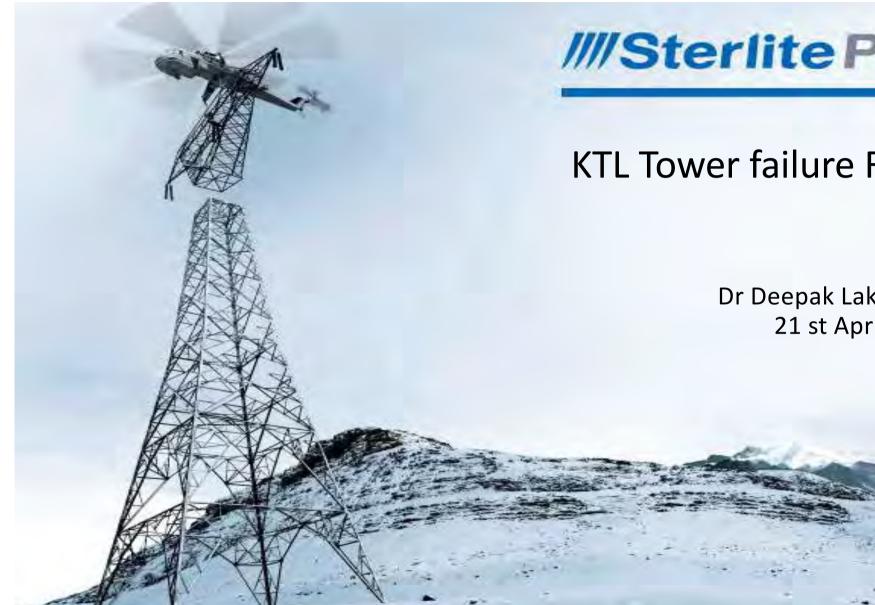
- 1) Exceptionally high wind condition prevailed for some time in the area on the day of failure of tower.
- 2) All suspension towers collapsed due to cascading
- 3) All plain area for long distance
- 4) Tower collapse in perpendicular direction pulling down balance towers
