Report of First Pilot audit of Transmission Tower by the audit team of the committee constituted for audit of transmission towers with respect to design and the life of the towers (on a 5% sampling basis).

Observations and Measurements of Transmission towers audited on 9th-10th January 2018

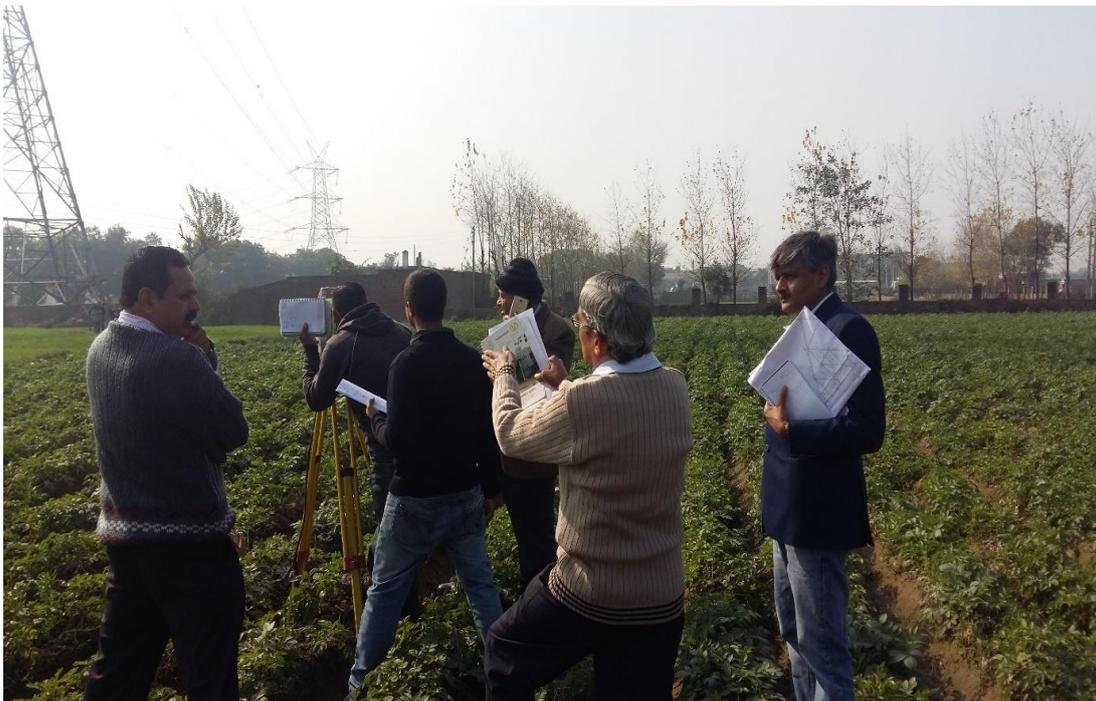
Fig. 1.1. Measurement of verticality using Total Station

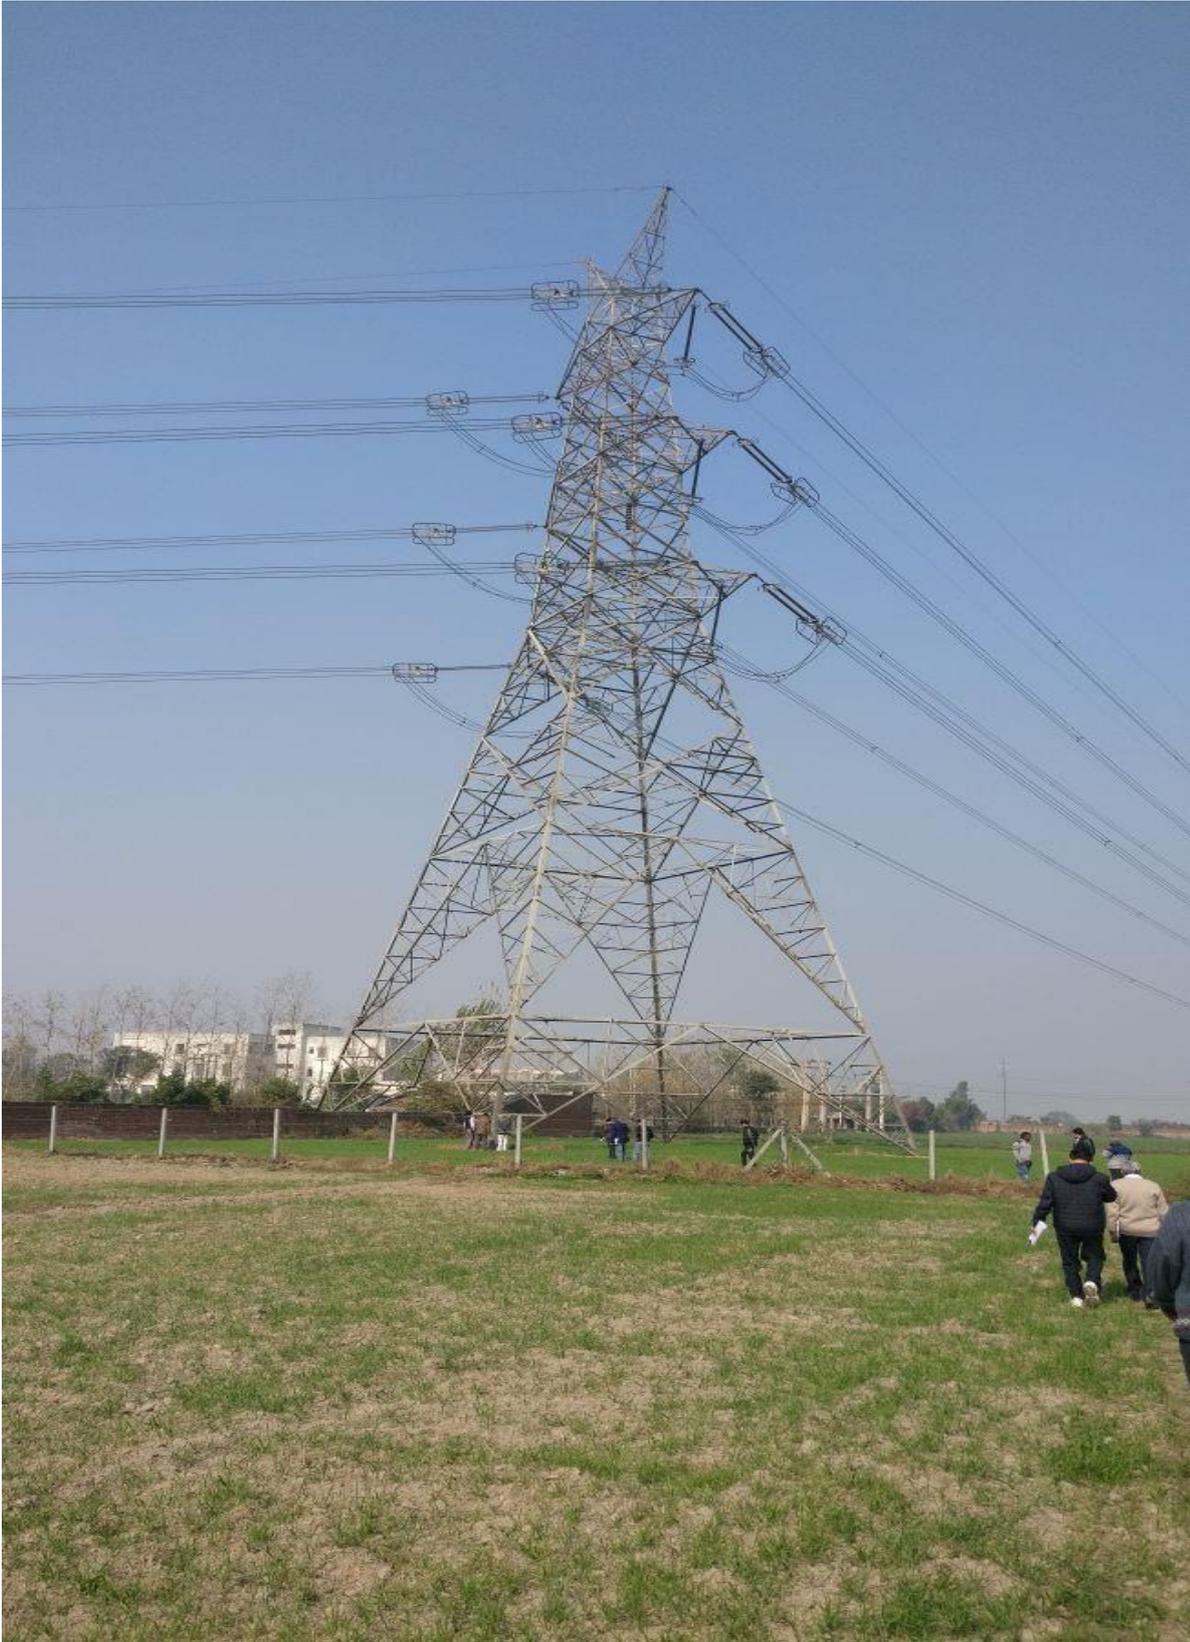
Fig. 1.2. Larger view of the tower for inspecting verticality

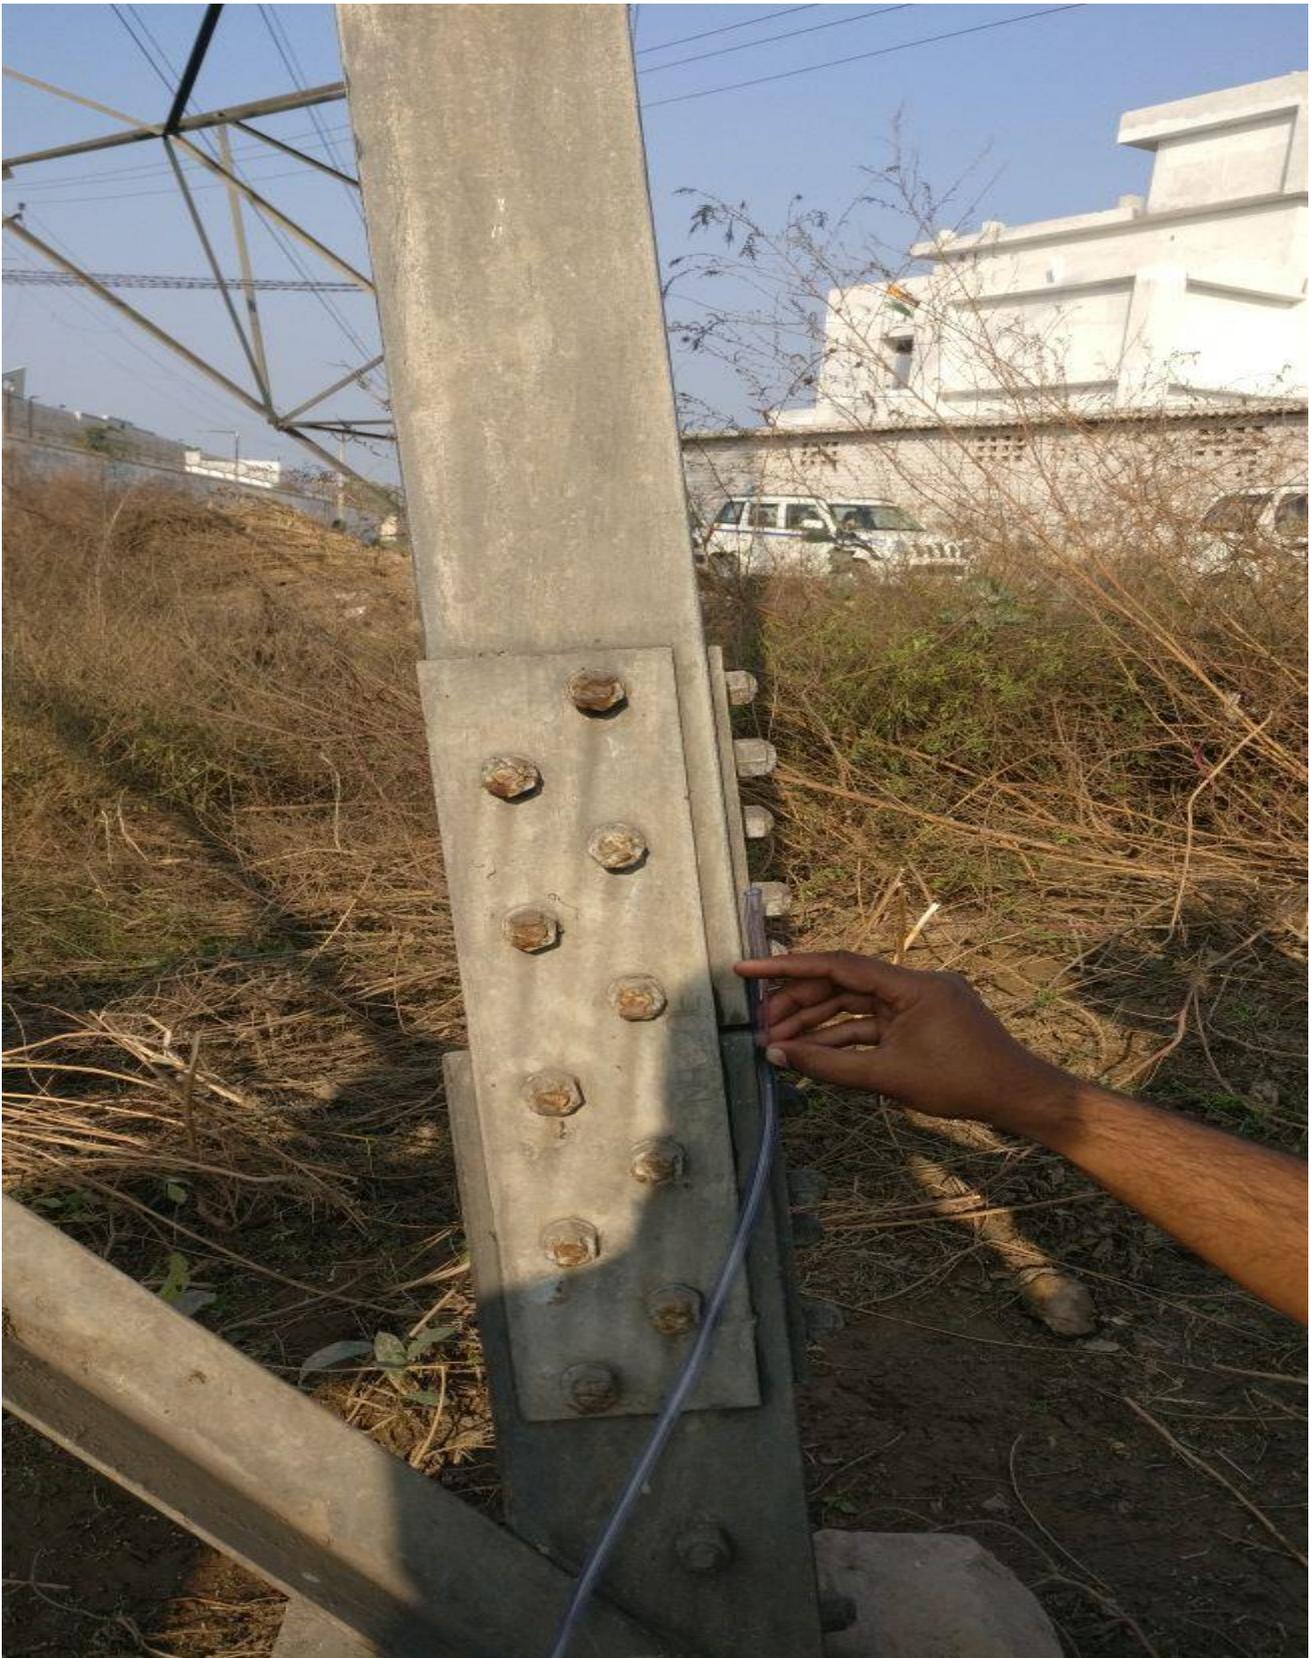
Fig. 2.1. Measurement of differential settlement of tower

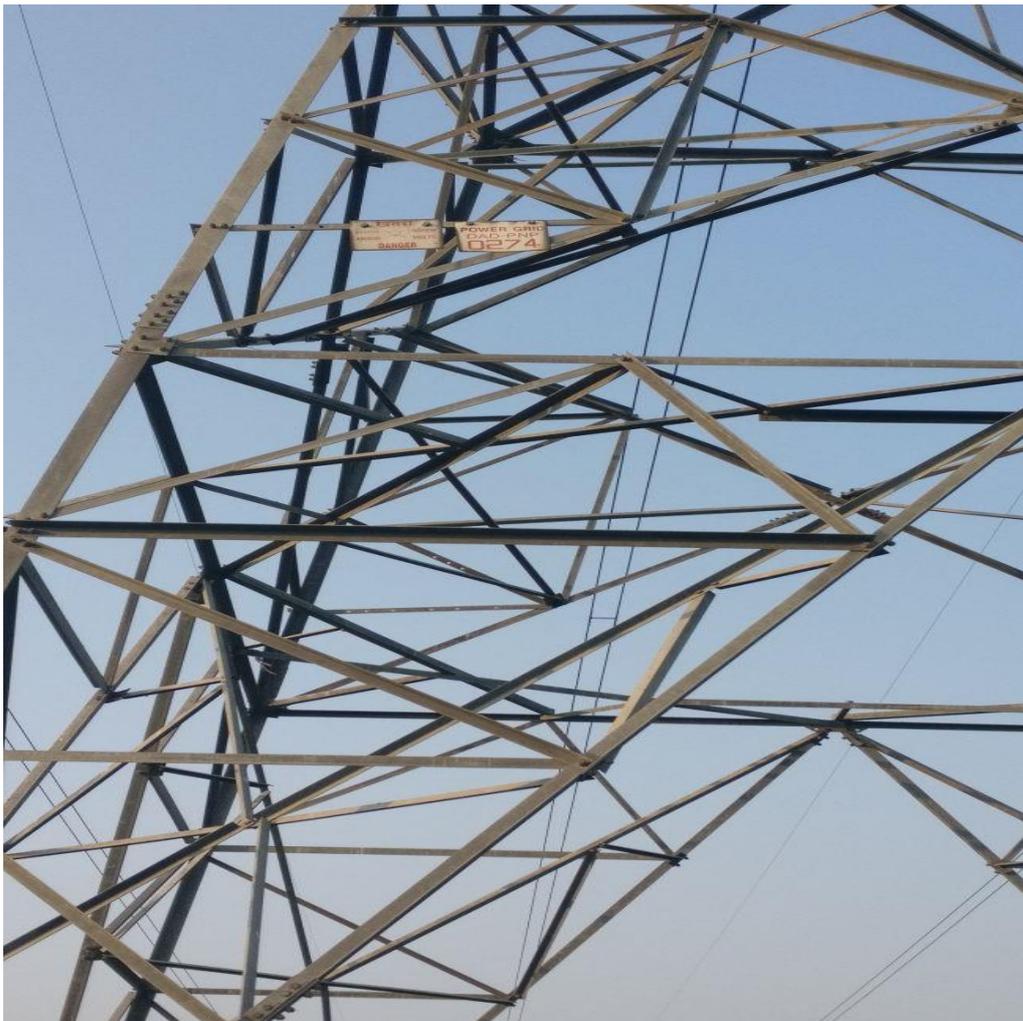
Fig. 3.1. Visual inspection of towers by binoculars

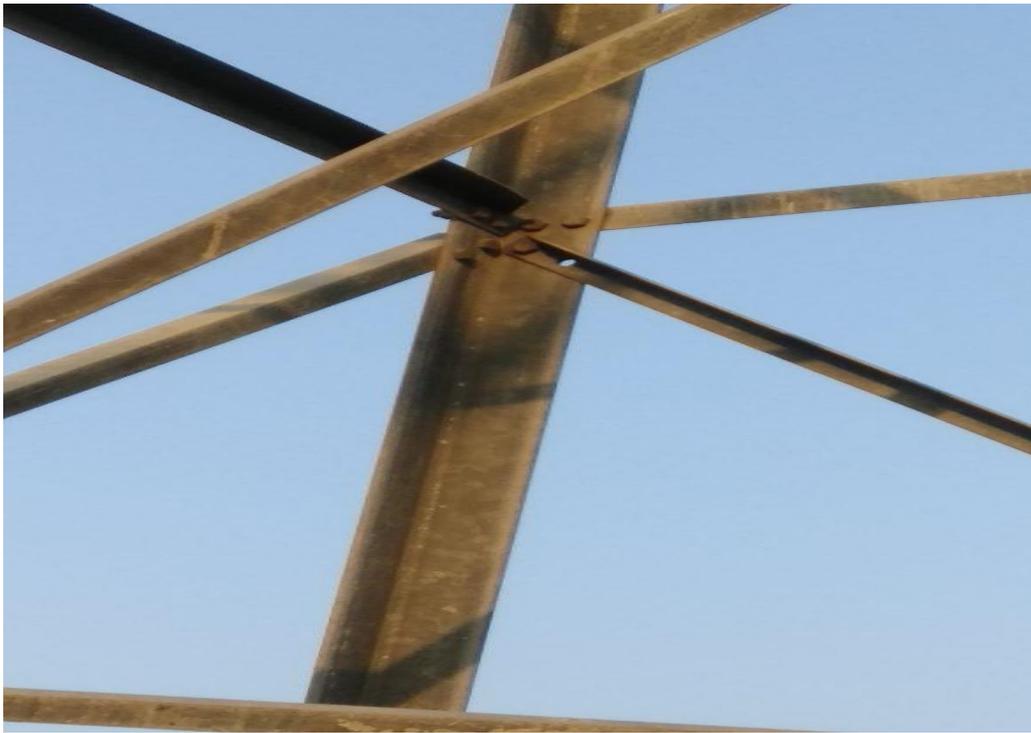
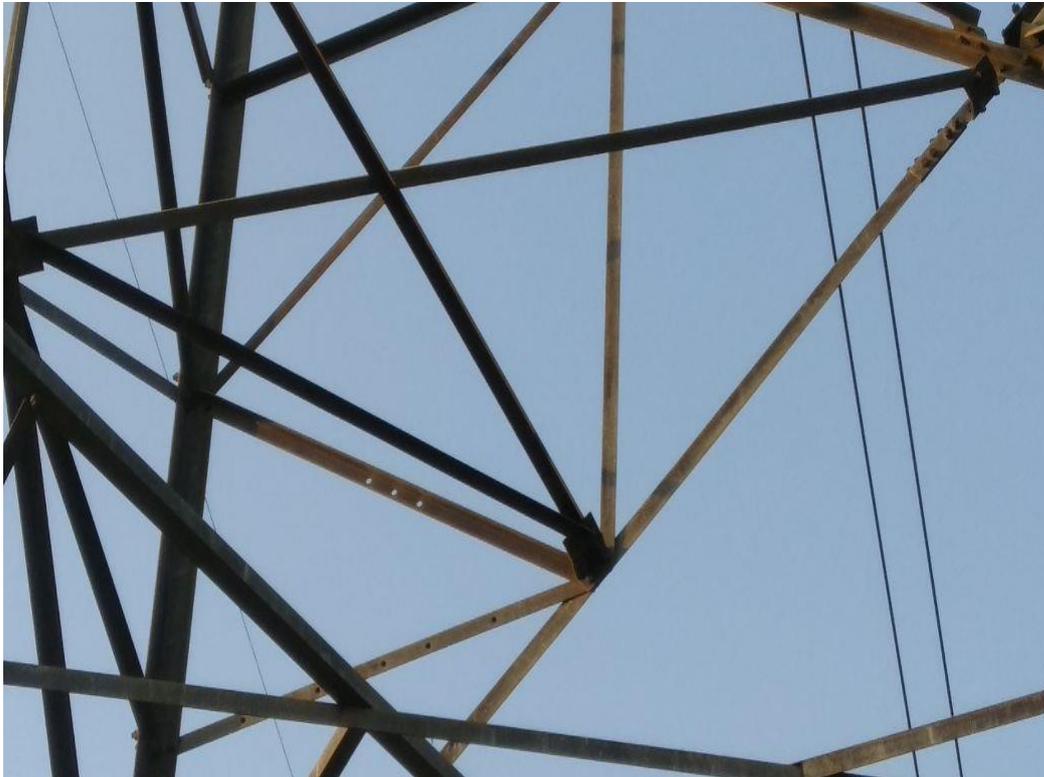
Fig. 3.2. Unplugged holes observed at Dadri Panipat Line (tower No. 274 A)

Fig. 3.3. Unplugged holes observed at Dadri Panipat Line (tower No. 274 A)

No damage to the tower was found. No bending/buckling was found. No members on the tower was found missing. No bolts on the tower was found missing. Leg slope of towers was aligned. Unplugged holes were found in the members of tower.

be avoided if the foundations of a given tower location is not designed for wet condition, partially/fully submerged condition. Powergrid should take notice of the differential settlement and should take necessary measure. Unplugged holes should be closed with suitable nut and bolt arrangement.

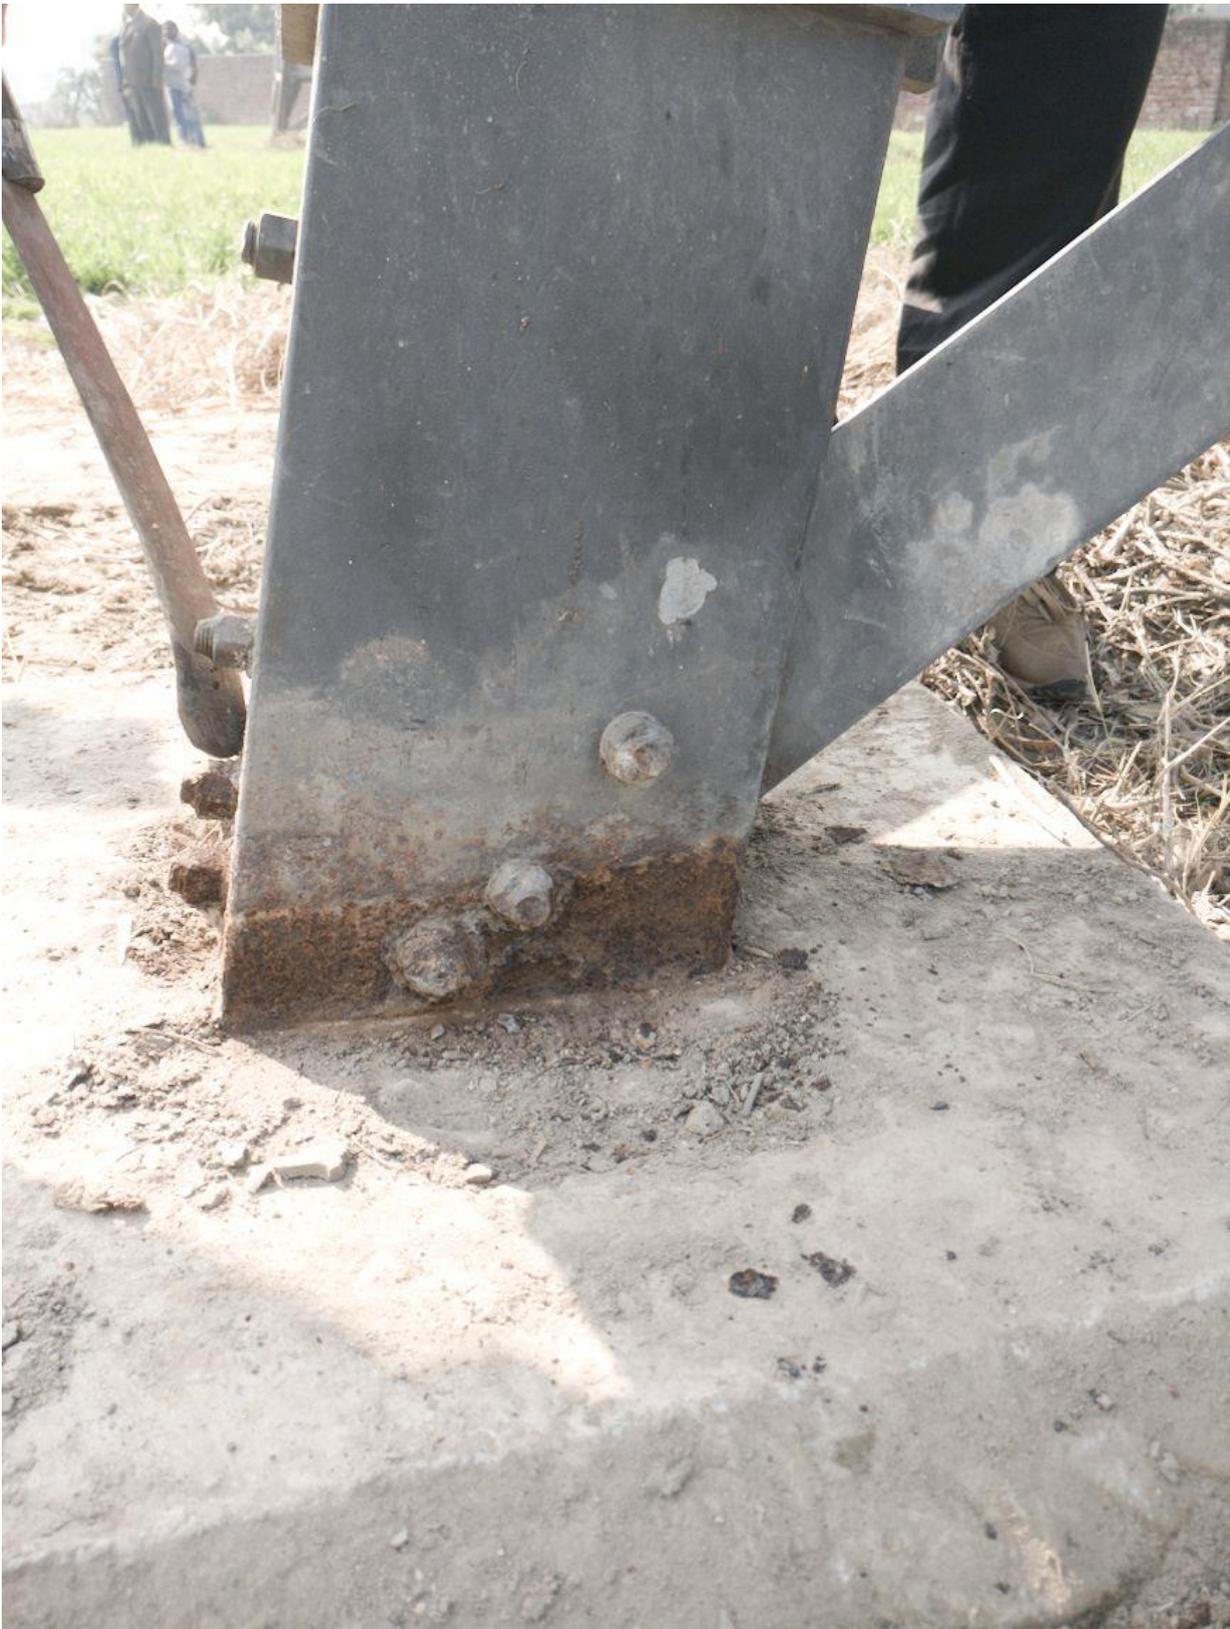
Fig. 6.1. Corroded leg of tower

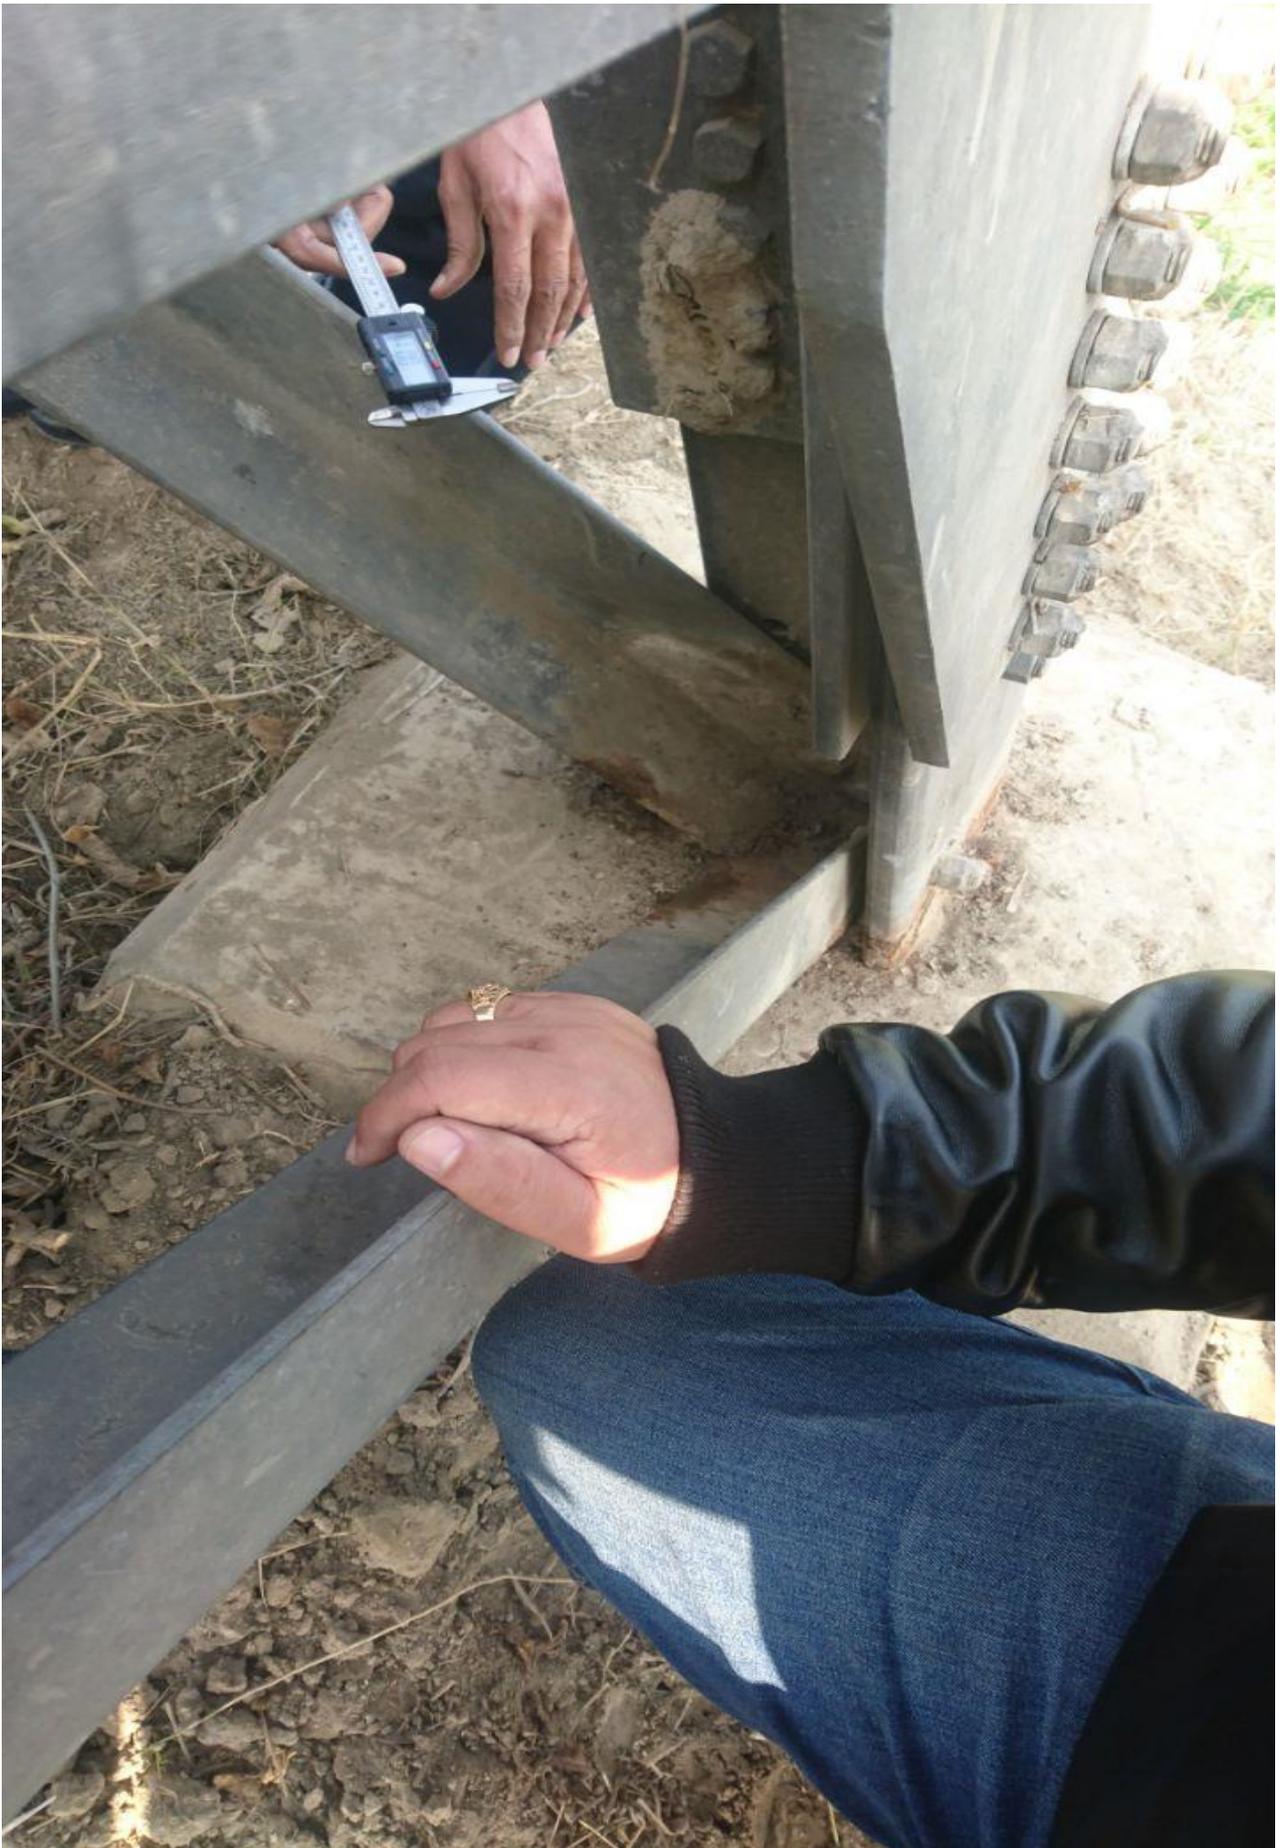
Fig. 6.2. Corroded member of tower
