Preliminary Site Inspection Report of Tower location nos. 282, 286 & 290 of 400 kV D/C Twin Moose Sambha – Amargarh Transmission Line of NRSS XXIX Transmission Limited ('NTL') in Rajouri district of Jammu on 17.11.2021

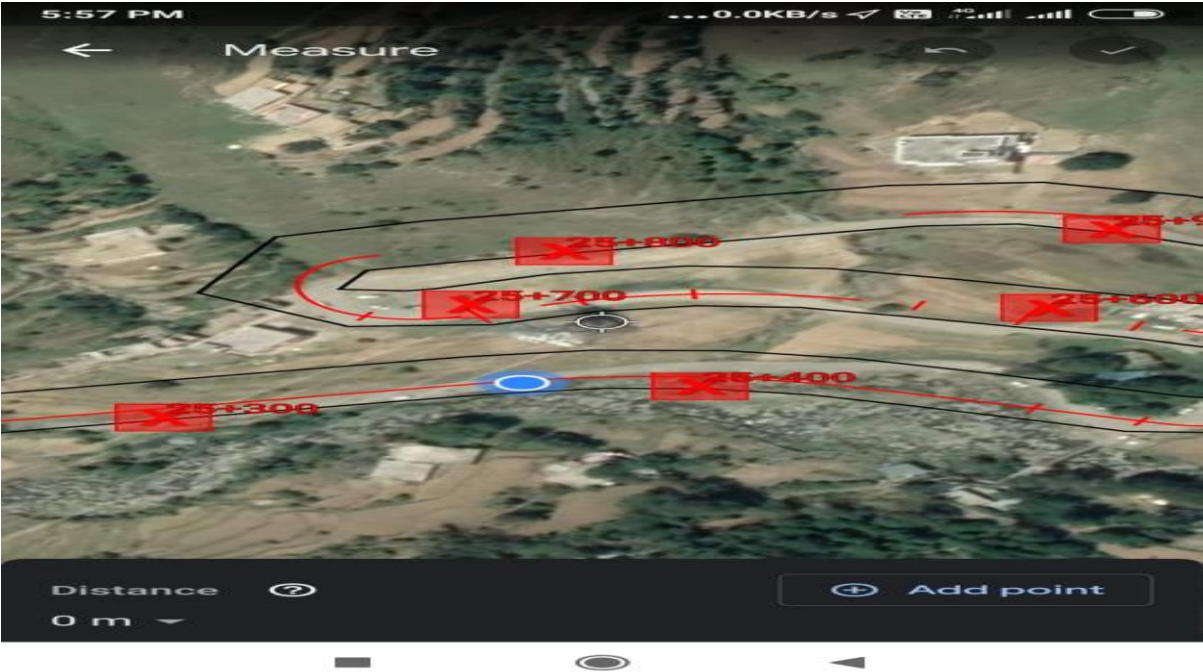
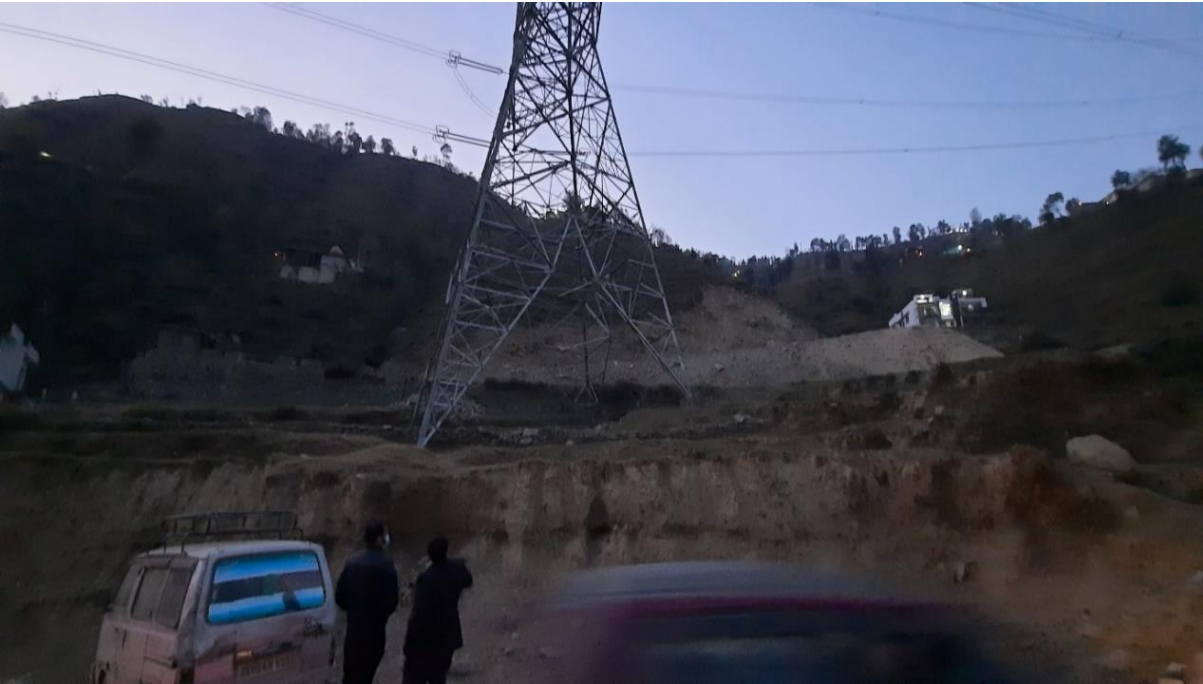
The tower is located near the river with very few trees in the vicinity (as shown in Fig. 1 & 1.a). There is no damage to the tower till now. All stubs and chimney were intact. Some excavation work has been done near the tower by the BRO. Since the slope at which the tower is located is not too steep, the tower foundation is at less risk to get damaged. However, since tower is very near to the road side, any further excavation may lead to exposure of its foundation and hence retaining wall, if required, may be provided to avoid soil erosion.

3. NTL and BRO jointly required to take suitable measures at the earliest to avoid further possible damages on the critical location no. 286.
4. At Tower location 282, some excavation work has been done, there is no damage to the tower. However, since tower is very near to the road side, any further excavation may lead to exposure of its foundation and hence retaining wall, if required, may be provided to avoid soil erosion.

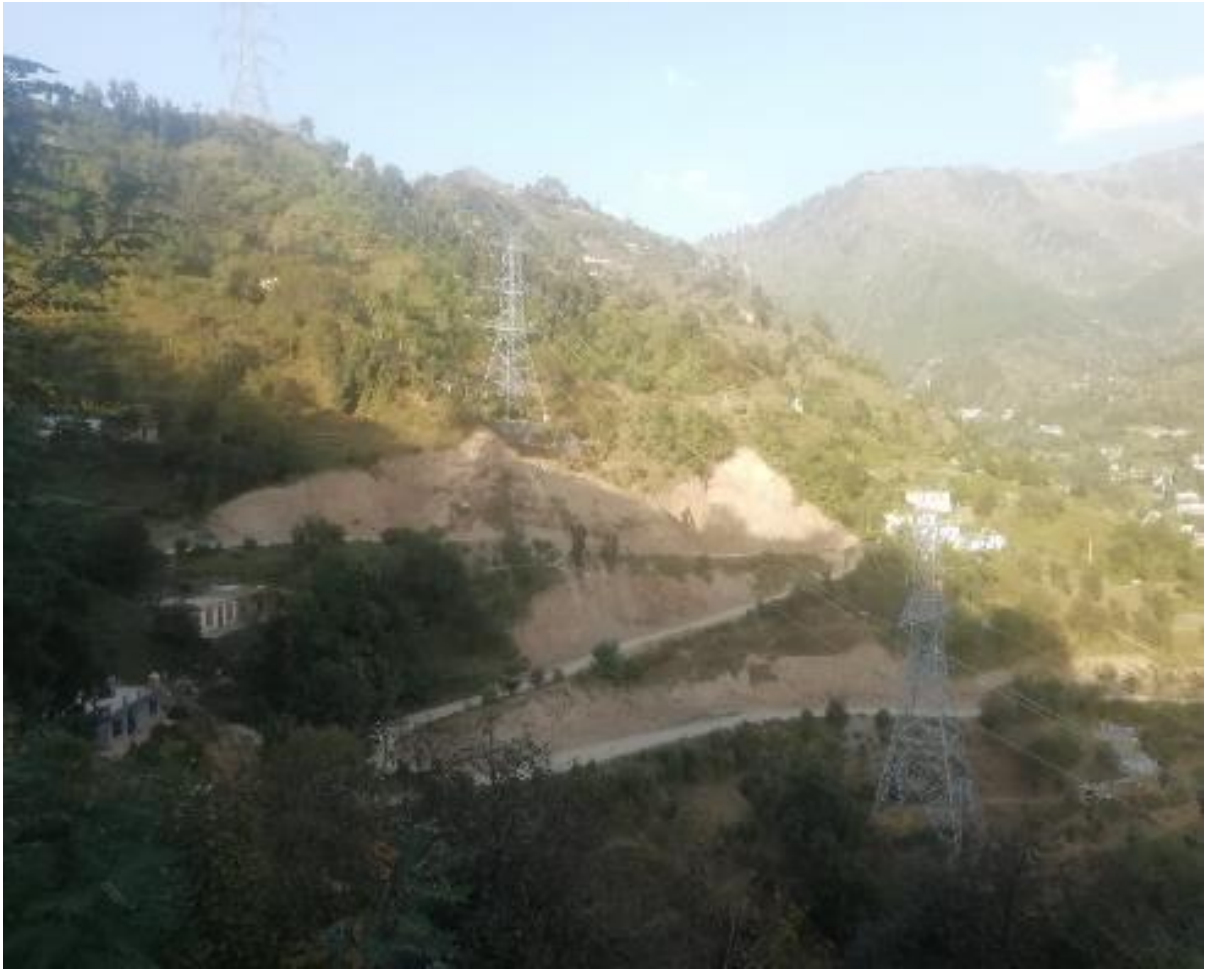
Fig 3

The tower is located in the upper side of the road about 20-25 feet away from outer side of the present road with very few trees in the vicinity (as shown in Fig. 3). The distance of tower from the RoW of the road, once it is widened, will become about 10 feet. The tower is located on the hilly slope (Fig 4, 5) which is very unstable and there is risk of soil erosion. Cracks have developed on the retaining wall and nearby house also. Prima facie on visiting the tower location it appears that the soil mass is unstable which has potential of sliding the tower foundation. Therefore, this location needs construction of retaining wall at the location of the soil cut. Further, at this location, in the surrounding soil, severe cracks have also developed. Any ingress of water through these cracks will further worsen the problem of sliding of soil mass. The treatment of these cracks seems to be of importance and needs to be taken care diligently. Geotechnical investigation to the hill strata is required to formulate the mitigation measures to protect the tower during road widening work.

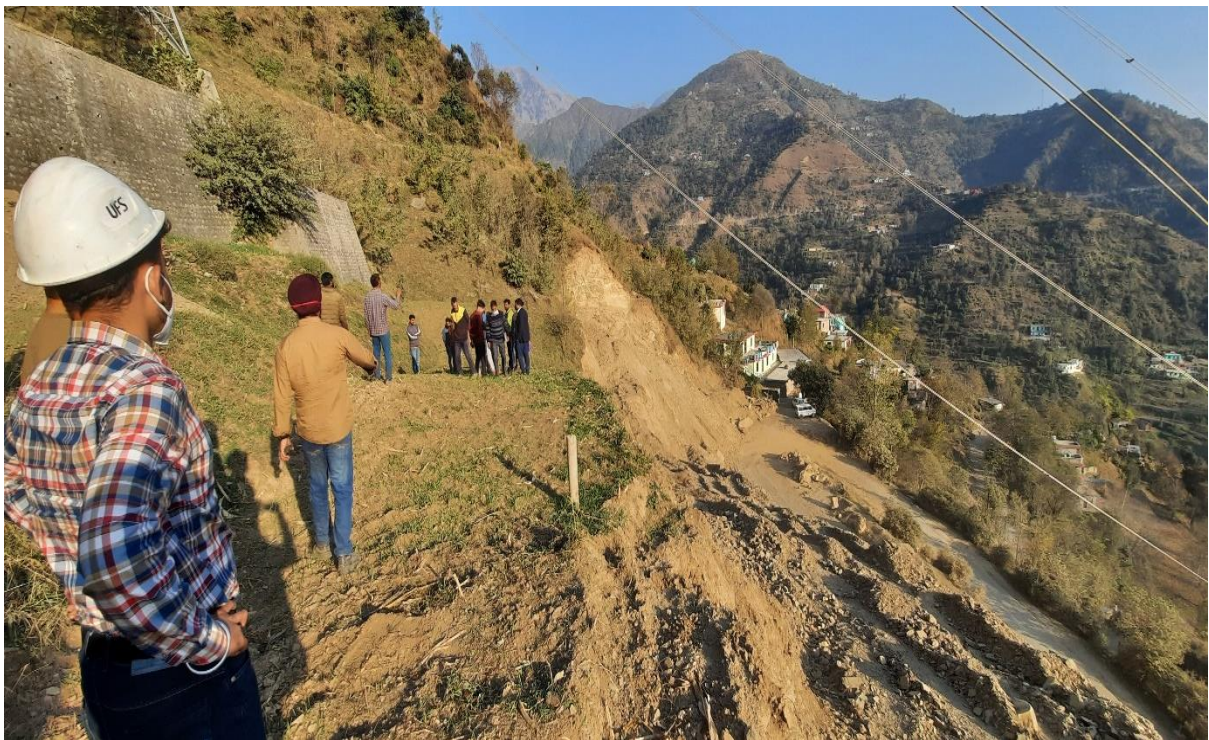
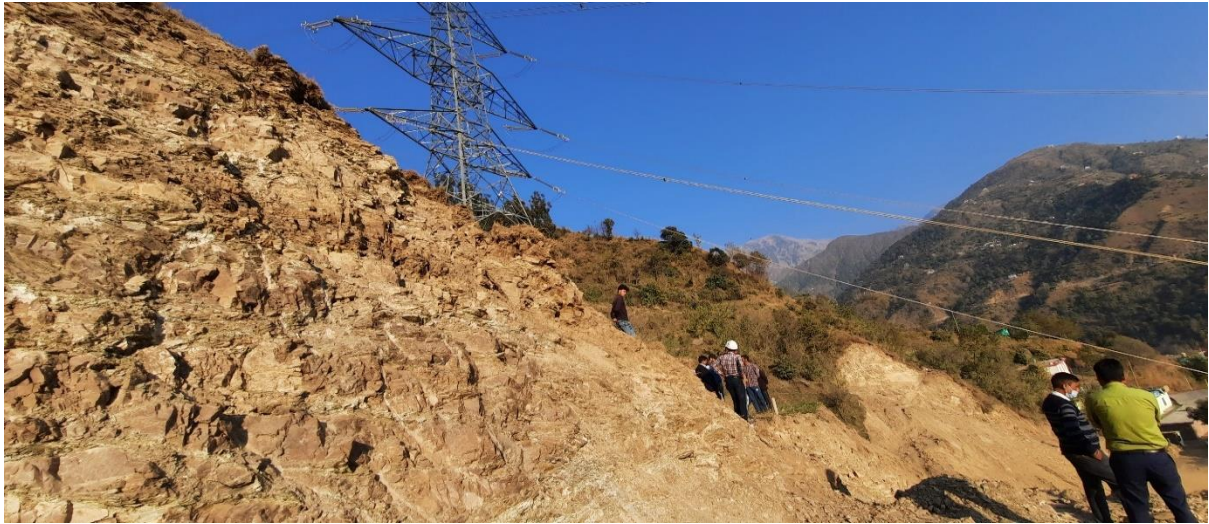
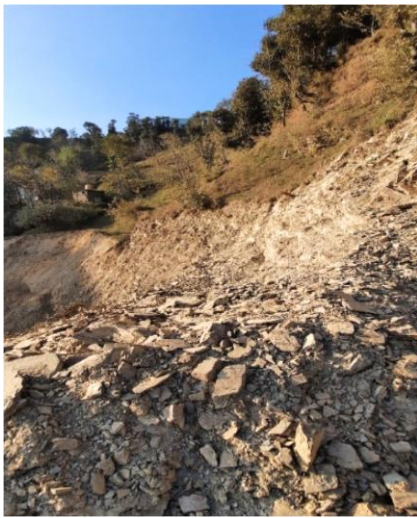
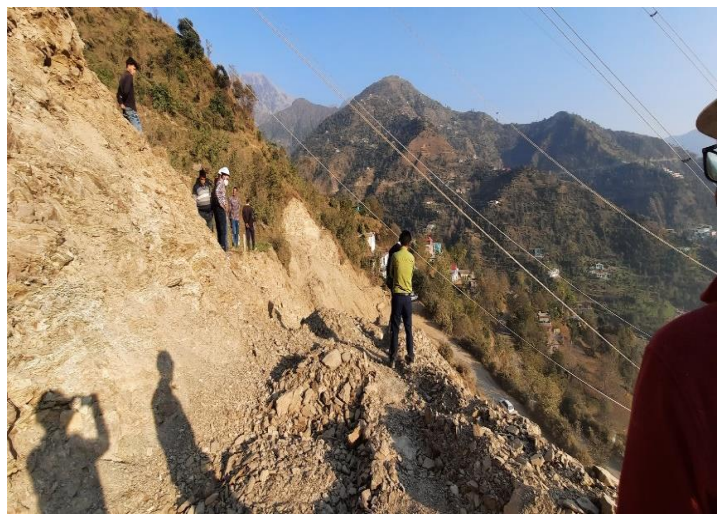
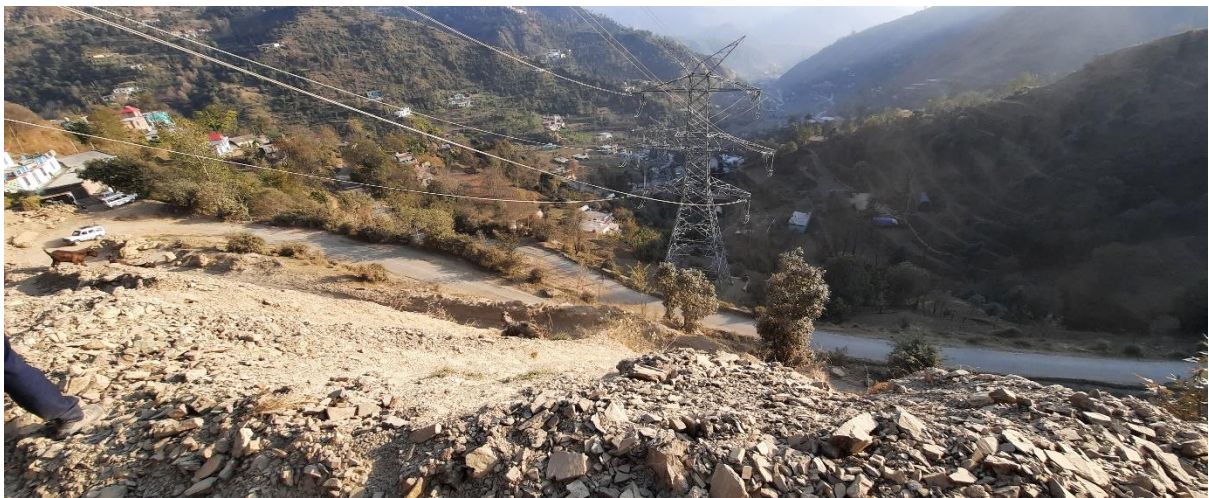
The excavation work was done in the downward side of the tower by the BRO for widening the road. (Fig 6-10)

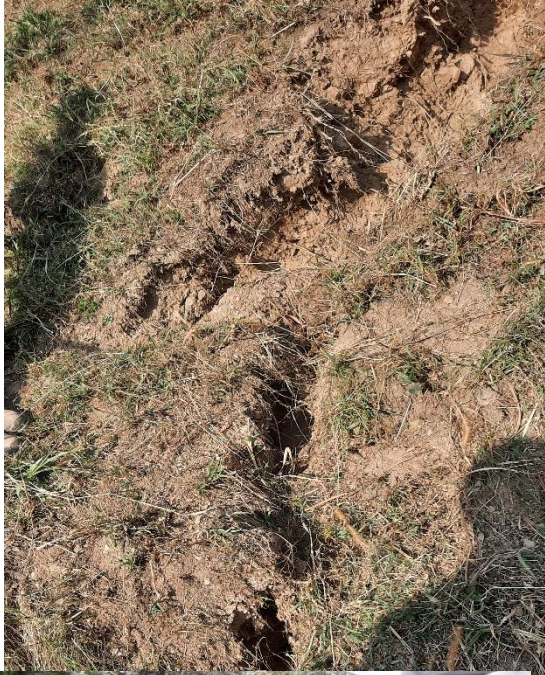
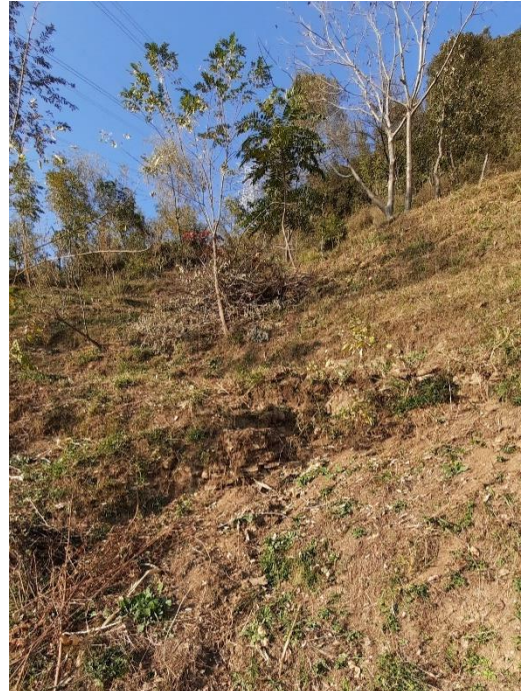
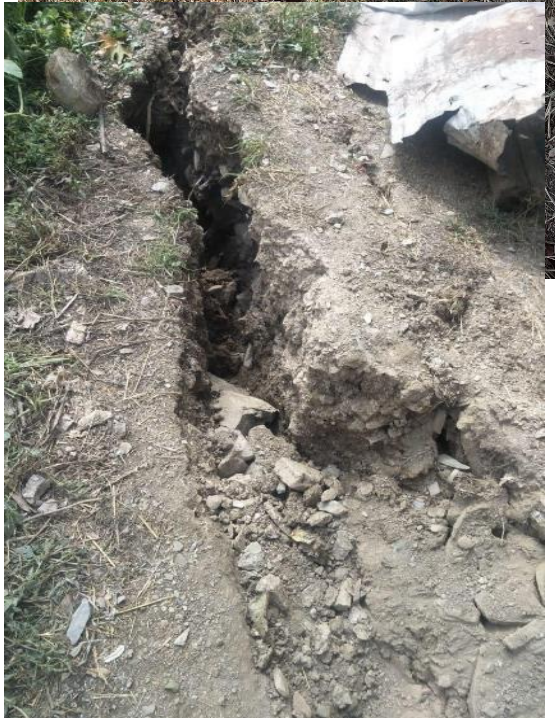
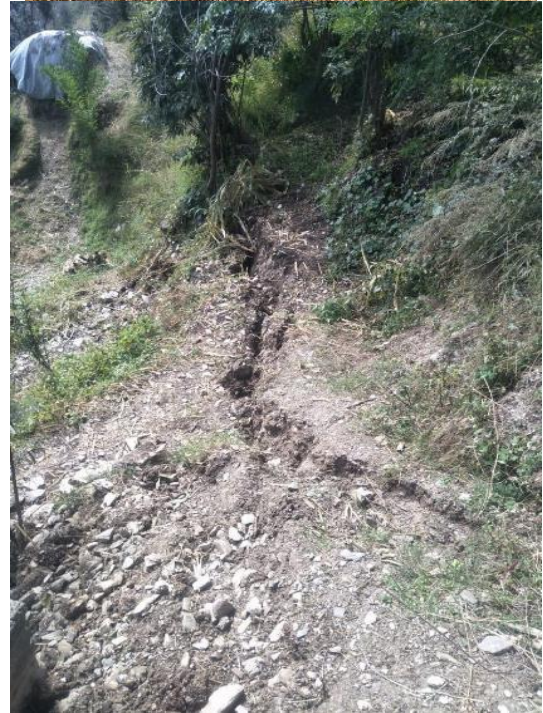
Figure 11-14 shows cracks on the mountain slope. It was observed that leg C of the tower had bent just above the stub and all the other legs were found to be normal.

1. At Tower location no. 286, excavation work has been done by BRO upto about 20-25 feet from tower. There are many cracks on the slope of the hill near the tower location. Any ingress of water through these cracks will further worsen the problem of sliding of

soil mass. The treatment of these cracks seems to be of importance and needs to be taken care diligently.

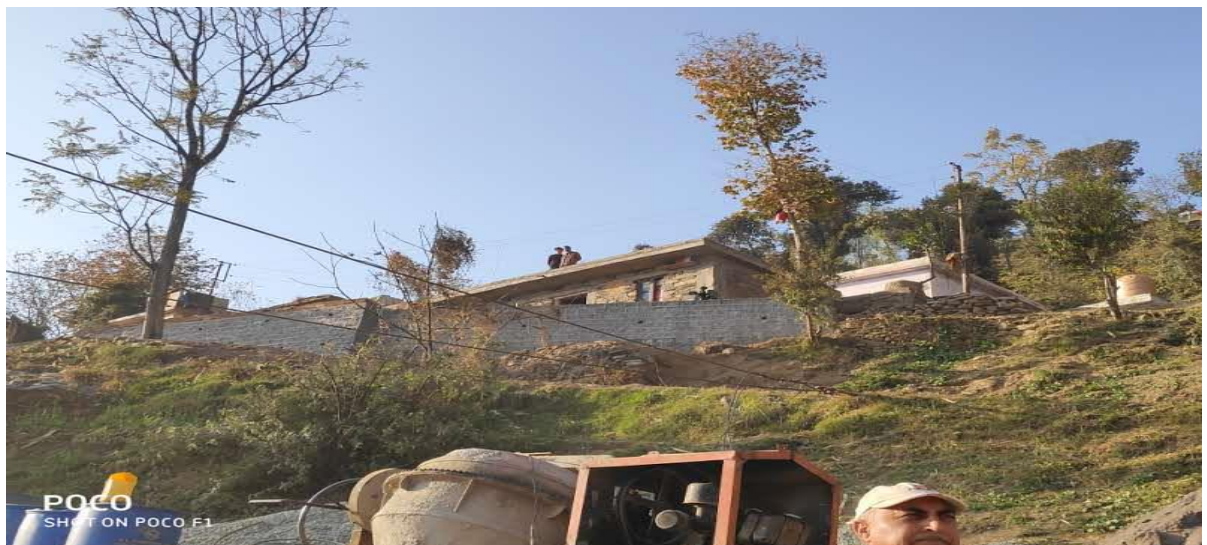
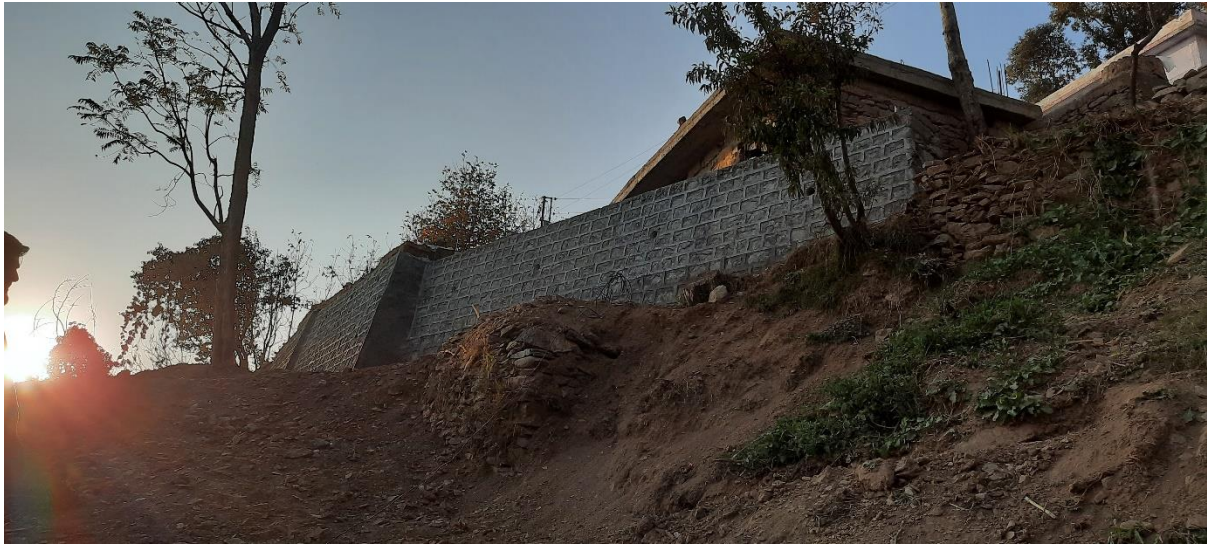
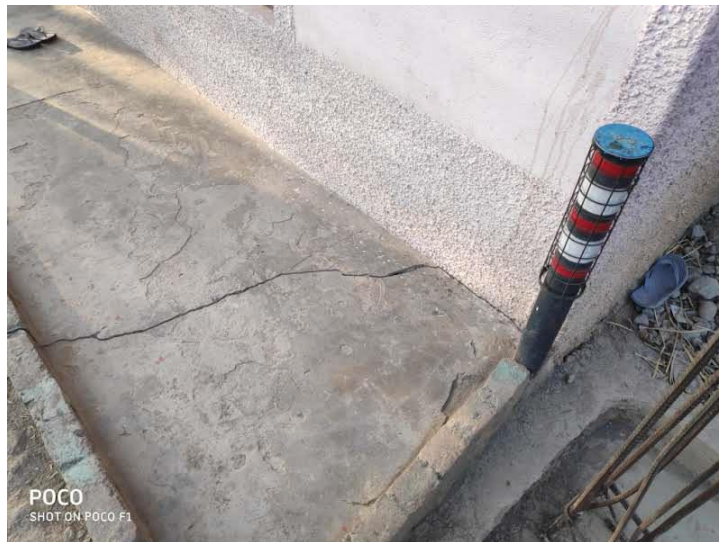
It has been seen that there are many cracks on the slope of the hill near the tower location. There has been crack on the wall and floor of the house located above the transmission tower. (Figure 24-26)

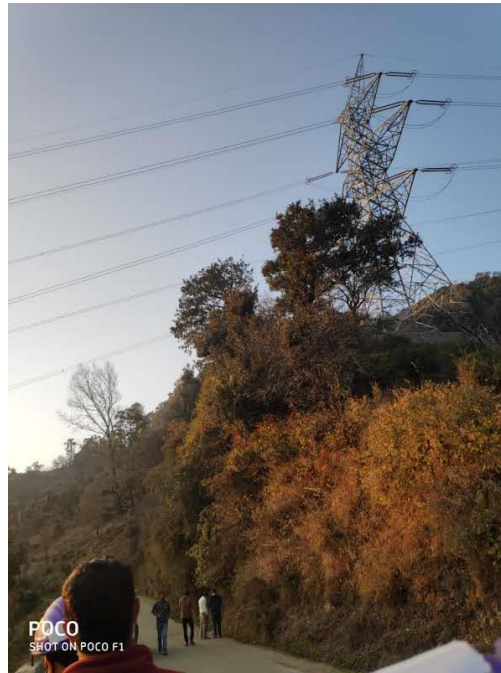
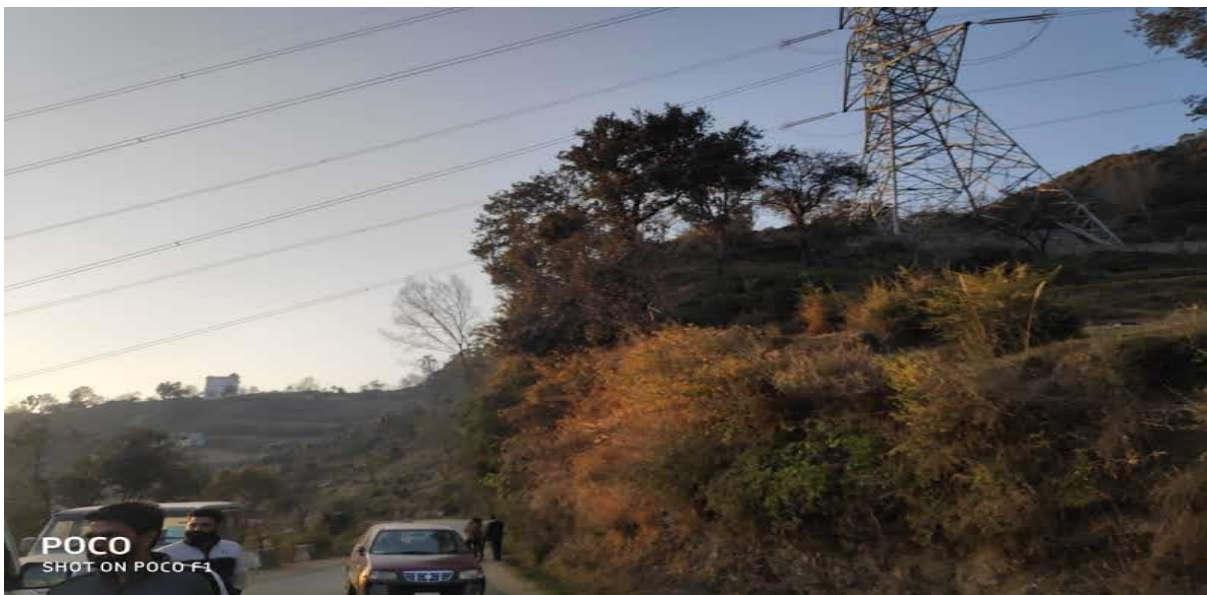
The tower is located on a steep hilly slope and very near to the road as shown in figure 27 and 28. It has been noticed that BRO has not started excavation work for widening of the road near this tower location. The tower is at high risk of collapsing when the excavation work will start. It is falling in the RoW of the proposed widened road. Proper steps are required to protect the hill slope before starting the excavation work.

5. At Tower Location 290, BRO has not started the construction of the road. The tower is very near to road and is located at a height. There is threat of tower collapsing if the excavation work is done near to subject tower location.

6. Joint action plan shall be prepared by the NTL and BRO as soon as possible and suitable measures shall be ensured before widening of the road to avoid damages to transmission towers.
