## REPORT OF STANDING COMMITTEE OF EXPERTS ON FAILURE OF 220 kV & ABOVE VOLTAGE CLASS SUBSTATION EQUIPMENT (JANUARY 2017-MARCH 2018)

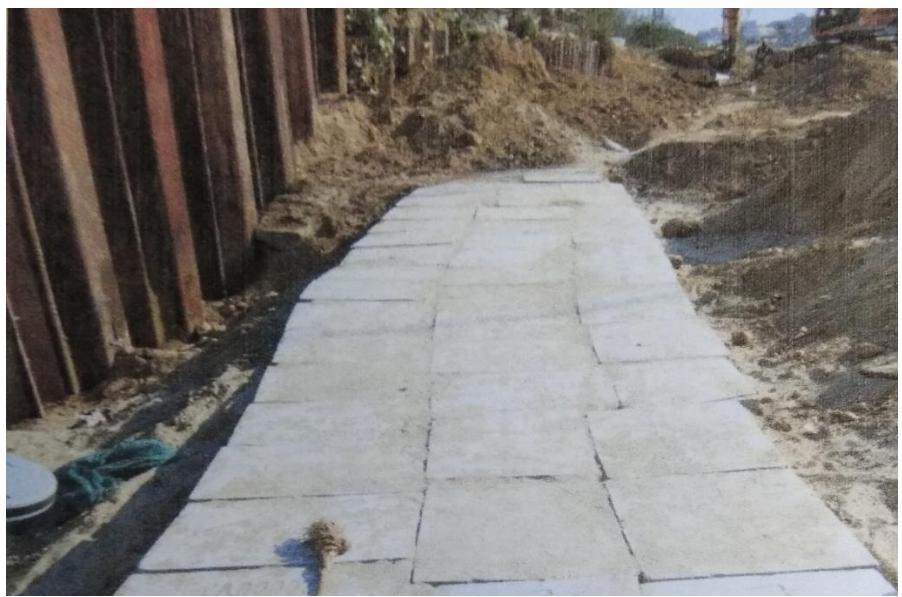
Exhibit-I

It was informed that both the circuits were covered with sand and concrete slab before fault (Exhibit-I). Soil was excavated to find faulty cable and all three single core XLPE cables of Maharani Bagh-Electric Lane circuit-I were exposed.

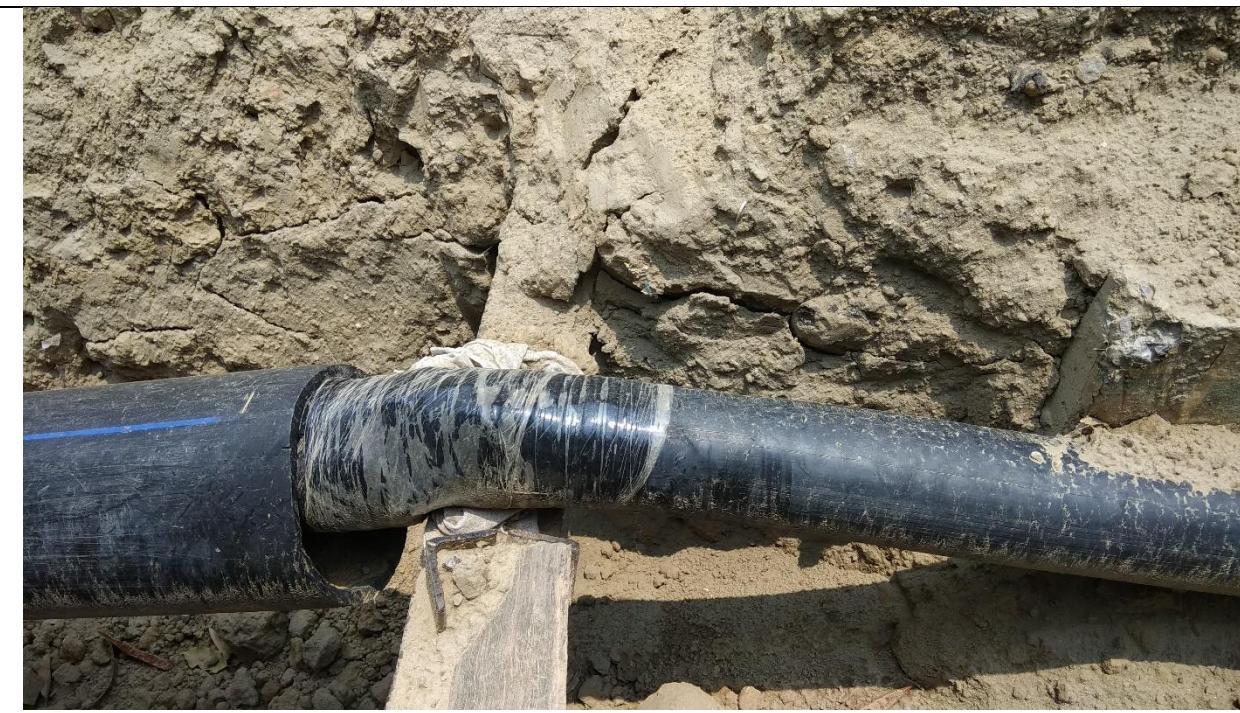
Exhibit-II

B-phase cable was found to be faulty and concerned part of the cable was found to be wrapped to prevent entry of water into the cable (Exhibit-II).

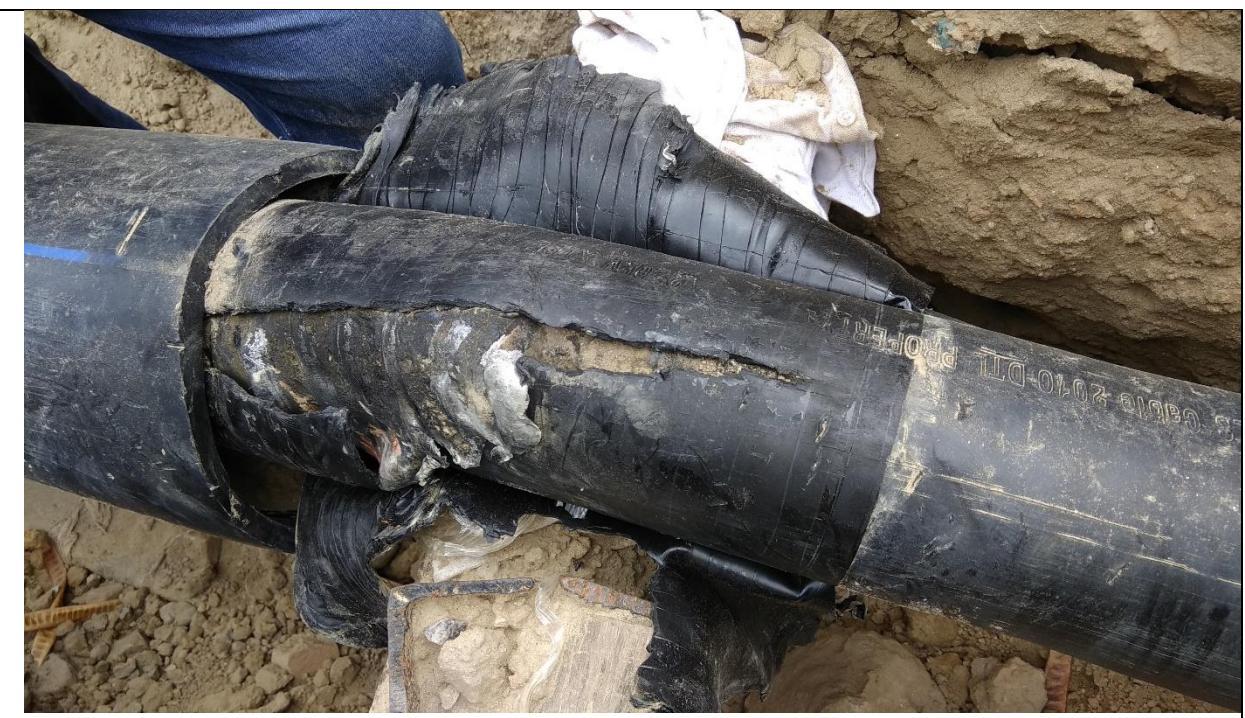
Exhibit-III

After removing wrapping it was observed that outer jacket of the cable was damaged and corrugated metallic sheath of aluminium had melted due to heat generated during fault (Exhibit-III).

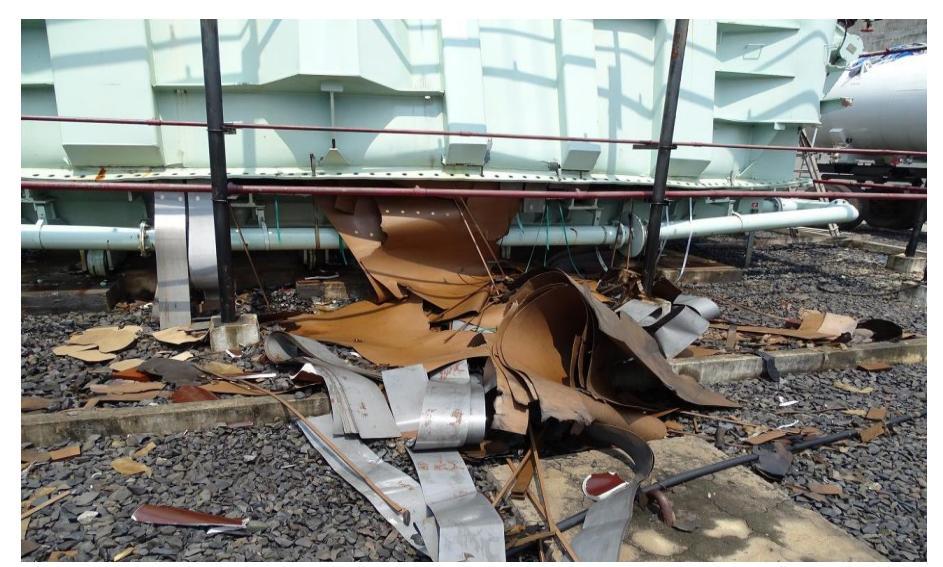
Main tank bell joint 72 bolts gave away and bell joint (400 kV) opened due to the energy of fault

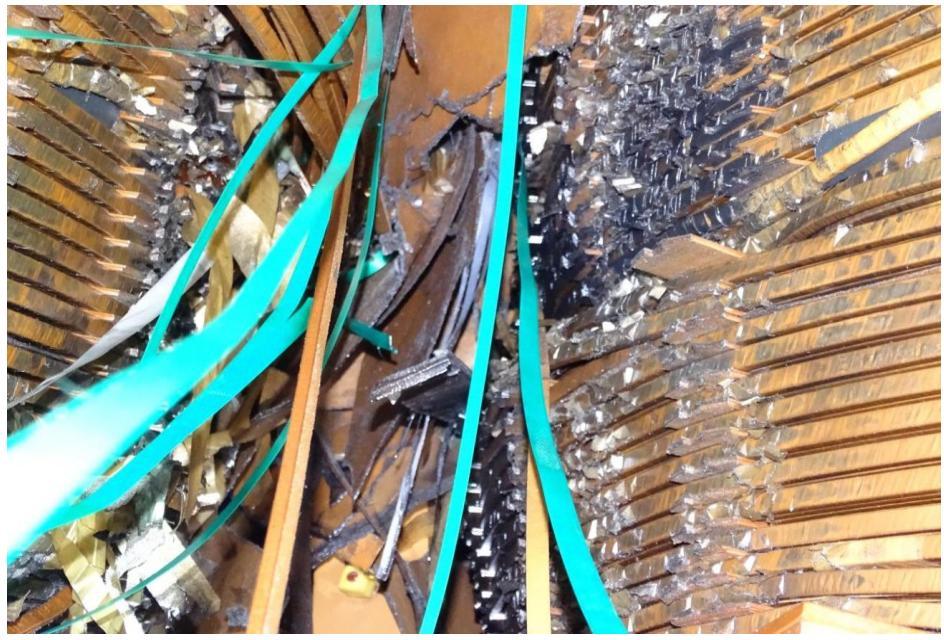
Y and B phase windings after removing the wraps

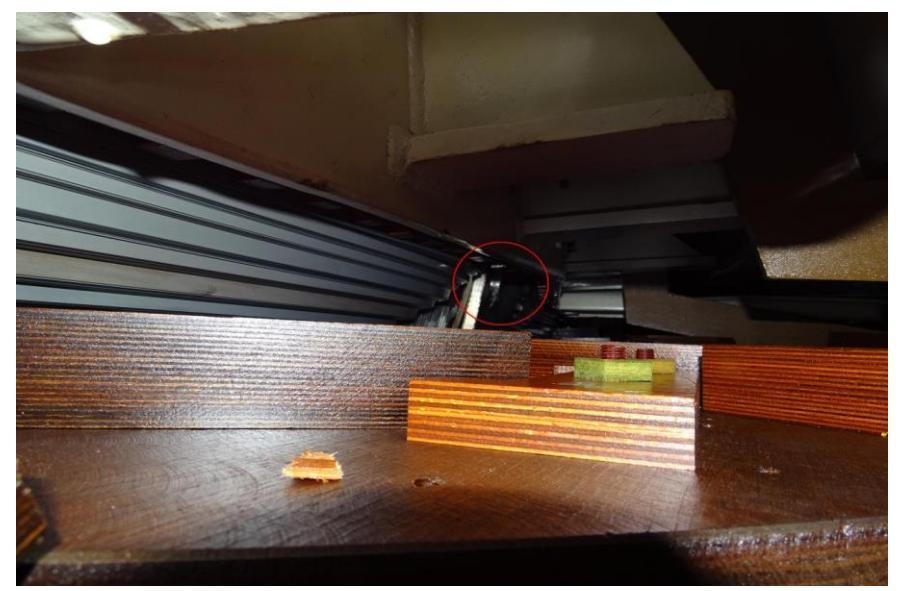
Accordingly internal inspection was carried out and no abnormality to the Cores was observed, except mechanical displacement as a consequence of winding displacement.

Top yoke displacement

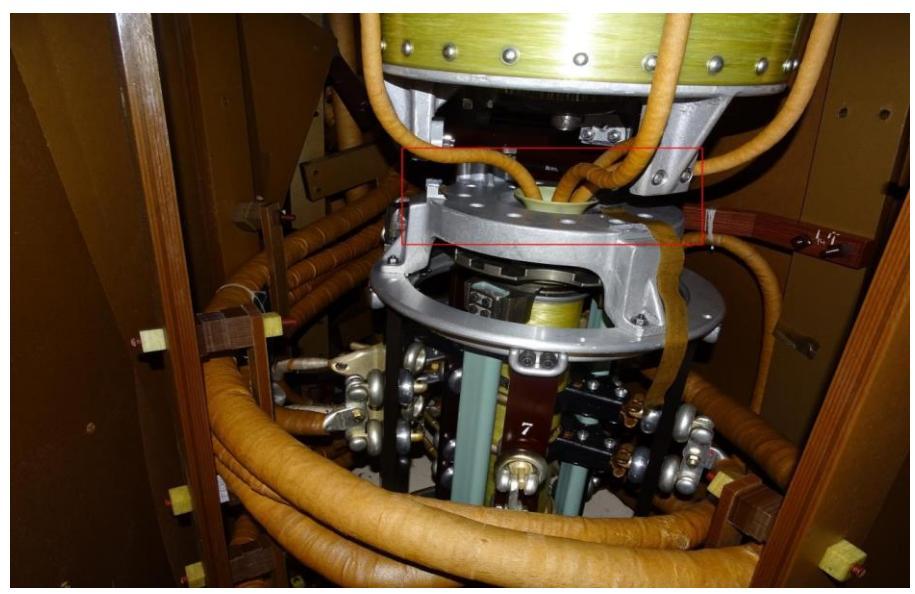
OLTC was operated manually and tap change occurred on all phases, indications also confirmed on the OLTC MB. However, due to the mechanical force the selector switch housing got detached from the diverter chamber for Y and B phases.

Detached selector switch housing

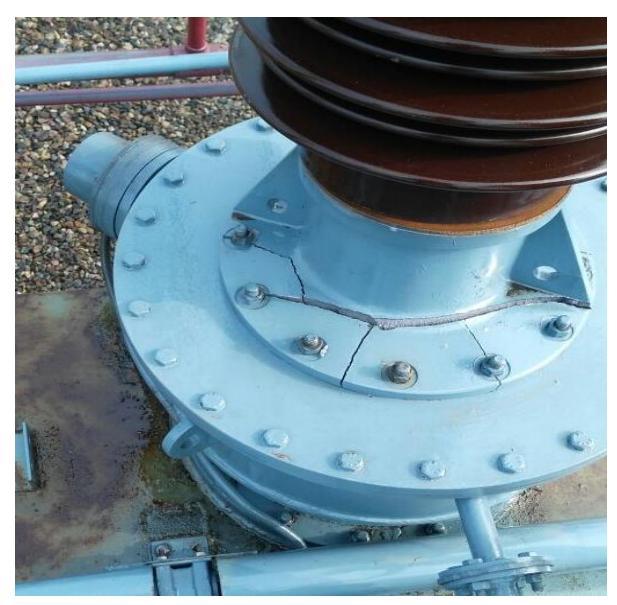
(220 KV Y PH BUSHING)

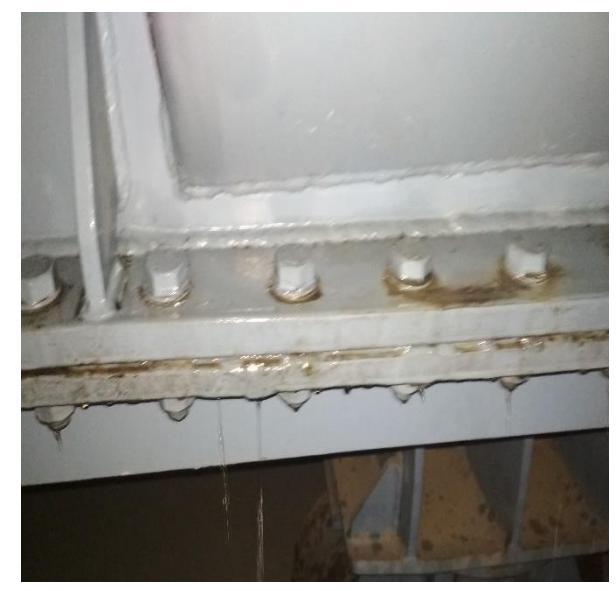
( LEAKAGE FROM BELL JOINT)

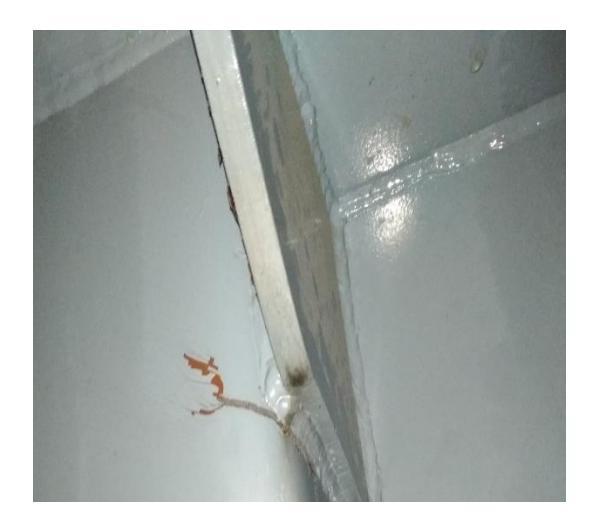
(CRACKS IN TANK)

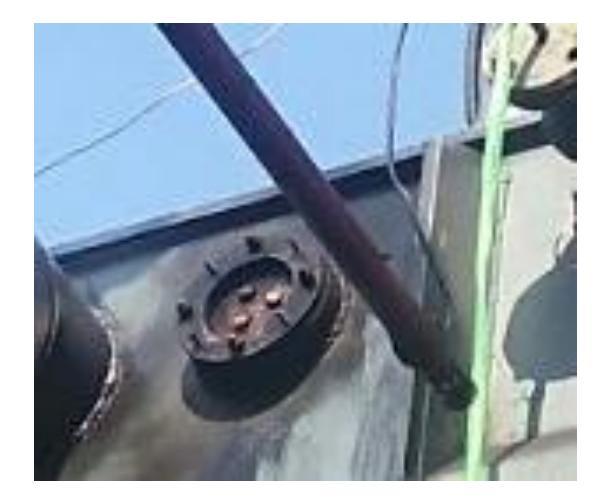
(DAMAGED CC-CL BLOCK)

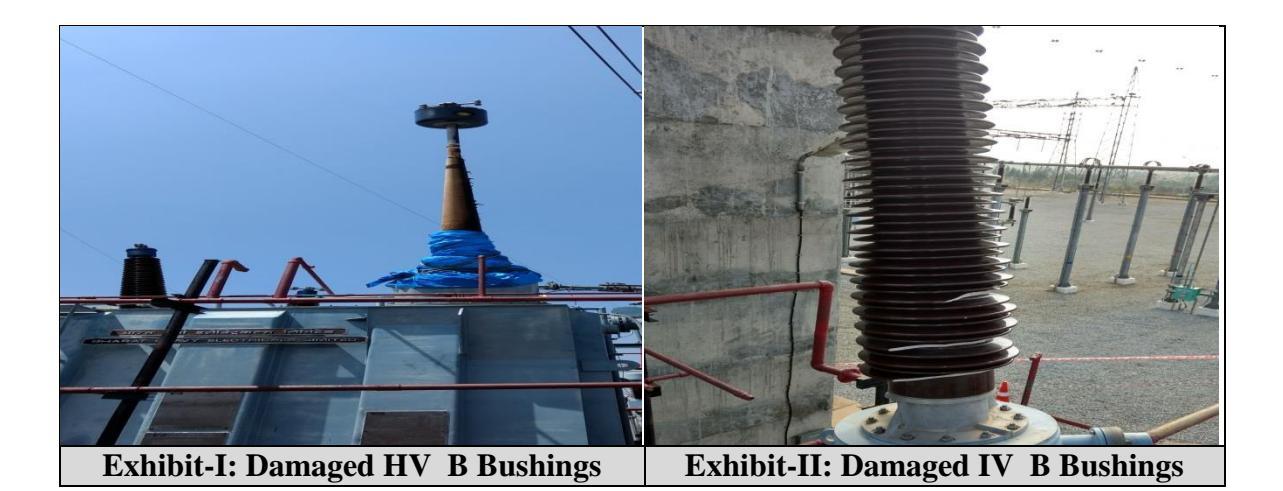
i. No external damage has been observed in the Transformer main tank as shown in Exhibit-I except shattering of porcelain of B phase bushing.

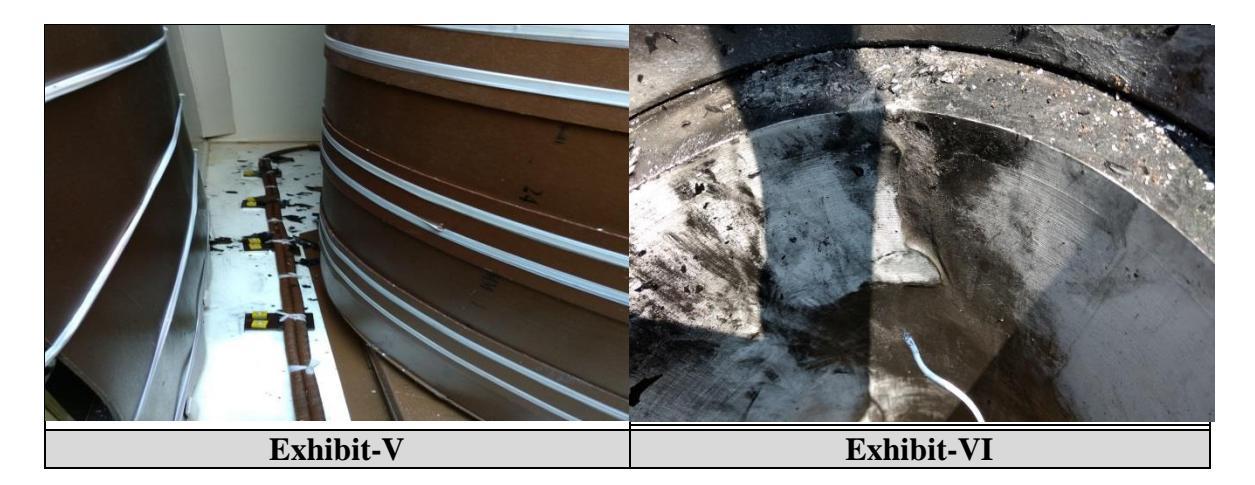
- iii. A clear hole was found in the air end portion of HV phase bushing **(Exhibit IV)**. The location of hole is approximately 1.7 mtr from bottom of bushing.
- iv. Oil end side porcelain of HV bushing was found to be completely shattered and porcelain pieces and burnt paper were found laid at the bottom of the tank at the bottom of the tank (Exhibit V).
- v. Some flash marks where found in the inner surface of the metalic portion meant for BCT accomodation of bushing (Exhibit VI)

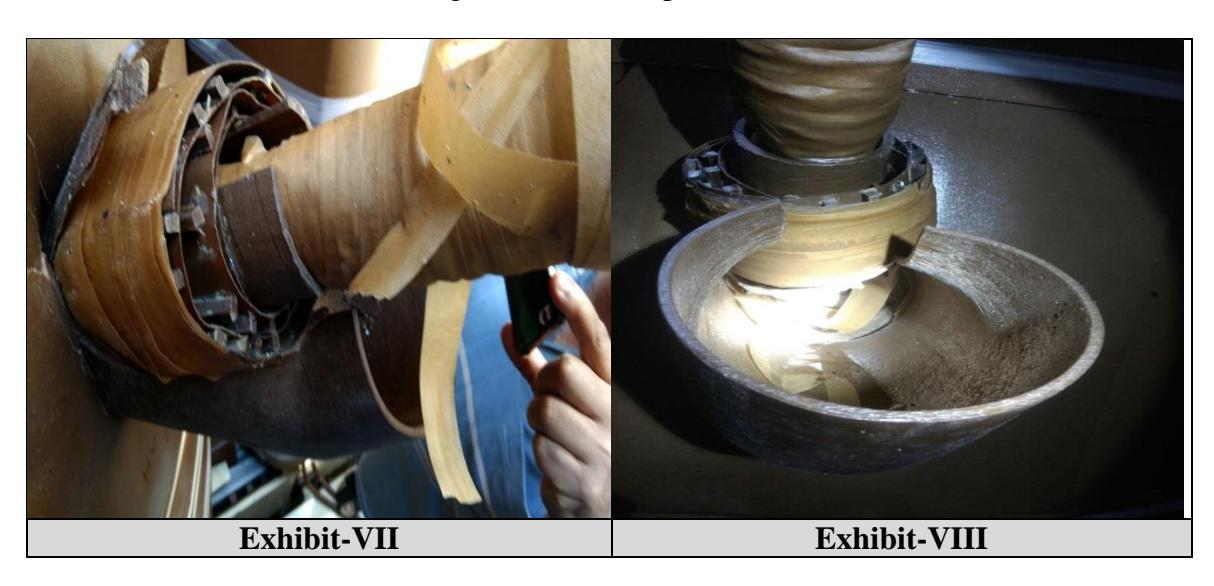
vi. HV winding lead take off was found to be damaged and uprooted. However, the winding lead was found to be intact as shown in Exhibit VII & Exhibit-VIII and no other visible abnormalities were noticed during the internal inspection.

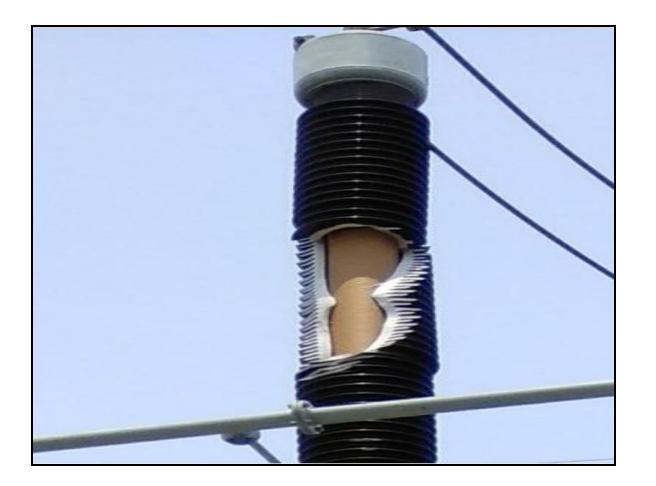
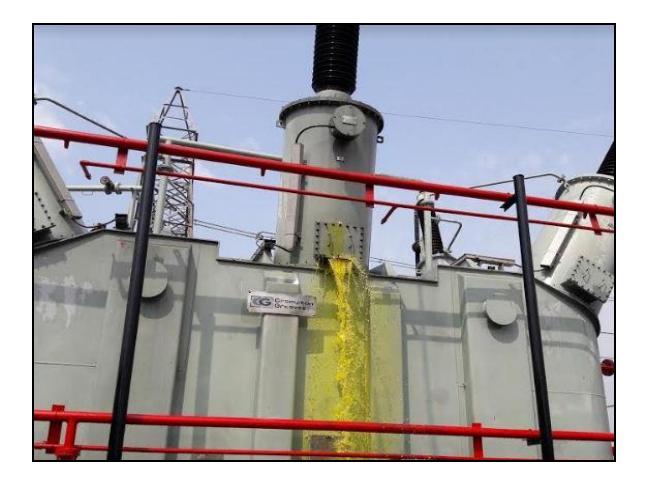
Porcelain Insulator was found to be detached from the Middle of the Y-Phase Bushing and scattered near the ground. Oil was also observed to be flowing out from the inspection cover at the bottom of the turret. The inspection turret was deformed and had attained concave shape facing inwards.

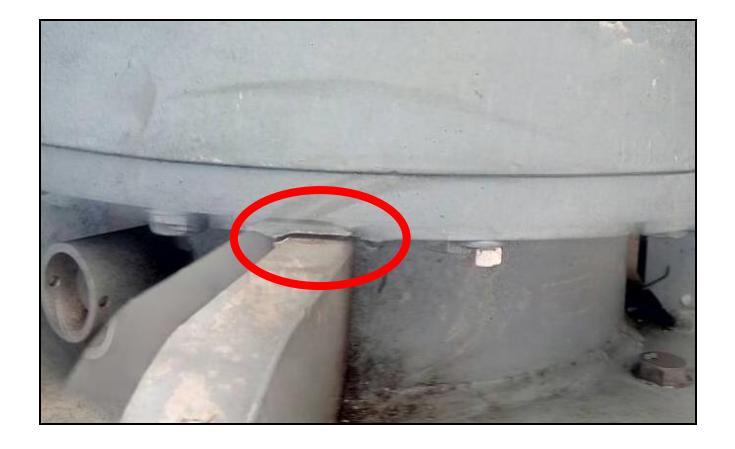
Cracks were observed on the metal flange joints.

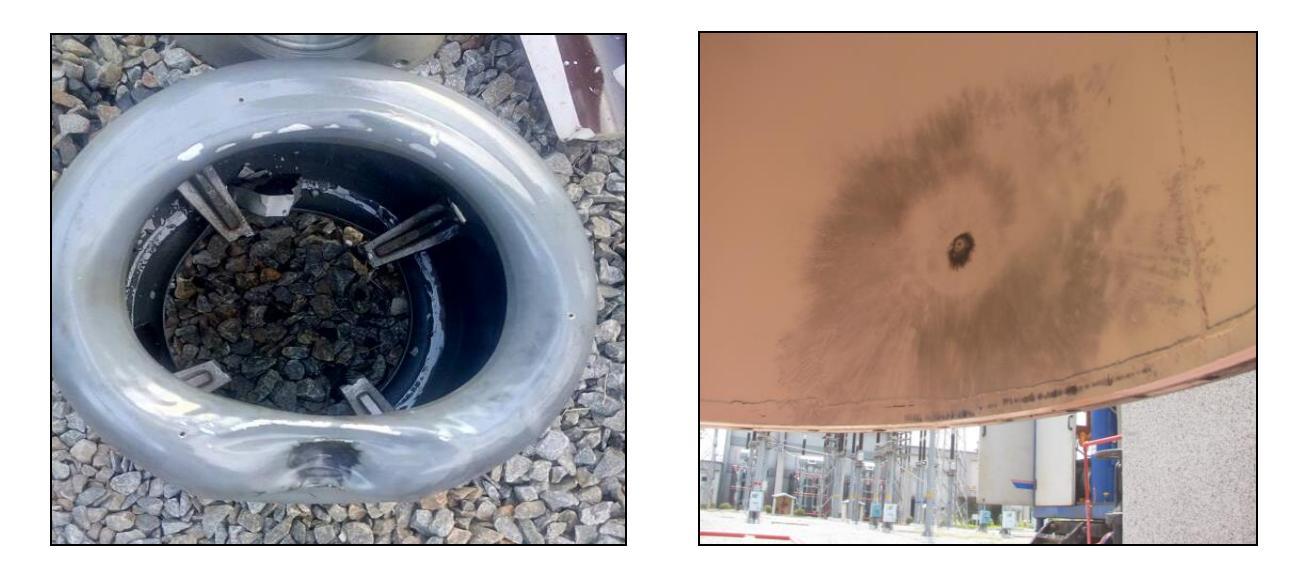
➢ It was observed that the inside body of the turret was having single point flashover mark. The Corona shield also contained flashover marks and was found to be damaged with broken connecting points.

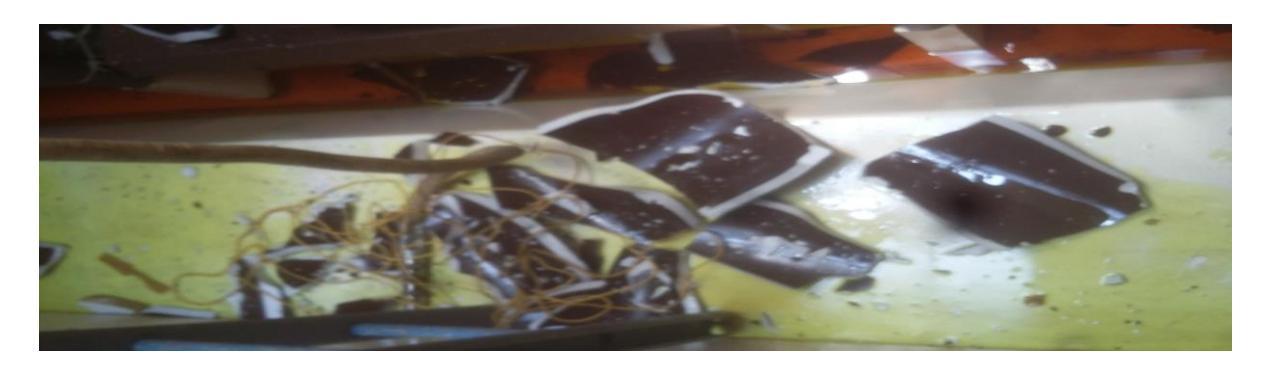
It was found that the oil end (bottom) porcelain dome of Y-Phase Bushing was broken and lying on the bottom and scattered inside the Reactor Main Tank.

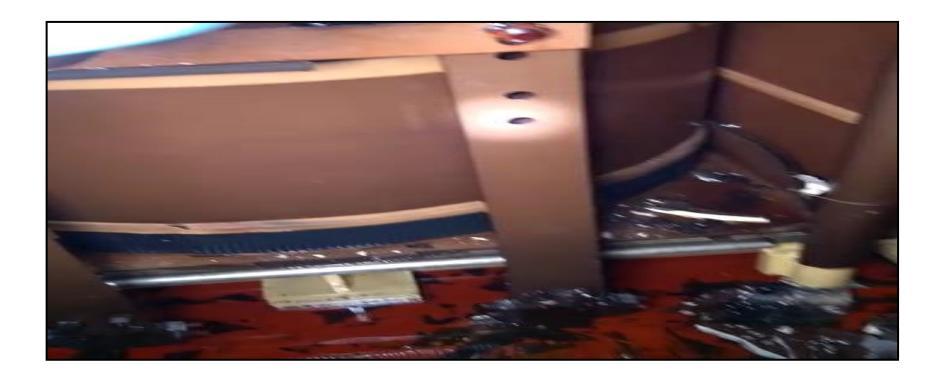
> Charred paper and broken pieces of oil end insulator were found in the bottom of the tank

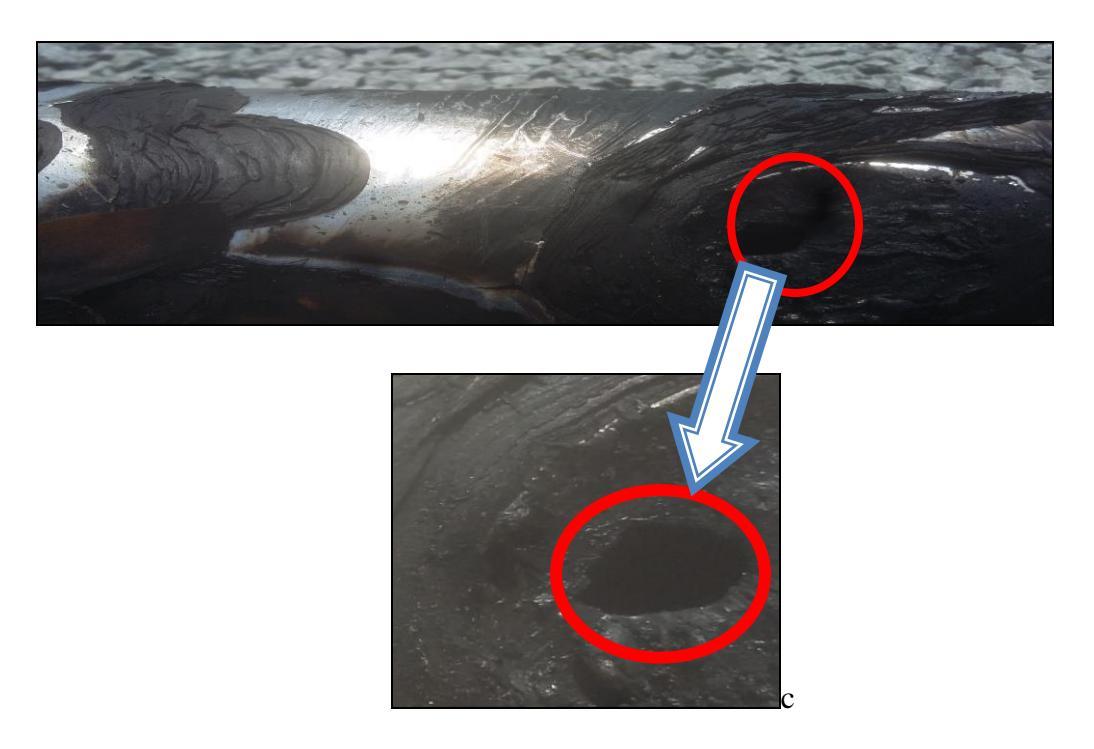
Puncture mark (hole) was observed in the metal rod of the bushing below the first aluminum insulation.

The hole was observed at a distance of 1.63 m from the bottom of the expansion chamber just beneath the first porcelain joint.

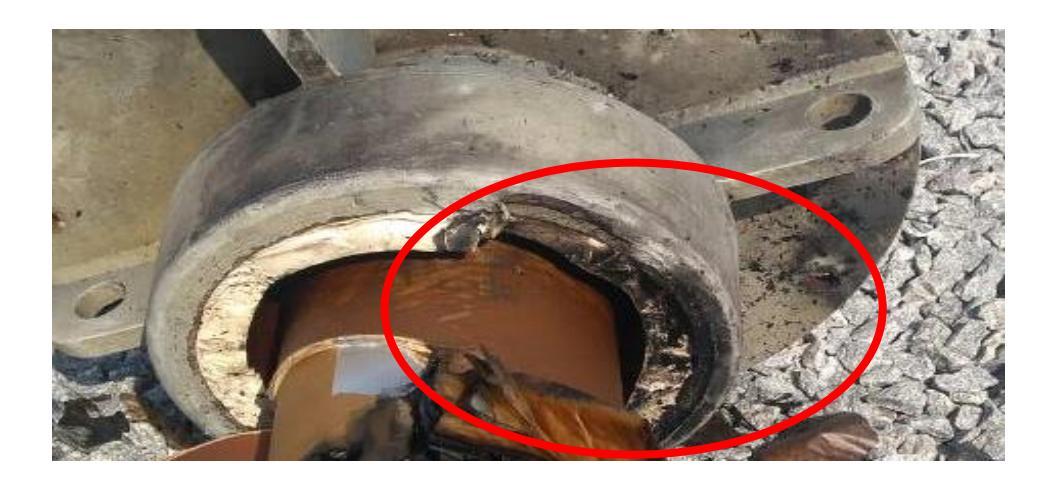
The metal flange was also found to be burnt at the bottom of the bushing with partial melting of the flange and signs of sparking present.

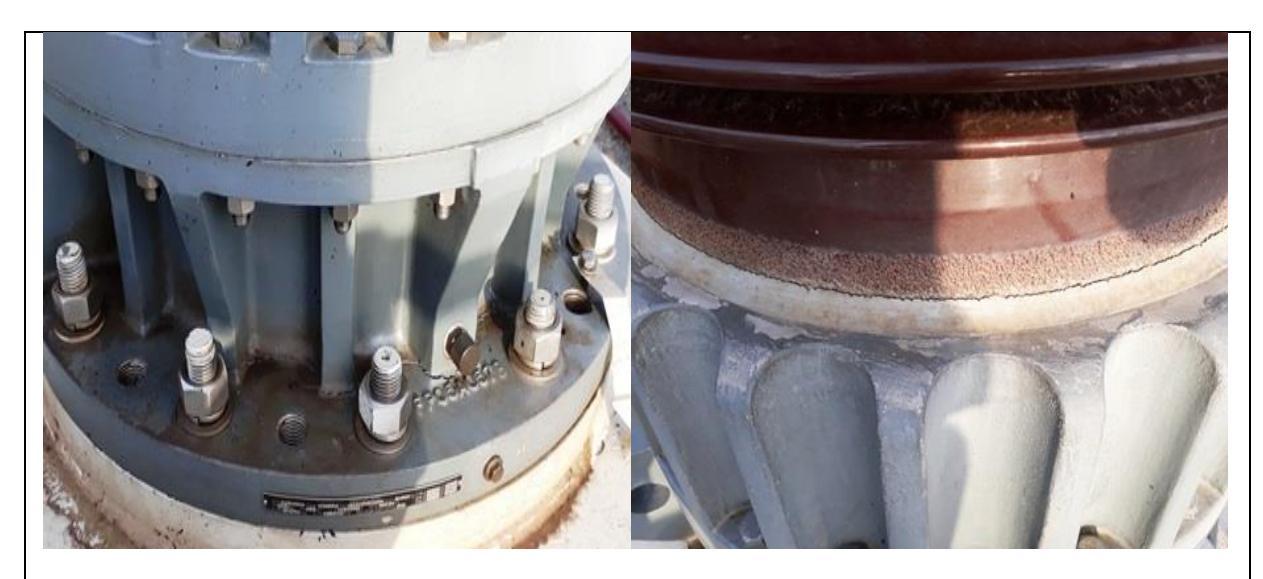
FIG-III (Crack in HV Bushing Flange & Cement Joint)

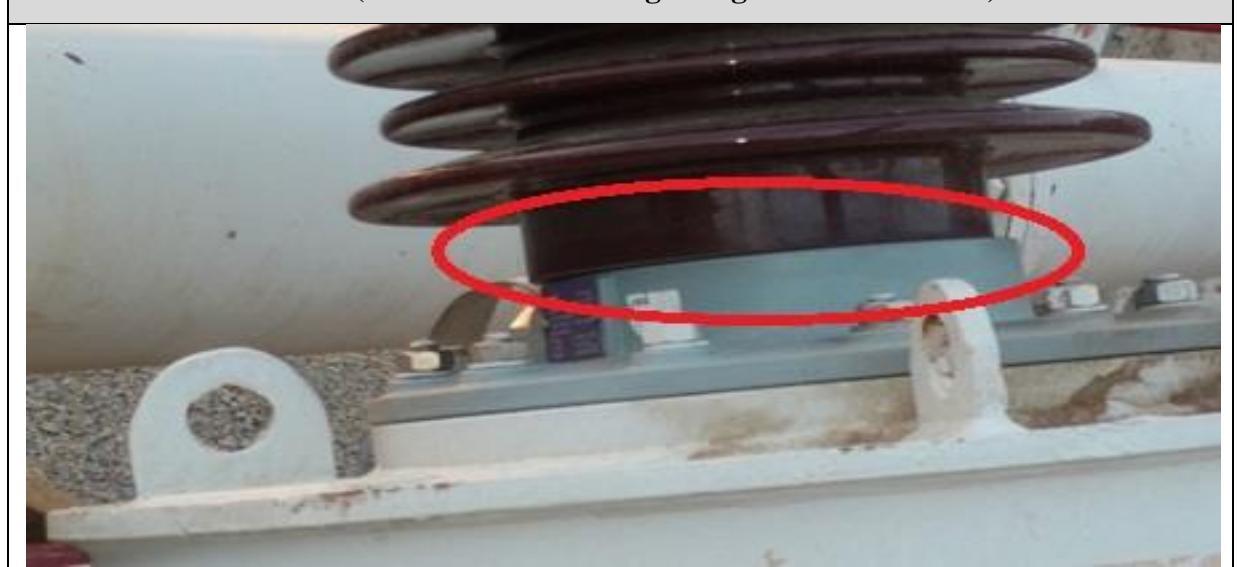
FIG-IV (Displacement in Neutral Bushing)

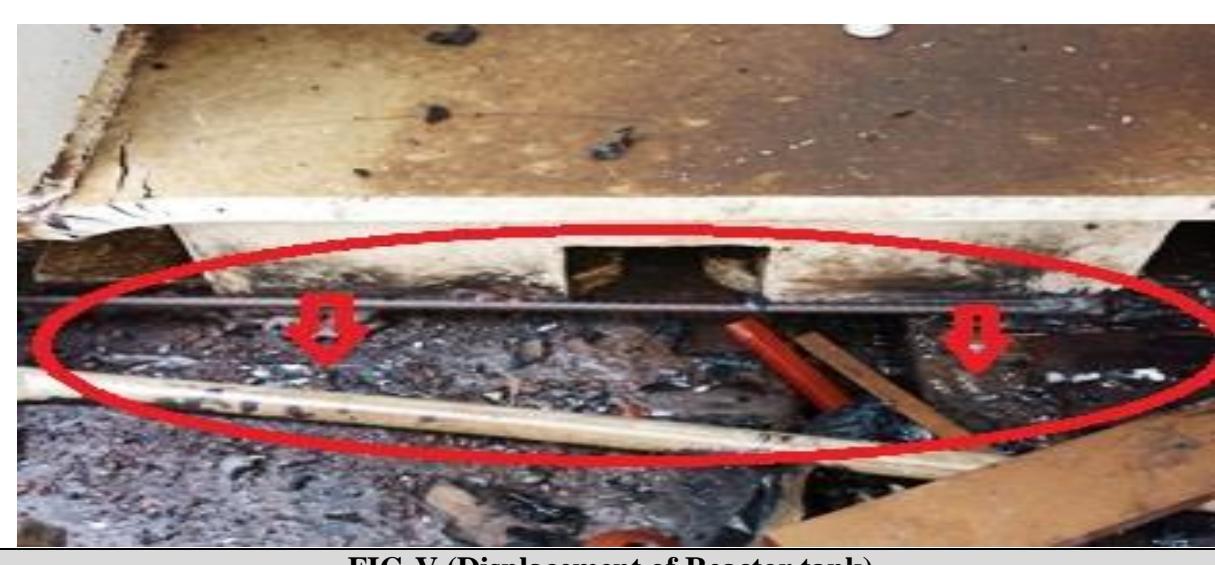
FIG-V (Displacement of Reactor tank)

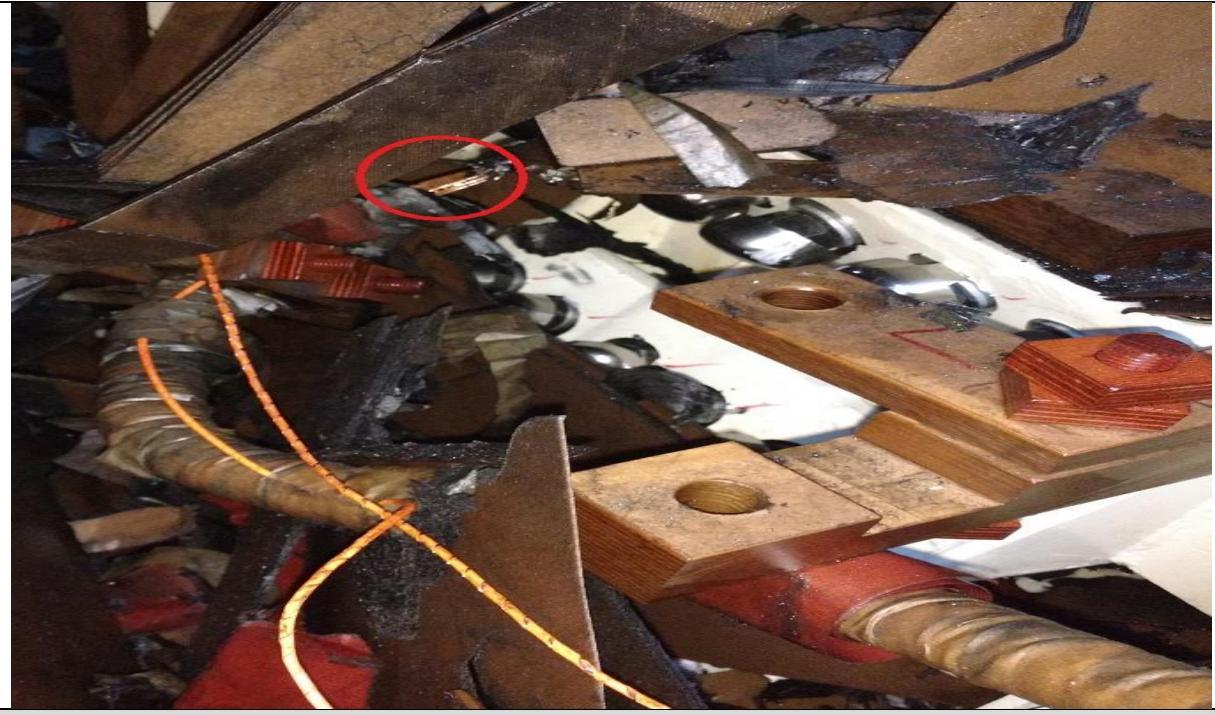
FIG-VIII (Failure of insulation near bottom neutral lead)

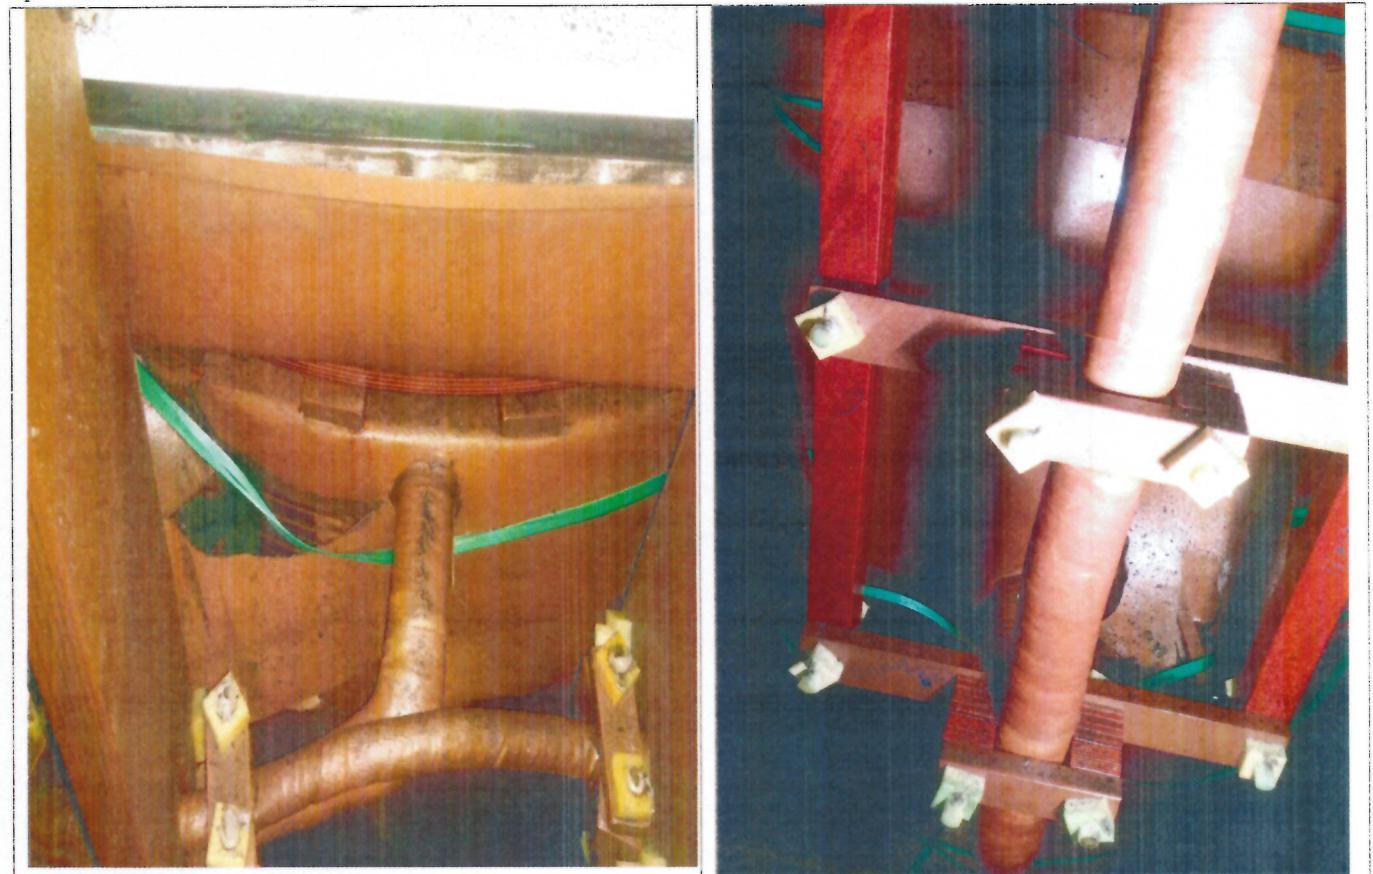
Accordingly internal inspection was carried out of the reactor in the presence of the representative of CGL, Mumbai. The HV Lead exits of R & B phase were found intact but the insulation around the Y phase was found damaged.
