REPORT OF STANDING COMMITTEE OF EXPERTS ON FAILURE OF 220 kV & ABOVE VOLTAGE CLASS SUBSTATION EQUIPMENT (APRIL 2018 - MARCH 2019)

Government of India केन्द्रीय विद्युत प्राधिकरण Central Electricity Authority विद्युत मंत्रालय Ministry of Power नई दिल्ली New Delhi

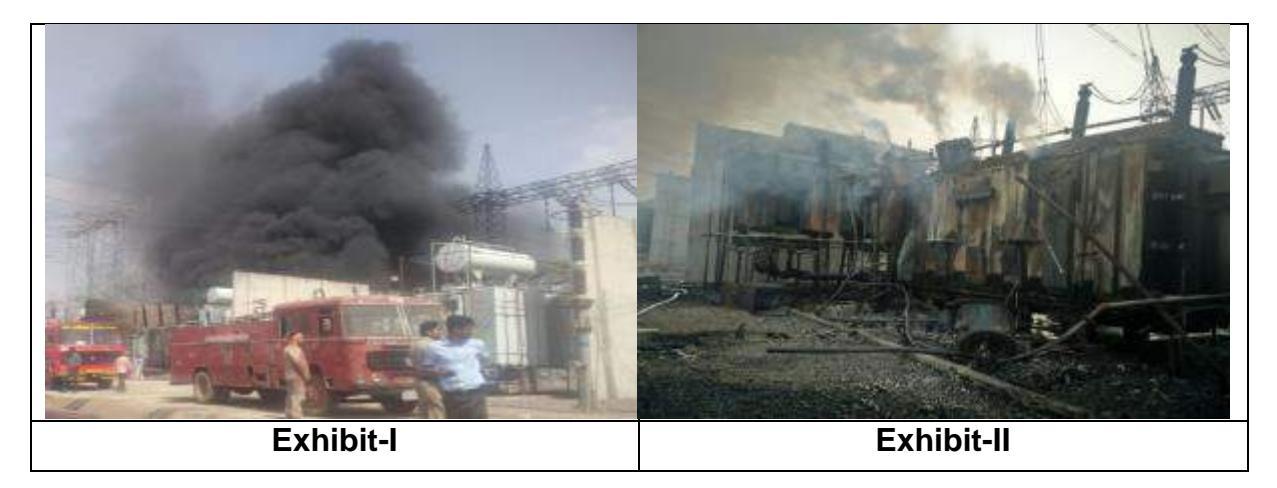
I. Transformer caught fire immediately after the tripping of the Transformer and fire was extinguished with the fire tender. However, the intensity of the fire was so severe that black smoke continued to come out of the tank for hours(Exhibit-I &II).

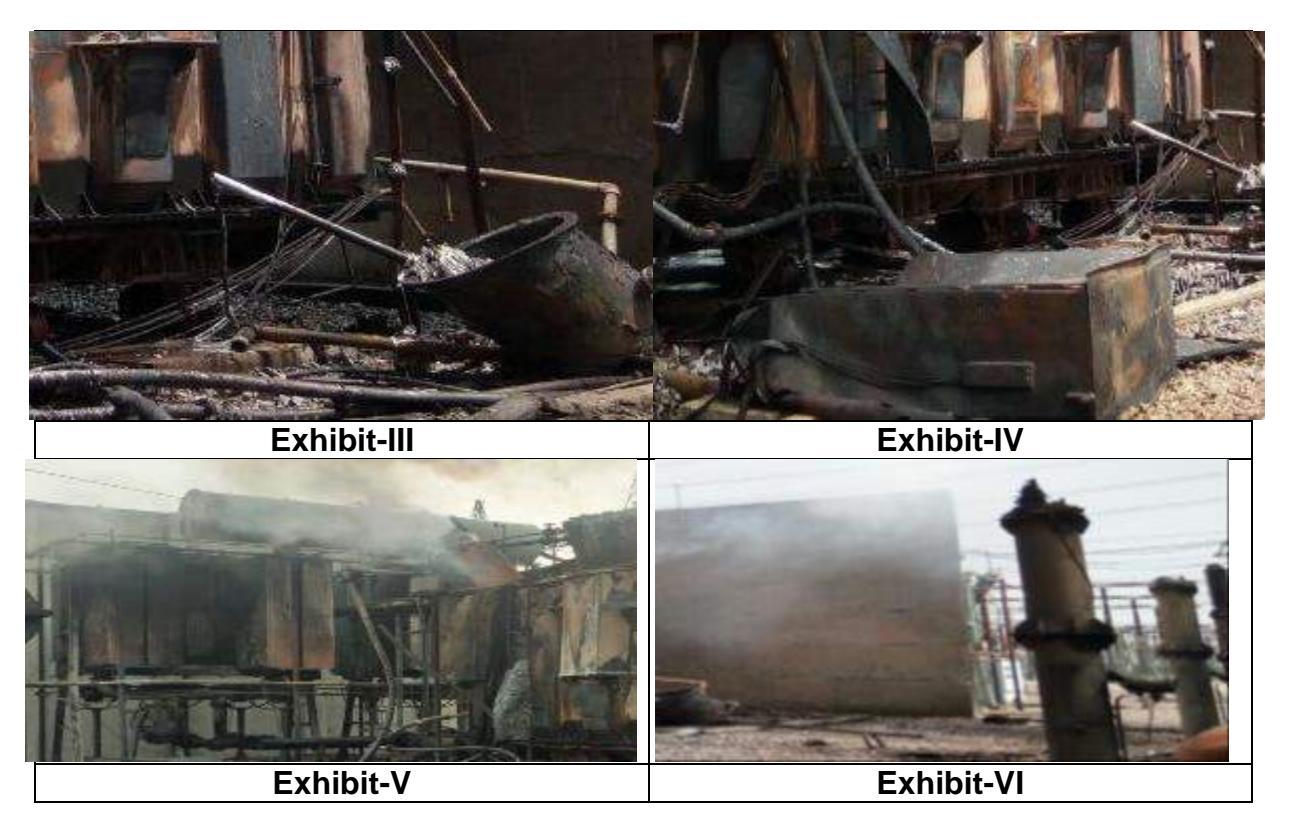
- II. All 3 HV bushings are burnt and damage busing parts are lying on the ground( Exhibit-III). All 220 kV & tertiary bushings found intact with the tank but due to intensity of the fire, all these bushings have also lost their property due to heat.
- III. Main tank found burnt and bulged towards HV side. Rim found distorted.
- IV. All Turret CT of R, Y & B phase were completely burnt/ damaged in this fire incidence.
- V. Due to heavy fire, all windings, insulations, cleat support and support structures were completely burnt out.
- VI. The marshaling box (Exhibit-IV), cables, Radiator pipe line, cooler bank, Conservator was also damaged badly due to fire.

VII. All 3 HV side LAs and associated structures (Exhibit-VI) were found to be damaged and lying on the ground. 220 kV side LAs were intact on the structure however, cannot be reused.

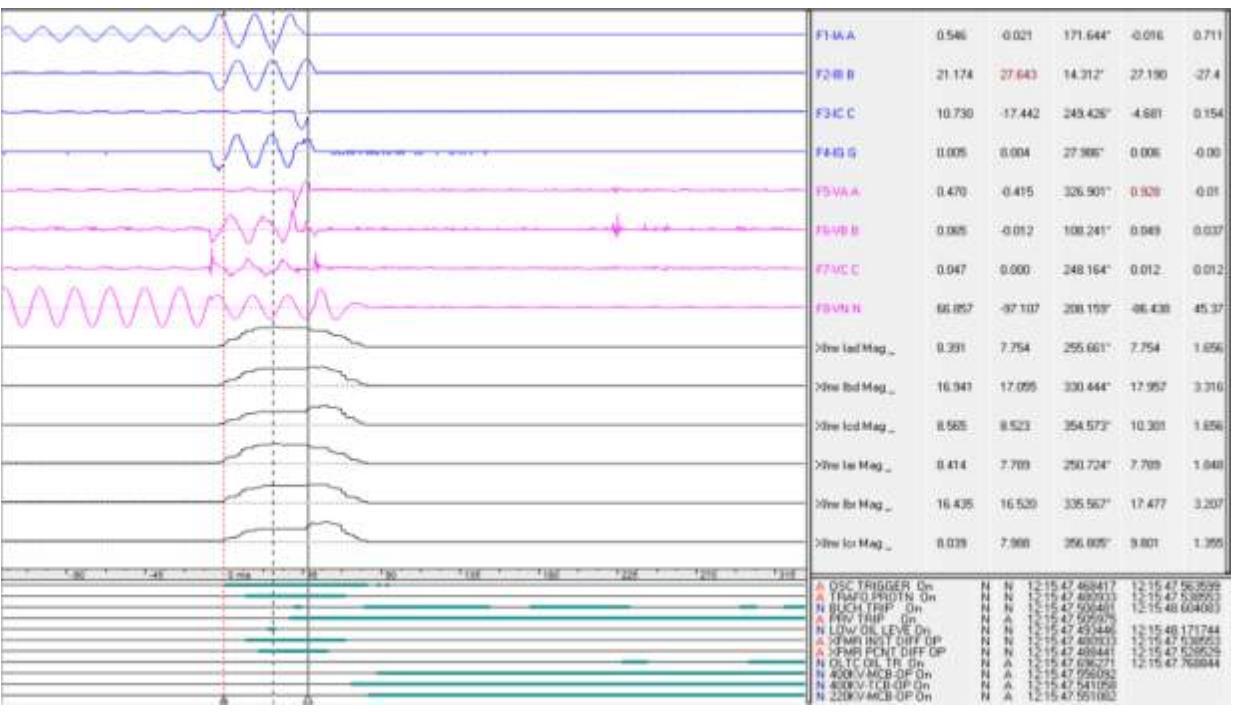
Figure: DR of Differential relay of 400kV ICT-I Gwalior

It was observed that there was fault current of 21.4 kA in Y ph of 400 kV side and 1.67 kA from 220 kV side. Fault current of 10.7 kA was also observed in B ph of 400 kV side after 40 ms.

As seen from Back O/C DR, Voltage of B ph bus reduced up to 8.6 kV. From DR and EL records, fault current got cleared in around 73 ms. Prima facie, it seems that fault was initiated from Y phase. It was suspected that faults may be initiated from the Y phase.

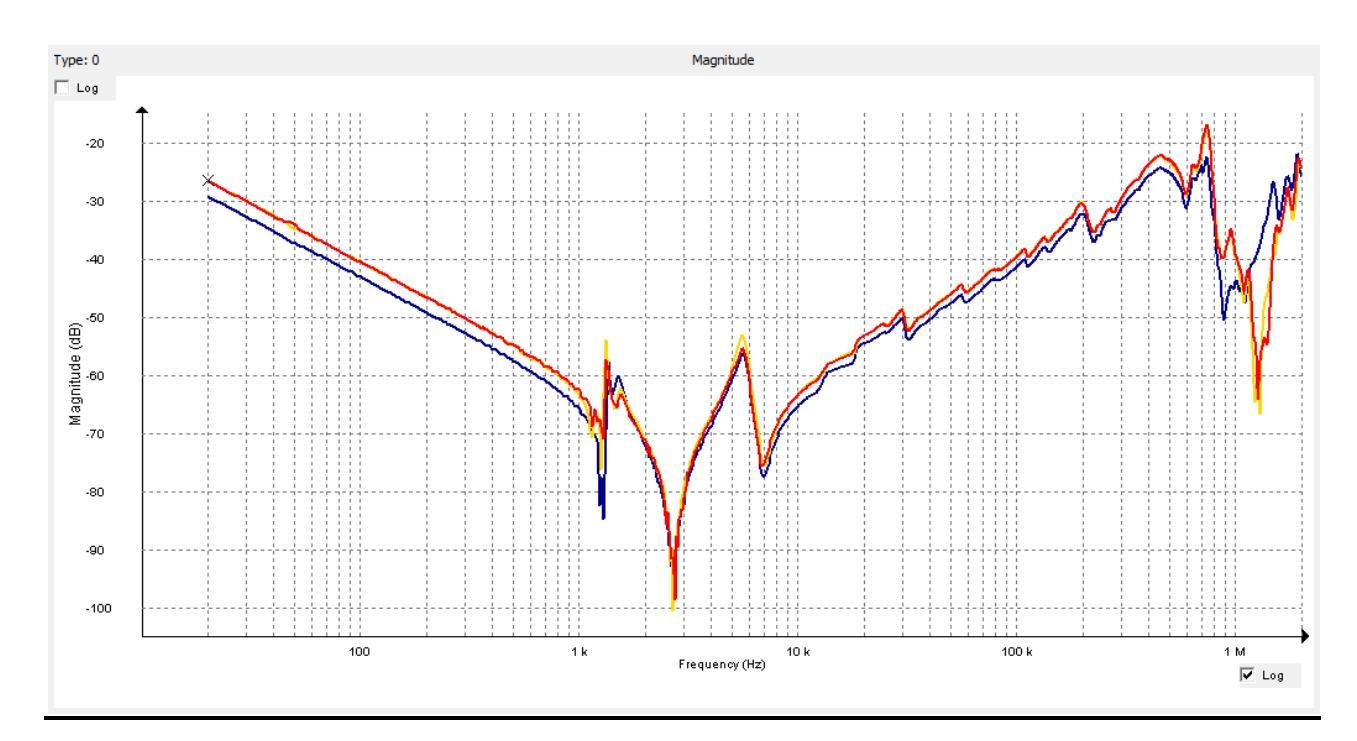
Resis	Windin stance	g [HV-N]	Resis	tance At	: 75º C	Factory Value At 75° C		Value At 75 ^o % Deviation C			
R	Y	В	R	Y	В	R	Y	В	R	Y	В
2.509	2.512	5.035	2.787	2.791	5.594	2.978	2.982	2.979	-6.4	-6.4	87.8

All LV test results indicate probable fault in B phase winding

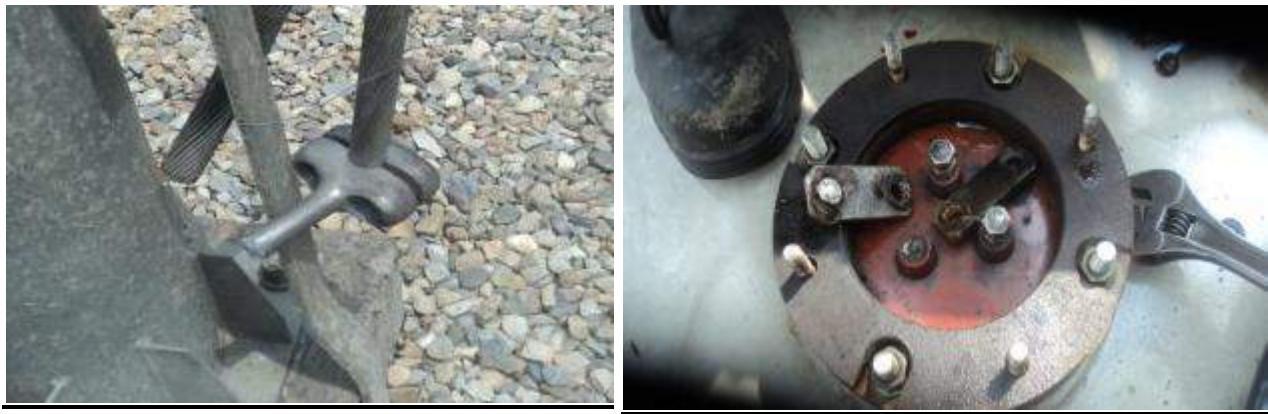
Exhibit-l

I. Twin moose connector of B-phase bushing found broken apart as shown in Exhibit-I.

- II. In CC-CL epoxy terminal board Core Clamp terminal was found melted as shown in Exhibit-II.
- III. LA of reactor is intact and no advances of LA counters were observed. LA counter are read as 7 for B-Phase, 4 for Y- phase & 6 for R- phase as shown in Exhibit-II.

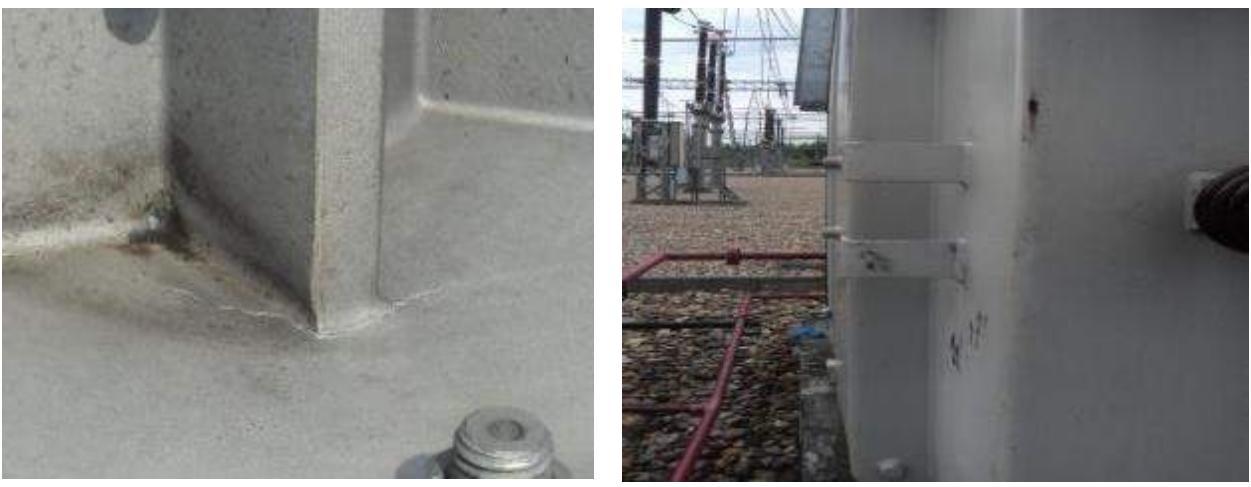
Exhibit-III

IV. Cracks developed in flange of R-phase (Sr.No: 1616740) & B-phase (Sr.No: 1616737) bushings as shown in Exhibit-III.

- V. Very slight bulging /deformation observed in reactor tank as shown in Exhibit-IV.
- VI. OTI & WTI reading went up to 75 centigrade max
- VII. Carbon particles were observed inside the Reactor and same were spread on core coil assembly as well as at the bottom of the tank as shown in Exhibit-V

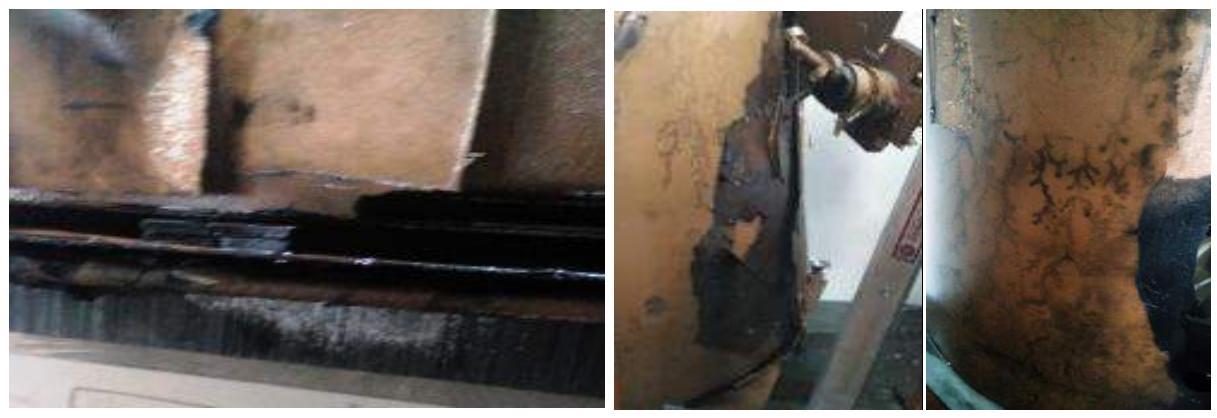
Exhibit-VII

- VIII. B-phase winding found damaged from lead take off location as shown in Exhibit-VI.
- IX. Melting of lamination was observed at the bottom cross flux plate as shown in Exhibit-VII. Melting of lamination sheets observed in auxiliary limb of core adjacent to R-Phase winding and bottom part of auxiliary limb adjacent to B-Phase winding.
- X. Tracking observed through outer press board barrier surface emanating from conductor of lower half of the winding to flux plate as shown in Exhibit-VIII. On further removal of the press board barrier, tracking and treeing marks resembling the

branches of a tree were observed on both side of the winding insulation from lead take off to the ground.

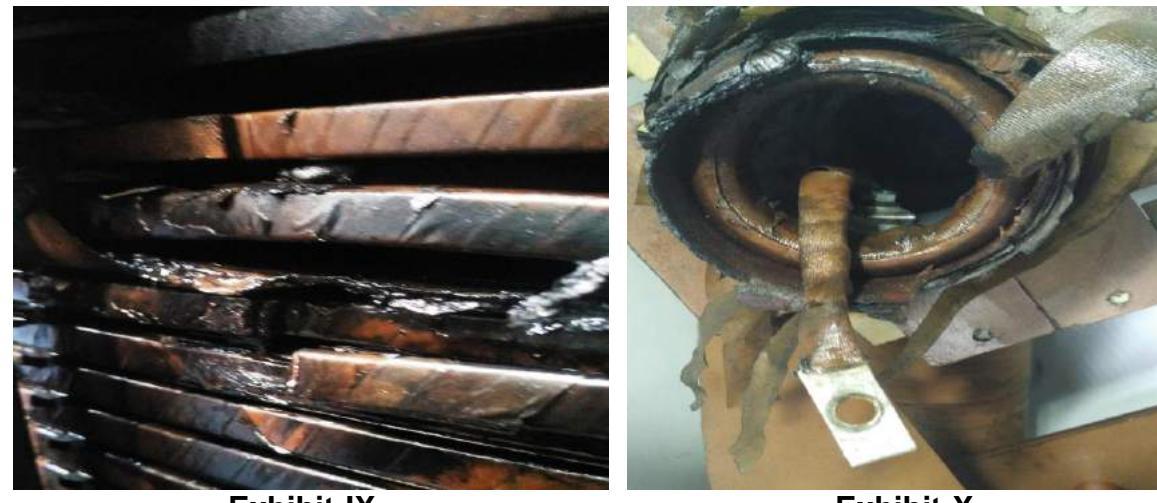
Exhibit-IX

XI. All the insulation pressboard barriers were removed and burning of Conductors is observed in lead take of area of winding. Two conductor strip were broken / melted in the 3rd disc from the top of the lower half the winding as shown in Exhibit-IX.

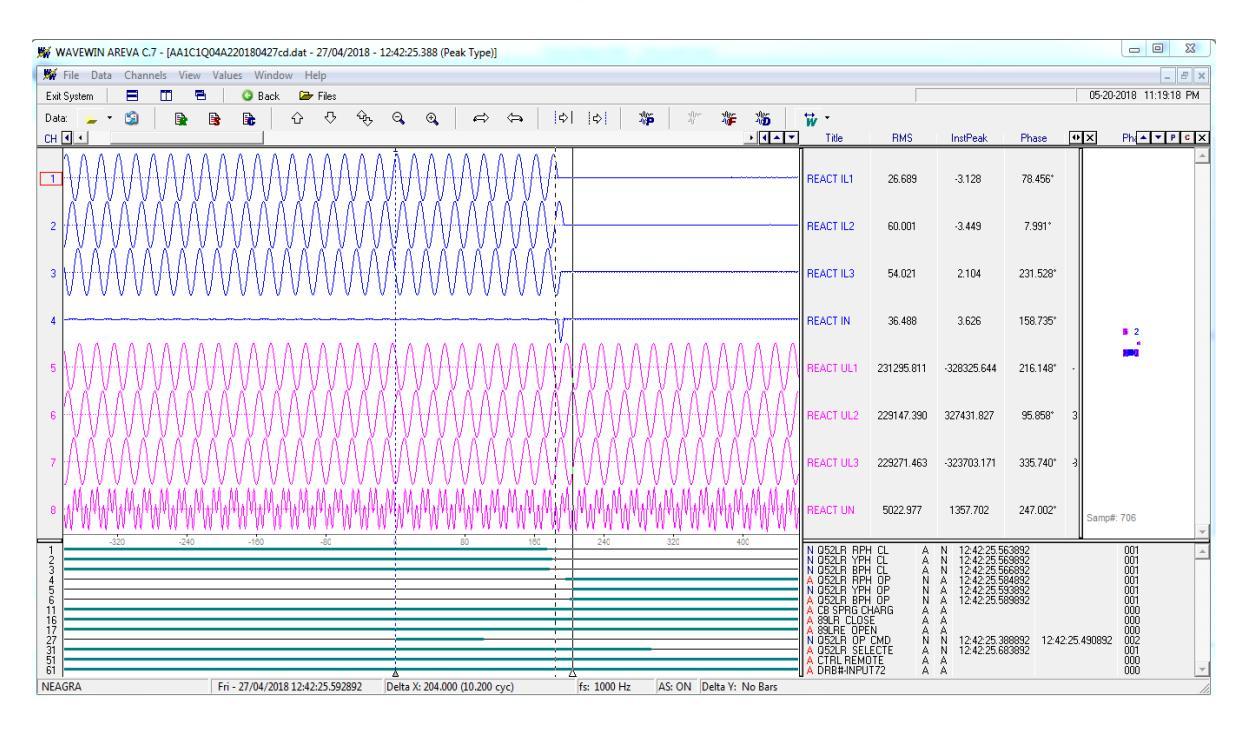
Fig-l

- XIII. As the on line DGA system was defective, any development of fault gasses during last two month prior to failure could not be known.
- XIV. Equi-potential lead was checked and was found to be intact as shown in Exhibit-X. Also, no such mechanical defect was observed in the lead take off area.
  - XV. Opening and closing voltage/current response taken at 12:45 hrs from CSD device was found to be normal as shown in Fig-I.
