Survey result report

Investigation of possibility of improving thermal efficiency and environmental performance at Durgapur Steel Thermal Power Station (DSTPS)

(Implementation of real-time unit performance management using IoT)

May 2018

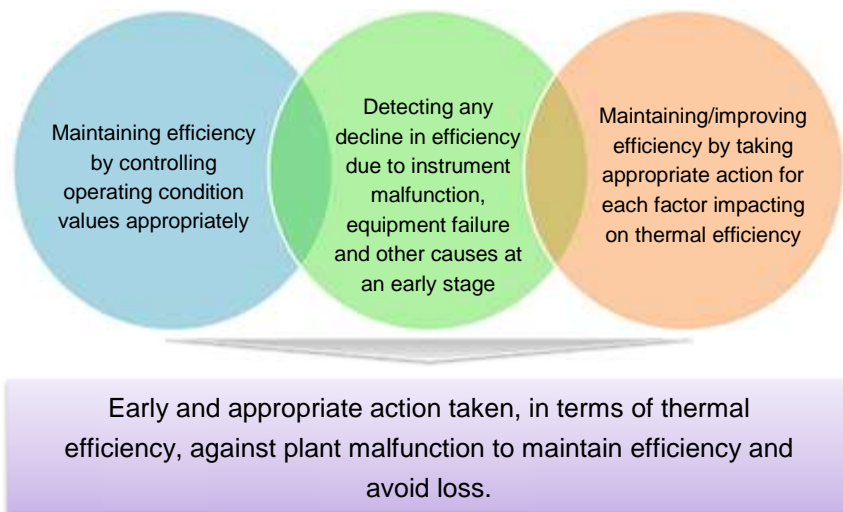
Figure 2-1 Approach to maintain/improve thermal efficiency of the plant alone

1. Appropriate control of operating condition
 - From the perspective of maintaining plant efficiency, key operating condition values of the equipment will be periodically monitored and if any changes such as a “deviation” from the reference condition or design values are observed, action will be taken immediately. (Example: changes in main steam temperature/pressure, feed water temperature, gas temperature, O₂ content, etc.)

2. Control of premonitory sign of potential decline in performance
 - Premonitory signs of various changes, including measuring instrument malfunctions, will be detected at an early stage by periodically checking all available operational data and determining the tendency indicated. Those early findings would help avoid any decline in thermal efficiency and alleviate equipment deterioration due to malfunction. (Example: Leakage from high-pressure heater tubes, increase in differential pressure and performance degradation of AH)

3. Appropriate proposal for each factor hindering thermal efficiency
 - Equipment with performance that declines progressively in the mid- to long term will be subject to long-term monitoring to identify factors hindering thermal efficiency. Repairs will be carried out at the right time before shutdown for periodic maintenance and other purposes, based on the tendency for thermal efficiency to decline and other information such as that provided by local engineers.

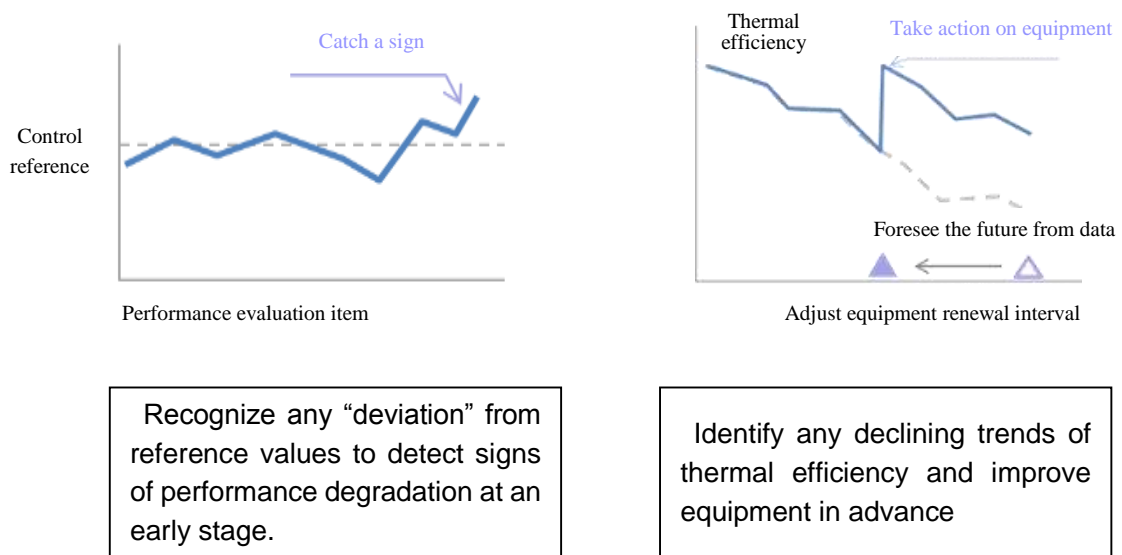
Figure 2-2 Image of early detection of anomalies by comparing operating conditions and reference values

The overall thermal efficiency of the thermal power equipment will be improved by reducing downtime and increasing the operation hours of the high-efficiency unit.

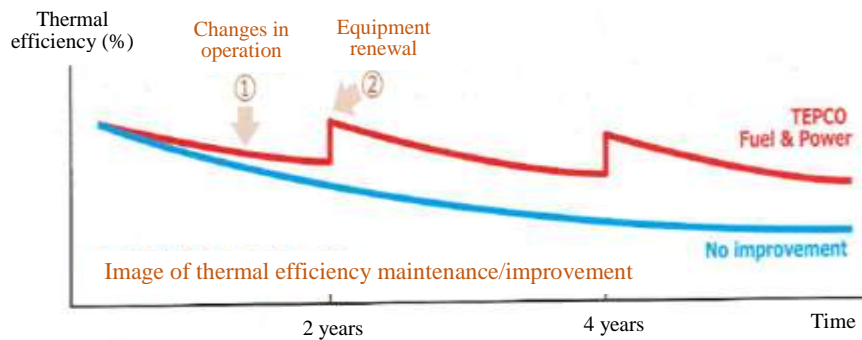
Figure 2-3 Image of thermal efficiency maintenance/improvement

- (1) Efficiency improvement by operation changes: The thermal efficiency will be maintained by actions such as changing the operating method of each piece of equipment and reviewing/optimizing their repair interval.
- (2) Improving efficiency by renewing equipment: Equipment is renewed during periodic inspections and equipment shutdowns.

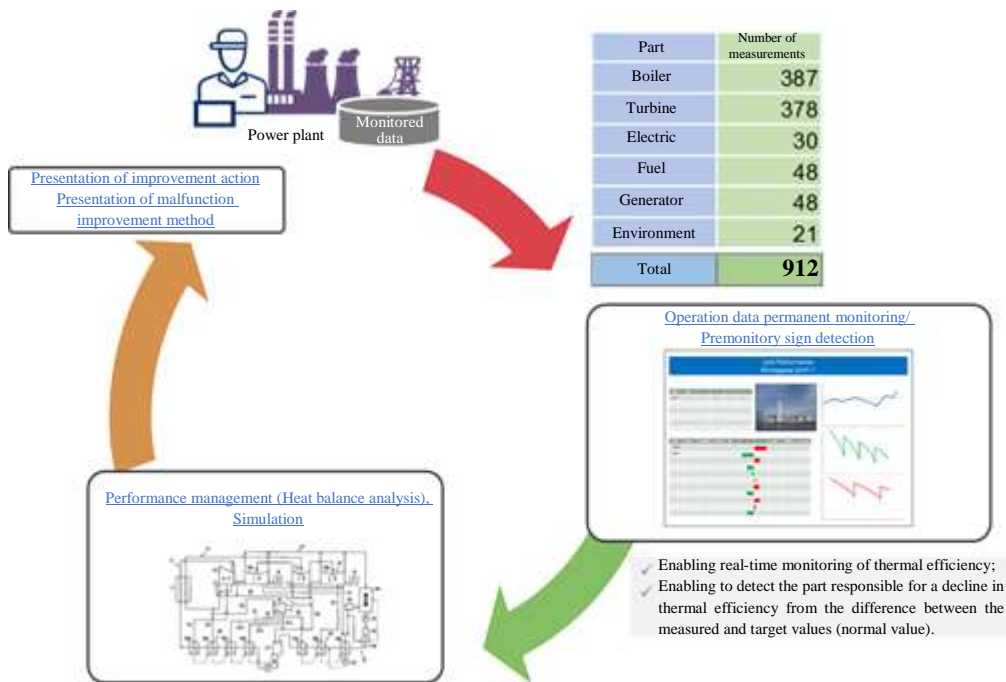
Figure 2-4 Image of the malfunction improvement loop, which starts from operational data monitoring

Furthermore, based on know-how developed to date, recommendations will be made to improve equipment and change operating values to help remedy causes of any decline in thermal efficiency and remedial actions conducted systematically during periodic inspections and unit shutdowns.

Repeating this process on an ongoing basis will help maintain/improve the thermal efficiency of the unit for the long term.

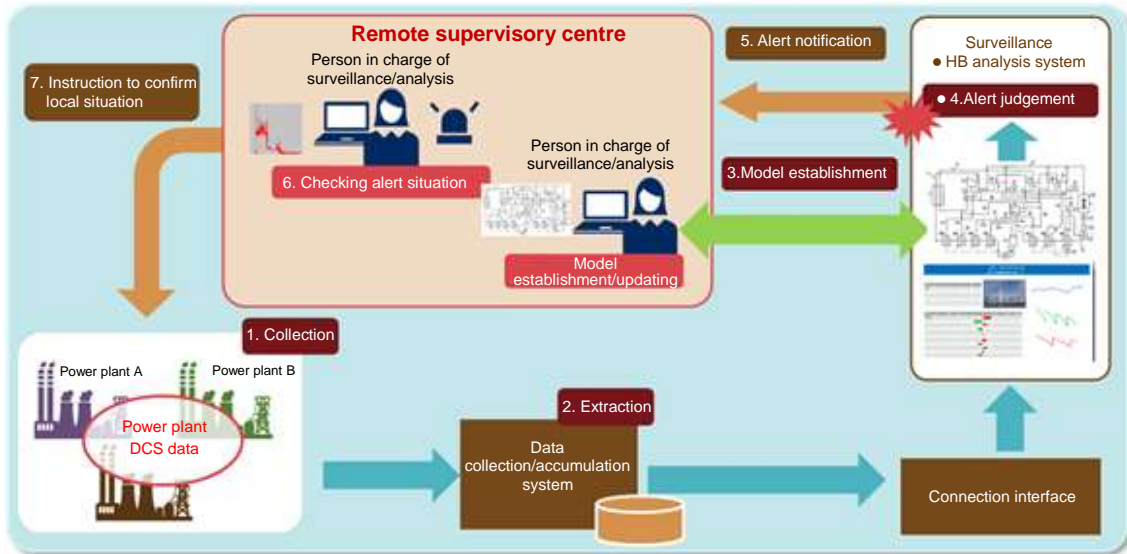
Figure 2-5 Image of Online Analysis

- (1) Important operating condition values are periodically monitored.
- (2) Monitored data are sent from the facility of the relevant country to Japan for remote surveillance.
- (3) If premonitory signs such as “deviations” are observed in operational data, contact will be made immediately with the local entity and actions to be taken will be recommended.

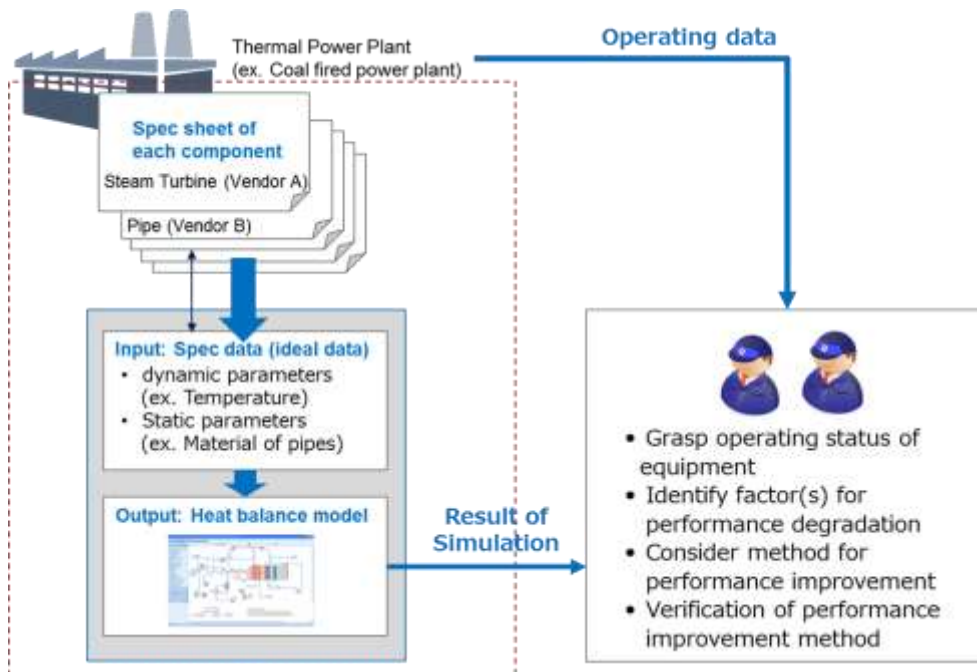
Figure 2-6 Image of Offline Analysis

During the exercise of this study, an offline analysis method is used.

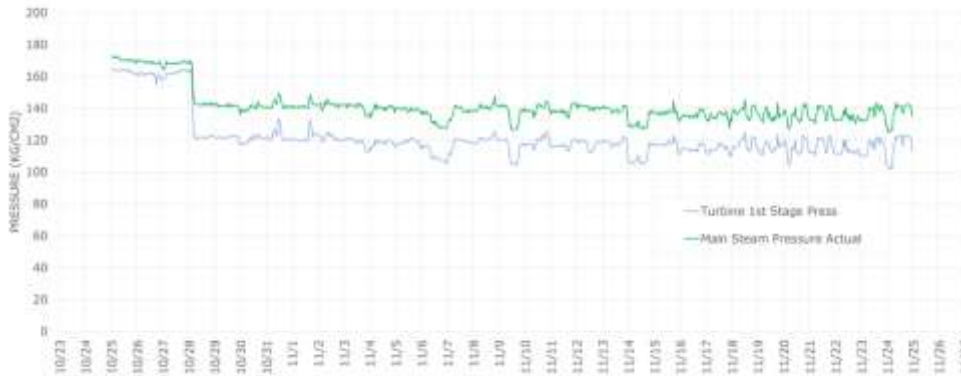
Figure 2-7 Record of the No. 1 Unit main steam pressure

(1) Main steam pressure record

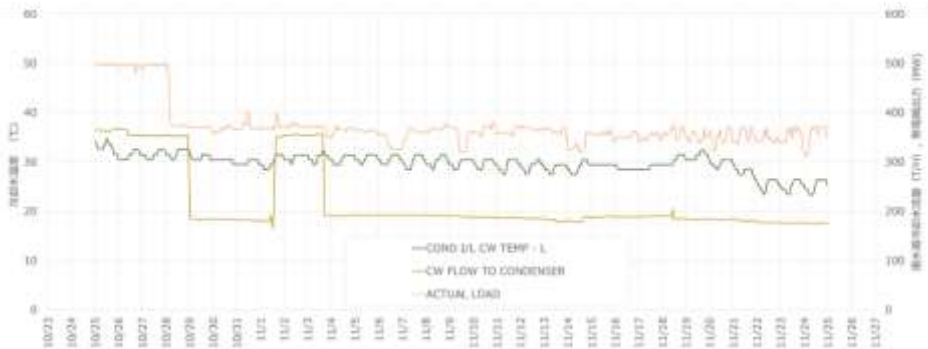
Figure 2-8 Record of the No. 1 Unit condenser cooling water temperature, flow and generator output

(2) Condenser cooling water temperature record

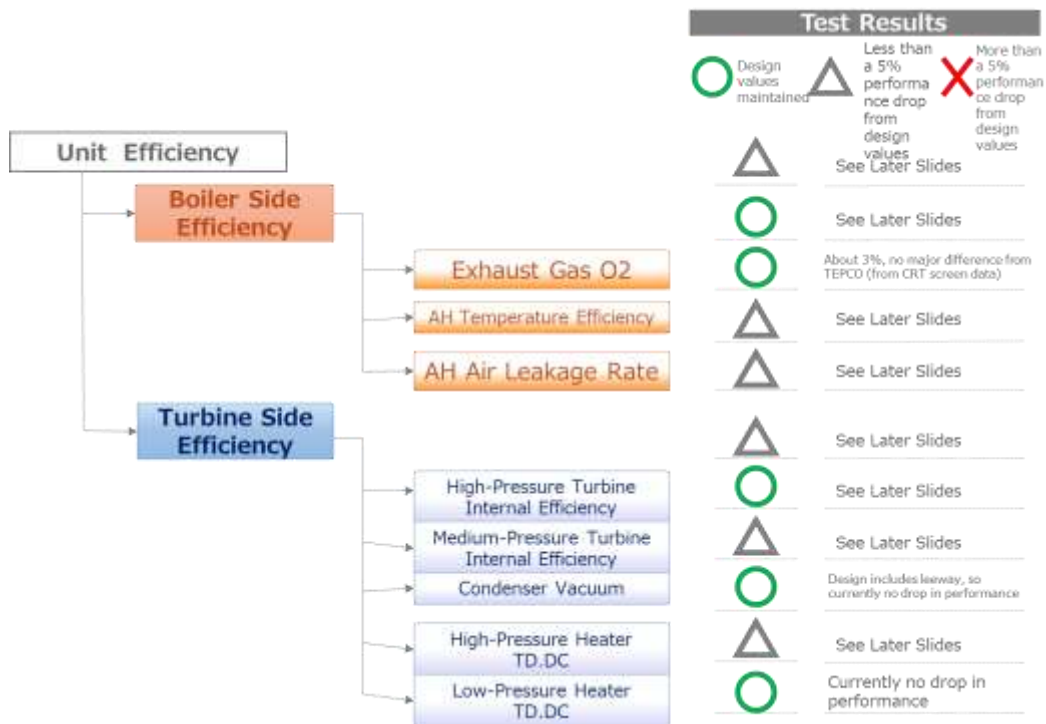
Figure 2-10 Result of performance diagnosis of the entire unit and by piece of equipment

Boiler efficiency was maintained at the design value. However, the air leakage ratio of the air heater (hereinafter, "AH") was high, causing the AH temperature efficiency ratio to decline and it emerged that such decrease, despite having minimal influence, was responsible for the drop in efficiency.

As for turbine efficiency, a decline in performance from the design value was observed. Following detailed performance diagnosis by individual equipment, a performance decrease due to age-related degradation emerged on the intermediate pressure turbine and the high-pressure heater.

The prime reason behind the decline in efficiency of the unit turned out to be the decline in efficiency of the turbine.

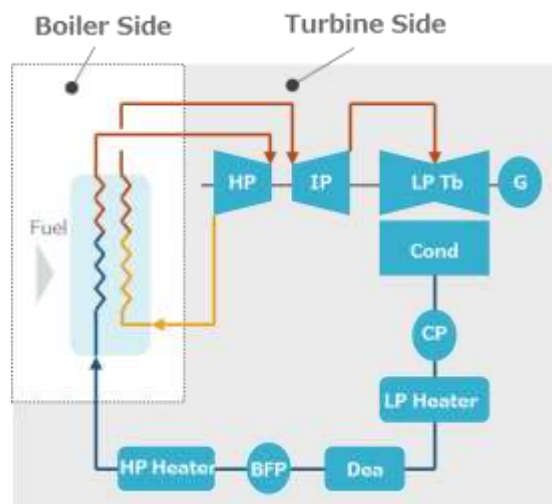
Figure 2-11 Unit components (Blue indicates turbine equipment)

Individually analyzed efficiencies constituting unit efficiency, i.e. turbine and boiler efficiencies, showed that the latter had remained at or exceeded the design value from the operation start while the former had dropped considerably.

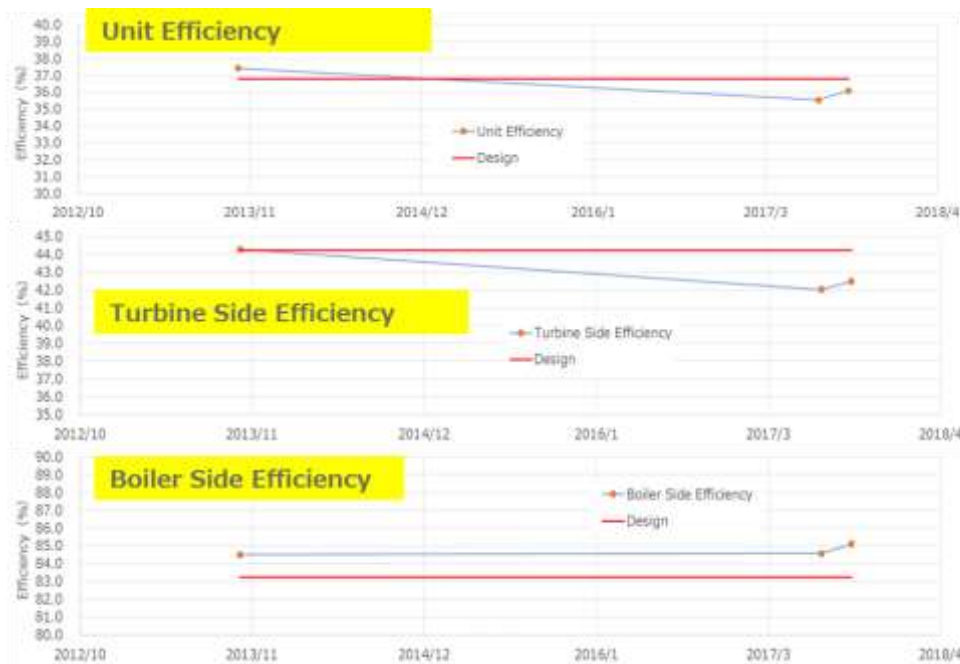
Figure 2-12 Actual performance and design value of the entire unit, turbine and boiler

Design	Guarantee test 2013/10/25	Before 2017 Inspection 2017/7/7	After 2017 Inspection 2017/9/15
Unit Efficiency	%	36.8	37.4	35.6	36.1
Turbine Side Efficiency	%	44.2	44.3	42.0	42.5
Boiler Side Efficiency	%	83.2	84.5	84.6	85.1

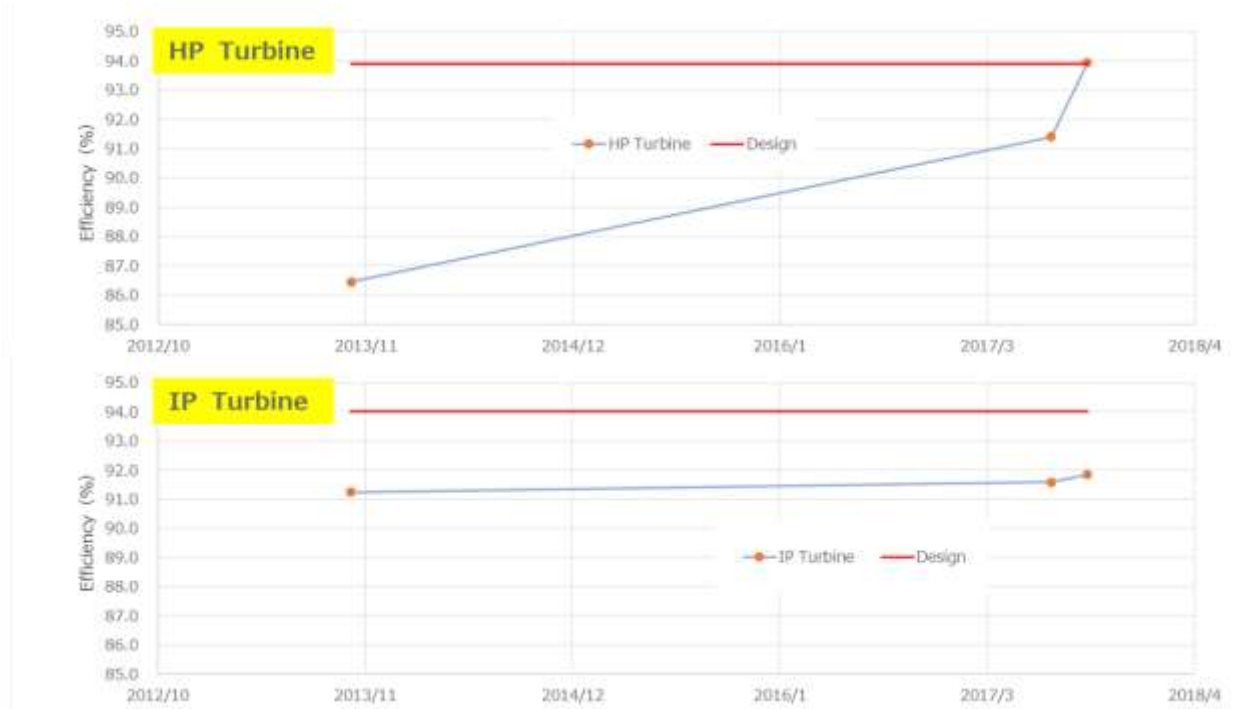
Figure 2-13 Performance of high- and intermediate-pressure turbines compared to the design value at operation start

Design	Guarantee test 2013/10/25	Before 2017 Inspection 2017/7/7	After 2017 Inspection 2017/9/15
HP Turbine Efficiency	%	93.9	86.5	91.4	93.9
IP Turbine Efficiency	%	94.0	91.3	91.6	91.9

Note: The performance at the operation start year (2013) was extremely low for both high- and intermediate-pressure turbines. Under normal circumstances, performance as low as this at the start of unit operation is unusual, hence the need to examine the accuracy of the data and the appropriateness of the measuring point choice.

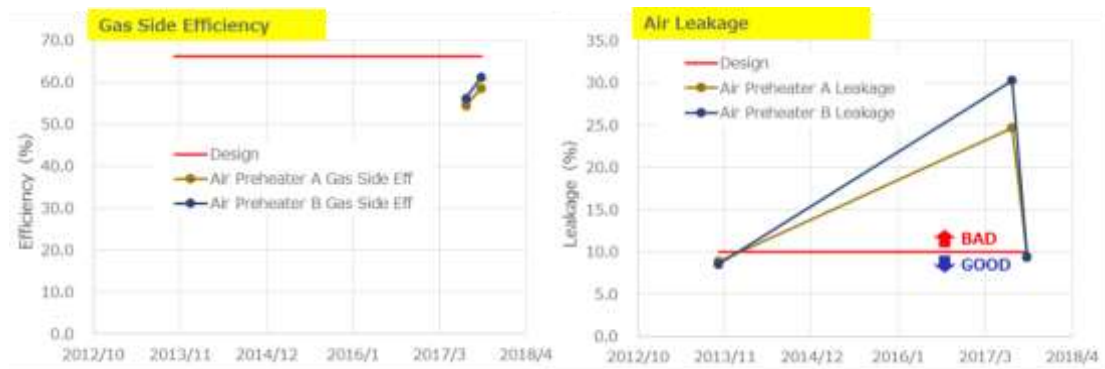
Figure 2-22 Transition and comparison with the design value of AH temperature efficiency and air leakage ratio

While the temperature efficiency and the air leakage ratio of air heater had declined since operation commenced, a periodic inspection carried out in 2017 showed that they had regained their design value.

The air heater functions to preheat combustion air via a heat exchange between the combustion exhaust gas generated in boiler and combustion air. Increased leakage from the combustion air side to that of exhaust gas will augment the forced draft fan load and result in loss of exhaust gas and a decline in efficiency.

From the data analysis made within this survey, it is inferred that there have been no leakages resulting in a boiler efficiency decrease and sealing properties were restored by the overhaul and repair carried out in the 2017 periodic inspection.

Design	Guarantee test	Before 2017Inspection	After 2017Inspection
			2013/10/25	2017/7/7	2017/9/15
Air Preheater A Gas Side Eff	%	66.2	-	54.4	58.61
Air Preheater B Gas Side Eff	%	66.2	-	56.11	61.24
Air Preheater A Leakage	%	10	8.90	24.69	9.48
Air Preheater B Leakage	%	10	8.57	30.29	9.33

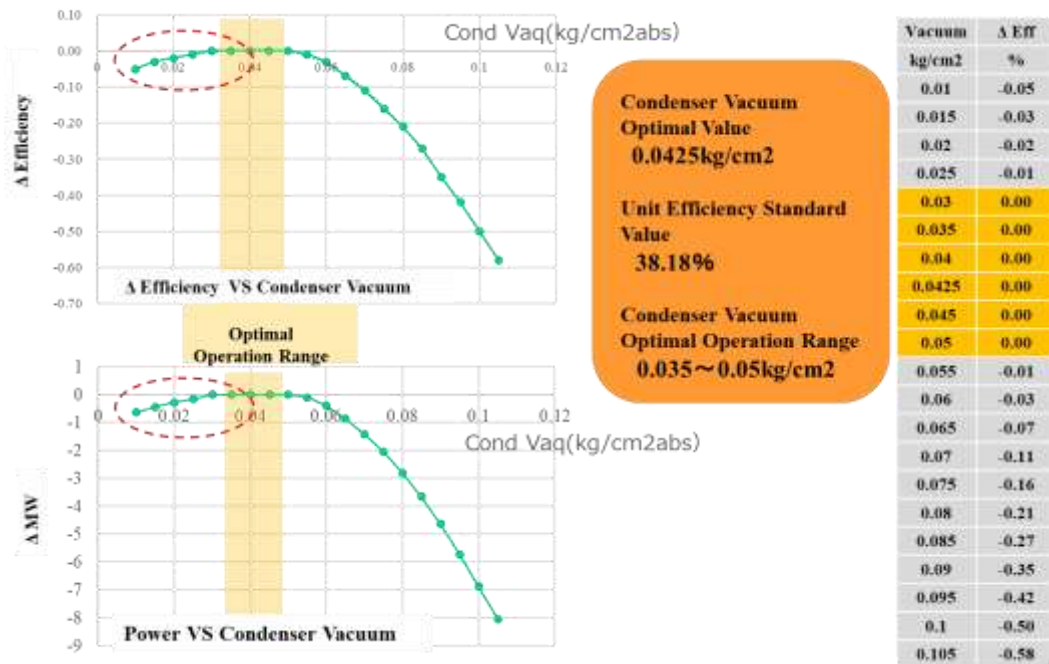
Figure 3-6 Correlation between the condenser vacuum degree and unit thermal efficiency

It was confirmed that the unit operates most efficiently when the vacuum is 0.04kg/cm² abs but loses efficiency when the vacuum exceeds this value due to an exhaust loss caused by the vacuum increase. Naturally, unit efficiency drops rapidly once the vacuum goes below 0.04kg/cm² abs. Therefore, efficient operation depends on controlling the vacuum degree to an optimal value in response to ever-changing external conditions.

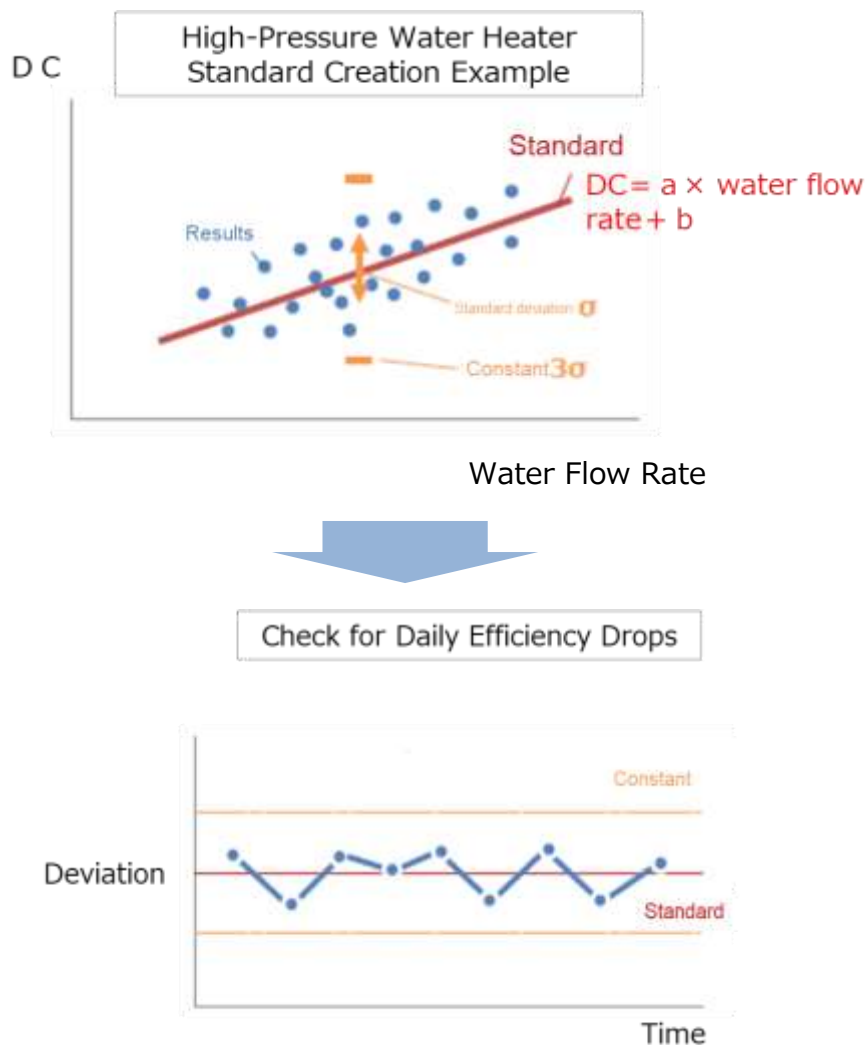
Figure 3-9 Image of more advanced performance management of a high-pressure feed-water heater

As shown in Figure 3-9, dispersion in performance and deviation from the reference performance values of a unit of equipment (or function) can be determined via graphs (visualization) prepared from operational data and performance data extracted through processing and totalizing those operational data.

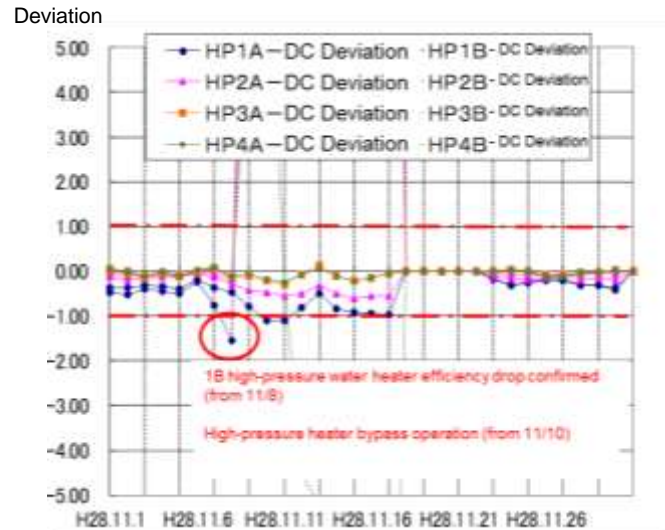
Figure 3-10 Trend of DC value among performance-monitoring parameters of a high-pressure heater

(1) Possible occurrence of some performance degradation was detected at an early stage, based on sudden changes in the performance-management parameters of a high-pressure feed-water heater.

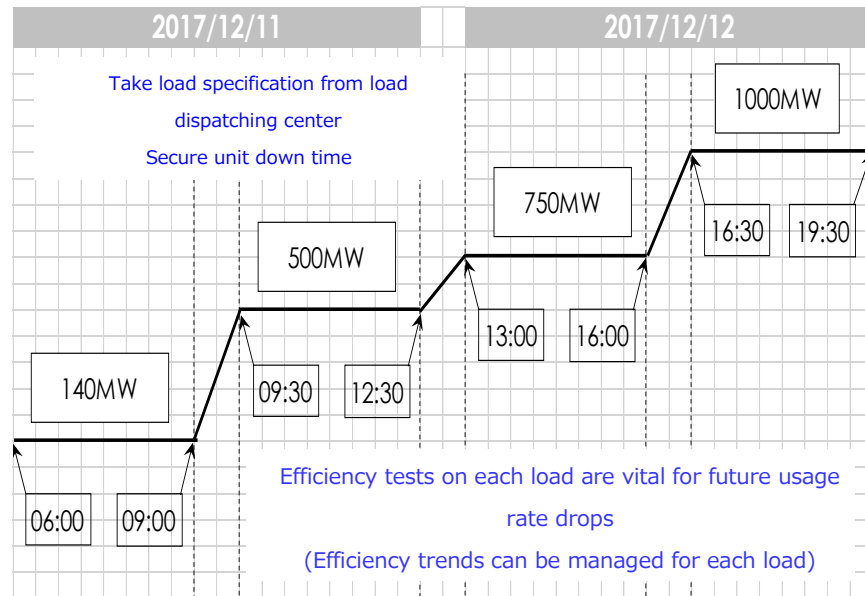
Figure 3-12 Example load assignment curve and output stabilization time for a performance test in TEPCO

Note: Equipment performances cannot be measured correctly when the condition is still fluctuating just after any change in output.

- (1) Securing an output stabilization time without receiving a load assignment from the load dispatching center.
- (2) Loads in performance test should be the same as those instructed during actual operation.

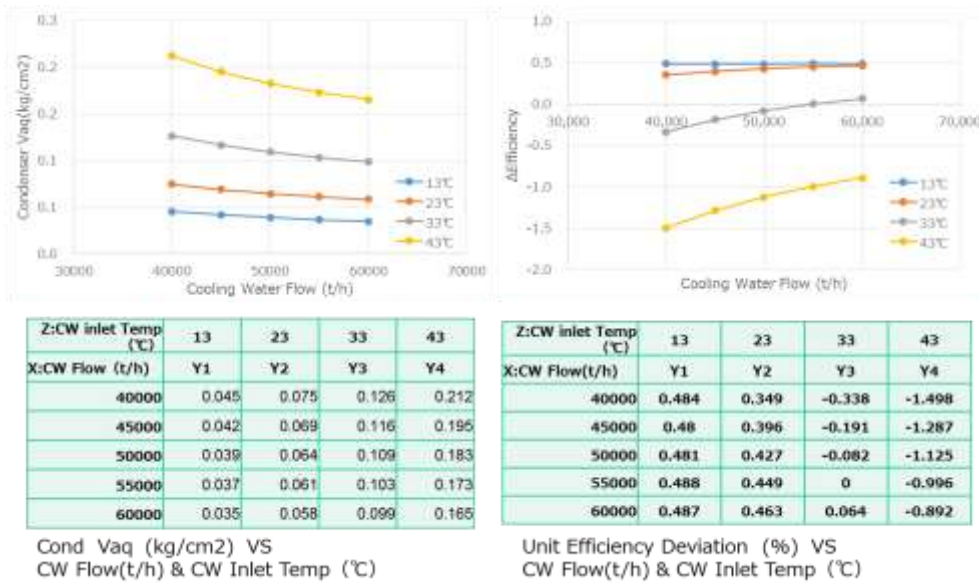
Figure 3-13 Design of temperature, pressure and optimal vacuum degree curve of condensate cooling water

Performance degradation due to condenser scaling and tube leaks will be detected at an early stage by implementing daily control of deviation from such “Reference”.
