SUB.:- Minutes of Meeting of Standing Committee of Experts to investigate the failure of 220 kV and above voltage class substation equipment held on 01.03.17 in CEA, New Delhi.

MINUTES OF MEETING OF THE STANDING COMMITTEE OF EXPERTS TO INVESTIGATE THE FAILURE OF 220 KV AND ABOVE VOLTAGE CLASS SUBSTATION EQUIPMENT HELD ON 01.03.2017 IN CEA, NEW DELHI, IN CONNECTION WITH REPORTED FAILURES FROM SEPTEMBER 2015 TO DECEMBER 2016 AT VARIOUS SUBSTATIONS IN THE COUNTRY

Condition Monitoring of EHV Instrument Transformers & Surge Arresters

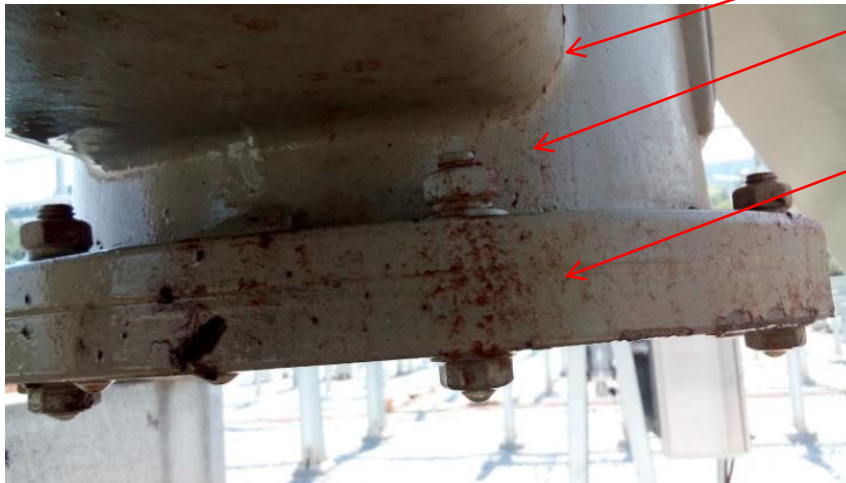
Check for oil leakage during service

- The oil leakage needs to be checked periodically

- at the welded joints (Fabrication)
- on the walls & joints (castings)
- at the sealing joints

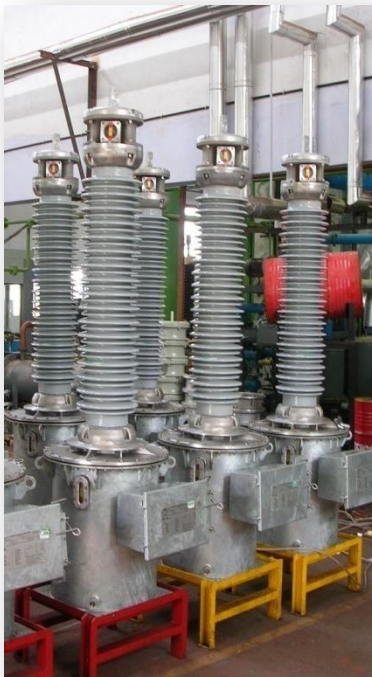
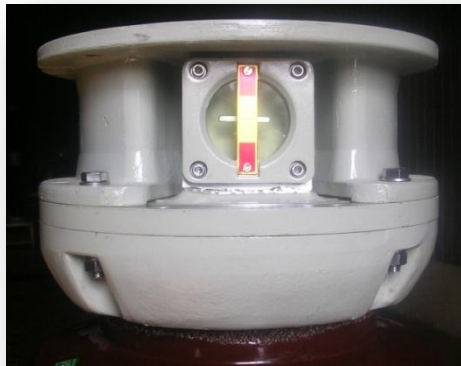
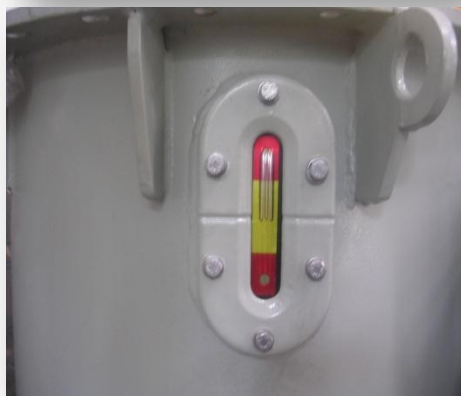
Bellow Function : CVT

- Compensates for the volumetric variation in oil volume due to temp. variation
- Maintains the desired pressure within the product & enhances PD inception voltage

Case A :

- All CVTs' Capacitor units & EMU units in the same bay have same oil level indication at any time
- **Conclusion :**
 - **Everything is normal**

- A Capacitor unit's indication is abnormally either lower or higher than others.
- **Conclusion :**
 - **Lower Leaking**
 - **Higher Gassing**

- A Capacitor unit's (on EMU) indication is lower & EMU unit's indication is higher than others.
- **Conclusion :**
 - **CC unit Leaking**

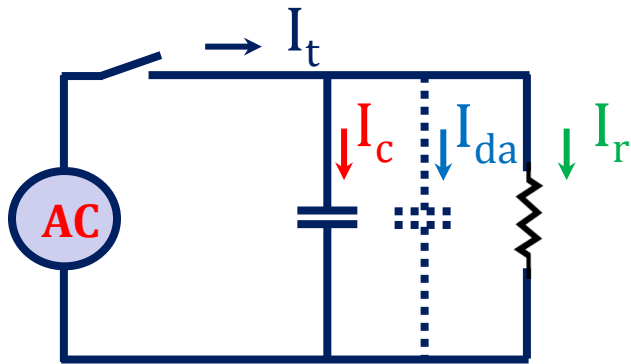
Insulation Model :

- The behavior under DC (IR) with 'time' is used as Polarization Index

▪ where,

- I_c = capacitive current
- I_{da} = dielectric absorption current
- I_r = loss current

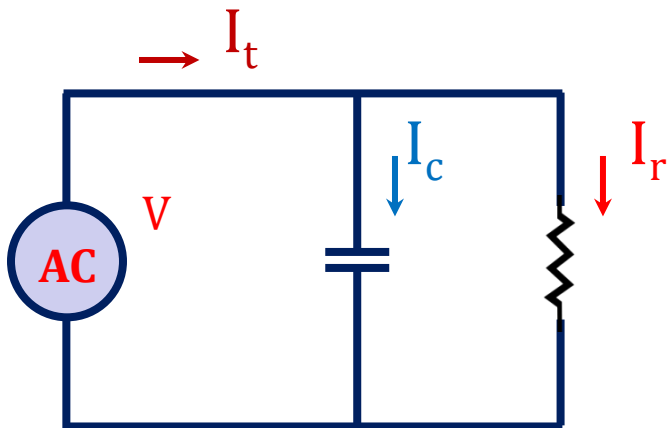
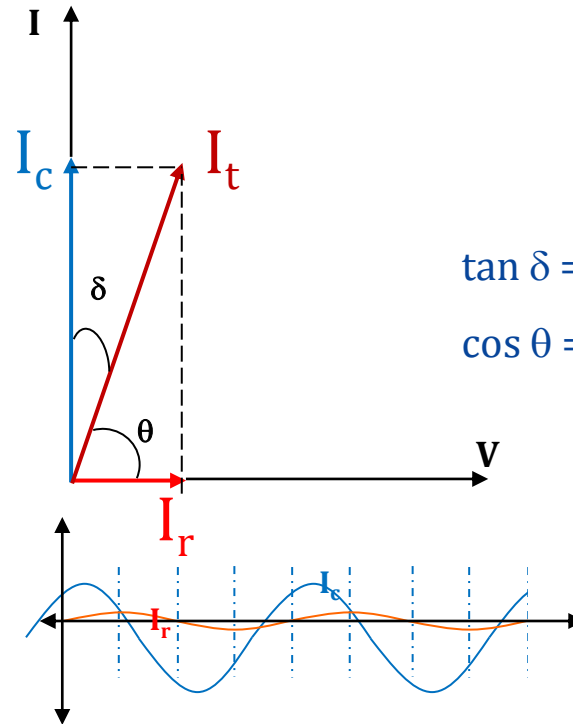
Insulation behavior under AC :

- A dielectric can be modeled as a capacitor in parallel with a resistor for AC behavior

$$\tan \delta = I_r / I_c = 1 / \omega CR$$

$$\cos \theta = I_r / I_t$$

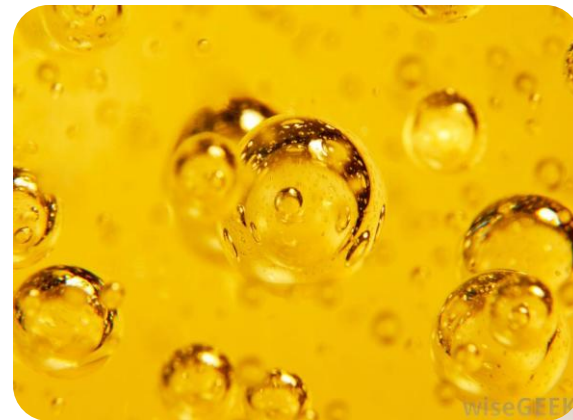
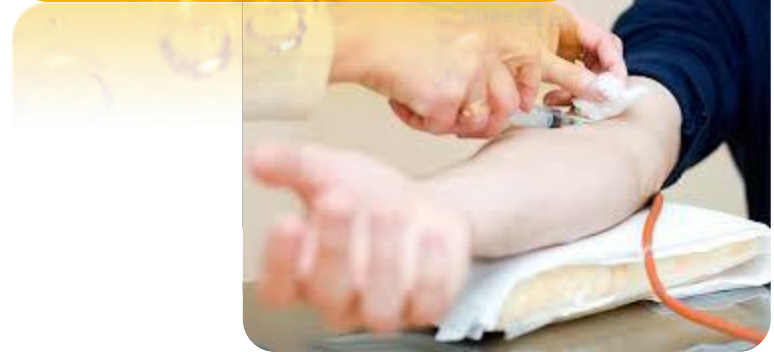
DGA

Different service conditions generate different gases in the product and they get **dissolved** in the oil ...

Gas Generation & Key gases

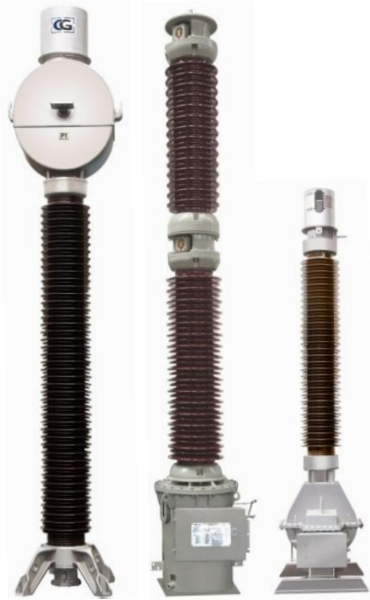
EHV Instrument Transformers

- Unlike Power Transformers, EHV ITs are hermetically sealed products and with low qty of oil within. Hence separate oil testing should be considered only if absolutely necessary

Caution :

- Oil (500 ml) can be taken out from only CT, IVT or EMU
 - No oil should be taken out from CC units
 - Oil should be taken out with proper instrumentations
-
- DGA in ITs to be done only if necessary as a confirmatory test, when normal monitoring tests indicate a problem

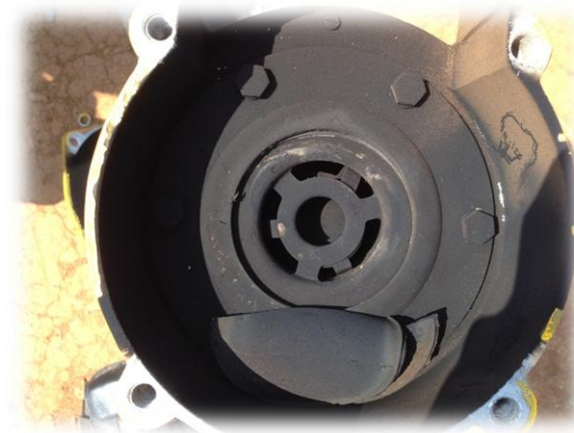
LA

In simple terms.....

$$\begin{array}{l} \text{Total Energy} \\ \text{(input at the terminal)} \end{array} = \begin{array}{l} \text{Diverted} \\ \text{(no worry)} \end{array} + \begin{array}{l} \text{Absorbed} \\ \text{(Hot ZnO blocks)} \end{array} + \begin{array}{l} \text{Passed On} \\ \text{(to be withstood)} \end{array}$$

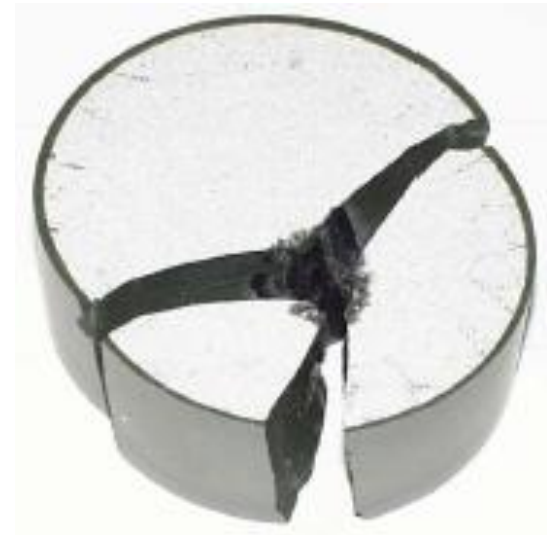
The block has to withstand the impulse energy without failing .

- Cracking : due to huge thermal stresses
- Puncture : due to Current concentration

▪ Known as **Energy Absorption Capability**

▪ It is the energy in joules (current density, or amp seconds) and duration of energy injection, required to damage an arrester permanently. The damage can be at a macroscopic level or a microscopic level.

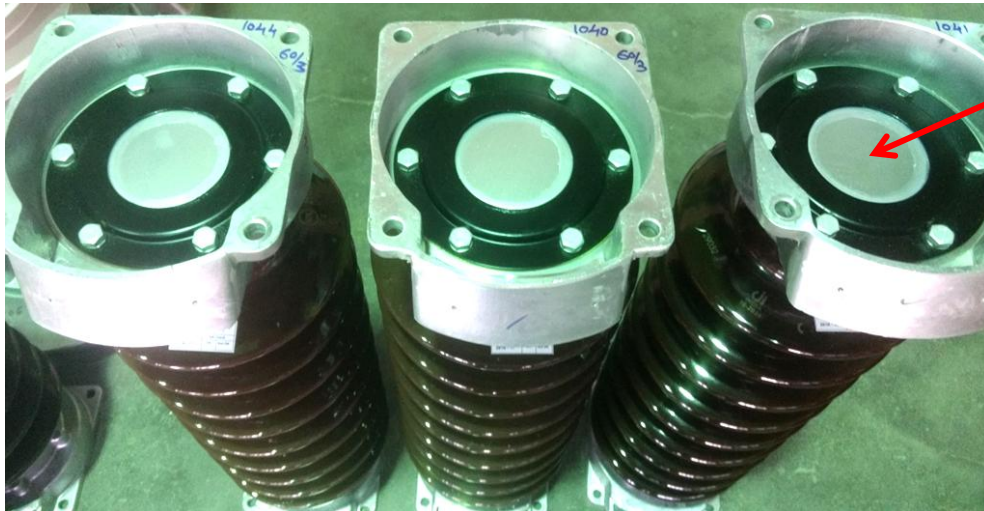
PRD condition : LA

- Pressure relief diaphragm ruptures when the internal pressure exceeds due to SA failure
- Any damage to this thin & sensitive material while handling & erecting will result into moisture entry into Arrester, which will lead to SA failure.

Pressure relief diaphragm

- If SA is kept on a uneven surface , it is likely to damage this PR diaphragm

- Check the condition before erecting the Arrester unit
- Ensure no damage during erection

- (h) Before erection, the condition of the Arrester unit should be checked and it should be ensured that there is no damage during erection. If SA is kept on an uneven surface, it is likely to damage the pressure relief diaphragm. Any damage to this thin & sensitive material while handling & erecting will result into moisture entry into Surge Arrester, which will lead to its failure.

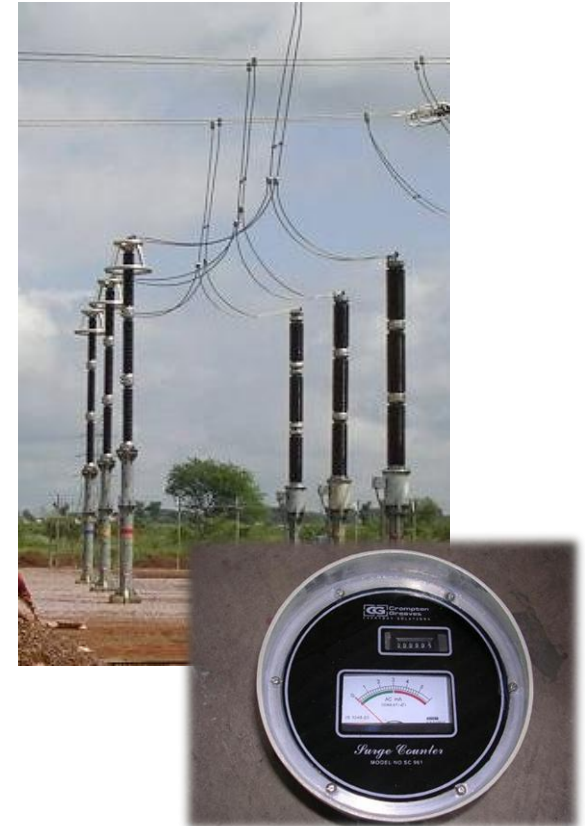
- Most primitive type of indication
- It just indicates the no. of times the SA operated
- If the SA failed, without even any conduction, it can point towards some conclusions, like moisture ingress & PD

B : Leakage Current :

- It indicates the total leakage current
- If there is any degradation in the ZnO blocks, for any reason, can indicate the integrity of the blocks
- It is still a primitive type of health monitoring

- (j) Monitoring of Leakage Current and IR value are essential for accessing the healthiness of Surge Arrestors (SAs). Measurement of the 3rd harmonic resistive component of leakage current is a very good method for assessing healthiness of SA which can be done on-line. If 3rd harmonic component of resistive current is more than 150 μ A then Insulation Resistance (IR) value test should also be conducted and if current exceeds 350 μ A then LA should be removed from service and replaced. The measurement of leakage current before and after the monsoon should be carried out so as to ascertain the effect of moisture.

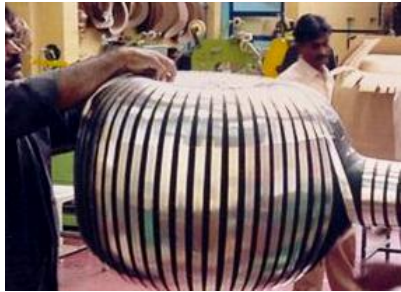
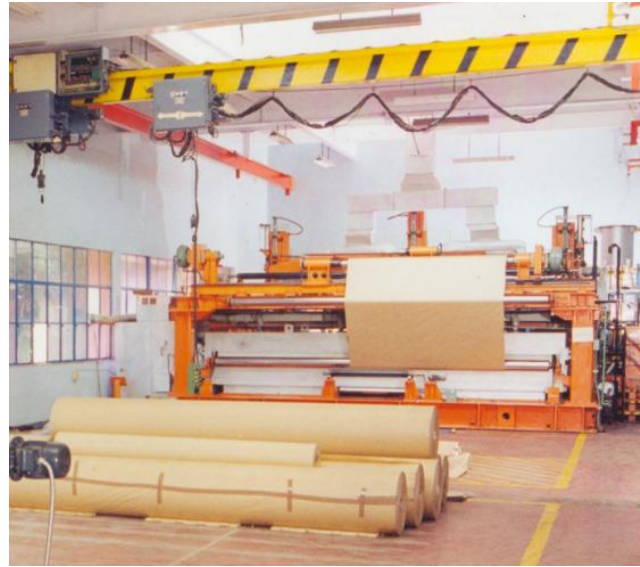
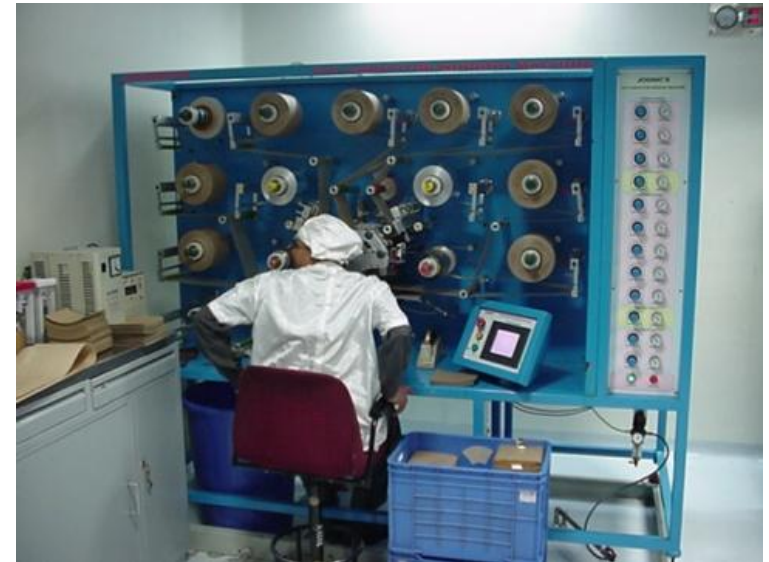
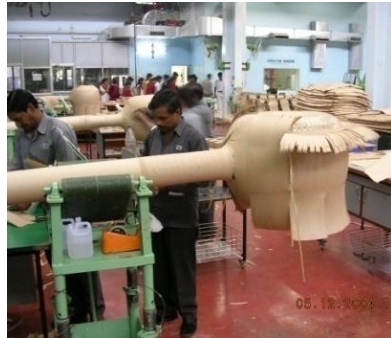
Feature : Fine & Uniform electrical grading

➤ The life of HV product is defined by the manufacture of High Voltage insulation

High degree sophistication is required in the manufacture of HV insulation

- Numerically controlled winding m/c to insert many no.of field control foils
- Manufacture of head insulation requires intricate & fine control of contours
- Clean and environmentally controlled clean rooms for insulation building

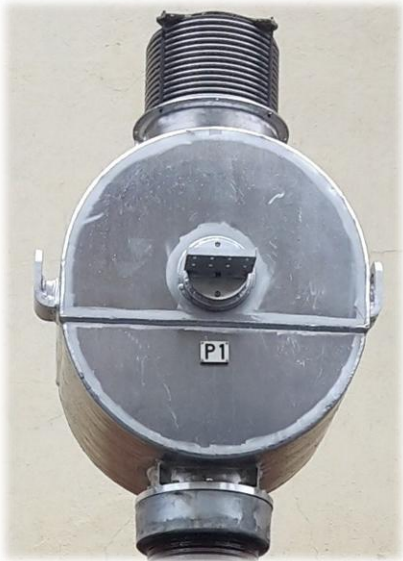
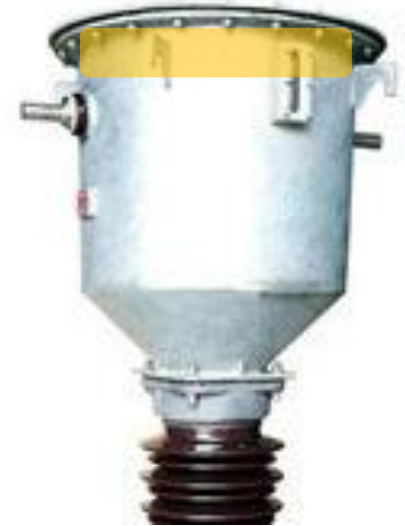
- Gas pressure is depended on the product oil volume
 - However, the gas gets absorbed into oil during hot temperature conditions, till oil saturates
 - When the product cools down, the absorbed gas is liberated as bubbles
 - If the gas volume (bubble), which is of low dielectric constant is near a high electric stress zone, they breakdown resulting into PD
 - This can multiply and eventually lead to a pressure build up and ultimate failure
- (most of these failures will happen at early mornings,
after a hot day)

- **Since bellow is fully filled with only oil, the above phenomenon does not happen and hence the PD inception voltage is always higher & hence longer Life**

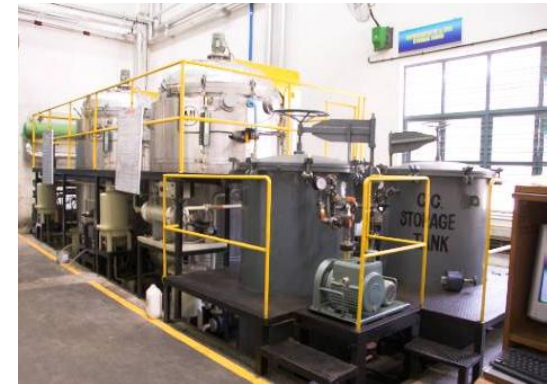
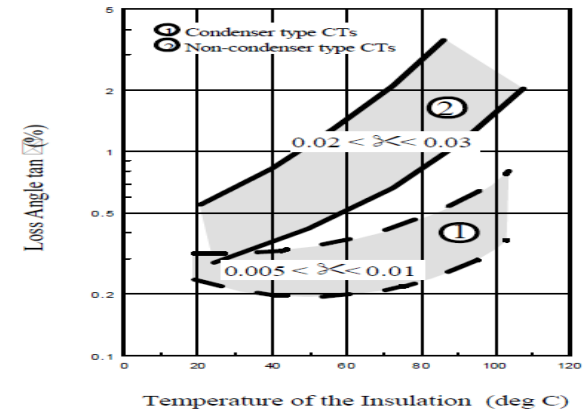
- One of the main reasons for HV product failure is the presence of moisture
- The method used for paper processing & subsequent assembly process used, determine the start of life
- Moisture migration between paper and oil is a phenomenon that can affect insulation at service. Hence paper & oil needs careful processing before impregnation.
- **Tan Delta of < 0.35 % at Um ...** A best insulation condition for a fresh unit

- **Negligible variation in measured Tan delta, between 10 kV - Um , indicates a well processed unit**

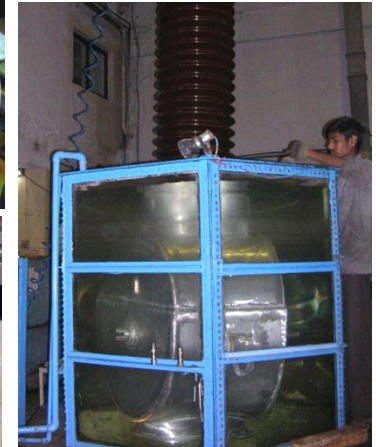
- One of the main reasons for HV product failure is the ingress of moisture
- Can be ensured by
 - Selection of sealing material
 - Designed O- rings & machined O ring grooves
 - Method of component leak testing (Helium leak test of critical component is necessary)
 - Method of complete product leak testing
- **Un-machined surfaces, poor sealing materials like cork gaskets, reduce the life of OIP products**

• Selection of sealing material & design of sealing surfaces is a crucial requirement for longer life

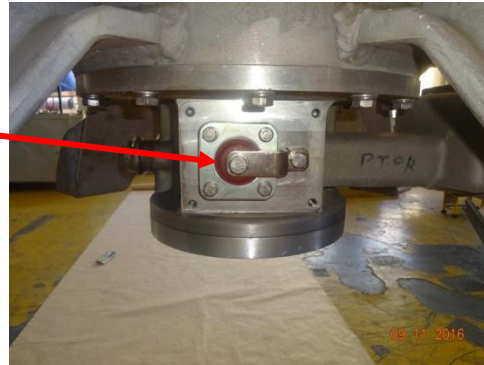
- Exclusive **HEAD** insulation checking terminal
(also designed to divert fault current)

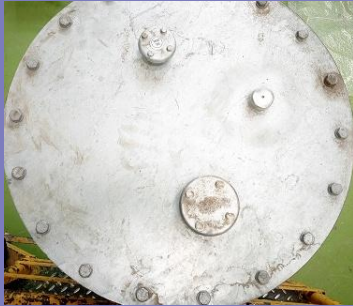
- Cycle valve for pressure release ... Poor sealing

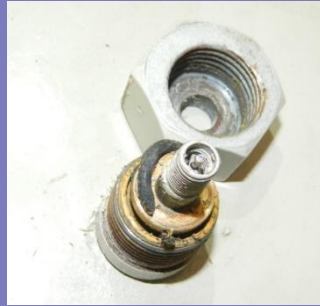
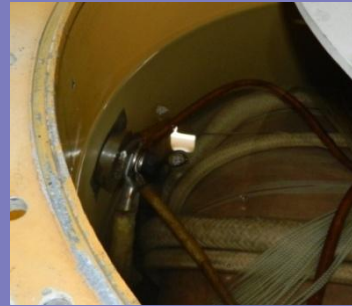
- Gas Cushion

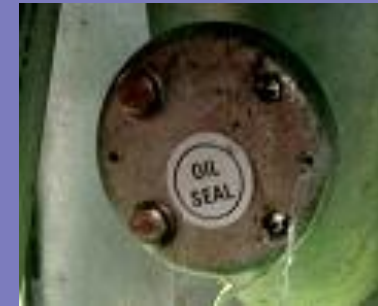
- Oil sampling valve ?
- Rusted already

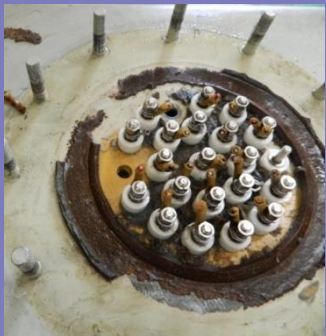
- Not machined sealing surface

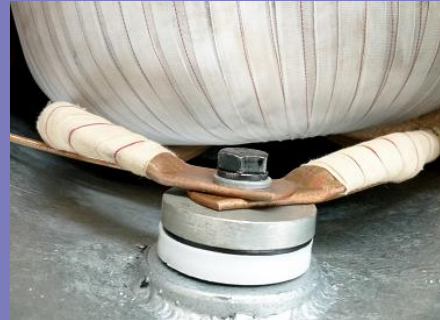
- MS bolt at current carrying junction

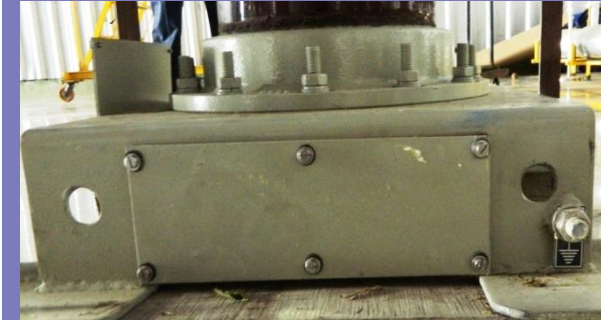
- Bolt Projection... Poor HV design
