Renovation & Modernisation of Kopili Hydro Electric Plant; NEEPCO

The Back ground, Execution, hurdles and Performance

M S JYRWA

ED(O&M) NEEPCO Ltd.

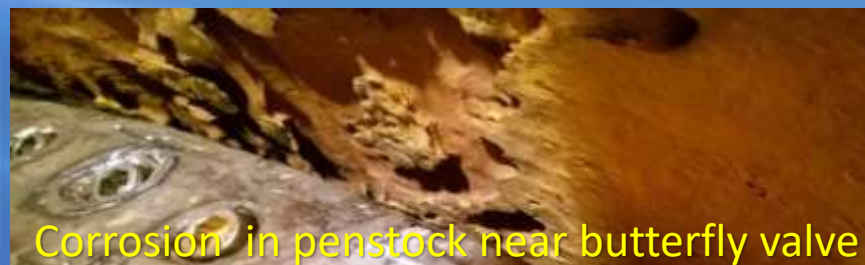
Corrosion in penstock near butterfly valve

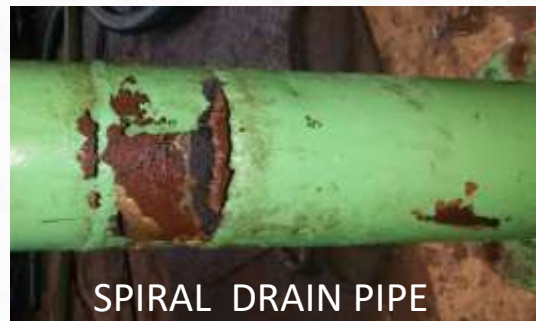
SPIRAL DRAIN PIPE

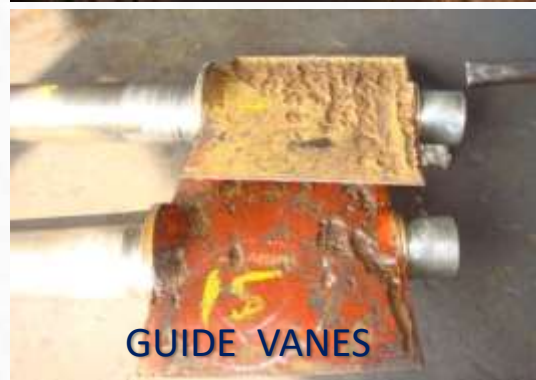
GUIDE VANES

- ✓ *All Dismantle-able under water parts were converted to Stainless Steel (Primarily ASTM 304 grade)*
- ✓ *Stay Ring , Stay Vane, guard Pipe etc. was 'TILED' with 3 mm SS Sheets*
- ✓ *Draft Tube liner converted to SS*
- ✓ *All Cooling water piping and Valves were also converted to SS*
- ✓ *Eroded Turbine Shafts were built up with 309L electrode, and then machined to size.*
- ✓ *MIV doors were tiled with SS plate*
- ✓ *Wherever Possible, slightly smaller size pipes were inserted into embedded pipes*

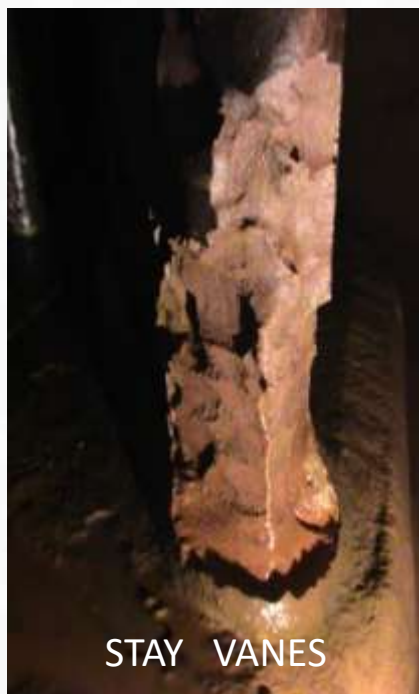
STAY VANES

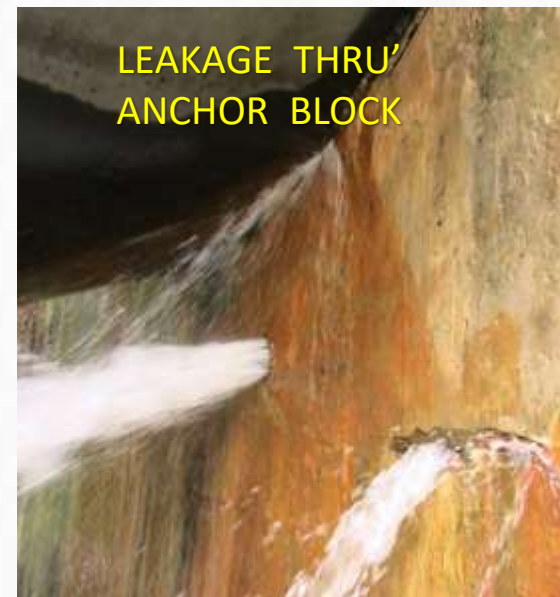
LEAKAGE THRU' ANCHOR BLOCK

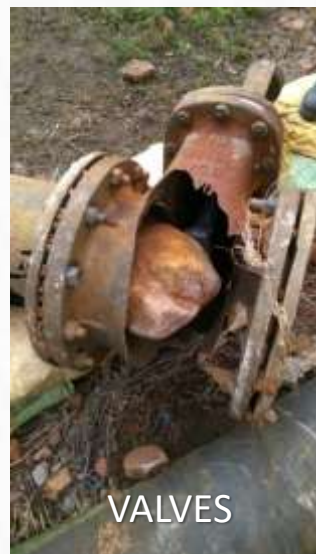
VALVES

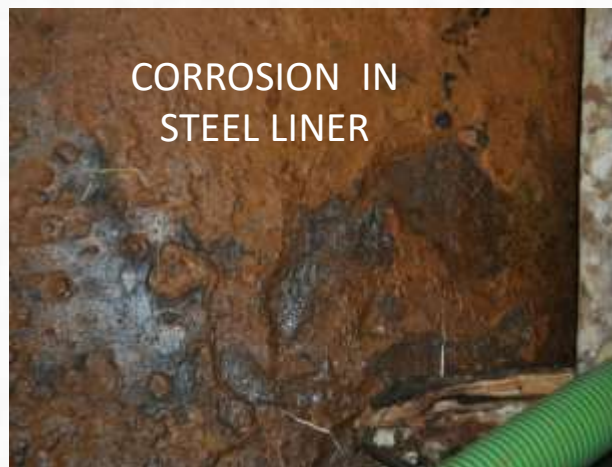
CORROSION IN STEEL LINER

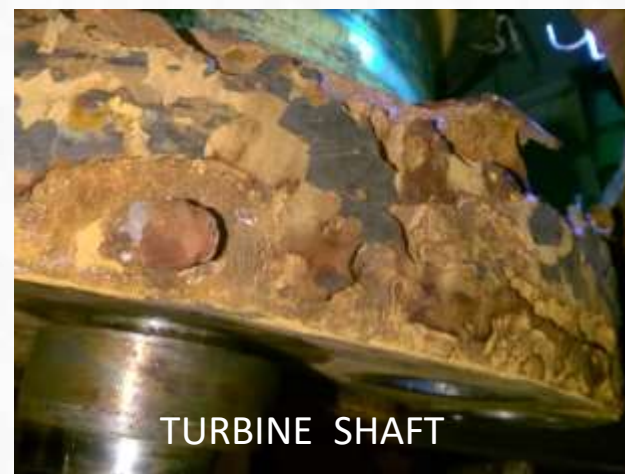
TURBINE SHAFT

- New MIVs of suitable grade of SS are being procured
- Specifications are being finalised for Stainless Steel Turbine Shaft

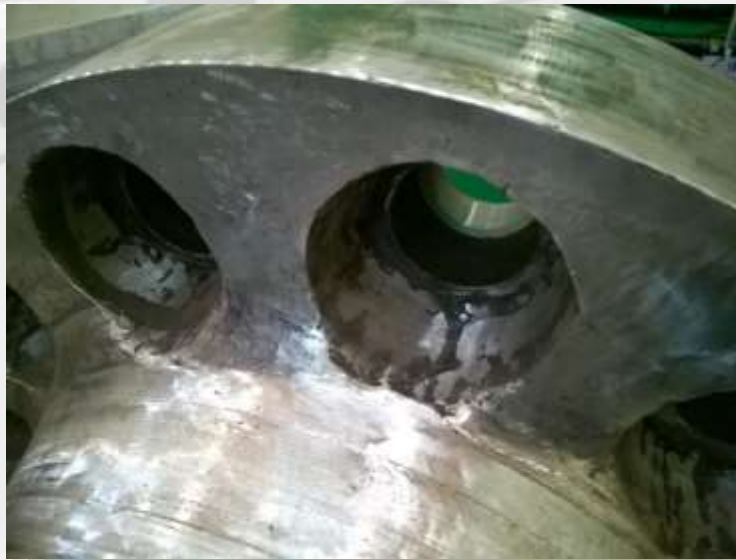
REPAIRED TURBINE SHAFT

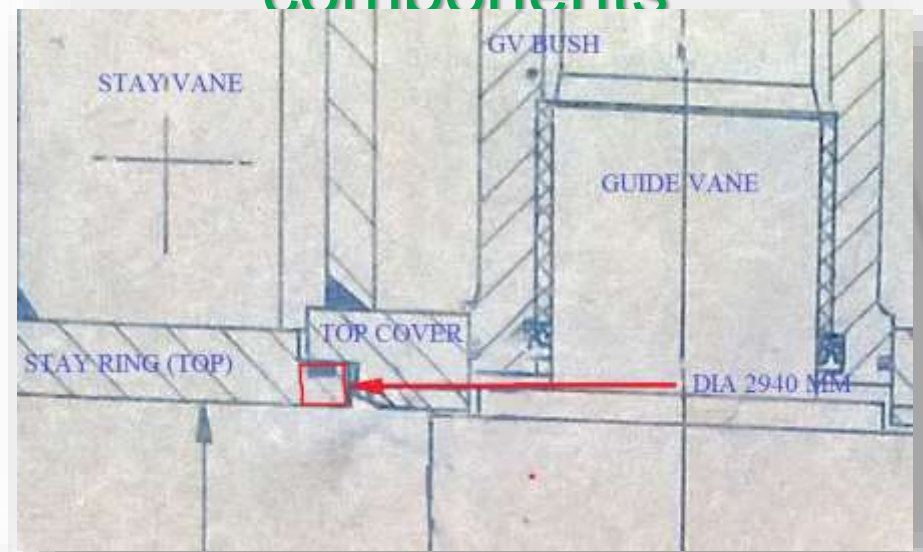
REPAIRING OF TOP COVER SITTING AREA

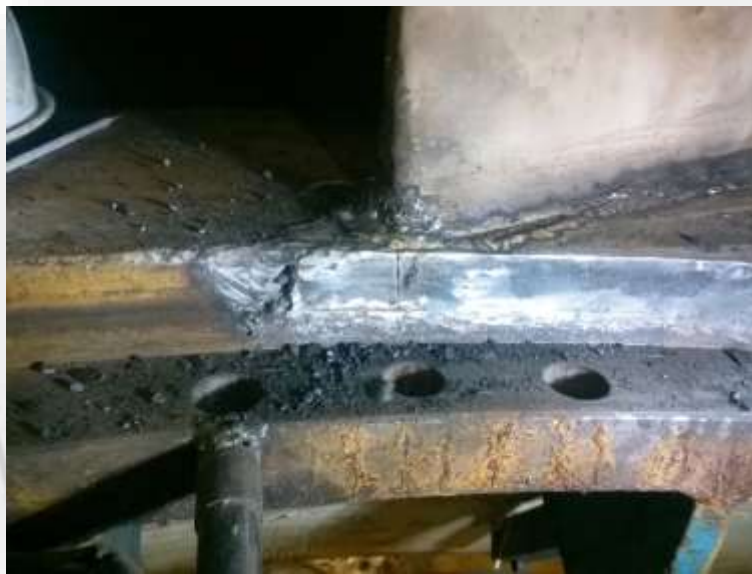
PIVOT RING SITTING AREA OF STAY RING

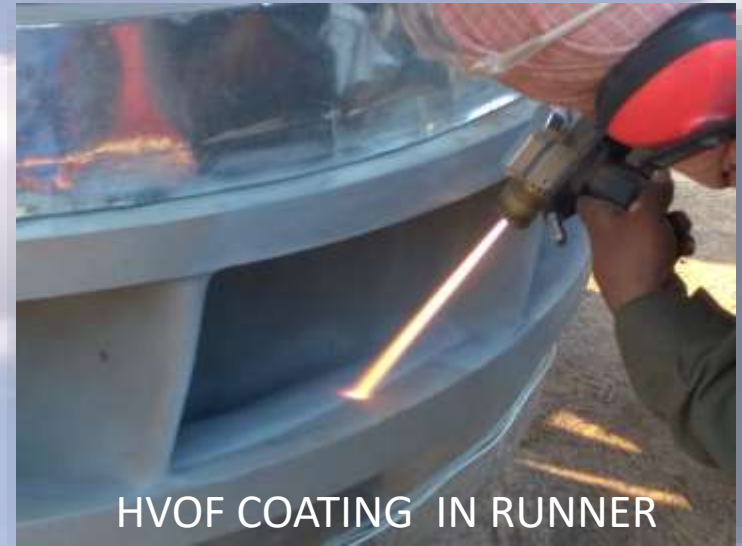
HVOF COATING IN RUNNER

- **HVOF**
- **Loctite Nordbak brush able ceramic (2 coats of 500-600 micron)**

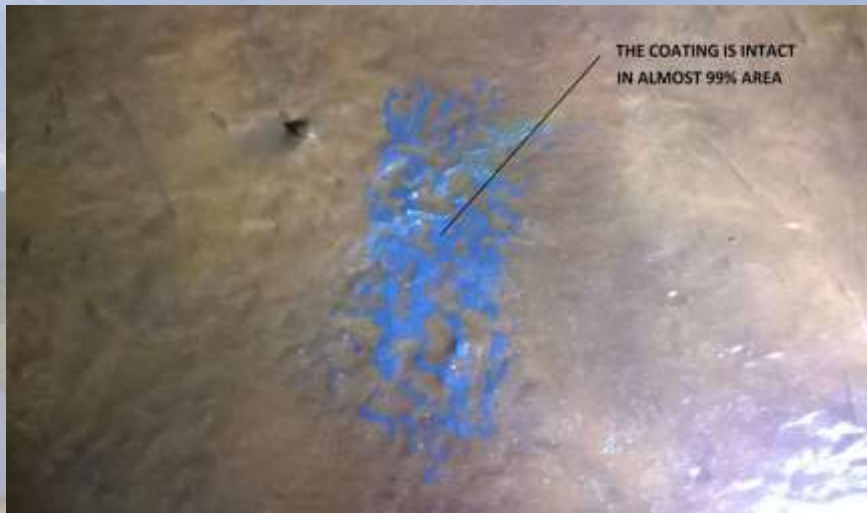
INSPECTION OF SPIRAL AFTER ONE YEAR OF APPLICATION OF LOCTITE COATING
