# **Report of the Committee on Addressing Insulator Failures on Transmission Lines**

**Government of India  
Ministry of Power  
Central Electricity Authority  
May, 2026**

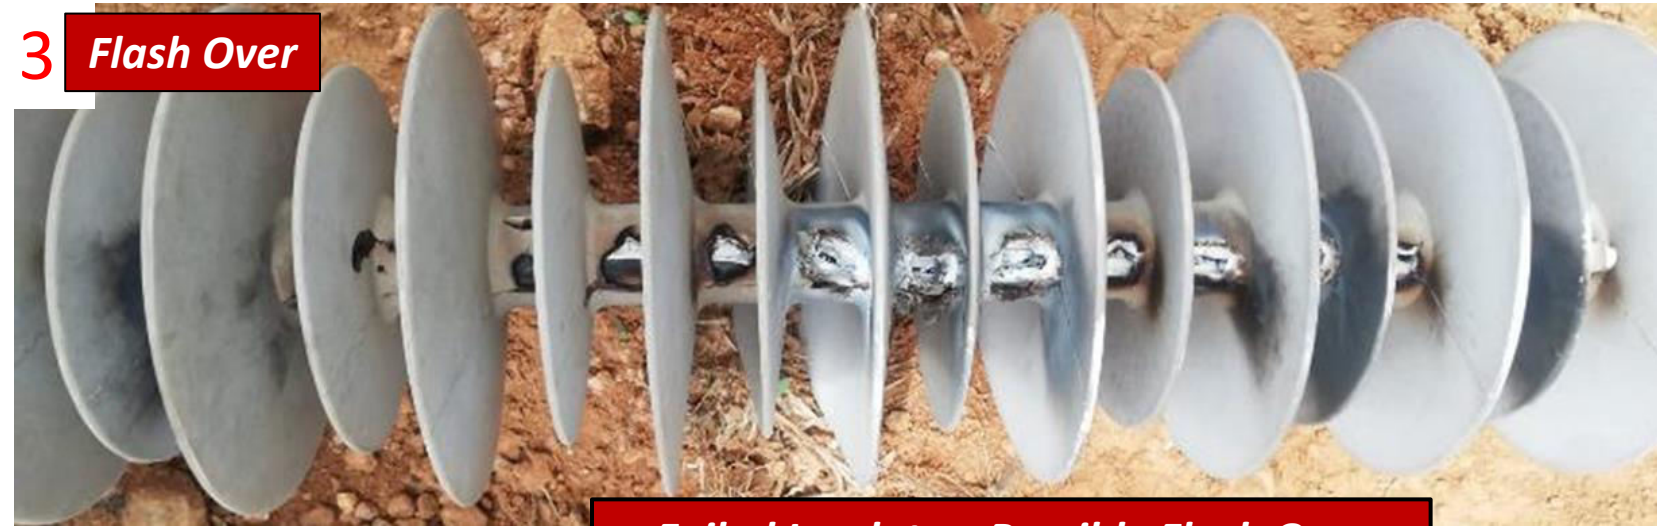
## 3 Flash Over

**Failed Insulator: Possibly Flash Over**

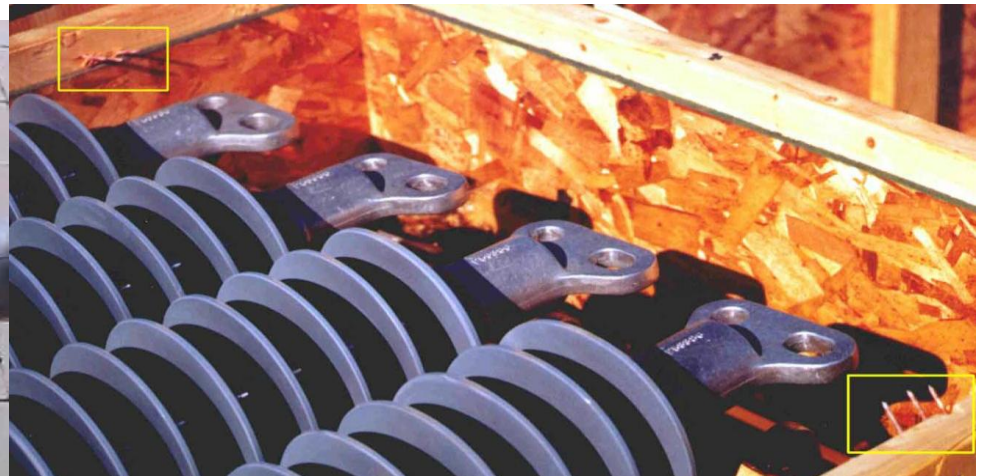
**Nails protruding from a crate can lead to insulator damage**

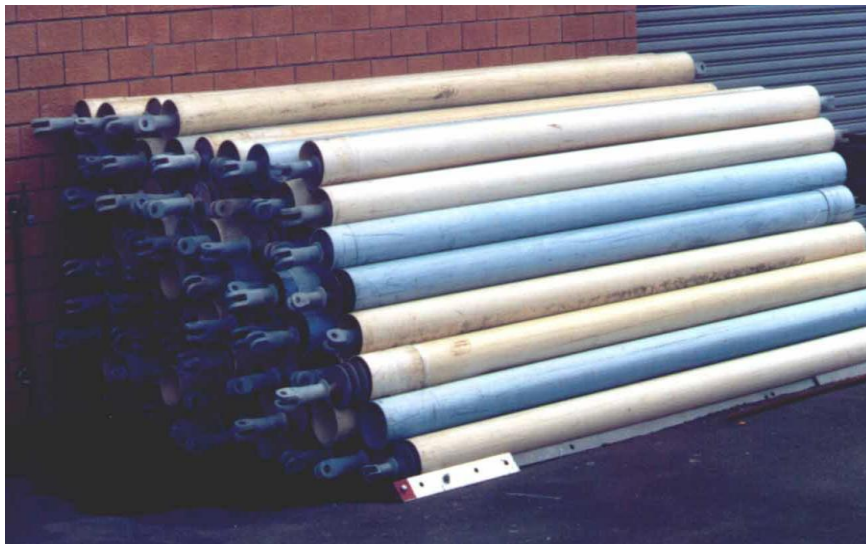
**Insulators stored in plastic pipes**

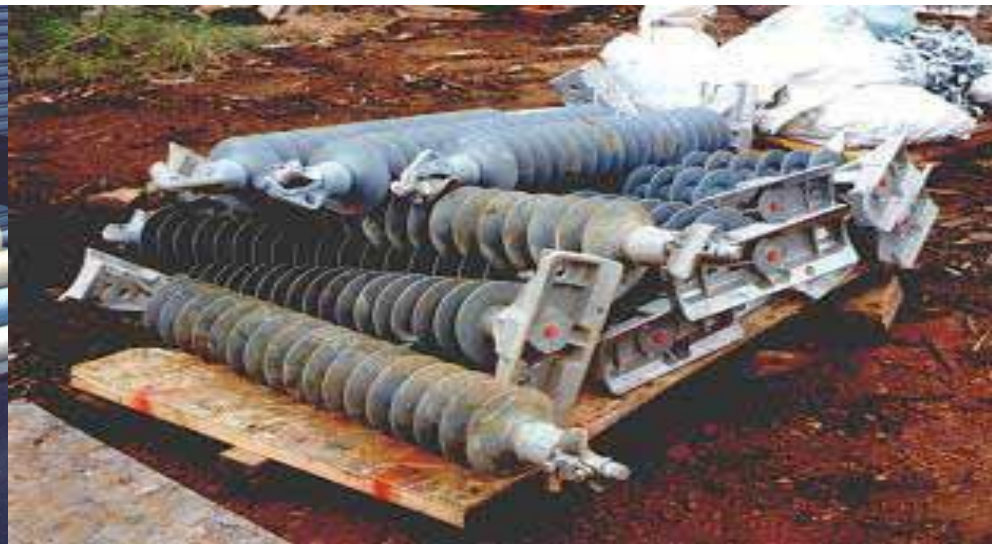
**Poor stacking and storage**

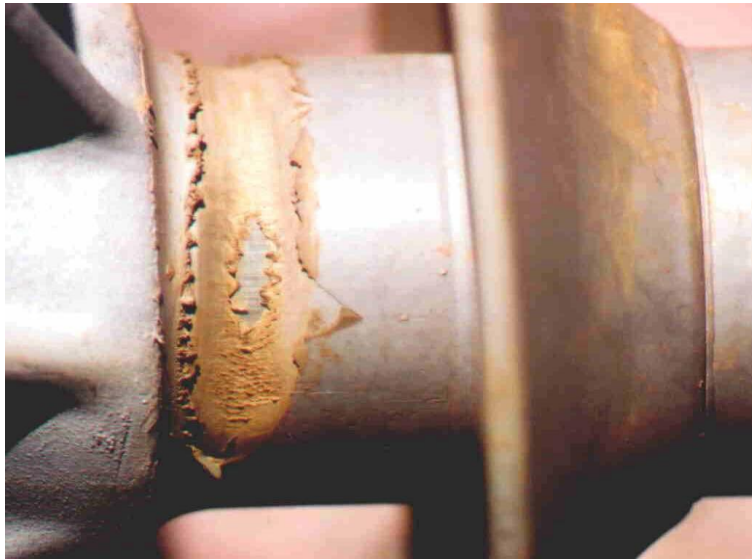
**Sheath damage due to rope abrasion**
