**भारत सरकार/ Government of India**  
**विद्युत मंत्रालय/ Ministry of Power**  
**केन्द्रीय विद्युत प्राधिकरण/ Central Electricity Authority**  
**विद्युत प्रणाली अभियांत्रिकी एवं प्रौद्योगिकी विकास प्रभाग**  
**Power System Engineering & Technology Development Division**

**विषय:** Minutes of the meeting of the Standing Committee of the Experts to discuss the failure of 220 kV and above voltage level Transformers during period of July, 2025 to December, 2025 -reg.

### Minutes of the meeting of the Standing Committee of the Experts to discuss the failure of 220 kV and above voltage level Transformers during period of July, 2025 to December, 2025 -reg.

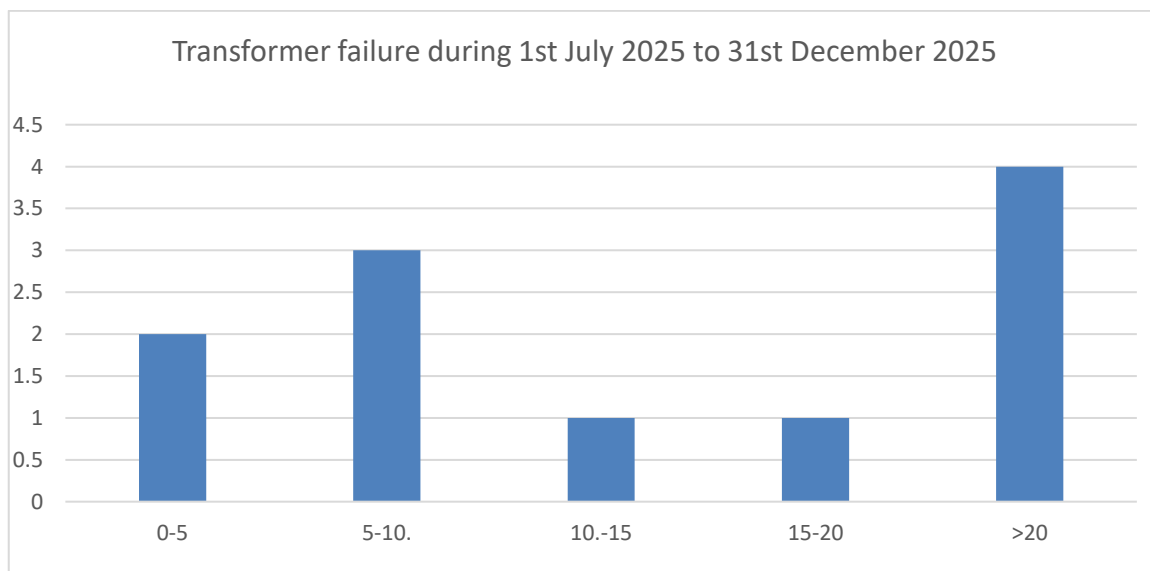
4. Out of total 11 failures of the Transformers occurred, 8 were of 220 kV class, 3 of 400 kV class and none of 765 class. Two Nos. of Transformers failed within five years, three Nos. of Transformers failed in 5-10 years of period. Two Nos. of Transformers failed during 10-20 years of their operation. Four Nos. of Transformers failed who had operation of more than 20 years. The transformers failures that occurred between 1st July 2025 and 31st December 2025 from the commissioning of the equipment is as per the below graph below:

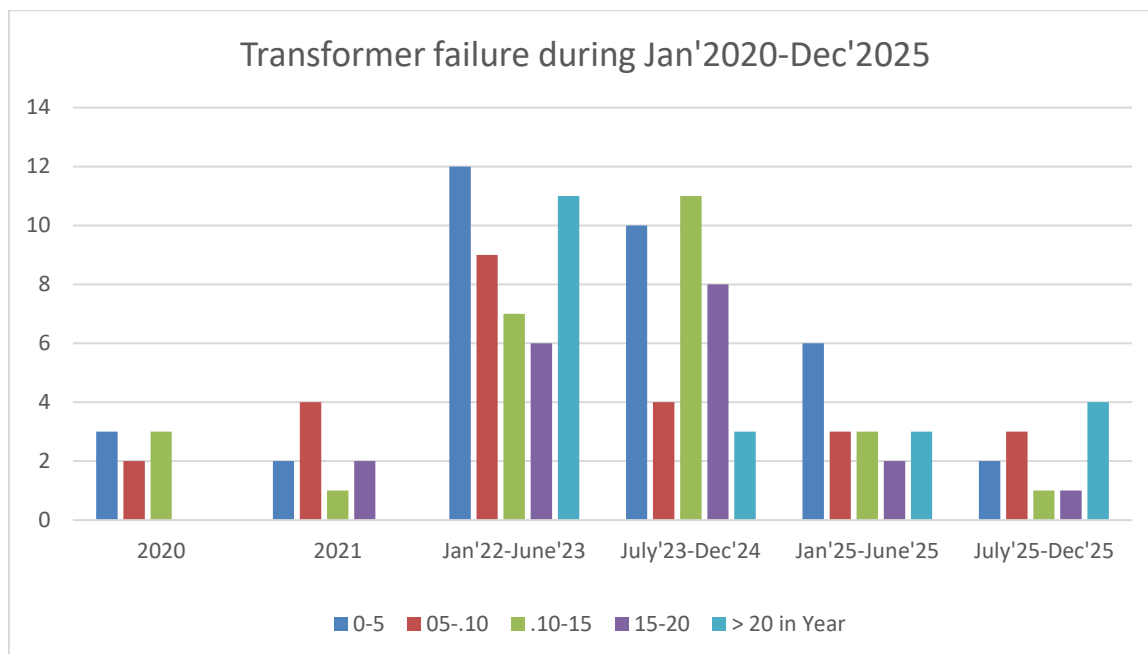
1. Failures of transformers during Jan'2020-Dec'2025: The number of different transformer failures as reported in the last 6.5 years to CEA has been shown in the graph below:
