**विषय: Report of the Standing Committee of Experts on failure of EHV transmission towers failed during the period January 2022 to December 2023-reg.**

**REPORT OF THE STANDING COMMITTEE OF EXPERTS ON  
FAILURE OF EHV TRANSMISSION TOWERS  
(JANUARY 2022 - DECEMBER 2023)**

### A.1 400 kV S/C Gooty-Somanhalli Transmission line failed on 8.05.2022

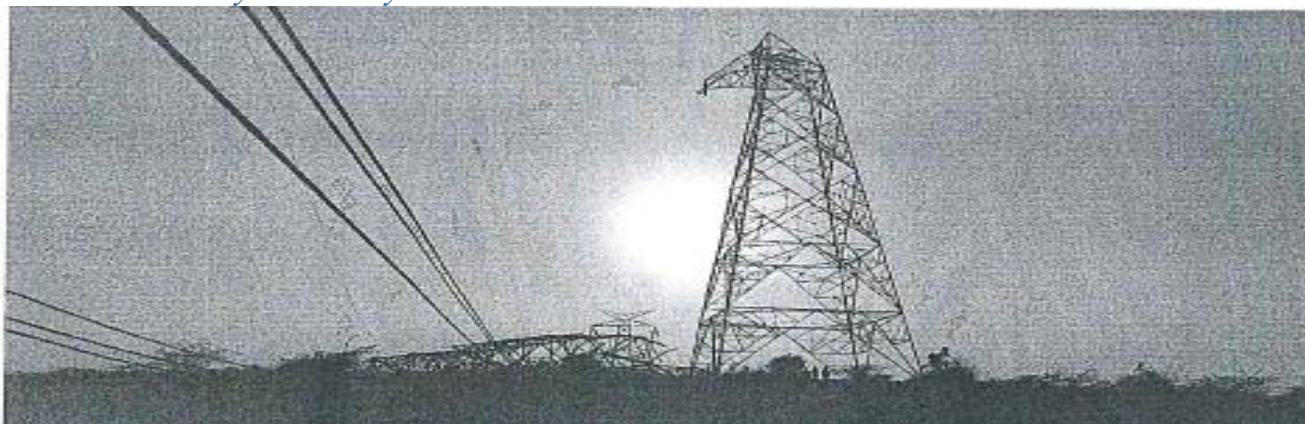
| | 2 | 1080 | DA+9 | 265 | NIL | <ul style="list-style-type: none"> <li>• Tower damaged partially as shown in Figs 4(d), 4(e), 4(f), 4(g).</li> <li>• All the four stubs of the tower along with foundation and chimney were intact.</li> <li>• Tower broken above bottom cross arm.</li> <li>• Anti-climbing device, name plate and phase sequence plate was missing.</li> <li>• Nut-bolt and many members of tower were missing from bottom part.</li> </ul> |

**Fig 4(e). Tower at Location No.: 1080 (DA+9)**

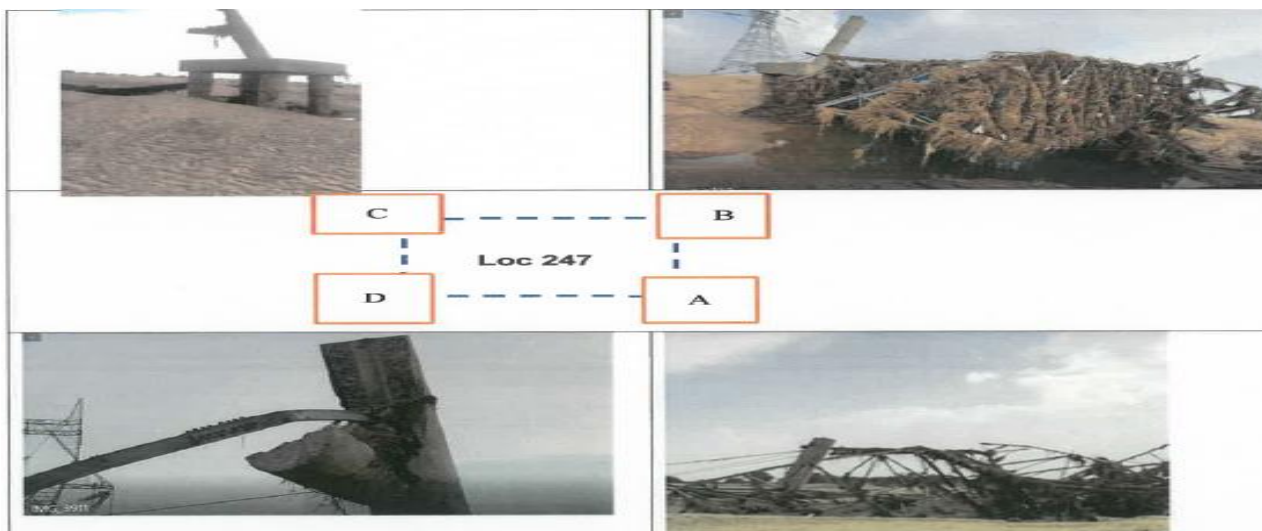
**Fig 5(b). Tower at Location No.: 247 (D+25)-Leg Positions**

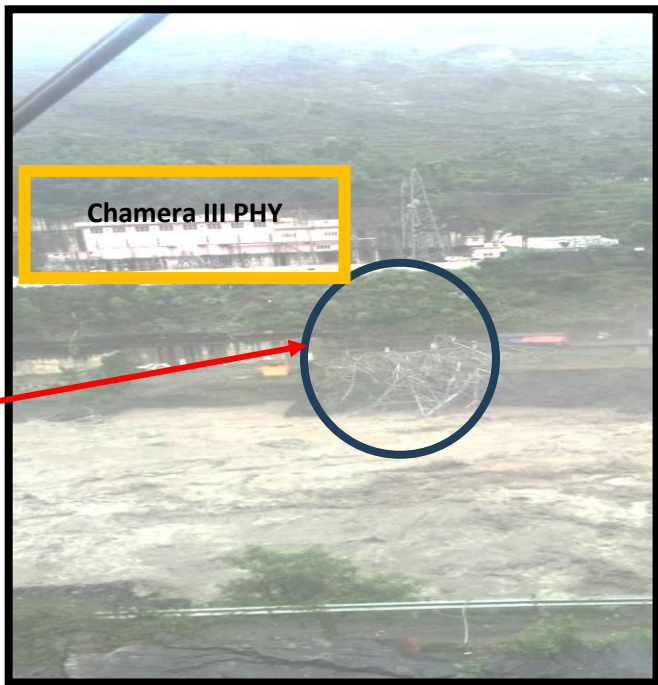
| 30) | Brief Description of failure:<br>[along with photographs(if available), other related information like tower schedule, newspaper clipping for cyclone / wind storm etc.] | <p><b>Tower No: 01:</b></p> <ul style="list-style-type: none"> <li>• Tension Type, DD+9 (Dead end tower at Chamera III HEP) Collapsed completely also damaging the gantry of Chamera III</li> <li>• Tower collapsed completely owing to flashfloods in Ravi River which took away the base of the foundation along with the protection walls. Flash floods exacerbated due to extensive water released from Chamera III added on by flash floods.</li> </ul> <p><b>Tower No: 02:</b></p> <ul style="list-style-type: none"> <li>• Tension Type, DD+3</li> <li>• Due to collapse of tower no 01, top and middle cross arms of right circuit (looking from Chamera III Towards Chamba) buckled due to sudden jerk during failure of tower no. 1.</li> </ul> |

| 31) | Probable cause of failure: | Prima facie, it seems that the damage has been caused due to extensive floods in River Ravi on account of sudden inrush of water owing to torrential rainfall over night in whole state of HP which has also led to extensive damage in other infrastructure leading to cutoff in connectivity at several places |

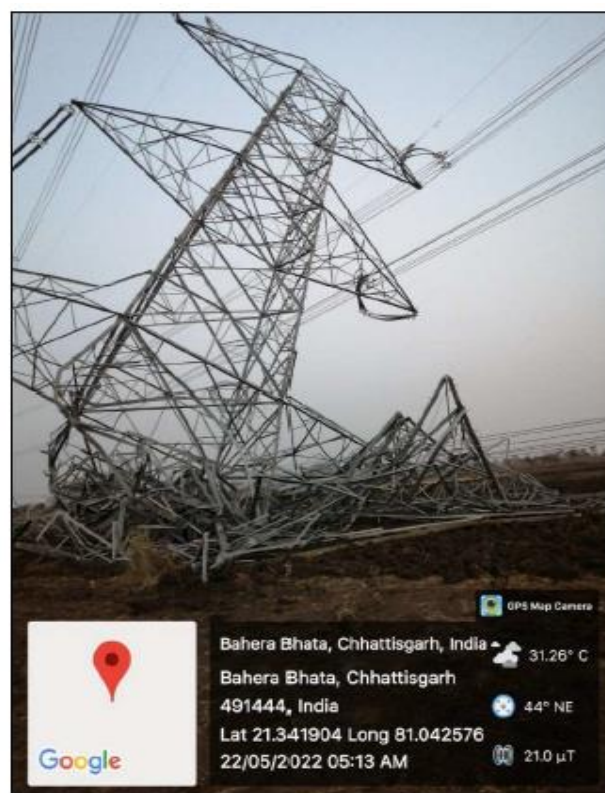
**Fig 9(a). Tower at Location No.: 413 (DHA+3)**

| | 1 | 413 | DHA+3 | | | <ul style="list-style-type: none"> <li>• Tower collapsed completely as shown in Fig 9(a) and 9(b).</li> <li>• Foundation was intact as shown in Fig 9(c).</li> <li>• Coping was damaged.</li> <li>• Main leg members along with many bracing members were deformed.</li> </ul> |

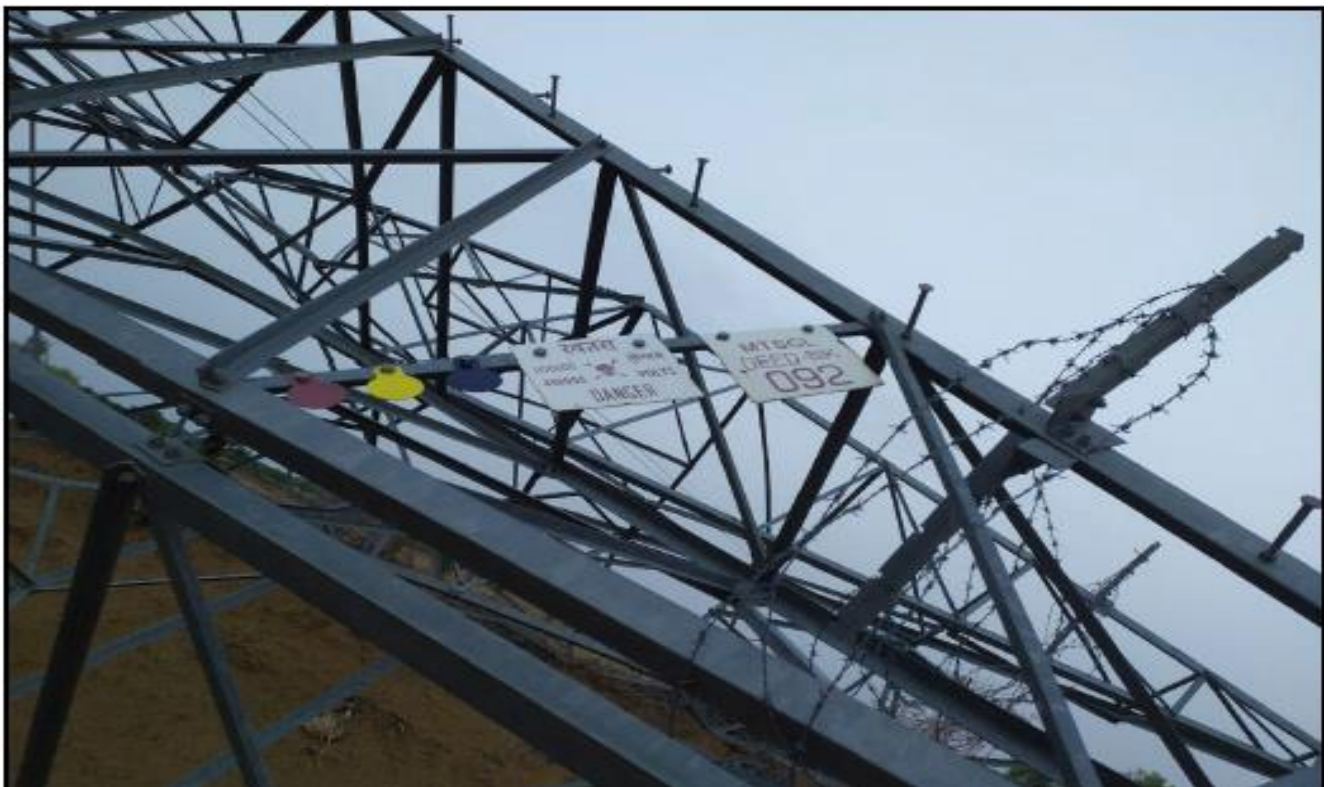
**Fig 3(c). Tower at Location No.: 92 (A+0)**

| | <b>2</b> | <b>92</b> | A+0 | | | <ul style="list-style-type: none"> <li>• Tower collapsed completely as shown Fig 3(c) and Fig (d).</li> <li>• Foundation was damaged.</li> </ul> |

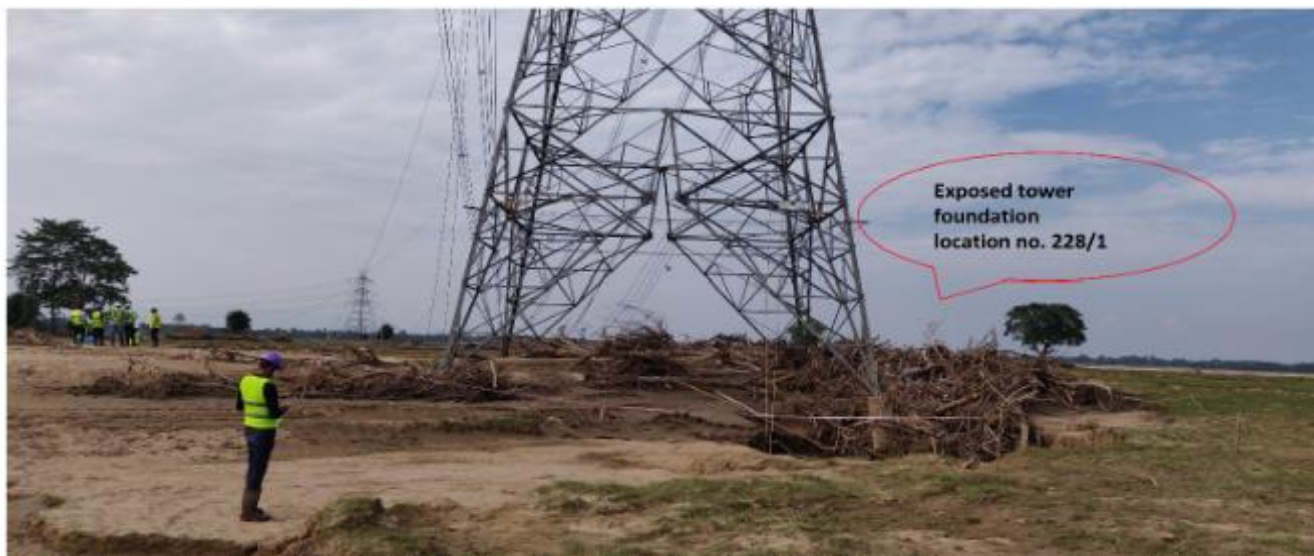
**Fig 2(c). Tower at Location No.: 228/1 (DA+0)**

| | 1 | 228/1 | DA+0 | 387 | 0° 0' 0" | <ul style="list-style-type: none"> <li>Tower collapsed partially as shown in Fig 2(b) and Fig 2(c).</li> </ul> |

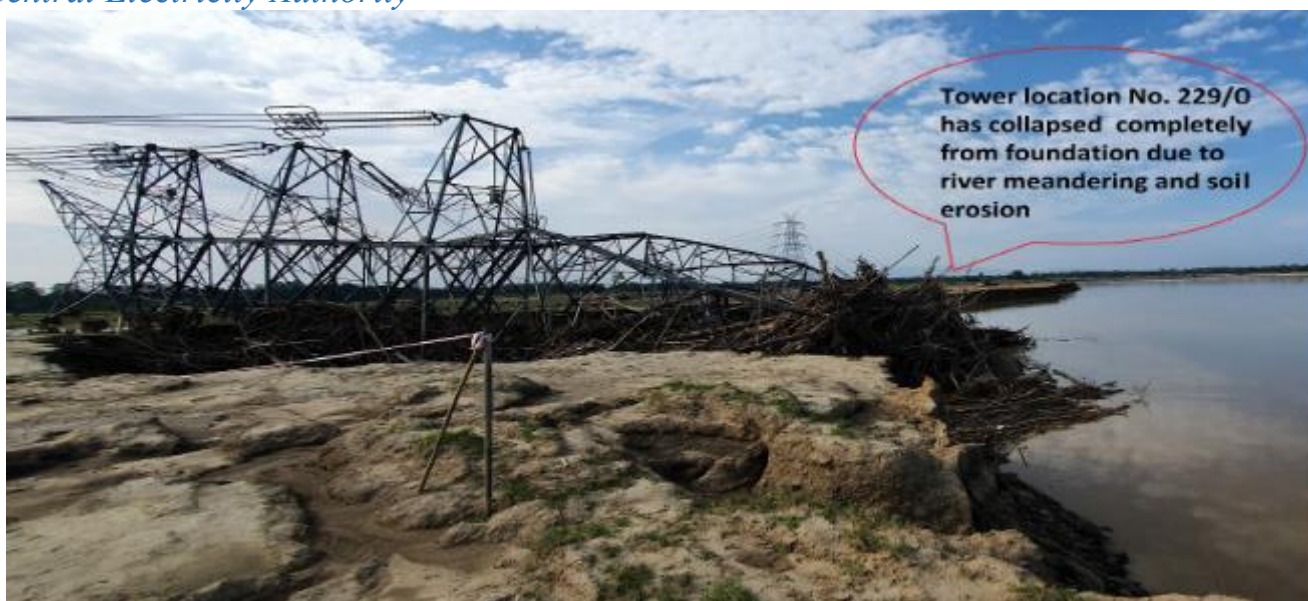
**Fig 2(d). Tower at Location No.: 229/0 (DD+0)**

| | 2 | 229/0 | DD+0 | 397 | 31° 56' 17" | <ul style="list-style-type: none"> <li>• Tower collapsed completely as shown in Fig 2(d).</li> <li>• Foundation had been swept off completely.</li> </ul> |

It was observed by the committee that the affected suspension and tension towers at location 228/1 & 229/0 respectively were located in plain field with few trees in vicinity near village Hemari Phura, Dongkamukam Taluk in West Karbi Anglong district (Assam). Tower at Location Numbers 228/1 was collapsed partially. All the four stubs of the tower and chimney were intact and one of the leg along with tower Foundation was exposed to atmosphere completely. Tower Peak was damaged and bent. Tower at Location Number 229/0 was collapsed completely and the foundation had been swept off completely.

The committee recommends that transmission lines should be routed a few kilometers away from river banks or anticipated future river courses. This measure aims to minimize the risk of damage to transmission towers due to changes in the river's course. The committee suggests the use of pile foundations based on thorough soil investigation reports and the latest high flood data because such foundations offer better stability and resistance to erosion.

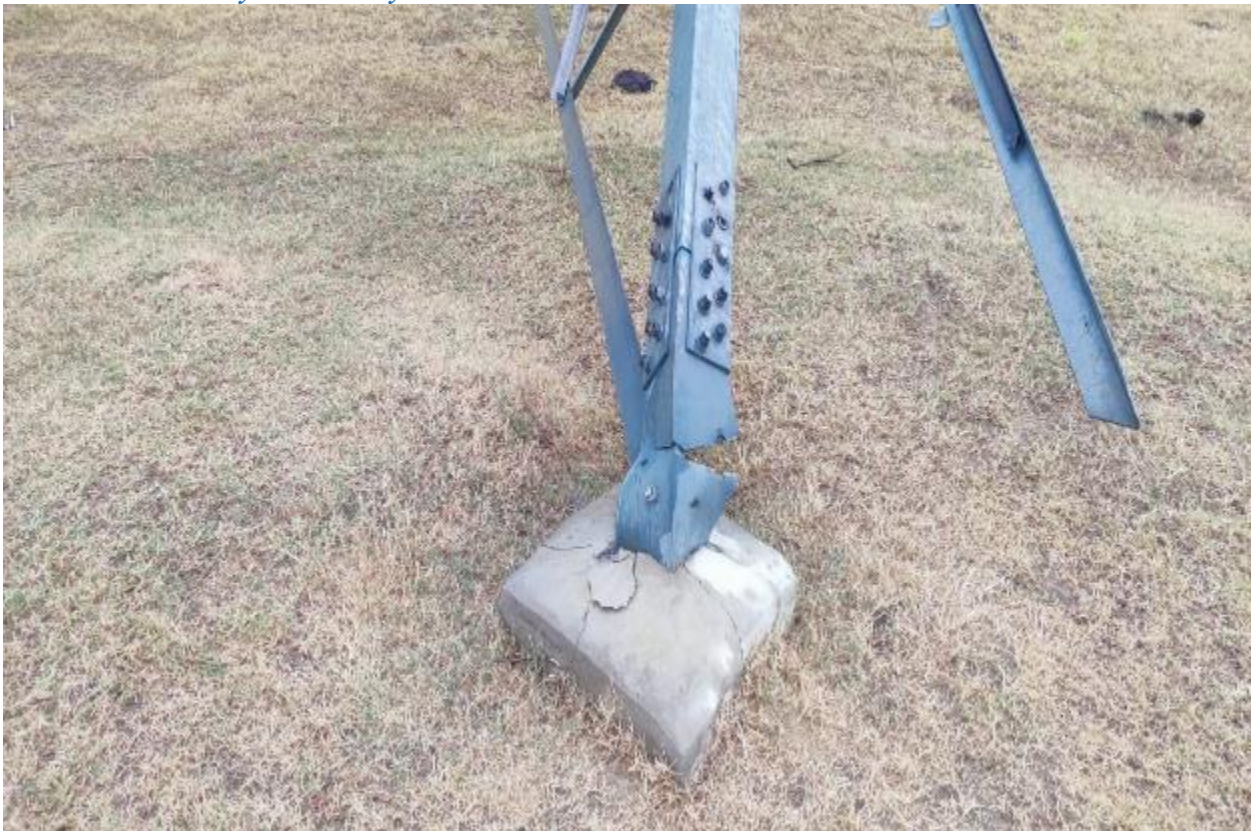
**Tower no. 60 stub:**

| 26. Condition of foundation after failure: | FOUNDATION REMAIN INTACT |
| 27. Brief Description of failure: | DUE TO HEAVY WIND STORM & CYCLONIC EFFECT IN THE AREA |
