२२० के वी एवं उच्चतर विभव के सबस्टेशनों के क्षतिग्रस्त उपकरणों पर विशेषज्ञों की स्थायी
समिति की रिपोर्ट

(अप्रैल २०१८-मार्च २०१९)

**REPORT OF STANDING COMMITTEE OF EXPERTS ON FAILURE OF 220 kV &
ABOVE VOLTAGE CLASS SUBSTATION EQUIPMENT
(APRIL 2018 - MARCH 2019)**

Central Electricity Authority
विद्युत मंत्रालय

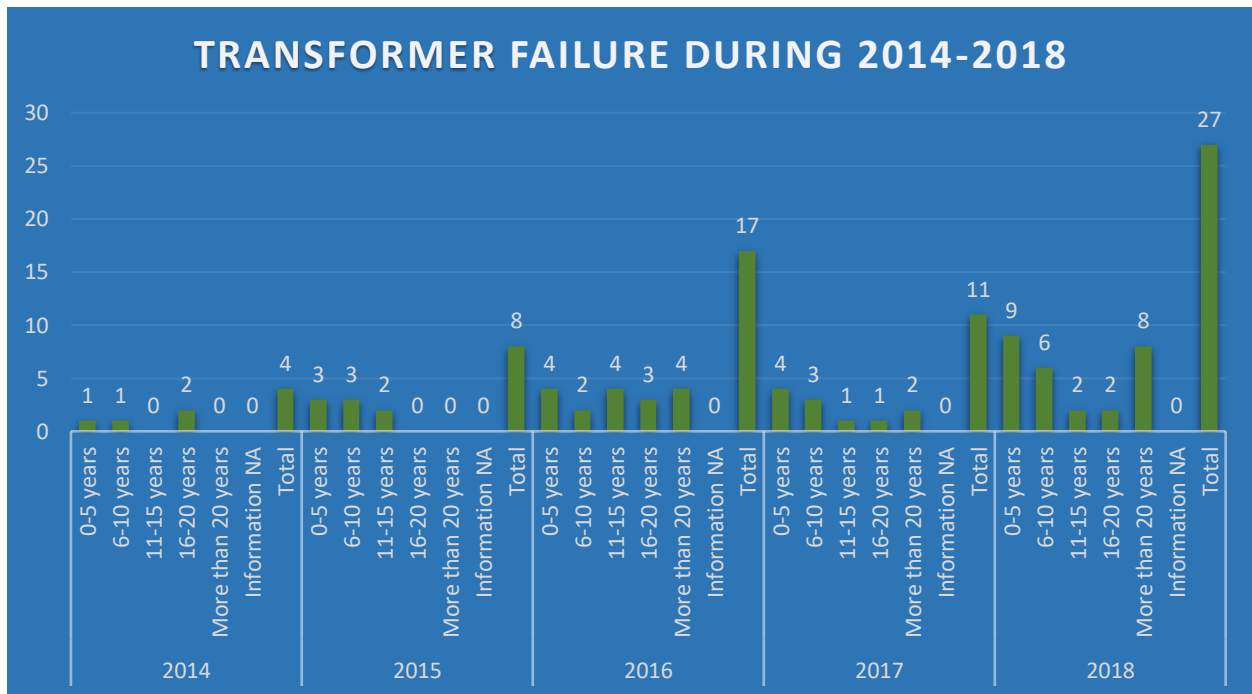
- (v) **Failures of transformers during 2014-2018:** The number of different transformer failures as reported in last 5 years to CEA has been shown in the graph below:

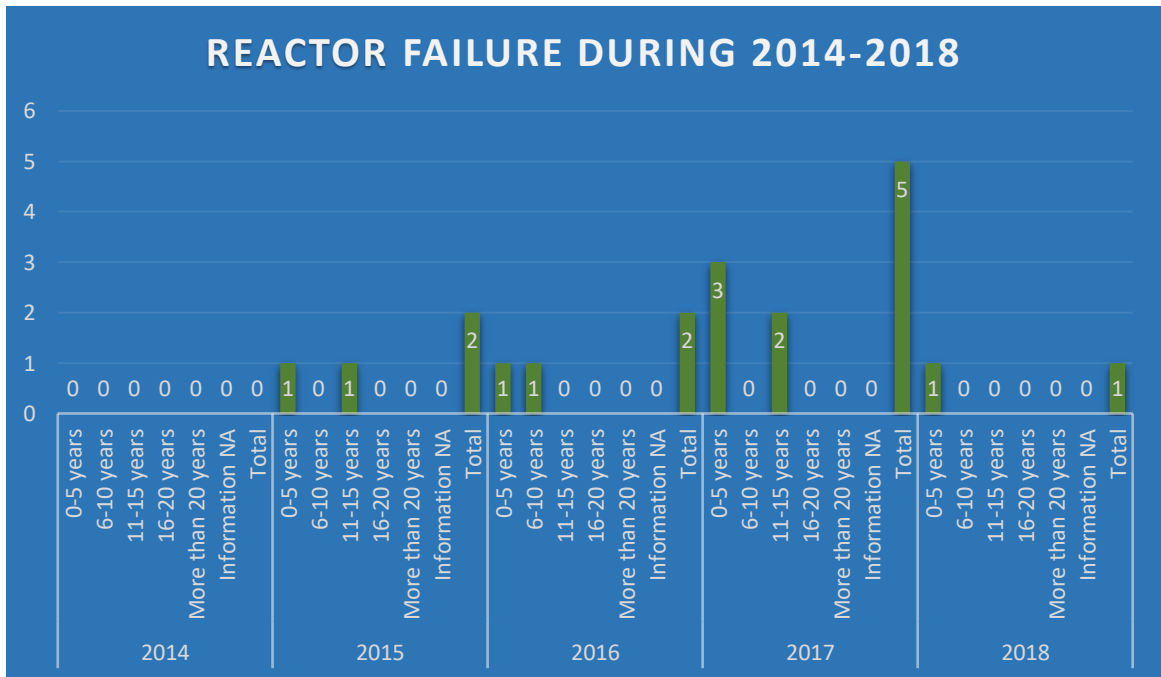
- (ii) In case of failure of Reactor in the substations of PGCIL, a team constituted by PGCIL carried out the investigation of failure of this Reactor. Reports as prepared by the team has been enclosed as Annexure-II.
- (iii) **Failures of reactors during 2014-2018:** The number of different reactor failures as reported in last 5 years to CEA has been shown in the graph below. No reactor failure was reported during 2014.

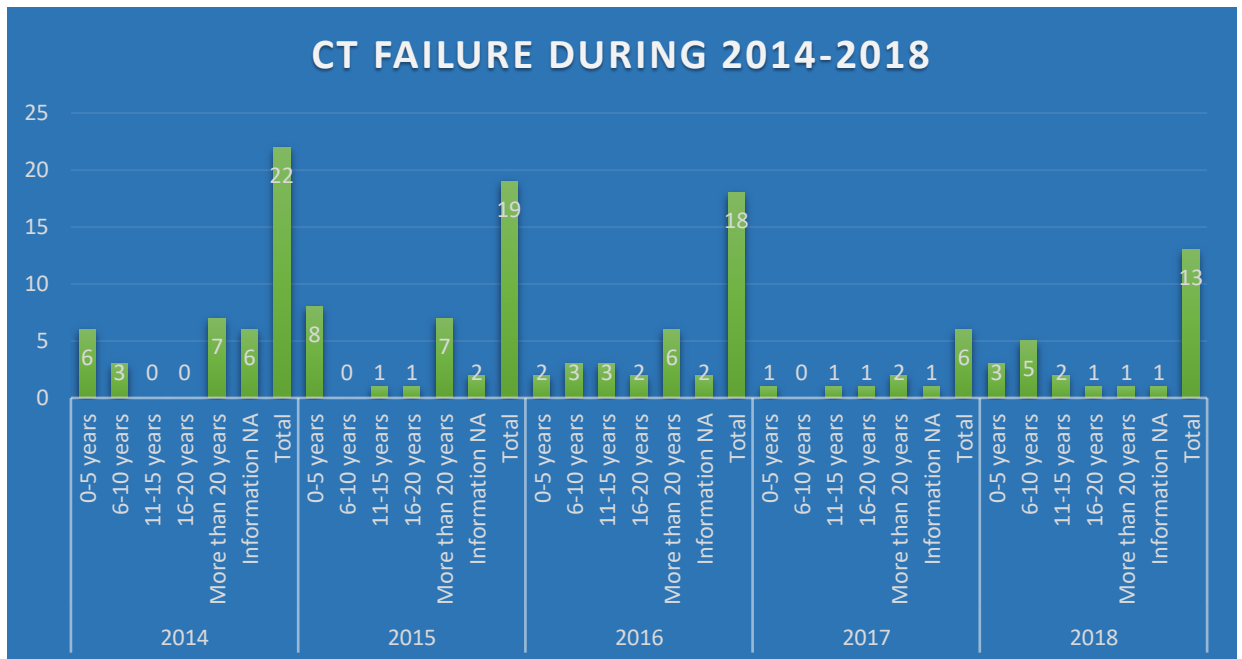
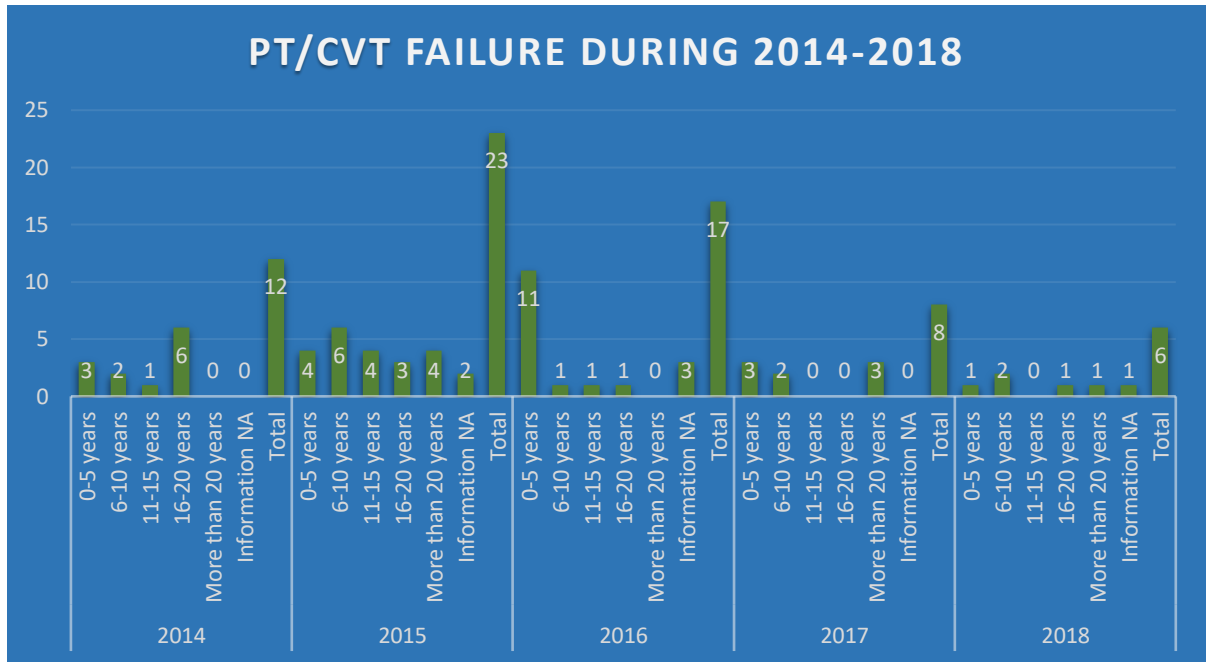
- (v) **Failures of CTs/PTs/CVTs during 2014-2018:** The number of different CT/PT/CVT failures as reported in last 5 years to CEA has been shown in the graph below.

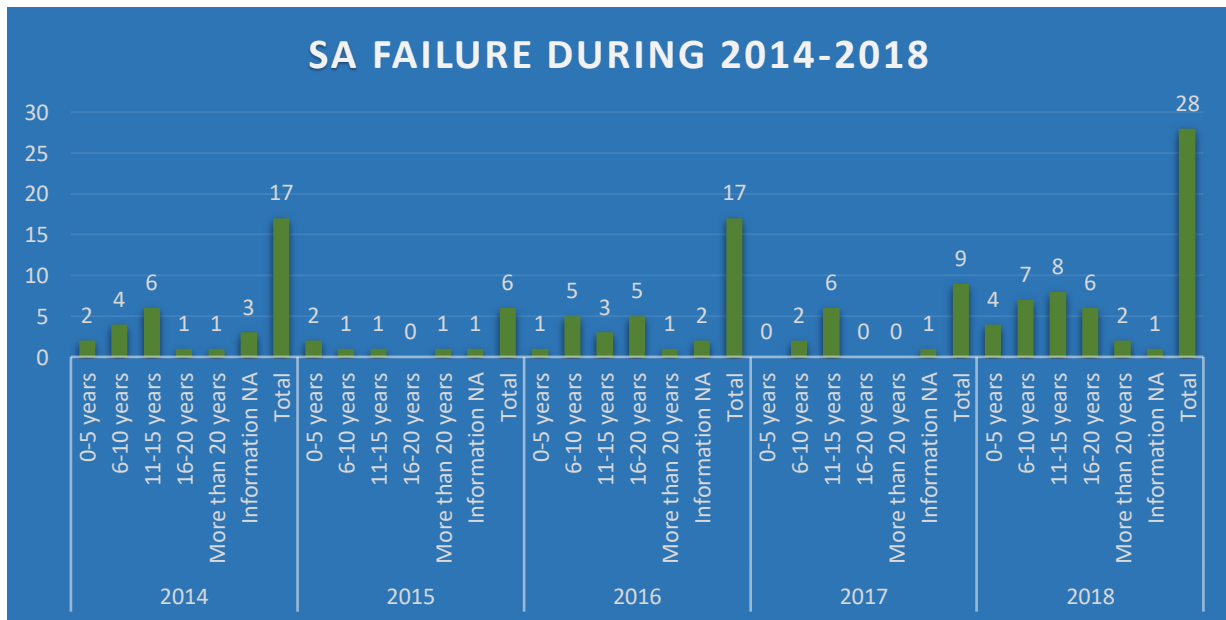
- (vi) As per the reports received by CEA, twenty-three (23) nos. of cases of SA failure occurred during the period from April 2018 to March 2019 have been reported to CEA by five (5) utilities. Out of these, seventeen (17) nos. of SAs are of 220/230kV class and rest six (6) nos. of SAs are of 400kV class.
- (vii) **Failures of SAs during 2014-2018:** The number of different SA failures as reported in last 5 years to CEA has been shown in the graph below.
