**REPORT OF STANDING COMMITTEE OF EXPERTS ON FAILURE OF 220 kV &  
ABOVE VOLTAGE CLASS SUBSTATION EQUIPMENT  
(SEPTEMBER 2015-DECEMBER 2016)**

भारत सरकार  
**Government of India**  
केन्द्रीय विद्युत प्राधिकरण  
**Central Electricity Authority**  
विद्युत मंत्रालय  
**Ministry of Power**  
नई दिल्ली  
**New Delhi**

**REPORT ON INVESTIGATION OF FAILURE OF 100 MVA, 220/66-33/11 KV POWER TRANSFORMER AT 220KV GEETA COLONY SUBSTATION OF DELHI TRANSCO LTD. (DTL)**

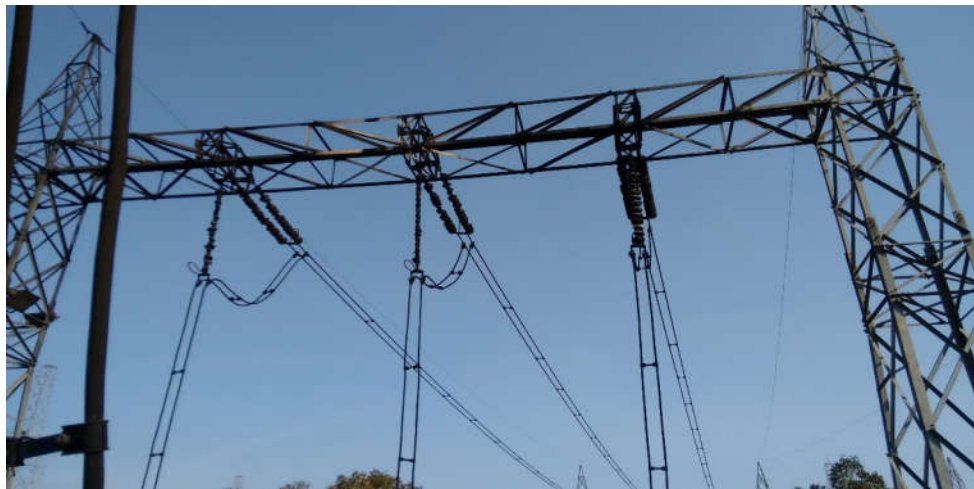
**Exhibit-X**

- 4.12 It was informed by DTL that surge counter of 220 kV R-phase surge arrester was not functional and it was bypassed through a cable.
- 4.13 Common earthing pit was provided for all three SAs (R,Y&B phases) on 220 kV side. Earthing electrode was not visible in any of the earth pits for transformer neutral and SAs on 400 kV & 220 kV side.
- 4.14 It was observed that the high resistive gravels spread over the earthmat in the switchyard area was covered with grasses in many areas of the switchyard defeating the very purpose of spreading of gravels.
