**REPORT OF THE STANDING COMMITTEE OF EXPERTS
ON FAILURE OF EHV TRANSMISSION LINE TOWERS
(APRIL 2018 – MARCH 2019)**

Central Electricity Authority

4.0 ANALYSIS OF FAILURE OF TOWERS OCCURRED DURING THE PERIOD FROM APRIL 2018, TO MARCH, 2019

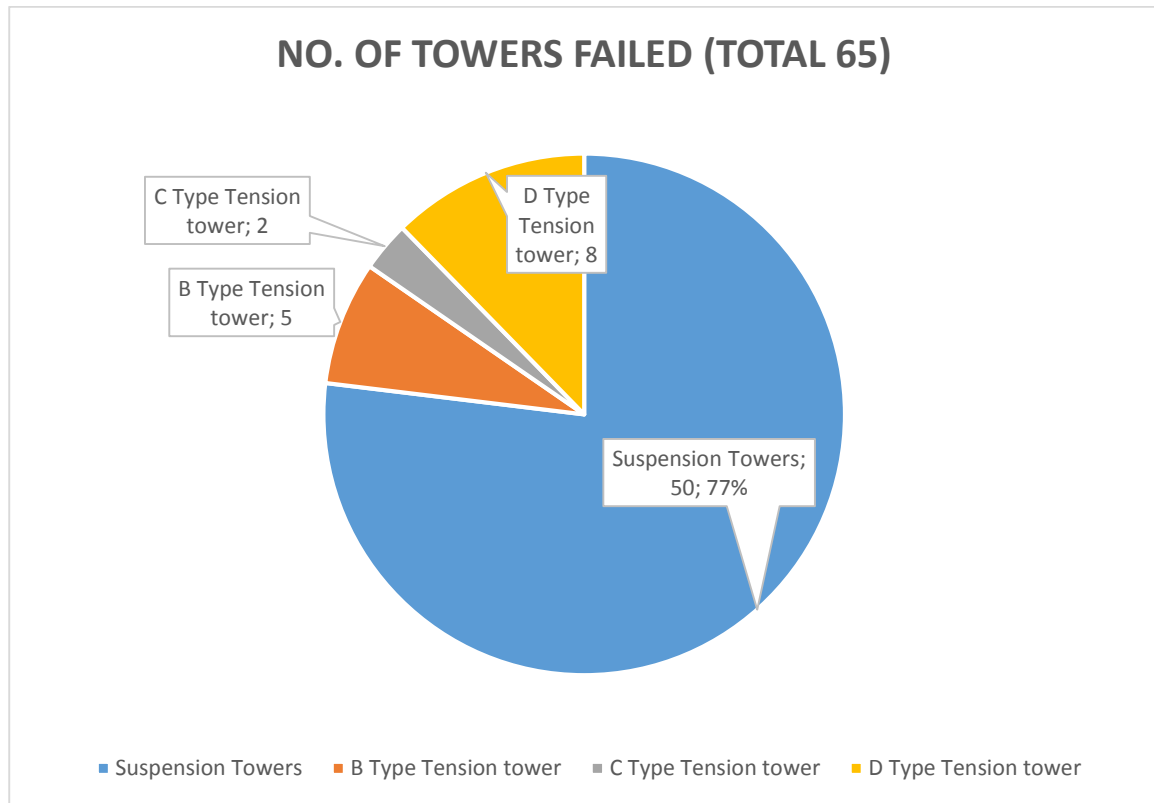
Fig.-1

- 2.5 Out of 65 Nos. of failed towers, 50 Nos. (77%) are of suspension type towers and rest 15 Nos. (23%) are tension type towers (fig.-1). All the fifteen (15) tension type towers failed

were of 400 kV voltage level and failure of tension type towers were not observed at any other voltage levels.

2.6 It has been observed that the failure rate of suspension towers is much higher in comparison to tension towers. This may be because the Suspension towers are not designed to take horizontal forces in the longitudinal direction and hence the failures of one suspension type tower causes secondary failure of adjacent suspension towers due to the pulling force of conductors. In view of above, the loading criteria for the suspension type towers have been made more stringent and the longitudinal and transverse force acting on Suspension type towers under security condition has been increased in revised IS 802 (2015). It is noted that none of the transmission lines, failed during the period from April 2018 to March 2019, were designed as per revised IS 802 (2015). However, as reported by the utilities, in some of the transmission lines the suspension towers were designed considering narrow front wind condition and with 75% wind in security condition.

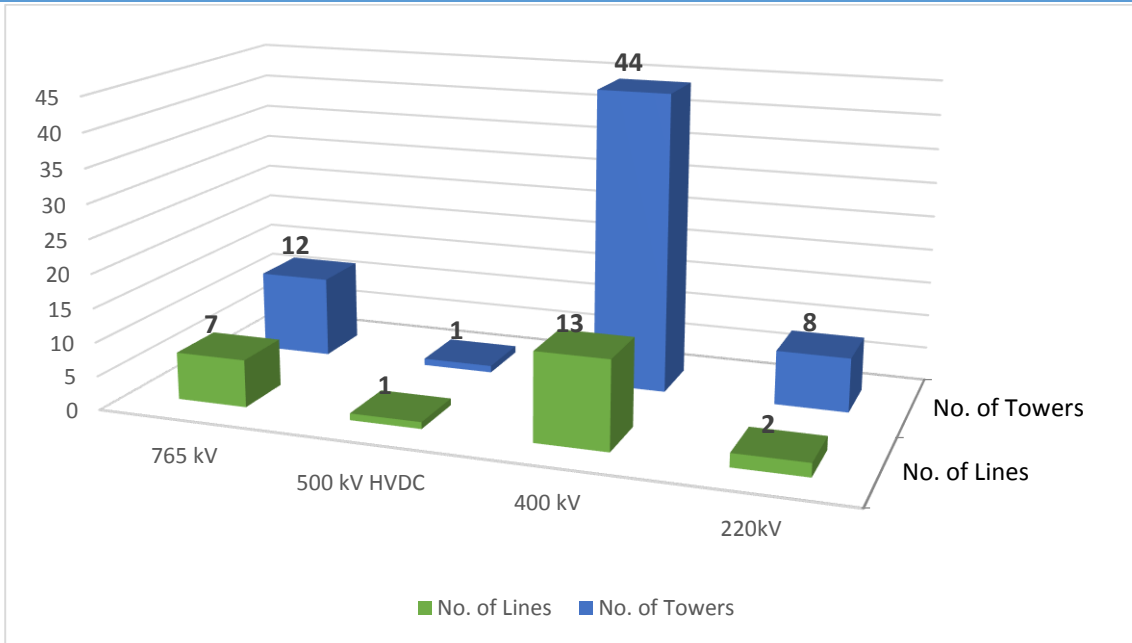
Fig.-2

2.7 No. of transmission lines and towers failed during the period from April 2018 to March 2019 with respect to voltage level is given below (fig.-2). The maximum no. of failure of transmission lines and transmission towers was at 400 kV voltage level. Out of total 65 towers of 23 Nos. of transmission lines, 44 (68%) towers of 13 (56 %) transmission lines were of 400 kV level. This may be because out of 419395 circuit kilometers (ckm) of 220 kV & above voltage level transmission lines in India, 182608 circuit kilometers (43.54%) are of 400 kV level transmission lines (as per data available till October, 2019). Higher no. of failure of transmission lines of 400 kV voltage level is corollary to highest no. of transmission lines at 400 kV Voltage level in India.

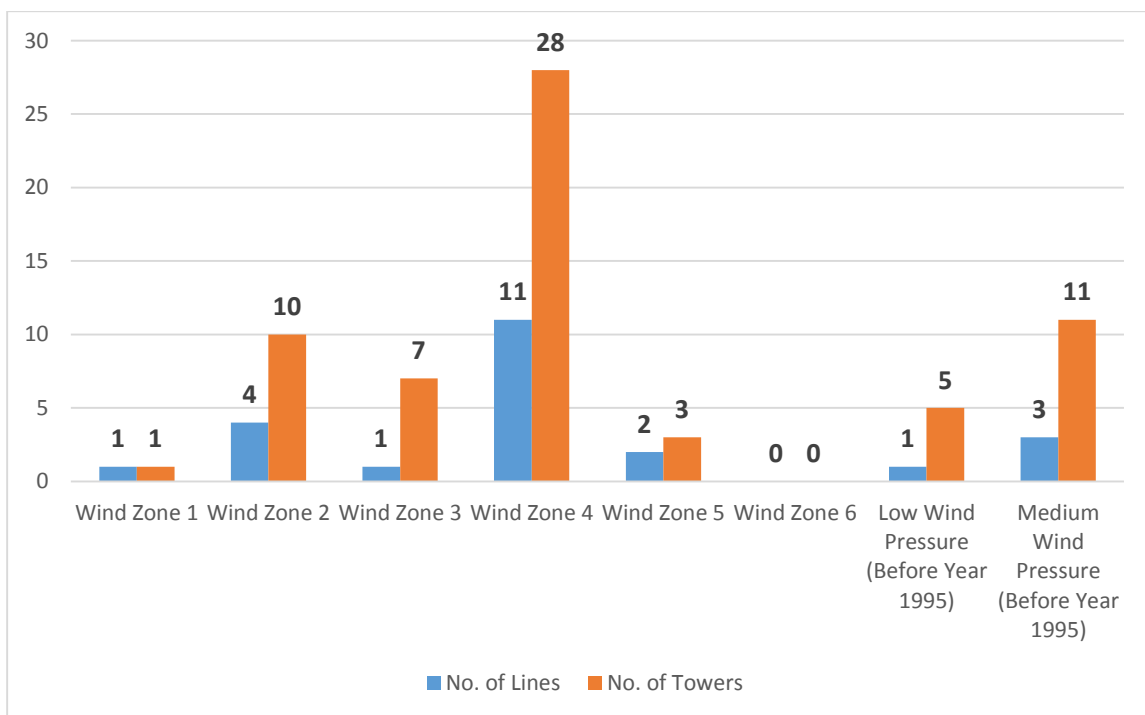
Fig.-3

2.8 Before the revision of IS 802 in 1995, the wind map of India was divided into three wind pressure zones i.e. light, medium & heavy. In the third revision of IS 802: 1995, 6 wind zones were specified dividing various regions on the basis of 3 second wind gust speed. No. of transmission lines and towers, failed during the period from April 2018 to March 2019 and designed according to various wind zones is given below (fig.-3). It can be seen that

- a) The maximum no. of failure of towers have occurred for transmission lines which were designed for Wind Zone 4; and,
- b) The maximum no. of transmission lines affected due to failure of towers are traversing through Wind Zone 4. It may be noted that maximum area of India is covered under this wind zone.

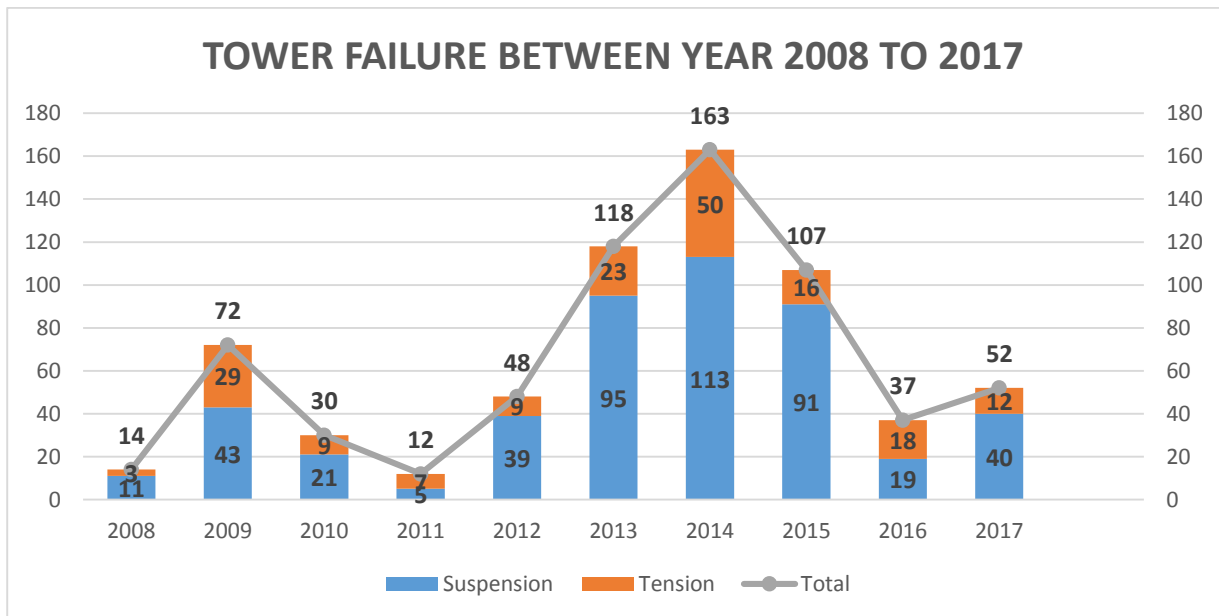
Fig.-4

5.2 The graph depicting the failures of towers occurred during past 10 years that have been discussed in the previous Standing committee meetings are shown below (Fig. 4). The maximum no. of failures i.e. 163 cases of tower failures occurred during year 2014. As has been observed in the previous Standing Committee meetings, the failure rate of suspension towers is much higher in comparison to tension towers. This may be because of the cascading effect of failure of suspension type towers i.e. secondary failure of adjacent suspension towers due to the pulling force of conductors which have been developed due to failure of another tower.

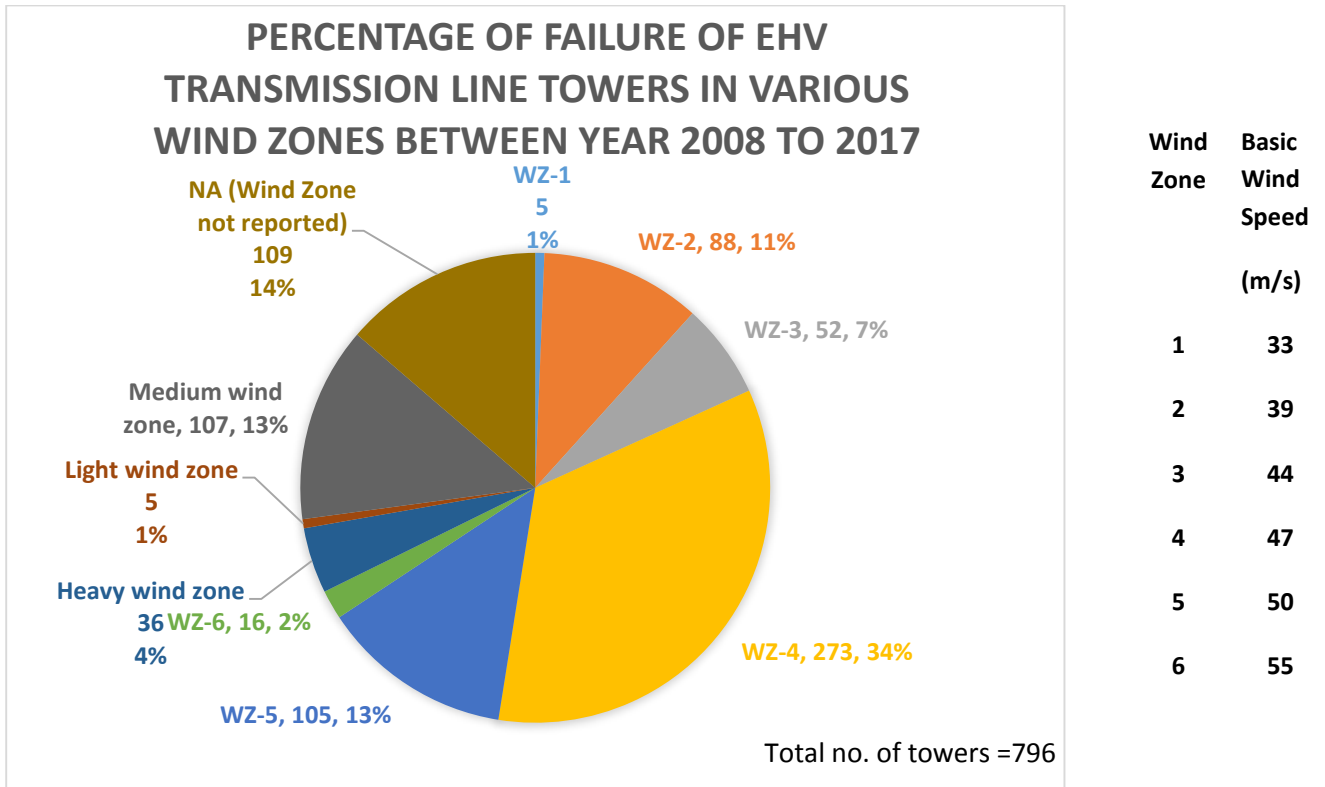
Fig.-5

5.3 Graph/Pie chart depicting percentage of failed EHV transmission towers with respect of various Wind zone of the country is shown below (Fig.5). The graph includes the details of transmission towers which were designed according to IS 802:1977 considering the three wind zones in the country namely, Light, Medium and High wind zones and failed after year 2005. The details of wind zones corresponding to 14% of towers are not

available in the records. Maximum percentage (34%) of towers which were failed were designed for wind speed of Wind Zone 4.

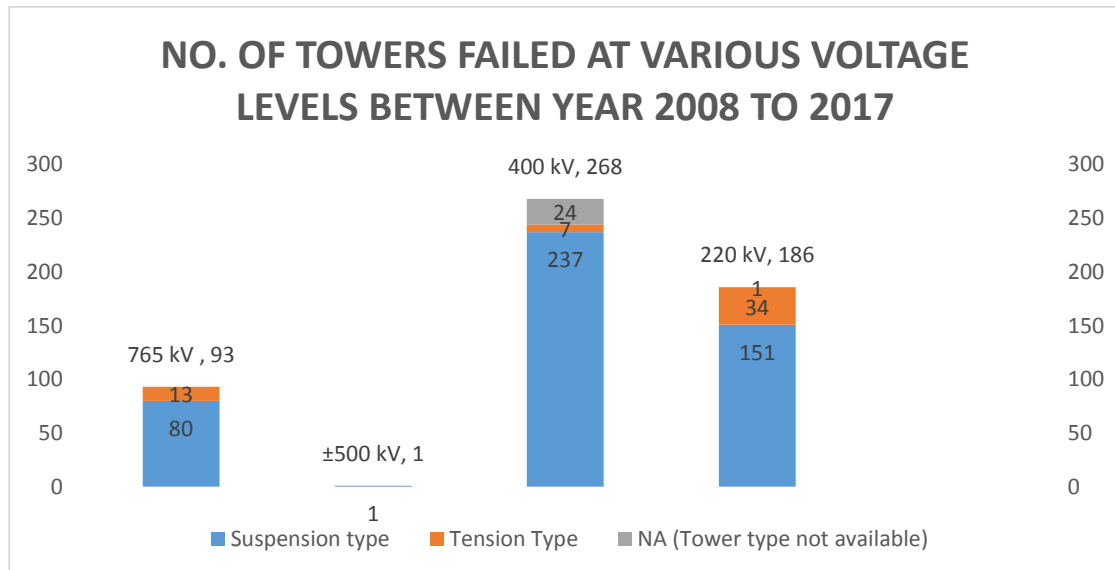
Fig.-6

5.4 The graph depicting the failures of towers at various voltage level that have occurred during past 10 years and intimated to CEA and have been discussed in the previous Standing committee meetings are shown below (Fig.6). It may be observed that towers of 400 kV voltage level have maximum incidences of failure. It may be noted that the mandate of the Standing Committee is to investigate failure of towers of 220 kV and above voltage class transmission line and the graph shows the details of only those transmission line failure which have been intimated to CEA and the large percentage of tower failure incidents reported to CEA pertains to PGCIL which has maximum no. of transmission lines at 400 kV level.

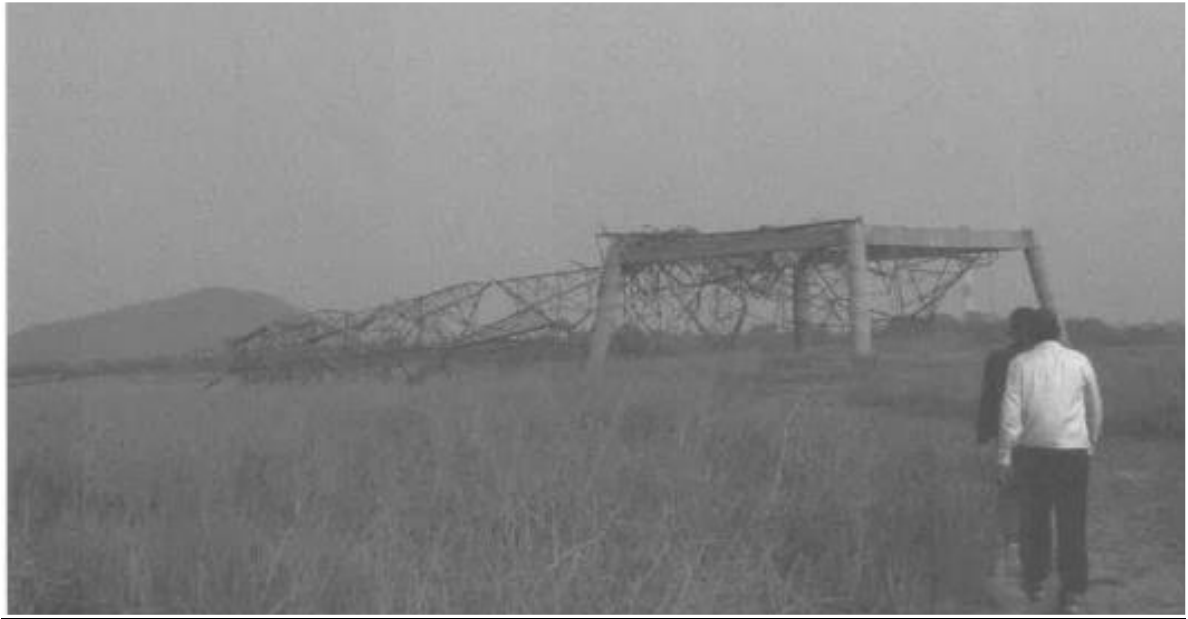
Probable Cause of Tower at Loc. No. 64

- f. As reported by PGCIL, a high intensity wind followed by rain fall was experienced in the area which damaged the thatched huts situated nearby to the tower locations. The same was confirmed by the local villagers.

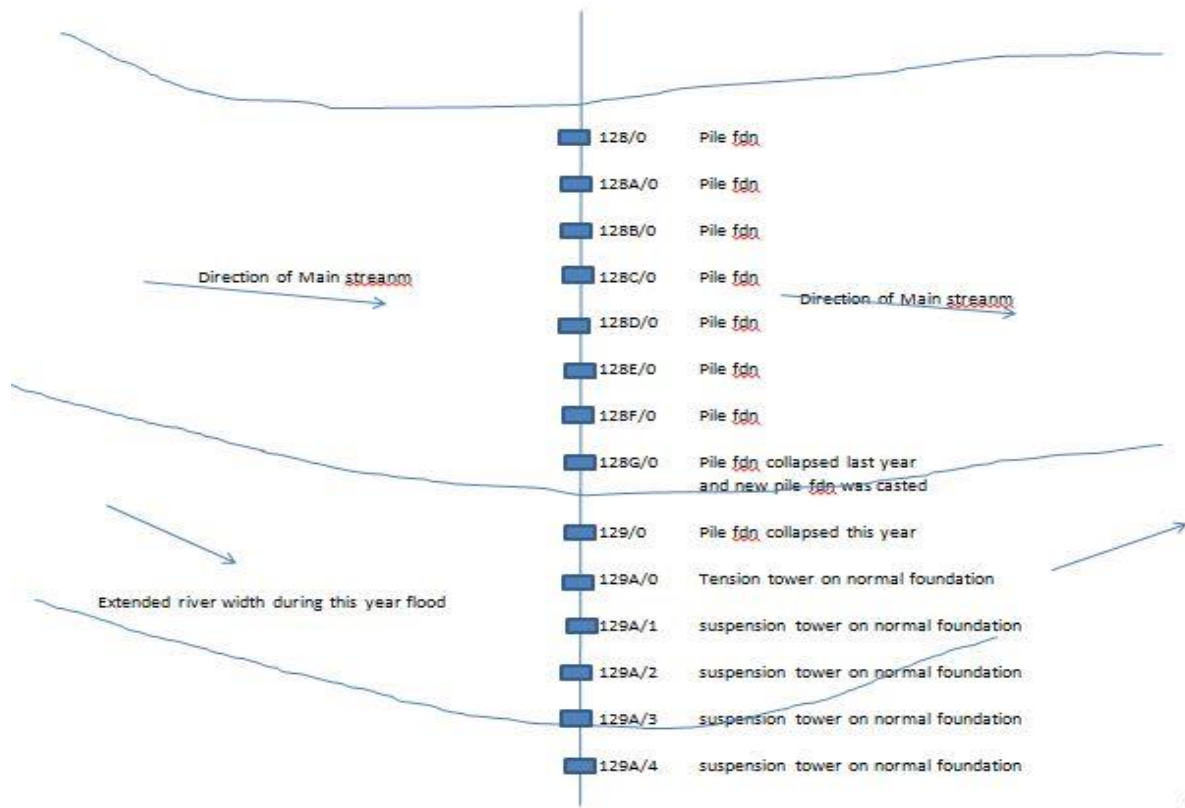
b. A schematic representation of plan indicating affected location on piles and normal foundation is shown below.

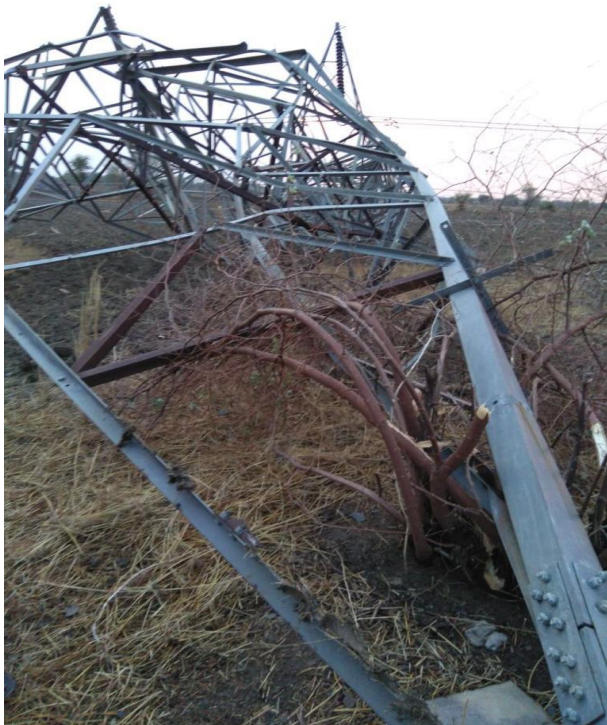
Tower at Loc. No. 570

- d. **Tower at Location 570 (FD0) & 571 (FD0)** were completely collapsed and were lying on the ground.
