KERALA STATE ELECTRICITY BOARD LIMITED

**RENOVATION, MODERNISATION,
UPRATING & LIFE EXTENSION OF
HYDROPOWER PLANT- DIVERSE
ISSUES AND HANDLING STRATEGIES**

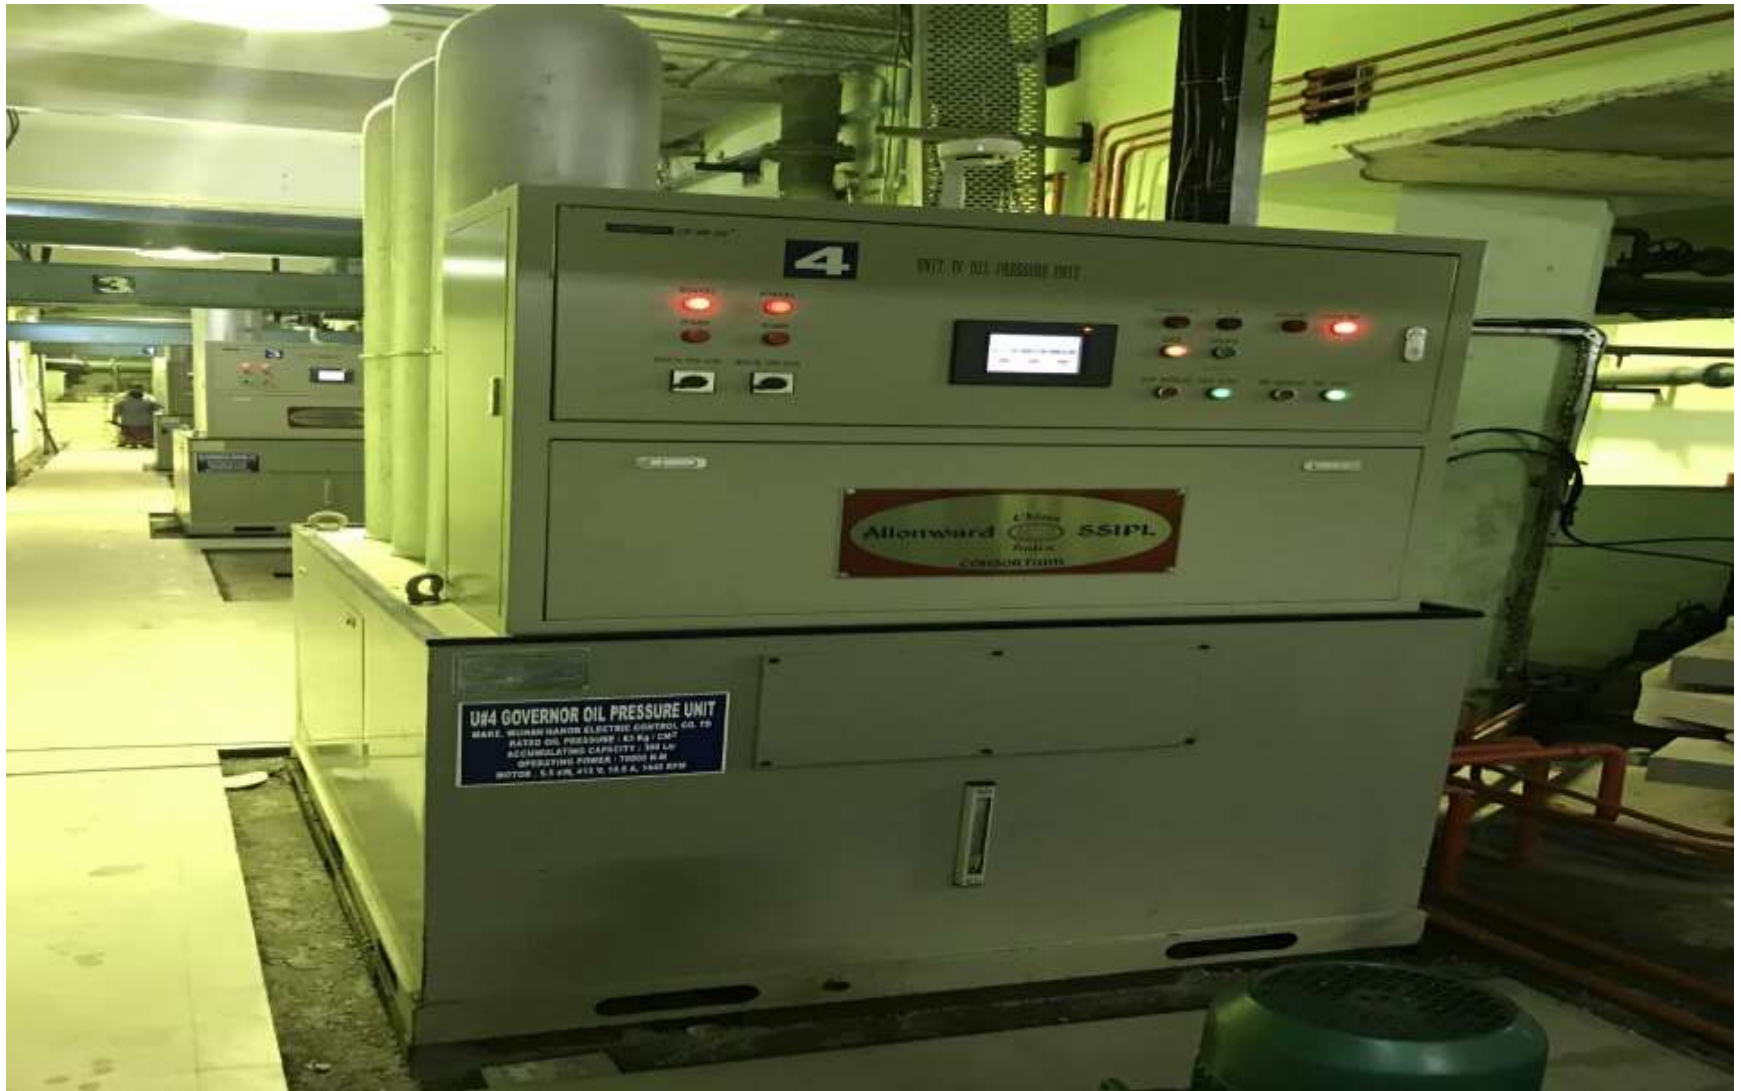
U#4 GOVERNOR OIL PRESSURE UNIT
MADE: HUNAN HANDE ELECTRIC CONTROL CO. TD
RATED OIL PRESSURE : 1.0 MPa / 150"
ACCUMULATING CAPACITY : 500 Ltr
OPERATING POWER : 7000W / 3P
MOTOR : 5.5 KW / 11.5 A / 380V / 1425 RPM
