## REPORT OF STANDING COMMITTEE OF EXPERTS ON FAILURE OF 220 kV & ABOVE VOLTAGE CLASS SUBSTATION EQUIPMENT (JANUARY 2017-MARCH 2018)

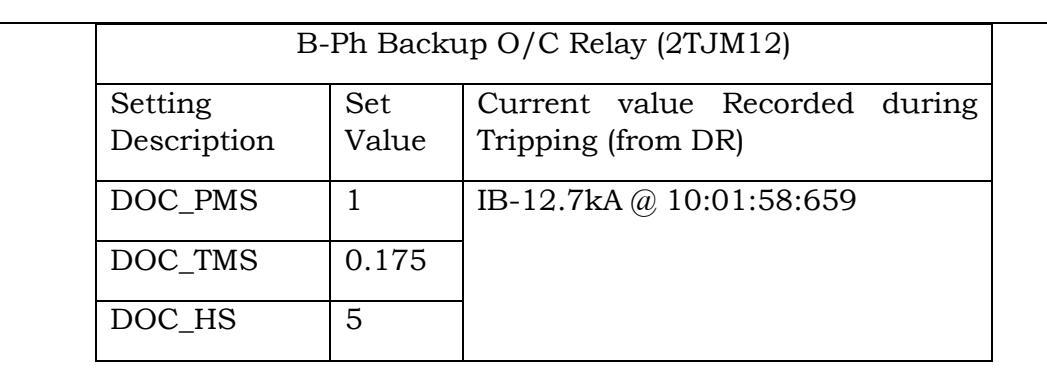
Differential Relay Setting (7UT613)							
Setting Description	Set Value	Current value Recorded during Tripping (from DR)					
1221-Pickup value of Differential Current (Diff>)	0.20I/I nO	IDiff-13.11/InO, IRest-1301/InO@ 10:01:58:640					
1231-Pickup value of High Set Trip (Dift>>)	9.61/In O	IDiff-9.811/InO@ 10:01:58:632

As evident in the DR, the high set Differential Trip (IDiff>>) of Differential relay had picked up @ 10:01:58:632hrs, i.e. around 12ms after differential pickup, and extended trip command to HV, IV and LV side Circuit Breakers through Group-A/B Trip relays. The fault had isolated at 10:01:58:678hrs. i.e. 58ms after differential pickup, by opening the circuit breakers from all voltage levels. Meanwhile, just before isolation of fault, at 10:01:58:654hrs the high set of ICT-2 B-Ph Backup O/C relay had also picked up and extended instantaneous trip command to the Group-A/B Trip relays. As recorded in the EL, consequent to the blasting of HV Bushing and sudden spillover/thrust of oil had caused the operation of Buchholz and PRV relays.

As such the operation of all protective relays and devices functioned in the intended manner and isolated the fault at shortest possible time.

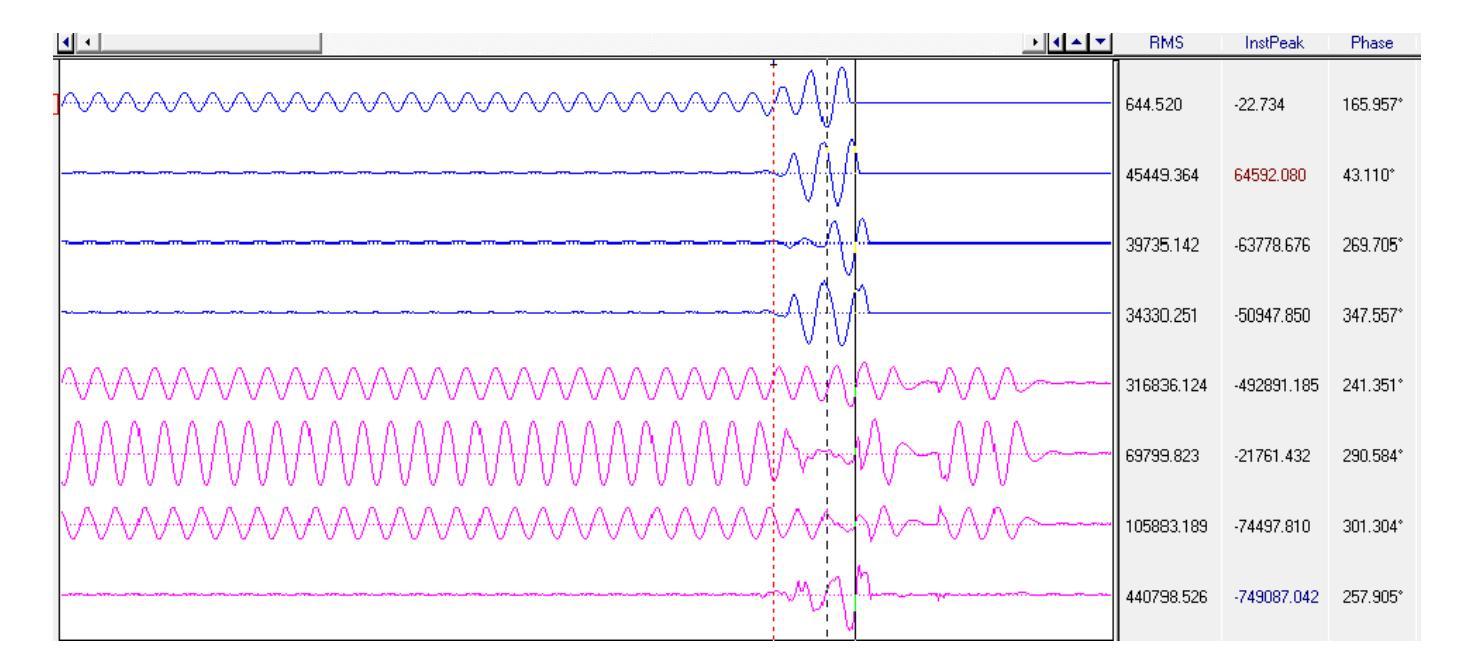
As can be seen from the DR, fault has originated in Y-phase and further spread to B-phase.

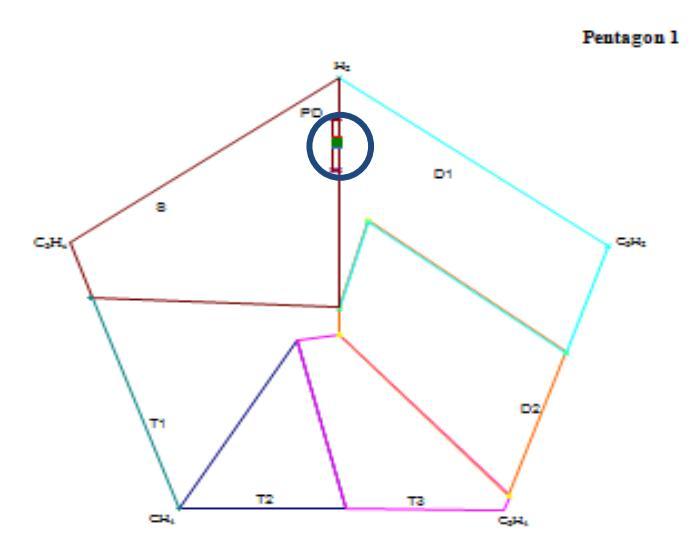
As can be seen from Duval's Pentagon 1, DGA results indicate continuous Partial Discharge inside the transformer. However, CO and CO2 seem to be stable over the period of measurement which indicates that no discharge is present in the insulation paper/ pressboards and the partial discharge

indicated by hydrogen rise is due to voids in oil insulation. As only H2 has crossed the fault limit and other gases are stable, no incipient fault can be deduced prior to failure.

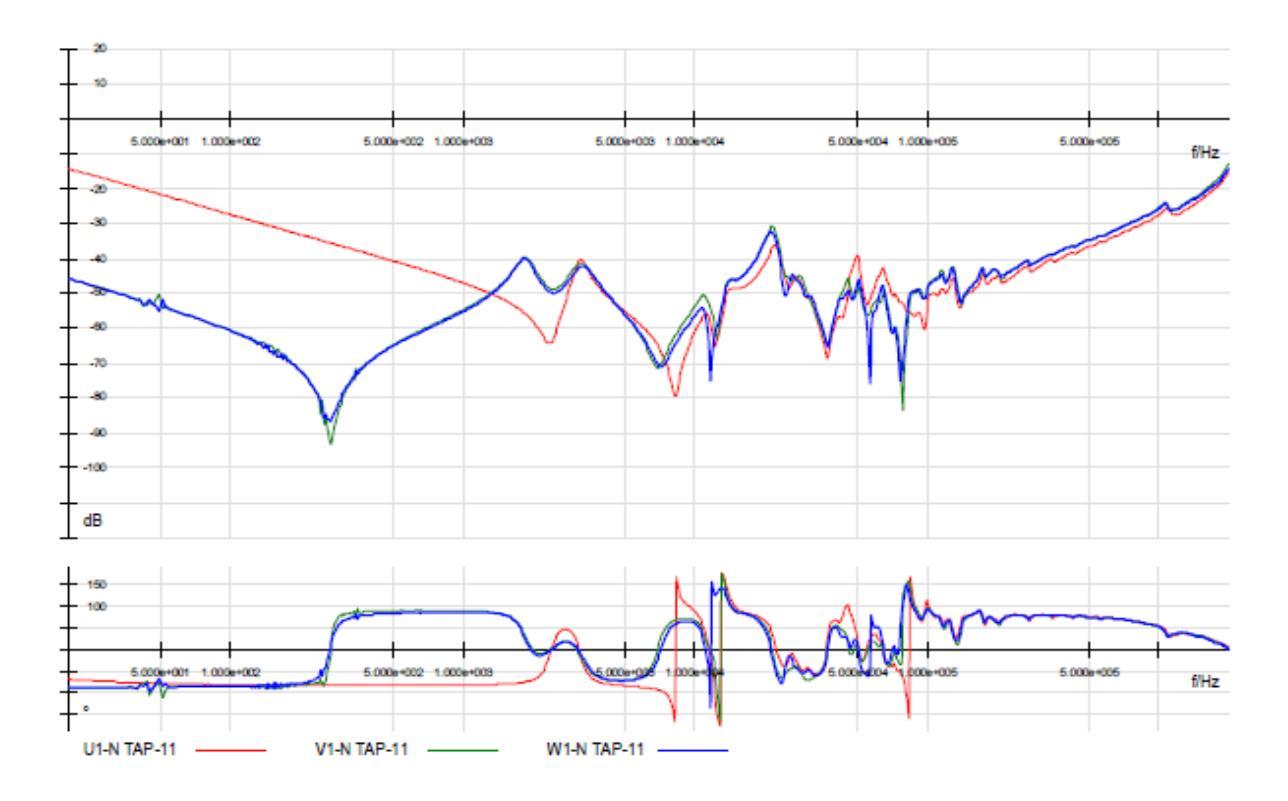
### Comparison of Three phase Open Circuit SFRA plot for 1U TO 2U, 1VTO 2V & 1W TO 2W at TAP- 11

Above two plots clearly indicate the shorting of R-phase core with partial damage of R-ph windings.

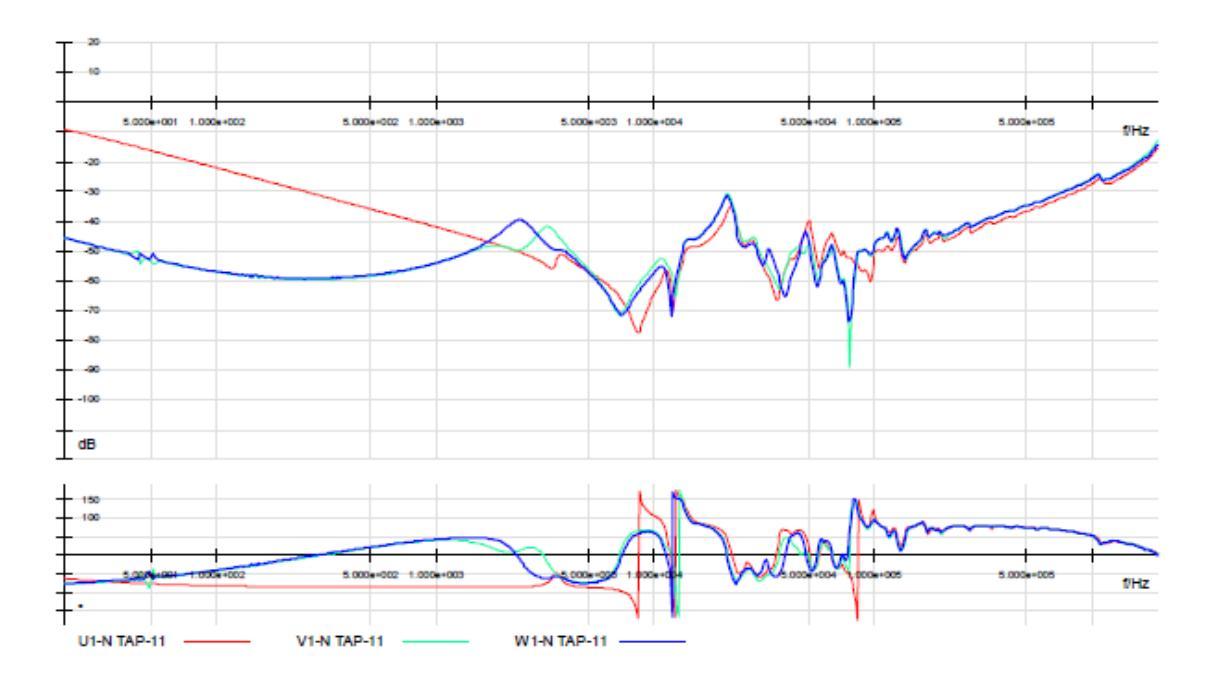
No deviation was observed was observed in HV-N IV shorted response, however, HV-N LV short response show clear deviation of Y and B phase signatures from R-phase. This might be caused due to improper elector switch contacts of OLTC or impact on series windings of Y and B phases

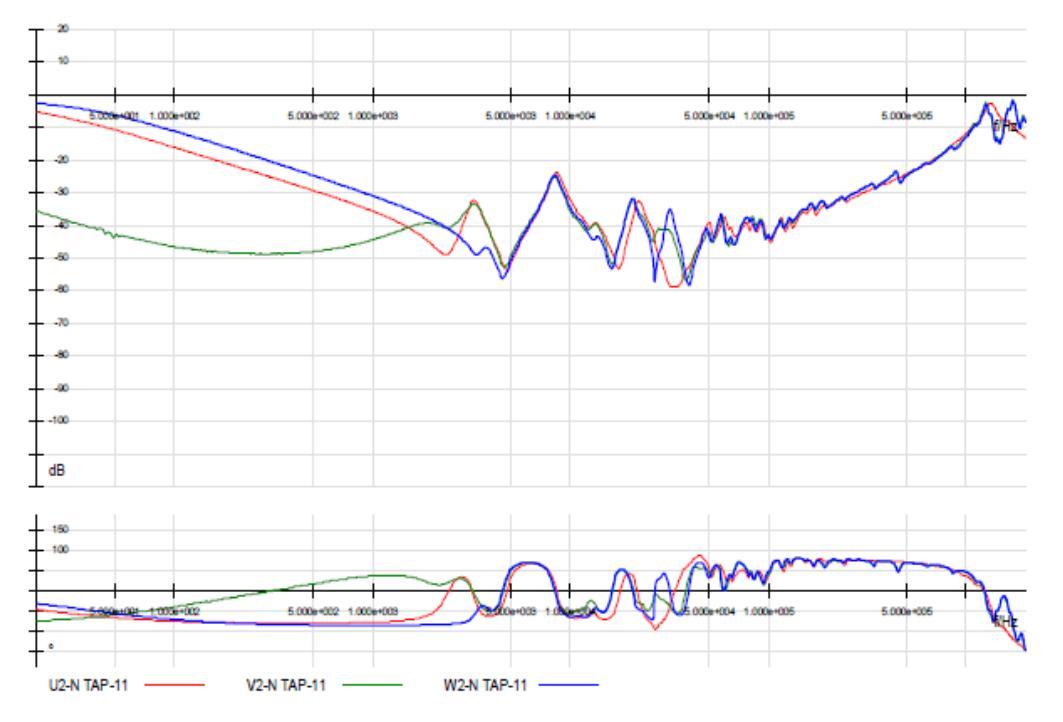
From the above signature, it can be inferred that the common winding part of Y-phase has been partially damaged.

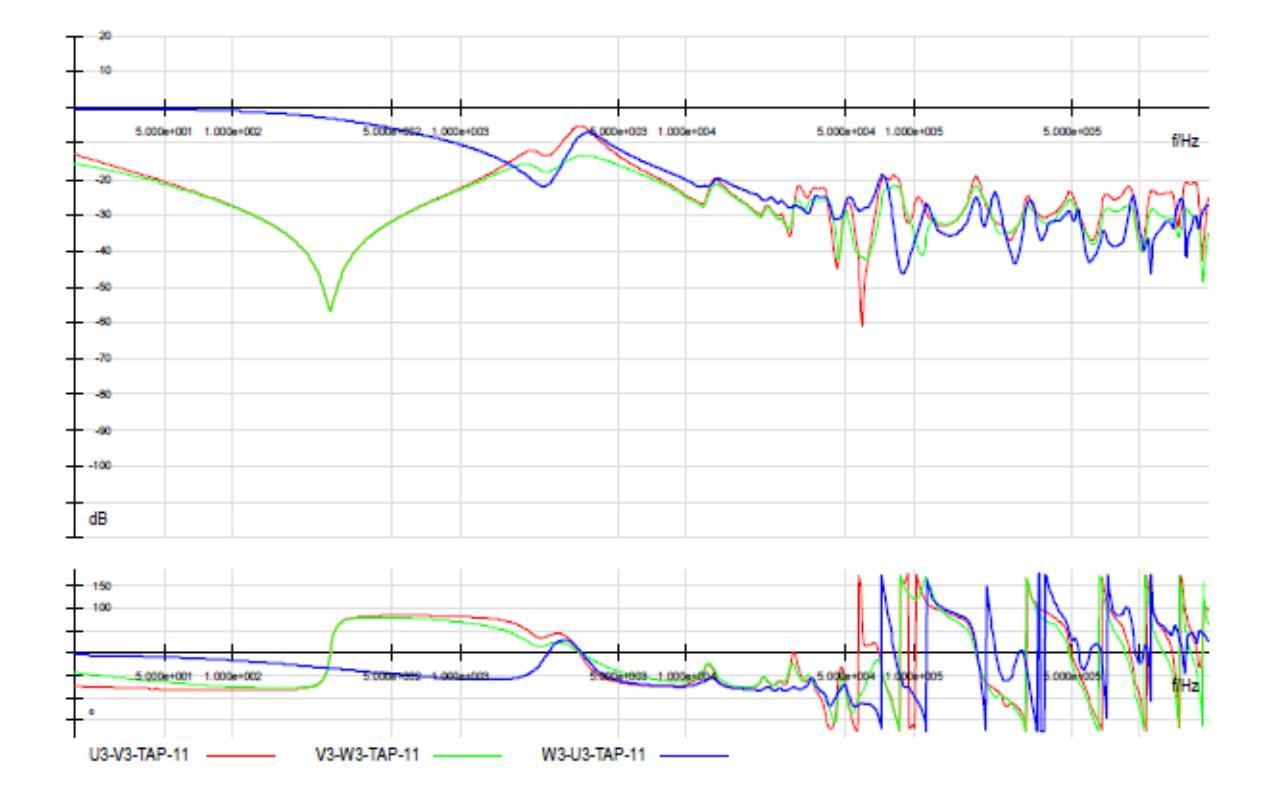
### Comparison of 3-ph Open Circuit SFRA plot for 3U TO 3V, 3V TO 3W & 3W TO 3U at TAP- 11

As can be seen, the response of interphase R-B tertiary connection is in deviation from other two responses in the low frequency (core) region. It can be inferred that the barrier insulation and spacers between core and tertiary of R-phase have been shorted.

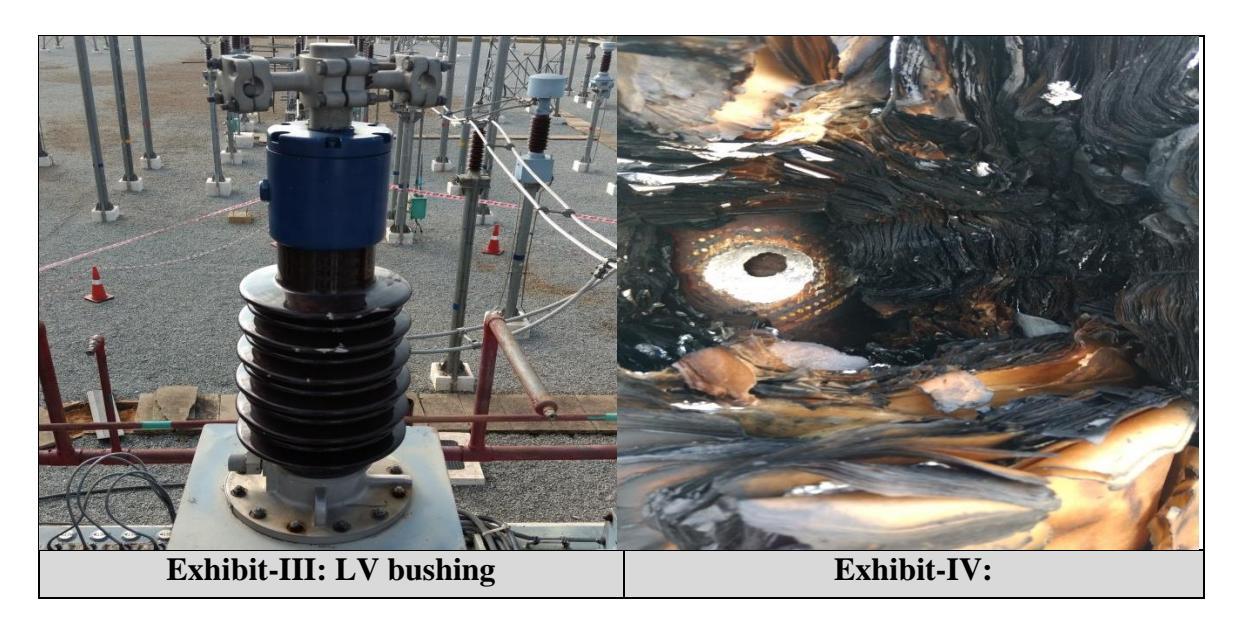
- ii. Blasting of HV Bushing led to consequential damage of following major equipments;
  - a. Porcelain of IV Bushing( Exhibit-II), LV II(Exhibit-III) Bushings
  - b. 2nos BPI for Neutral Bus bar
  - c. One number 390kV LA
  - d. ACSR Twin moose 400kV conductor clamp 1no
  - e. Radiator Fins -3 nos
  - f. Through Clamp between BPI & Neutral

- iii. A clear hole was found in the air end portion of HV phase bushing **(Exhibit IV)**. The location of hole is approximately 1.7 mtr from bottom of bushing.
- iv. Oil end side porcelain of HV bushing was found to be completely shattered and porcelain pieces and burnt paper were found laid at the bottom of the tank at the bottom of the tank (Exhibit V).
- v. Some flash marks where found in the inner surface of the metalic portion meant for BCT accomodation of bushing (Exhibit VI)

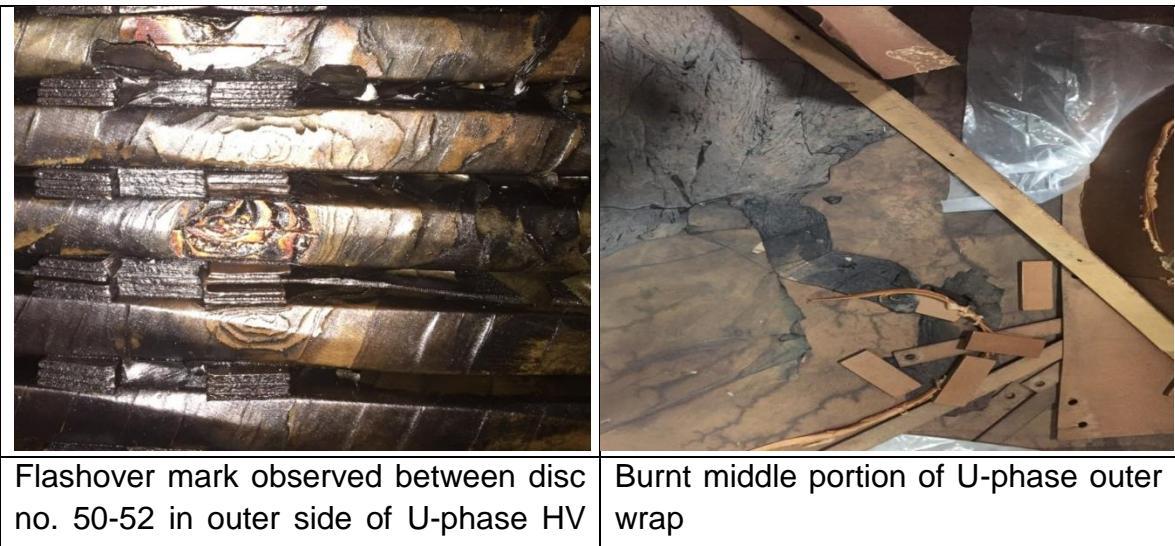
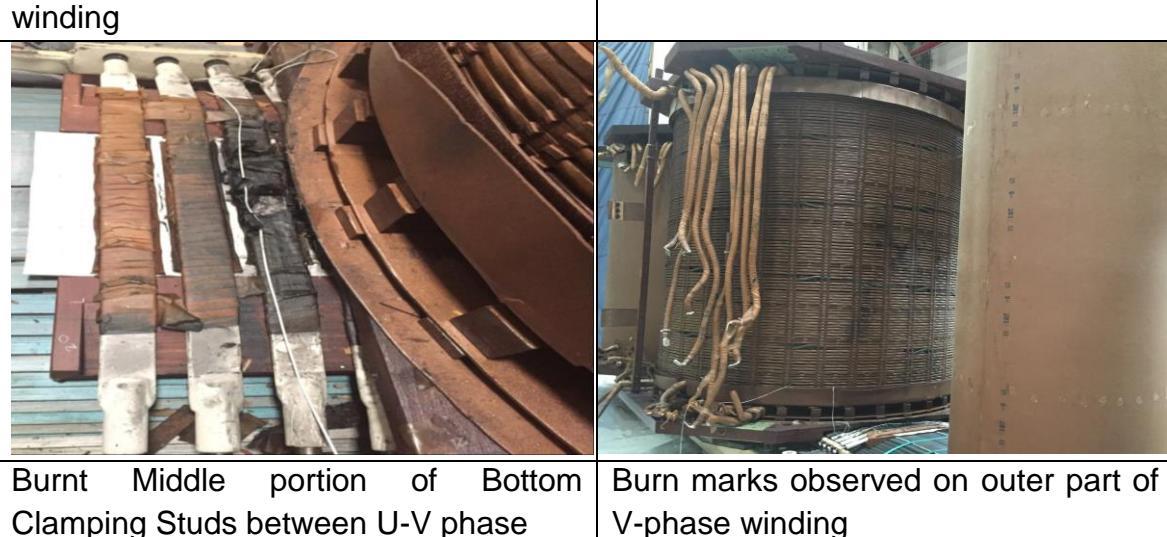
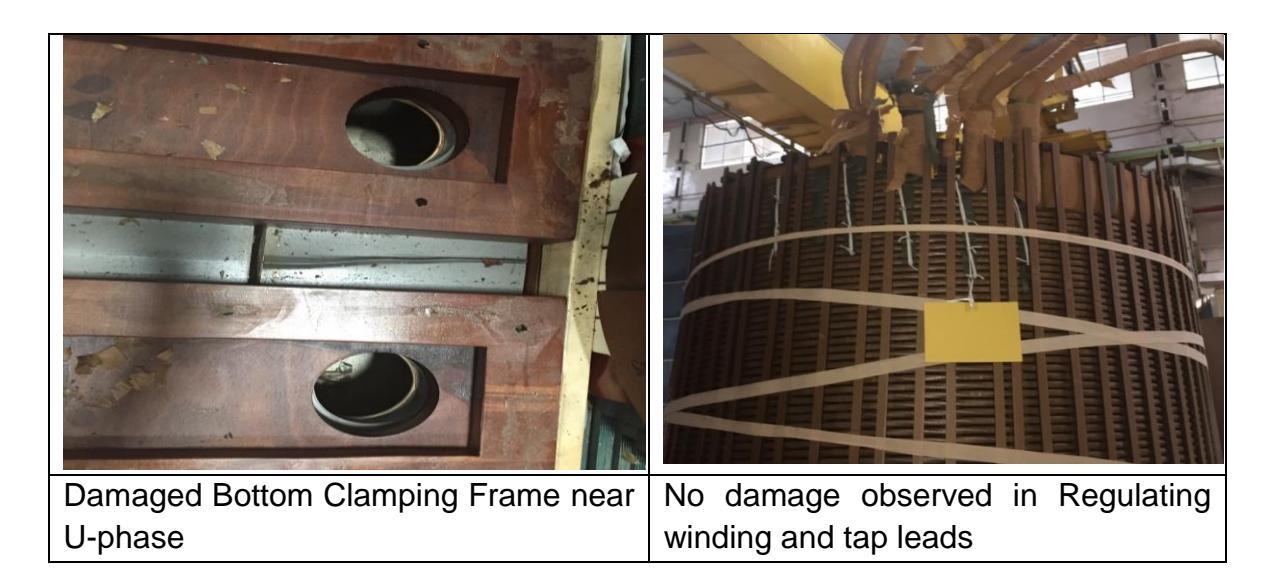
- f. The middle part of bottom yoke clamping studs between U and V phases was found to be burnt.
  - g. Burn marks were also observed in outer part of V-phase winding outer wrap. No further burn mark was observed from outside on coil stacks of V and W phase windings.

From the inspection, it may be inferred that failure of Transformer was occurred due to failure of R phase winding. As suspected earlier, tap lead was not involved in the failure. Faults may be initiated due to inter turn of windings/ inter disc in HV series winding. Considering the extent of damage, carbonization and exposure of other winding insulations, it is recommended to replace all the windings along with all insulation materials and tank. Old windings shall be made scrapped.

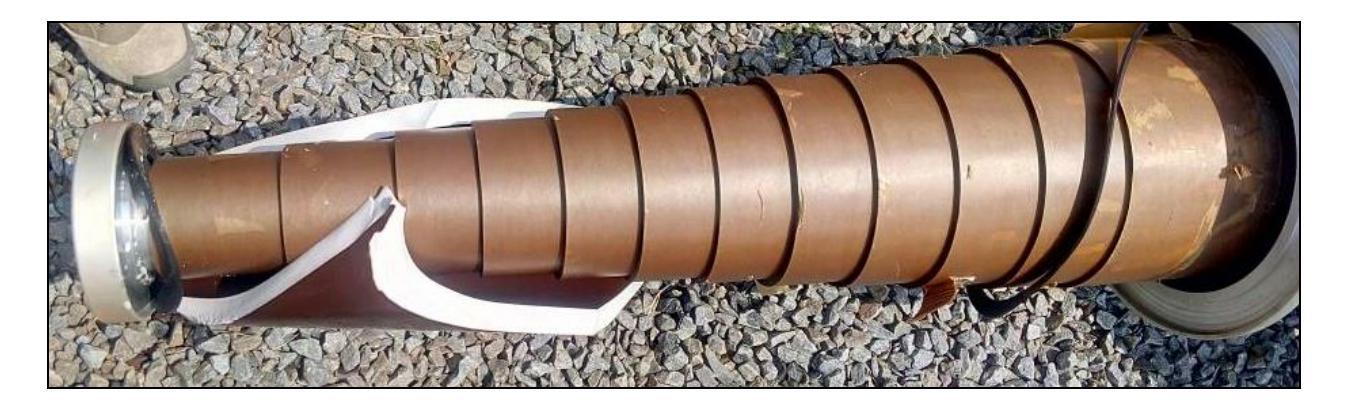
No burn/ flashover marks observed on paper insulation. This confirmed absence of any partial discharge in the bushing.

➢ It was observed that the inside body of the turret was having single point flashover mark. The Corona shield also contained flashover marks and was found to be damaged with broken connecting points.

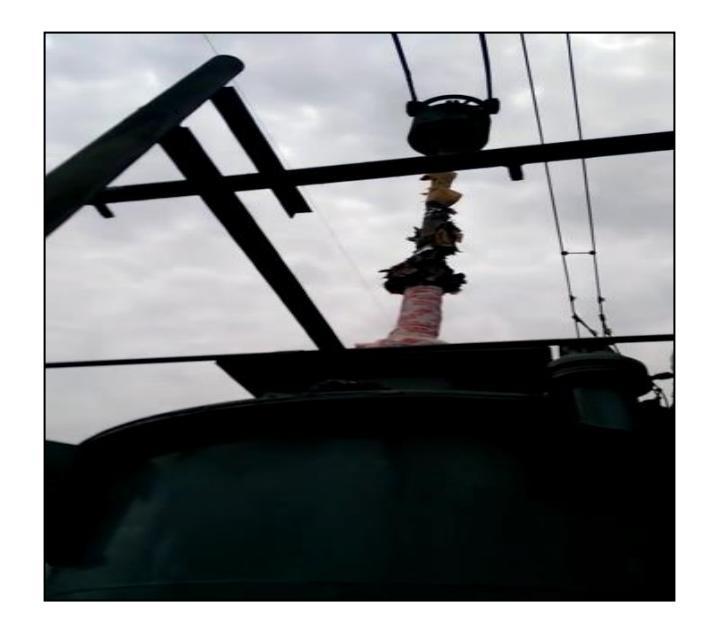
The Agra-Bhiwadi-1 Line tripped at 01:27 Hrs on 22.05.2017 on single phase fault on R-N at 15.7 km (Main 1) from Agra End with failure of bushing. During failure, fault current of 35.78 kA was recorder to have flown through the reactor. The bushing of the Agra- Bhiwadi1 LR was charred from the top and subsequently caught fire. The burning oil falling from the bushing damaged the nearby cables and Marshaling Box. However, recording instruments were found to be in working order.

The outer sheath of the cable from reactor to MB box was found to be burnt and MB was found to be damaged.

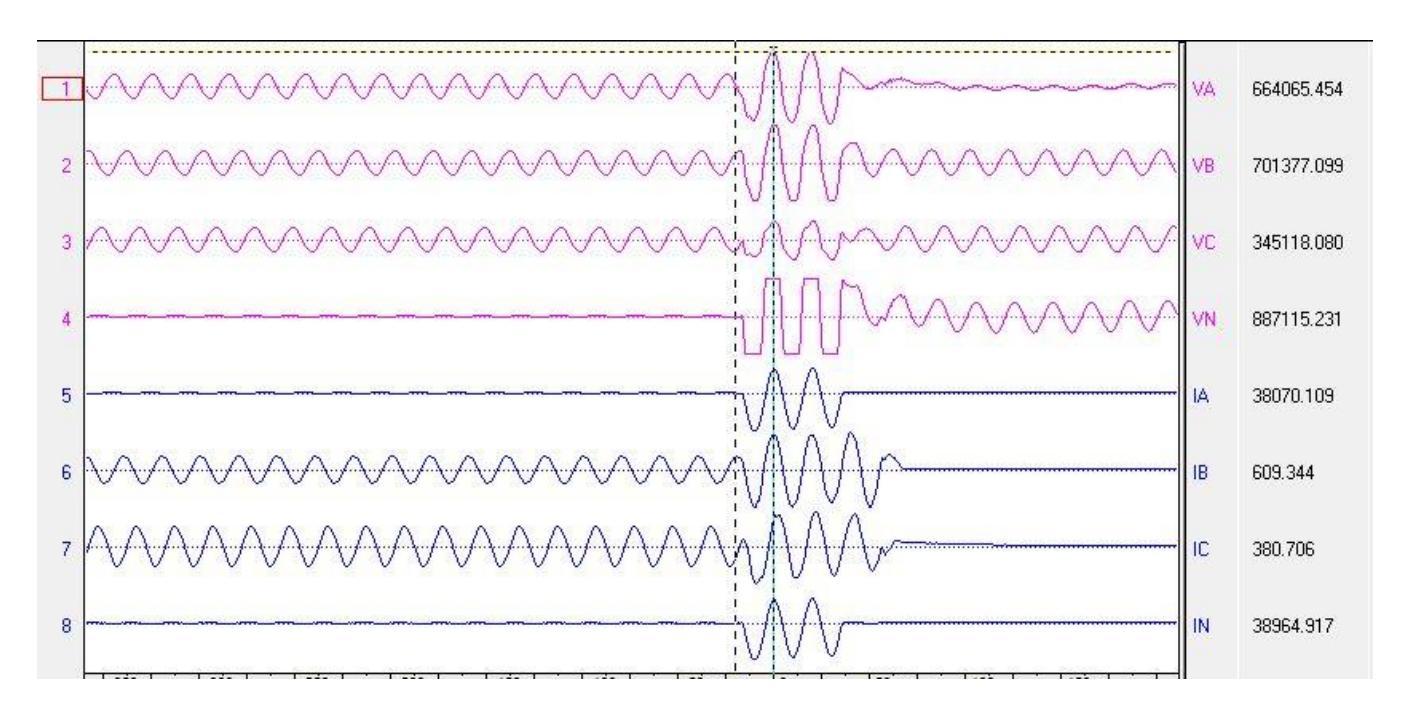
As can be seen from the DR, distortion has been observed in the voltage waveform about 20ms prior to fault. Complete phase shift has been observed in the B-phase and partial phase shift in the Y-phase and R-phase. The bushing being aged (about 31 years old) had weaker insulation and thus could not sustain this high voltage. Spark developed in the bushings causing its failure.

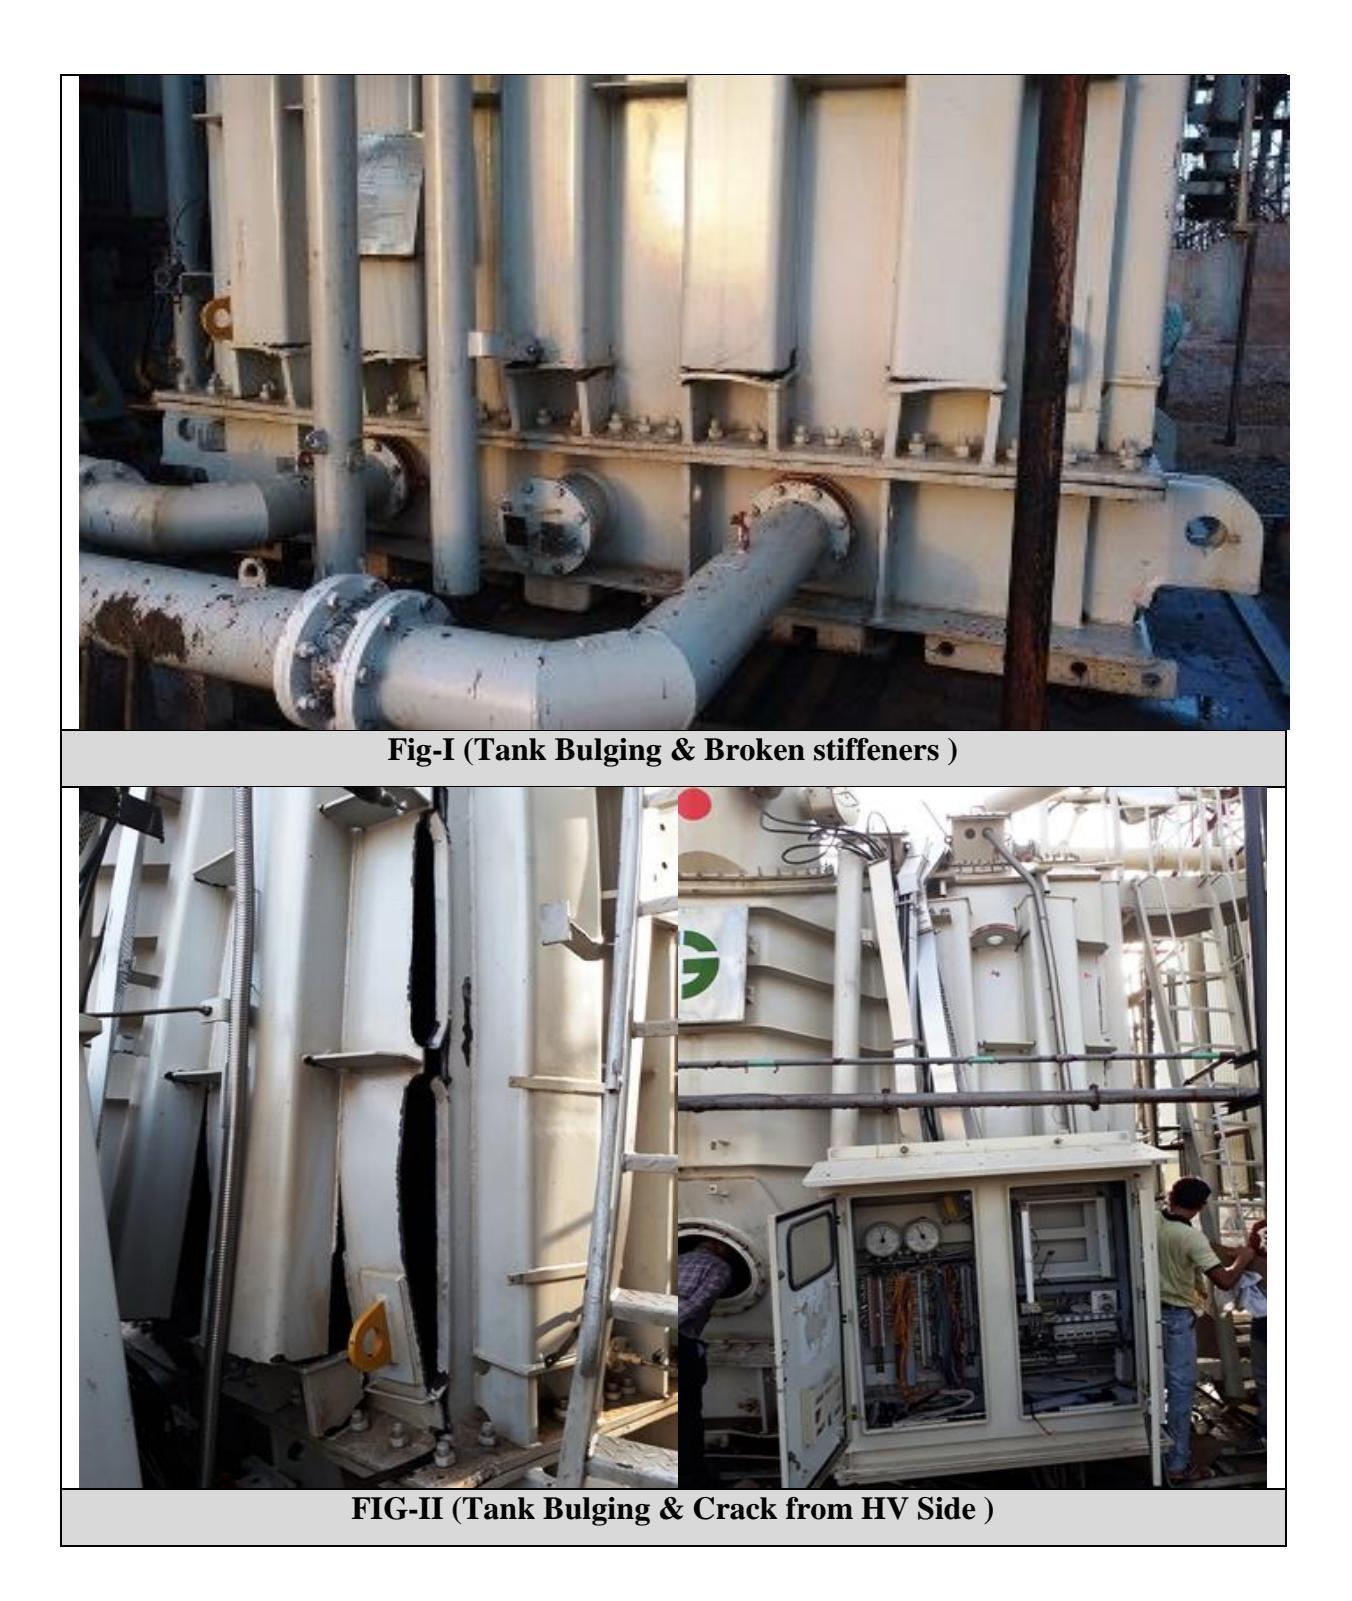
# Photos of Failures of 765kV 80MVAr Bina-II reactor

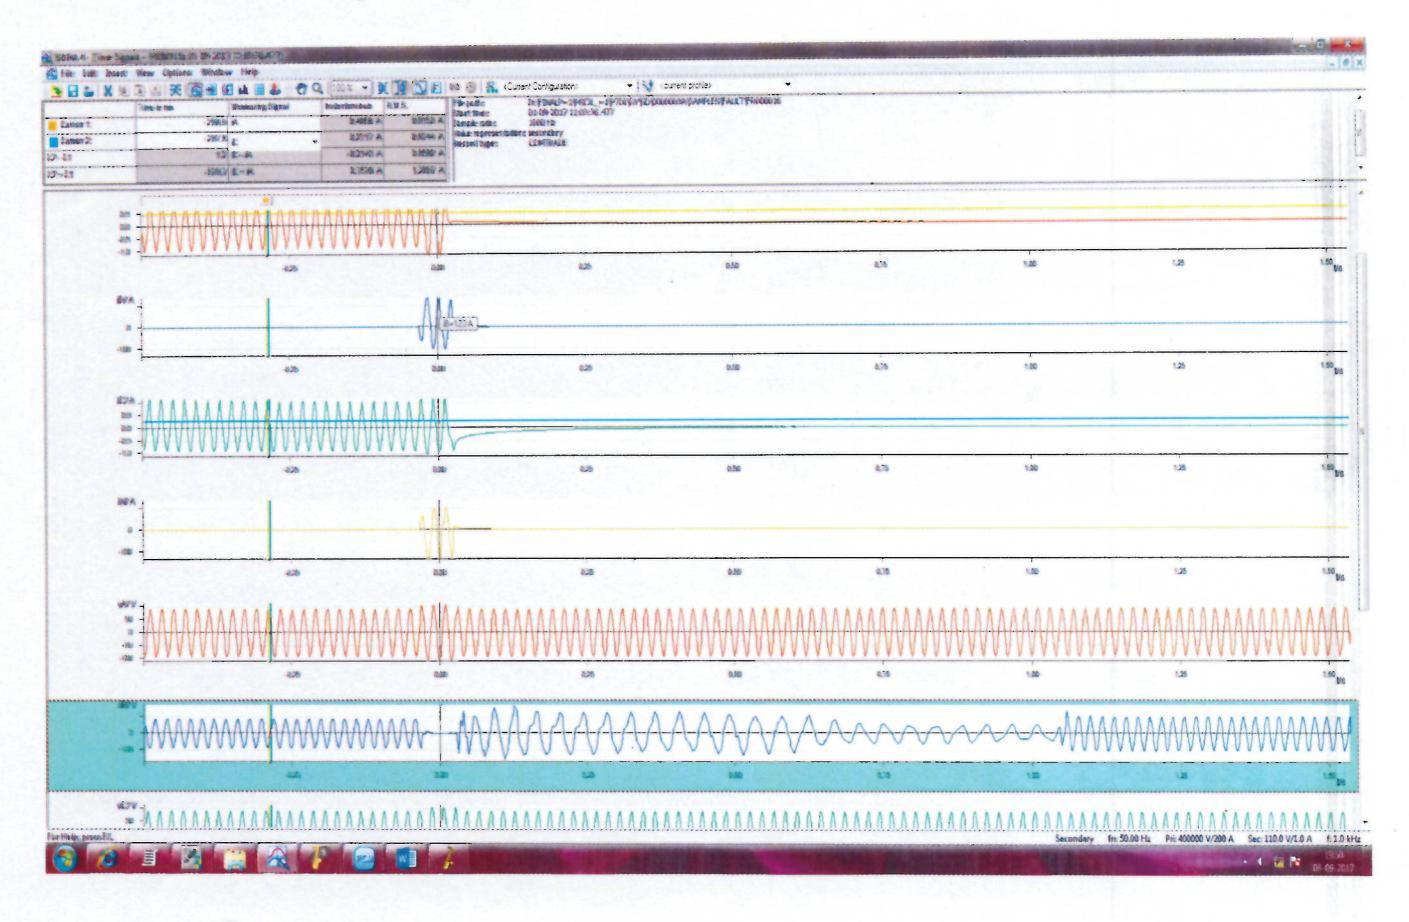
The DR of the REF during the tripping is as shown:

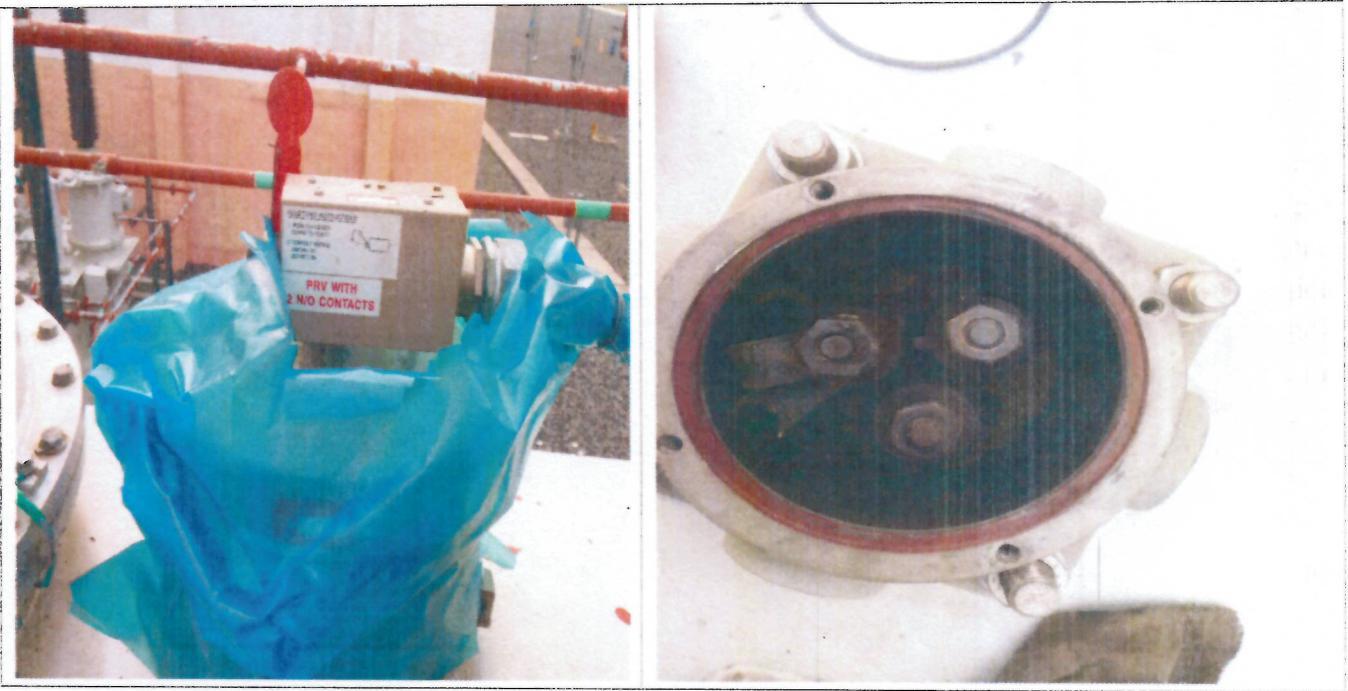
There is no visual damage to the bushings of the reactor. The main tank is also intact and there is no bulging or any physical damage. Both the PRDs have operated and oil has been discharged. CC-CL Earthing link on top of the reactor was found damaged. The PRD and Buchholz of main tank and the NGR were covered tightly with plastic sheets and tied tightly and there was no indication of moisture ingress.

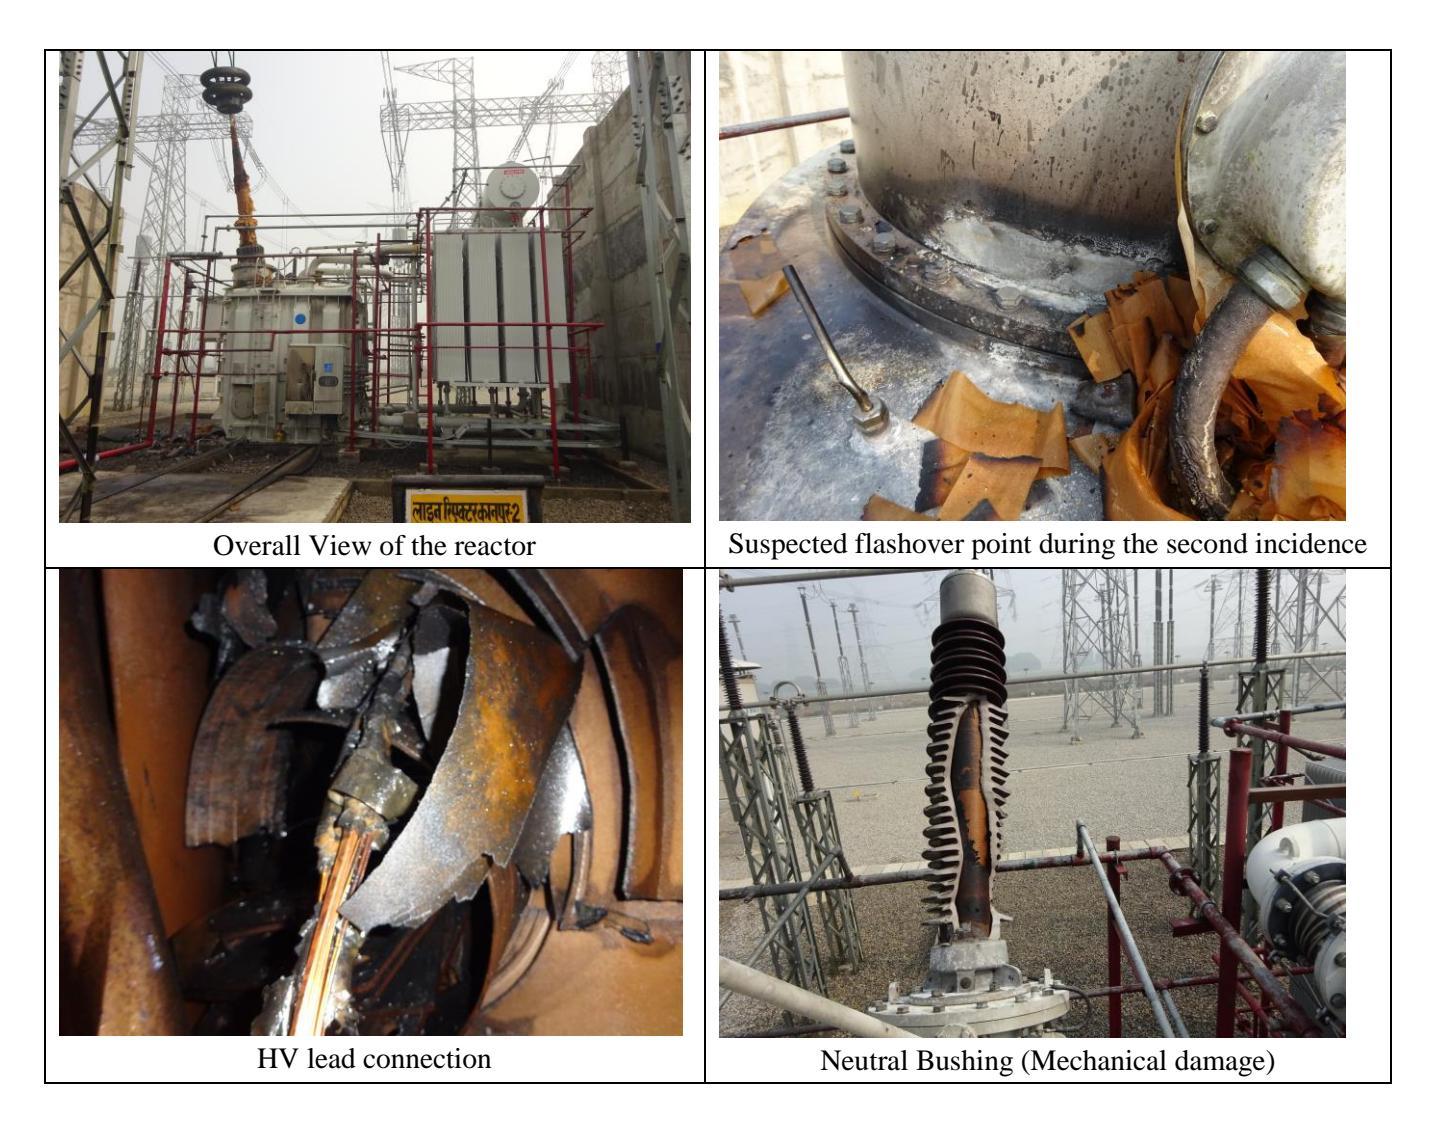
Internal inspection at site indicates that the HV lead exit has violently sheared away from the HV bushing and the insulation is completely burnt. However the HV bushing oil end corona ring seems to be intact and there was no abnormality observed on the tan delta point. The neutral lead is intact in the neutral bushing. The portion of winding visible also seems to be intact except for minor fire damage. This indicates that the fault has initiated from the HV lead exit to Static end ring (SER) of the neutral end of the winding either at the top or bottom. However the end point of the flash over or the route taken by the flashover can only be clear during the factory inspection.

The second fault seems to have been caused due to burning material rising from the reactor which caused an ionized path to the HV bushing from the line (which was charged) above the failed reactor. The flashover then travelled through the bushing CT and then through the tank so it cannot be seen in the Neutral CT.
