REPORT OF STANDING COMMITTEE OF EXPERTS ON FAILURE OF 220 kV & ABOVE VOLTAGE CLASS SUBSTATION EQUIPMENT (APRIL 2018 - MARCH 2019)

Government of India केन्द्रीय विद्युत प्राधिकरण Central Electricity Authority विद्युत मंत्रालय Ministry of Power नई दिल्ली New Delhi

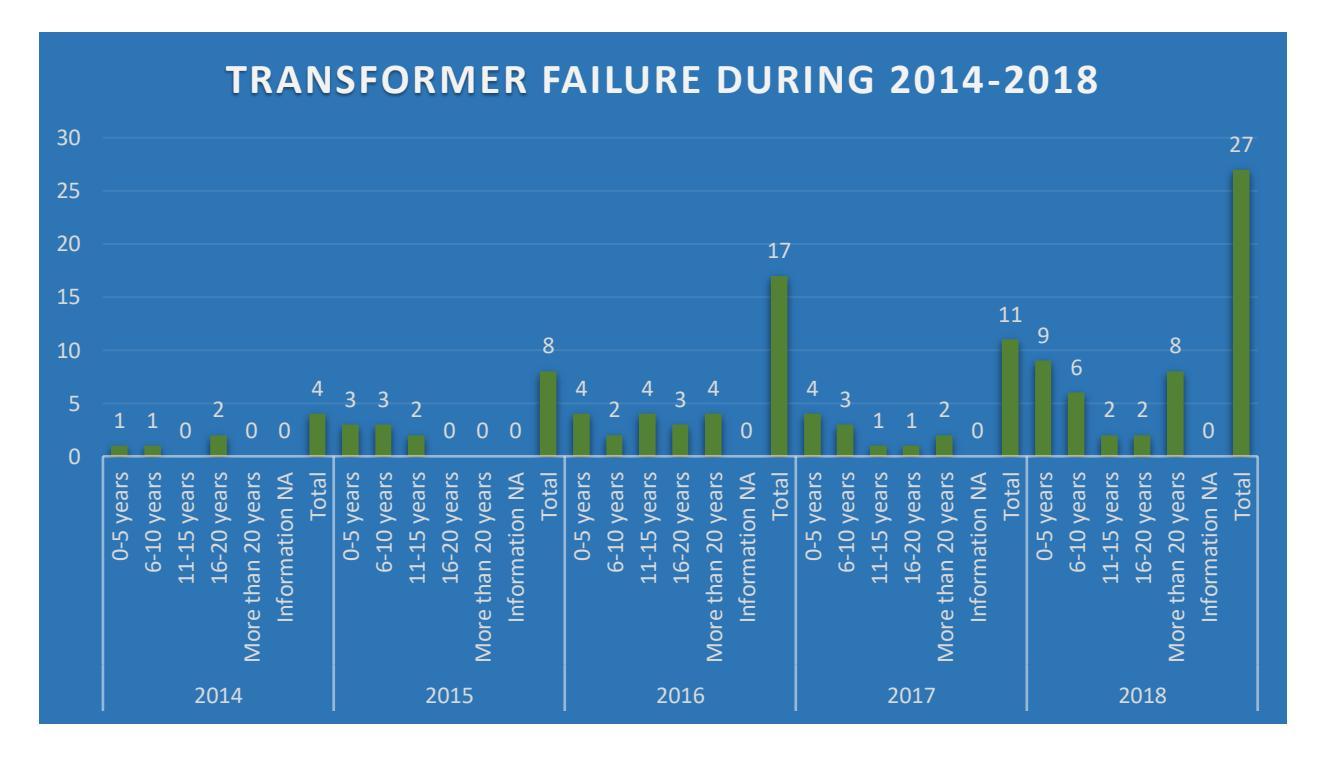
- (v) **Failures of transformers during 2014-2018:** The number of different transformer failures as reported in last 5 years to CEA has been shown in the graph below:

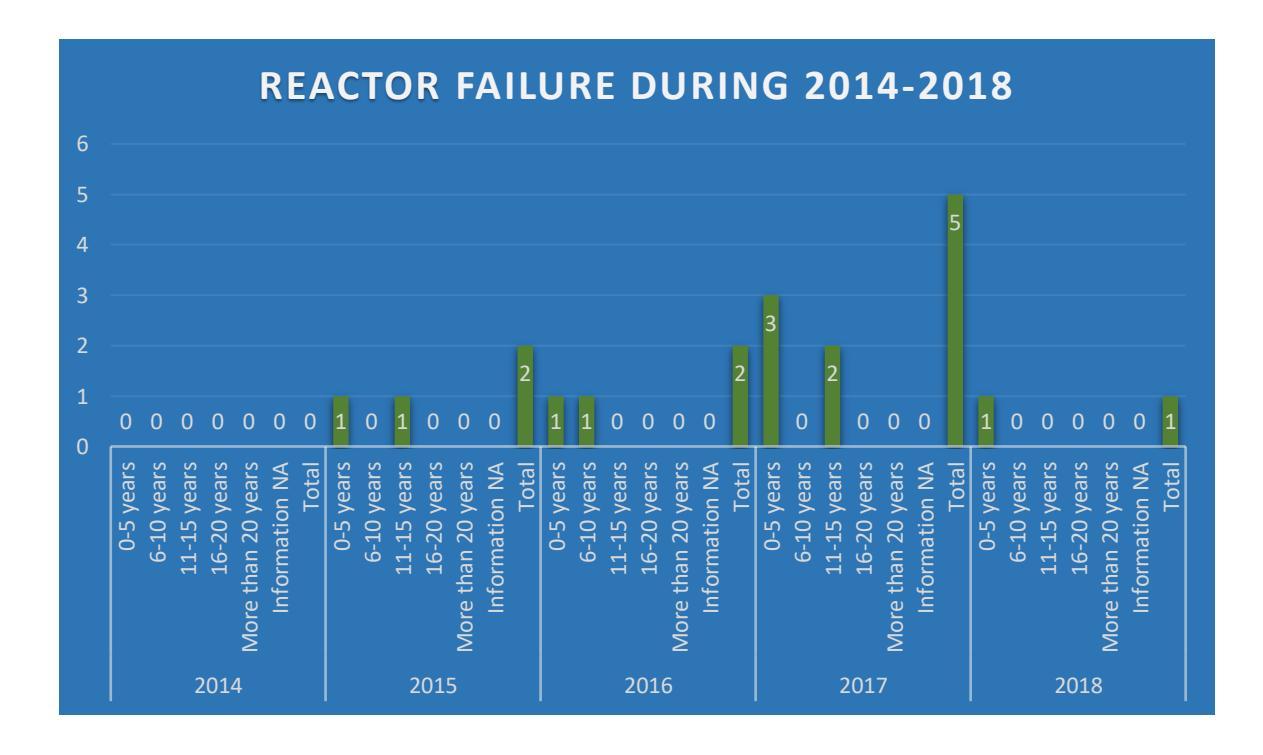
- (ii) In case of failure of Reactor in the substations of PGCIL, a team constituted by PGCIL carried out the investigation of failure of this Reactor. Reports as prepared by the team has been enclosed as Annexure-II.
- (iii) **Failures of reactors during 2014-2018:** The number of different reactor failures as reported in last 5 years to CEA has been shown in the graph below. No reactor failure was reported during 2014.

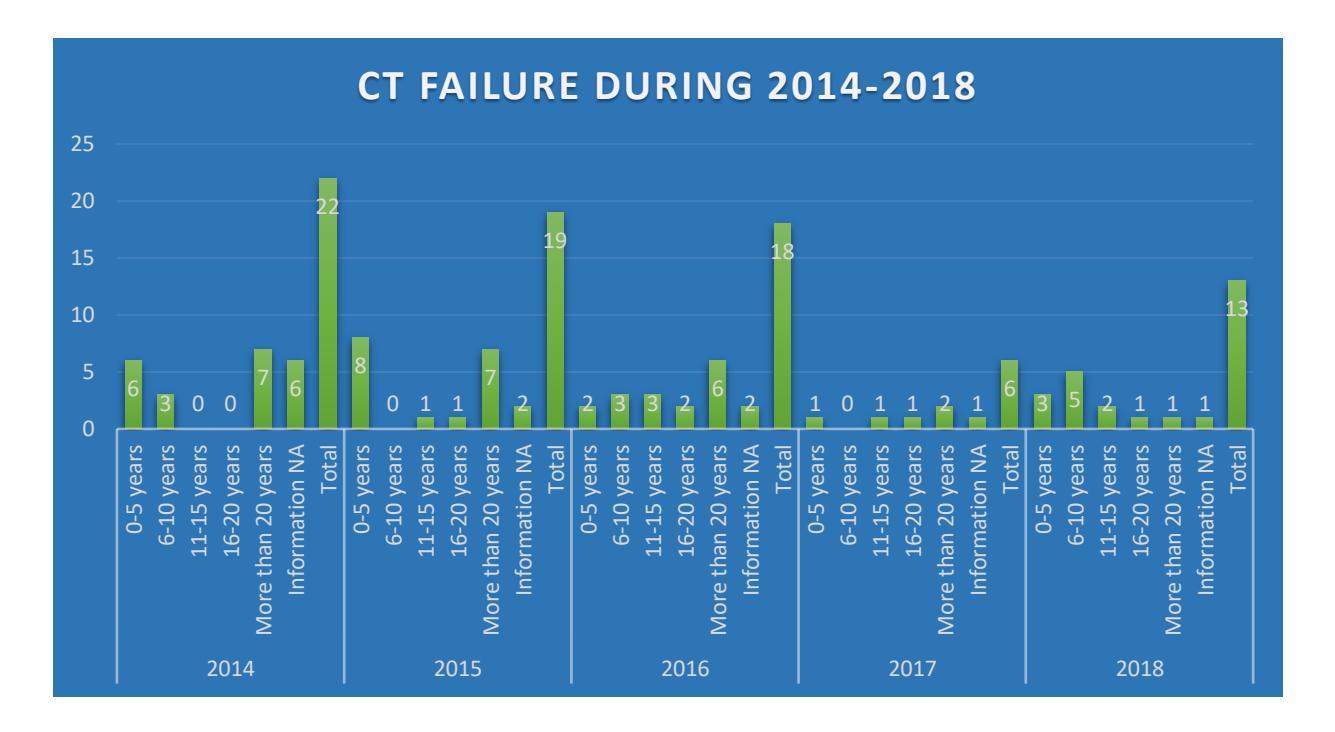
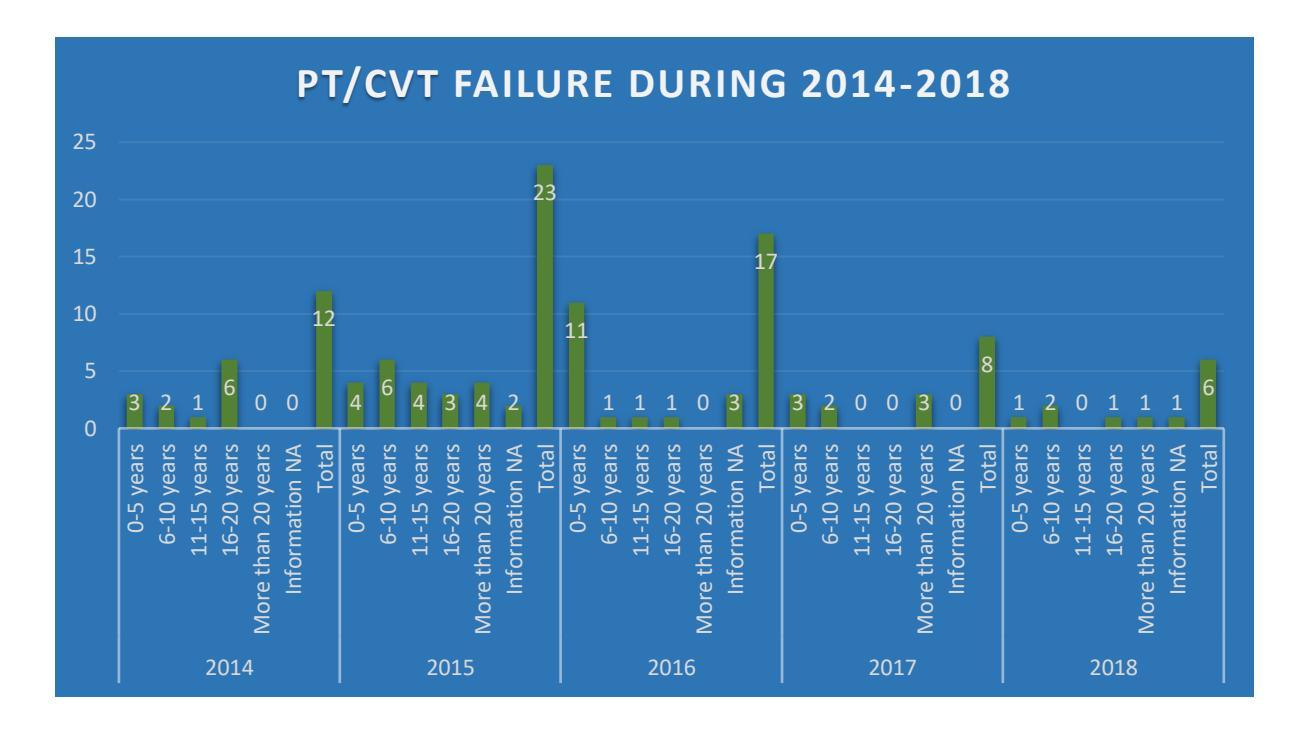
- (v) **Failures of CTs/PTs/CVTs during 2014-2018:** The number of different CT/PT/CVT failures as reported in last 5 years to CEA has been shown in the graph below.

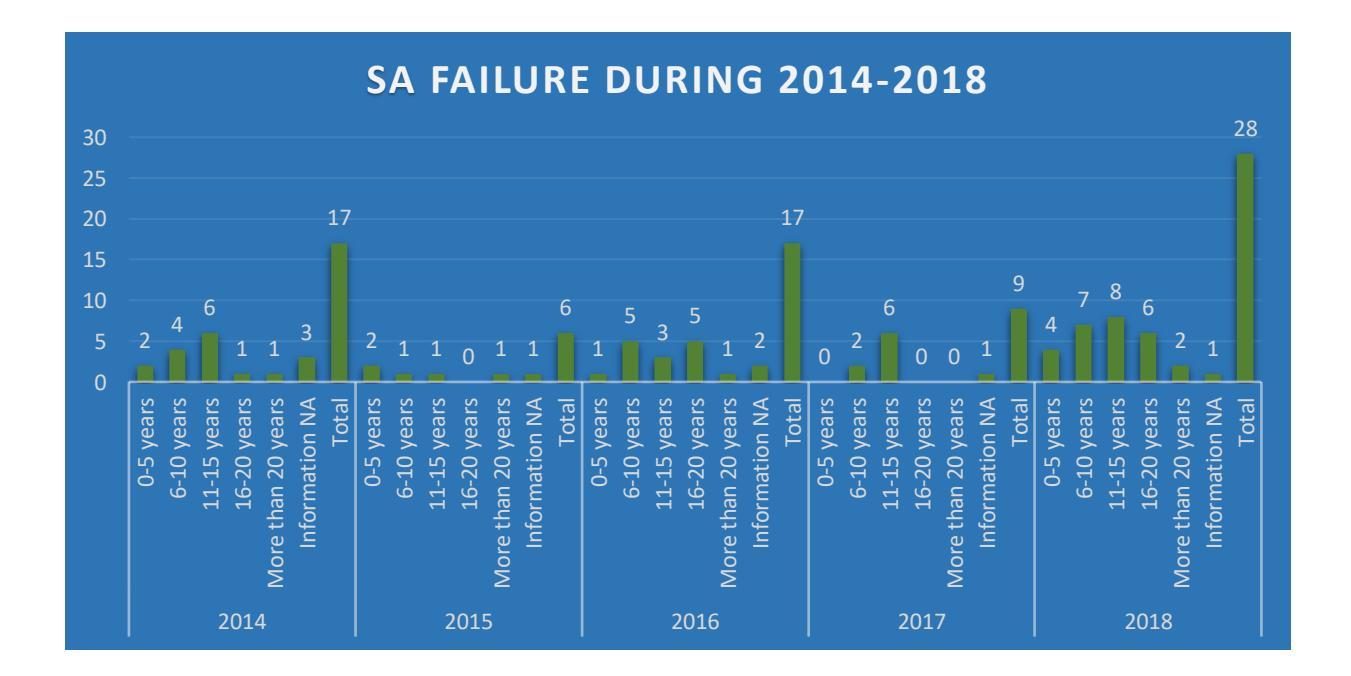
- (vi) As per the reports received by CEA, twenty-three (23) nos. of cases of SA failure occurred during the period from April 2018 to March 2019 have been reported to CEA by five (5) utilities. Out of these, seventeen (17) nos. of SAs are of 220/230kV class and rest six (6) nos. of SAs are of 400kV class.
- (vii) **Failures of SAs during 2014-2018:** The number of different SA failures as reported in last 5 years to CEA has been shown in the graph below.
