**REPORT OF THE STANDING COMMITTEE OF EXPERTS
ON FAILURE OF EHV TRANSMISSION LINE TOWERS
(APRIL 2018 – MARCH 2019)**

Central Electricity Authority

Ministry of Power

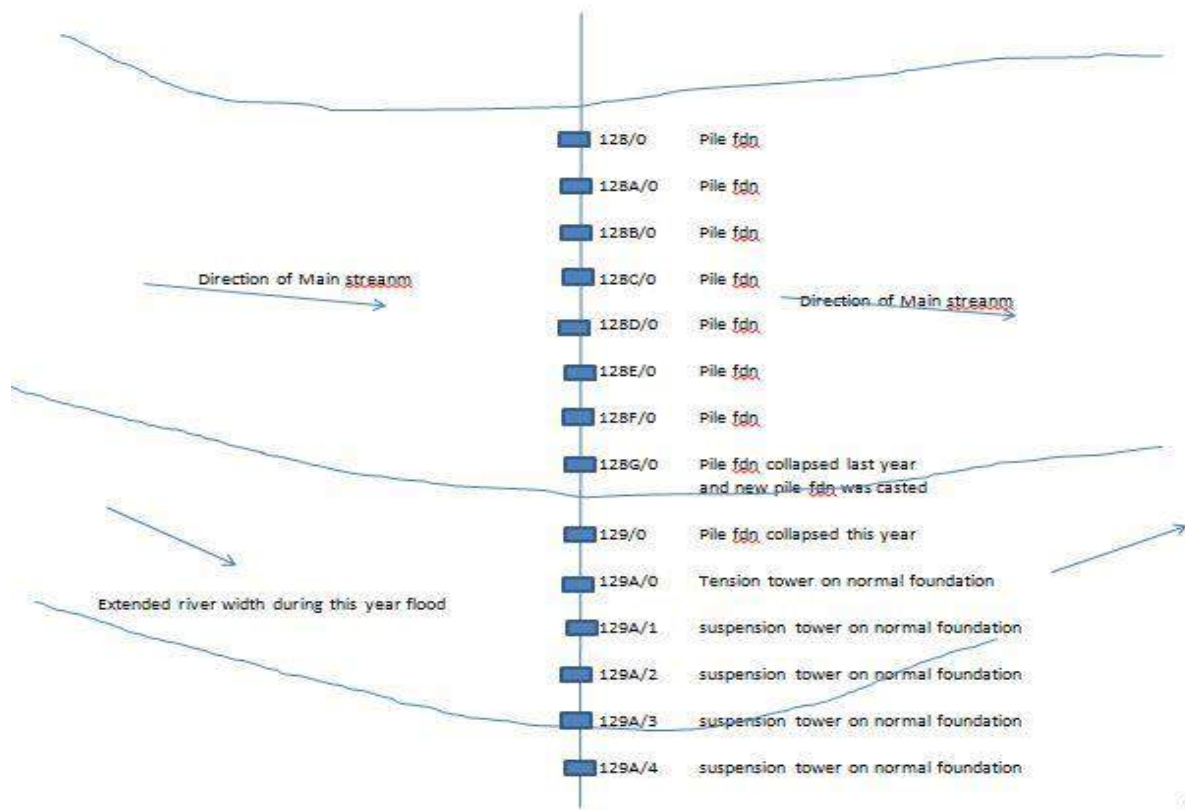
b. A schematic representation of plan indicating affected location on piles and normal foundation is shown below.

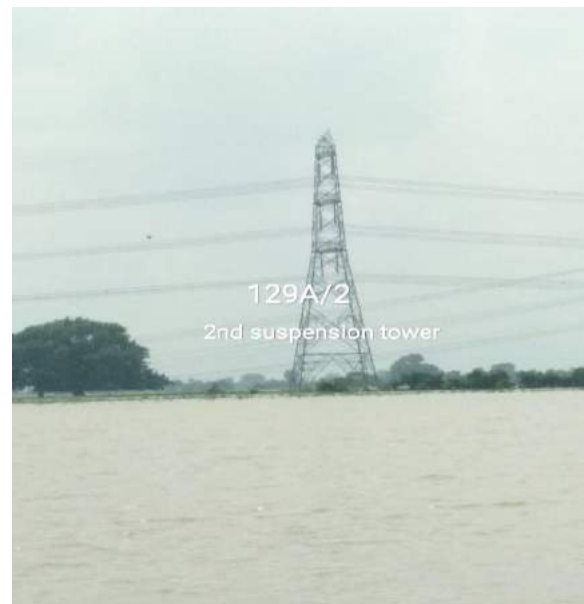
Tower at Loc. No. 129A/2

5	129A/1	DA+3	395	--	Open cast type	Loc. is on the island within extended river course. Tower is submerged approx. 1m in water
6	129A/2	DA+0	395	--	Open cast type	Loc. is on the island within extended river course
7	129A/3	DA+3	395	--	Open cast type	Loc. is on the island within extended river course
8	129A/4	DA+0	395	--	Open cast type	River is flowing near edge of water
9	129A/5	DA+3	395	--	Open cast type	submerged area
10	129A/6	DA+0	398	--	Open cast type	submerged area
11	130/0	DD+09		44°42'52"LT	Open cast type	submerged area

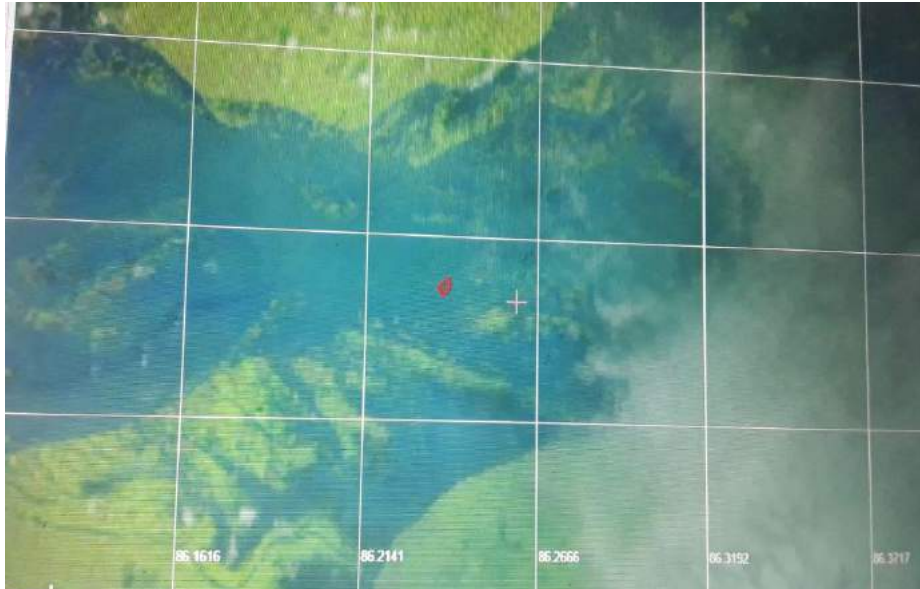
- i. PGCIL informed that after discussion with the local people in the nearby villages, it was gathered that every year the river course is changing towards right bank (towards Patna). Analysis of Google Map for the change in river course during last five years at the crossing locations was done PGCIL. From the analysis, it was clear that there is continuous river bank erosion towards Patna side bank and the distance of river course from bank location no. 129/0 (tower no. 568) has reduced from 576m in Feb-2013 to 105m in Dec-2017. Further, satellite map of 10th Sept-2018 shown below also highlights the heavy soil erosion towards the collapsed tower location (marked as red dot).

Committee noted that the transmission line had had previously failed in the year 2016 in which the same segment of transmission line crossing the river Ganga was affected due to soil erosion by the changing river course. Committee observed that over the years, the course of river Ganga is continuously changing towards right bank (towards Patna). Committee also noted that the failed tower was casted on pile type foundation. Committee observed that course of water in Ganga river was diverted due to heavy flood and heavy soil erosion towards river bank (Patna side) was observed leading to collapse of tower at loc. No. 129/0 (DD+9). Earth wire peak and one side of bottom cross arm of tower at Location No. 128G/0 (DD+25) & One side of bottom cross arm of tower at Location No. 129A/0 (DD+0) had been damaged due of pull of conductor towards collapsed tower at loc. No. 129/0 (DD+9)

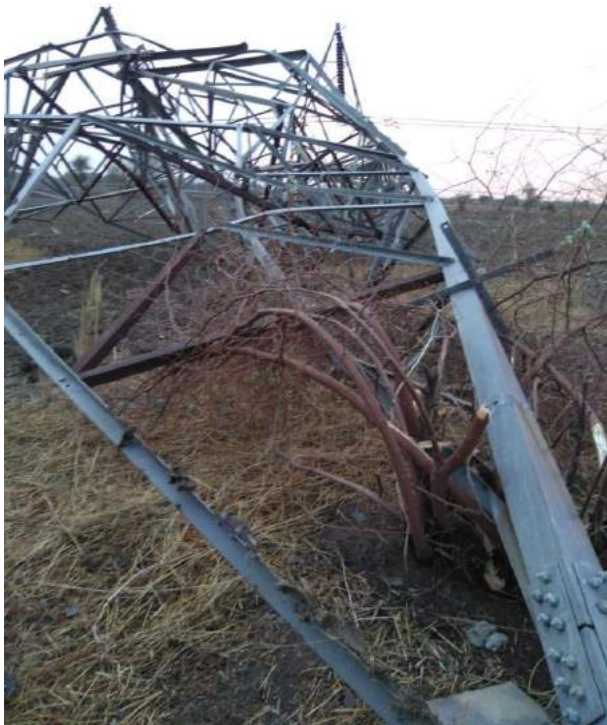
Tower at Loc. No. 570

- d. **Tower at Location 570 (FD0) & 571 (FD0)** were completely collapsed and were lying on the ground.
