### क्षतिग्रस्त ट्रांसमिशन लाइन टॉवरों पर विशेषज्ञों की स्थायी समिति की रिपोर्ट

REPORT OF THE STANDING COMMITTEE OF EXPERTS ON FAILURE OF EHV TRANSMISSION LINE TOWERS (APRIL 2019 – DECEMBER 2021)

भारत सरकार Government of India केन्द्रीय विद्युत प्राधिकरण Central Electricity Authority

### **EXECUTIVE SUMMARY**

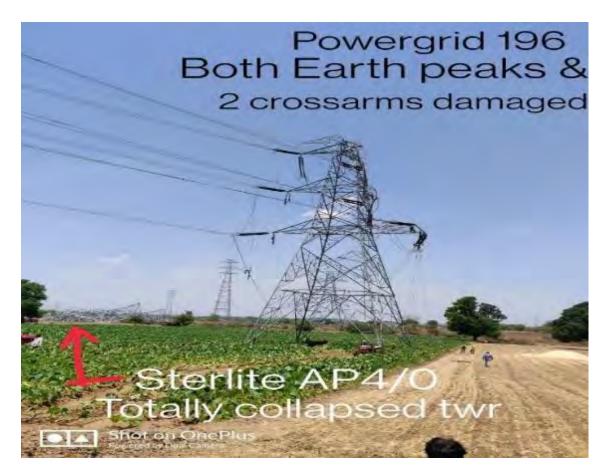
Location No. 196( DD+0)

- a. The 400 kV Khandwa-Indore transmission line of POWERGRID was crossed over between tower locations 196(DD+0)-197(DC+9) by the 765 kV Khandwa Dhule D/C transmission line of M/s Sterlite Power. At the time of failure incident, the 765 kV Khandwa Dhule D/C transmission line with Hexa AAAC Moose conductor per bundle configuration was under construction, however, the stringing of crossing span between Towers AP4/0 and AP5/0 was complete.
- b. As reported by POWERGRID, on 16.04.2019, there was high speed wind conditions in the affected area (village Toksar near Sanavad) during which the crossing Towers AP4/0 and AP5/0 of 765 kV D/C Khandwa-Dhule line of M/s Sterlite collapsed due to which the conductors of this line fell over POWERGRID's 400 kV D/C Khandwa-Indore Line in the span between towers 196-197.
- c. Due to falling of Hexa AAAC Moose conductor on the span, the tower

at Location No. 196 (DD+0)) was damaged from above waist level. Both earthwire peaks and two cross arms of the tower were damaged. The conductor and insulators in the span were also damaged. At Location No. 197 (DC+9) tower was intact, however, the insulators were observed to be damaged.

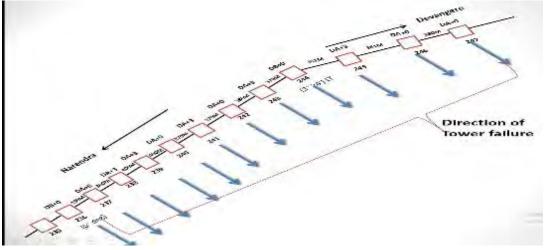
a. The affected tower locations 237 to 246 were located in undulated agriculture field with few trees in vicinity near village Kadkol, Savanur Taluk in Haveri district (Karnataka). All the ten towers had fallen in the direction perpendicular to the line. Indicative diagram of the fallen towers is shown below:

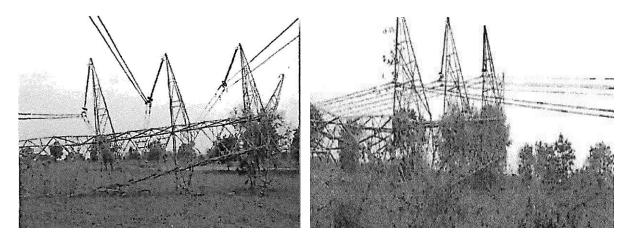
Tower at Loc. No.237 (DA+6)

SI. No.	Loc. No.	Tower Type	Span (in m)	Angle of Dev.	Extent of Damage
1	237	DA+6	360	NIL	<ul> <li>Tower collapsed completely.</li> <li>All the four stubs were intact.</li> <li>Minor damage to chimney at leg C was observed. Coping of the chimney was also damaged.</li> </ul>
2	238	DA+3	400	NIL	<ul> <li>Tower collapsed completely.</li> <li>Stub cleat of Leg C &amp; Leg D of the tower were damaged &amp; other two stubs along with foundation &amp; chimney were intact.</li> </ul>
3	239	DA+3	400	NIL	<ul> <li>Tower collapsed completely.</li> <li>All the four stubs of the tower along with foundation and chimney were intact.</li> </ul>

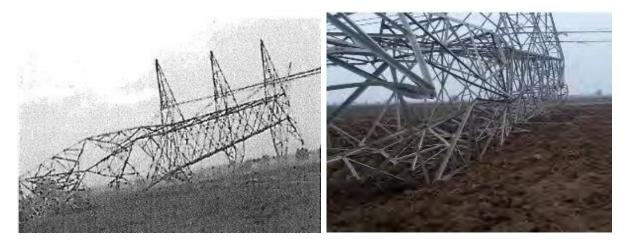
Tower at location No. 241 (DA+3)

1		[		
4	240	DA+0	370	NIL	<ul> <li>Tower collapsed completely.</li> <li>All the four stubs of the tower along with foundation and chimney were intact.</li> </ul>
5	241	DA+3	370	NIL	<ul><li>Tower collapsed completely.</li><li>Stubs were observed to be bent, though foundations were intact.</li></ul>
6	242	DA+0	380	NIL	<ul><li>Tower collapsed completely.</li><li>Stubs were observed to be bent, though foundations were intact.</li></ul>
7	243	DA+3	378	NIL	<ul><li>Tower collapsed completely.</li><li>Stubs were observed to be bent, though foundations were intact.</li></ul>
8	244	DB+0	381	3º24' LT	<ul> <li>Tower collapsed completely.</li> <li>Tower members below first cross arm level were badly damaged and entangled.</li> </ul>
9	245	DA+3	381	NIL	<ul> <li>Tower collapsed completely.</li> <li>The land at tower location was with gradient. The fall of the tower was towards the slope.</li> <li>Stubs (cleats) of leg C &amp; Leg D of the tower were failed. Other two stubs and chimney were intact.</li> </ul>

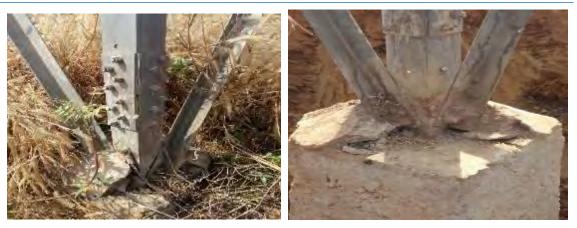
- There were very few obstructions in the vicinity of the transmission line to dampen the intensity of wind speed caused due to thunderstorm.
  - Tower foundation chimneys were covered in the soil and surrounded by long grass.

- Stub levelling difference at the top of the stubs & Longitudinal and traverse deflections of tower were within limits.
  - Coping of some of the chimneys were found damaged & due to ingress of water to the chimney, stubs were rusted.

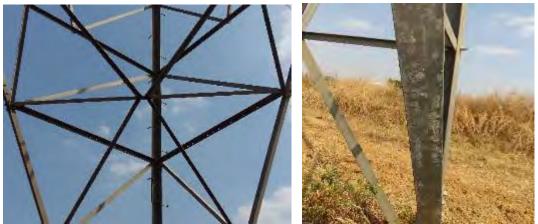
- To ascertain the quality and workmanship of the concreting work done for the foundations, Non-Destructive Testing (NDT) – Rebound Hammer Test was conducted at locations 226 and 220 of the line in the presence of the Committee Members.
- The towers have been constructed generally in order and no major structural deficiency has been observed.
- The basic dimensions of the foundations, galvanization thickness on the tower parts, section sizes and type of steel (MS or HT) were found to be within the permissible tolerance limits.
- Extra/additional holes on the main legs and other tower members were not plugged with nut & bolt in few towers. Pitting corrosion on the face of the bracing was observed.

• Committee concluded that the combined effect of deficiencies in the erection and maintenance of transmission line like corrosion of stubs & bracings, unplugged holes etc and the wind storm observed in the area might have caused the failure of towers. Since, wind speed data during the storm was not available, it was not possible to ascertain whether the wind speed exceeded the specified wind speed corresponding to Wind Zone 1 (33 m/s) for which tower has been designed.

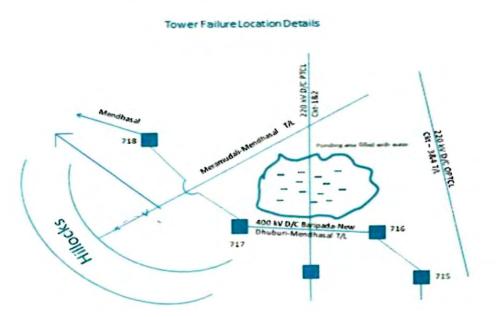
g. As reported by POWERGRID, the affected tower was situated in plain field with few trees in vicinity. On one side of the location, there was a hill at about 75 m-100 m distance, whereas other side was plain land with few undulations and sparse low height vegetation. In forward and backward span of collapsed tower, line was crossing over 400 kV D/C and 220 kV D/C (ckt-I & II) lines of OPTCL.

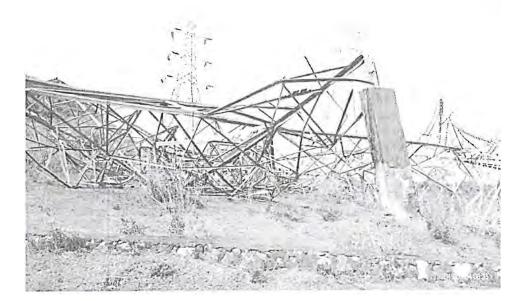
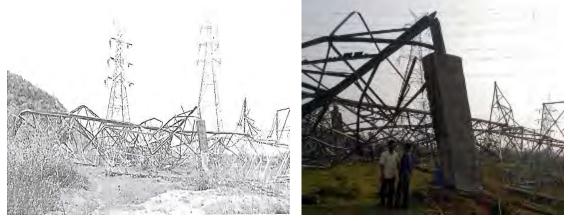
Tower at location No. 717 (DD+25+4m RC)

h. As reported by POWERGRID, the tower located at Location No. 717 (DD+25+4 RC) collapsed completely on the ground in the transverse

direction. The Main leg/stubs of the failed tower were double angle (star angle) parts. In three legs out of four legs, one of star angle section got torn near joint with stub, whereas in fourth leg, one of the angle section of the stub was torn.

- i. The cyclone "Fani", which was categorized by IMD as extremely severe Cyclone with a gust wind speed ranging upto 200 kmph, made its landfall on the coast of Odisha on 02.05.2019. The impact of cyclone severely affected the transmission & distribution infrastructure in the State of Odisha. The intensity of the wind might have increased due to plain area with few vegetation in the vicinity of collapsed tower on the one side and the hill on the other side.
- j. As reported by POWERGRID, the tower foundations were also checked for any damage and no failure of foundation was observed except the damage in chimney portion of foundation of one leg. The towers were checked thoroughly and no members and bolts & nuts were found missing.

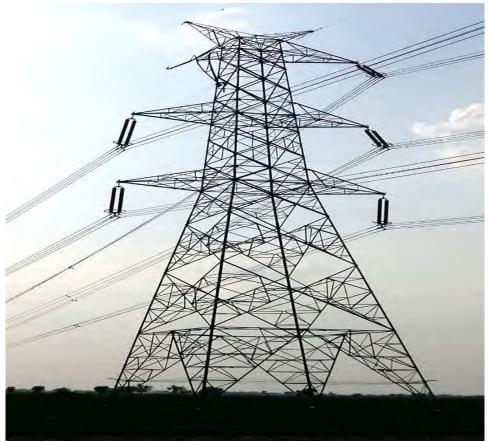
Tower loc. No. 546 (DA+0)

- b. All the affected towers were suspension type towers. The towers at location nos. 547 (DA+0), 548 (DA+0), 549 (DA+0), 551 (DA+0), 552 (DA+9) were completely collapsed & lying on ground and tower at location No. 550 (DA+0) was damaged above the 2<sup>nd</sup> panel level and tower at location No. 546 (DA+0) was intact however, damaged from top cross arm only. Anti-climbing device were provided and no missing of tower members observed in any of the tower.
- c. **Tower at Location No. 546 (DA+0)** was located in plain terrain. When facing towards Gooty, the left side top cross arm of the tower was observed to be broken and conductor had fallen on ground. The rest of the tower structure was intact. All the foundation chimneys & stubs were intact. All Chimneys were above ground level. Anti-climbing device, name plate of tower, danger plate and phase sequence plate were provided.

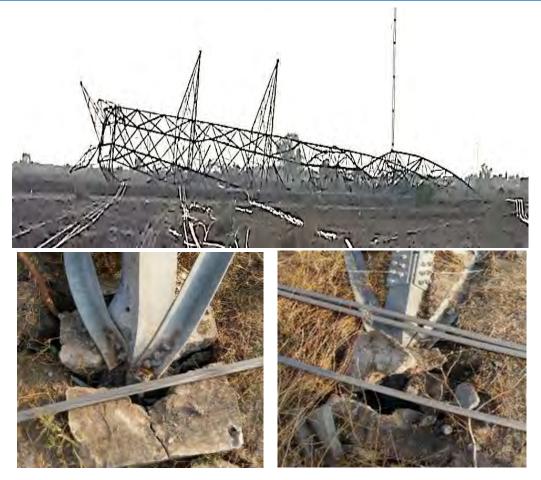
Tower loc. No. 548 (DA+0)

e. **Tower at Location No. 548 (DA+0)** was completely collapsed to the ground from the stub level in transverse direction towards left side when observed facing Gooty. All four stubs of the tower were bent. Rusting at the bottom end of all the stubs (near to chimney) was observed. All chimneys were almost covered in the soil and found damaged. Coping of legs were damaged. No missing tower members/ nut bolts were found.

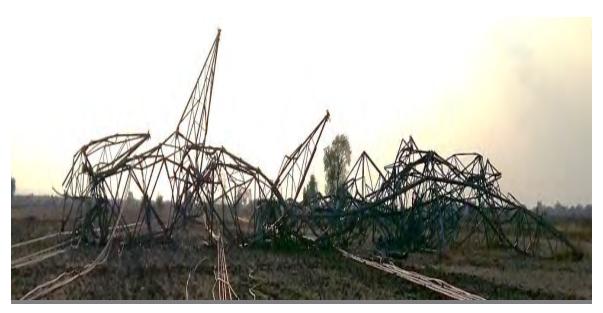
Tower loc. No. 549(DA+0)

f. Tower at Location No. 549 (DA+0) was completely collapsed on the ground from the stub level in transverse direction towards left side when observed facing Gooty. All foundation chimneys were almost covered in the soil & grass. Rusted stub of Leg A was broken from bottom end (near to chimney) and the remaining three were bent. No missing tower members/ nut bolts were found.

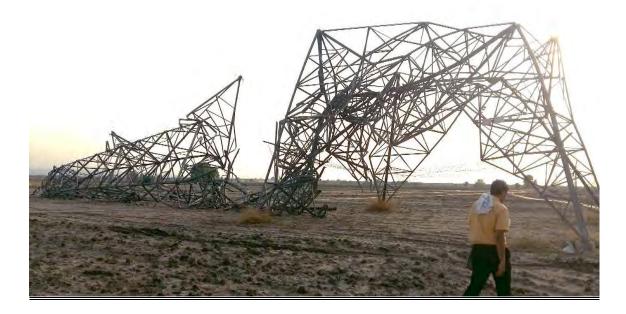
Tower loc. No. 550 (DA+0)

g. **Tower at Location No. 550 (DA+0)** was bent from 1<sup>st</sup> panel level and collapsed to the ground in transverse direction to the line towards left side when observed facing Gooty. All four stubs of the tower were bent. Rusting of all stubs, nuts & bolts at the bottom end of stubs (near to chimney) was observed. Coping of legs were damaged due to the impact of falling tower. No missing tower members/ nut bolts were found.

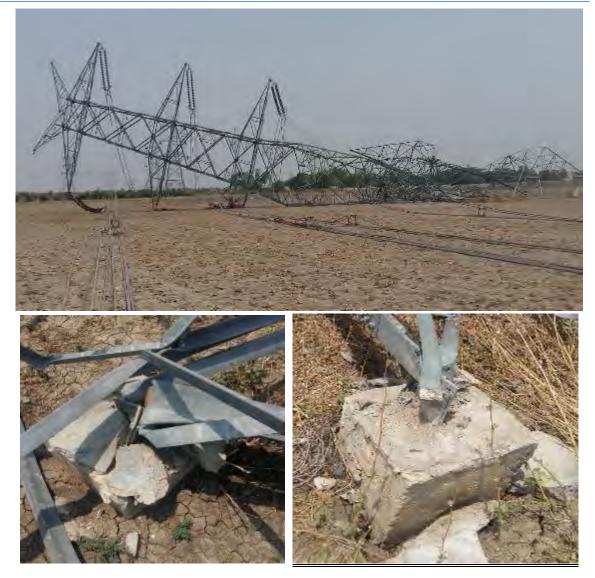
Tower loc. No. 552 (DA+9)

i. Tower at Location No. 552 (DA+9) was located in plain terrain. The tower had completely collapsed to the ground from the stub level in transverse direction towards left side when observed facing Gooty. The Stub of leg D was observed to be not in centre of chimney. Stubs of Leg C & Leg D were broken from bottom end (near to chimney) and the remaining two stubs were bent. Rusting at the bottom end of stubs (near to chimney) was observed. Chimneys were found to be damaged.

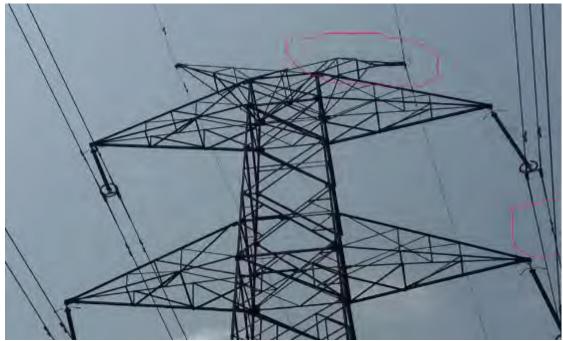
Tower at location No. 360 (DA+0)

b. **Tower at location No. 360 (DA+0)** was located in plain terrain with slope terrain in both side. Right side OPGW Earth wire peak of the tower was bent when facing towards Davangere. Anti-climbing device, name plate of tower, danger plate and phase sequence plate were provided.

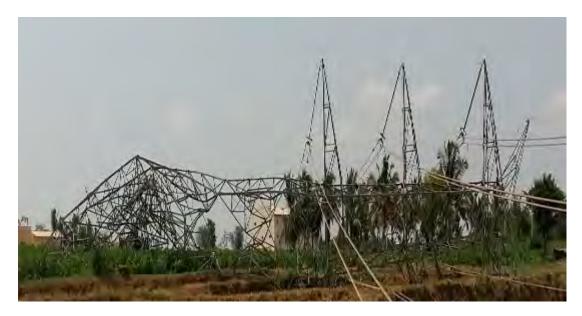
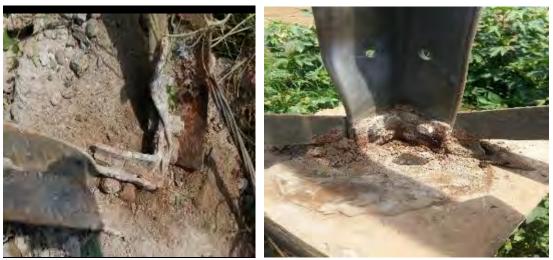
Tower at location No. 361 (DA+3)

c. **Tower at location No. 361 (DA+3)** was located in sloped terrain. The tower had completely collapsed to the ground in transverse direction towards right side when observed facing Davangere. Failure of Stub Cleat of leg — A & C was observed. Other two stubs of the tower along with foundation & chimney were intact. Chimney of leg C was covered in the soil and remaining three chimneys were above ground. Rusting at the bottom end of all the Stubs (near to chimney) was observed. The tower got bent from 1<sup>st</sup> panel level and had fallen in transverse direction to the line. Coping was also damaged due to the impact of tower collapse. No missing tower members / nut bolts were found.

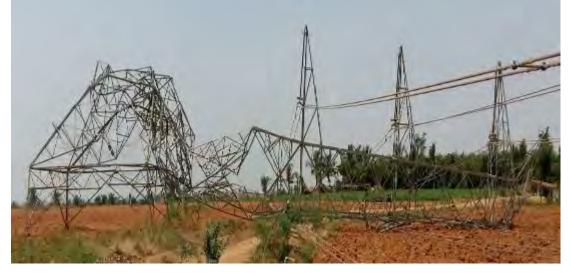
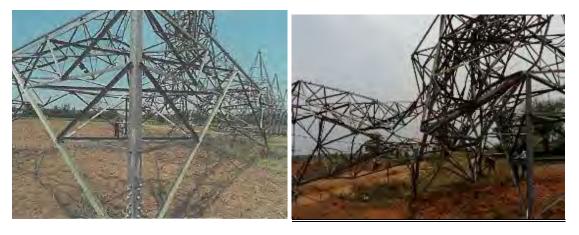
Tower at location No. 362 (DA+3)

d. **Tower at location No. 362 (DA+3)** was located in plain terrain. The tower got bent from 1st panel level and completely collapsed to the ground in transverse direction to the line towards right side when observed facing Davangere. All the four stubs of the tower along with foundation were intact. Leg B of the tower was found broken and other three legs were bent from 1st panel level. The leg member of the +3 m extension was found to be bent but the bracing members / diagonals of +3 m extension was found to be in order. All Chimneys were above ground level. Coping of chimneys were not done properly.

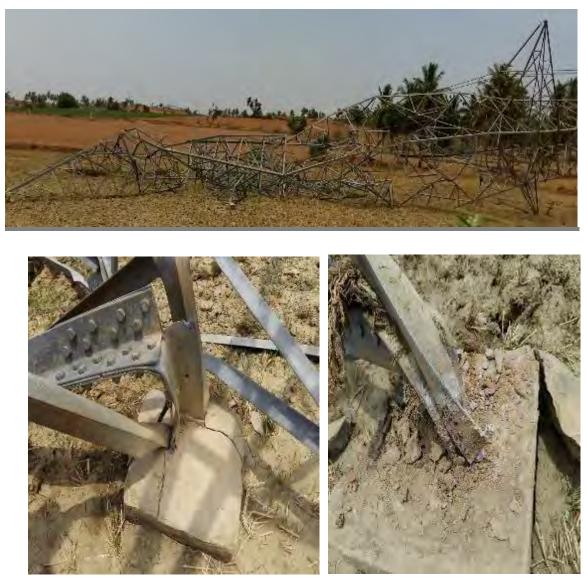
Tower at location No. 363 (DA+9)

e. **Tower at Location No. 363 (DA+9)** was completely collapsed to the ground from the stub level in transverse direction towards right side when observed facing Davangere. The Stub of Leg B was not in the center of chimney and it was broken from bottom end (near to chimney). The remaining three stubs were bent. Rusting at the bottom end of all the Stubs (near to chimney) was observed. All the chimneys were intact however, almost covered in the soil. Coping of the chimneys was found damaged.

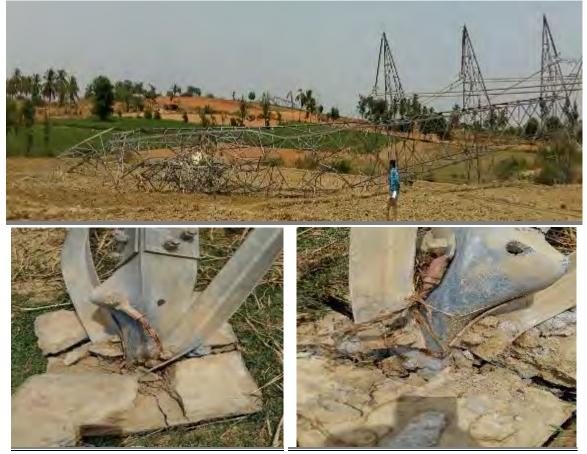
Tower at location No. 364 (DA+9)

f. **Tower at location No. 364 (DA+9)** was completely collapsed to the ground from the stub level in transverse direction towards right side when observed facing Davangere. All the four stubs of the tower were bent. All chimneys were covered in the soil and rusting at the bottom end of all the Stubs (near to chimney) was observed. Chimneys of leg C & leg D were damaged and other two were intact. Coping of all chimneys was found damaged. Extra holes were not plugged with nuts & bolts.

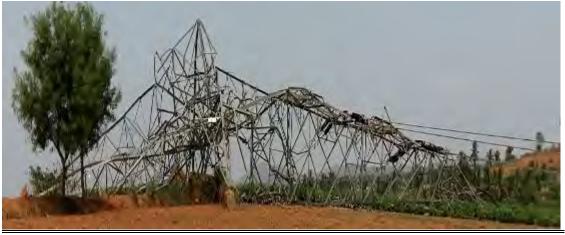
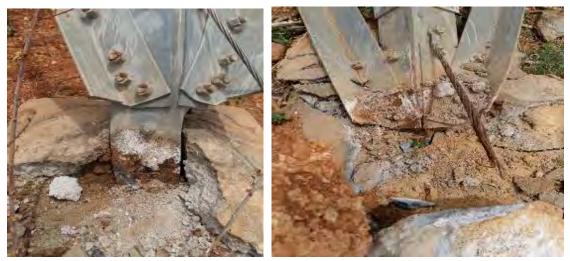
Tower at location No. 365 (DB+0)

**g. Tower at location No. 365 (DB+0)** was B-Type Tension Tower with double string porcelain insulators. The tower got completely collapsed to the ground in transverse direction towards right side when observed facing Davangere. All 4 stubs of the tower were bent. Rusting at the bottom end of all the Stubs (near to chimney) was observed. Foundation chimneys were covered in the soil except leg A. Chimneys of leg C & leg D were damaged and other two were intact. Coping of all chimneys was found damaged. Many nuts & bolts of tower were plugged out.

Committee noted that two incidences of failure of this line had occurred within a time span of two months and in total sixteen (16) towers of the line had failed. Committee noted that deficiencies like, rusting in the stubs, miss-alignment of stubs & concrete pedestal, unplugged holes, improper coping of the chimney & covered in the grass, etc. were observed by the team which visited the tower failure sites. Further, the failed towers were located in the open field areas with very few trees/vegetation around the towers, however, these were designed considering Terrain Category-II.

erection, residual stresses were developed in the towers and these have failed due to loads developed due to high wind speed observed in the area on the date of failure.

Committee suggested that since this transmission line has failed twice in a year, the patrolling frequency may be increased. Committee noted that even small errors during erection or compromises in the integrity of structure may lead to its collapse. Utilities should improve their erection and operation & maintenance practices and ensure that structural strength is not compromised due to deficiencies like, unplugged holes, rusting of stubs, etc.

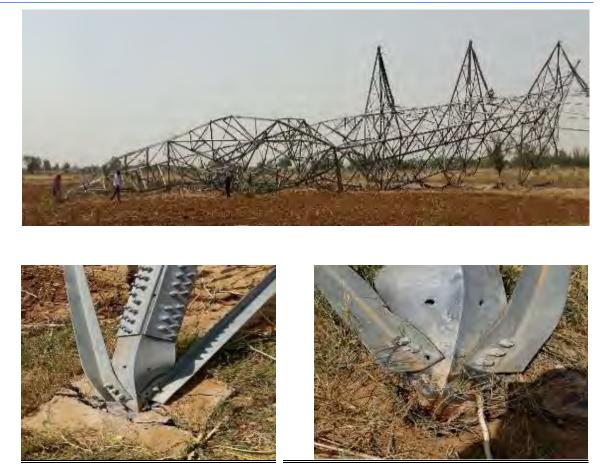
Location No. 340 (DA+0)

**d. Tower at Location No. 340 (DA+0)** was completely collapsed to the ground from the stub level in transverse direction towards right side when observed facing Sikar. Foundation chimney of leg D was found damaged & other three chimneys were observed to be intact. Chimneys of leg A & leg C were fully covered in soil. Coping of chimneys were not done. All four stubs were damaged.

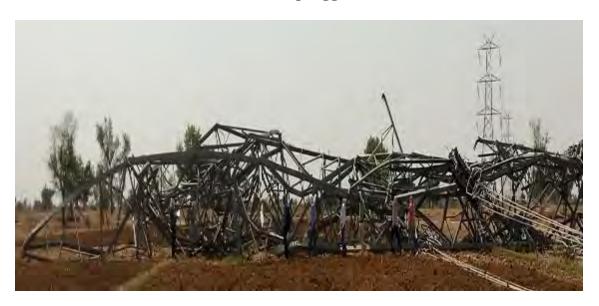
e. Tower at Location No. 341 (DC+0) was completely collapsed to the ground in transverse direction, towards right side when observed facing Sikar. All four stubs were fully damaged. Coping of the chimneys was not provided and rusting at the bottom end of all the stubs (near to chimney) was observed. Extra holes were not plugged with nuts & bolts.

The committee noted the above and concluded that due to improper erection, the strength of structure was reduced and these have failed on account of loads developed due to high wind speed observed in the area on the date of failure.

Committee advised POWERGRID to improve their operation & maintenance activities as there are many failures in Agra region in past years. Special measures like higher frequency of patrolling of the lines may also be adopted by POWERGRID. Committee also advised POWERGRID to ensure that Reliability level to be adopted for all the future transmission lines shall be in accordance to CEA Regulations and as per latest IS codes, recommendations of the Standing Committee and Task Force, as applicable.

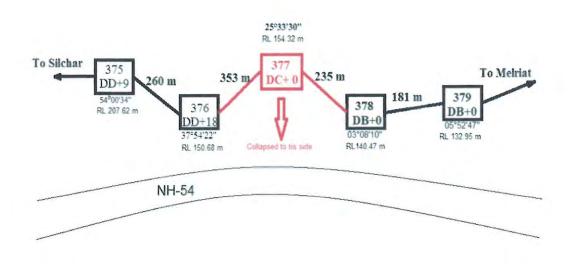
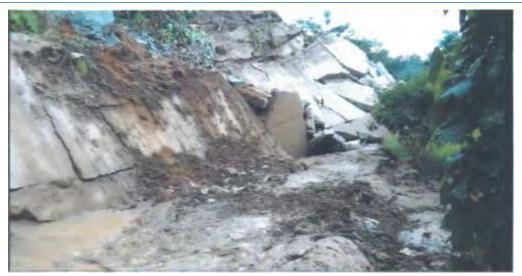
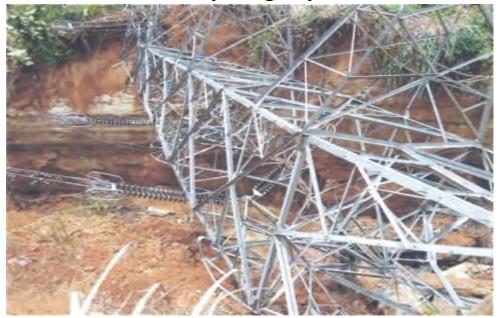
Location No. 377 (DC+0)

- b. **The tower at location No. 377 (DC+0**) is located in Mualkhang Village, Sub Division Kawnpui, District Kolasib, Mizoram and was on uphill side of the NH 54. The Tower had collapsed completely in the direction as indicated in the diagram below.
- c. As reported by POWERGRID, there was a landslide due to which a huge land mass got separated from the hill downwards creating a deep canyon in between the hill. The fault line of the separation passed through the foundation of the Leg-A due to which tower completely collapsed. Due to the landslide, large boulder/stones also fell on the NH-54 and blocked it completely damaging about 150 m of the National Highway.

Committee noted the above and concluded that due to sudden movement of the landmass during the landslide, the foundation of the tower became instable which led to collapse of tower at location No. 377 (DC+0).

Committee suggested that Utilities should ensure that proper geological investigation of the land mass is carried out before spotting of the tower structures and the necessary strengthening measures, for tower foundations for the hill slope, if required, should be taken proactively, so that such incidences does not repeat and lead to failure of other towers.

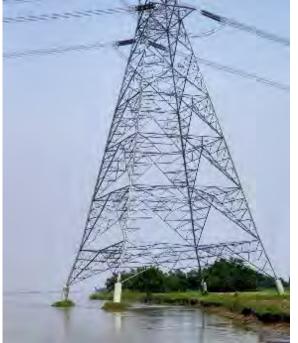
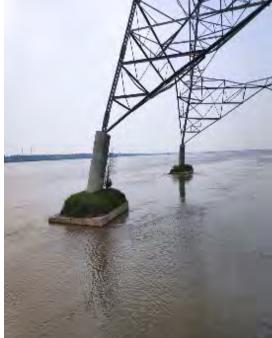
Location No. 409 (DC+0) (Just before Collapse of Tower)

- d. Tower at location No. 409/0 (DD+25) of 400 kV D/C (Quad) Patna-Kishanganj transmission line was designed with Pile foundation. As reported by POWERGRID officials, during the recent heavy flood in the Kosi River, the tower had become vulnerable due to sinking of two legs due to soil erosion by the river. Leg D and some other members were deformed due to differential settlement of pile foundation under leg A and leg D. POWERGRID officials at site undertook de-stringing work between loc. 409 to 410 to isolate the location number 409 for protecting other locations of possible damage due to likely collapse of tower at location 409. However, on 06.08.2019 during de-stringing work between locations 409 & 410, deformed tower at location 409 collapsed completely at and fell down in the river Kosi towards location number 408.

- e. Leg A & D: Pile caps were partially submerged in water and it was excessively tilted. Differential settlement of the pile caps was clearly visible. Chimney of both legs were intact however stub was sheared from the top.

**Leg B & C:** Chimney were completely torn/broken and some of reinforcement of the chimney was exposed/deformed. Stubs were torn/bend and separated from concrete of chimney. Pieces/lump of concrete of chimney were observed to be fallen on ground.

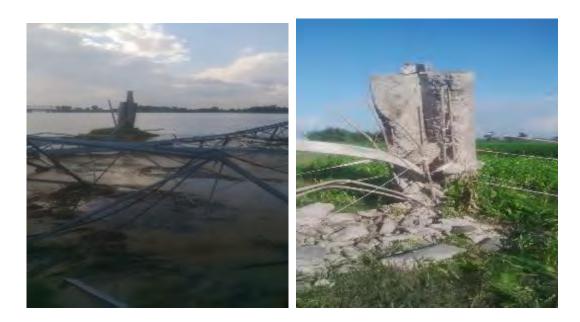
### Location No. 409 (DC+0) (After Collapse)

- g. As reported by POWERGRID, due to river flow, the tower foundations got displaced from their original position and the back to back distances between legs were different from the design dimensions.
- h. POWERGRID informed that the failed tower has been shifted to another location for restoration and higher scouring depth has been considered for new pile foundation.
- i. POWERGRID submitted the reports of Concrete cube tests & the Non Destructive Tests conducted on the pile foundations which were done at the time of erection of the line and these were found to be in order.

Committee noted that even though the highest water level measured during the flood was lower than the HFL level considered in designing of pile foundations, the Pile foundations had failed. Further, Committee noted that one of the failed tower had been tested for +9 m body extension and has been erected with +25 m body extension with the tower structure. Committee requested POWERGRID to review the design of Tower extension part adopted in the failed tower location to ensure the stability of bottom most panels as the Kbracing placed at this panel appears to be not bearing the loads because of very high base width to height ratio.

Committee recommended that proper anticipation of change in course of river on the basis of river flow data of previous years should be done by the transmission utilities. Additional precautions like routing of transmission lines few kilometres away from the river bank/ anticipated future river course, use of pile foundation/additional piles etc. should be adopted by utilities. Moreover, in case of damage of foundation of towers, the foundation design is required to be examined.

Providing proper Protection (retaining wall, Gabion wall etc., proper revetment & use of geo-synthetic material in foundation, concrete encasing & painting of stub in water logging areas etc. may also be considered, wherever required.

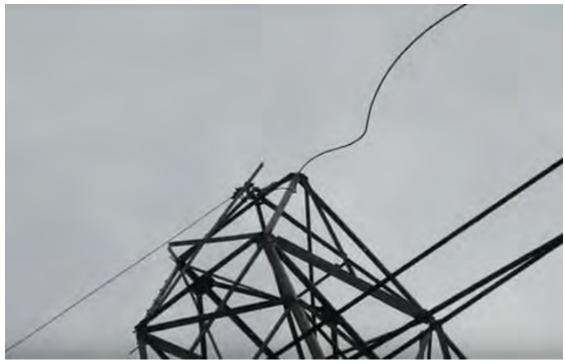
Tower Location No. 90 (A+3)

c. **Tower at location No. 90 (A+3)** was in erect position. The earthwire peaks of the suspension tower have got damaged due to sudden force exerted by conductor due to collapse of tower at location number 92. Rest of the tower was reported to be intact with no missing tower members and nuts & bolts.

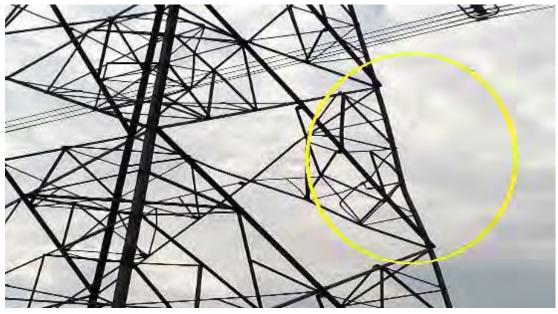
Tower Location No. 91 (A+0)

d. **Tower at location No. 91 (A+0)** was partially damaged due to sudden jerk exerted by the pull of conductors during collapse of tower at location No. 92. POWERGRID informed that the main leg along with bracing members and few redundant members of the tower had buckled. Foundations of all the four legs were intact. The tower was also checked for any missing members /nuts & bolts. No missing members/bolts & nuts were found. However, few blank holes were visible in members at different places.

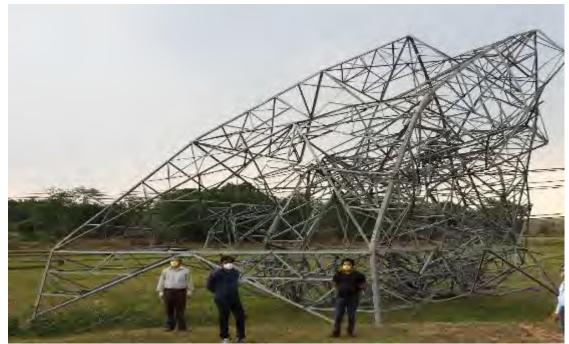
Tower Location No. 92 (A+3)

e. **Tower at location No. 92 (A+3)** had collapsed above the +3 M body extension portion and fell over in twisted condition in transverse direction. Due to tower collapse, two stubs were also observed to be damaged. POWERGRID official informed that the tower was checked thoroughly and no missing tower members/ nut bolts were found. The anti-climbing device (ACD) was also in place and condition of concrete in the visible chimney portion were observed to be good.

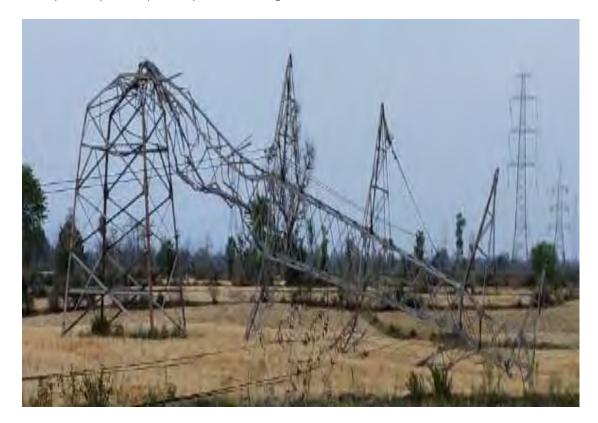
Tower Location No. 948 (DA+0)

- b. All the collapsed towers fell in the same transverse direction of line and all the failed towers had collapsed above the 1<sup>st</sup> section level. All of the stubs, in each of the four towers, were reported to be intact.
- c. POWERGRID officials informed that at the time of tower collapse, heavy localized whirling wind storm prevailed in the vicinity of affected stretch of transmission line and the above windstorm has also caused extensive wide spread damages to nearby trees and nearby other structures. The same was also reported in local newspapers as well. From the failure pattern it appears that tower failure was initiated due to high intensity localized wind storm at Location number 951(DA-6) and because of cascading effect, other three towers at location numbers 948(DA+0), 949(DA+0), 950(DA+0) also collapsed.

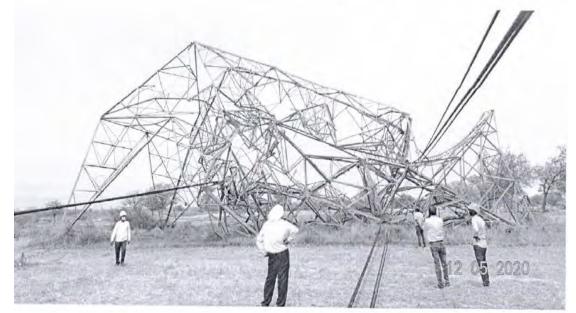
Tower at Location No. 642 (A+0)

c. Tower at location No. 642 (A+0) had collapsed from second panel level and fell over in transverse direction. Due to tower collapse, three stubs were also observed to be damaged. The top portion of the tower was toppled and hit the bottom panel. POWERGRID official informed that the tower was checked thoroughly and no missing tower members/ nuts & bolts were found and condition of concrete in the visible chimney

#### portion were observed to be good.

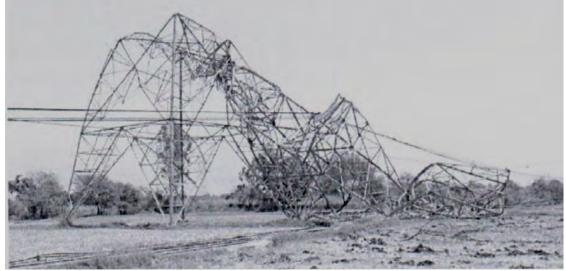
Tower at Location No. 641 (A+0)

d. **Tower at location No. 641 (A+0**) had failed from third panel level and collapsed in diagonal direction towards location No. 640. It was observed that the main leg along with the bracing members and few redundant members on one of the transverse faces were severely buckled and jumbled together. The stub of one of the leg was observed to be damaged.

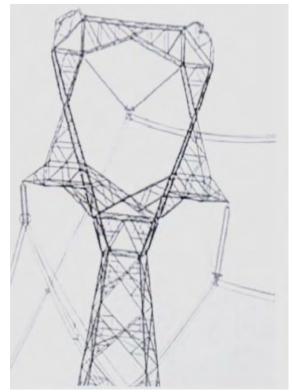
Tower at location No. 640 (A+3)

e. **Towers at location No. 640 (A+3) & 643 (A+0)** were in erect condition. One Earthwire peak of the tower at location No. 643 was damaged whereas both of the earthwires peaks were damaged at tower at location No. 640. These were observed to be secondary failures due to sudden force exerted by tower collapse at nearby locations. It was reported by POWERGRID that rest of the structure of these towers were intact and no missing members/nut bolts were observed at these sites.

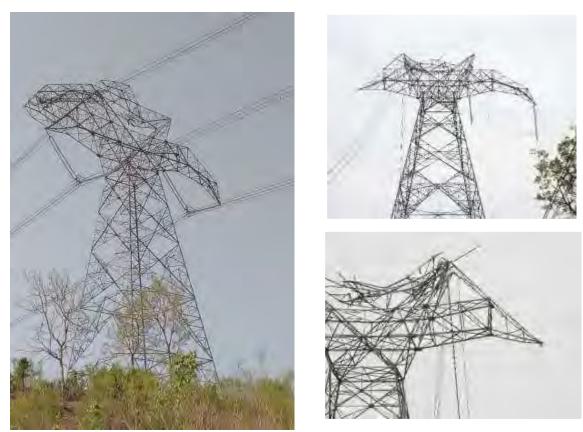
Tower at Location No. 430 (B+0)

- c. **Tower at location No. 430 (B+0)** was damaged from the cage section at side cross arm level. One of the cross arms, the K-frame portion of the tower body and both earth-wire peaks were damaged.
- d. As reported by POWERGRID, tower members in cross arm cages and Kframe portion have failed due to excessive transverse wind load on conductor and tower during the localized wind storm which had prevailed on the date of occurrence. Further, the tower was checked thoroughly and no tower members/nuts & bolts were found missing in the affected section of the tower.

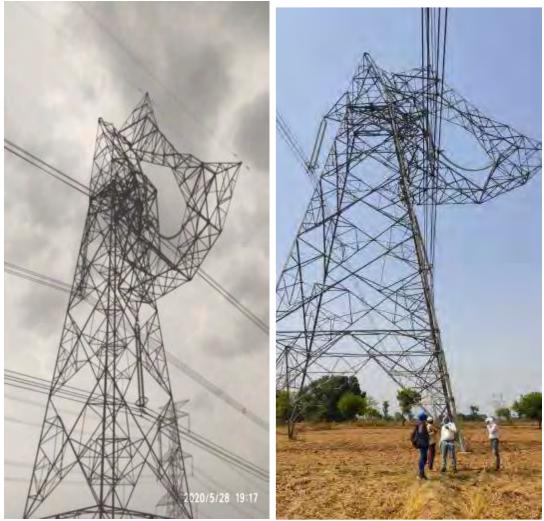
Tower at Location No. 673 (A+0)

- c. **Tower at location No. 673 (A+0)** was bent from above the waist level in the transverse direction. The delta portion of the tower members got buckled and was resting on lower tower body. All stubs (including chimneys) and legs just above stubs were intact.
- d. As reported by POWERGRID, tower failure was initiated due to high intensity localized wind storm. Tower members in K-frame portion have failed due to excessive transverse wind load on conductor and tower. Further, the tower was checked thoroughly and no tower members/nuts & bolts were found missing in the tower.

The Committee noticed that this transmission line was erected using same tower design as in the 765 kV Gaya-Fatehpur S/C transmission line (Wind Zone-4) with Delta configuration. The failure of these 765 kV Delta configuration suspension type towers had been investigated by the Standing Committee of Experts for investigating failure of transmission line towers in the year 2015. Design review analysis of this type of tower of PGCIL was carried out by CPRI on directions of the Standing Committee and strengthening of few members above the waist level by replacing existing members with new members were proposed. The failed tower had not been strengthened. The pattern of failure of transmission towers from the waist level, i.e. from the K-frame section, is similar to past failures of towers of similar configuration observed in previous years. The inadequacy in tower structure of 765 kV S/C Delta configuration suspension type towers coupled with the reported storm caused the failure of towers.

Committee advised POWERGRID to ensure that the strengthening mechanism adopted is in accordance with the suggestions of Standing Committee in previous meetings. Committee recommended that the transmission line utilities should avoid the use of the Delta

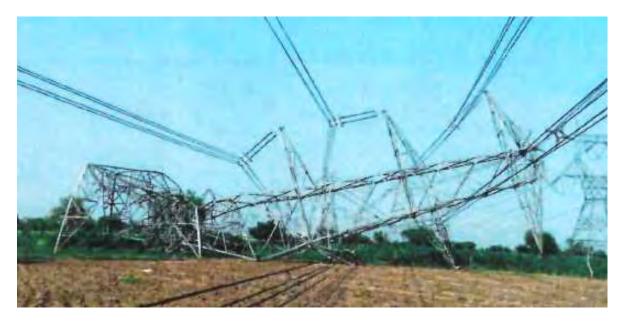
Tower at Location No. 12 (DA+0)

c. Tower at location No. 12 (DA+0) was completely collapsed to the ground in transverse direction towards ckt-I side. As reported by POWERGRID, all four stubs were damaged and no tower members/nuts & bolts were found missing at the location.

Committee noted that the high wind velocity might have prevailed in the vicinity of transmission line. However, POWERGRID could not provide wind speed data from any authenticated observatory indicating speed of wind prevailing at the failure location at the time of the failure. Committee noted that the due to the deficiency in erection/O&M of the transmission line, the tower structures were inherently weak which failed during the high wind incident observed in the area. The wind had caused failure of transmission tower at location No. 12 (DA+0) which subsequently led to failures of the towers at Location Nos. 13, 14 & 15 due to pulling force of the conductors.

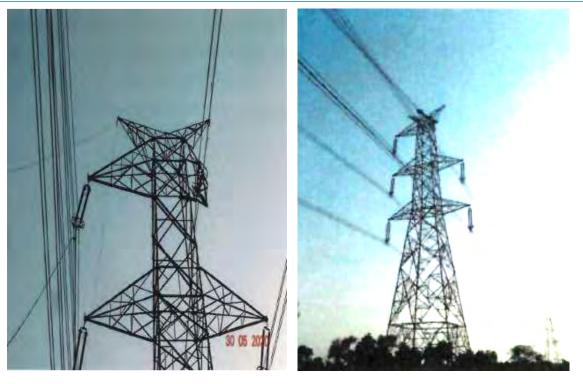
Tower at Location No. 13 (DA+0) Tower at Location No. 14 (DA+0)

- d. **Tower at location No. 13 (DA+0**) was in erect position. The top cross arm of the tower (ckt-II) was damaged due to the jerk developed by conductors.
- e. **Tower at location No. 14 (DA+0)** was in erect position. The top cross arm of the tower (ckt-II) was damaged. As reported by POWERGRID, the conductor between location No. 14, 15 & 16 broke and crossed over ckt-I top conductor and fell on the ground. The Broken cross arm at the tower No. 14 was pulled towards location No.13.

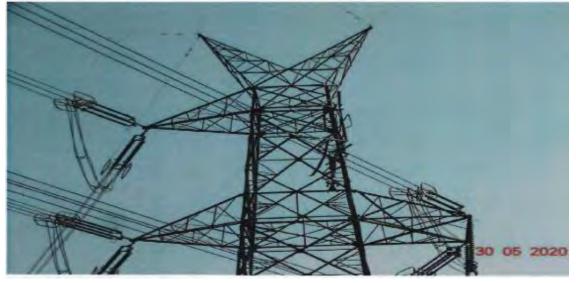
Tower at Location No. 15 (DD+0)

f. **Tower at location No. 15 (DD+0)** was in erect position and the top box cross arm (ckt-II) of the tower was almost detached from the tower body and major portions were reported to be found at the other side in the field. Some of the members of the cross arm were also reported to be hanging from the tower body. The top two panel members, leg & bracing members in longitudinal direction were also damaged due to impact of counter weight of broken insulator string. It was reported that the top conductor of the span between locations 15 to 16 had went to other side of the towers, however earth wire peaks were not damaged. As reported by POWERGRID, the conductor between location Nos. 14, 15 & 16 broke and crossed over ckt-I top conductor and fell on the ground. The Broken cross arm at the tower No. 14 was pulled towards location No.13.

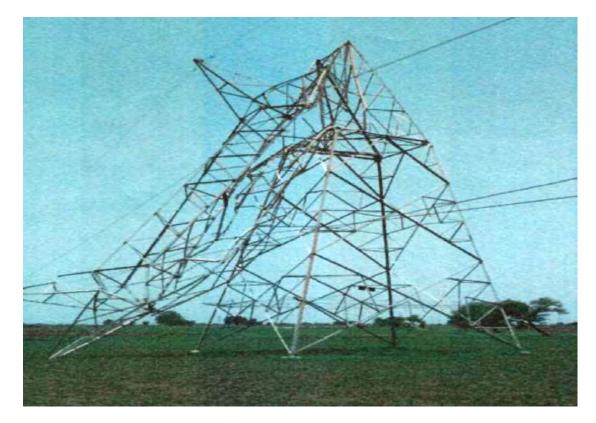
c. **Tower at location No. 213 (A+O)** was bent from the waist level in the transverse direction. The lower part of the tower was in erect condition and no damage was observed to the foundation and stubs. The top portion of tower structure toppled and bent from tower waist level. As reported by POWERGRID, the tower was checked thoroughly and no tower members/nuts & bolts were found missing in the tower. Further, for collapsed tower location different foundation dimensions like back to back dimension, diagonal distance, difference in levels etc were found to be generally in line with approved drawing.

Further, the committee noted that this transmission line is around 20 years old. The high wind velocity might have prevailed in the vicinity of transmission line in the transverse direction leading to failure of tower at location No. 213(A+0). However, POWERGRID could not submit wind speed data from any authenticated observatory indicating speed of wind prevailing at the failure location at the time of the failure. In absence of wind speed data from authenticated observatory, it is not possible to conclude that wind speed might have exceeded the design wind speed.

transmission line and in case repeated failures are observed in the line in future, the decision for adopting the strengthening of transmission line by providing hip bracing in the bottom most panels for the towers designed according to IS 802:1977, may be discussed and finalized in the meetings of the Committee.

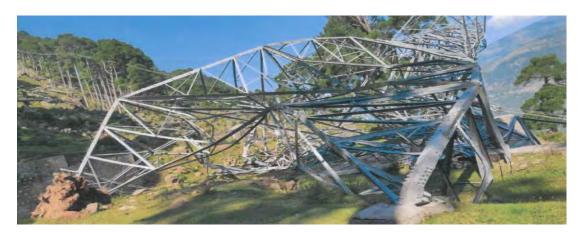
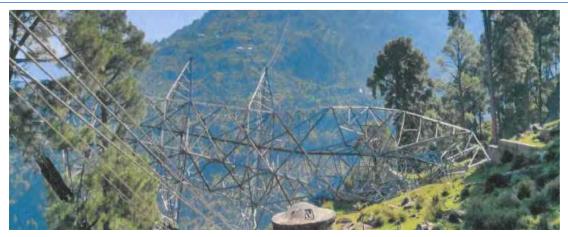
Tower at Location No. 261(DB+6)

d. **Tower at location No. 261 (DB+6)** was having reinforced tower foundations. The tower had collapsed completely to the ground in almost transverse direction to the line. All the four main legs and the stubs were damaged. As reported by POWERGRID, Leg 'C' of the tower was observed to be sheared near the stub joint. Common plan bracings and some of the members in the cage section of the tower were fractured and deformed.

- e. POWERGRID informed that no major landslide/ settlement was observed at the failure site. The Level and diagonal dimensions were measured and it was observed that differential settlement seems to have occurred over a longer period of time which might have resulted in sinking of Legs A & B.
- f. The measurements of Level difference with respect to leg "C" were as under:
  - Leg A 0.667 Meter down
  - Leg B 0.597 Meter down
  - Leg C 0.00 Meter (Reference)
  - Leg D 0.014 Meter Up
- g. The back to back and diagonals measured by POWERGRID site officials were as under:
  - Back to Back of Stub

Committee observed that the failure of tower at location No. 261 (DB+6) had occurred due to buckling/deformation of tower members due to differential settlement of foundation pits. POWERGRID is required to take suitable safety measures considering the geotechnical investigation and suggested that an avalanche protection / retaining wall may also be constructed around the tower to safeguard the tower from hitting of the boulders.

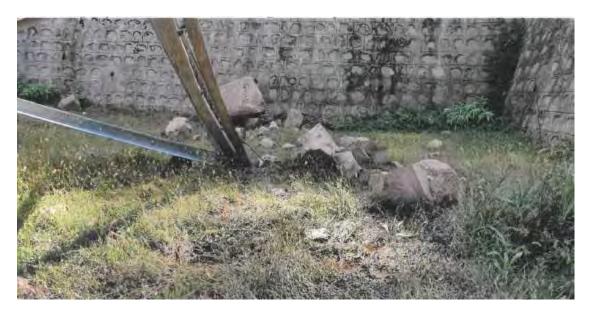
h. As reported by POWERGRID officials, some of the Uphill Boulders were also found hitting the lower legs, however, the upper soil strata was observed to be stable.

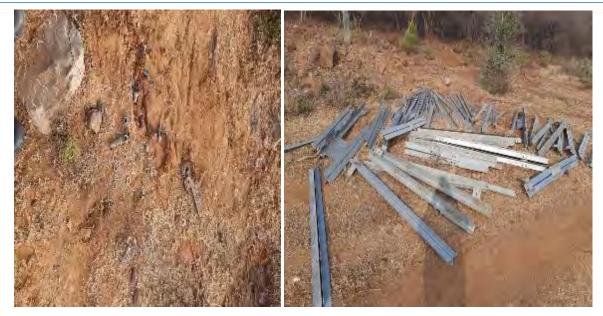
Bolts/Nuts, cutting tools & Removed tower members Found at Site

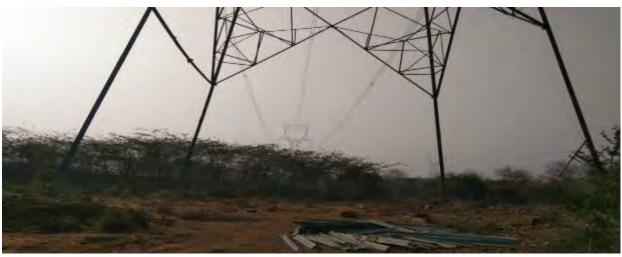
Tower at Loc. No.612 (A+0)

- c. **Tower at Location No. 612 (A+0)** was in erect position, however it was observed that all the redundant members of bottom section and three main plans bracing of the tower had been removed. Number of tower pieces removed from bottom panel, bolts/nuts along with cutting tools were also found at location No. 612(A+0).
- d. POWERGRID officials informed that as per the data available in PATROSOFT, the patrolling of above locations were carried out on 12<sup>th</sup> October 2020 and no missing tower members / nuts & bolts were observed at that time.
- e. POWERGRID informed that the incidence of theft has been reported to the local police station and FIR has been lodged. In this line, incidences of theft had been observed earlier also and many communications with the local administrative bodies in this regard had been made.

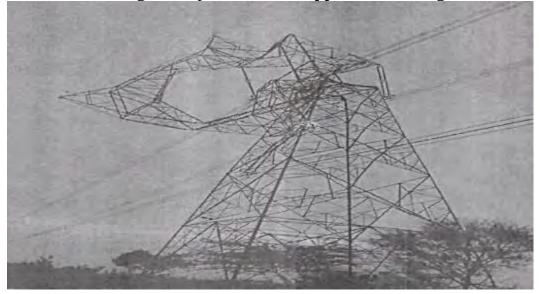
Tower at Loc. No. 33/3 (A+0)

- b. **Tower at Location No. 33/3 (A+0)** was located in plain field with few trees in vicinity near village Jhatikara (New Delhi) at around 20 km from Jhatikara substation of POWERGRID. Tower was damaged from the waist level and damaged part was still hanging in the transverse direction. Most of the members above waist level were in jumbled condition. Bulging of tower members below the waist level and above basic tower level was observed. It was also observed that one arm of the 'V' insulator string (of middle phase) was detached from tower while the other was still connected. Insulators of outer phases were damaged and both the 'I' string (outer phases) were still attached with tower.

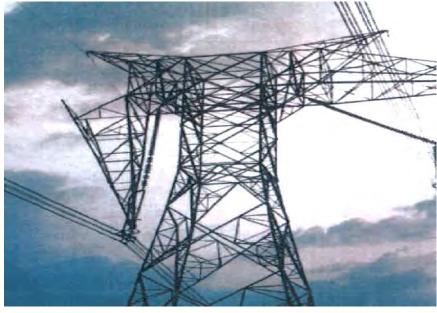
Tower at Loc. No. 3118 (A+0)

b. **Tower at Location No. 3118 (A+O)** was located in plain field area near village Baraijot/Sekhpura, Kalwari Taluk in Basti district (Uttar Pradesh). The tower was in erect condition and only one cross arm of pole-II of tower was damaged. All the stubs and rest of the tower were

found intact.

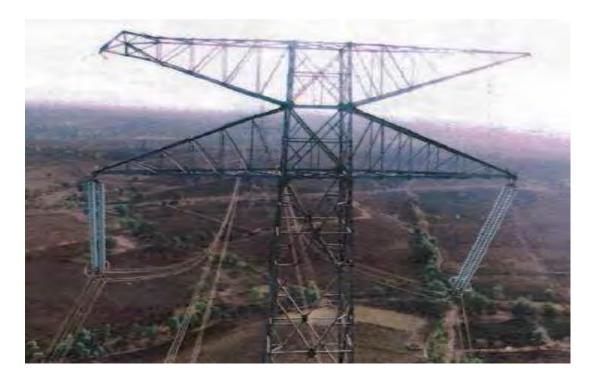
#### Tower at Location No. 322 (DA+6)

b. **Tower at Location No. 322 (DA+6)** was in erect condition. The tip of earth wire peak of circuit-I was buckled/damaged. All the stubs and other tower members were intact.

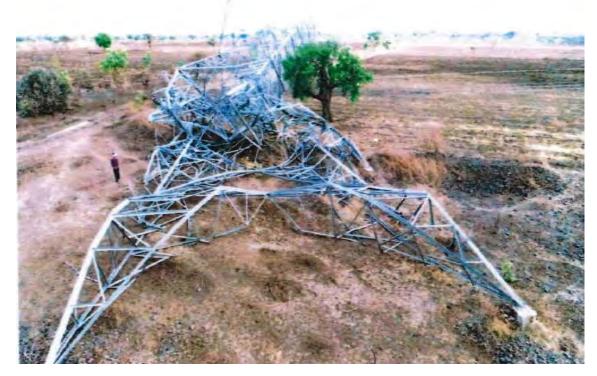
**c.** Tower at Location No. 321 (DA+3) was damaged from stub level and was collapsed in transverse direction to the line. All the four stubs of tower were completely damaged.

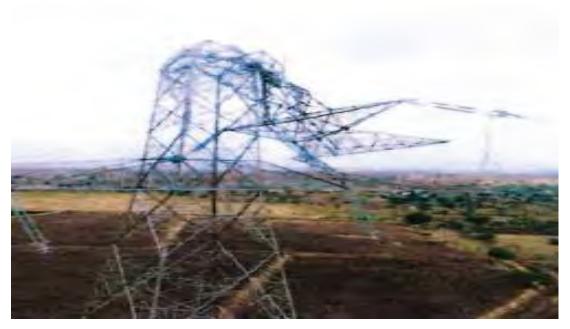
Tower at Location No. 320 (DA+0)

d. **Tower at Location No. 320 (DA+0) & 319 (DA+0)** were buckled from middle cross arm level and the top portion of the towers were resting on the base structure. All the four stubs of both the towers were intact.

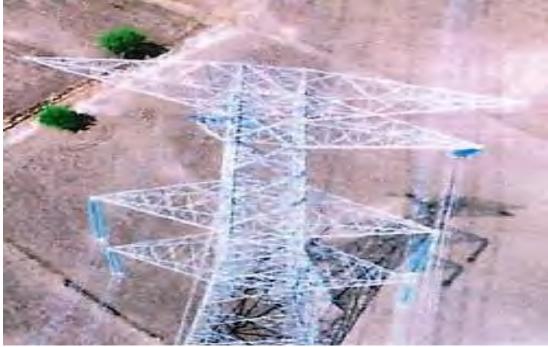
e. Tower at Location No. 318 (DA+3) was in erect condition. The top cross arm for circuit-II was damaged. All the four stubs of tower were intact.

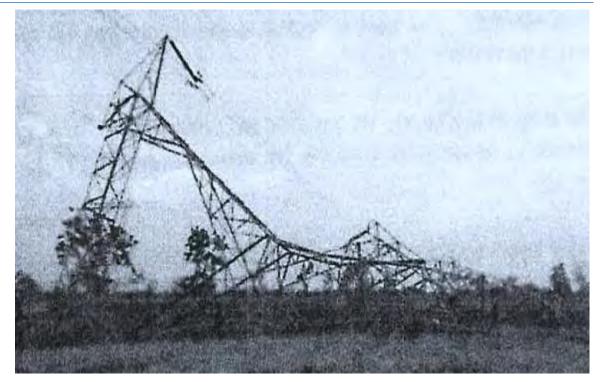
Tower at Loc. No. 320 (A+3)

b. **Tower at Location No. 320 (A+3)** was located in plain field area at about 73 km from Bhilai sub-station. The tower got collapsed completely to the ground from the stub level in transverse direction to the line. All the stubs of the tower were damaged. POWERGRID informed that different foundation dimensions like back to back, diagonal distance, levels were also checked and the same were found to be generally in line with approved drawing and there were no missing members in the tower structure.

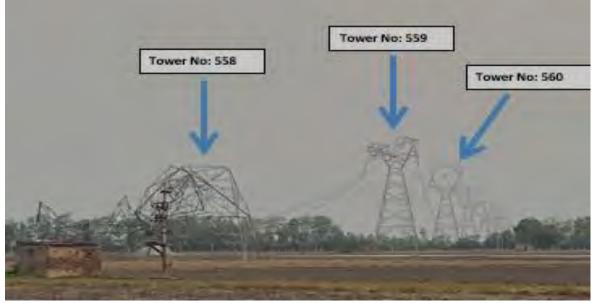
b. **Tower at Location No. 558 (A+0)** was collapsed from the first cross bracing level in transverse direction to the line towards left side when observed facing Moga end. Tower's Leg A was found bent from just above the second panel level and other three legs were bent from just above the K-frame level. All the foundations chimneys and stubs were intact. All chimneys were covered in the soil. It was also observed that extra holes were not plugged with nuts & bolts.

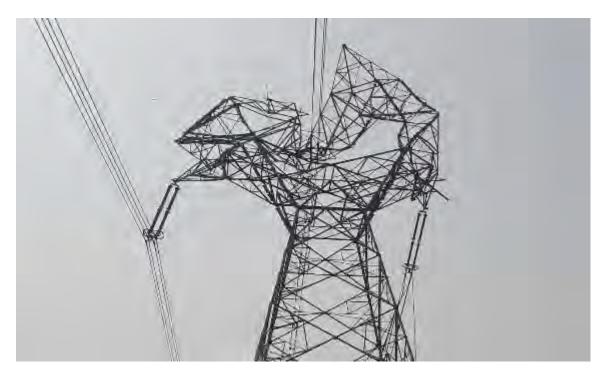
Tower at Loc. No.559 (A+3)

c. **Tower at Location No. 559 (A+3)** was in erect condition. The cage portion of tower body i.e. K fame was completely distorted and buckled inwards and the same was resting on tower structure below waist level.

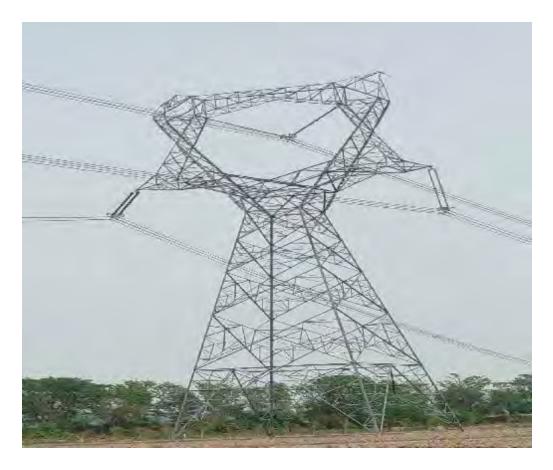
#### Tower at Loc. No.560 (A+3)

d. **Tower at Location No. 560 (A+3**) was in erect position. The right side peak of the tower got buckled and remaining tower structure was intact.

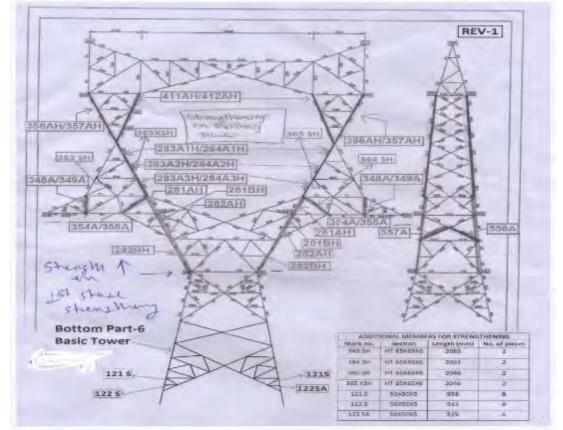
First Stage Tower Strengthening Drawing

• The previous failures of the 765 kV S/C Delta configuration towers had been investigated by Standing Committee and the Committee had suggested strengthening of these towers. It was informed by POWERGRID that the failed towers were strengthened two times after commissioning. In the first stage additional members (shown as dark) for strengthening were provided as below:

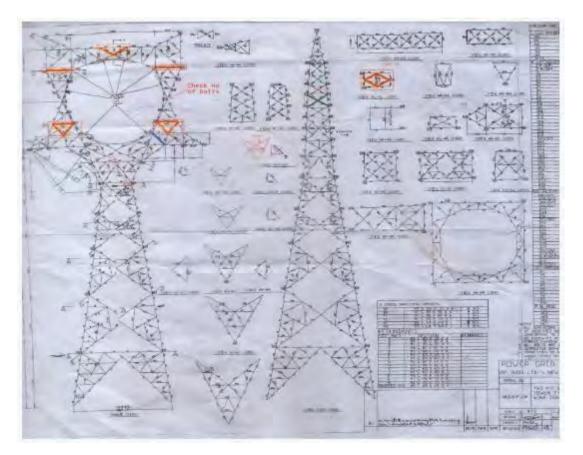
#### Second Stage Tower Strengthening Drawing

• In the Second stage, tower strengthening of cross arms/peak members and redundant members was done at these failed location towers (as highlighted in attached drawing).

- The above mentioned tower strengthening in both the stages was done with clamping of additional members rather than replacing old members with new one.
- b. To examine the chemical and material properties, samples from the affected tower locations No. 558 & 559 were selected from site and sent for testing at independent NABL accredited lab. All the tower steel samples were found acceptable as per the relevant Indian Standards.

Committee advised POWERGRID to ensure that the strengthening mechanism adopted is in accordance with the suggestions of Standing Committee recommended in previous meetings. It was emphasized that after every failure the concerned utility needs to submit the actual wind velocity prevailed in the affected area so that the investigating team of standing committee could get reference wind speed prevailed over that area. In this matter, the respective utility may seek the help of IMD to get the wind data obtained from observatory/ Satellite/Radar.

Committee also advised POWERGRID to monitor the failure of already strengthened towers and in case repeated failure of such towers is observed, than POWERGRID should review the strengthening mechanism adopted for such structures.
