### क्षतिग्रस्त ट्रांसमिशन लाइन टॉवरों पर विशेषज्ञों की स्थायी समिति की रिपोर्ट

REPORT OF THE STANDING COMMITTEE OF EXPERTS ON FAILURE OF EHV TRANSMISSION LINE TOWERS (APRIL 2019 – DECEMBER 2021)

भारत सरकार Government of India केन्द्रीय विद्युत प्राधिकरण Central Electricity Authority

### **EXECUTIVE SUMMARY**

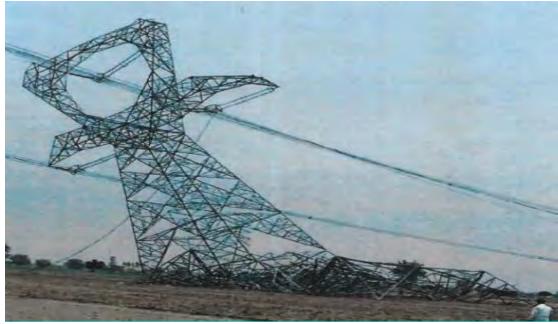
Tower at Loc. No.293 (B+25)

d. **Tower at Location No. 293 (B+25)** was spotted at 0° angle of deviation with +25M extension for Power line crossing of 220 kV D/C Kirori-Samain transmission line of HVPNL. The tower was observed to be hanging and tilted in the transverse direction to the line and tower portion above 0 M level, i.e. basic body of tower was intact. The tower body portion below 0 M level, i.e. the body extension part, was severely damaged and most of the tower members in this portion were jumbled. Due to the collapse of tower, the stubs of all four legs were also damaged. There was superficial damage to the chimney concrete as well.

Committee noted that only the +25 m Body extension part was damaged and basic body structure of the failed tower was intact. Committee also noted that the failed tower at location No. 293 was of B type tower with +25 m body extension and was spotted with a lower span

Committee observed that case of +25 m body extension, normally the stub setting templates are not available and props are used for this purpose. Special precaution is required to be taken to ensure the correct slope of stubs in addition to the correct back to back distance between the stubs.

Committee noted that in this case the B type tower have been spotted with lower span values and with zero degree deviation angle and hence, have inherent safe margin. In case failure was due to high speed wind as reported by POWERGRID, the nearby suspension type towers would have collapsed instead of this tower. Further, as only the extension part had collapsed and basic body structure is intact, it indicates that there must have been some erection deficiency in erection of extension part which had led to collapse of tower.

Committee advised POWERGRID to review the design & erection practice adopted by them for the construction of +25m body extension parts of the tower to avoid similar incidences of failure in future.

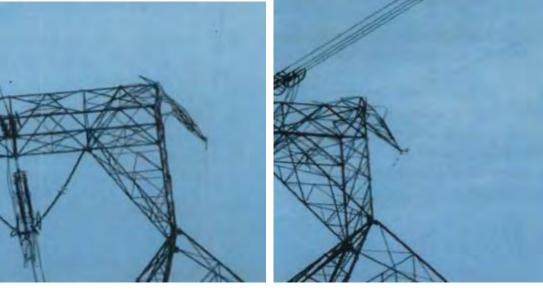
Tower at Loc. No.292 (C+0)

e. Towers at Location No. 292 (C+0) & at location No. 294 (C+25) were in erect position. One side earth wire peak of the towers was damaged. POWERGRID informed that the towers had damaged due to the sudden jerk caused by collapsed tower at location No. 293.

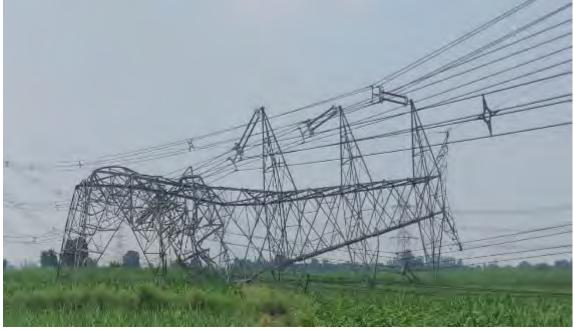
Tower at Loc. No.389 (DA+0)

b. **Tower at Location No. 389 (DA+0)** was located in the agricultural field. The tower was collapsed from the first panel level in transverse direction to the line. One of the stubs was bent and three stubs were found to be intact. The coping of the chimneys were cracked.

Committee advised that the transmission lines should be designed and erected as per latest IS codes, Regulations and recommendations of the Standing Committee / Task Force, as applicable.

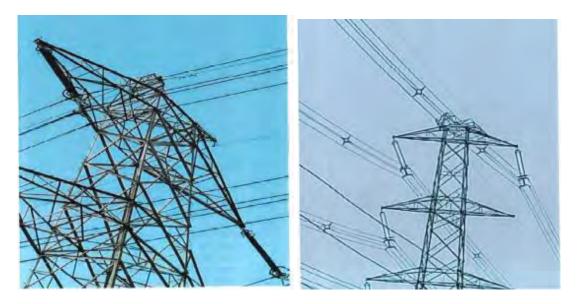
Tower at Loc. No.388 (DA+0)

c. Tower at Location No. 388 (DA+0) & 390 (DA+0) were in erect condition. The earth wire peak of the circuit-I side of the tower at location No. 388 (DA+0) was damaged, whereas at location No. 390 (DA+0) both the earth wire peaks were damaged.

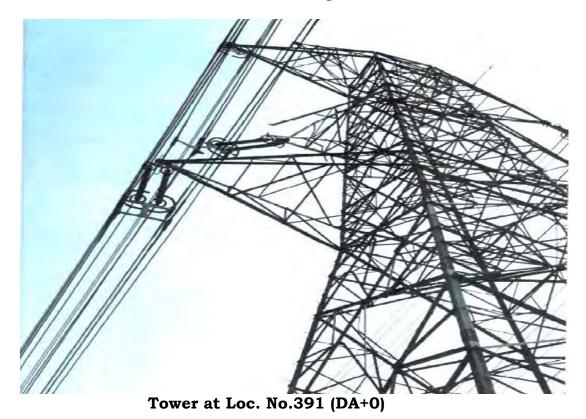
**d. Tower at Location No. 391 (DA+0)** was located in agricultural field and all the foundations/legs of the tower were covered with vegetation/crops. The tower was in erect condition. The middle cross arm of circuit-II of the tower was damaged.

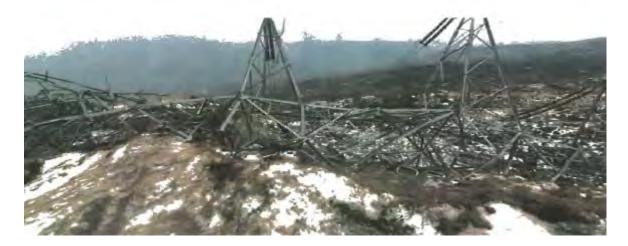
Tower at Loc. No.145 (DC+3R)

- b. **Tower at Location No. 145 (DC+3R)** was located in hilly terrain near village Kathar (Upparmadha), Chenaini Taluk in Udhampur district (Jammu & Kashmir), around 47.3 km from Kishenpur substation. The tower was completely collapsed and all four stubs of the tower were bent/damaged.

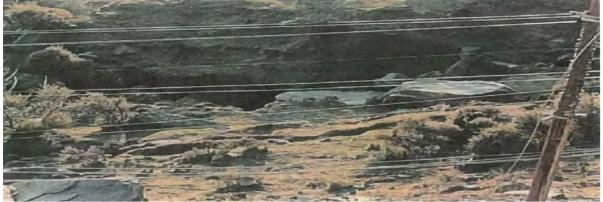
f. POWERGRID informed that their officials also visited tower at location No. 144 and a wide crack in the land and bulging of soil near to the tower location was found. It was informed that the bulging of soil indicates gradual land sliding in the near vicinity of the towers.

Bulging of Soil in the Vicinity of Tower at Loc. No.144 (DB+0)

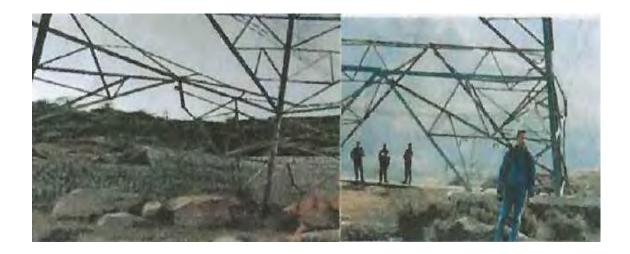
g. Due to this sliding of foundation, many tower members of tower of location 144 were seen bent. Bracing of the lower panel was also

observed bulging outward.

Bulging of Tower at Loc. No.144 (DB+0)

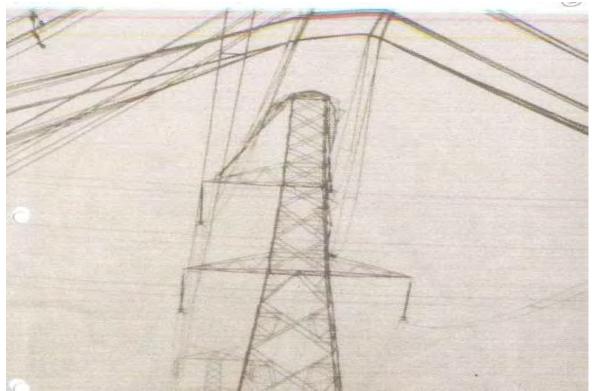
Tower at location No. 217 (FDO)

c. Falling of Hexa AAAC Moose conductor on the span resulted into excessive loading and damaged the towers at locations No. 216 (FD0) & 217 (FD0). The top portion of the tower at location No. 216 (FD0) was damaged and at location No. 217 (FD0) peak, top cross arm & middle cross arm of one of the circuits were damaged. The conductor in the span and insulators were also damaged.

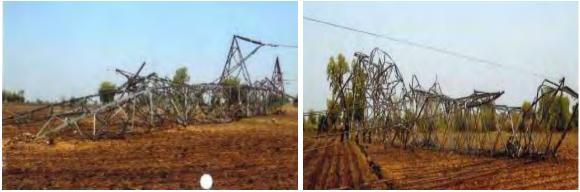
Tower at loc. No. 136 (FD 0)

c. MPPTCL representative informed that on 02.06.2019 heavy thunderstorm with cyclonic wind was observed in the area which resulted in the failure/ collapse of these towers in transverse direction to the line. To examine the failure, a Team of Experts was constituted by MPPTCL. The team along with Expert of Design of towers visited the tower failure site to investigate the cause of failure of structures and had opined that these structures had failed due to heavy cyclonic circulation in the area.

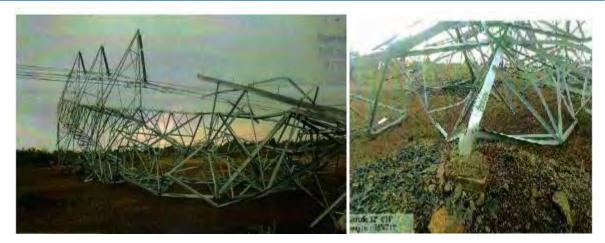
Tower at location No. 148 (FDO)

SI. No.	Loc No.	Tower Type	Observations/Extent of damage
1	148	FD0	Tower was completely collapsed to the ground in transverse direction from the stub level. All the four stubs and two of the chimneys were reported to be damaged. All the hardware fittings were damaged.
2	149	FD0	Tower was completely collapsed to the ground in transverse direction from the stub level. All of the four stubs & chimneys were reported to be damaged.
3	150	FD0+6	Tower was collapsed from the second panel level in the transverse direction and was lying on the ground All of the four stubs and two of the chimneys were reported to be bent/damaged.
4	151	FD0	Tower was collapsed from the second panel level in the transverse direction and was lying on the ground. All of the stubs and chimneys were reported to be intact.
5	152	FD0+3	Tower was partially damaged and was in erect condition. The peak of the tower was damaged. All of the cross arms of one circuit and top cross arm of second circuit were also damaged. All of the stubs and chimneys were reported to be intact.

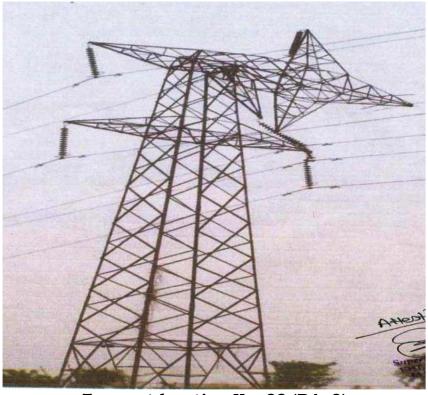
Tower at location No. 22 (DA+0)

- f. Falling of Hexa AAAC Moose conductor on the span resulted into excessive loading and damaged the tower at Location No. 22. The top portion of the tower was bent and rested on the lower tower body. The conductor in the span & insulators attached were also damaged.

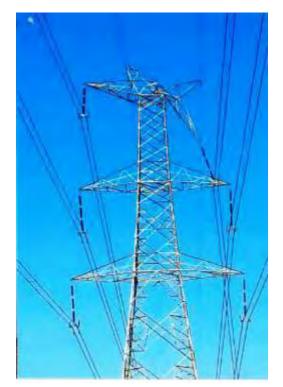
Tower at loc. No. 562

SI. No.	Loc. No.	Tower Type	Extent of damage
1	562	DA+0	Tower was partially damaged and was in erect condition. One Earthwire peak and one top cross arm damaged. All stubs were intact.
2	563	DA+6	Tower was partially damaged and was in erect condition. One Earthwire peak, top cross and canopy portion damaged. All stubs were intact.

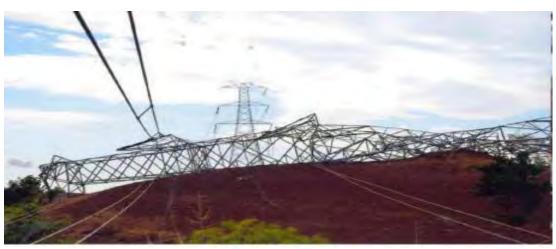
Tower at loc. No. 564

3	564	DA+0	Tower was completely collapsed in transverse direction from stub level. All four stubs were damaged/bent.
4	565	DA+6	Tower was completely collapsed in transverse direction from first panel level. All four stubs were bent.
5	566	DC+10	Tower was partially damaged and was in erect condition. One of the earthwire peak was damaged. One of the top phase conductor was snapped and rested on bottom phase conductor of second circuit.

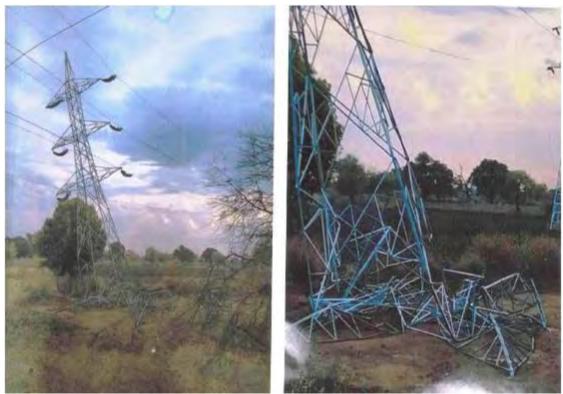
Tower at location No. 11A

- a. It was reported by MPPTCL that for raising the road clearance between towers at location No. 11 & 12, which was affected due to widening of National Highway 7 by NHAI, the tower at location No. 11A(DA+10) was erected. This tower was designed and constructed by MPPTCL. The tower was designed for wind zone 4 as per IS 802:1995 and was of suspension type with +10 m body extension.
- b. The failed tower at location No. 11A (DA+10) was damaged from the bottom portion of the structure. All the four stubs of the tower were bent. Approximately 15 m (including +10 m body extension) bottom portion of the tower was damaged and rest of the tower structure was connected to the conductors and was in slanted position as can be seen in the picture given below.

- c. As reported by MPPTCL, on the date of failure a thunderstorm with high speed wind and rains was observed in the area. The tower at location No. 11A failed during this thunderstorm which also caused uprooting of various trees and severe damage to structures located in the vicinity.
- d. MPPTCL representative informed that a tower failure investigation committee was constituted by MPPTCL to investigate the failure incident. This committee observed that back to back distance of foundations was in order and no member was missing.

Committee noted that the transmission line is almost 50 years old. However, failed tower was newly erected at location No. 11A on 07.06.2019 and the same had failed on 13.06.2019, i.e. within a period of one week. Committee observed that as the basic tower structure of failed tower is intact and only the body extension part had failed, it appears there might be some deficiencies in the erection of tower which had led to failure of tower structure in the high wind speed event observed in the area on 13.06.2019.

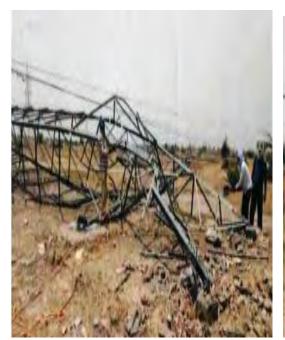
Tower at location No. 17

a. The failed towers were located in plain terrain. All the failed eleven towers were suspension type (DA+0) towers. All the affected towers were collapsed completely to the ground in transverse direction from stub level. The details of damaged towers is as follows:

SI. No.	Loc. No.	Tower Type	Extent of damage
1.	14	DA+0	Tower was completely collapsed from the stub level. All the stubs and chimneys were damaged.
2.	15	DA+0	Tower was completely collapsed from the stub level. Two of the stubs and chimney were damaged.
3.	16	DA+0	Tower was completely collapsed from the stub level. One of the stubs and chimney were damaged
4.	17	DA+0	Tower was completely collapsed from the stub level. Three of the stubs and chimney were damaged
5.	18	DA+0	Tower was completely collapsed from the stub level. One of the stubs and chimney were damaged
6.	19	DA+0	Tower was completely collapsed from the stub level. Two of the stubs and chimney were damaged.
7.	20	DA+0	Tower was completely collapsed from the stub level. One of the stubs and chimney were damaged

Committee advised MPPTCL to enhance the scrutiny of material testing to ensure that good quality raw material is used in erection of transmission lines. Committee highlighted that the strength of tower structures gets compromised due to missing bolts and utilities should be highly cautious to ensure that erection deficiencies are avoided in the tower structures. Further, the Committee decided that black (un-galvanized) towers should not be used by the utilities in the erection of future transmission lines.

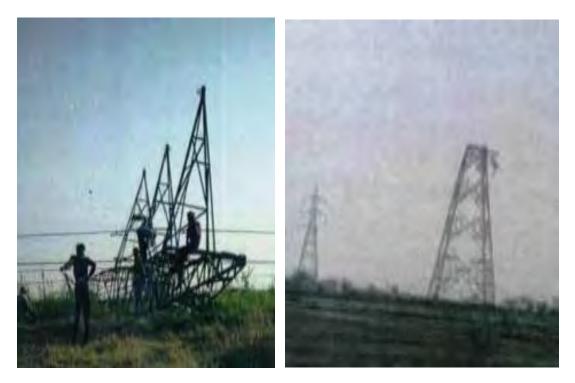
Tower at loc. No. 31 (BO)

a. The failed transmission towers were located in plain terrain with few trees in the vicinity. The towers were located near village Bamour Tehsil, Morena District, M.P. All the affected towers were suspension type. The details of damaged towers is as follows:

SI. No.	Loc. No.	Tower Type	Extent of damage	
1	31	DA	Tower was completely collapsed to the ground in transverse direction. All the four stubs were damaged. The portions of chimneys, above the ground level, were also damaged.	
2	32	DA+3	Tower was partially damaged above the bottom cross arm level. The portion of tower structure above the lowest cross arm level got bent & sheared from the tower. The lower tower structure was erect. All the stubs were intact.	
3	33	DA+3	Tower was in erect condition and was partially damaged. One of the bottom cross arms of the tower of ckt-II was damaged and got bent. All of the stubs were intact.

Committee concluded that the high wind velocity might have prevailed in the vicinity of transmission line in the transverse direction leading to failure of towers. However, wind speed data received from any authenticated observatory indicating speed of wind prevailing at the failure location at the time of the failure is not provided by the transmission utility. In absence of wind speed data from authenticated observatory, it is not possible to conclude that wind speed might have exceeded the design wind speed. However, Committee observed that during the high wind speed event that occurred on the previous day, residual stresses might have developed in the tower structures which led to failure of these towers in the high wind speed event observed on 29.05.2021.

Committee advised that the transmission lines should be designed and erected as per latest IS codes, Regulations and recommendations of the Standing Committee and Task Force, as applicable. Committee advised MPPTCL that if failure of transmission towers occurs, the failed towers should be replaced by towers designed as per latest IS codes.

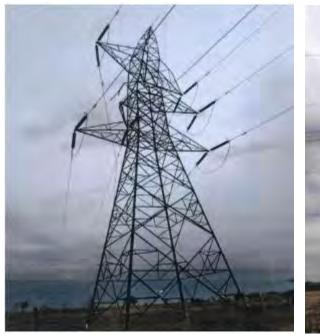
Tower at location No. 90

SI. No.	Loc. No.	Tower Type	Extent of damage
1	90	Tension	Tower was in erect condition. The tower was partially damaged and buckled from the bottom cross arm level. All stubs & chimneys were intact
2	91	Suspension	Tower was completely collapsed to the ground in transverse direction. One of the stubs was damaged.

Committee observed that the transmission towers used in the line were heavily rusted. Committee further noted that multiple towers had failed in the region on 28.05.2021 and on 29.05.2021.

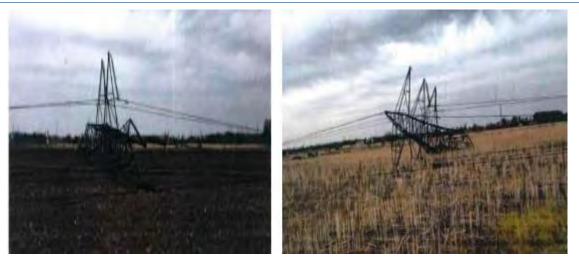
Tower at loc. No. 92

3	92	Suspension	Tower was completely collapsed to the ground in transverse direction. Three of the stubs were damaged.			
4	93	Suspension	Tower was completely collapsed in transverse direction from first panel level. Two of the stubs were damaged.			
5	94	Tension	Tower was partially damaged and was in erect condition. The Middle phase cross arm of ckt-I was damaged and was found lying on the ground. The peak portion of the tower was buckled. One of the earthwire peaks was damaged.

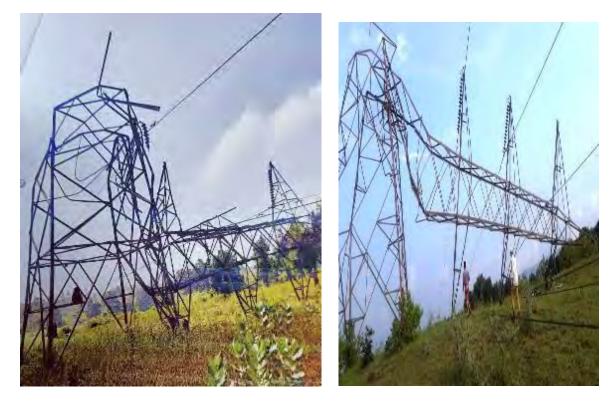
Tower at location No. 84

SI. No.	Loc. No.	Tower Type	Extent of damage
1.	84	suspension	The tower was damaged from the second panel level and collapsed in transverse direction of the line. The upper portion of the tower got sheared and was lying on the ground. All the stubs and chimneys were intact. The members were heavily rusted.
2.	85	suspension	The tower was damaged from the second panel level and collapsed in transverse direction of the line. The stubs and chimneys were intact. The members were heavily rusted.

b. As reported by MPPTCL, on the date of failure high intensity storm was observed in the area which caused the failure of towers. The high speed winds also caused uprooting of various trees and severe damage to structures located in the vicinity. The same was also covered in the local newspaper and was confirmed by the residents of the nearby villages.

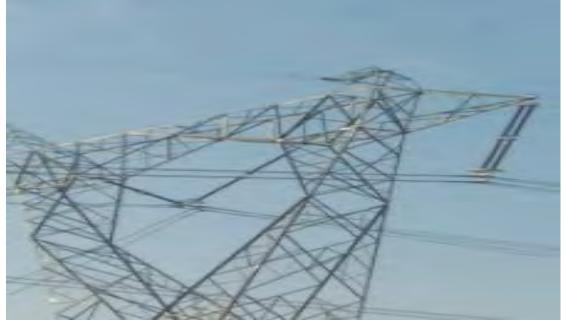
Tower at Loc. No.146 (A+0)

b. Tower at Location No. 146 (A+0) was reported to be in erect condition. One of the peaks of this tower supporting OPGW link was damaged.

- d. UPPTCL officials informed that high speed localized thunderstorm condition with exceptionally high wind velocity was observed in the vicinity of failed transmission towers on 03.05.2020. Further, the towers are located in valley portion having small hills at both sides. Due to these conditions the wind load acting on the towers was increased which ultimately caused failure of tower at location No. 147 (A+6). The peak at location No. 146 was damaged due to pulling load/jerk of earthwire/OPGW developed due to failure of tower at location No. 147.

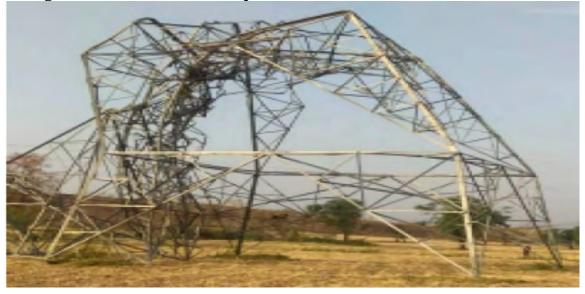
Tower at Loc. No.147 (A+6)

c. **Tower at Location No. 147 (A+6)** was located in plain field with few trees in vicinity. The tower was collapsed in the transverse direction to the transmission line from 1<sup>st</sup> panel level. All the four stubs of the tower along with foundation were reported to be intact.

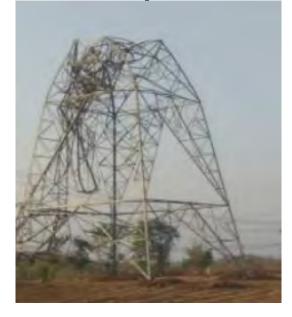
Tower at Loc. No.161 (A+6)

- b. UPPTCL officials informed that high speed localized thunderstorm condition was observed in the affected area on 03.05.2020 in which four (4) towers of the line at location No. 161 to 164, were collapsed.
- c. **Towers at Location No. 161 (A+6) & 162 (A+6)** were located in hilly field with few trees in vicinity. The towers were collapsed from basic body level above the +6 m body extension portion in the direction of transmission line. All the four stubs of the towers along with

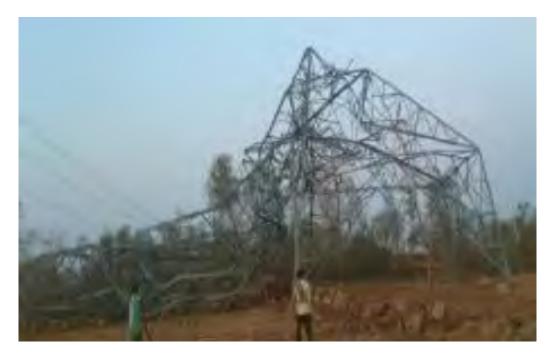
Tower at Loc. No.163 (A+0)

d. **Tower at Location No. 163 (A+0)** was collapsed completely from the first panel, in the transverse direction perpendicular to the transmission line. All the four stubs of the tower were reported to be damaged.

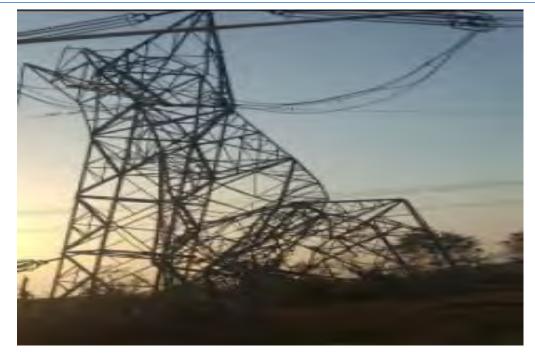
Tower at Loc. No.164 (D+3)

e. Tower at Location No. 164 (D+3) was collapsed in the transverse direction. One out of four stubs of the tower was reported to be damaged.

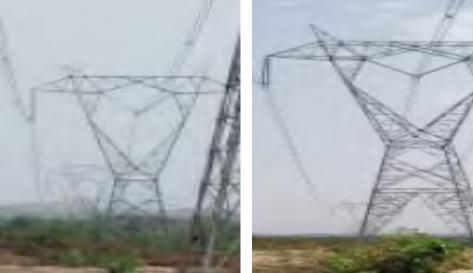
Tower at Loc. No.179 (A+3)

- f. UPPTCL representative informed that the restoration work of the failed towers was under execution and subsequently on 28.05.2020, in another high wind speed condition developed in the area and failure of four (4) towers at location No.179 to 182 were observed. The towers of the affected sections were located in valley portion having small hills at both sides.
- g. Towers at Location No. 179 (A+3) & 180 (A+3) were in erect condition. The Earth Wire peak of the tower at Location No. 179 (A+3) & the Cross Arm of the tower at Location No. 180 (A+3) was damaged. The remaining tower structures and all the four stubs along with foundation of the tower were intact in both the towers. UPPTCL representative informed that these were secondary failures occurred due to pulling force/ jerk of conductor/ Earthwire developed due to failure of nearby tower at location No. 181.

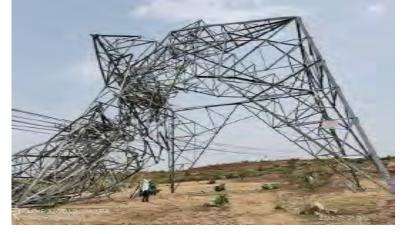
Tower at Loc. No.181 (A+9)

h. **Tower at Location No. 181 (A+9)** was collapsed form the first cross arm bracing level in the transverse direction to the transmission line. All the four stubs along with foundation of the tower were found reported to be intact.

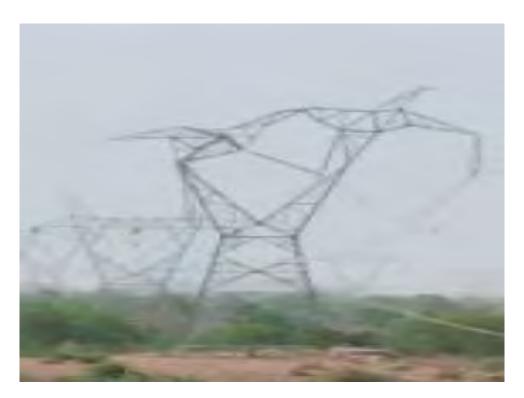
Tower at Loc. No.182 (B+6)

i. **Tower at Location No. 182 (B+6)** was in erect condition. The tower portion above waist level i.e. K portion of the tower was damaged. All the four stubs along with foundation of the tower were intact. UPPTCL representative informed that this was the secondary failure occurred due to pulling force/ jerk of conductor developed due to failure of nearby tower at location No. 181.

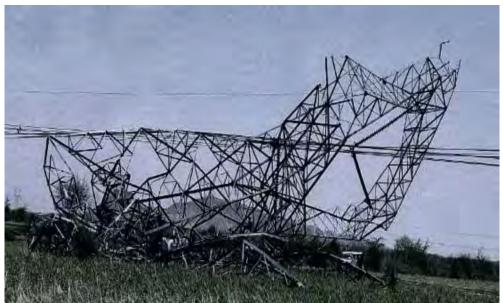
Tower at location No. 394 (72/1(TTA+3))

- a. Representative from RVPN informed that a high wind storm was observed in the area on 04.06.2020 during which two towers at separate sections/ locations of the line were observed damaged/ collapsed. However, no information regarding the wind speed observed during the incident is available with RVPN.
- b. **Tower at location No. 394 (72/1(TTA+3))** was located in the plain field with few trees in the vicinity. The tower was completely collapsed to the ground. Two No. of stubs were reported to be damaged and two No. stubs were buckled.

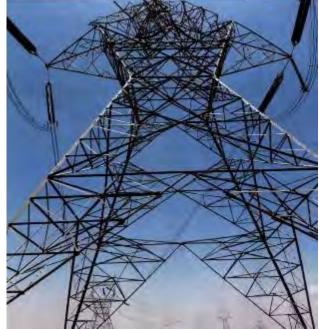
Tower at location No. 355 (61/0(TTC+3))

c. **Tower at location No. 355 (61/0(TTC+3))** was located in the plain field with few trees in the vicinity. The tower was in erect condition. The members of the tower in the delta portion were bent & buckled inwards. The lower portion of the tower & the stubs/foundations were intact. All four conductors of Y-phase with tension strings, extension links and connecting plates with two members detached from tower main body and fell down towards location No. 356. Due to this detachment, top portion of tower bent in opposite direction towards location No. 354).

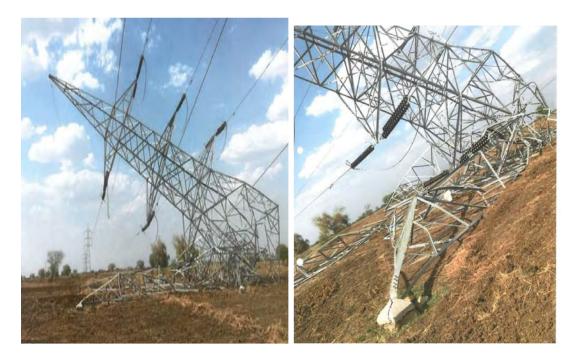
**b.** Tower at location No. 390 (DC+15) was collapsed from the stub level. All the foundations were reported to be intact. The conductors of the line were intact and the upper portion of the collapsed tower was hanging in tilted position by the conductors.

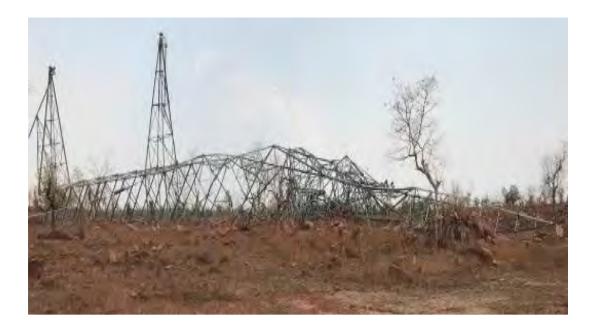
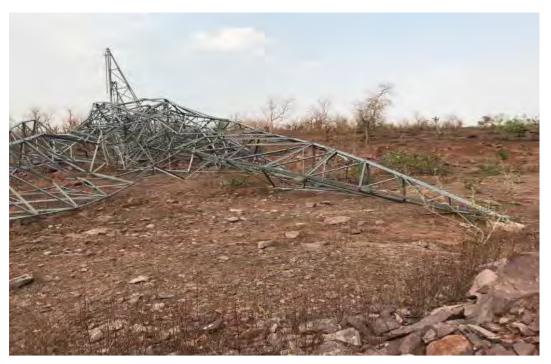
b. The towers at location No. 17/9 to 17/12 were all suspension towers and were completely collapsed to the ground in perpendicular direction to the line. The tower at location No. 17/8 (A+0) was in erect condition and was partially damaged.

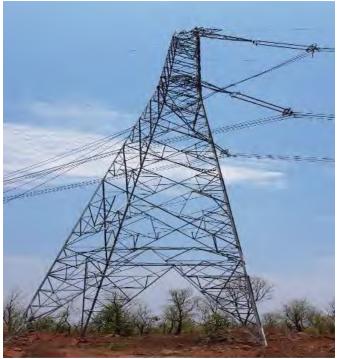
Tower at location No. 18/0 (SD+0)

c. The cascading impact was controlled by the consecutive angle type tower. However, the top portion of the angle type tower above the top cross arm got damaged.

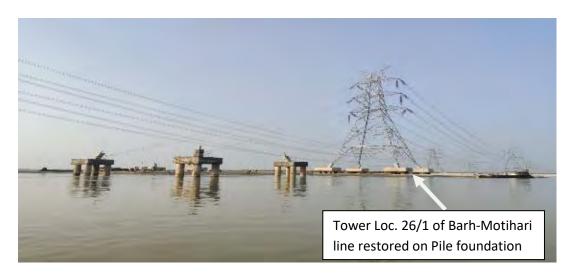
- e. In the floods that ravaged the region in 2017, the pile foundations at location No. 26/1 (of Barh-Motihari line-one pile leg got washed away) and location No. 27/1 (of Motohari-Gorakhpur line - one pile leg got settled and pile cap got tilted) were affected. As informed by DMTCL representative, a new pile foundation, with 40 meter depth, for tower at location No. 26/1 (Barh-Motihari line) was constructed and line was restored using this tower. A new pile foundation, with 40 m depth was also planned for location No. 27/1 (Motihari-Gorakhpur line) and the same was under construction at the time of failure. The team which visited the tower failure site observed that the tower at location No. 27/1 (Motihari-Gorakhpur line) was still in tilted position and has not been restored and the same is prone to failure. However, despite flooding of the river banks and high water levels, this already tilted tower was not affected further in 2019. DMTCL representative informed that the tower has been shifted to new pile foundations in March, 2020.

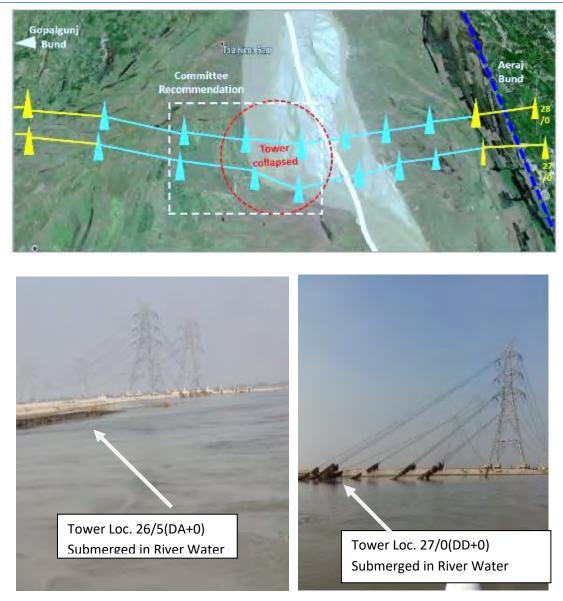
Tower at Loc. No.26/5 (DA+0) Tower at Loc. No.27/0 (DD+0) of Motihari-Gorakhpur Line

Committee noted that the towers were designed and erected on normal open cast foundation and pile type foundations were not considered at these locations. A new water course was created due to high floods & the foundation of towers could not withstand against scouring effect/action of the river and transmission lines had failed due to the change in the river course.

Committee highlighted that adoption of Pile type foundation should be envisaged by the transmission utilities on the basis of river flow data of previous years & previous changes in the course of river observed in the region and, additional precautions like, routing of transmission lines few kilometers away from the river bank/ anticipated future river course, Providing proper revetment & use of geo-synthetic material in foundation, concrete encasing & painting of stub in water logging areas, etc. should be adopted by utilities, wherever required.

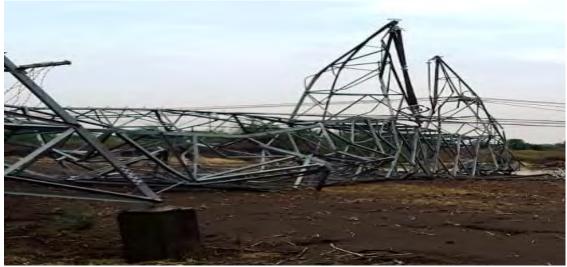
Tower at location No. 431 (A+3)

b. Towers at location No. 431(A+3), 432 (A+3) & 433 (A+0) were collapsed in transverse direction to the line. The foundations of these towers were observed to be damaged.

Committee discussed the failure pattern observed in the case and noted that the chemical composition of some of the failed tower members was not as per IS codes. Due to higher percentage of Carbon, and Phosphorous observed in the samples, the material might have become prone to brittle fracture.

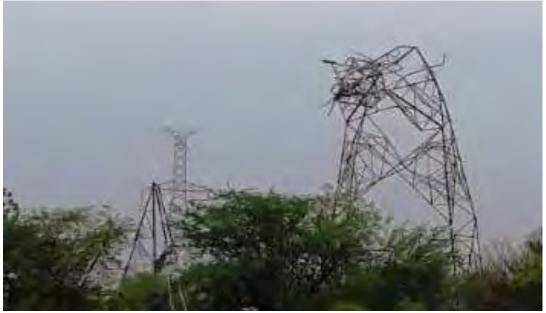
Tower at location No. 434 (A+0)

c. **Tower at location No. 434 (A+0)** was collapsed from mid portion of the tower structure. The bottom cage portion of the tower was in erect condition and the top portion of the tower structure got sheared away from the lower tower body and was lying on the ground. The foundations of the tower were reported to be intact.

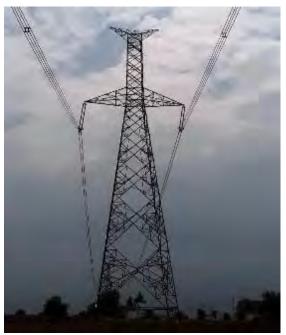
Tower at location No. 435 (A+3)

d. Towers at location No. 435(A+3), 436 (A+0) & 437 (B+0) were in erect position. The top cross arm of the tower at location No. 435 (A+3) was sheared away and was lying near the tower structure. Whereas in case of towers at location No. 436 (A+0) & 437 (B+0), the top cross arms were twisted and resting on the tower structure. The lower portions of the tower structures were observed to be intact.

Cross arm Lying near tower

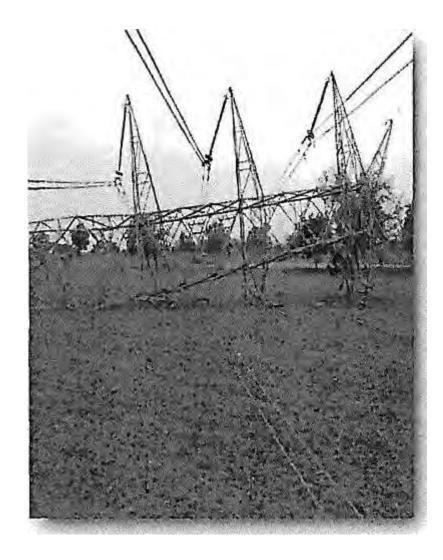
Loc. No. **237**

Date of Failure/ Commissioning		28.04.2019 /Feb 2008
No. of Towers failed	Tension tower	1
	Suspension tower	9
	Total	10
Observations		<ul> <li>Vertical configuration, Conductor Type :- Twin Moose ACSR</li> <li>Line designed as per IS:802 1995, Wind Zone-1</li> <li>All the ten towers have fallen in the perpendicular direction to the transmission line.</li> <li>The suspension towers are designed for wind zone-1 and tension towers are designed for wind zone-2</li> <li>The towers from tower locations 237 to 246 have collapsed completely to the ground. There is no failure of foundation.</li> <li>Material test Results are within limit.</li> </ul>
		<b>Reason Given by Utility :-</b> All the ten towers are collapsed due to high speed localized thunderstorm/ windstorm in this area which has resulted in the large wind load on phase conductors and earth wire as well as on the tower body itself beyond the design values.

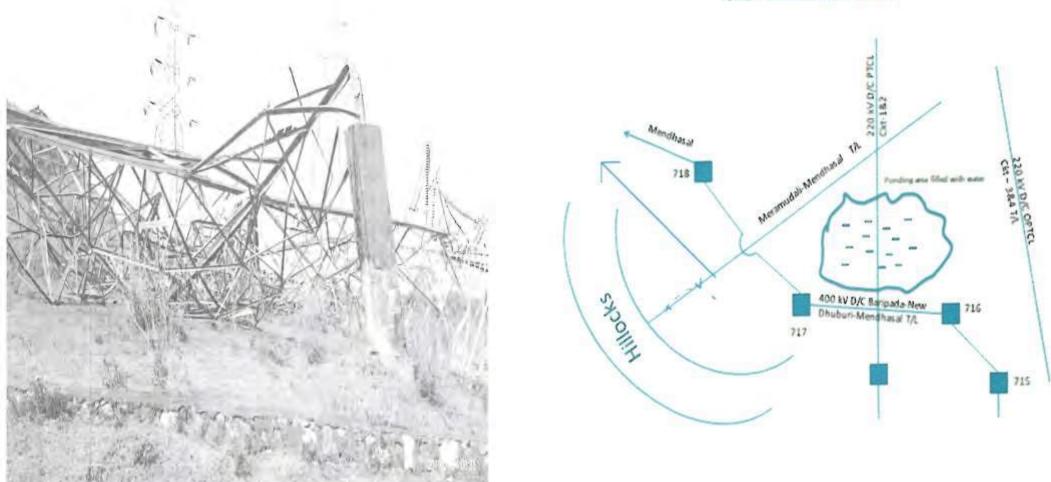
Loc. No. 717 (DD+25+4m RC)

Date of Failure/ Commissioning		03.05.2019/01.09.2011
No. of Towers	Tension tower	1
failed	Suspension tower	0
	Total	1
Observations		<ul> <li>Tower at location no. 717 (DD+25+4m RC) failed completely to ground in transverse direction</li> <li>Conductor Type :- ACSR Twin Moose</li> <li>The tower at location no. 717 collapsed completely on the ground in the transverse direction.</li> <li>Tower designed for wind zone -V (50 m/s), IS 802-1995</li> </ul>
		<b>Reason Given by Utility :-</b> Due to the cyclone 'FANI', speed of the winds were more than 200 Km/hr which initiated the tower failure.

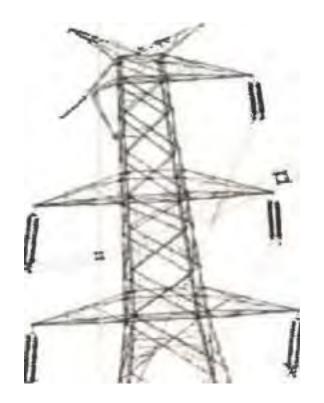
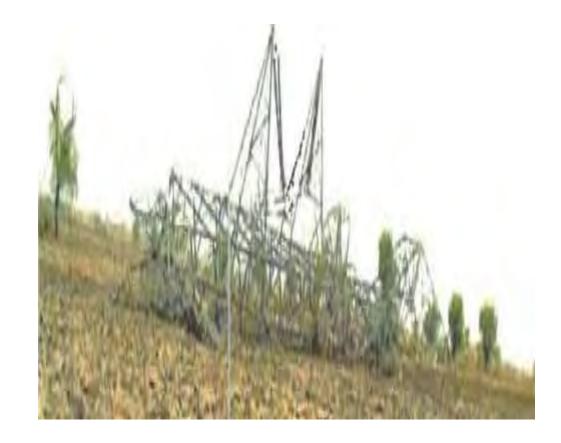
Date of Failure/ Commissioning		27.05.2019/Apr. 2013
No. of Towers	Tension tower	0
failed	Suspension tower	7
	Total	7
Observations		<ul> <li>Tower Configuration :- Vertical</li> <li>Conductor Type :- Quad Moose ACSR</li> <li>All six towers collapsed in the direction perpendicular to the transmission line.</li> <li>Line designed as per IS:802 1995, Wind Zone-2</li> <li>Towers at location no. 547 to 552 were collapsed,</li> <li>At location no. 546top cross arm got damaged.</li> </ul>
		<b>Reason Given by Utility :-</b> All towers were collapsed due to the high speed localized thunderstorm in this area.

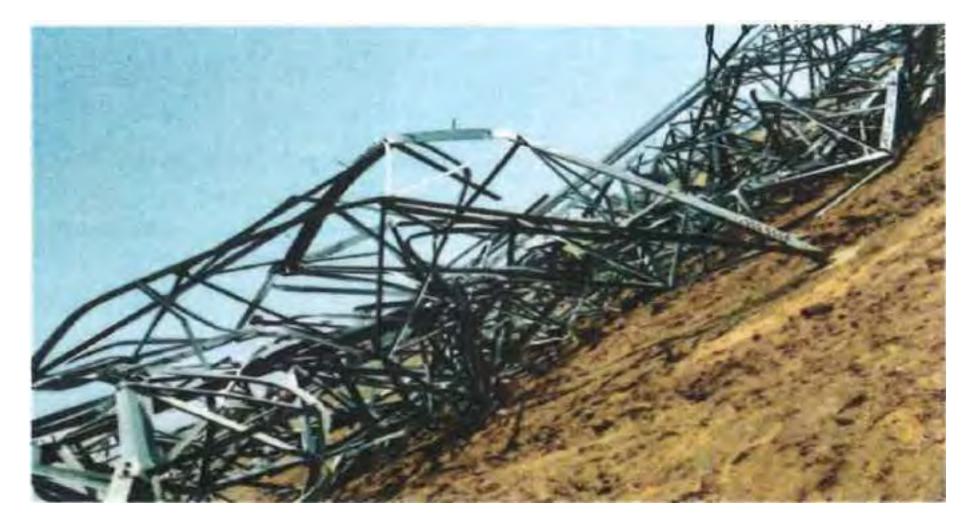
Location no. 340

Date of Failure/ Commissioning		12.06.2019/17.10.2013
No. of Towers failed	Tension tower	1
	Suspension tower	2
	Total	3
Observa	tions	<ul> <li>Tower Configuration :-Vertical configuration</li> <li>Conductor Type :-Quad Moose ACSR Conductor.</li> <li>The towers at locations no. 339 to 341 have collapsed completely to the ground.</li> <li>Wind Zone 4(47 m/s);</li> <li>Line is designed as per IS 802-1995</li> </ul>
		<b>Reason Given by Utility :-</b> All towers were collapsed due to the high intensity localised windstorm in this area.

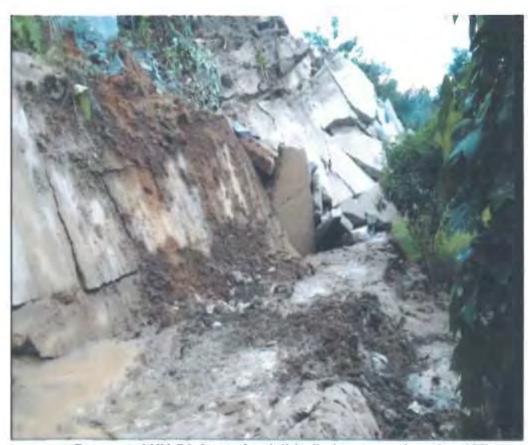
Date of Failure/ Commissioning		19.07.2019/Dec 2018
No. of Towers	Tension tower	1
failed	Suspension tower	0
	Total	1
Observations		<ul> <li>Tower Configuration :- Vertical</li> <li>Conductor Type :-Twin ACSR Moose</li> <li>The Tower Location No. 377 fully collapsed laterally due to displacement of landmass suddenly during landslide.</li> <li>The foundation of the Leg-A fell on the fault line of the separation and completely collapsed.</li> <li>The tower had a deviation of 25°33'30" towards right.</li> <li>Wind Zone 6</li> </ul>
		<b>Reason Given by Utility :-</b> The tower at this location collapsed due to the displacement of landmass during landslide.

Destroyed NH-54 due to landslide (below tower location 377

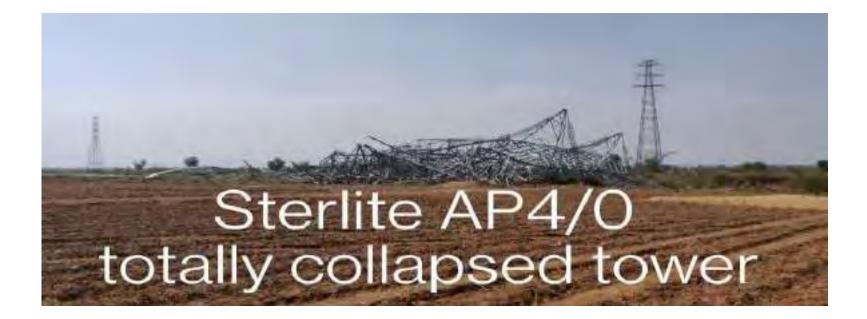
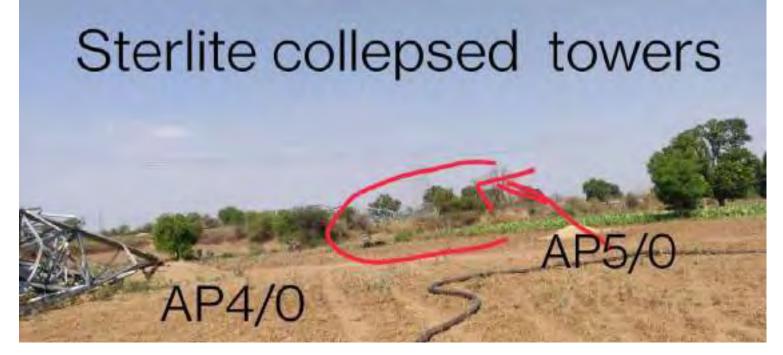
Date of Failure/ Commissioning		16.04.2019/ under construction
No. of Towers	Tension tower	0
failed	Suspension tower	5
	Total	5
Observations		<ul> <li>Details were requested from Sterlite Power vide letter dated 23.04.2019.</li> <li>M/s Sterlite vide letter dated 27.04.2019 submitted the following <ul> <li>As the transmission line is under construction, the Investigation of failure is being done at their end.</li> </ul> </li> </ul>
		<b>Reason Given by Utility :-</b> due to strong wind and heavy rainfall.

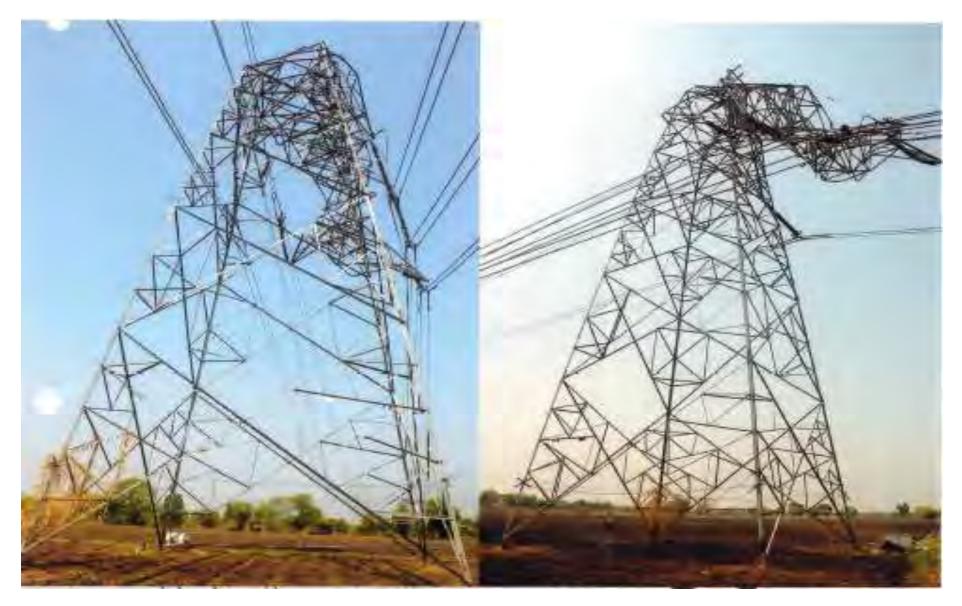
### **Tower at Location 127**

Reason Given by Utility :- All towers were collapsed due to the high windstorm in this area.

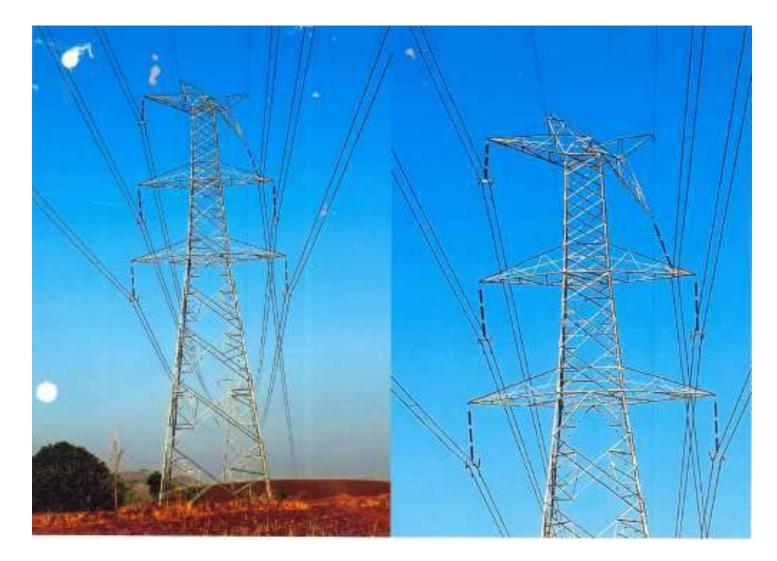
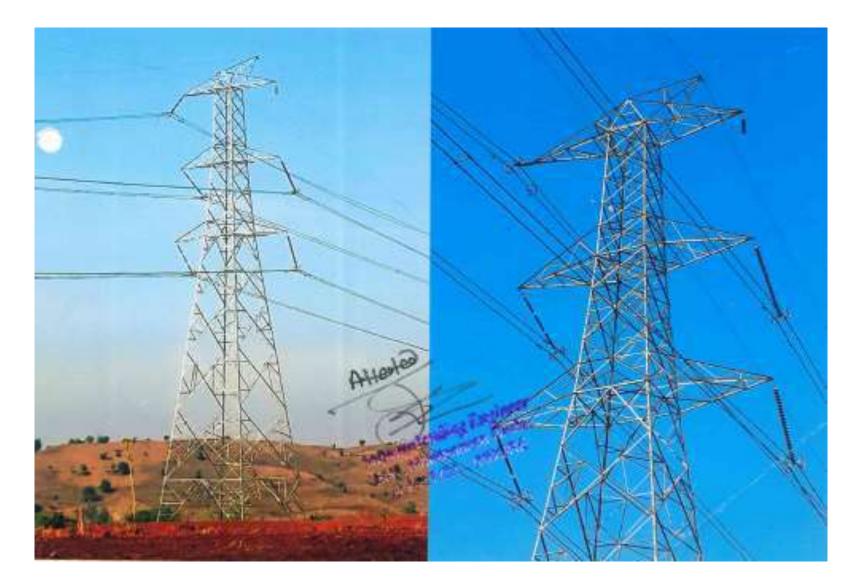
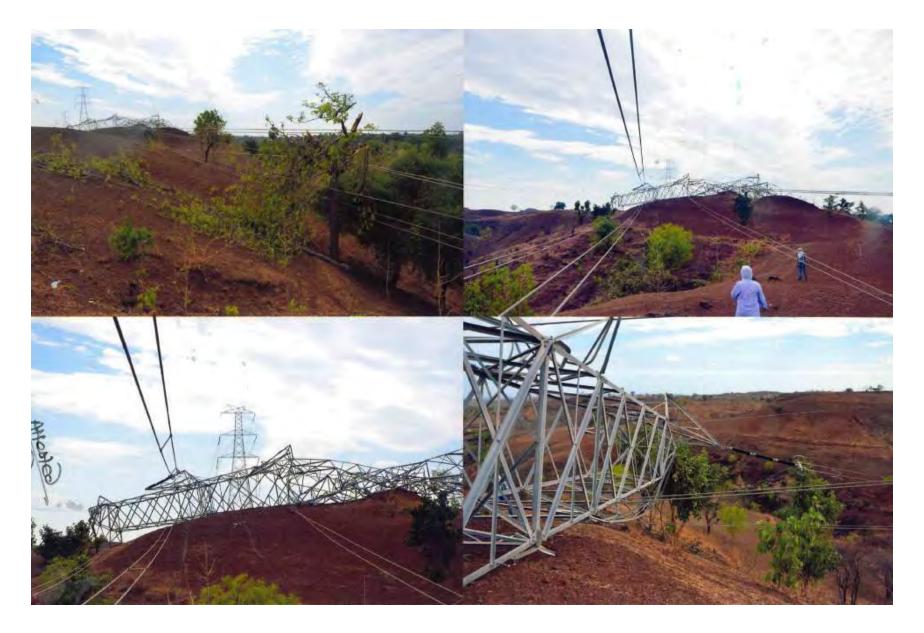
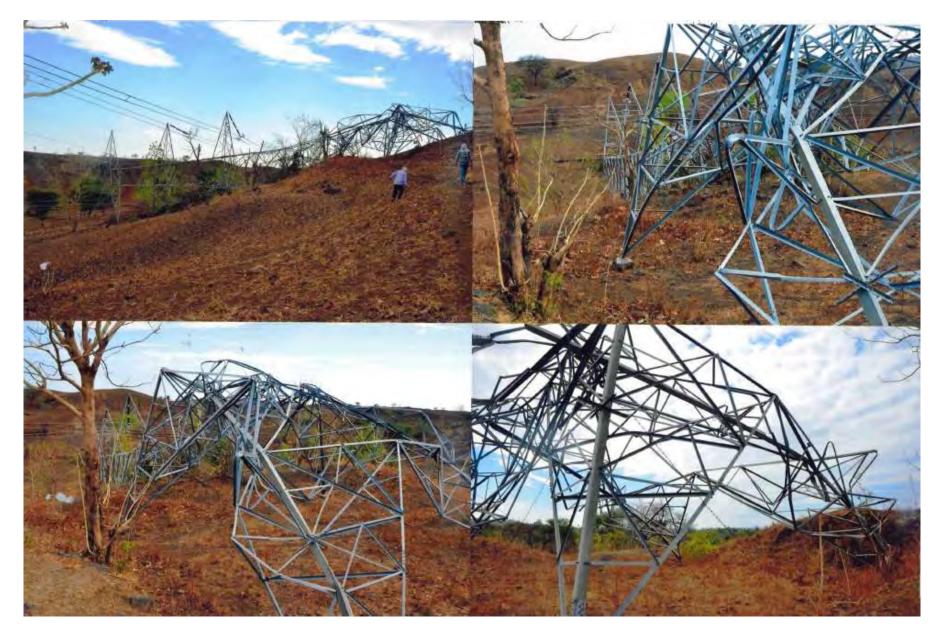
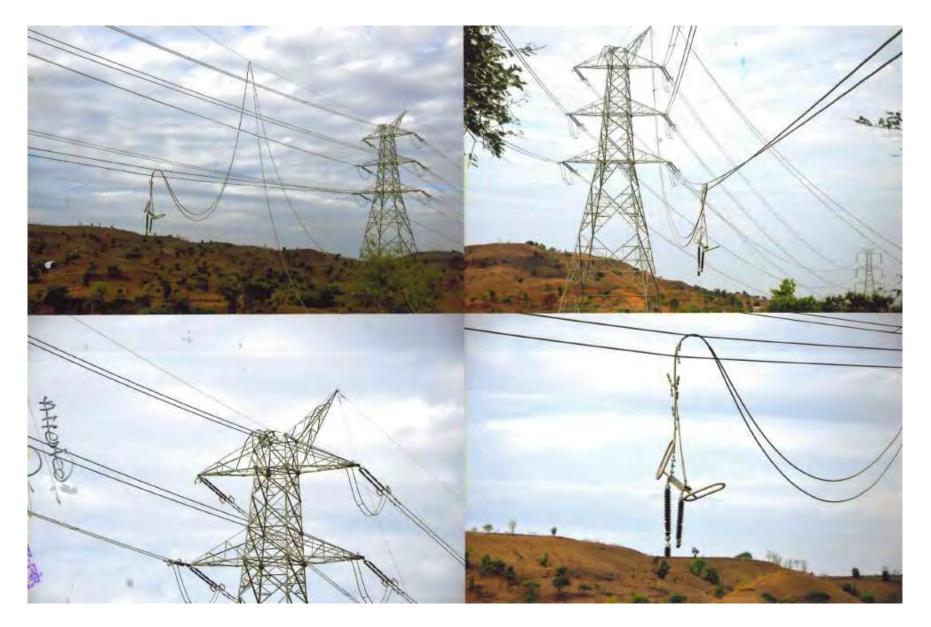
### 400 kV DCDS Rajgarh-SSP TRANSMISSION LINE OF MPPTCL

Date of Failure/ Commissioning		11.06.2019/2002
No. of Towers failed	Tension tower	1
	Suspension tower	4
	Total	5
Observations		<ul> <li>Conductor Type :- Twin Moose ACSR</li> <li>Insulator type :- I insulator string</li> <li>Two suspension towers at location no. 565(FDO+6) &amp; 564(FDO) are collapsed and three towers at location no. 566(FD30+10), 563(FDO+6) &amp; 562(FDO+O) are partially damaged.</li> <li>Wind Zone- medium</li> <li>As per the test report attached, one of the failed tower members failed to conform to desired specifications/values of the Tensile strength, yield stress and elongation parameters.</li> <li>Line designed as per IS:802 1977 though commissioned in 2002</li> </ul>
		Reason Given by Utility :- Heavy Wind Storm

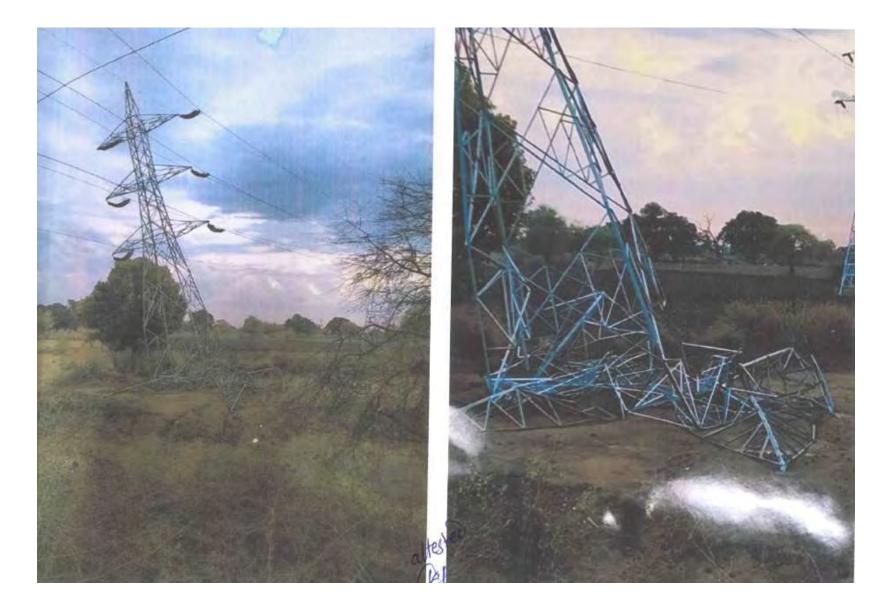
#### Tower at location 11A

Date of Failure/ Commissioning		13.06.2019/07.06.2019 (line was commissioned in year 1962)
No. of Towers	Tension tower	0
failed	Suspension tower	1
	Total	1
Observations		<ul> <li>Conductor Type :- Zebra ACSR Conductor</li> <li>1 no. tower between location no. 11 and 12 (B0+10 m) is collapsed.</li> <li>Collapsed Tower was erected in 2019 for crossing of NHA1 between location no. 11 &amp; 12.</li> <li>Tower collapsed by bending all 4 stubs with +10 m extension portion completely &amp; 5 mtr lower portion of the tower super structure collapsed.</li> <li>Line was designed for medium wind zone; IS: 802-1977.</li> <li>Design details of new tower are awaited.</li> </ul>
		Reason Given by Utility :- Heavy wind and thunderstorm

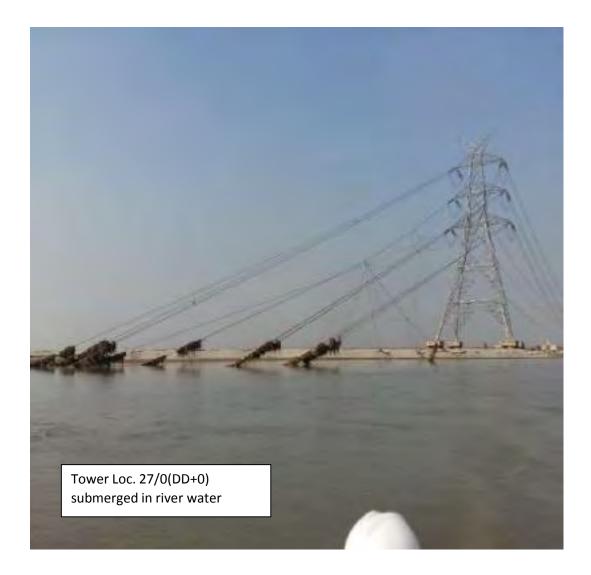
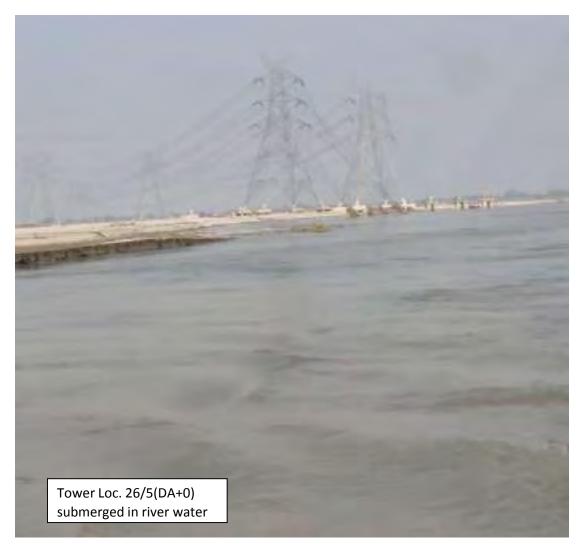
# 400kV D/C Motihari-Gorakhpur TRANSMISSION LINE OF DMTCL

Date of Failure/ Commissioning		15.08.2019 & 25.09.2019 /2017
No. of Towers failed	Tension tower	1
	Suspension tower	1
	Total	2
Observations		<ul> <li>Conductor Type :- Quad AAAC Moose</li> <li>Insulator type :- Tension type string at location no. 27/0 and I type string at location no. 26/5</li> <li>Line designed as per IS:802 1995, Wind Zone-4</li> <li>One tower at location no. 27/0 (DD+0) (Pile type foundation) collapsed on 15.08.2019 and other tower at location no. 26/5 (Suspension type) collapsed on 25.09.2019</li> </ul>
		<b>Reason Given by Utility :-</b> Due to subsequent change in course of Gandak river which results in erosion of river banks in short span by strong river current. This caused collapse of tower at location no. 27/0. Subsequently, there was heavy rains in the region and the washing of the river bank still continued which results in washing away of tower foundation of tower at location no. 26/5 and resulting in collapse of tower.
