### क्षतिग्रस्त ट्रांसमिशन लाइन टॉवरों पर विशेषज्ञों की स्थायी समिति की रिपोर्ट

REPORT OF THE STANDING COMMITTEE OF EXPERTS ON FAILURE OF EHV TRANSMISSION LINE TOWERS (APRIL 2019 – DECEMBER 2021)

भारत सरकार Government of India केन्द्रीय विद्युत प्राधिकरण Central Electricity Authority

### **EXECUTIVE SUMMARY**

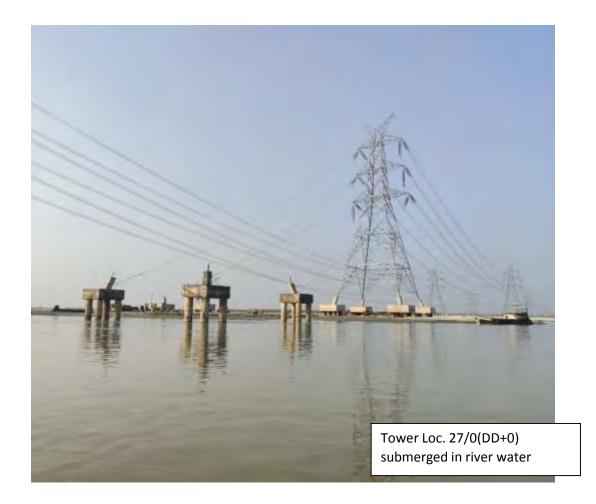
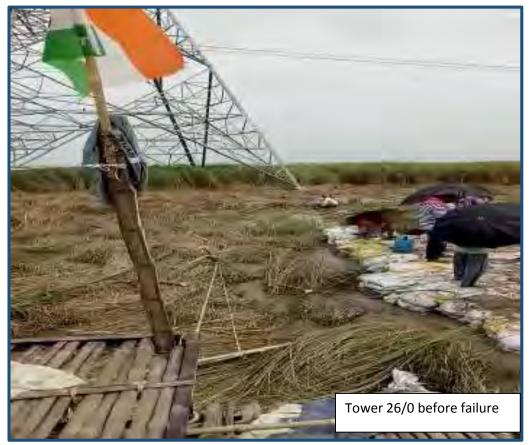
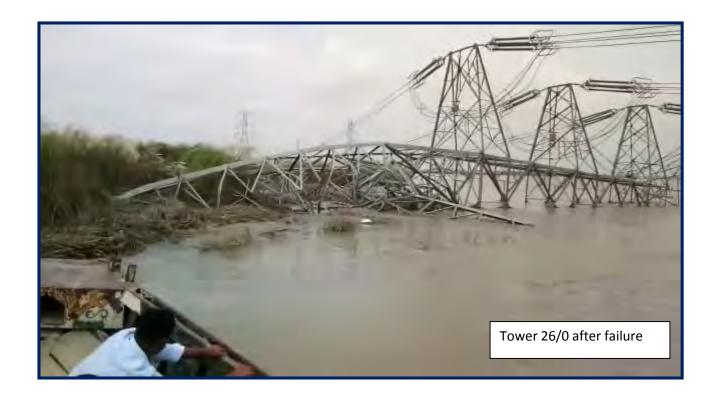
# 400kV D/C Barh-Motihari TRANSMISSION LINE OF DMTCL

Date of Failure/ Commissioning		04.09.2019 & 07.10.2019/ 2017
No. of Towers failed	Tension tower	1
	Suspension tower	1
	Total	2
Observations		<ul> <li>One tower at location no. 26/0 (Tension type) collapsed on 04.09.2019 and other tower at location no. 25/5 (Suspension type) collapsed on 07.10.2019</li> <li>Conductor Type :- Quad AAAC Moose</li> <li>Insulator type :- Tension type string at location no. 26/0 and I type string at location no. 25/5</li> <li>The tower at location 26/0 and 25/5 was initially located on land and nearest water stream was around 600m and 1000m away respectively.</li> <li>Short piles of 2 meters depth were provided to develop additional uplift resistance force and to improve the factor of safety.</li> <li>Line designed as per IS:802 1995, Wind Zone-4</li> </ul>
		<b>Reason Given by Utility :-</b> Due to sudden change in course of river, the tower at location no. 26/0 and 25/5 experienced very high current and continuous change in discharge rate of water from Valmiki dam causing drastic change in water levels causes rapid cutting of one river bank and washing away of tower foundation which results in collapse of tower. Conductor along with other line material on both side of tower also get damaged

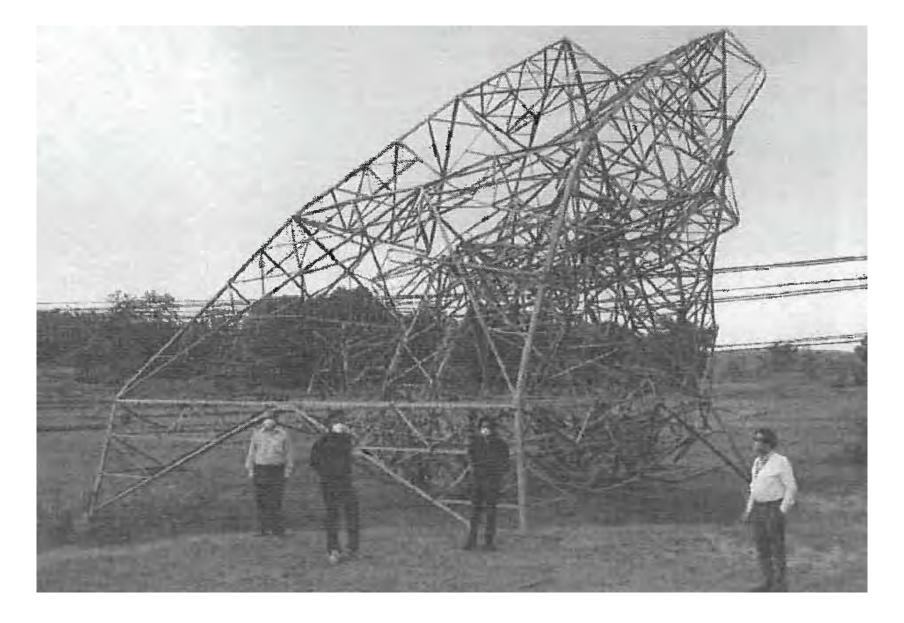
# Tower at location 92 (A+3)

Date of Failure/ Commissioning		21.04.2020/31.03.2014
No. of Towers	Tension tower	0
failed	Suspension tower	3
	Total	3
Observa	itions	<ul> <li>Line is designed as per IS 802:1995</li> <li>Wind Zone-2</li> <li>Horizontal Configuration</li> <li>Quad ACSR Bermisis Conductor</li> <li>One tower at Loc. no. 92 (A+3) has collapsed completely</li> <li>Partial damage to peak / cross arms of towers at loc. nos. 91 (A+0) and 90 (A+3).</li> <li>Material test reports found to be in order.</li> </ul>
		Reason Given by Utility :- High intensity whirlwind

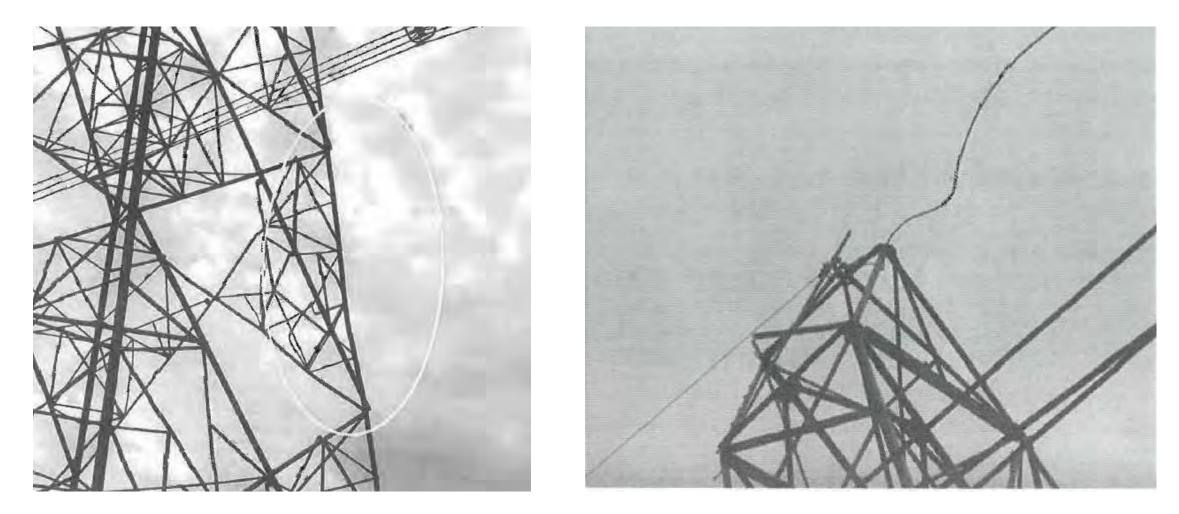
Tower at location 90 and 91

Bent Main leg of Loc. 91 (A+0)

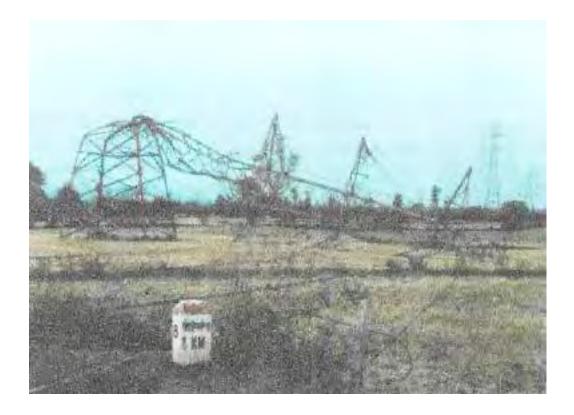
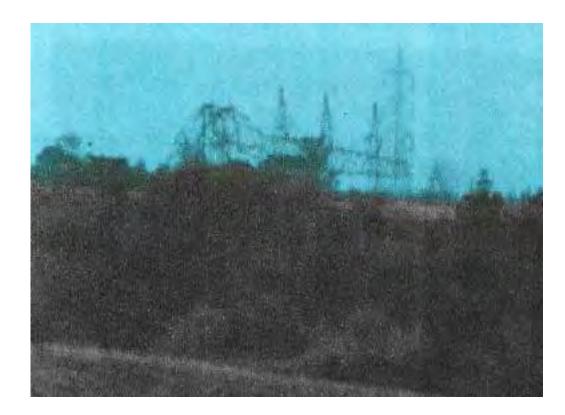
### Tower at location 948 and 949

Date of Failure/ Commissioning		30.04.2020/07.11.1989
No. of Towers	Tension tower	0
failed	Suspension tower	4
	Total	4
Observa	tions	<ul> <li>The tower used in this line is were designed and supplied by Russia (Erstwhile USSR)</li> <li>Vertical Configuration</li> <li>Twin ACKC Conductor</li> <li>Four suspension towers at location no. 948,949,950 ( all DA+0) and 951 (DA+6) collapsed</li> <li>The line is having glass insulators in single suspension I string configuration.</li> <li>Wind speed submitted by utility- approx. 120 kmph.</li> <li>Last patrolling reported to be done on 17.01.2020</li> <li>Previous failure of line was in 2009. Three suspension towers collapsed.</li> <li>Material Test report-</li> <li>Three members (Member 4, 8 &amp; 9) failed in ultimate stress test.</li> <li>Two members (member 3 &amp; 6) had silica content more than prescribed limit.</li> </ul>
		Reason Given by Utility :- High speed windstorm

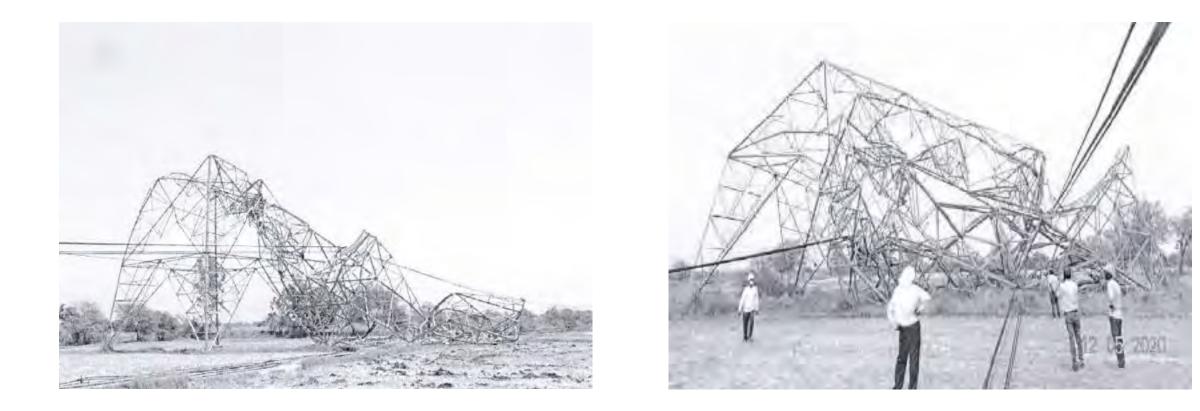
### Tower at location 641 and 642

Date of Failure/ Commissioning		10.05.2020/June 2013
No. of Towers	Tension tower	0
failed	Suspension tower	4
	Total	4
Observations		<ul> <li>Line is designed as per IS 802:1995</li> <li>Wind Zone-4</li> <li>Delta Configuration</li> <li>Two towers at location no. 641 (A+0) and 642 (A+0) are completely collapsed and towers at location no. 640 (A+3) and 643(A+0) was partially damaged.</li> <li>The line is having porcelain insulators in I-V-I configuration.</li> <li>ACSR Bersimis conductor</li> <li>As per POWERGRID, the strengthening of the failed towers was completed.</li> <li>Material testing report found generally to be within limits except the elongation percentage of two MS members which is marginally lower (21.84% &amp; 22.10%)- required 23%</li> </ul>
		Reason Given by Utility :- High speed windstorm

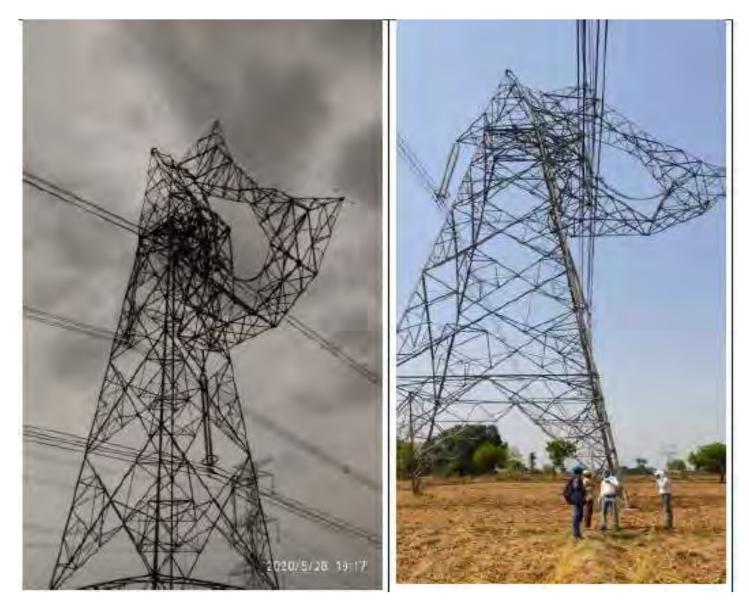
Date of Failure/ Commissioning		28.05.2020/ 30.04.2013
No. of Towers	Tension tower	0
failed	Suspension tower	1
	Total	1
Total Observations		<ul> <li>Line is designed as per IS 802:1995</li> <li>Wind Zone-4</li> <li>Delta Configuration 765 kV S/C suspension tower failed.</li> <li>One tower at Location Nos. 673 (A+0) bent from above waist level</li> <li>The line is having porcelain insulators in I-V-I (DI -DV-DI String) configuration.</li> <li>Failed tower location was not taken up for strengthening.</li> <li>As reported by utility, some towers of 220kV Satna -Chhatarpur (MPPTCL) transmission line, 132 KV Satna - Satna (Prism Cement), 132 KV Satna - Majhgawan transmission line, 132 kV Satna -Satna Cement transmission line were also collapsed</li> <li>Material Testing report found to be within limit.</li> </ul>
		Reason Given by Utility :- High speed windstorm

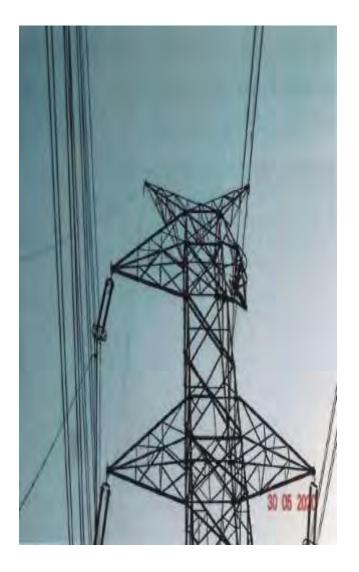
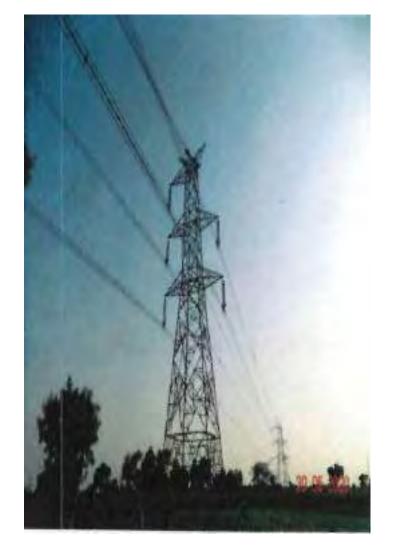
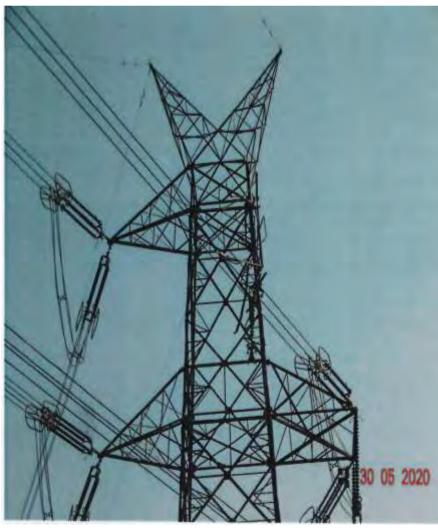
Tower at location 13 (DA+0)

Date of Failure/ Commissioning		29.05.2020/January 2014
No. of Towers	Tension tower	1
failed	Suspension tower	3
	Total	4
Observa	itions	<ul> <li>Line is designed as per IS 802:1995.</li> <li>Previous failure in June 2019- locations no. 339 to 341 ( 2 suspension one tension) have collapsed completely</li> <li>Wind Zone-4</li> <li>Vertical Configuration</li> <li>Tower at location no. 12(DA+0) has collapsed and all four stubs damaged.</li> <li>Cross arms of towers at location no. 13(DA+0), 14(DA+0) and 15 (DD+0) has been damaged.</li> <li>Material testing report found to be within limit.</li> </ul>
		Reason Given by Utility :- High speed localized thunderstorm

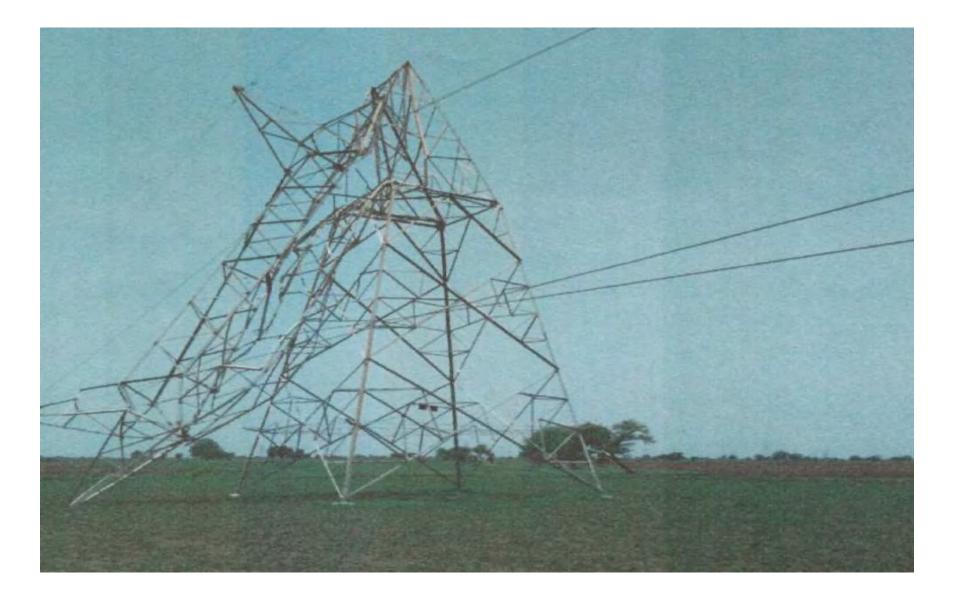
# Tower at location 213 (A+0)

Date of Failure/ Commissioning		03.07.2020/10.01.2000
No. of Towers	Tension tower	0
failed	Suspension tower	1
	Total	1
Observa	itions	<ul> <li>Line is designed as per IS 802:1977</li> <li>Medium Wind Zone</li> <li>Horizontal Configuration</li> <li>Reported as First incident of failure in transmission line by utility.</li> <li>Tower used for transmission line is of 400 kV S/C (Horizontal Configuration)</li> <li>One tower at location no. 213 (A+0) has damaged from the waist level.</li> <li>Material testing report found to be within limits.</li> </ul>
		Reason Given by Utility :- High speed localized thunderstorm

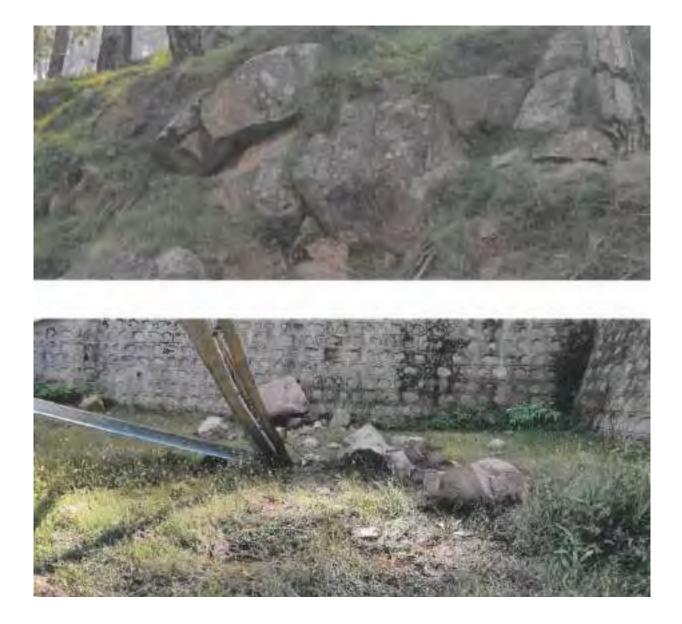
Photograph of uphill side boulders

Date of Failure/ Commissioning		10.09.2020/19.01.2018
No. of Towers	Tension tower	2
failed	Suspension tower	0
	Total	2
Observations		<ul> <li>Line is designed as per IS 802:1995</li> <li>Wind Zone-4</li> <li>Vertical Configuration</li> <li>Tower at location no. 261 (DB+6) has collapsed</li> <li>Damage in top cross arm of the tower at location no. 262 (DC+4.5)had occurred.</li> <li>No landslide &amp; uphill landslip noticed at location &amp; soil seems to be stable.</li> <li>Material test report found to be in order.</li> </ul>
		<ul> <li>Reason Given by Utility :-</li> <li>Gradual differential settlement of Pits A and B and jerk from hitting by boulders from upside hill.</li> <li>Single circuit stringing may have caused unequal load distribution &amp; torsional stress in tower which may have aggravated the tower collapse.</li> </ul>

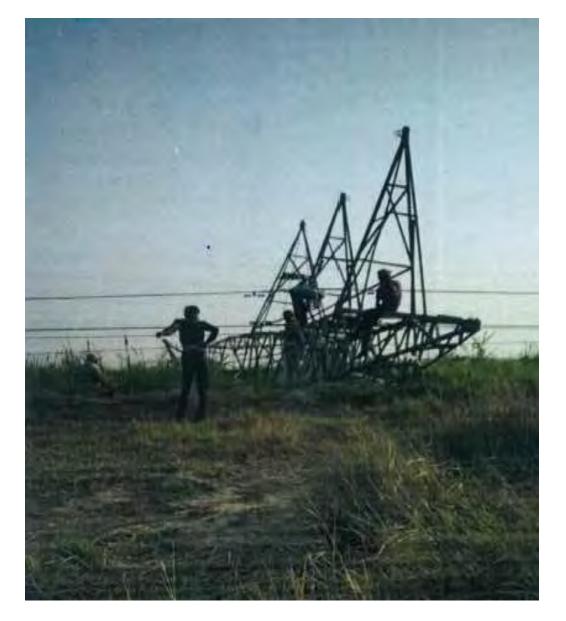
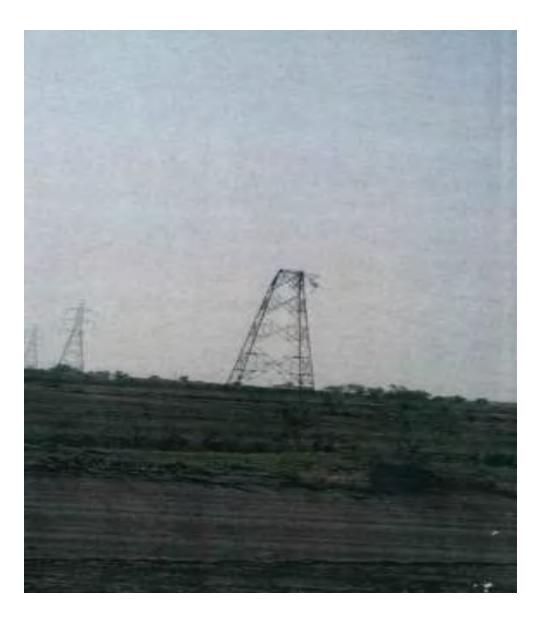
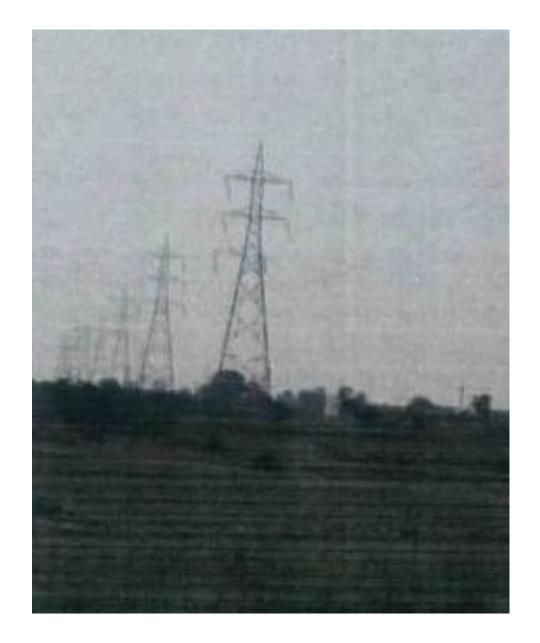
Date of Failure/ Commissioning		29.05.2020/16.02.2017
No. of Towers	Tension tower	0
failed	Suspension tower	3
	Total	3 [Location Nos.: 31(B0), 32(B0+3) & 33(B0+3) ]
Total         Observations		<ul> <li>Conductor Type :- ACSR Zebra</li> <li>Tower at location 31(B0) collapsed, tower twisted from bottom phase cross arm at location 32(B0+3) and only bottom phase cross arm of CKT-II damaged at location 33(B0+3).</li> <li>Tower designed for wind zone 4 (wind speed 47m/s = 169.2kmph)</li> <li>Tower designed as per IS: 802-1995</li> <li>Wind speed informed by IMD to MPPTCL on 29.05.2020 – 7 kmph</li> <li>Continuous record of wind is not available with IMD.</li> <li>Material Test reports are found within limits.</li> </ul>
		Reason Given by Utility :- Heavy Thunderstorm/Cyclone

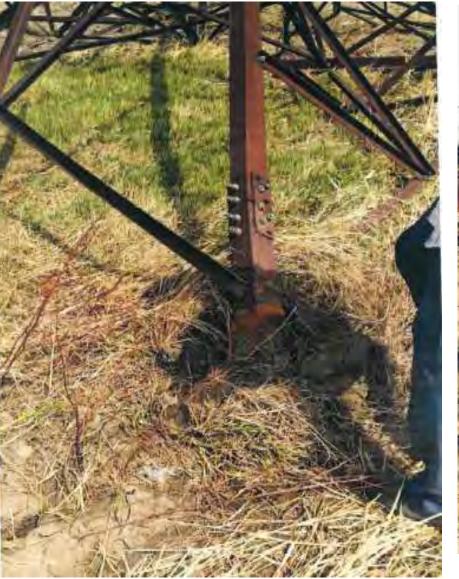
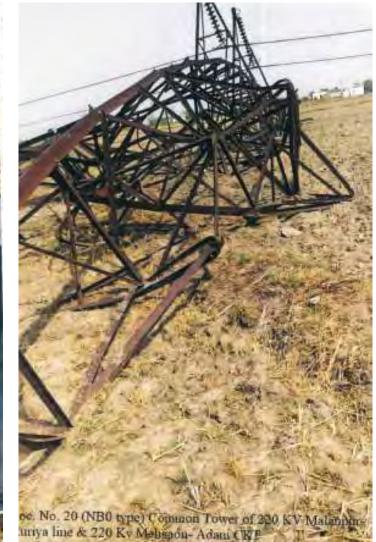
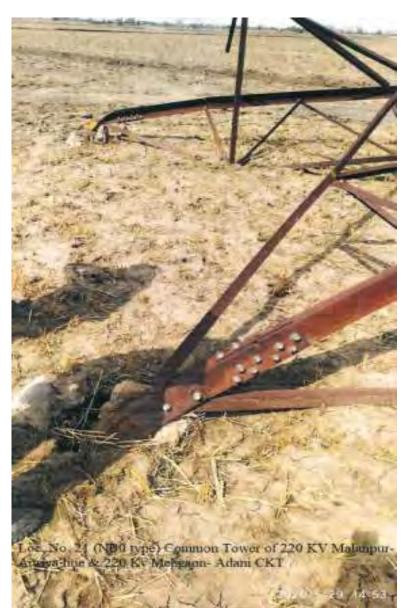
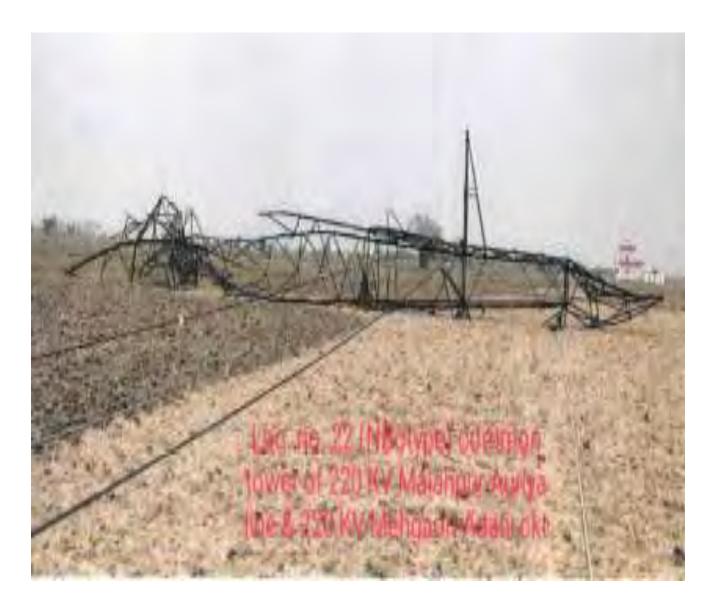
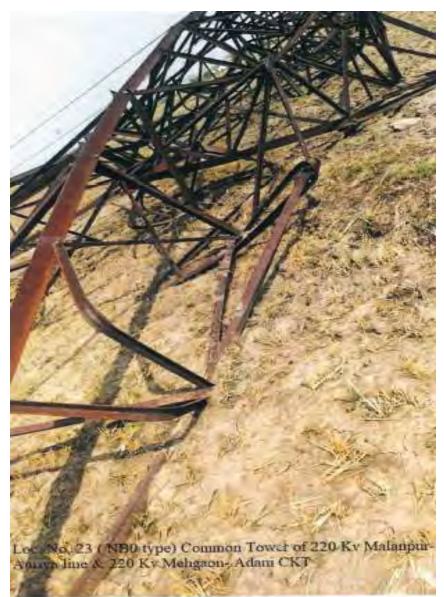
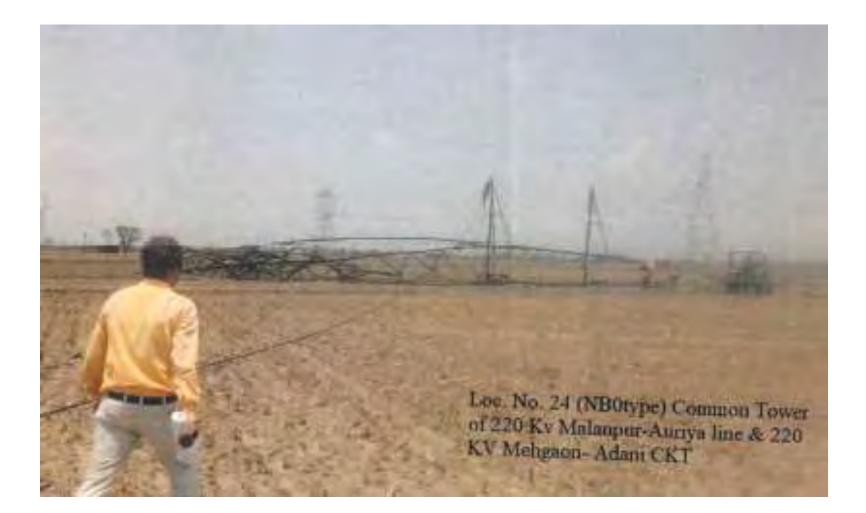
#### **Tower at location 20**

Date of Failure/ Commissioning		28.05.2020/17.11.1993
No. of Towers	Tension tower	0
failed	Suspension tower	11
	Total	11 [Location Nos.: 14 to 24]
Observations		<ul> <li>Conductor Type :- AAAC Zebra</li> <li>11 nos (Suspension) towers collapsed from ground level.</li> <li>No damage to Foundation is reported</li> <li>Tower designed as per IS: 802-1977</li> <li>Wind speed informed by IMD to MPPTCL on 28.05.2020 – 5 kmph</li> <li>Continuous record of wind is not available with IMD.</li> <li>Material Test reports- One of the sample failed in tensile strength test.</li> <li>Members Rusted &amp; Bolts are missing (As observed from images).</li> </ul>

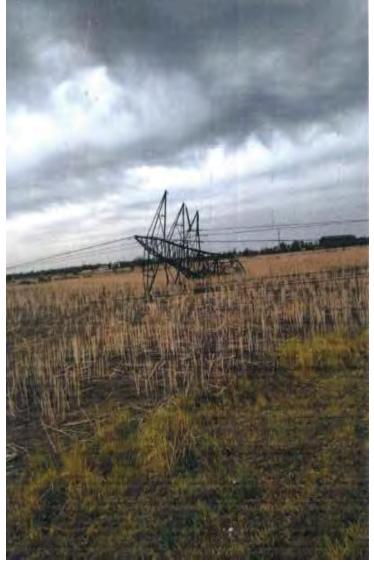
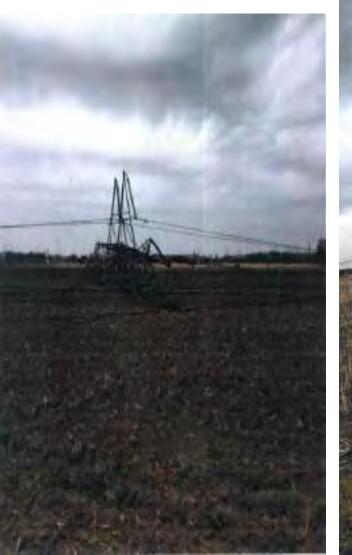
#### **Tower at location 93**

Date of Failure/ Commissioning		29.05.2020/ 2010
No. of Towers	Tension tower	2
failed	Suspension tower	3
	Total	5 [Location Nos.: 90 to 94 ]
Observations		<ul> <li>Conductor Type :- ACSR Zebra</li> <li>05 nos (03 nos suspension &amp; 02 no Tension) towers are collapsed</li> <li>Tower designed for wind zone 4</li> <li>Tower designed as per IS: 802-1995</li> <li>Wind speed informed by IMD to MPPTCL on 29.05.2020 – 7 kmph</li> <li>Continuous record of wind is not available with IMD.</li> <li>Material Test reportsfound to be within limits.</li> </ul>
		Reason Given by Utility :- Heavy storm/cyclone

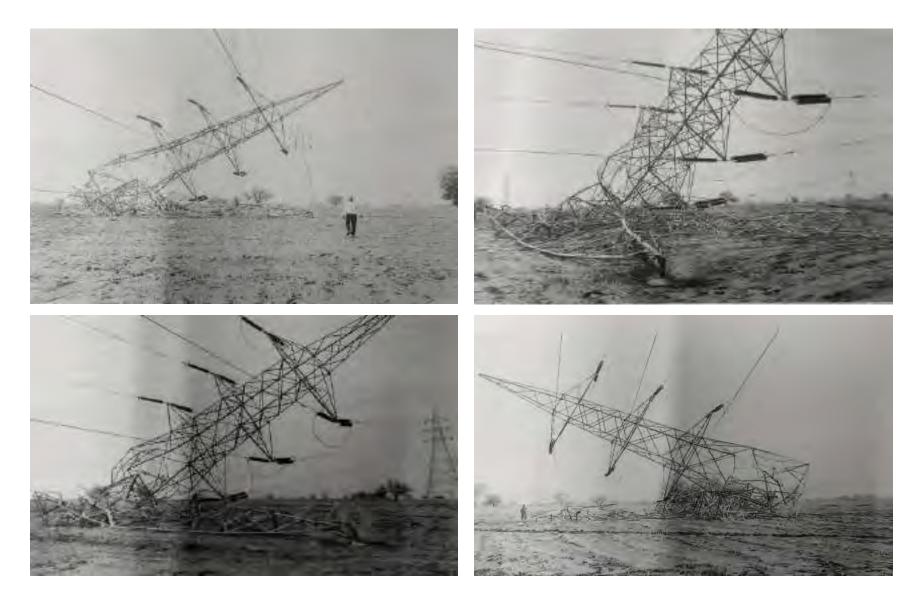
## Photographs of Collapsed Towers

Date of Failure/ Commissioning		17.04.2020/2003
No. of Towers	Tension tower	2
failed	Suspension tower	0
	Total	2[ Location Nos.: 389 & 390 ]
Observations		<ul> <li>Conductor Type :- Drake</li> <li>02 nos (Tension) towers ( B type) are collapsed.</li> <li>There is no damage to Foundation</li> <li>Tower designed for wind zone 2</li> </ul>
		Reason Given by Utility :- Heavy rain and swirl wind

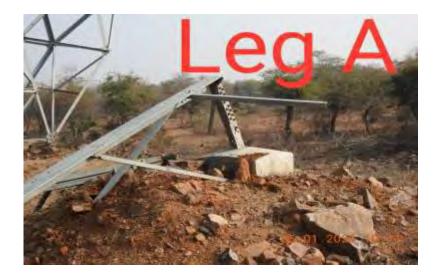
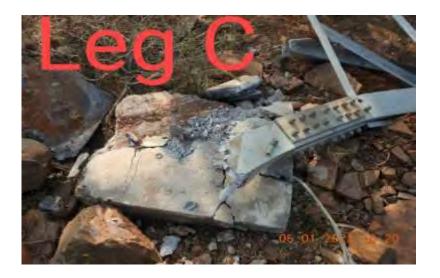
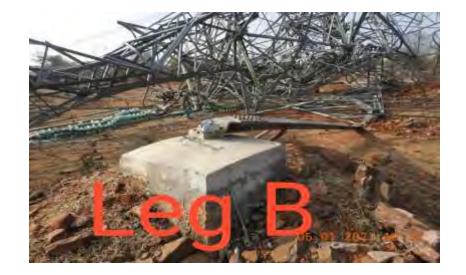
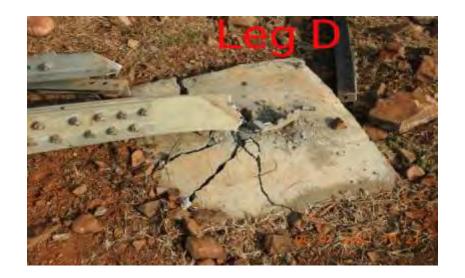
## Legs of tower at location 611

Date of Failure/ Commissioning		05.01.2021/ May 2014
No. of Towers failed	Tension tower	1
	Suspension tower	0
	Total	1
Observations		<ul> <li>Delta Configuration</li> <li>The Tower is designed as per IS 802: 1995 and Wind Zone-4</li> <li>The tower at location no. 611 has collapsed from top of concrete, just above stub level on the ground in the transverse direction.</li> <li>Removed tower member pieces, bolts and nuts were found scattered at the tower collapse site.</li> <li>Cutting of main bracing observed.</li> <li>All the redundant members of bottom section and three main bracing of the adjacent suspension tower at location no. 612 (A type) has also been removed, but the tower is standing.</li> <li>Last patrolling was done on 12.10.2020- No theft observed by utility representatives.</li> </ul>
		Reason Given by Utility :- Theft/ Sabotage of Tower members

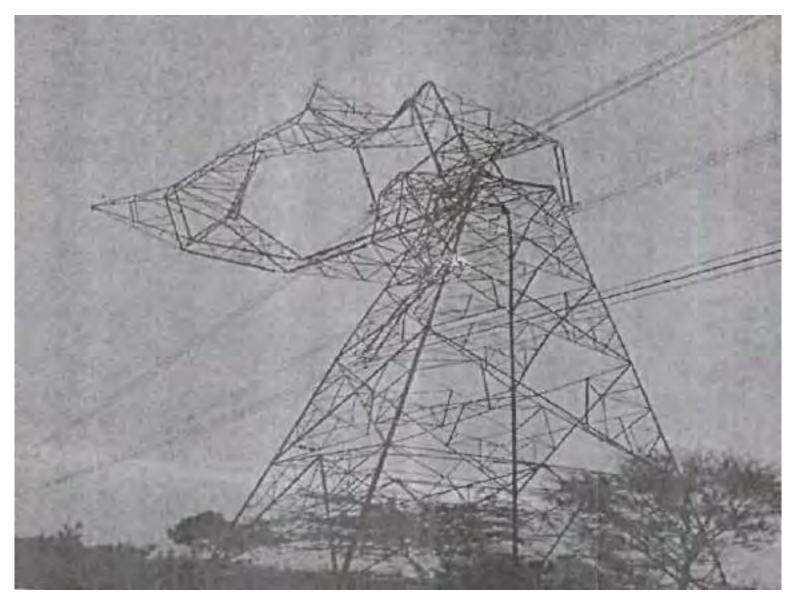
## Tower at location 59 (33/3)

Date of Failure/ Commissioning		06.05.2021/01.10.2012
No. of Towers failed	Tension tower	0
	Suspension tower	1
	Total	1
Observations		<ul> <li>Delta Configuration</li> <li>Quad ACSR Bermisis Conductor</li> <li>Line is designed as per IS 802:1995 and Wind Zone-4</li> <li>Tower is designed with Double I-V-I insulator string</li> <li>Tower at location no. 59 (33/3) (A+0) has been damaged from the cross arm level</li> <li>Previous failure on 16.05.2018- one tower failed (suspension type)- location no. 17 (A+0).</li> <li>All strengthening, including as suggested by Manitoba Hydro, has been completed at the failed site location.</li> </ul>
		Reason Given by Utility :- Highly localized Thunderstorm with high speed wind

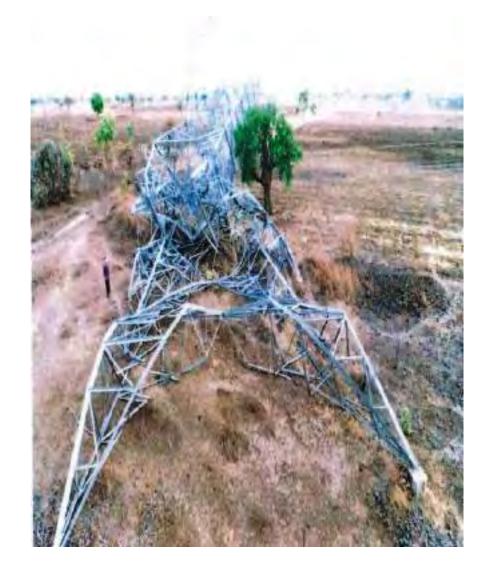
Date of Failure/ Commissioning		27.05.2021/ July 2014
No. of Towers failed	Tension tower	0
	Suspension tower	5
	Total	5
Total Observations		<ul> <li>Hexa Zebra ACSR Conductor</li> <li>Line is designed as per IS 802: 1995 and Wind Zone-2</li> <li>The Tower is designed with Double I String having Glass insulator.</li> <li>Tower at location no. 321 (DA+3) collapsed.</li> <li>Peak of the tower at location no. 322 (DA+6) was damaged.</li> <li>Tower at location no. 319 and 320 got buckled from middle cross arm.</li> <li>At tower location 318, Top CKT-II cross arm got damaged.</li> <li>This is first incident of failure of towers in this line.</li> <li>Reliability Level</li> </ul>
		Reason Given by Utility :- High speed Windstorm/ Thunderstorm

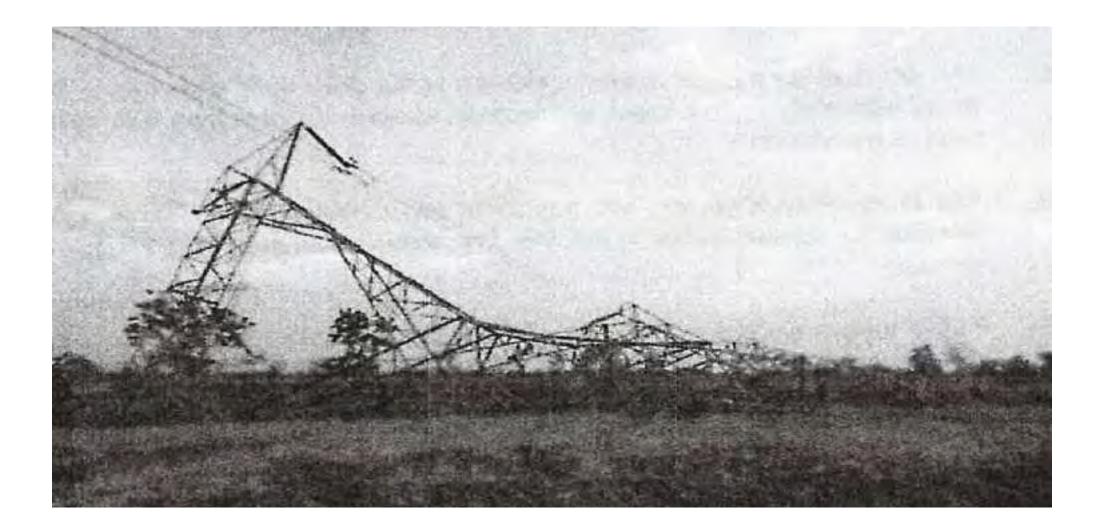
#### 400 KV Korba-Bhilai-1 Transmission Line of POWERGRID

Date of Failure/ Commissioning		30.05.2021/03.01.1983
No. of Towers failed	Tension tower	0
	Suspension tower	1
	Total	1
Total Observations		<ul> <li>Line is designed as per IS 802:1977</li> <li>Horizontal Configuration</li> <li>Suspension towers are designed with Single "I" Insulator Strings</li> <li>Tower at location no. 320 (A+3) has bee collapsed from stub level.</li> <li>2<sup>nd</sup> instance of failure in line.</li> <li>1<sup>st</sup> failure in 2009</li> </ul>
		Reason Given by Utility :- Highly Localized Thunderstorm with high speed wind

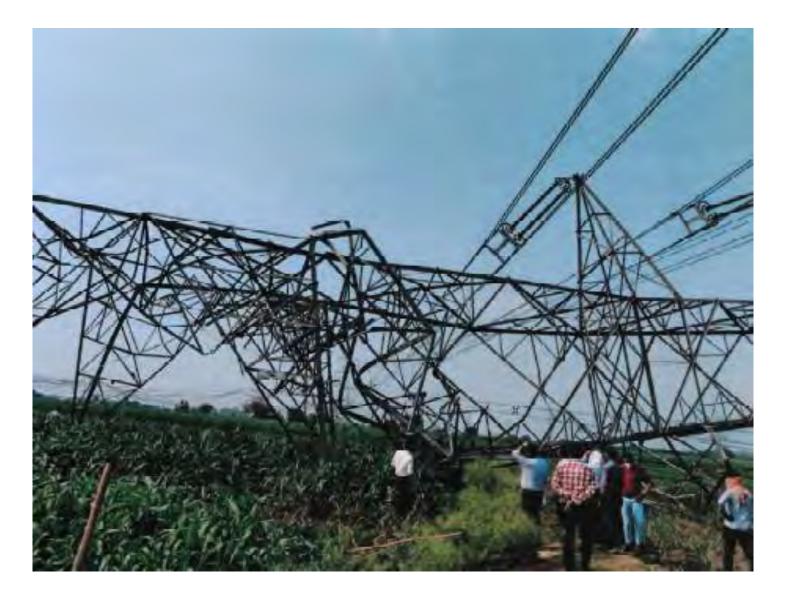
## 400 KV D/C (Quad) Kaithal-Baghpat transmission line of POWERGRID

Date of Failure/ Commissioning		08.07.2021/ Nov 2010/ LILO of Kaithal Meerut in Baghpat done in 2016
No. of Towers failed	Tension tower	0
	Suspension tower	4
	Total	4
Observations		<ul> <li>Tower is located in LOOP in portion of 400 kV Kaithal-Baghpat transmission line.</li> <li>Line is designed as per IS:802 1995 and Wind Zone 4.</li> <li>Reliability Level-I used for designing these towers</li> <li>As highlighted by utility, as per NBC map-2016 location lies in WZ-5.</li> <li>The tower is designed for Quad ACSR Moose conductor with double I string having porcelain disc insulators. At present, the line is having polymer insulators.</li> <li>Tower at location no. 389(DA+0) has collapsed.</li> <li>Tower at location no. 388 (DA+0) : Earth wire peak of CKT-I side has damaged.</li> <li>Tower at location no. 390 (DA+0) : Both earth wire peak damaged</li> <li>Tower at location no. 391 (DA+0) : Middle cross arm of CKT-II damaged.</li> <li>Material Test report awaited.</li> </ul>

Reason Given by Utility :- High speed windstorm/ thunderstorm

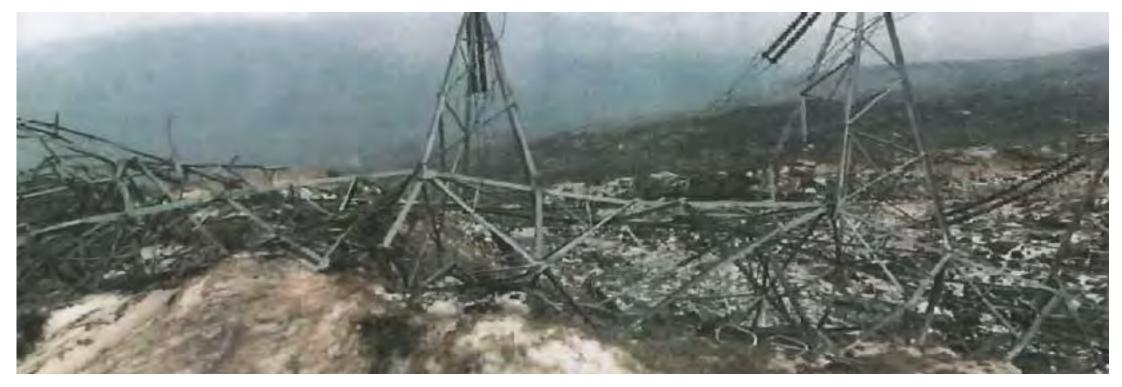
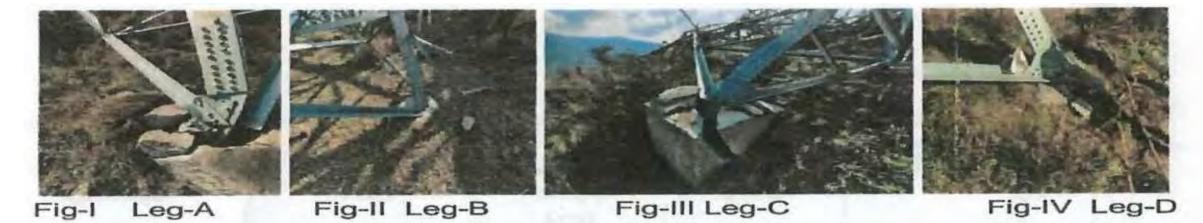
## 400 KV Kishenpur-New Wangpoh CKT 3&4 Transmission Line of POWERGRID

Date of Failure/ Commissioning		23.10.2021/29.07.2017
No. of Towers failed	Tension tower	1
	Suspension tower	0
	Total	1
Observations		<ul> <li>Twin ACSR Moose conductor</li> <li>Tower is designed as per IS 802: 1995 and Wind Zone-2</li> <li>Tower is having Porcelain Disc insulators</li> <li>Tower at location 145 (DC+3) has collapsed</li> <li>A wide crack adjacent to location no. 144 was seen which indicates gradual land sliding around location 144.</li> </ul>
		<b>Reason Given by Utility :-</b> The gradual sliding of landmass at location no. 144 has led to increases tension between span 144-145 causing excess loading on tower no. 145. During Hailstorm, heavy winds and contraction of conductor due to sudden fall in temperature on the day of incident has further aggravated the stress in tower at location no. 145 which caused its failure.

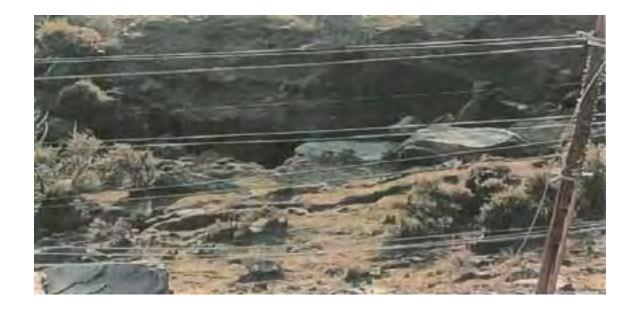
Cracks near Tower at location no. 144

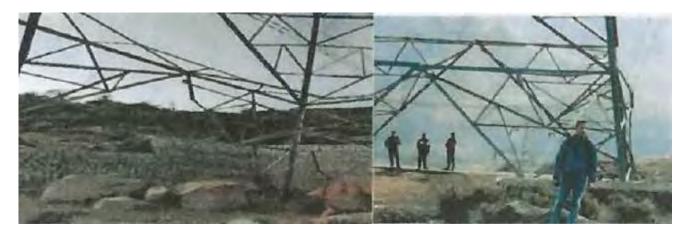
Bending of members of Tower at location no. 144

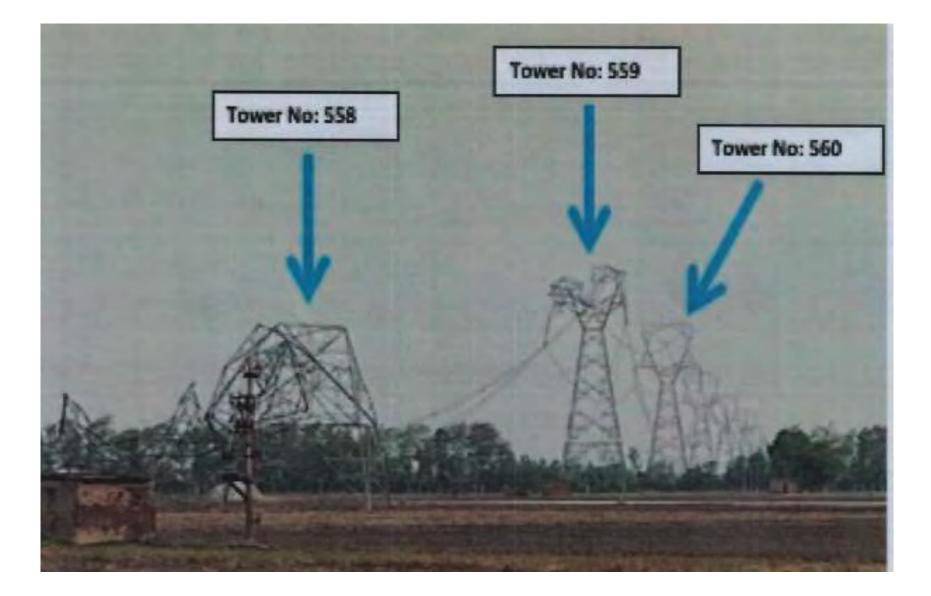
#### Tower at location 558, 559 & 560

Date of Failure/ Commissioning		10.06.2021/ May 2015
No. of Towers failed	Tension tower	0
	Suspension tower	3
	Total	3
Total Observations		<ul> <li>Delta Configuration towers</li> <li>Line is designed as per IS:802 1995 and Wind Zone 4</li> <li>Quad ACSR Bermisis Conductor</li> <li>Tower is designed with Double I-V-I insulator string</li> <li>Tower at location no. 558 (SA+0) has been collapsed</li> <li>Cross arm of Tower at location no. 559 (SA+3) has damaged</li> <li>Peak of the Tower at location no. 560 (SA+3) has damaged</li> </ul>
		Reason Given by Utility :- High speed windstorm/ thunderstorm

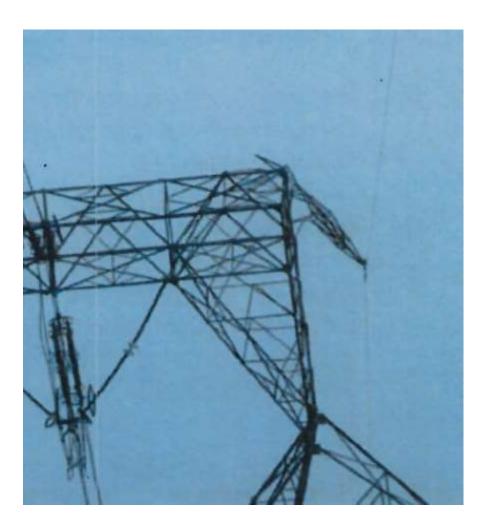
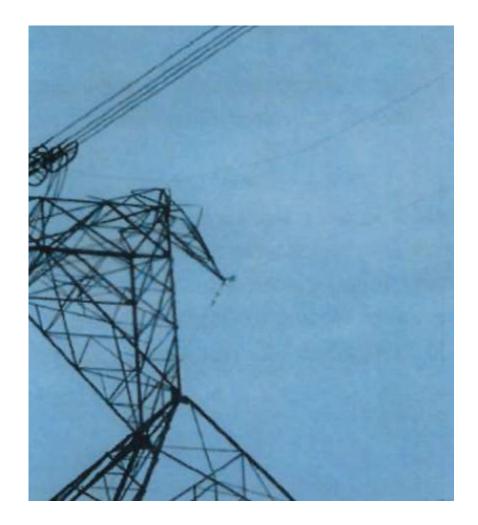
#### Tower at location 292 & 294

Date of Failure/ Commissioning		12.06.2021/ 01.06.2012
No. of Towers failed	Tension tower	3
	Suspension tower	
	Total	3
Observations		<ul> <li>Line is designed as per IS:802 1995 and Wind Zone 4</li> <li>Quad ACSR Bermisis Conductor</li> <li>Delta Configuration</li> <li>Type B Tower is designed with Double V-V-V insulator string</li> <li>One tower at location no. 293 (B +25) has collapsed</li> <li>Earth peaks of adjacent towers at location no. 292 and 294 has damaged</li> </ul>
		Reason Given by Utility :- Highly Localized Windstorm with high speed wind

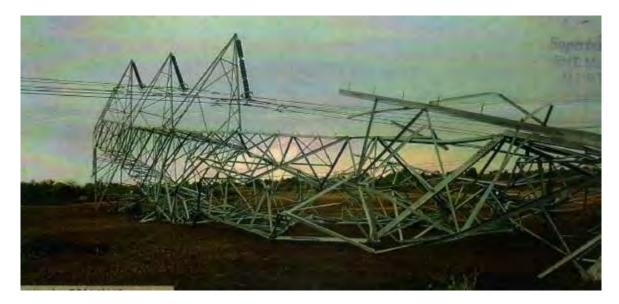
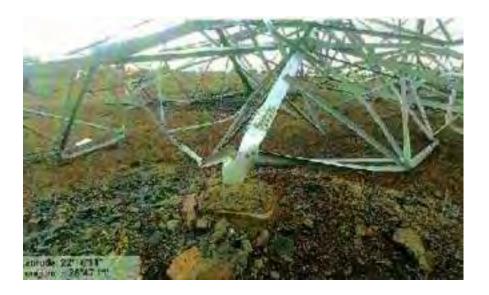
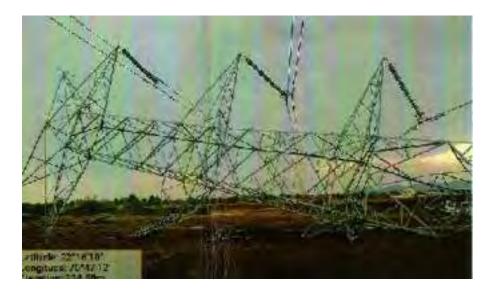
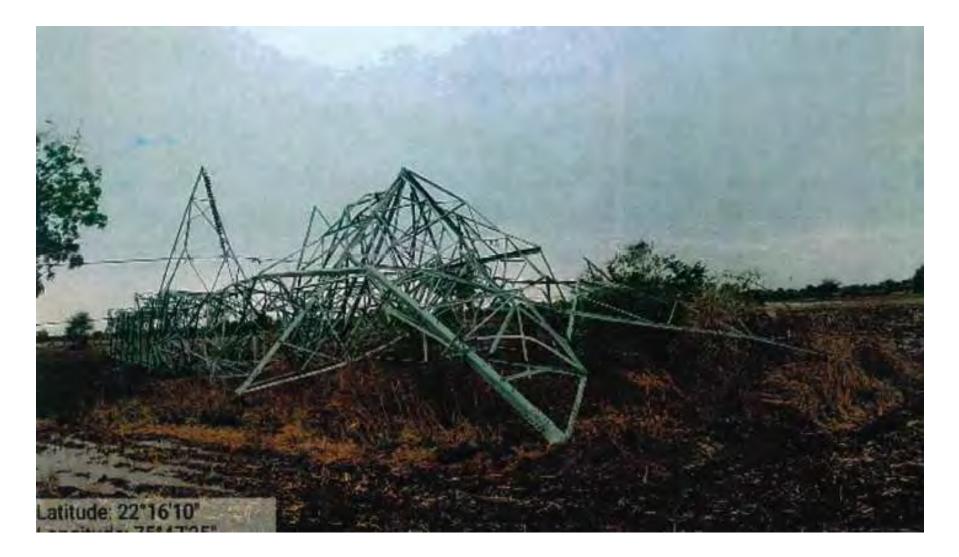
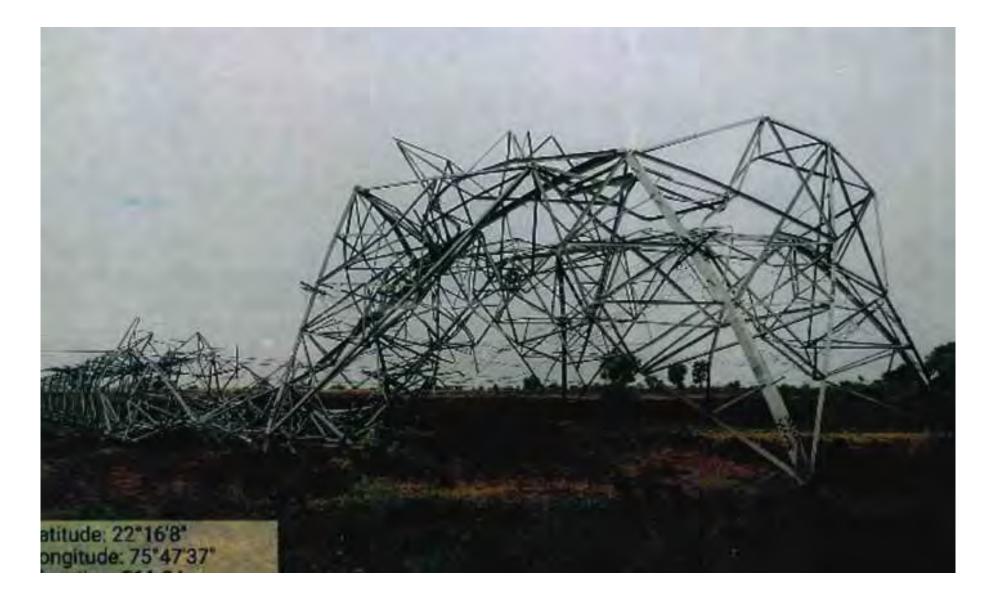
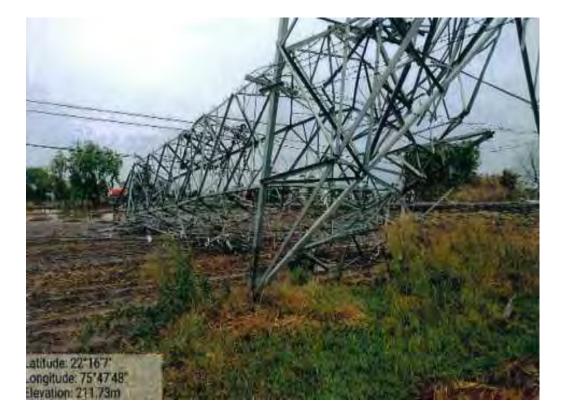
#### 400 KV D/C Malwa TPH (SSTPH)-Pithampur Ckt I&II line of MPPTCL

Date of Failure/ Commissioning		29.05.2021/ 2013
No. of Towers failed	Tension tower	0
	Suspension tower	5
	Total	5
Observations		<ul> <li>Tower located in Wind Zone 3</li> <li>Line is designed as per IS:802 1977- medium wind pressure.</li> <li>Twin Moose ACSR Conductor in vertical configuration.</li> <li>Line failed in 2019, 2020 &amp; in 2021- different locations.</li> </ul>
		Reason Given by Utility :- Heavy wind storm
