### क्षतिग्रस्त ट्रांसमिशन लाइन टॉवरों पर विशेषज्ञों की स्थायी समिति की रिपोर्ट

REPORT OF THE STANDING COMMITTEE OF EXPERTS ON FAILURE OF EHV TRANSMISSION LINE TOWERS (APRIL 2019 – DECEMBER 2021)

भारत सरकार Government of India केन्द्रीय विद्युत प्राधिकरण Central Electricity Authority

### **EXECUTIVE SUMMARY**

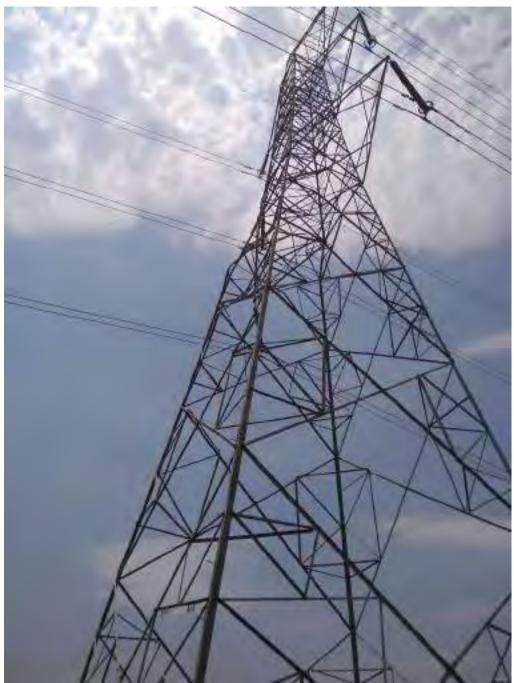
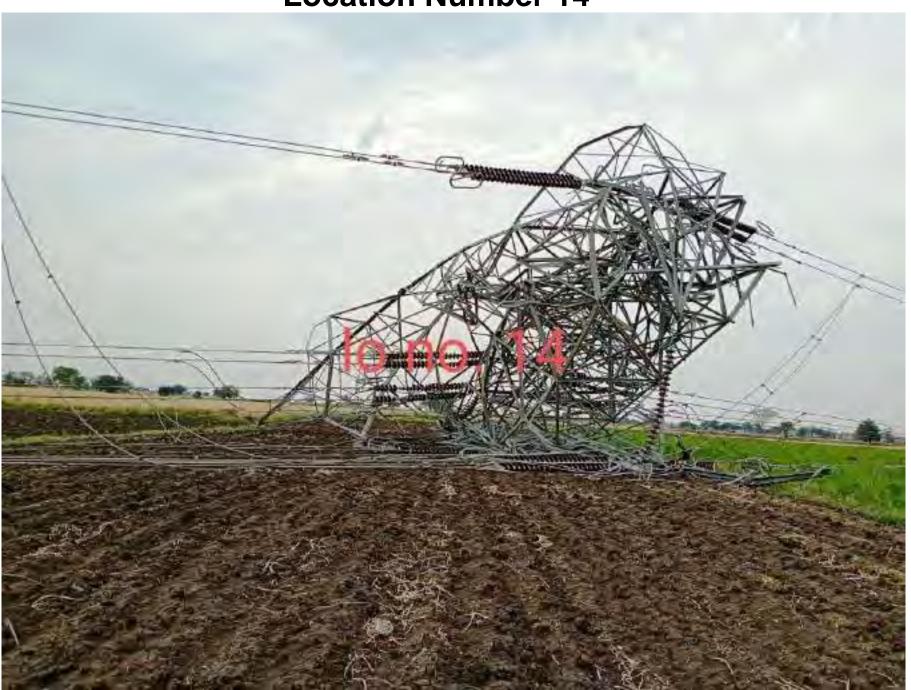
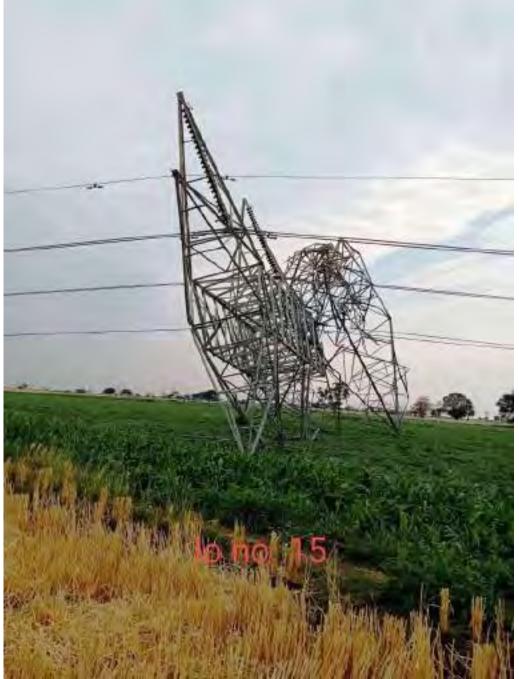
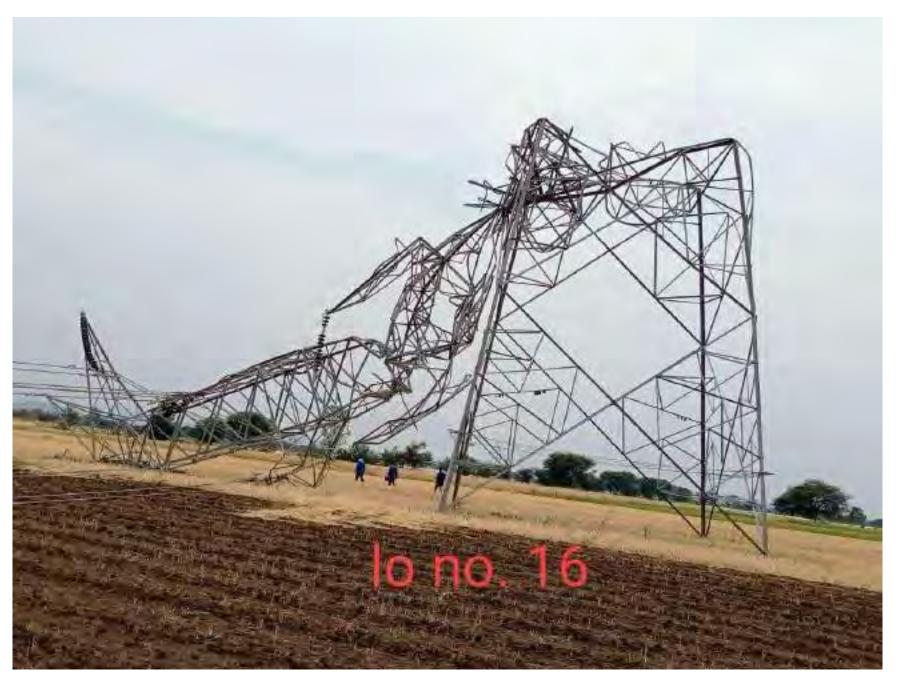
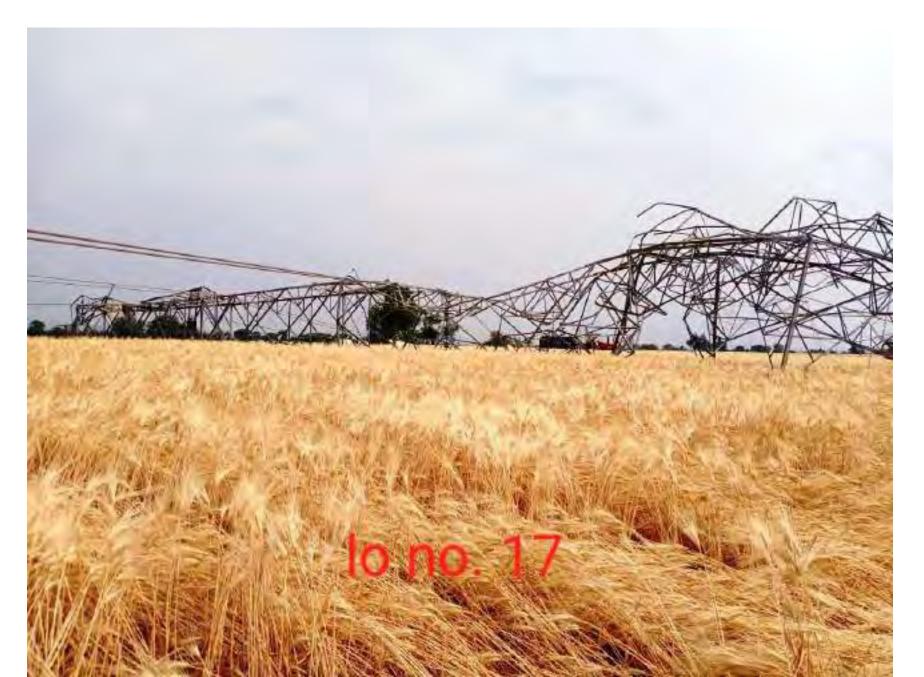
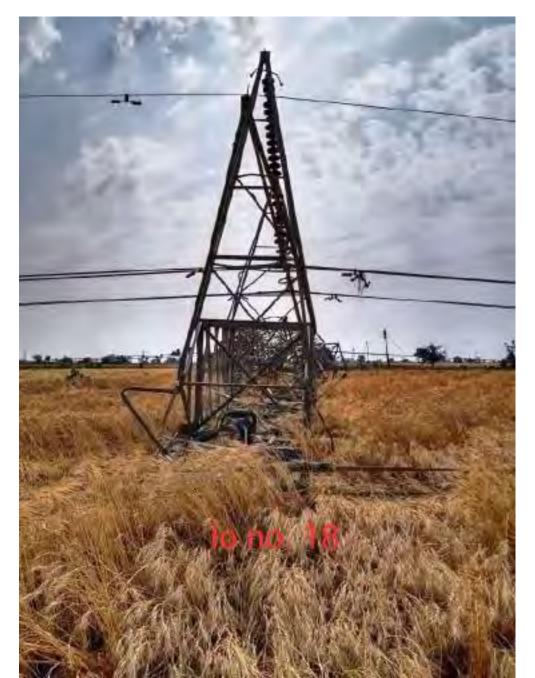
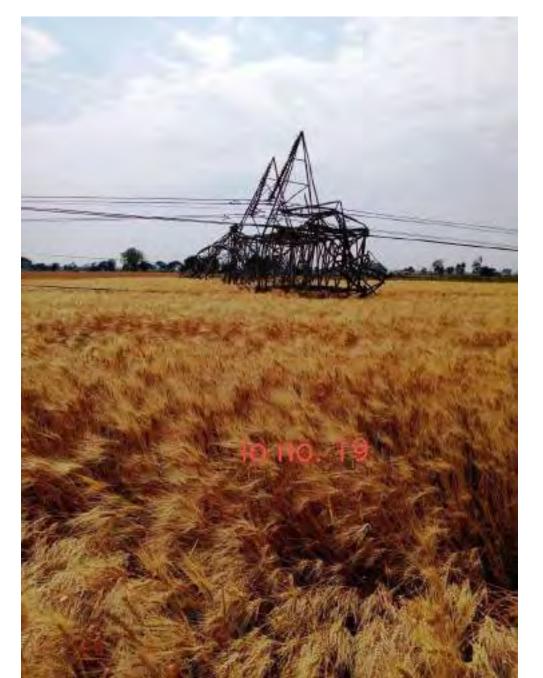
## 3. 400kV Malwa TPH Pithampur

- > Date of Failure: 26/03/2020, Commissioning: 2013
- > Line designed as per IS 802:1977, Wind Zone: Medium
- Conductor: Twin Moose, Insulator: I String
- Line designed as per IS 802:1977
- Number of Tower collapsed: 6 numbers Suspension and 1 number Tension tower.
- Reason of Failure: Cyclonic circulation in the area resulting into collapse of location number 13 to 19.
- MPPTCL will take up the strengthening work of all suspension towers of this design.

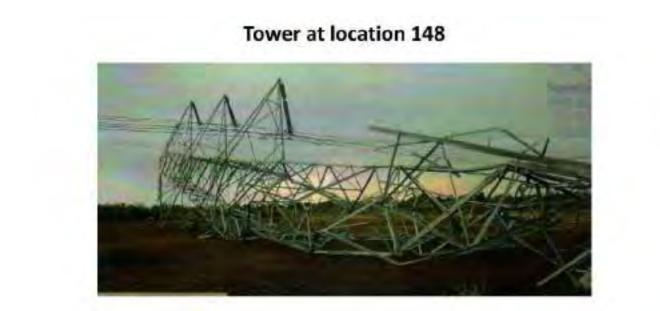
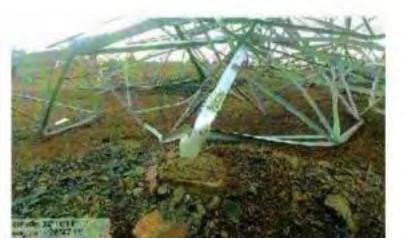
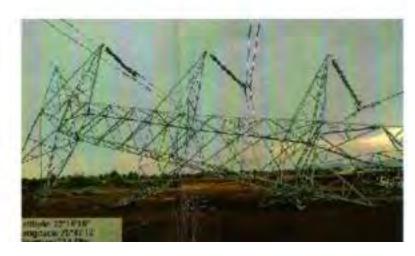
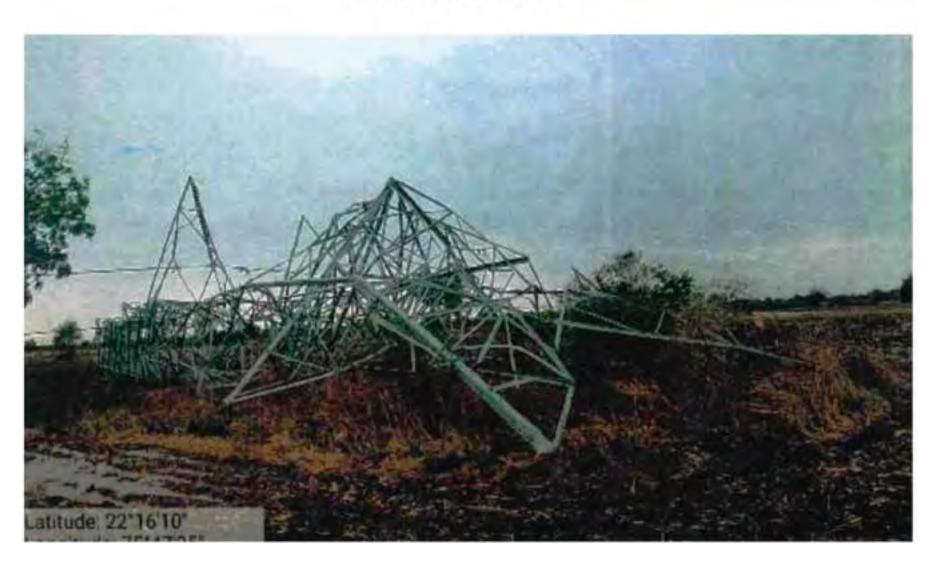
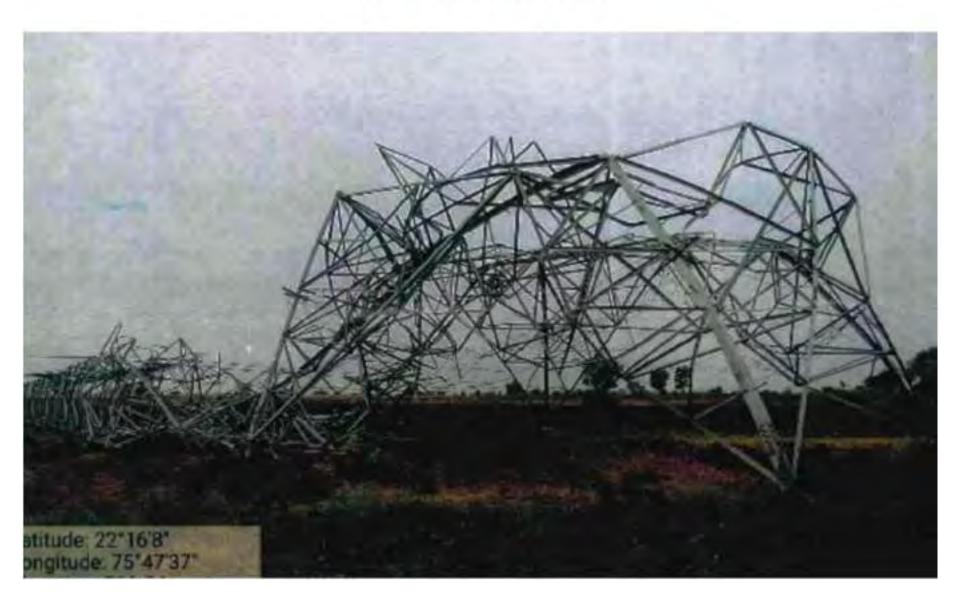
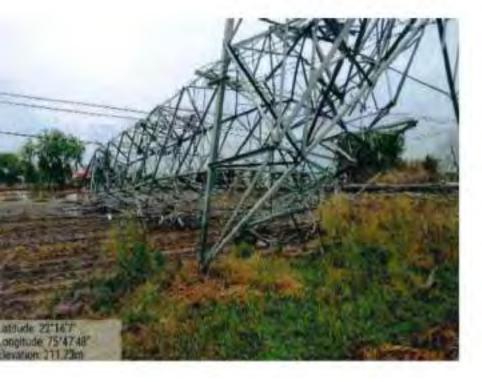
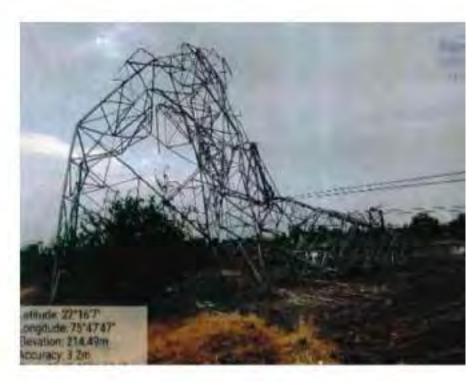
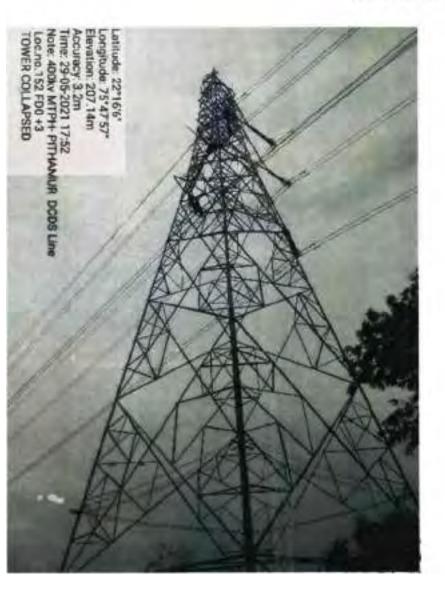
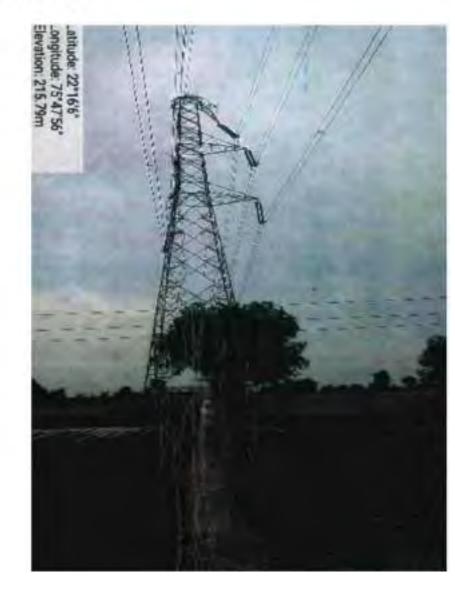
## 4. 400kV Malwa TPH Pithampur

- Date of Failure: 29/05/2021
- Year of Commissioning: 2013
- Wind Zone: Medium
- Line designed as per IS 802:1977
- Number of Tower collapsed: 5 numbers Suspension towers.
- Reason of Failure: Cyclonic circulation in the area resulting into collapse of location number 148 to 152.
- > Line towers also collapsed in 2019 and 2020.
- MPPTCL will take up the strengthening work of all suspension towers of this design.

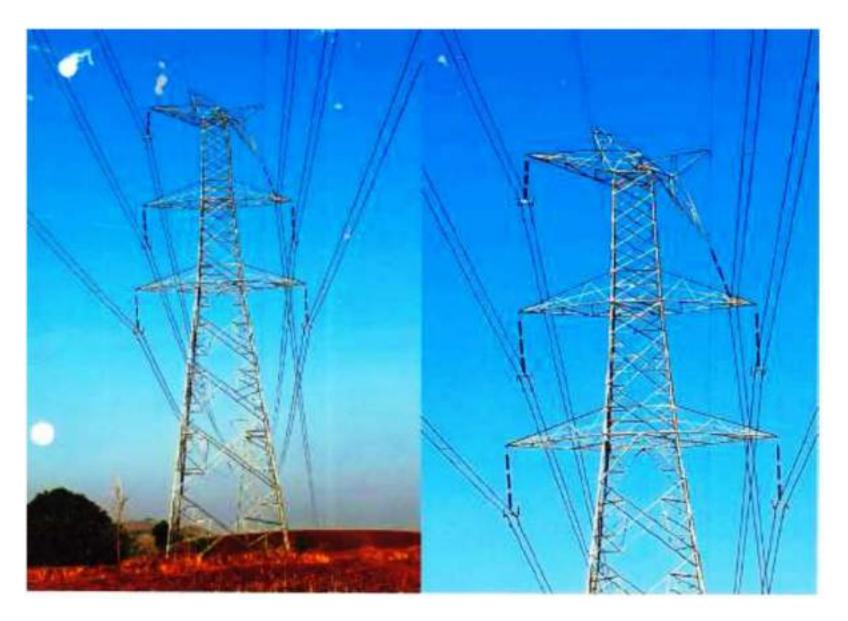
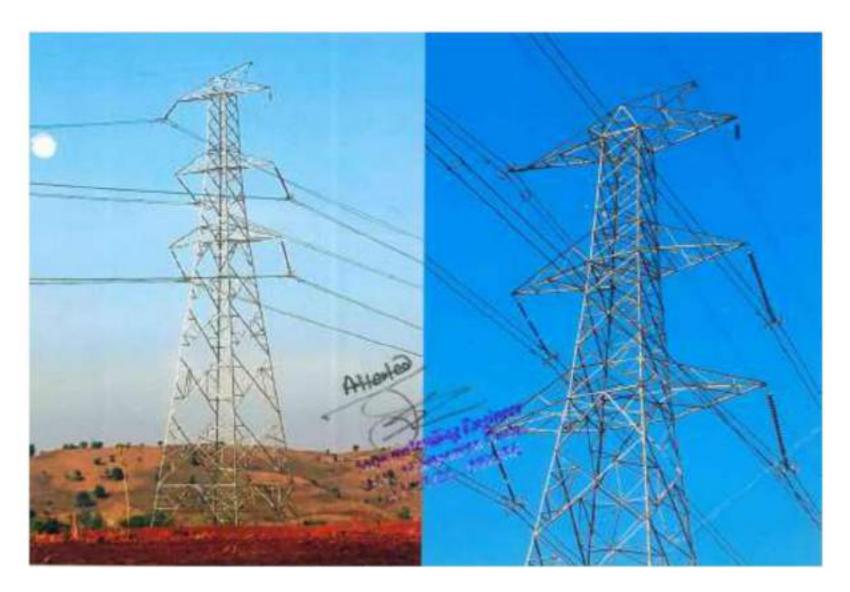
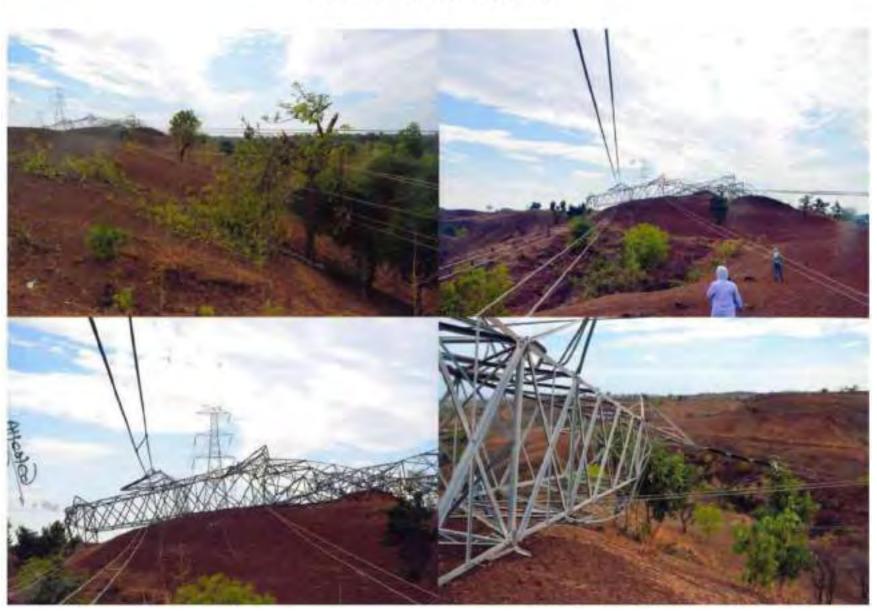
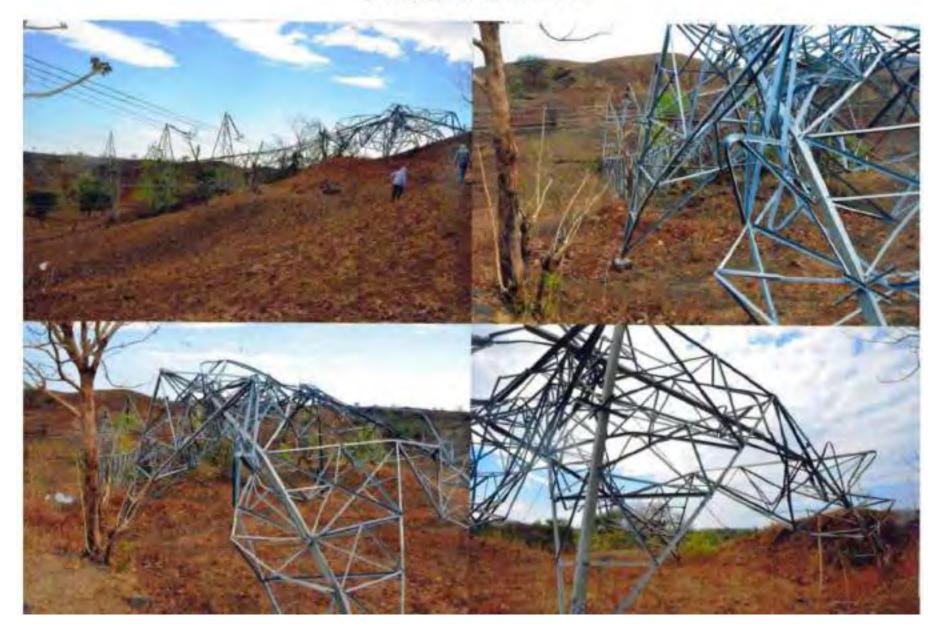
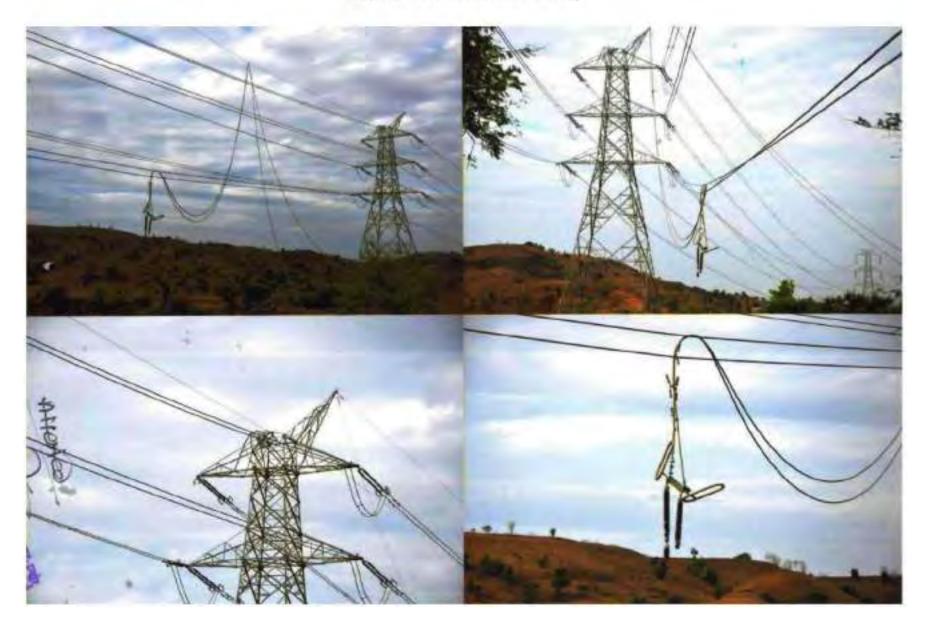
## 5. 400kV Rajgarh SSP

- Date of Failure: 11/06/2019
- Year of Commissioning: 2002
- Wind Zone: Medium
- Line designed as per IS 802:1977
- Number of Tower collapsed: 4 numbers Suspension and 1 number Tension tower.
- Reason of Failure: Cyclonic circulation in the area resulting into collapse of location number 564, 565 and partial damage to 562, 563 & 566.
- MPPTCL will take up the strengthening work of all suspension towers of this design.

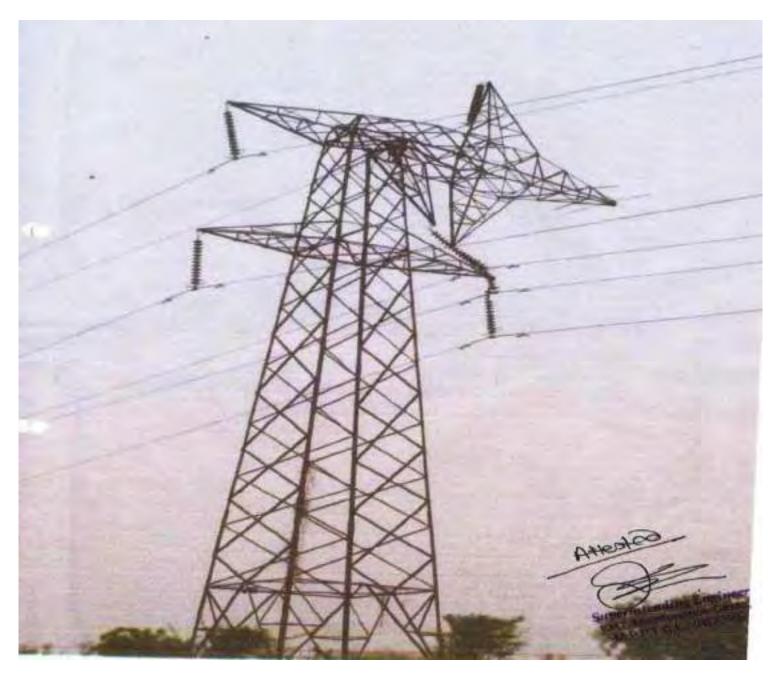
## 6. 220kV Omkareshwar Barwaha Tap Nimrani

- Date of Failure: 16/04/2019
- Year of Commissioning: 1982
- > Wind Zone: Medium
- Line designed as per IS 802:1977
- > Number of Tower collapsed: 1 numbers Suspension
- Reason of Failure: Collapse of 765kV Khandwa Dhule line of M/s Khargone Transmission Corporation Limited.
- This resulted in excessive loading on our Transmission Line resulting into partial damage of tower.

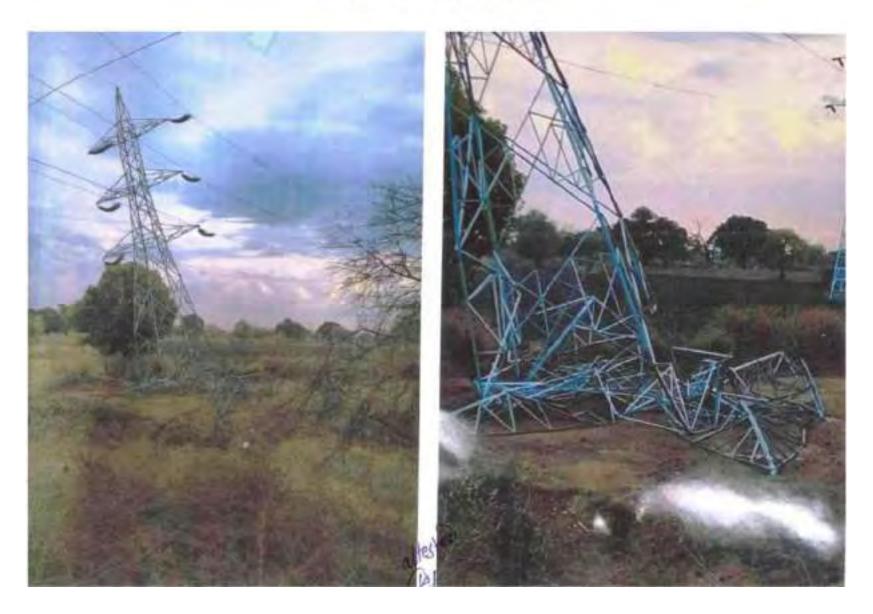
#### Tower at location 11A

- > Date of Failure: 13/06/2019
- > Year of Commissioning: 1962/2019
- Line designed as per IS 802:1977 Wind Zone Medium.
- Collapsed Tower designed as per IS 802:1995 and Wind Zone 4.
- Number of Tower collapsed: 1 numbers Suspension location bottom portion with +10M Extension.
- Reason of Failure: Heavy wind and Thunderstorm in the area.

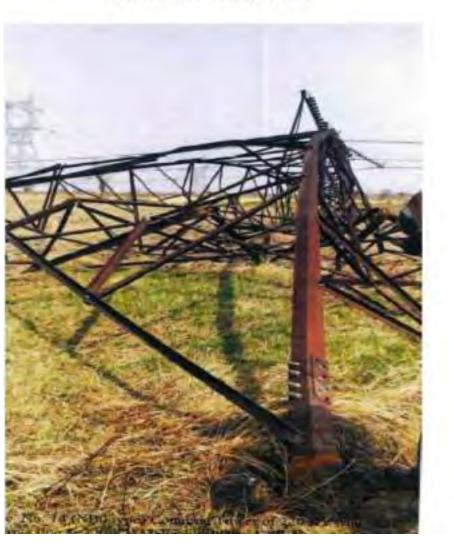
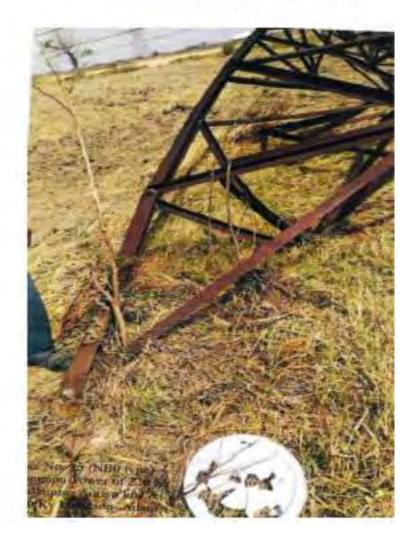
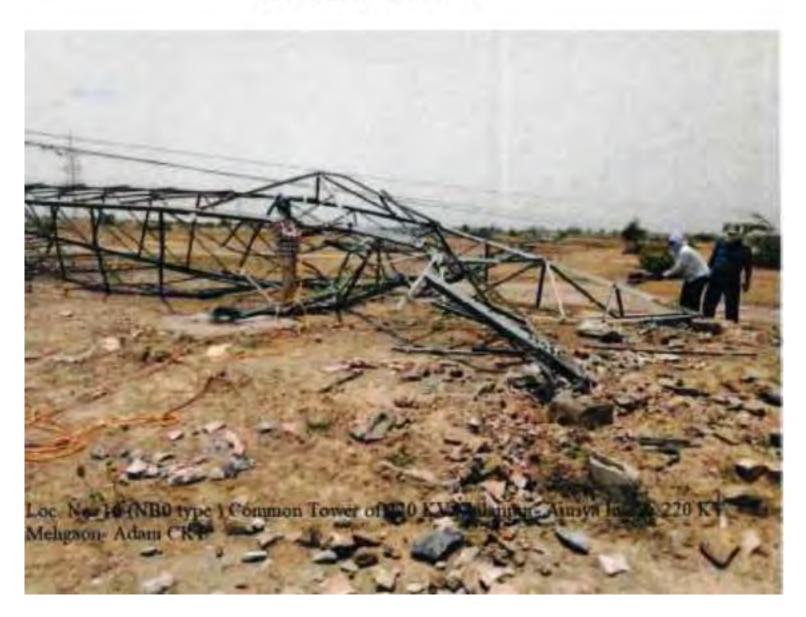
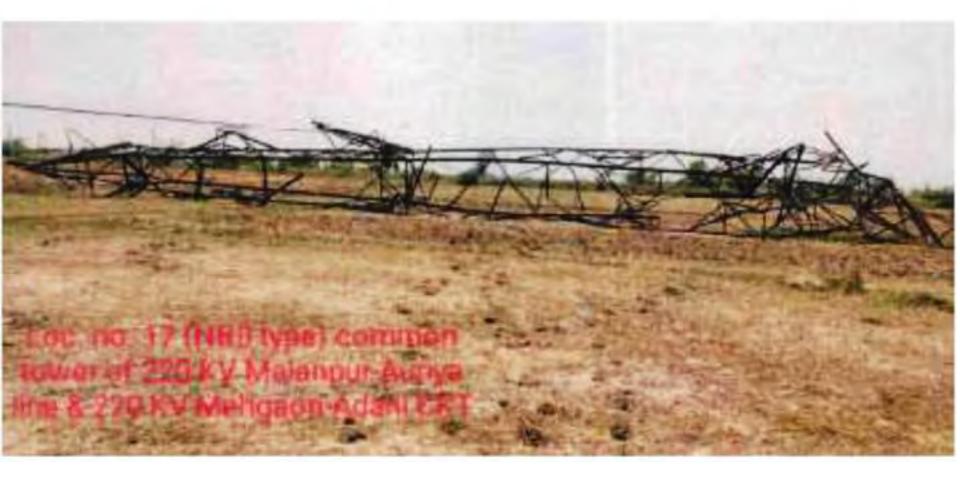
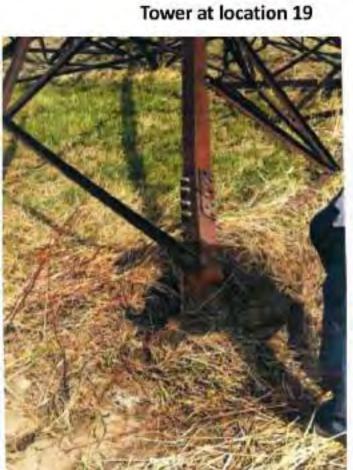
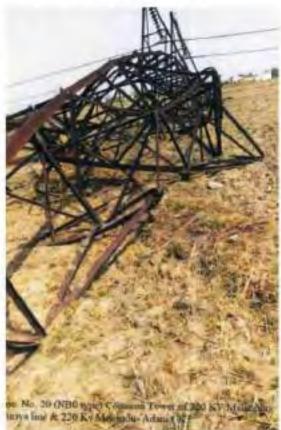
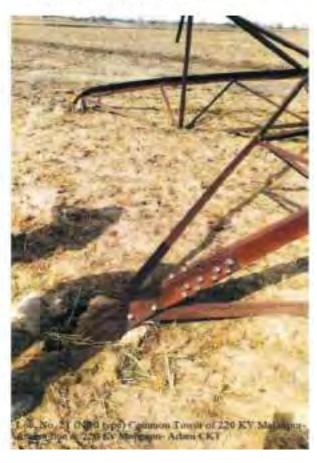
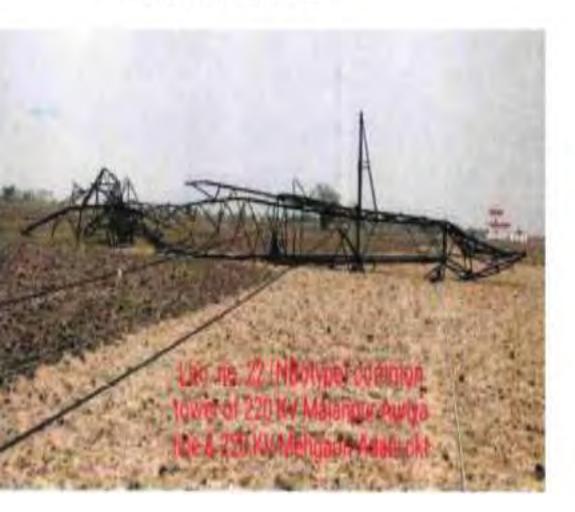
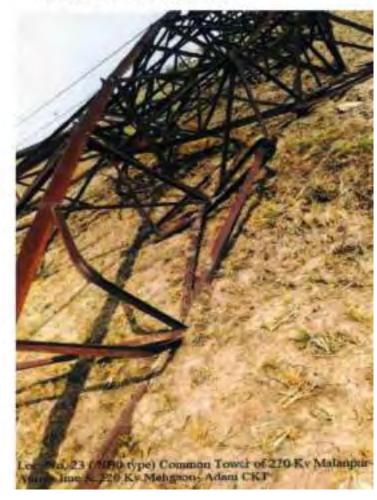
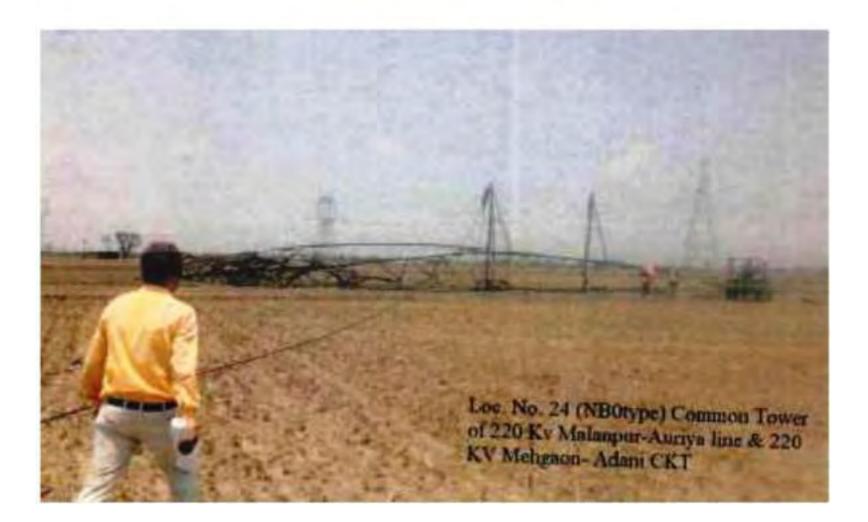
## 8. 220kV Malanpur Auraiya & Mehgaon Adani

- > Date of Failure: 28/05/2020
- Year of Commissioning: 1993
- > Wind Zone: Medium
- Line designed as per IS 802:1977
- Number of Tower collapsed: 11 numbers Suspension location from 14 to 24.
- Continuous record of wind speed is not available with IMD.
- Reason of Failure: Heavy Thunderstorm and Cyclone in the area.

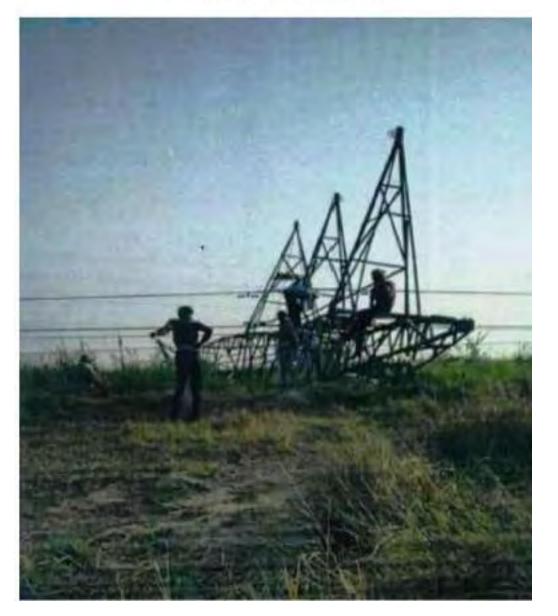
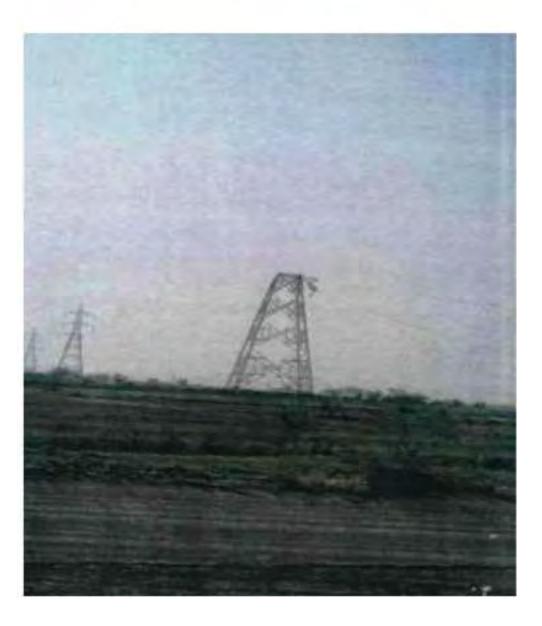
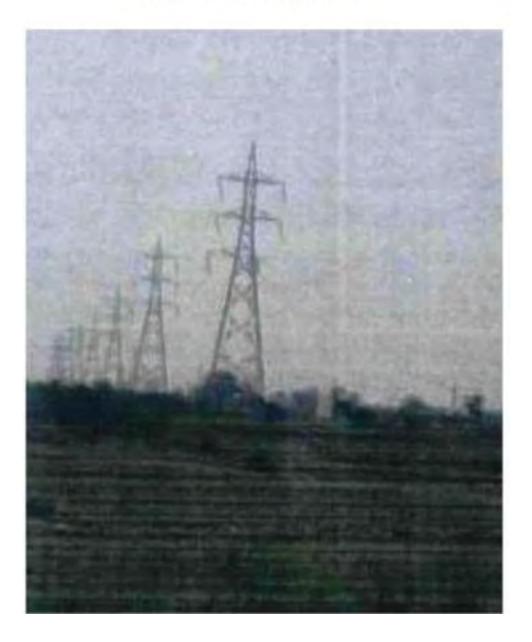
# 9. 220kV Malanpur Morena

- > Date of Failure: 29/05/2020
- > Year of Commissioning: 2017
- > Wind Zone: Medium
- Line designed as per IS 802:1995
- Number of Tower collapsed: 3 numbers Suspension location.
- Continuous record of wind speed is not available with IMD.
- Reason of Failure: Heavy Thunderstorm and Cyclone in the area.

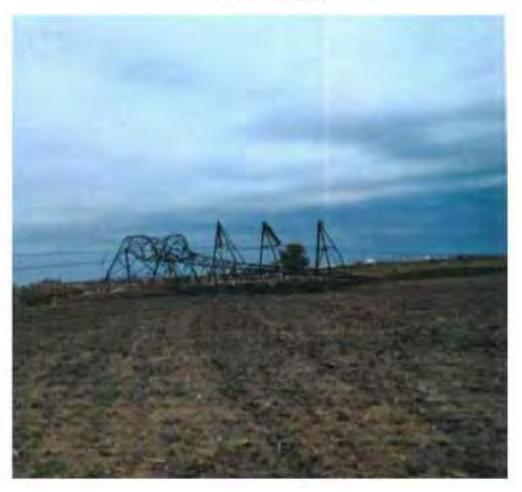
# 10. 220kV Malanpur PGCIL

- Date of Failure: 29/05/2020
- Year of Commissioning: 2010
- > Wind Zone: 4
- Line designed as per IS 802:1995
- Number of Tower collapsed: 3 numbers Suspension location and 2 numbers Tension location.
- > Continuous record of wind is not available with IMD.
- Reason of Failure: Heavy storm and Cyclone in the area.
- As may be seen total 19 towers damaged in the area of different transmission lines. This indicates presence of strong cyclonic wind resulting into damage.

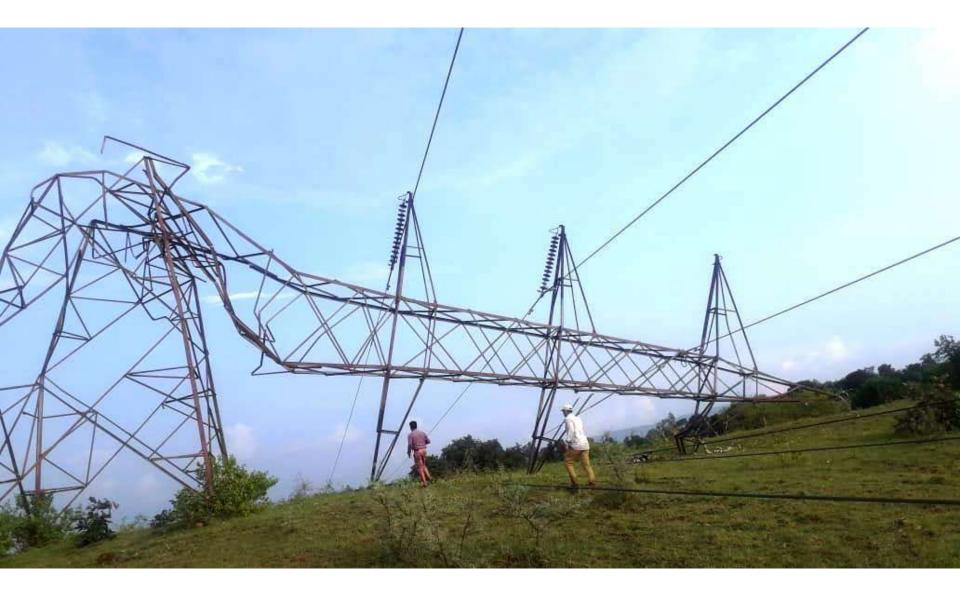
## **Location Number 84**

- Date of Failure: 21/09/2021
- Year of Commissioning: 1996
- > Wind Zone: Medium
- Line designed as per IS 802:1977
- Number of Tower collapsed: 2 numbers Suspension location collapsed.
- Reason of Failure: Heavy cyclonic wind and Thunderstorm in the area.

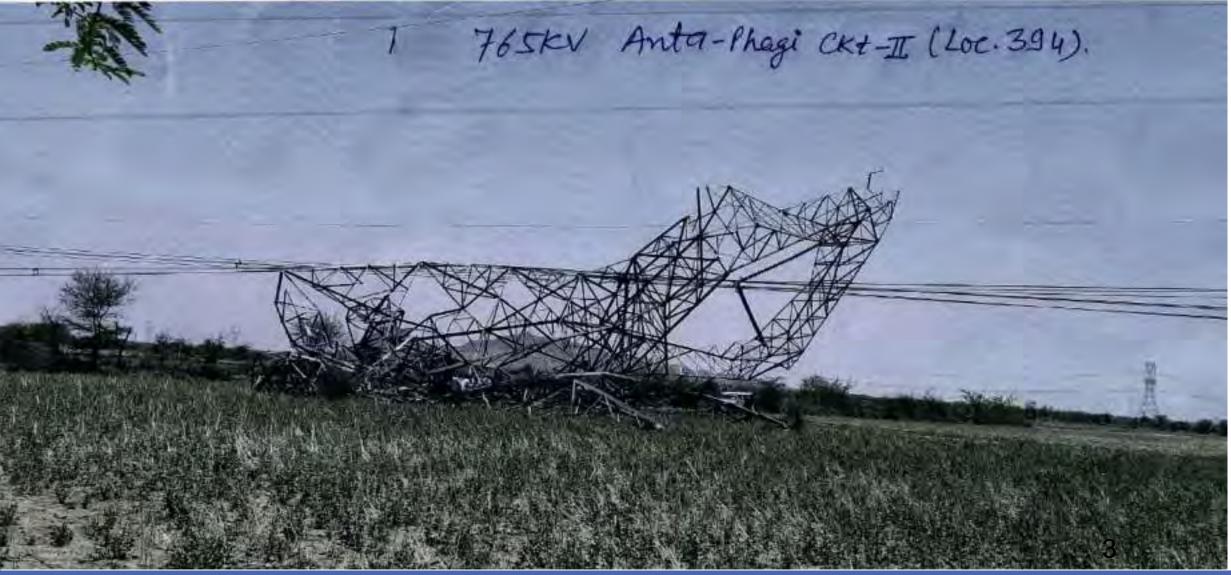
765 KN Anter-Phagi CKt-II (Loc. 394)

Non-strengthening of towers by replacement of members with higher section and non-providing additional members.

- 1. 765 kV single circuit A-Type tower strengthening is required as per PGCIL pattern.
- 2. If the soil surrounding the chimney top is above the chimney top level, extension of chimney should be done to protect the stub from rusting, coping if damaged or not done, should be properly done.
- 3. ACDs (Anti Climbing Devices), if not provided or have been stolen, should be provided now.
- 4. All the Tower members and plates must be fitted with nut and bolts of proper size. No any hole should be remained empty.
- 5. Over size or loose nut & bolts must be replaced by proper size nut & bolts and proper tightening should be done.
- 6. All the towers must be checked thoroughly regarding tightening all its members and plates.

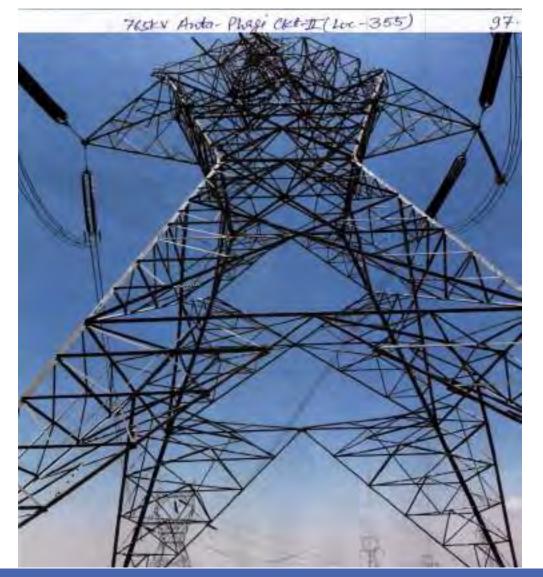
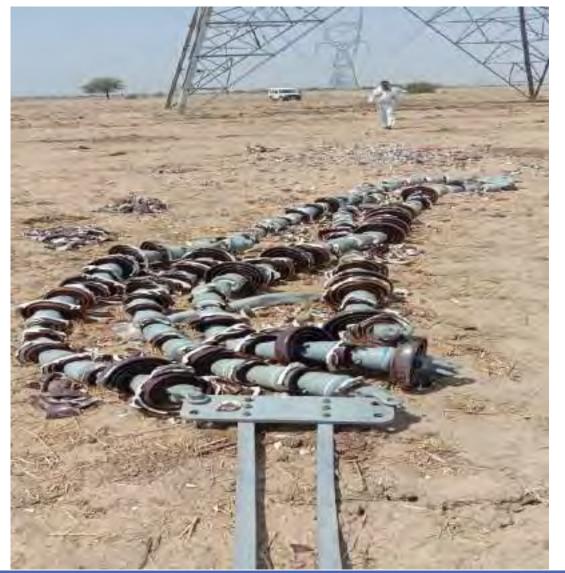
# REPORT OF DAMAGED TOWER OF 765 KV ANTA-PHAGI LINE (CKT.II)- LOCATION NO. 61/0 {Loc No 355} (TTC+3)

- ≻All four conductors of Y-phase with tension strings, extension links and connecting plates with two members marked as APC 373 detached from tower main body and fell down towards location No. 356. Due to this detachment, top portion of tower bent in opposite direction towards location No. 354).
- >While inspecting all four tension strings, it was observed that there is no flash over mark on Discs, which shows that there is no electrical reason of failure.
- >Lower portion of the tower is found in good condition.

- 8. Missing members If any must be provided by new members with same section and type of steel (MS/HT).
- 9. If revetment at any location is required, it should be done immediately.
- 10. The representative of the firm may be called in the field and in his presence fitting of spacers should be checked so frequent loosening of spacers should be resolved.
- 11. If any sub-conductor of the quadruple bundle of 765 kV line is repaired/replaced, the tension of all four sub-conductors must be equalized to avoid the damage of conductors due to spacers.
- 12. Corona rings where ever not provided on the lines must be provided immediately.

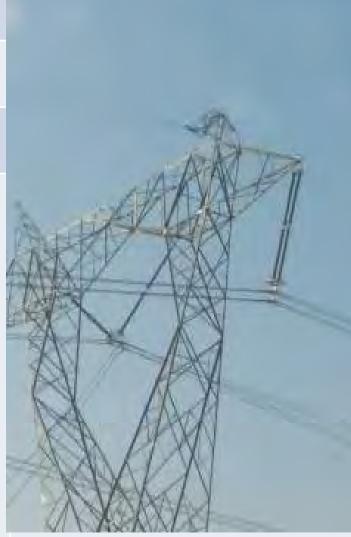
date	01/10/2010
Date of Failure	03/05/2020
Date of restoration	21/05/2020
Tower No and Type	146 (A+0)
Observations	Tower Configuration :- Horizontal Conductor Type :- Quad Bersimis ACSR
	OPGW peak of this tower had damaged.
	Line designed as per Wind Zone-4
	Reason :- Tower was collapsed due to the high speed localized thunderstorm in this area.

IIT Kanpur had submitted report and found in analysis that 22 members of A type Tower and 16 members of D Type Tower have slenderness ratio greater than unity and recommended additional back-to-back angles, channels and plate as appropriate to the failed members and adopting HT steel of the strengthening of these failed towers.

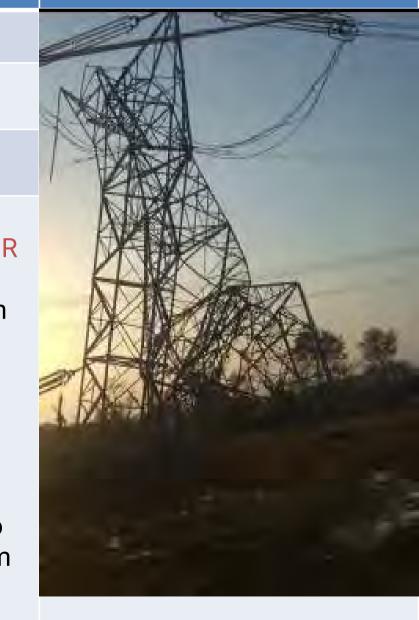
date	
Date of Failure	03/05/2020
Date of restoration	29/06/2020
Tower No and Type	164 (D+3)
Observations	Tower Configuration :- Horizontal Conductor Type :- Quad Bersimis ACSE This tower collapsed in the direction of inclination/ perpendicular to the transmission line and 1 No. stub was also found to be damaged. Line designed as per Wind Zone-4 Reason :- Tower was collapsed due to the high speed localized thunderstorm in this area.

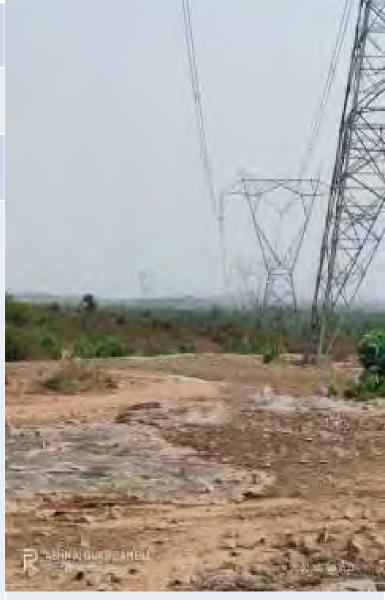
Commissio ning date	11/04/2017
Date of Failure	28/05/2020
Date of restoration	29/06/2020
Tower No and Type	179 (A+3)
Observation s	Tower Configuration :- Horizontal Conductor Type :- Quad Bersimis ACSR
	EW peak damage at this tower due to tension in conductor.
	Line designed as per Wind Zone-4
	Reason :- Tower was collapsed due to the high speed localized thunderstorm in this area.

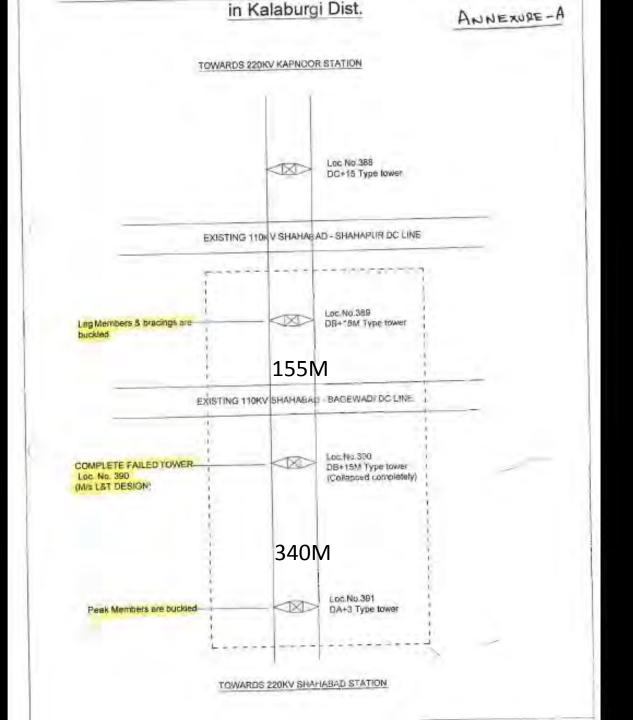
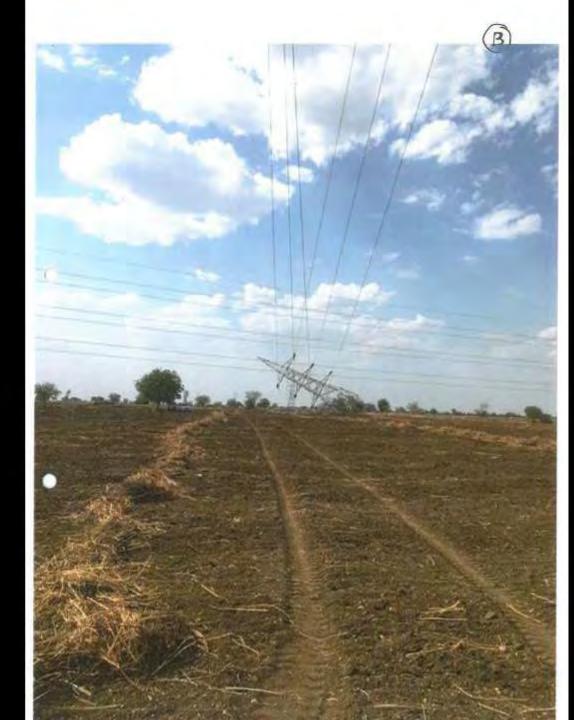
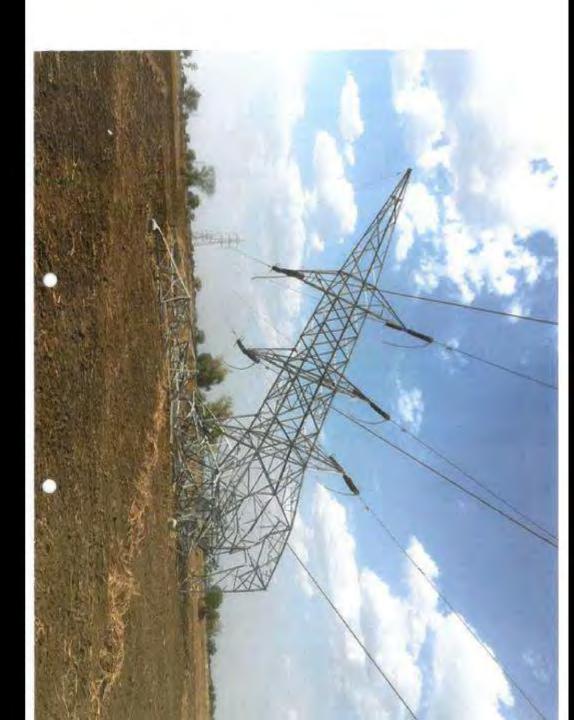
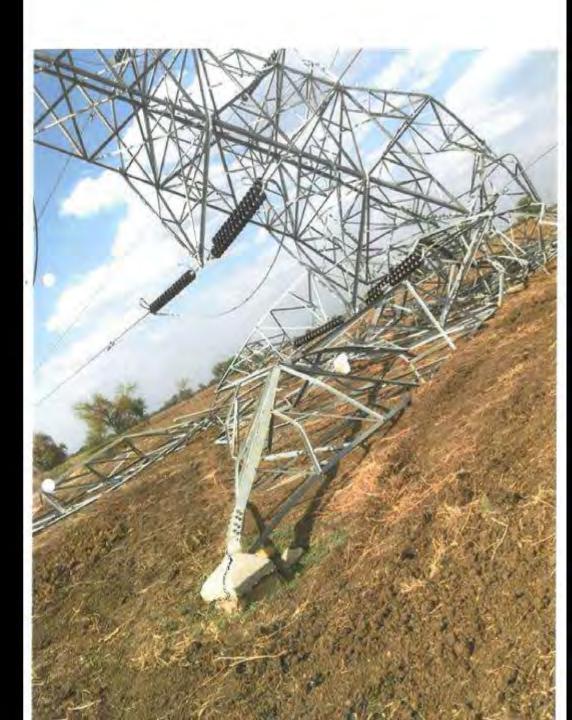
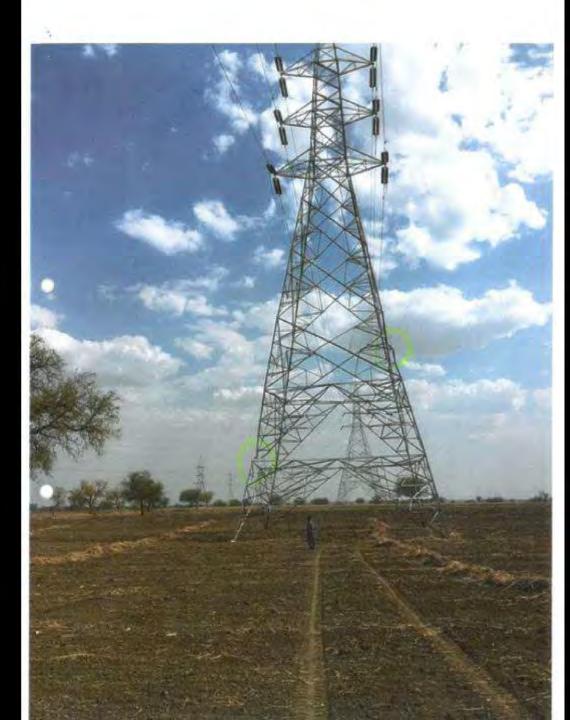
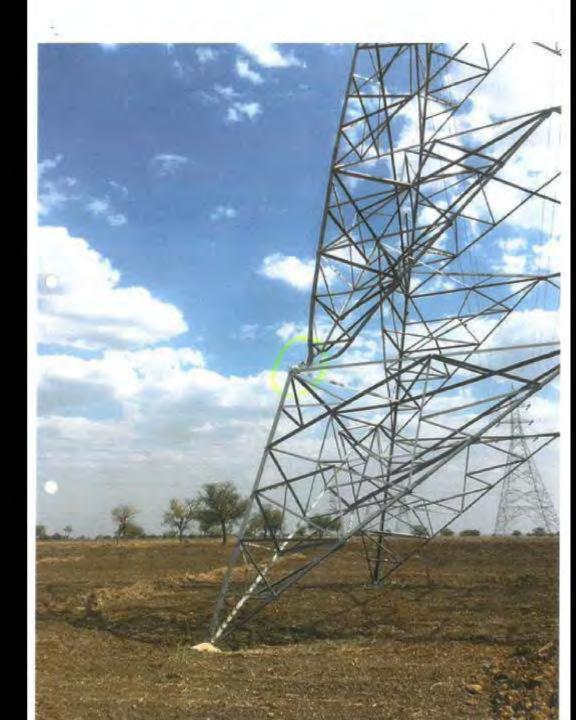
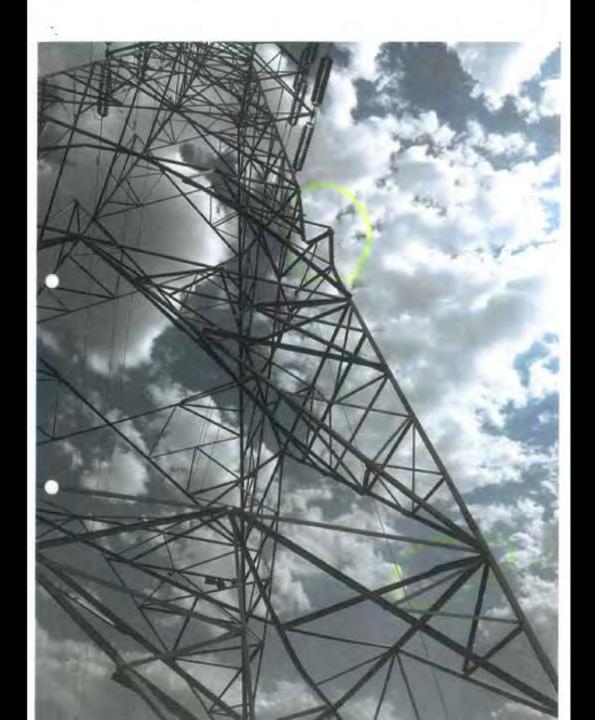
# FAILURE OF 220KV KAPNOOR-SHAHBAD-SHAHPUR D/C LINE AT LOC NO 389 & 390

24	Brief Description of failure	On 17.04.2020 at 17:15HRs the 220kV line tripped on DPR at both ends. On inspection it was found that tower no 390(DB+15) was collapsed and T.No 389(DB+18) main leg member damaged due to heavy rain and whirl wind.
25	Probable cause of failure	<ul> <li>Towers designed as per IS 802:1977 in which only transverse load(wind in 0 deg) was considered for calculation of wind load on conductor, insulator, ground wire and tower body. Hence these towers are vulnerable to high wind loads.</li> <li>Span length between loc 389(DB+18) to 390(DB+15) was 155M &amp; between Loc No 390 (DB+15)to 391 (DA+3)was 340M. In case of towers with higher body extensions such as +15M, +18M &amp; +24M, the wind load is the major governing factor under normal condition. Hence in order to compensate the higher wind pressure, the wind spans are generally reduced such that, the total wind load (wind on conductor, insulator string) on the tower remains same as original design. As long as the wind is with in permissible limits, the tower sustains the load. In the instant case, the wind span is found to be on the higher side and hence more wind loads have acted on the tower No 390. Heavy whirl wind which passed through this stretch acted on weakened tower which could not resist the heavy wind.</li> </ul>

- The failed "DB+15" tower was replaced by 220kV "DD+15" at loc No 390.
- "DB+18" tower was provided at location no 389.
- The Buckled peak members of the tower at location no 391 (DA+3) was replaced.

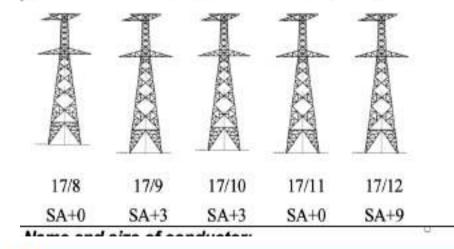
Location no. 17/9, 17/10, 17/11, 17/12 were totally collapsed and location no. 17/8 is Partially damaged.

4) location no. 17/11 (A+0) tower no. 97 - fully collapsed.

5) location no. 17/12 (A+9) tower no. 98 - fully collapsed.

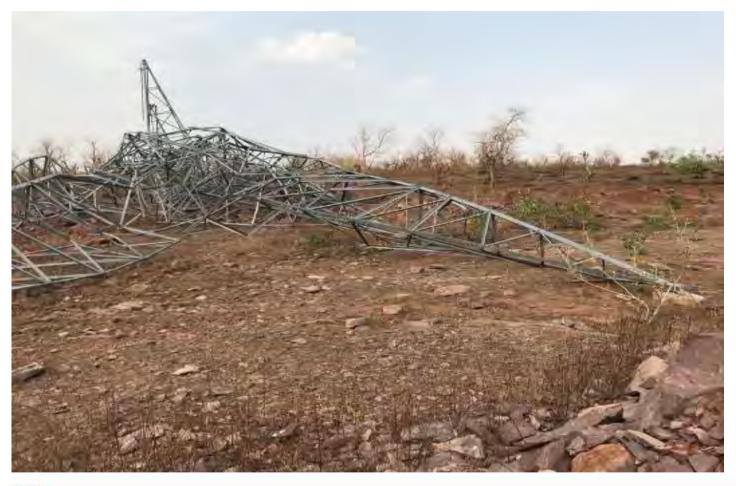
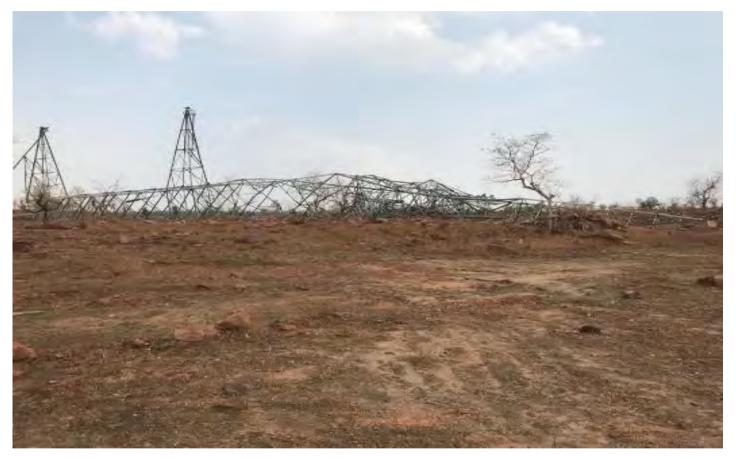
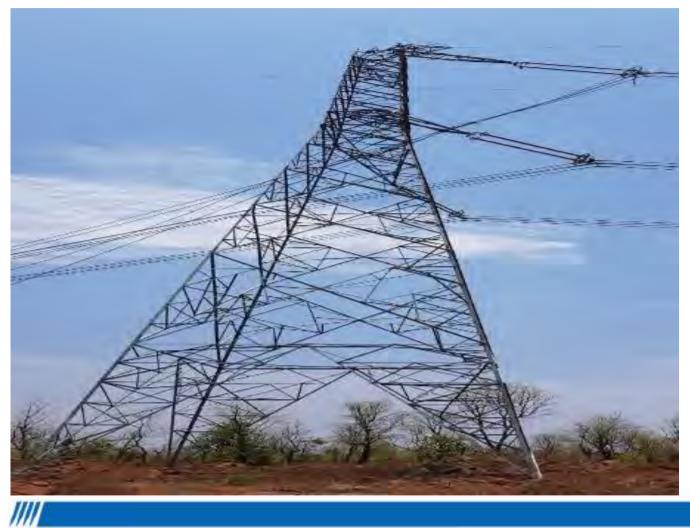
#### TOWER DAMAGES

- 1) Exceptionally high wind condition prevailed for some time in the area on the day of failure of tower.
- 2) All suspension towers collapsed due to cascading
- 3) All plain area for long distance
- 4) Tower collapse in perpendicular direction pulling down balance towers
