### क्षतिग्रस्त ट्रांसमिशन लाइन टॉवरों पर विशेषज्ञों की स्थायी समिति की रिपोर्ट

REPORT OF THE STANDING COMMITTEE OF EXPERTS ON FAILURE OF EHV TRANSMISSION LINE TOWERS (APRIL 2019 – DECEMBER 2021)

भारत सरकार Government of India केन्द्रीय विद्युत प्राधिकरण Central Electricity Authority

### **EXECUTIVE SUMMARY**

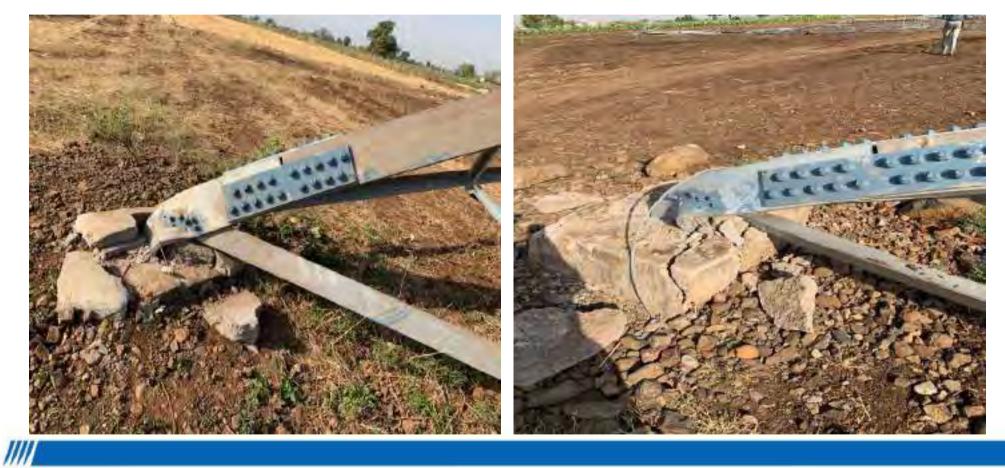
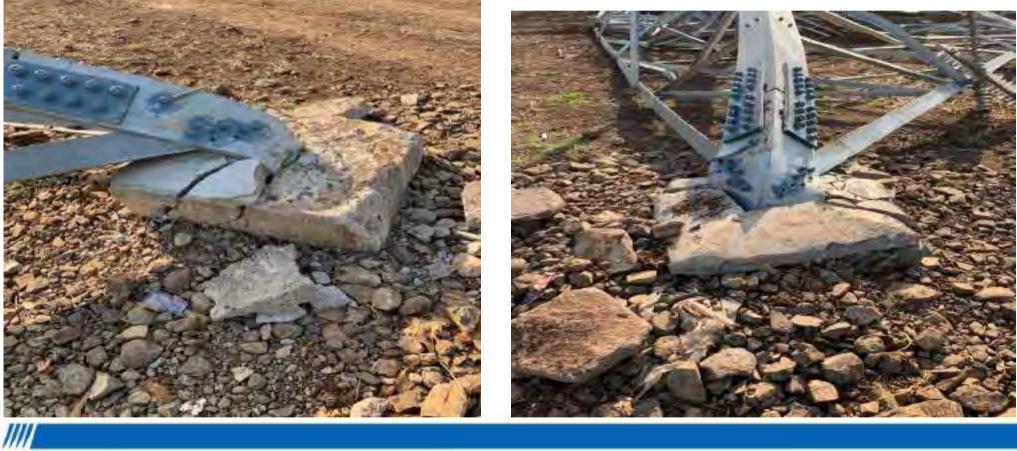
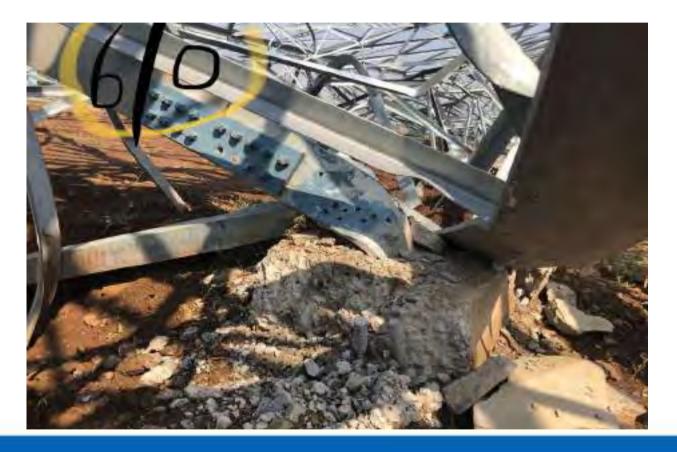
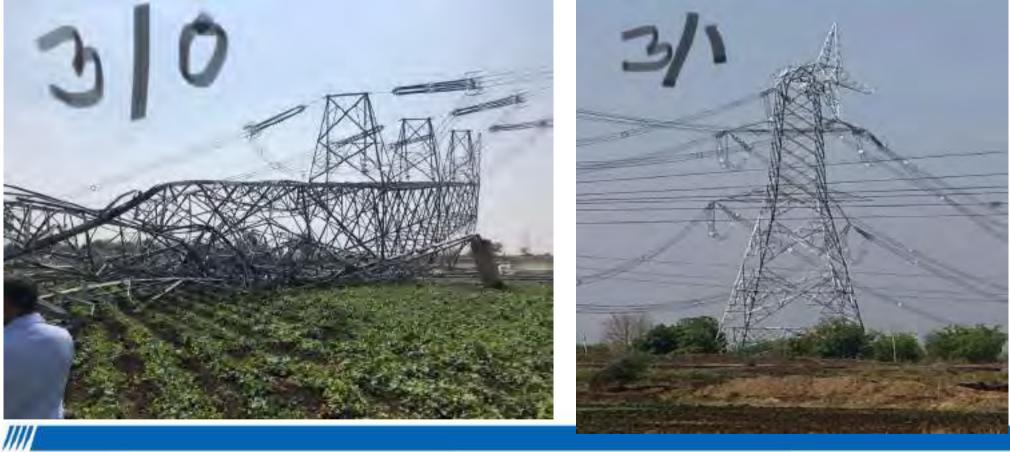
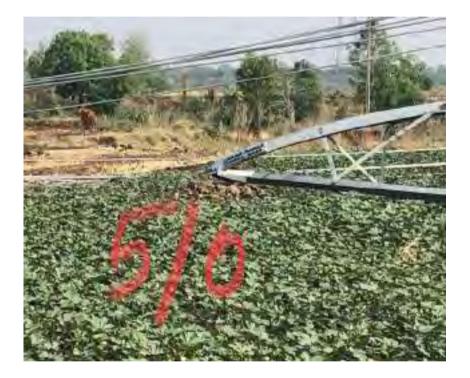
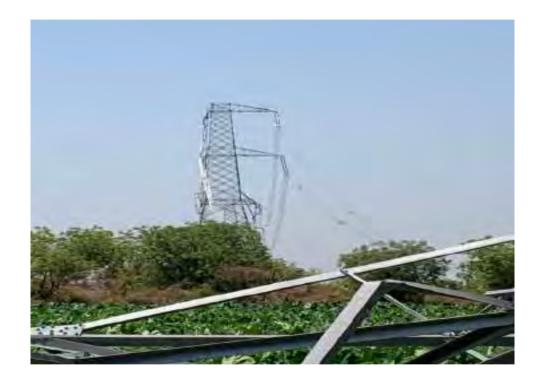
#### FOUNDATION -DAMAGES

- A) 5 Towers (4 nos DD+30, 1 DD+18) towers collapsed perpendicular to the line.
- B) Conductors fell on the Powerlines of PGCIL and MPTCL damaging their towers and caused their outage .
- C) 2 tower cross-arms damaged as cascading impact .
- D) 2 suspension tower earth-wire peaks damaged , and towers are under tension on insulators , need to be supported by guys to prevent possible collapse
- E) Stubs are bent at the Chimney, Foundation chimney shall need to be broken for providing the Butt Joints and then additional reinforcement shall be provided to reinforce the chimney.
- F) All the hardware fittings got completely damaged,
- G) Panel nos 3,4 &5, main leg cut and separated.

Committee recommended – 6 Pile foundations from the insurance DMTCL has moved 10 towers to Pile foundations

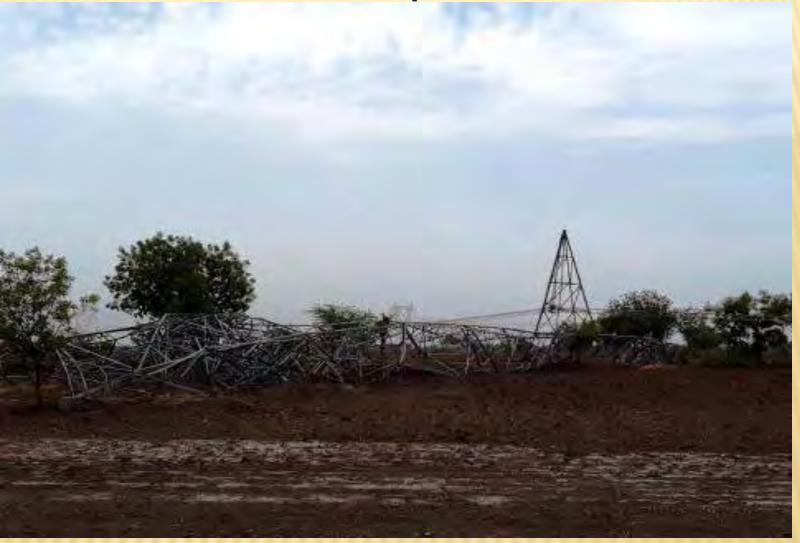
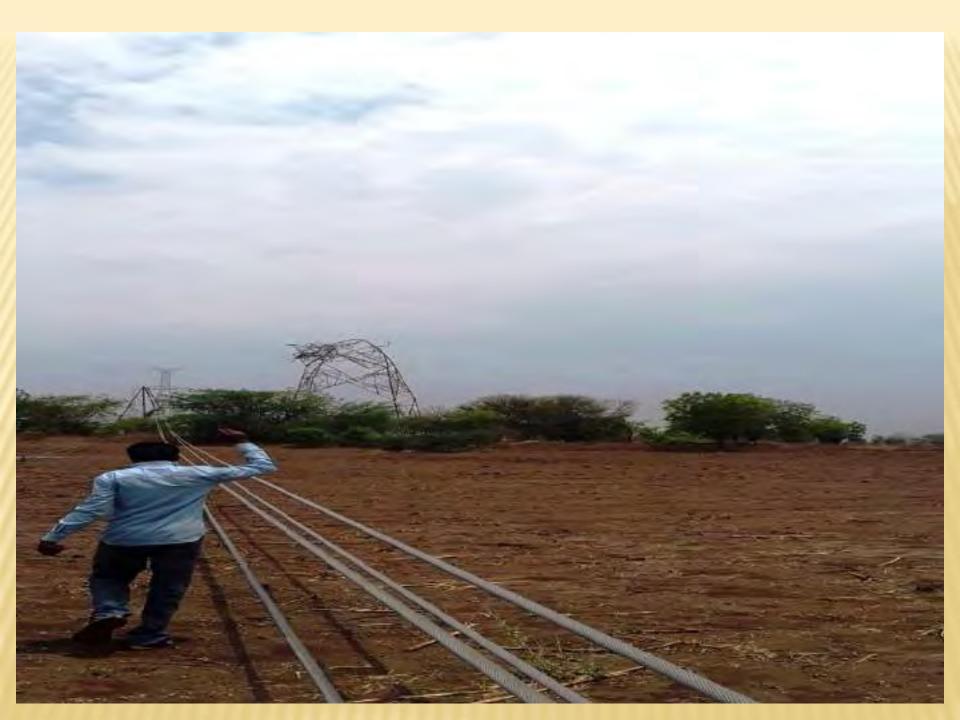
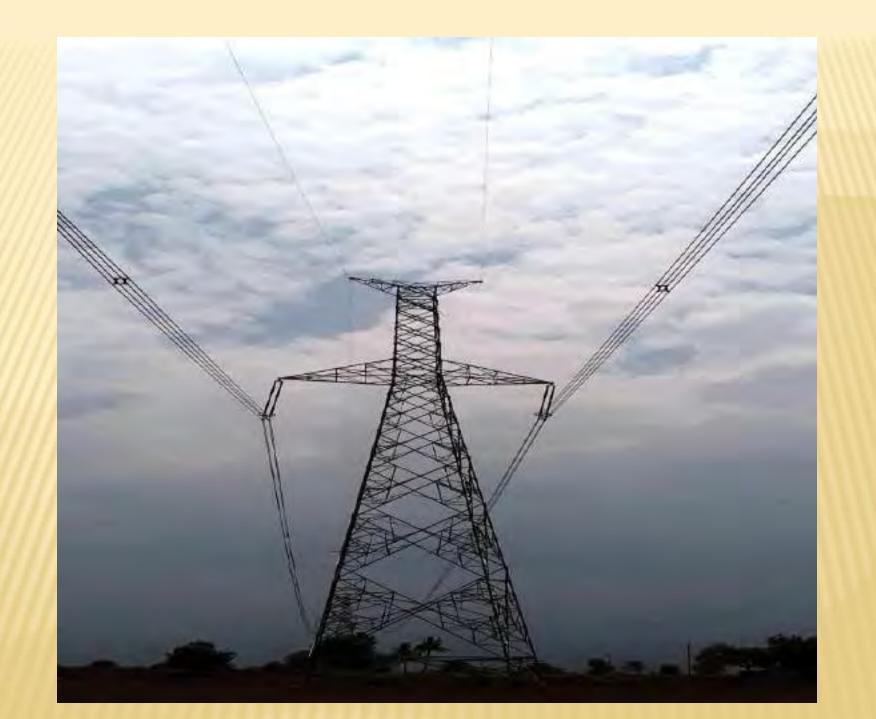
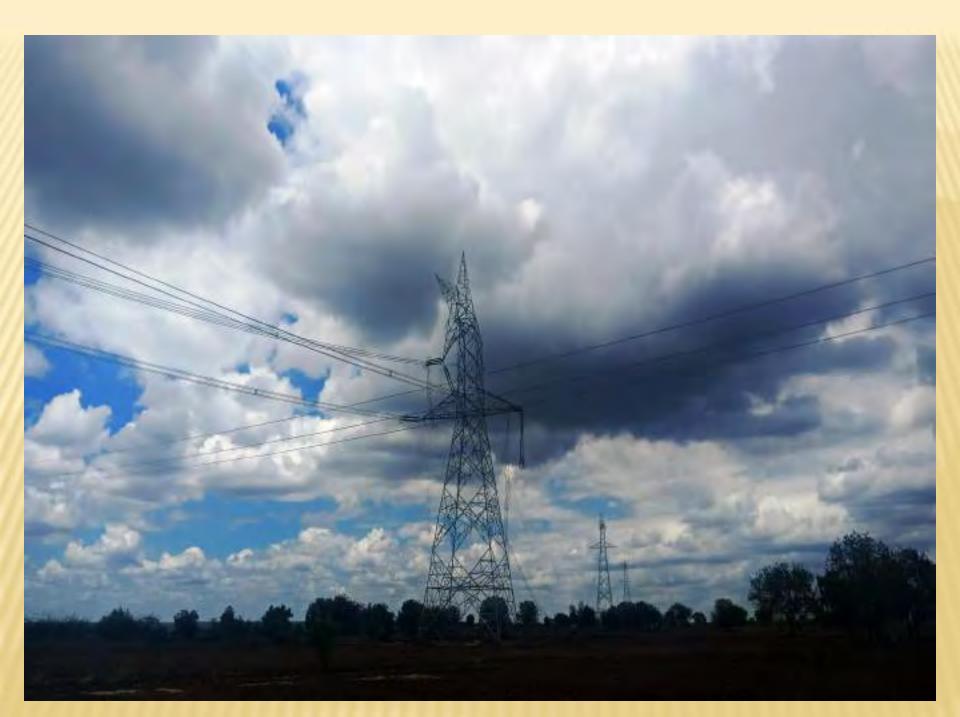
# **Tower Collapse Pictures**

Trucon Associates had design the all tower for RSTCPL Raichur-Sholapur Line II.
 Trucon Associates also check the all parameters of design and found that there is no issue on tower design. The Tower may collapse because of up and down thrust movement of wind on that day & time as mentions by Reconnect energy report.
 RSTCPL noted the same that the tower collapsed may be because of up thrust twister movement on tower. Local villagers also witnessed the same on that day.
