**भारत सरकार/Government of India**  
**विद्युत मंत्रालय/Ministry of Power**  
**केन्द्रीय विद्युत प्राधिकरण/Central Electricity Authority**  
**विद्युत प्रणाली अभियांत्रिकी एवं प्रौद्योगिकी विकास प्रभाग**  
**Power System Engineering & Technology Development Division**

**विषय:** Minutes of the meeting of Standing Committee of Experts on failure of EHV transmission towers failed during the period from January 2025 to June 2025-reg.

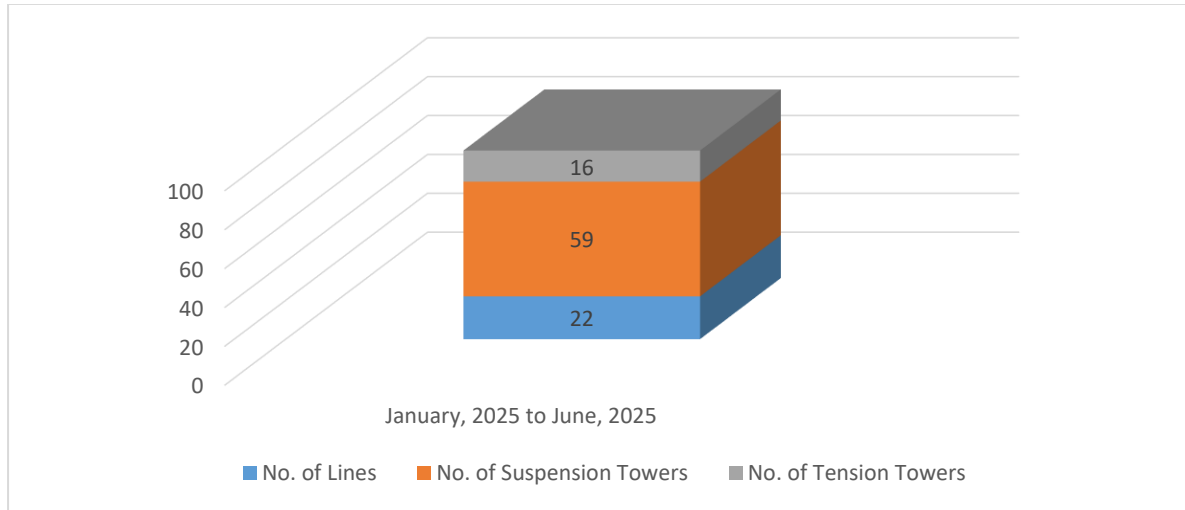
**Fig. 1**

- b) The total number of incidences of failures of EHV Transmission Line Towers, and the Nos. of affected Tension type and Suspension type towers that have been reported to CEA for the period of January, 2025 to June, 2025 are indicated in the Fig. 1 given below.

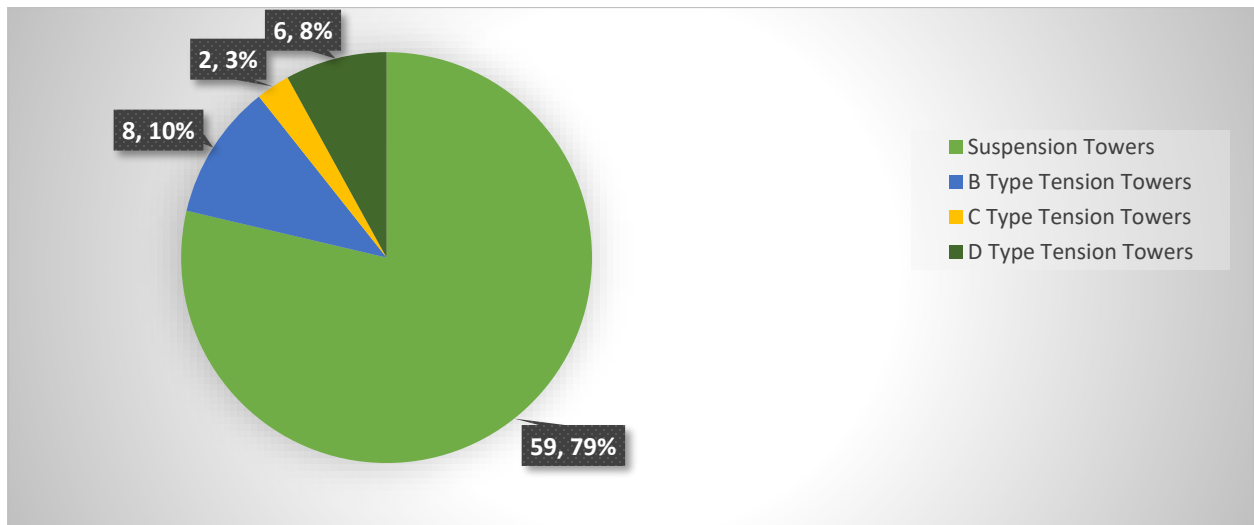
- e) It can be seen from the below **Fig. 3** that out of total 75 nos. of EHV Line Tower failure, 59 nos. are of Suspension type tower leading to its share of 78.7 % of total towers failed and 16 nos. are of Tension type towers leading to its share of 21.3 % of total towers failed. Out of total 16 nos. of Tension Type tower, 8 nos. are of Type B, 2 nos are of Type C and 6 nos are of Type D Tension type tower.

- f) It has been observed that the failure rate of Suspension type tower is much higher in comparison to Tension type tower. This may be because in normal terrain, generally, the nos. of Suspension type tower in any particular line is much higher than that of Tension type tower. Further, the Suspension type towers are not designed to take horizontal forces in the longitudinal direction and hence the failures of one suspension type tower causes secondary failure of adjacent Suspension towers due to the pulling force of conductors. In view of above, the loading criteria for the Suspension type towers have been made more stringent and the longitudinal and transverse force acting on Suspension type towers under security condition has been increased in revised IS 802: 2015.

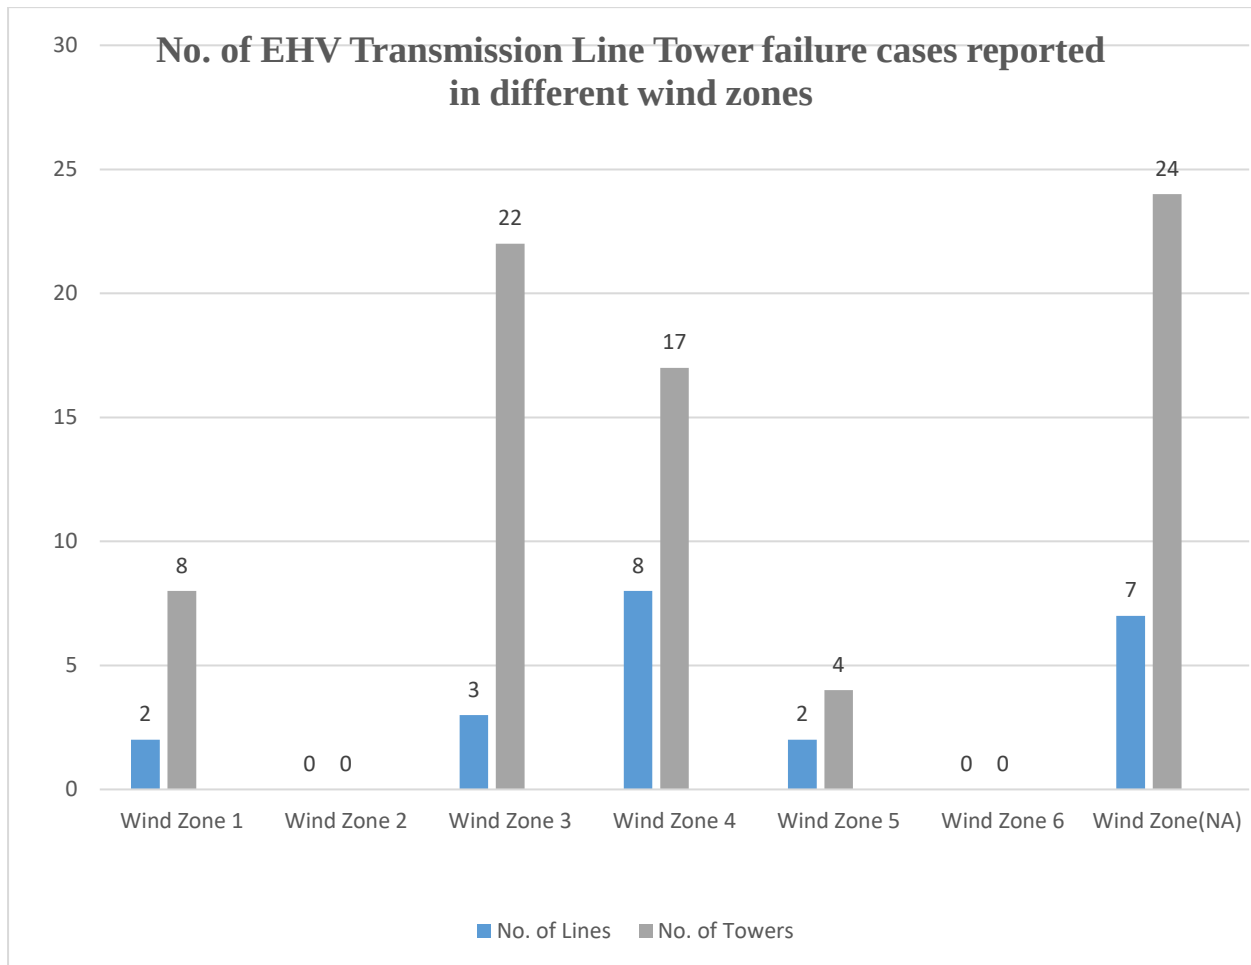
- g) The wind map of India was divided into three wind pressure zones that is light, medium & heavy, before the revision of IS 802 in 1995. In the third revision of IS 802: 1995, 6 wind zones were specified dividing various regions on the basis of 3 second wind gust speed. The no. of transmission lines and towers, failed during the period from January, 2025 to June, 2025 and designed according to various wind zones is given in **Fig. 4** below. It can be seen that the maximum No. of failure of towers have occurred for transmission lines which were designed for Wind Zone 3 and 4. It may be noted that maximum area of India is covered under the wind zones 2 and 4.

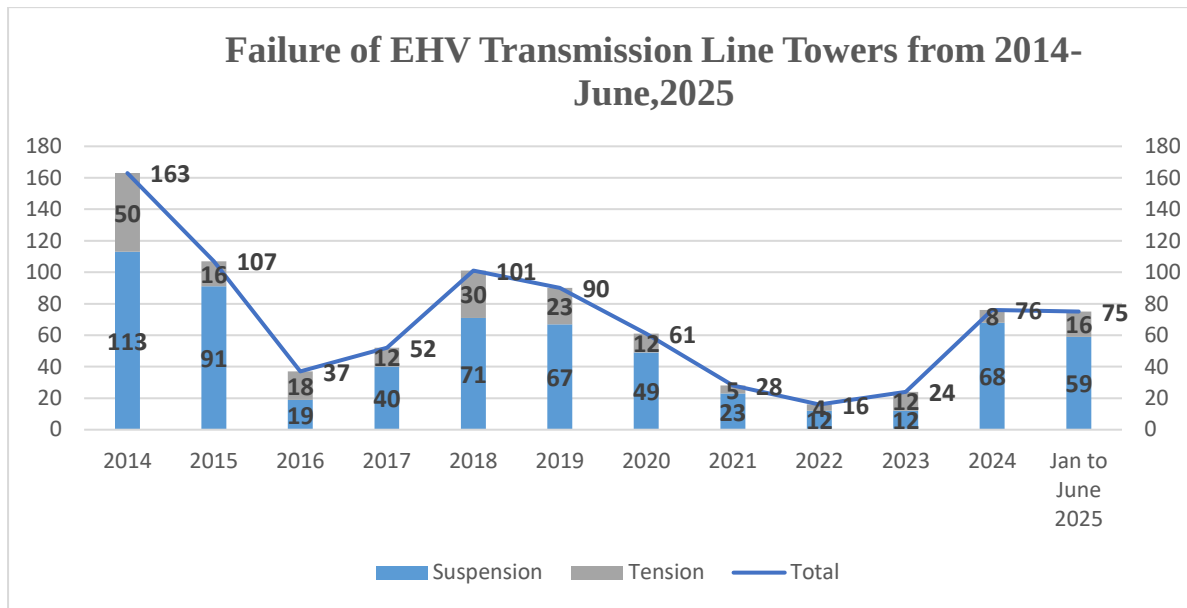
**Fig. 5**

- a) The details of previous EHV Transmission Line Tower failure incidents which were reported to CEA and have been discussed in the past Standing Committee meetings from the year 2014 onwards have been analysed by CEA and the graph depicting the failures of EHV Transmission Line towers occurred during past years (2014-June, 2025) that have been discussed in the previous Standing committee meetings are shown below in **Fig. 5**. The maximum No. of failures, i.e., 163 cases of tower failures occurred during year 2014. As has been observed in the previous Standing Committee meetings, the failure rate of suspension towers is much higher in comparison to tension towers. This may be because of the cascading effect of failure of suspension type towers i.e. secondary failure of adjacent suspension towers due to the pulling force of conductors which have been developed due to failure of another tower.

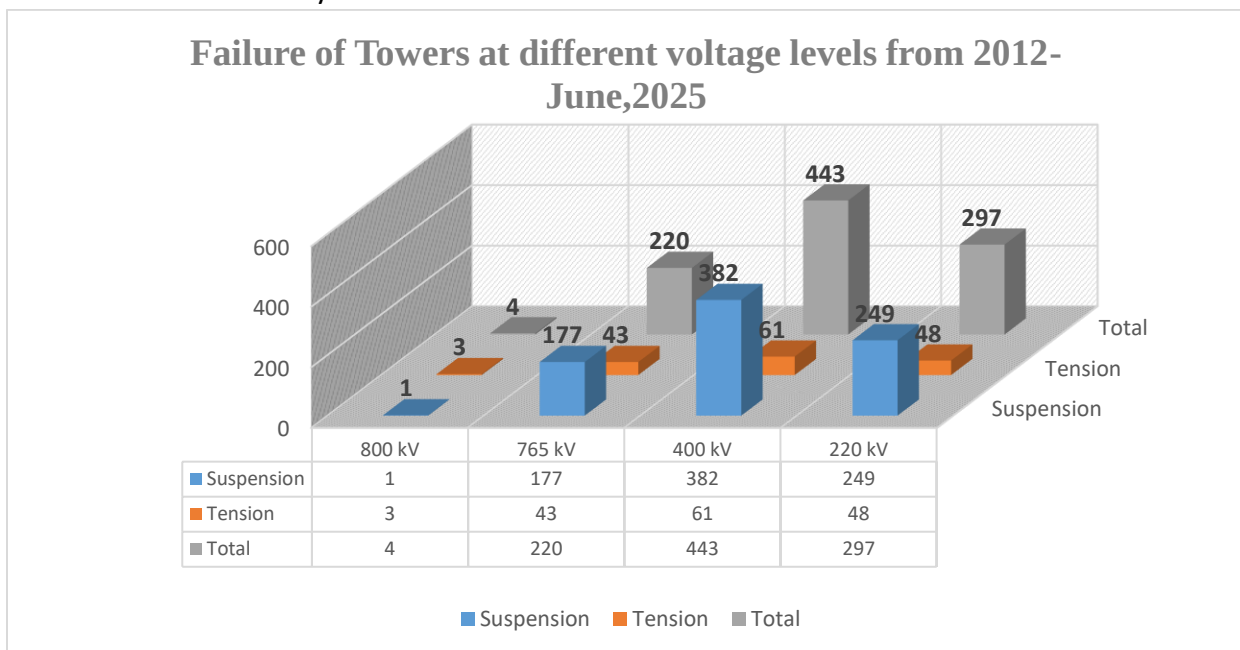
**Fig. 6**

b) The graph depicting the failures of towers at various voltage levels that have occurred in past years (2012-June 2025) and intimated to CEA which have been discussed in the Standing committee meetings are shown below in Fig. 6. It may be observed that towers of 400 kV voltage level have maximum incidents of failure. It may be noted that the mandate of the Standing Committee is to investigate failure of towers of 220 kV and above voltage class transmission line and the graph shows the details of only those transmission line failures which have been intimated to CEA.
