**विषय:** Minutes of the meeting of Standing Committee of Experts on failure of EHV transmission towers failed during the period from July, 2025 to December, 2025-reg.

## 5. Statistics and Analysis of the EHV Transmission Line Tower failure:

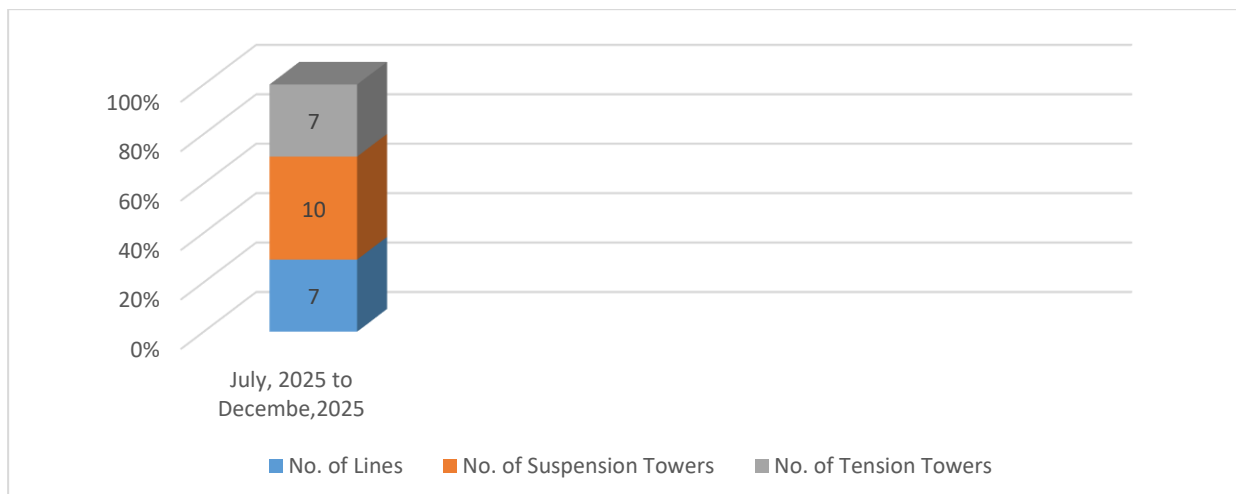
**Fig. 1**

b) The total number of incidences of failures of EHV Transmission Line Towers, and the Nos. of affected Tension type and Suspension type towers that have been reported to CEA for the period of January, 2025 to June, 2025 are indicated in the Fig. 1 given below.

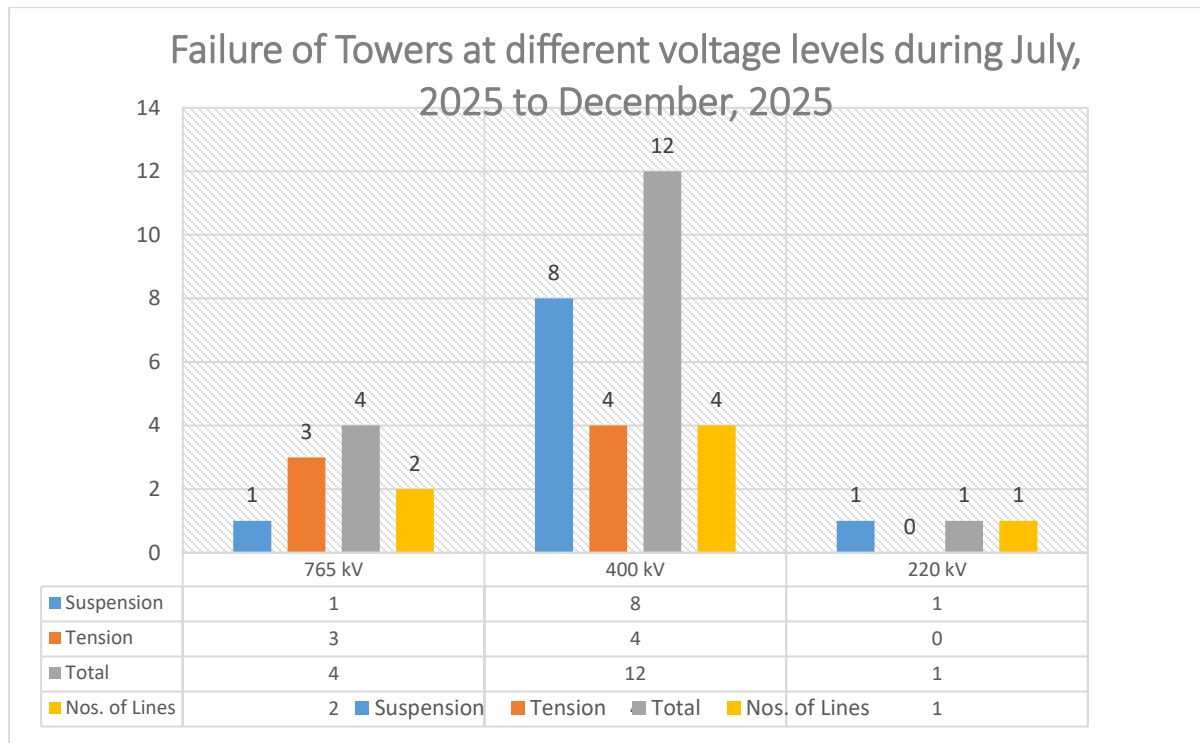
- d) It can be seen from the below **Fig. 2** that at 765 kV Voltage level, 1 Nos. of Suspension type tower and 03 Nos. of Tension Type towers were failed in 02 No. of Transmission Line, at 400 kV Voltage level 08 Nos. of Suspension type tower and 04 Nos. of Tension type towers have failed in 04 Nos. of Transmission Line, and at 220 kV Voltage level 01 No. of Suspension type tower was failed in 1 No. of Transmission Line.

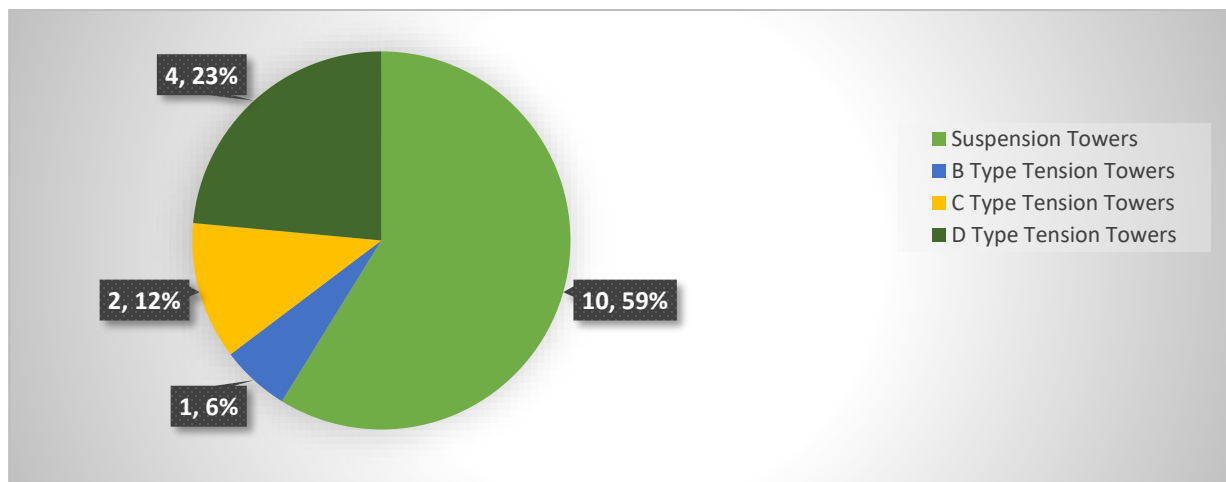
e) It can be seen from the below **Fig. 3** that out of total 17 Nos. of EHV Line Tower failure, 10 Nos. are of Suspension type tower leading to its share of 59 % of total towers failed and 07 Nos. are of Tension type towers leading to its share of 41 % of total towers failed. Out of total 07 Nos. of Tension Type tower, 01 No. are of Type B, 02 Nos are of Type C and 4 Nos. are of Type D Tension tower.

f) It has been observed that the failure rate of Suspension type tower is higher in comparison to Tension type tower. This may be because in normal terrain, generally, the nos. of Suspension type tower in any particular line is much higher than that of Tension type tower. Further, the Suspension type towers are not designed to take horizontal forces in the longitudinal direction and hence the

failures of one suspension type tower cause secondary failure of adjacent Suspension towers due to the pulling force of conductors. In view of above, the loading criteria for the Suspension type towers have been made more stringent and the longitudinal and transverse force acting on Suspension type towers under security condition has been increased in revised IS 802: 2015.

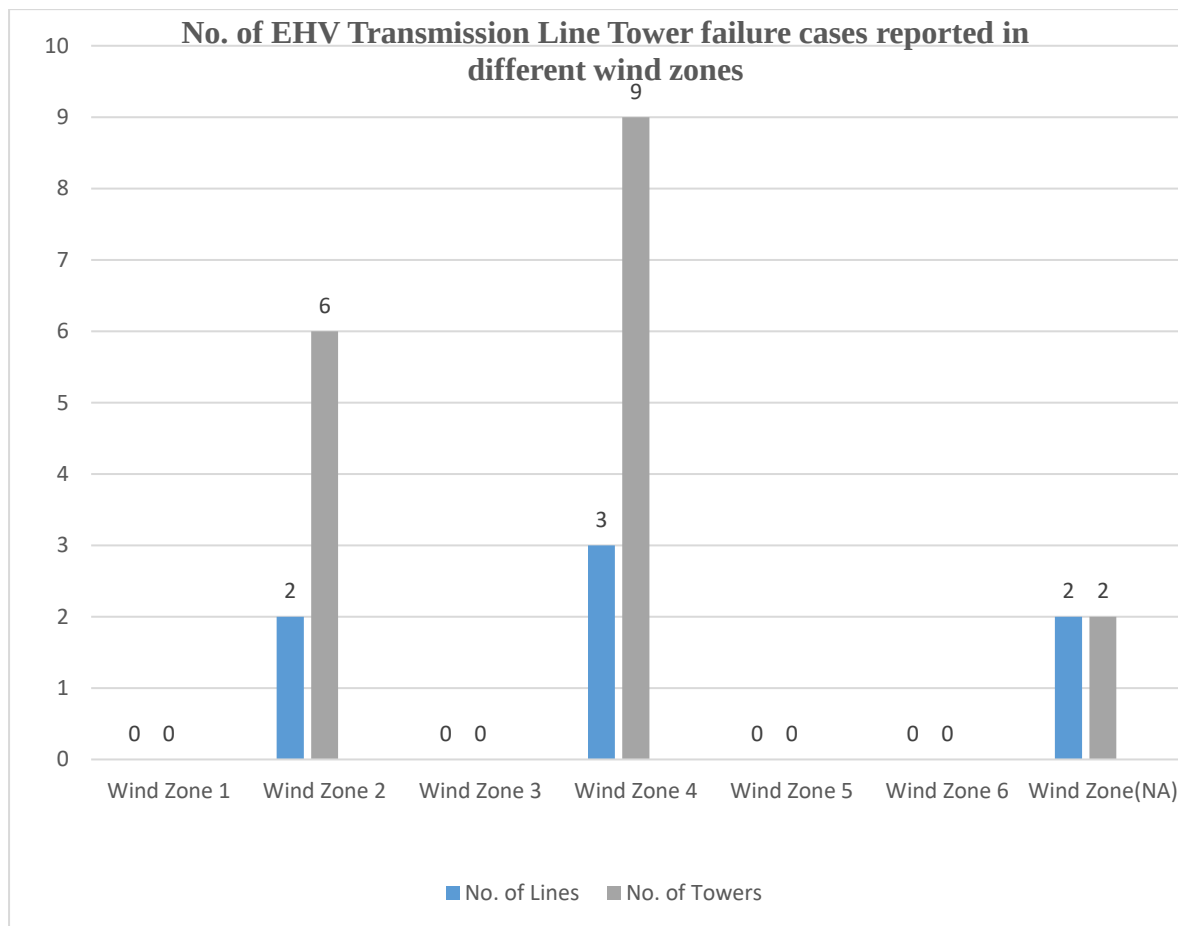
- g) The wind map of India was divided into three wind pressure zones that is light, medium & heavy, before the revision of IS 802 in 1995. In the third revision of IS 802: 1995, 6 wind zones were specified dividing various regions on the basis of 3 second wind gust speed. The No. of transmission lines and towers, failed during the period from July, 2025 to December, 2025 and designed according to various wind zones is given in **Fig. 4** below. It can be seen that the maximum no. of failure of towers have occurred for transmission lines which were designed for 4. It may be noted that maximum area of India is covered under the wind zones 2 and 4.

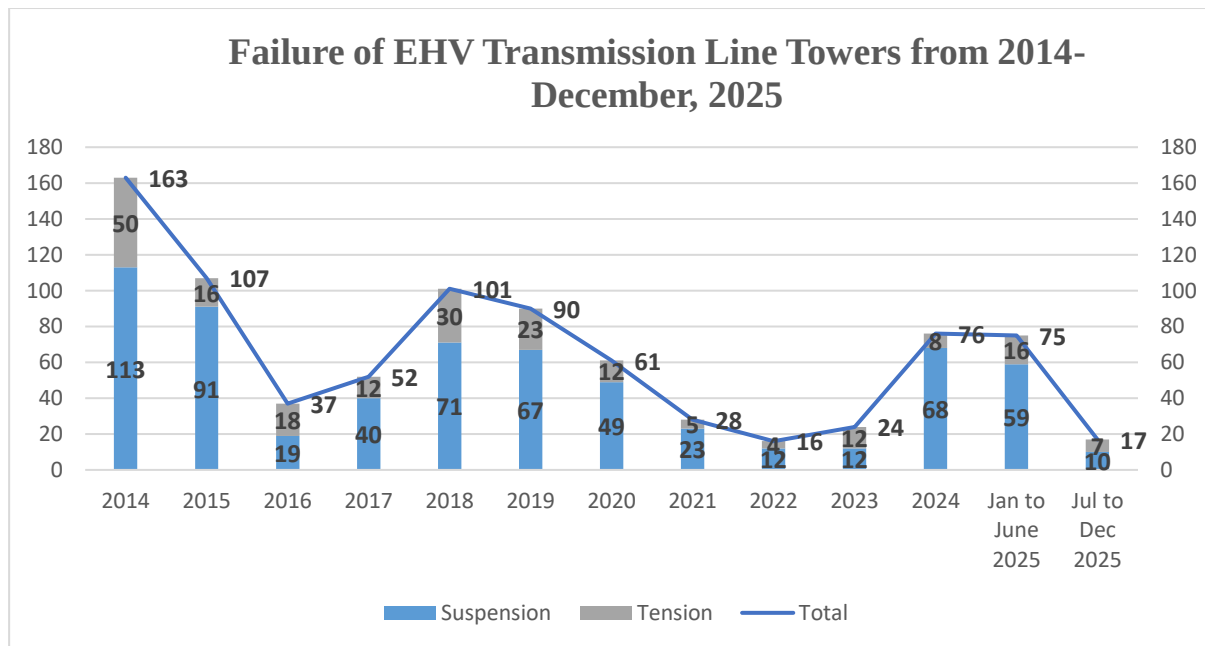
**Fig. 5**

- a) The details of previous EHV Transmission Line Tower failure incidents which were reported to CEA and have been discussed in the past Standing Committee meetings from the year 2014 onwards have been analysed by CEA and the graph depicting the failures of EHV Transmission Line towers occurred during past years (2014-2025) that have been discussed in the previous Standing committee meetings are shown below in **Fig. 5**. The maximum No. of failures, i.e., 163 cases of tower failures occurred during year 2014. As has been observed in the previous Standing Committee meetings, the failure rate of suspension towers is much higher in comparison to tension towers. This may be because of the cascading effect of failure of suspension type towers i.e. secondary failure of adjacent suspension towers due to the pulling force of conductors which have been developed due to failure of another tower.

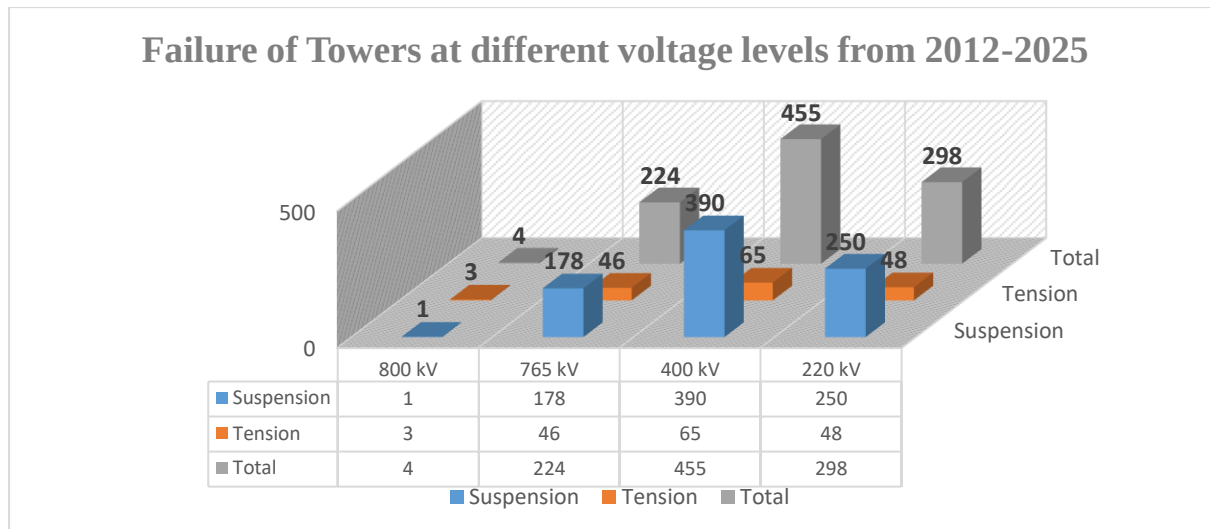
**Fig. 6**

- b) The graph depicting the failures of towers at various voltage levels that have occurred in past years (2012-2025) and intimated to CEA which have been discussed in the Standing committee meetings are shown below in Fig. 6. It may be observed that towers of 400 kV voltage level have maximum incidents of failure. It may be noted that the mandate of the Standing Committee is to investigate failure of towers of 220 kV and above voltage class transmission line and the graph shows the details of only those transmission line failures which have been intimated to CEA.
