REPORT OF STANDING COMMITTEE OF EXPERTS ON FAILURE OF 220 kV & ABOVE VOLTAGE CLASS SUBSTATION EQUIPMENT (APRIL 2019 - DECEMBER 2021)

Government of India Central Electricity Authority Ministry of Power New Delhi

(In fulfillment of CEA's obligation under Section 73(1) of the Electricity Act, 2003)

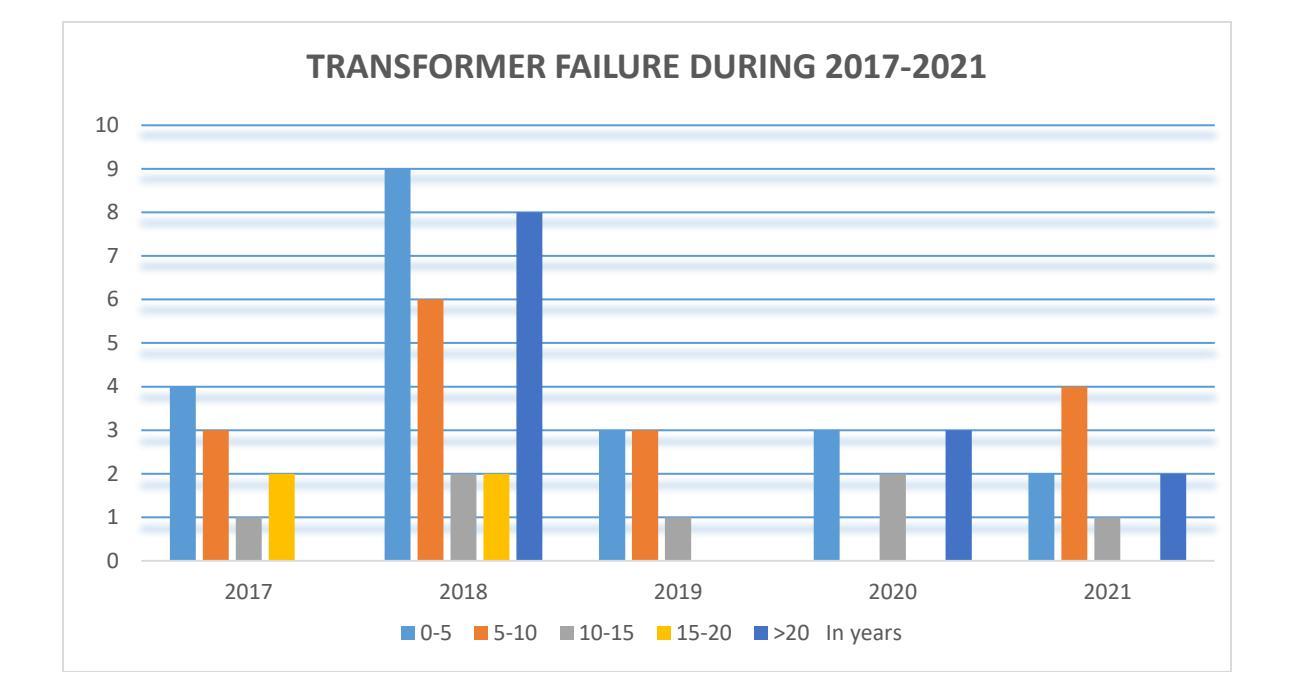
- iii. As can be seen from Table 3 above, twenty-four (24) transformer failure cases from April 2019 to December 2021 have been reported by eight (8) Utilities to CEA. It is a matter of concern that more than 50% of the reported failed transformers were in operation/service for less than 10 years. It is highlighted that a large number of transformer failure cases remain unreported as many of power utilities [State Transmission Utilities, Private Utilities/Licensees, Central Transmission Utilities, Public Sector Power Utilities] in the Country have not reported the failures.
- iv. Failures of transformers during 2017-2021: The number of different transformer failures as reported in the last 5 years to CEA has been shown in the graph below:

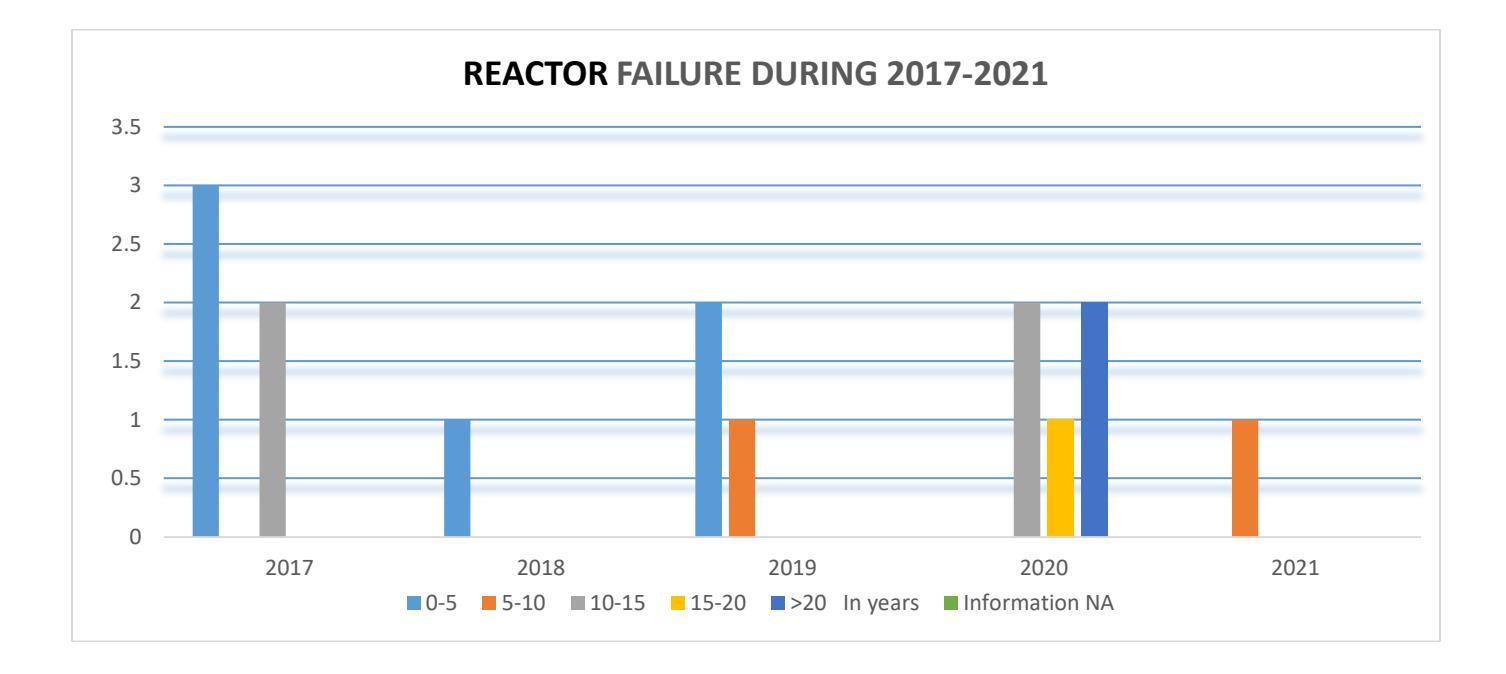
ii. Failures of reactors during 2017-2021: The number of different reactor failures as reported in the last 5 years to CEA has been shown in the graph below.

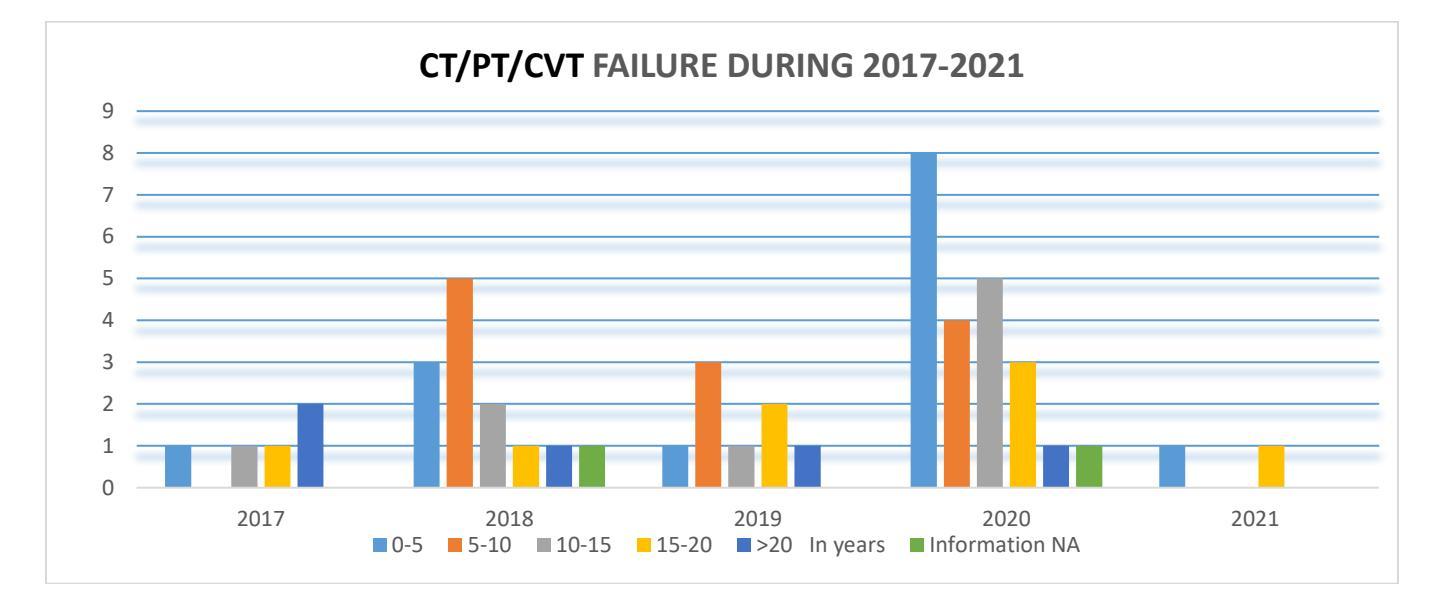
v. Failures of CTs/PTs/CVTs during 2017-2021: The number of different CT/PT/CVT failures as reported in last 5 years to CEA has been shown in the graph below:

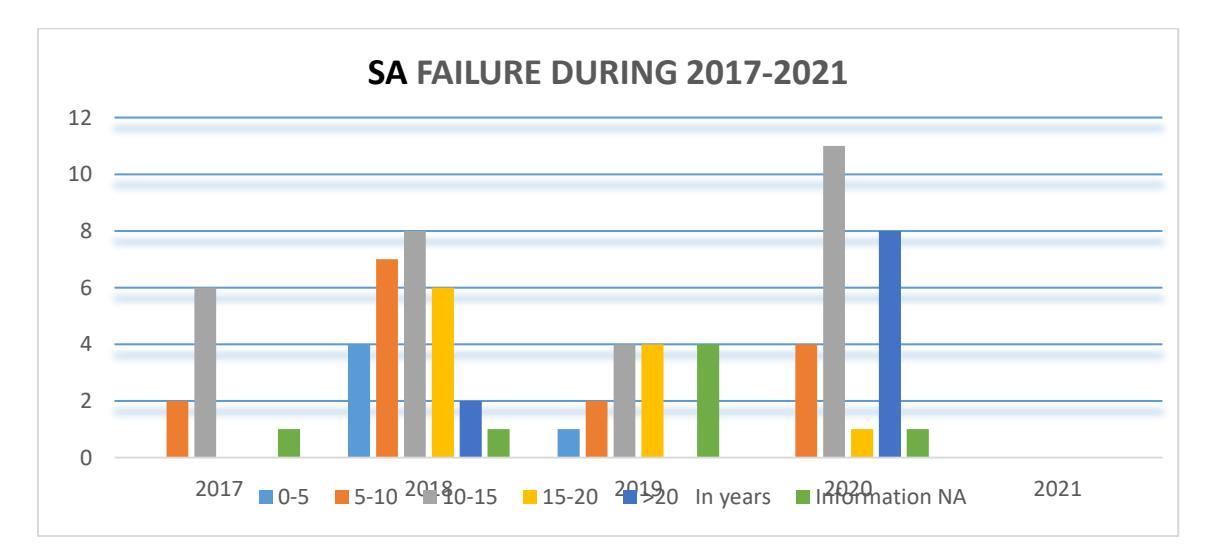
- vi. As per the reports received by CEA, forty (40) Nos. of cases of SA failure that occurred during the period from April 2019 to December 2021 have been reported to CEA by six (6) utilities. Out of these, fourteen (14) Nos. of SAs are of 220/230/245 kV class, five (5) Nos. of SAs are of 400/390 kV class and rest twenty one (21) are 198 kV class.
- vii. Failures of SAs during 2017-2021: The number of different SA failures as reported in the last 5 years to CEA has been shown in the graph below.
