# **Report of the Committee on Addressing Insulator Failures on Transmission Lines**

**Government of India  
Ministry of Power  
Central Electricity Authority  
May, 2026**

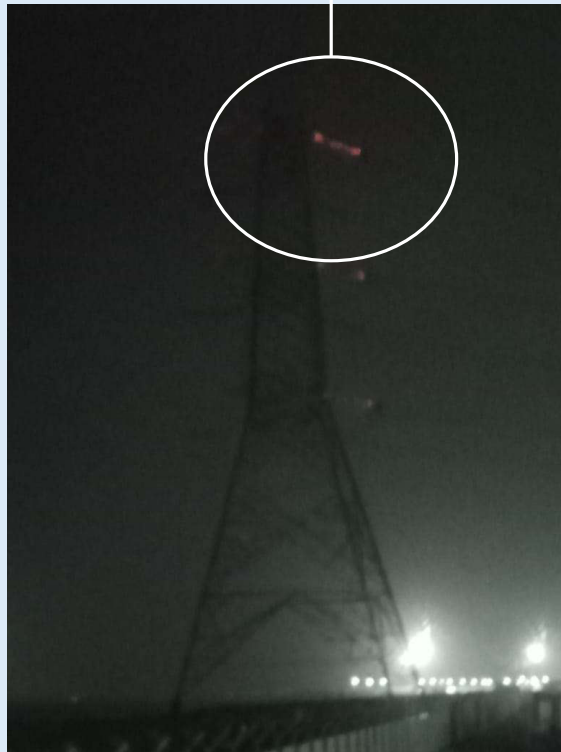
Insulator in Night with Fog

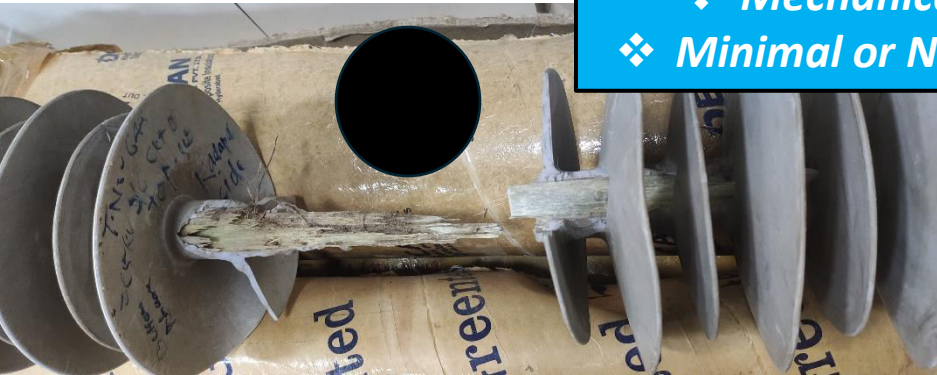
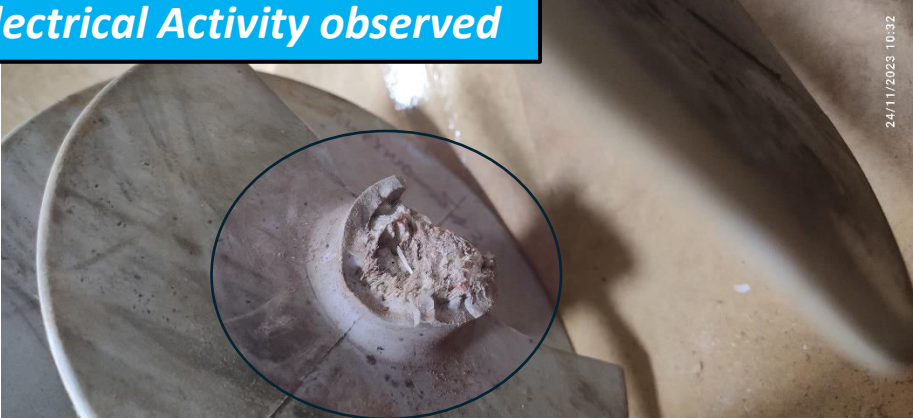
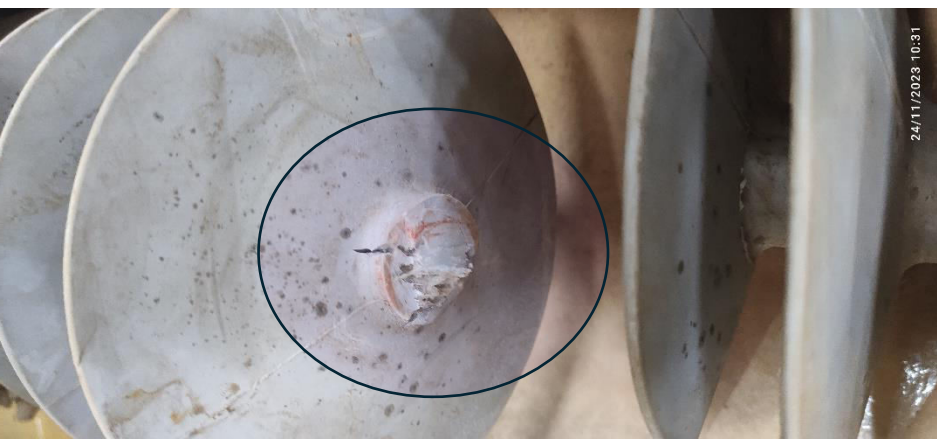
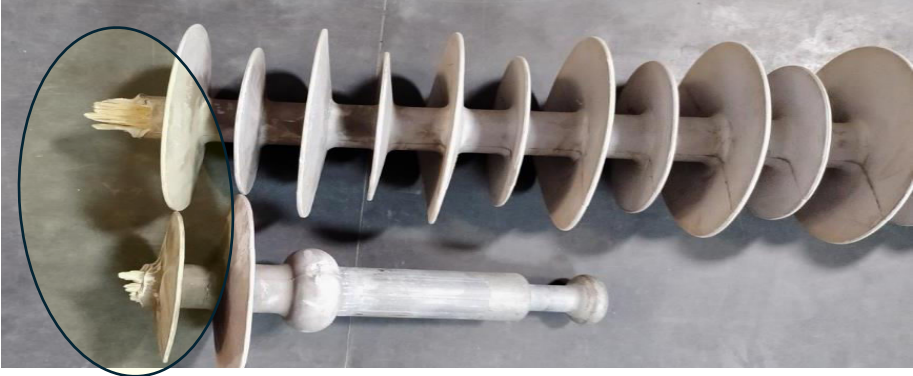
1 Fractured

❖ Mechanical Failure: Fractured View  
❖ Minimal or No Electrical Activity observed

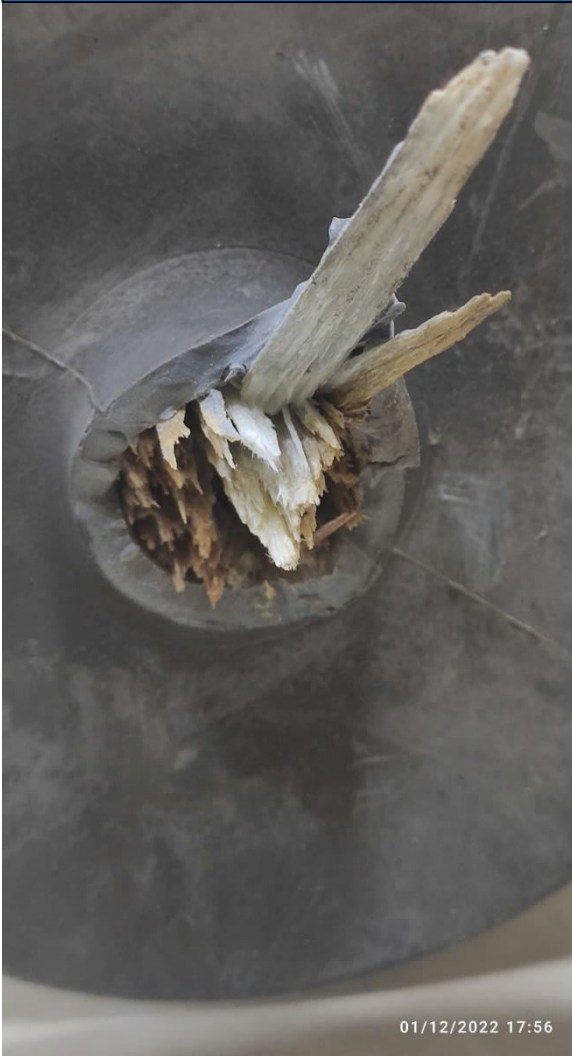
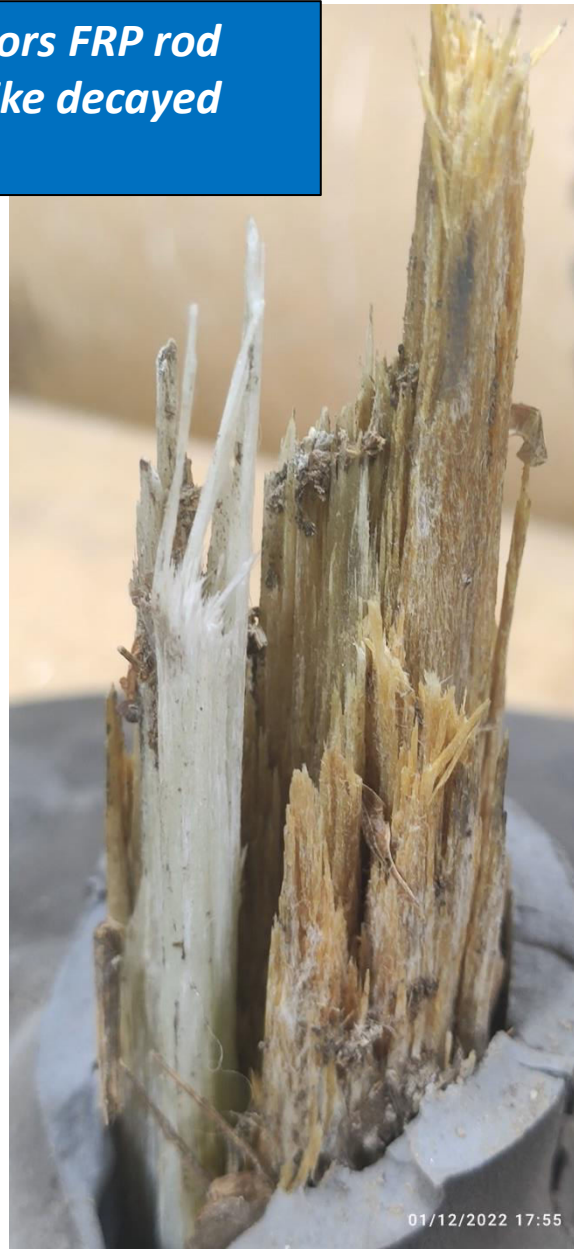
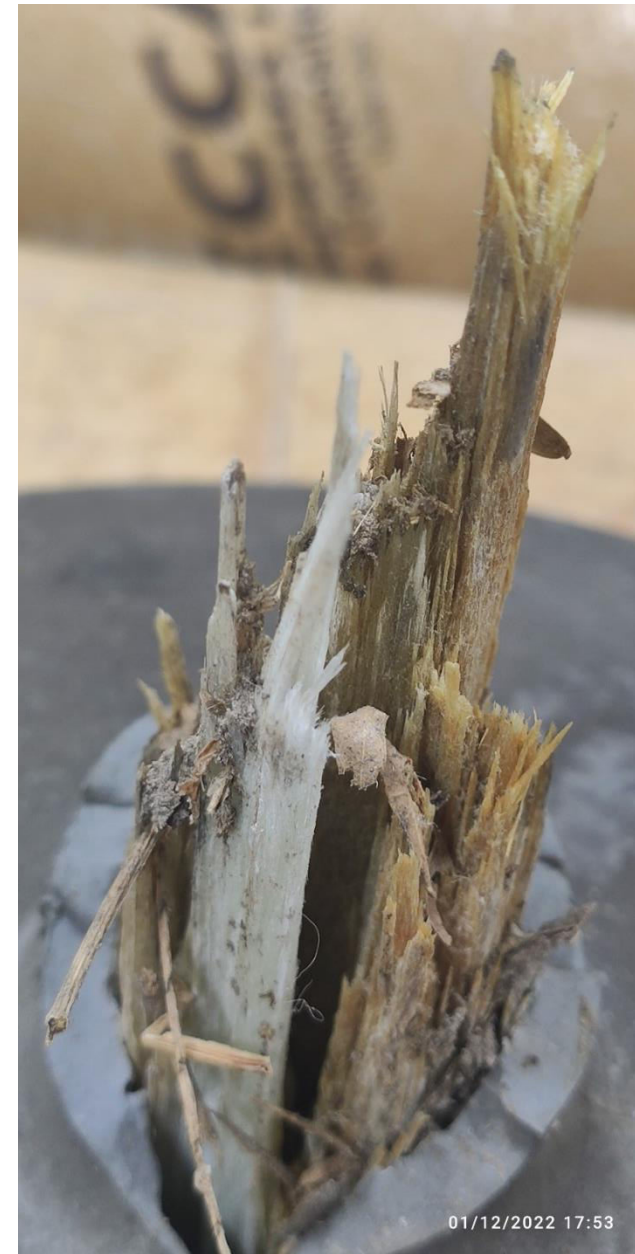
# Fracture Analysis

*In some cases, fractured insulators FRP rod degraded severely and looked like decayed wood.*

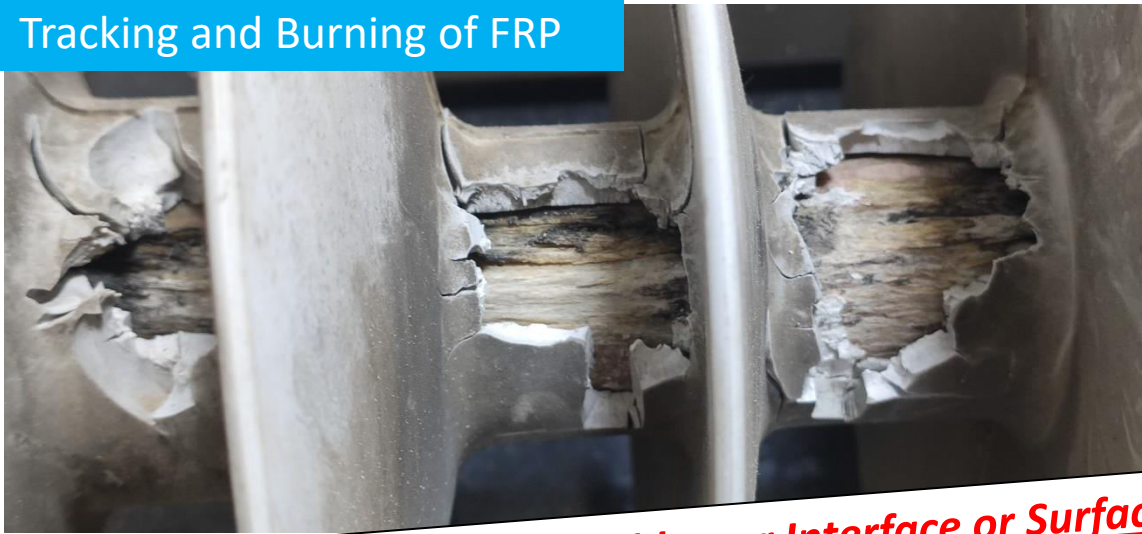
## Tracking and Burning of FRP

- Tracking Marks
- Rubber Tear out
- Minimal burning marks FRP/Rubber

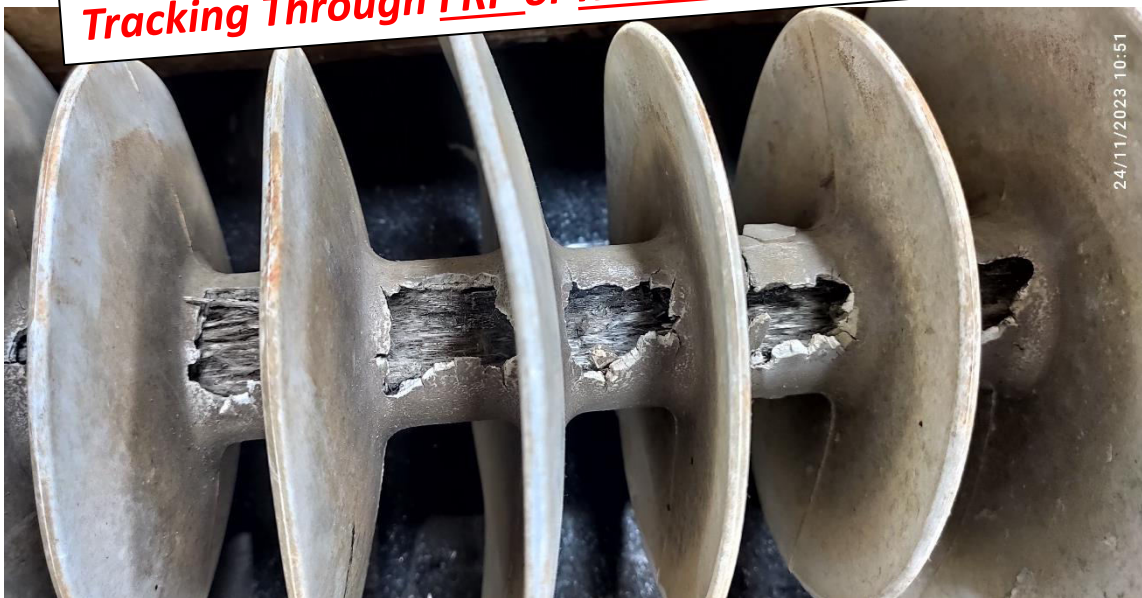
Tracking Through FRP or Rubber or Interface or Surface.....?

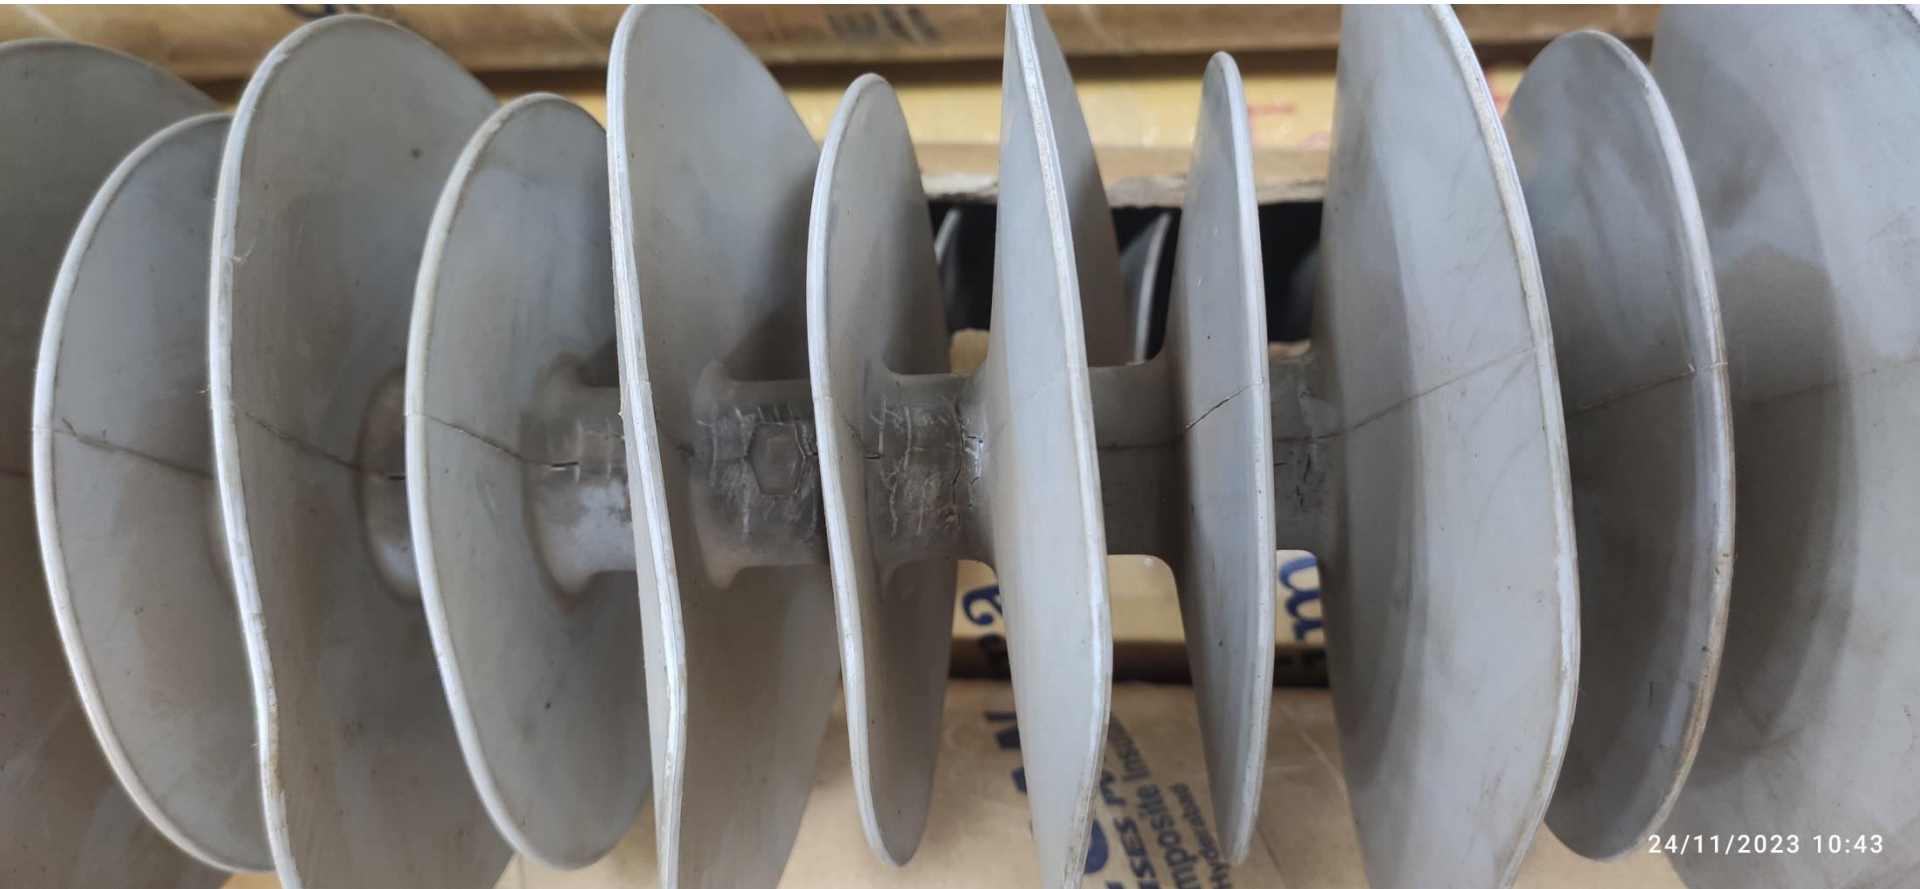
***Progression of Phenomenon***

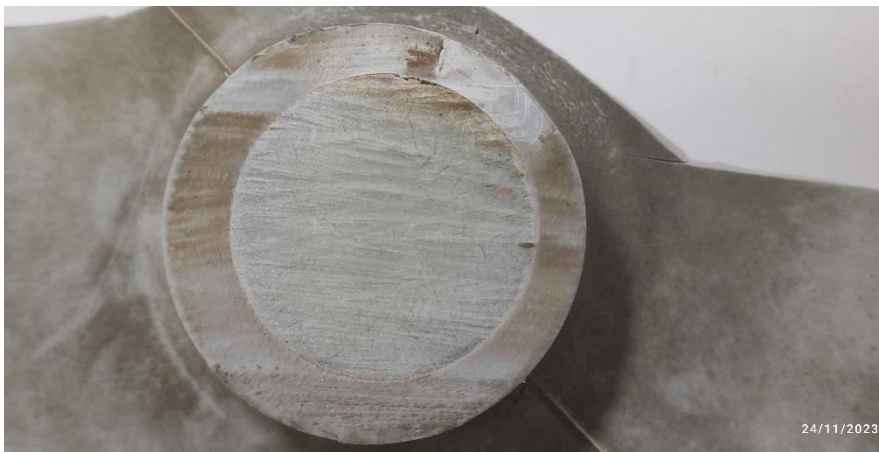
***Progression of Phenomenon: Crack opening***

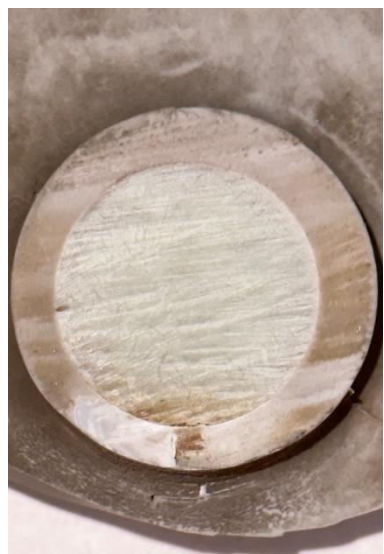
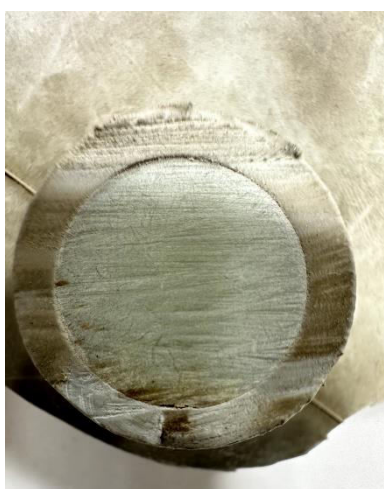
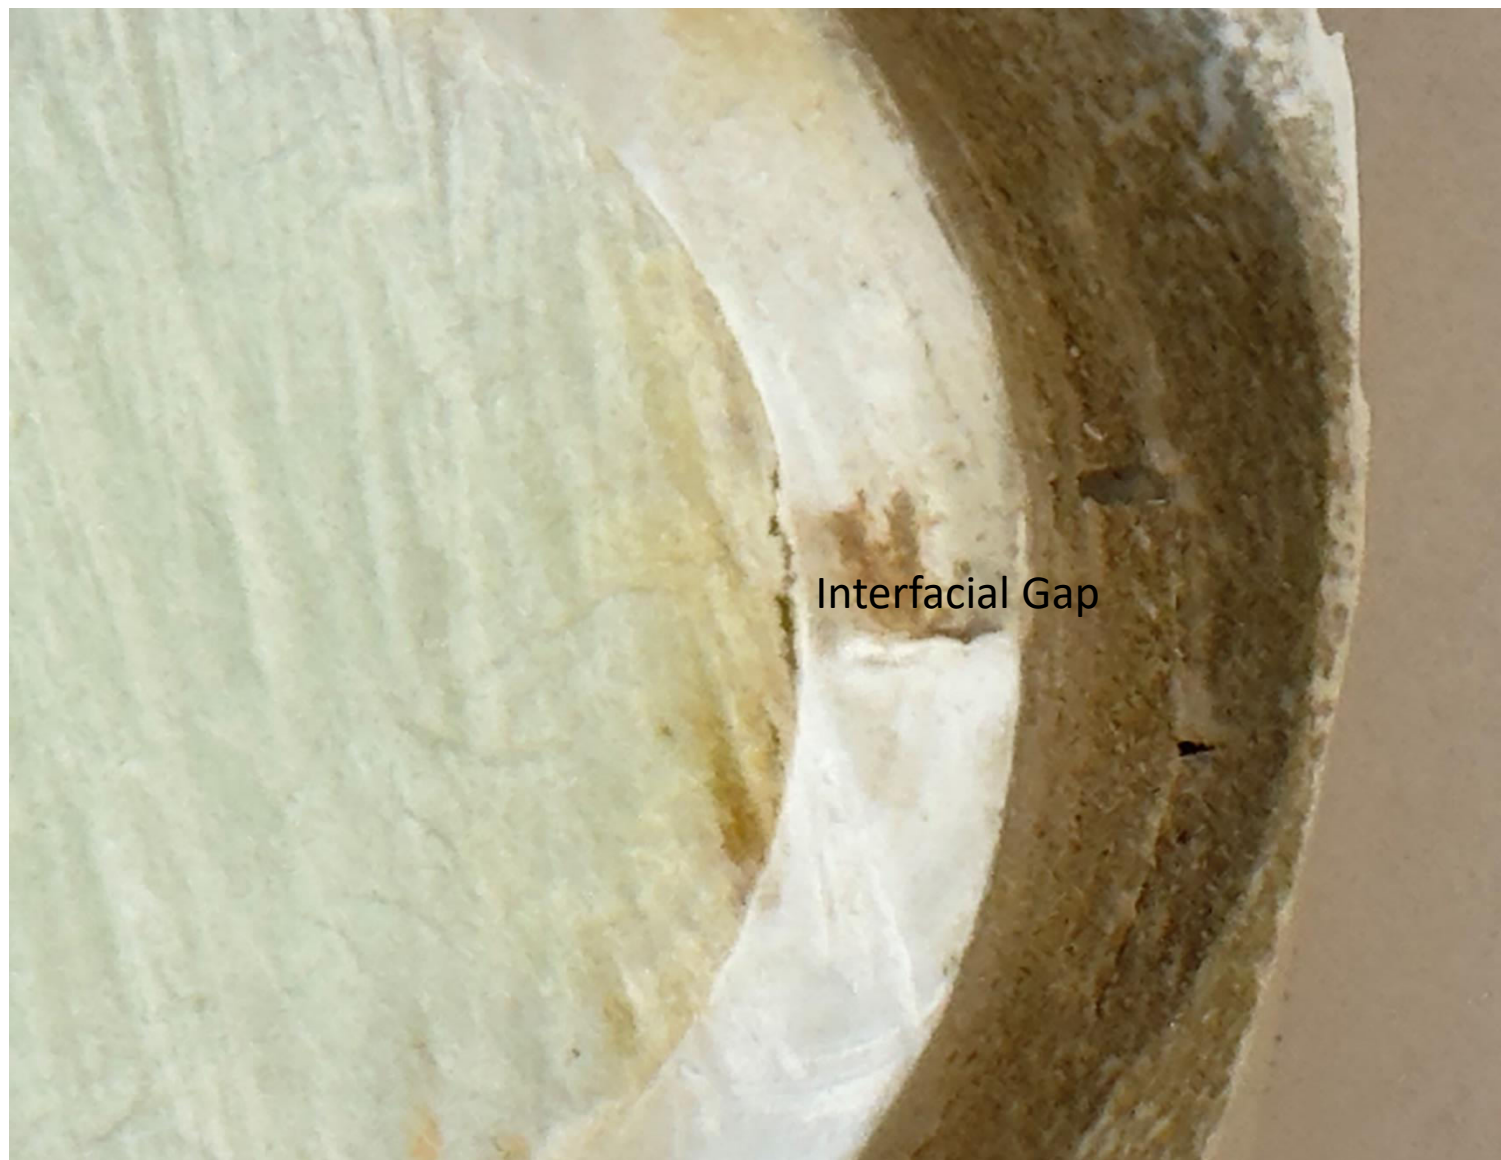
**Beginning of Tracking/Leakage Current.....?**

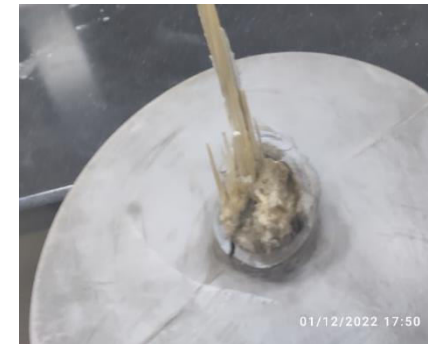
- Manufacturing defect in terms of non-uniform molding of silicon rubber around the FRP rod.
- In few cases brittle fracture of FRP rod was observed
- Very few insulators failed mechanically. These very few mechanically failed CLR insulators do not show signature of electrical activities/phenomenon. In such cases the location of fracture was different from most of the fracture failure initiated due to electrical activities/phenomenon.

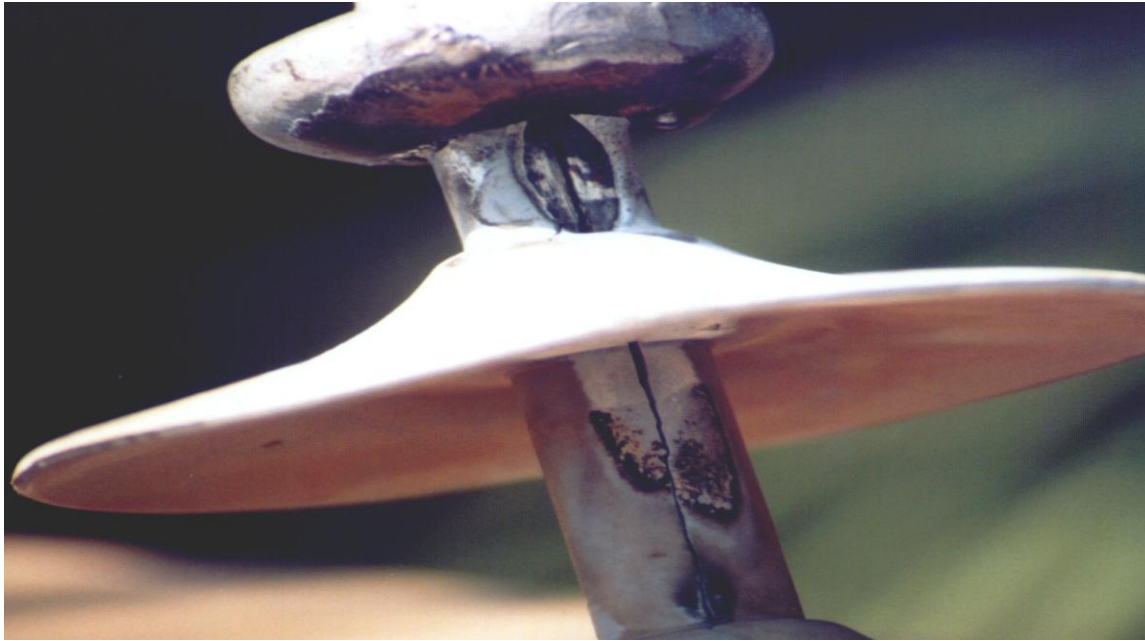
**Electrical failure of a core owing to splitting during line construction**

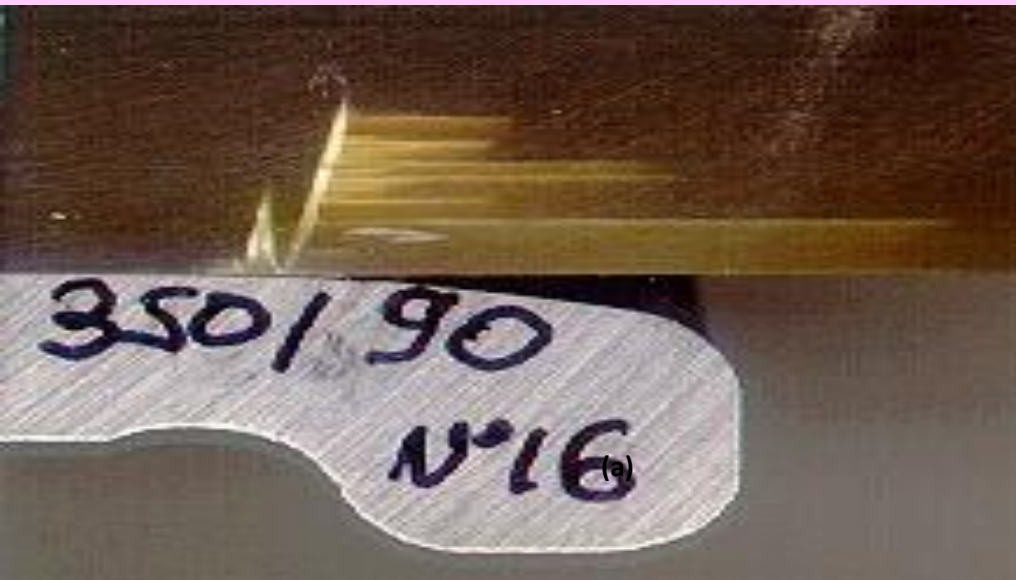
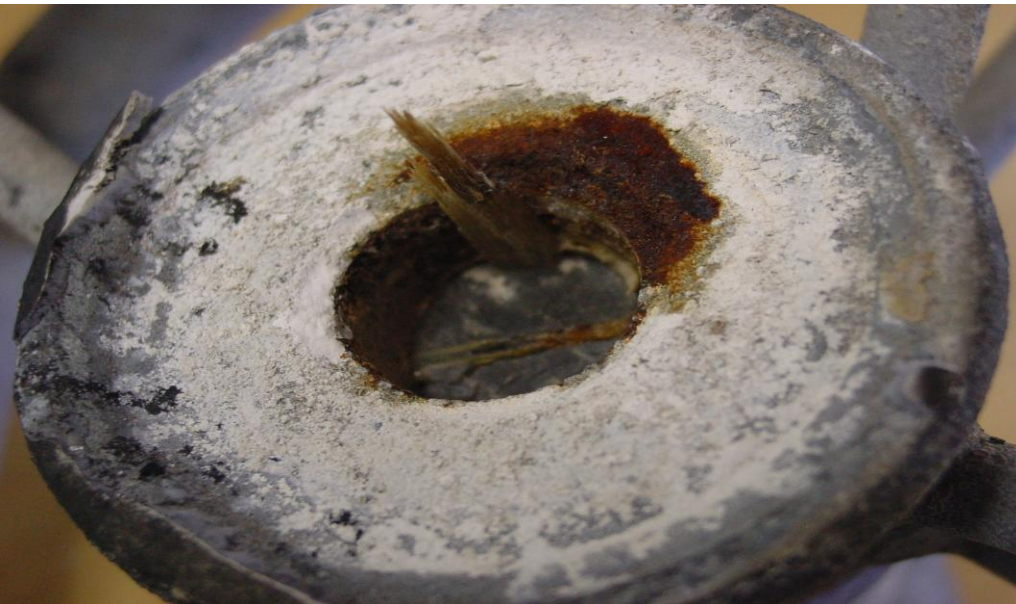
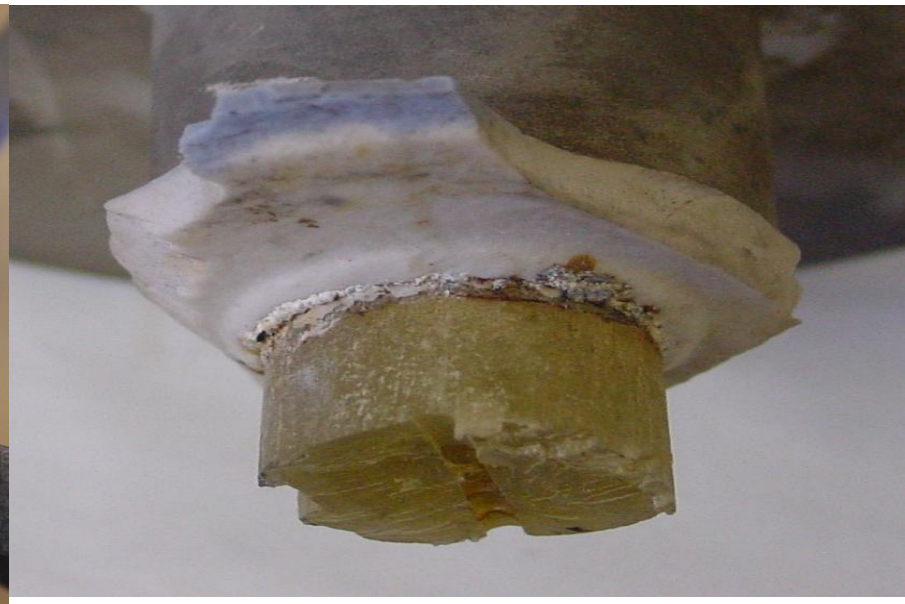
Initial (a) and subsequent (b) damage of a line post core subjected to excessive bending load

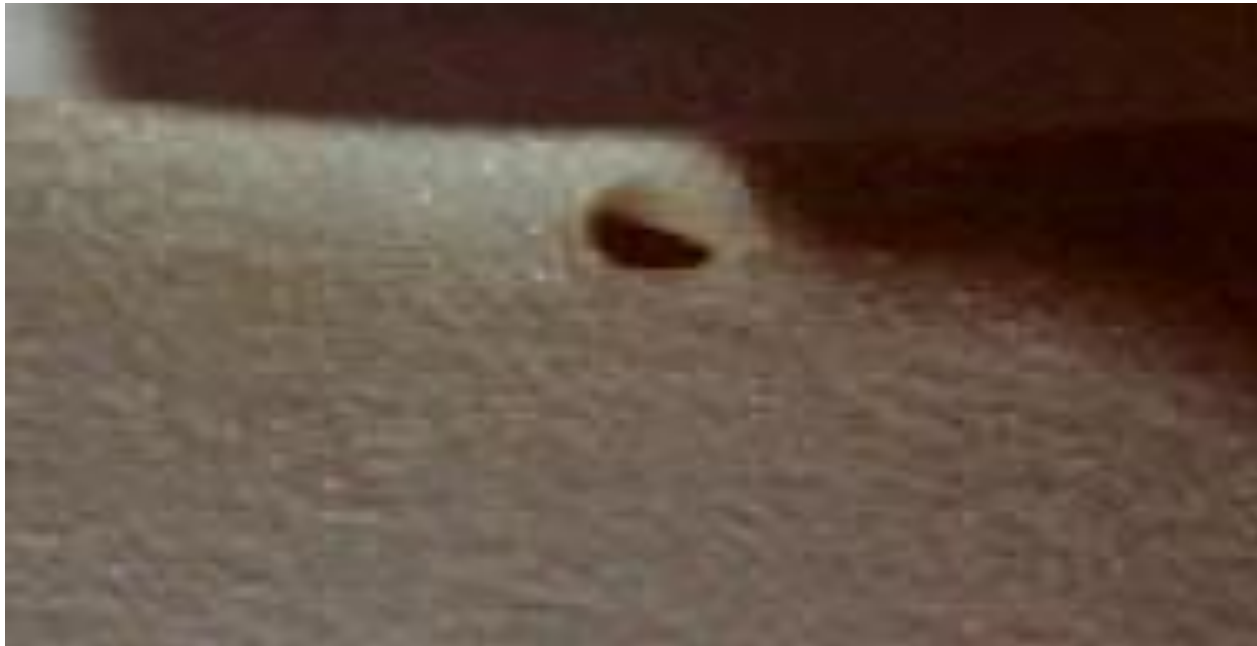
**Punctured Silicone Rubber shed**

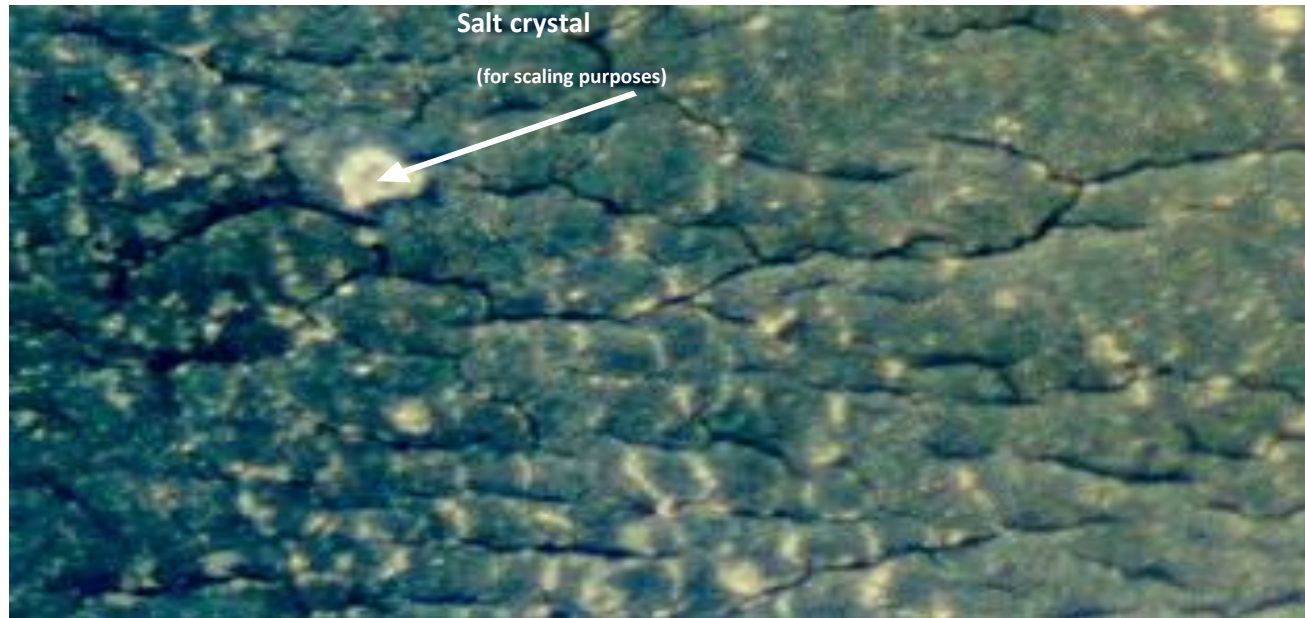
**Crazing or cracking**

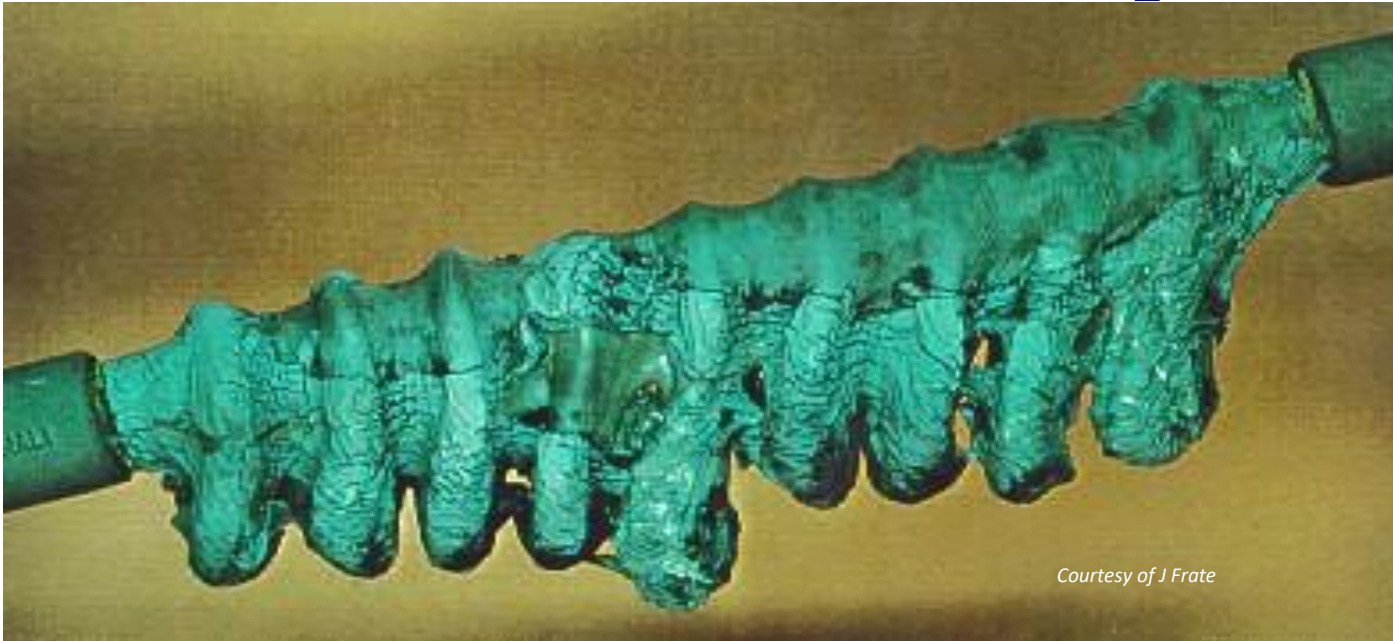
**Hydrolysis of  
epoxy  
housing  
material**

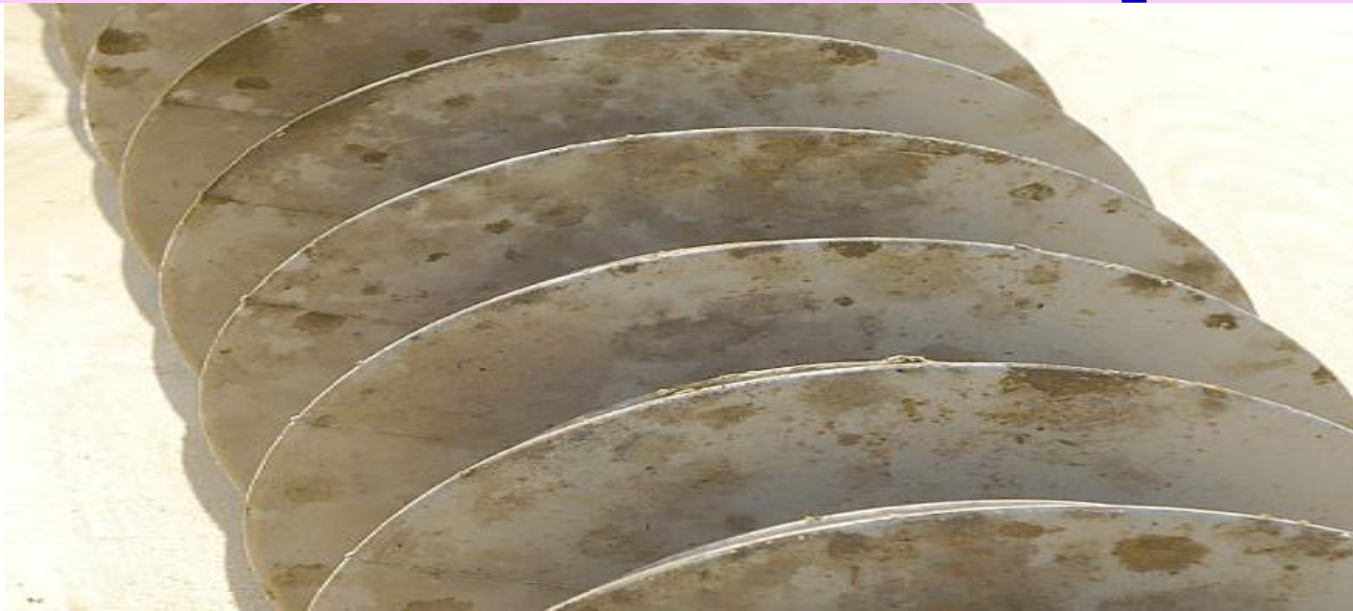
**Colonization by  
Aspergillus niger  
&  
Cladosporium is  
easily removed**

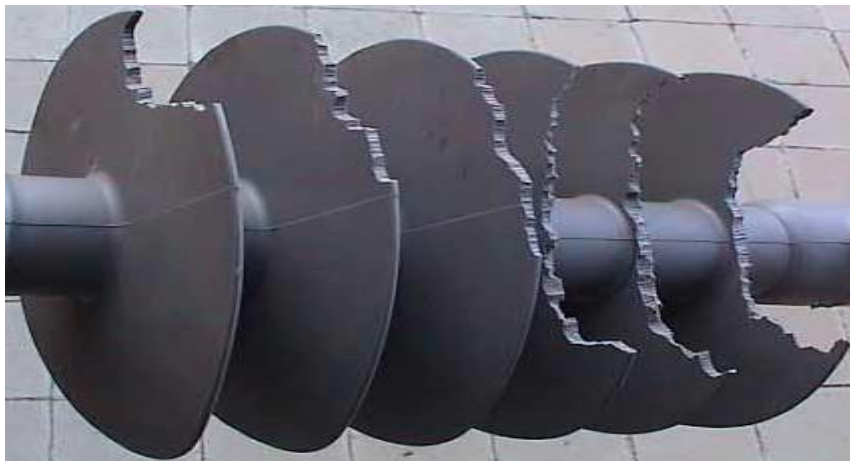
**Example of rodent attack**

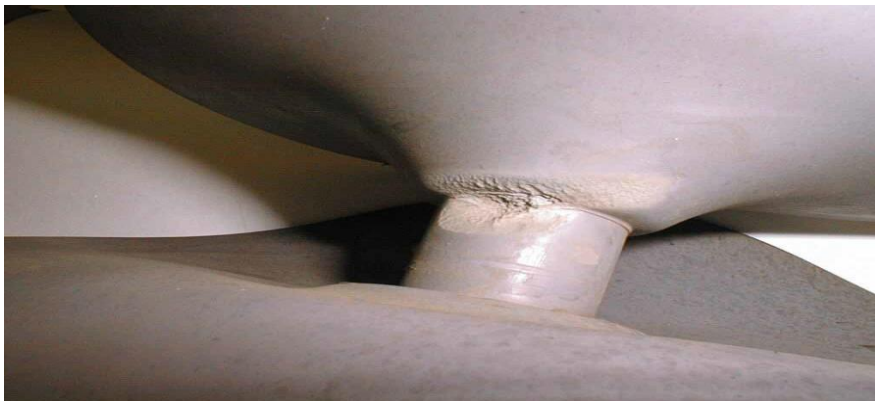
**Housing damage from lifting line**
